### **Re: Monthly Report Summary #4 for the Mesa 500-kV Substation Project**

CPUC Site Inspection Report  
January 2 and 25, 2018

## Mesa 500-kV Substation Project CPUC Site Inspection Form

<b>Project:</b>	Mesa 500-kV Substation Project	<b>Date:</b>	January 2, 2018
<b>Project Proponent:</b>	Southern California Edison	<b>Report #:</b>	VS013
<b>Lead Agency:</b>	California Public Utilities Commission	<b>Monitor(s):</b>	Vince Semonsen
<b>CPUC PM:</b>	Lisa Orsaba, Energy Division	<b>AM/PM Weather:</b>	Hazy with some sunshine, and cool with a slight breeze
<b>E &amp; E CM:</b>	Jenny Vick	<b>Start/End Time:</b>	1000 to 1230
<b>Project NTP(s):</b>	NTP-1, NTP-2

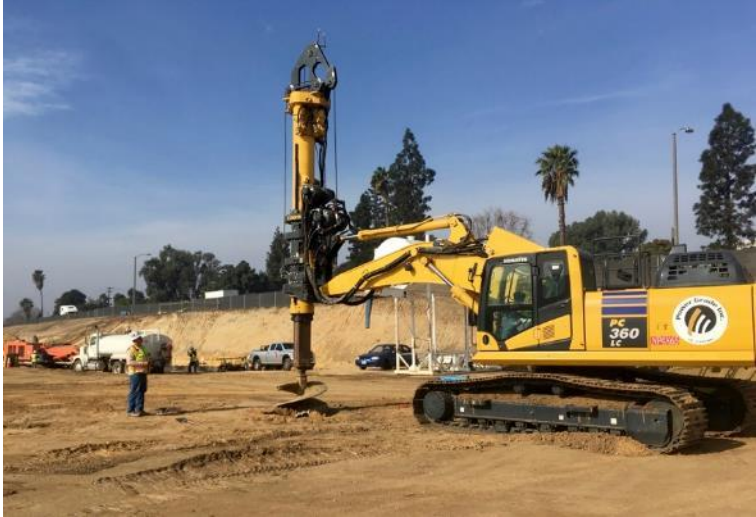
Near the Kiewit jack-and-bore pit, Power Grade crews were drilling a foundation hole for a lattice steel tower (Photo 1). Paleontological monitor Hannah Cohen (Paleo Solutions) was spot-checking the work at the Kiewit jack-and-bore pit (MM CR-4). At the Kiewit jack-and-bore pit, work had just begun on the deep excavation of the water line trench (Photo 2). Ahead of the trench work, the crew was using an excavator to strip a 35-foot-wide by 5-foot-deep swath of soil. This soil was being stockpiled on either side of the trench (Photo 3).

Photo 1 – Drilling work for a new lattice steel tower near the Kiewit jack-and-bore pit.
1/2/18	Mesa Substation – Kiewit Jack-and-Bore Pit	 	Photo 2 – Deep excavation begins for the waterline trench. Photo facing west.

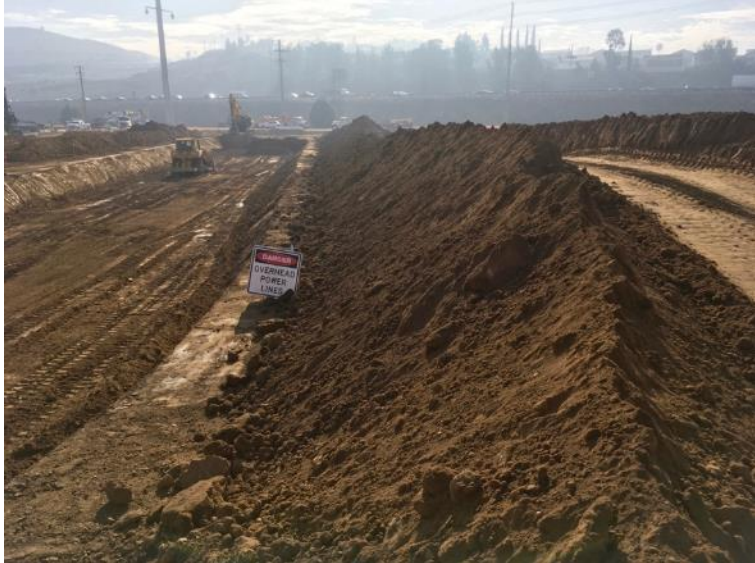
Photo 3 – Shallow trenching for the waterline. Photo facing south.
1/2/18	Mesa Substation

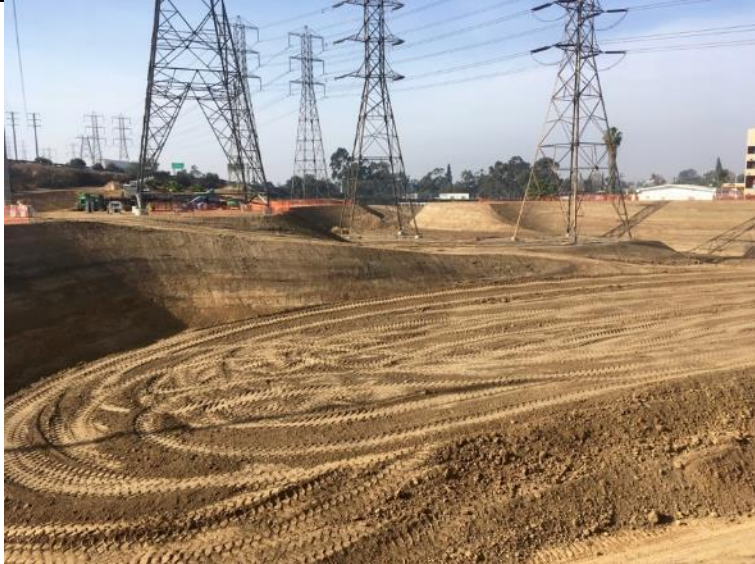
No work was taking place in the detention basin (Photo 4), but a variety of construction activities were taking place just east of the detention basin at the 16-kV switchrack (Photo 5).

Photo 4 – Detention basin. Photo facing west.
1/2/18	Mesa Substation

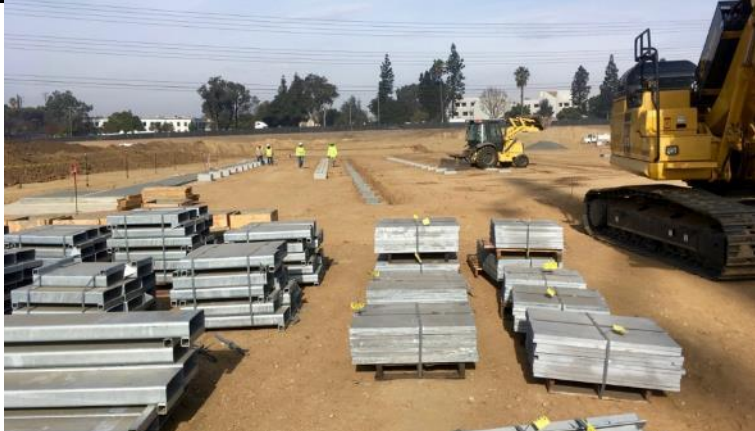
Photo 5 – Concrete pouring for the 16-kV switchrack. Photo facing north.

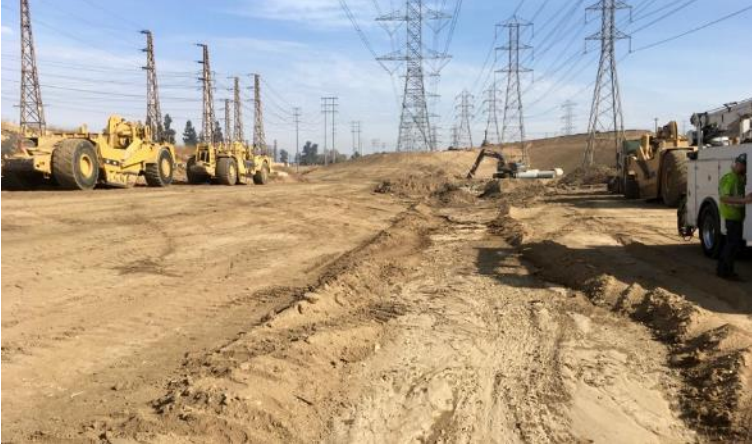
Photo 9 – Dry drainage channel through the vehicle parking area. Photo facing east.
1/2/18	Mesa Substation – Market Place

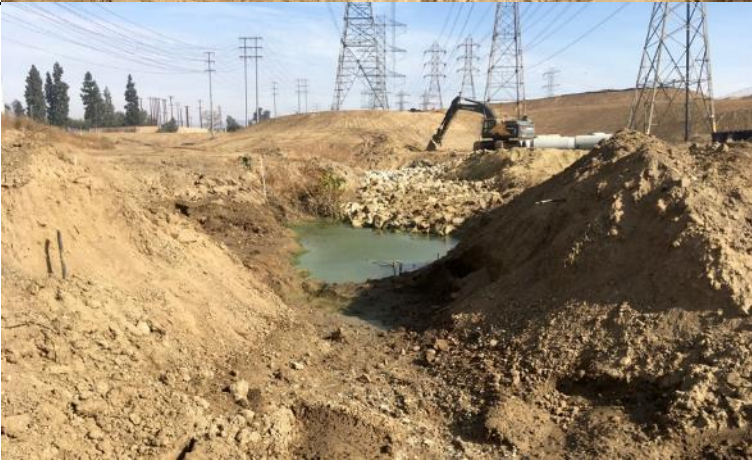
At the MarketPlace, a crew was unloading more storm drain pipe in preparation for additional work in the area (Photo 11). Biological monitor Matt Daniele (ICF) (APM-BIO-04, MM BR-2) was overseeing the work. During the time of my site visit, water was not flowing through the equipment parking area; however, some of the equipment had been parked in other areas (Photo 9). I noted some ponded water in the old drainage channel, and more water began flowing from the drain pipes while I was onsite (Photos 10 and 11). This situation will be exacerbated by winter rains.

Photo 10 – Poned drainage detention basin that was opened. Photo facing east.
1/2/18	Mesa Substation – Market Place

It is recommended to develop a plan for handling water entering the Mesa Substation site.

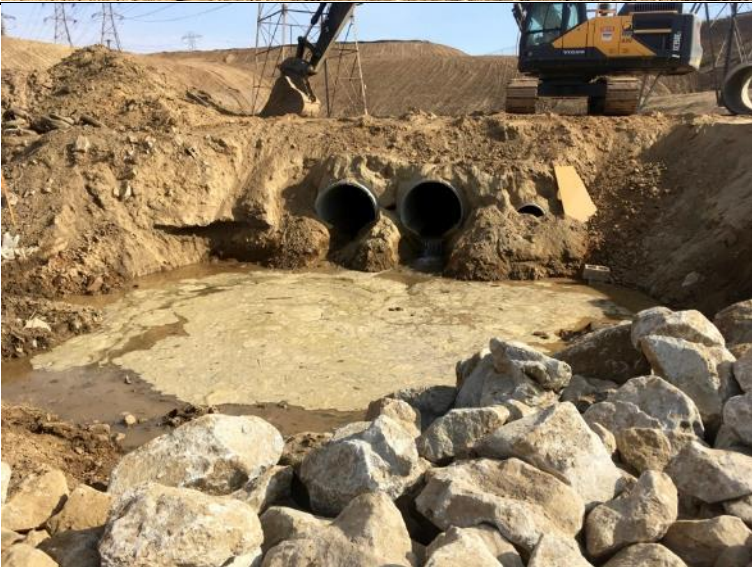
Photo 11 – Drain pipes with water flowing in from offsite.

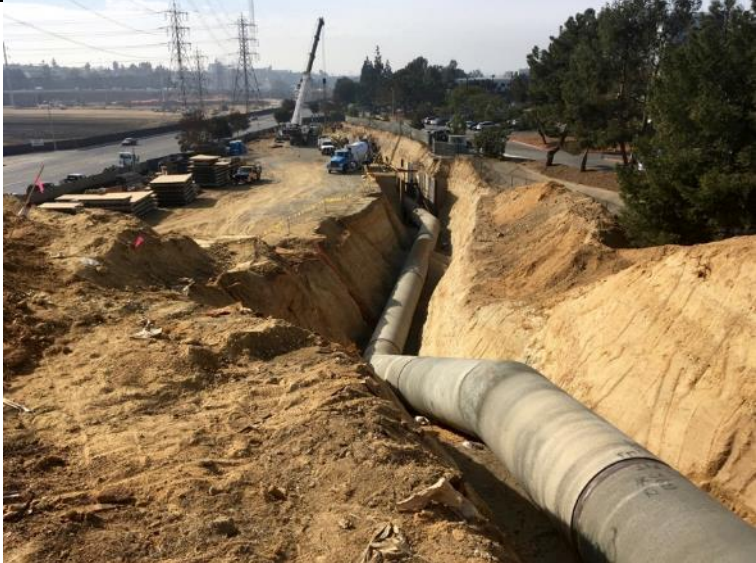
North of Potrero Grande Drive, the Kiewit crew was focusing their efforts on stabilization of the water pipe and building and pouring headwalls (Photos 13 and 14). Most of the Kiewit jack-and-bore pit was dusty, with spoil piles requiring coverage or the application of water for dust control.

Photo 13 – Water pipe in the trench. Photo facing west.

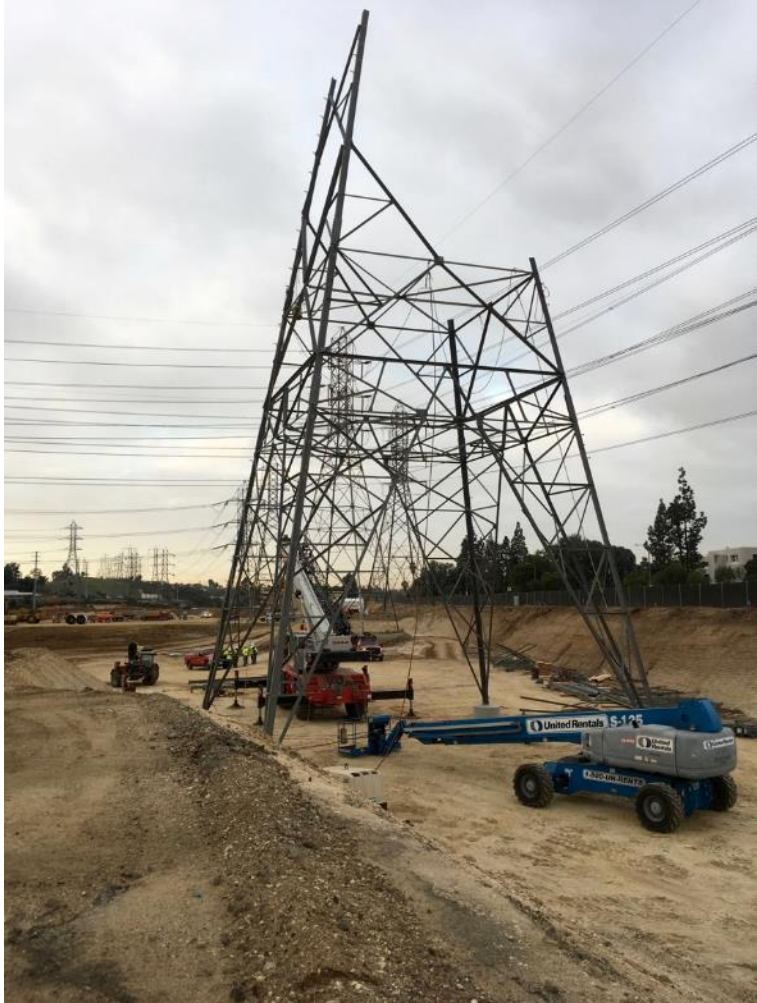
I arrived onsite at 0700 and began a walking tour of the Mesa Substation site. My first observation was of a large lattice steel tower under construction just west of the Mesa Substation entrance (Photo 1).

Photo 1 – New lattice steel tower under construction just west of the Mesa Substation site entrance. Photo facing west
1/25/18	Mesa Substation

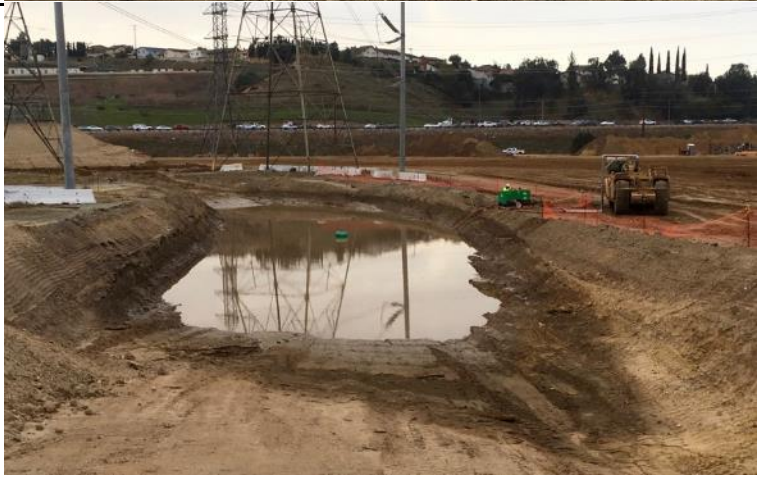
The weather system that moved through southern California in mid-January produced a fair amount of rainfall on the Mesa Substation site. I spoke with Power Grade foreman Willie Clark who said that a large amount of rainwater runoff entered the Mesa Substation site from offsite locations (particularly from the MarketPlace) and filled several detention basins (Photos 2 and 8). According to Willie Clark, project work was shut down for about a week, with much of that time spent pumping water into various basins. Crews have been using the captured runoff water for dust control and compaction.

Photo 2 – Temporary onsite retention basin. Photo facing south.

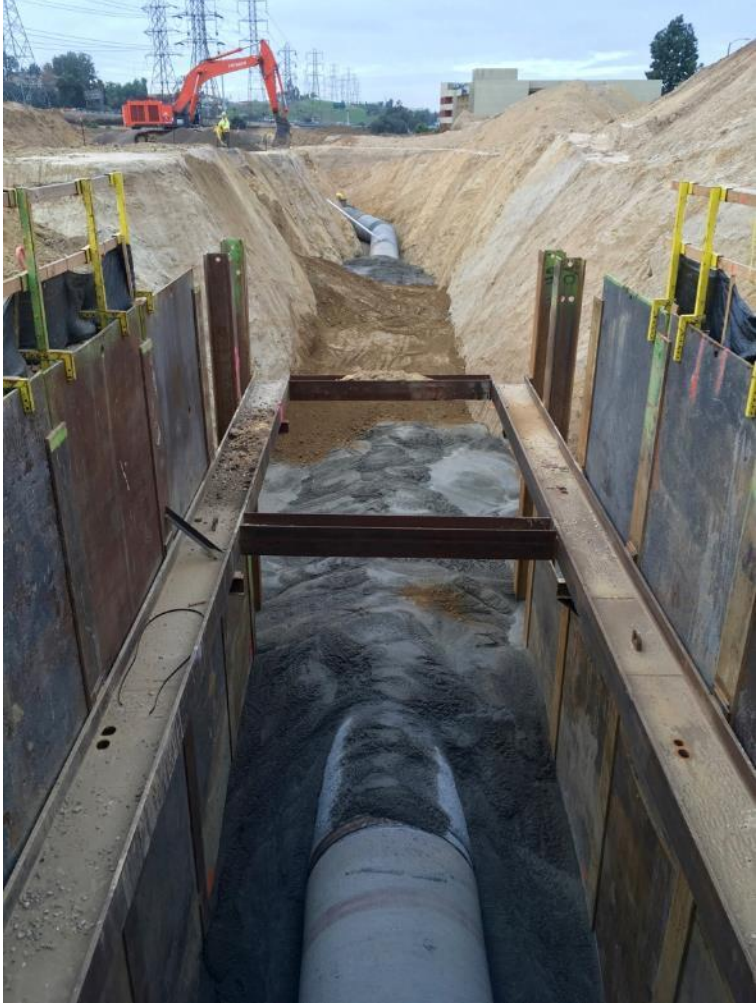
Crews were continuing their work installing the water line through the Mesa Substation site (Photos 3, 5, and 6). Willie Clark said that the entire water line trench has been dug; therefore, water line work was now focused on installation, welding, and backfilling. Once the pipe is installed, crews will complete the tie-in work at both ends of the new water line.

Photo 3 – Water line coming out of the exit hole and being backfilled. Photo facing southwest
1/25/18	Mesa Substation

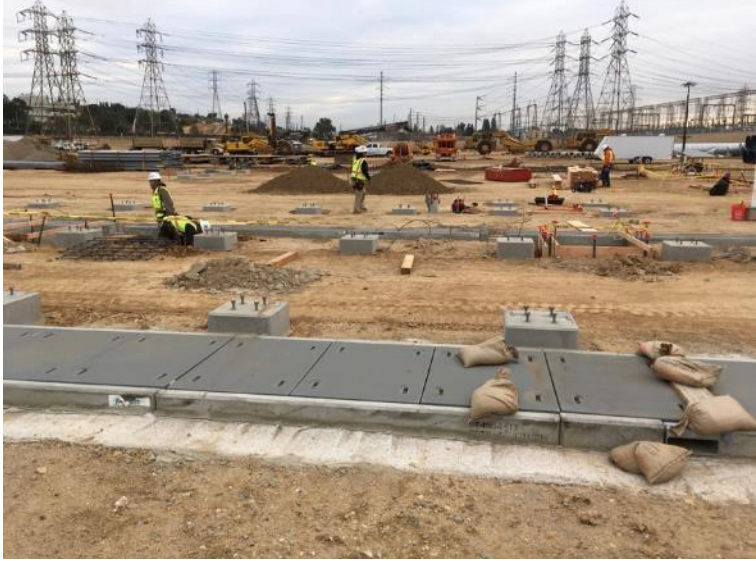
There was a lot of activity around the 16-kV switchrack, with a number of carpenters building forms for the various foundations (Photo 4). Overhead work was being conducted on the new towers located along the southern boundary of the Mesa Substation site (Photo 7).

Photo 4 – 16-kV switchrack area. Photo facing east

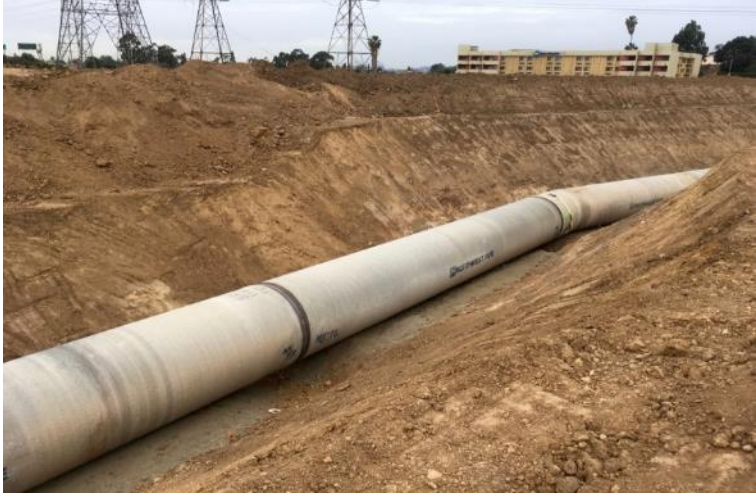
Photo 5 – Water line running through the middle of the Mesa Substation site. Photo facing northwest.
1/25/18	Mesa Substation

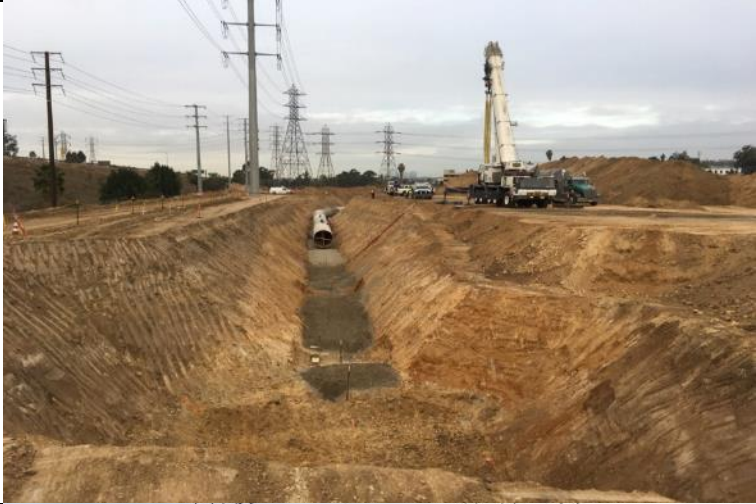
Photo 6 – End of the water line trench near the southern tie-in point. Photo facing west.
1/25/18	Mesa Substation

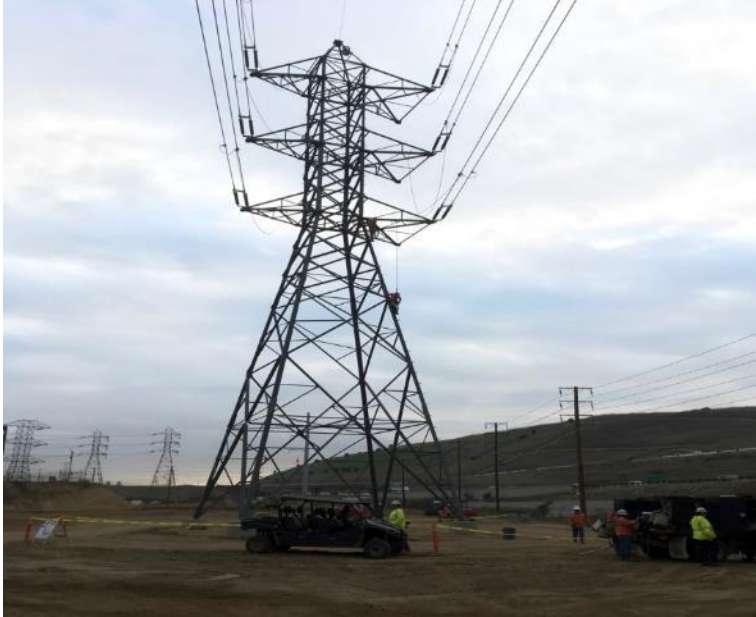
Photo 7 – Crew working on the new towers. Photo facing east.

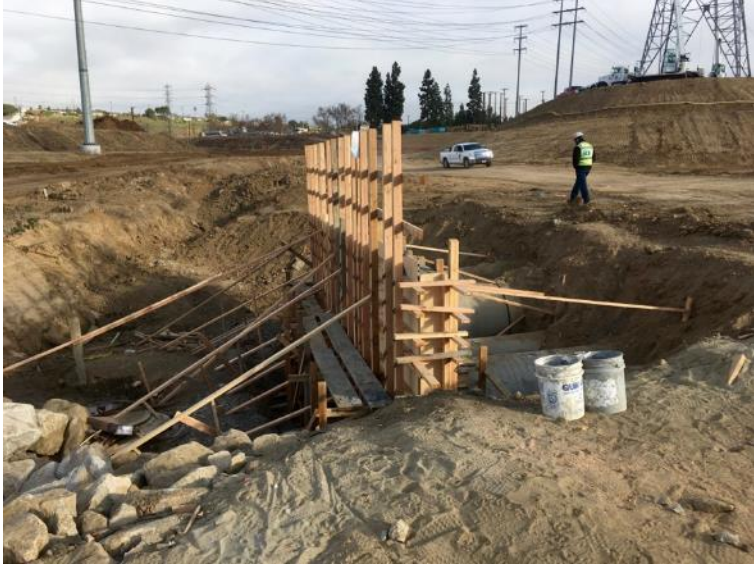
At the MarketPlace, crews have poured the headwall for the storm drain and will be resetting the riprap shortly (Photo 12). Biological monitor Matt Daniele (ICF) (APM-BIO-04, MM BR-2) monitored this crew.

Photo 12 – Headwalls were formed and poured. Photo facing northeast.
1/25/18	Mesa Substation

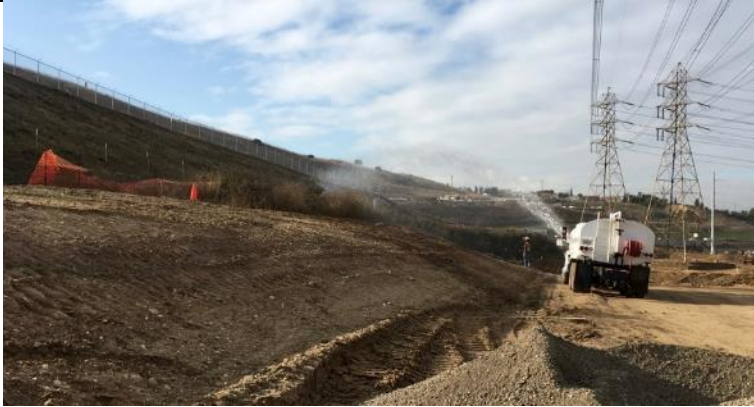
Photo 13 – Rinsing the ESA habitat. Photo facing southwest.
1/25/18	Mesa Substation

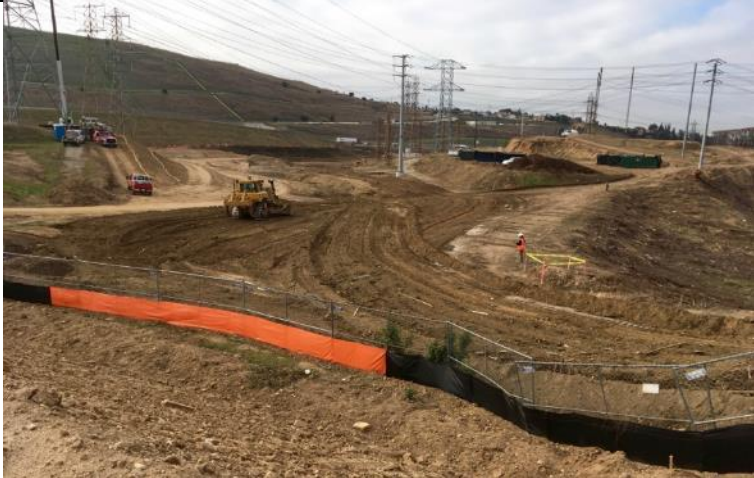
A bulldozer was moving soil near Greenwood Avenue (Photo 14). Biological monitor Jenni Snibbe (ICF) was overseeing this work.

Photo 14 – Earthwork being conducted by one bulldozer near Greenwood Avenue. Photo facing southwest.

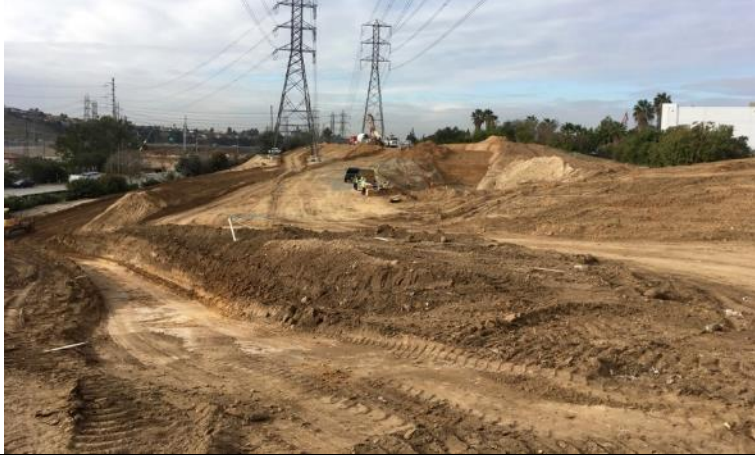
Project activities north of Potrero Grande Drive included some bulldozer work under the new transmission lines (Photo 15), pouring new tower foundations (Photo 16), and backfilling the water line (Photo 17). Paleontological monitor Bobby Ebelhar (Paleo Solutions) was spot-checking this work (MM CR-4). The water line coming from the exit hole will need to be backfilled (Photo 18).

Photo 15 – Earthwork within the transmission corridor and near the water line tie-in, north of Potrero Grande Drive. Photo facing west.
1/25/18	Mesa Substation

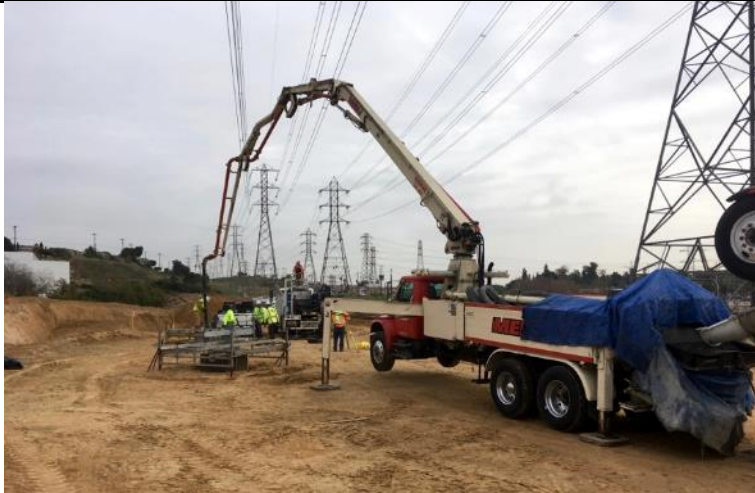
Photo 16 – Pouring lattice steel tower foundations. Photo facing east.
1/25/18	Mesa Substation

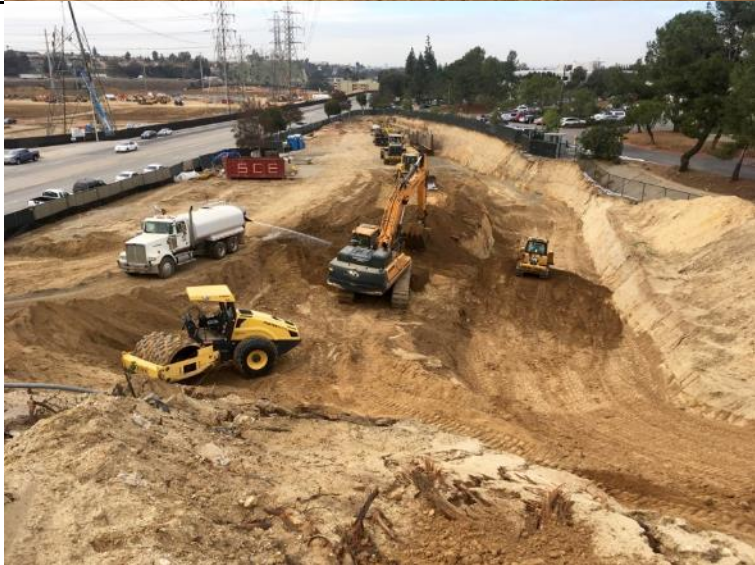
Photo 17 – Backfilling the water line near the exit hole north of Potrero Grande Drive. Photo facing west.

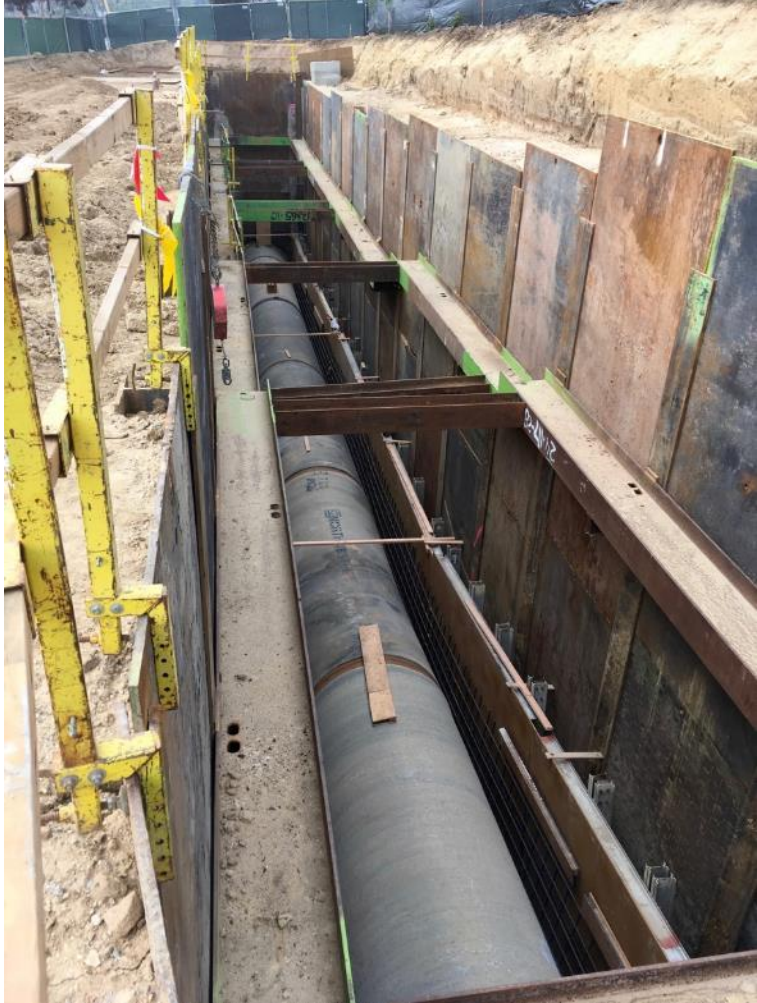
Photo 18 – Water line coming out of the exit hole.
1/25/18	Mesa Substation

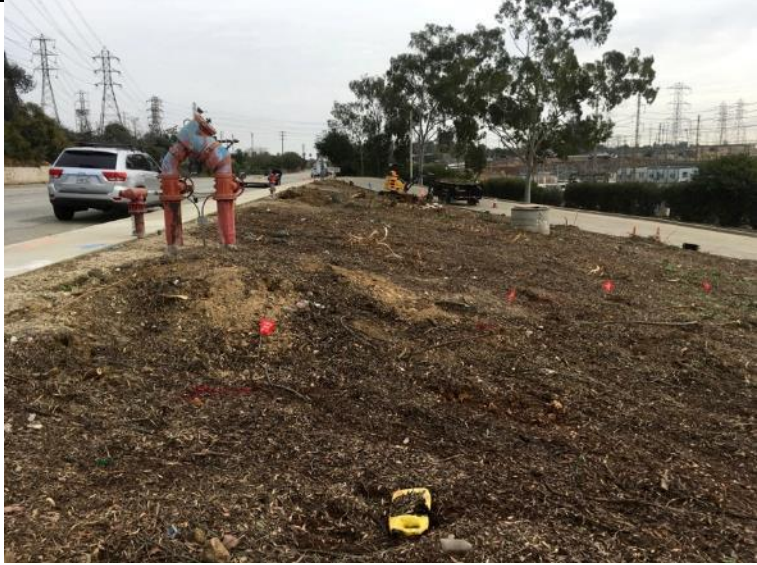
Vegetation removal was conducted earlier in the day in a small location adjacent to Potrero Grande Drive (Photo 19).

Photo 19 – Some vegetation removal was completed along Potrero Grande Drive.

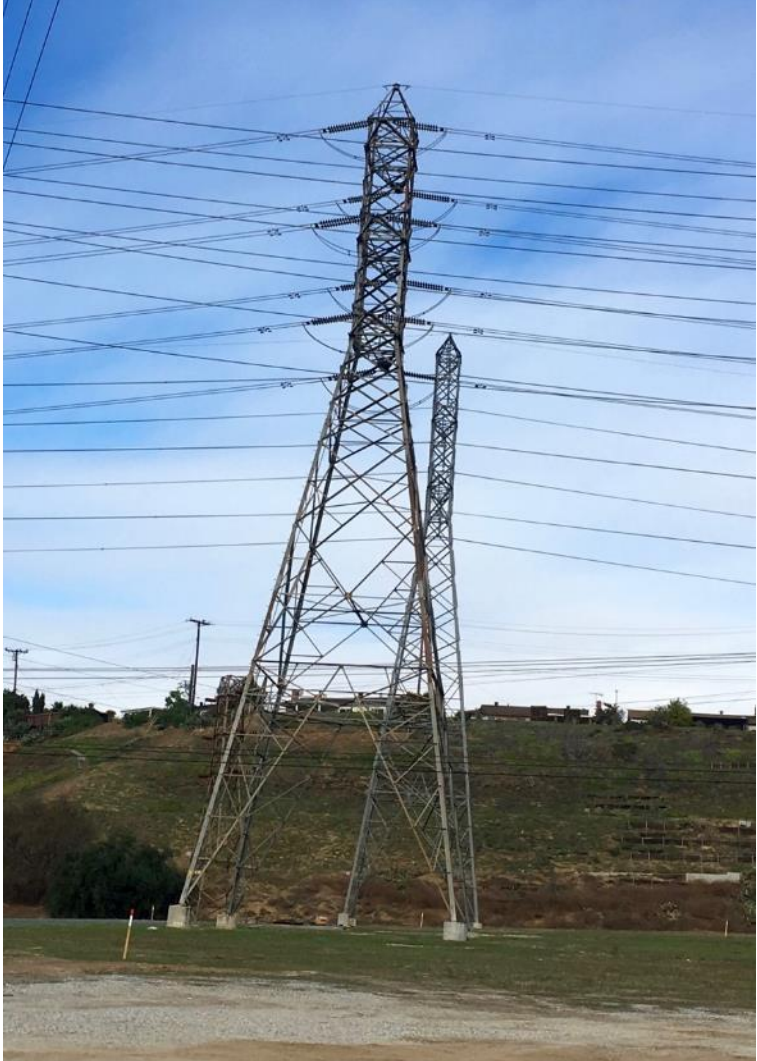
Before I left the Mesa Substation site, I observed a pair of red-tailed hawks building a nest in a tower in the Kiewit yard (Photo 20). Project workers are aware of this nest, and construction crews are currently not using this yard.

Photo 20 – Red-tailed hawks are building a nest in this tower.

Bird surveys and buffers will be important for nesting bird season (MM BR-11).
