Re: Monthly Report Summary #6 for the Mesa 500-kV Substation Project

CPUC Site Inspection Report

Mesa 500-kV Substation Project CPUC Site Inspection Form

Project:	Mesa 500-kV Substation Project	Date:	March 6, 2018
Project Proponent:	Southern California Edison	Report #:	VS018
Lead Agency:	California Public Utilities Commission	Monitor(s):	Vince Semonsen
CPUC PM:	Lisa Orsaba, Energy Division	AM/PM Weather:	Sunny, with mild temperatures and a light breeze
E & E CM:	Jenny Vick	Start/End Time:	1030 to 1330
Project NTP(s):	NTP-1, NTP-2

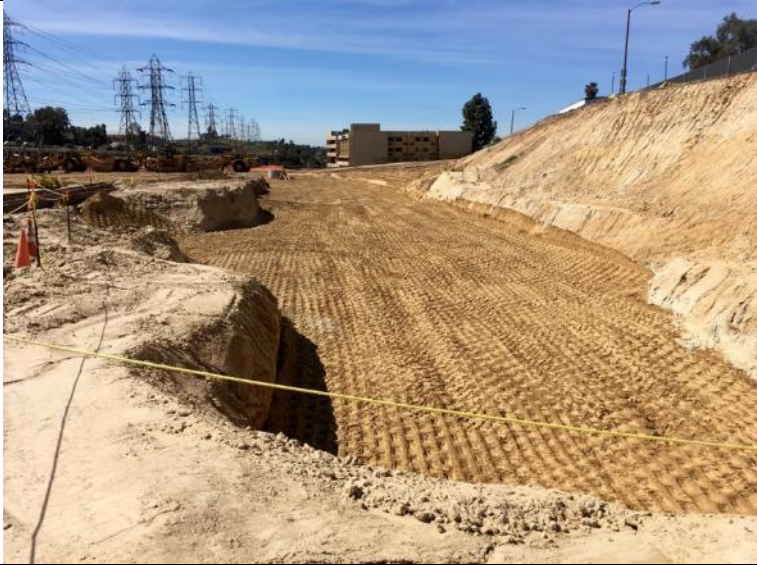
Crews were using two horizontal directional drilling (HDD) rigs. The first HDD operation (Photo 2) had bored out north of Potrero Grande Drive, and it appeared that crews were preparing to ream the hole (Photo 17). The second HDD operation was using a bigger drill that required larger support equipment. All appeared to be well contained (Photo 3). The water line coming out of the exit hole was nearly backfilled and had the shoring plates pulled (Photo 4). The water line manholes were still being worked on (Photo 5).

Photo 4 – Backfilling the water line was nearly complete. Photo facing southwest.
3/6/18	Mesa Substation

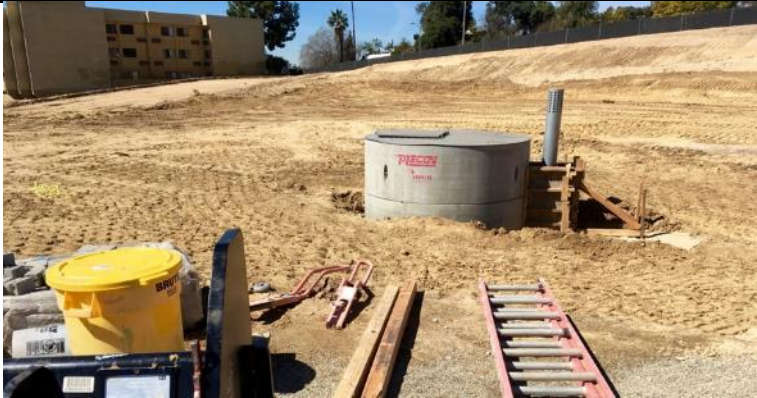
Photo 5 – Work continues on the water line manholes. Photo facing northwest.
3/6/18	Mesa Substation

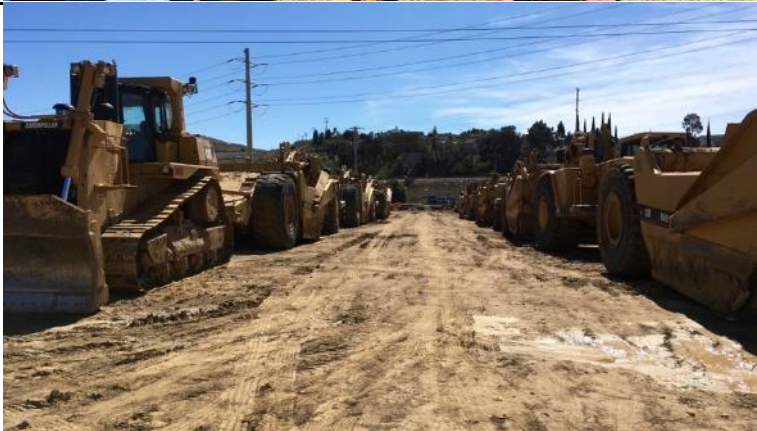
Numerous pieces of equipment were parked between the 16-kV switchrack area and the detention basin (Photo 6). Drip pans had been placed under most of the equipment; however, some of the pans appeared to have been randomly placed, and some equipment needed more than one pan. I spoke with ULM Services, Inc., project coordinator Pete Lubich about this issue and he said he would have someone check the pans. The detention basin was still quite full (MM HY-3) and was being used for dust control (Photo 7). Construction activity was ongoing at the 16-kV switchrack area (Photo 8).

Photo 6 – Parked equipment. Photo facing south.

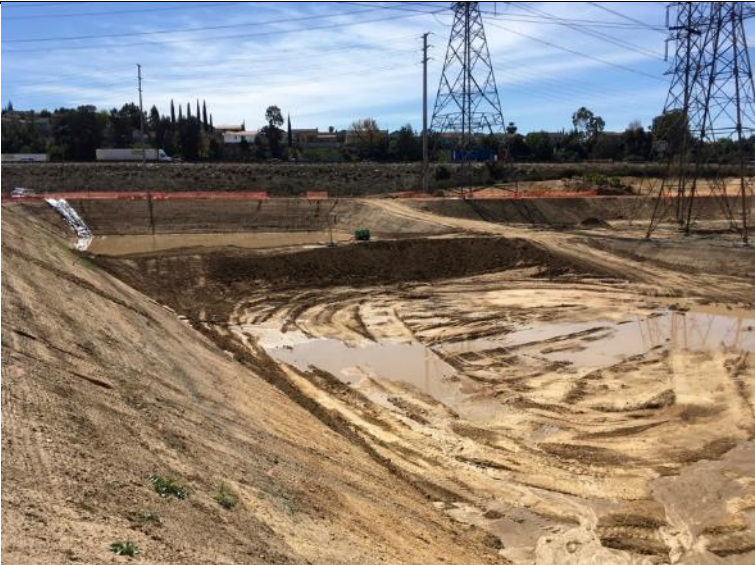
Photo 7 – Water detention basin near the west end of the Mesa Substation project. Photo facing south.
3/6/18	Mesa Substation

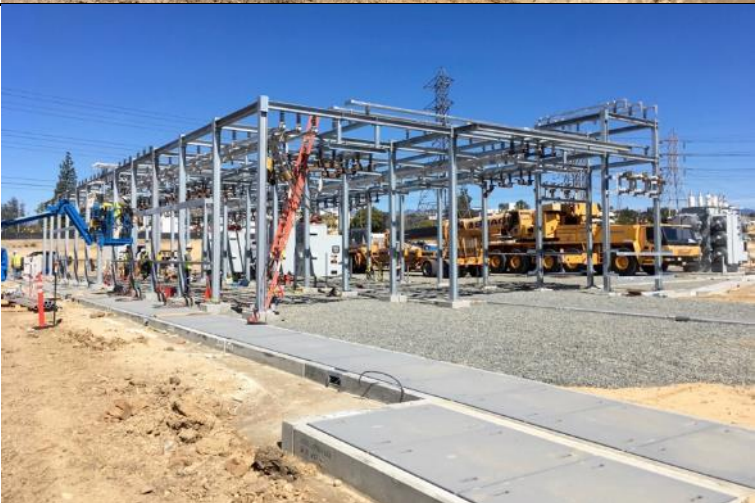
Photo 8 – Extensive work activity at the 16-kV switchrack.
3/6/18	Mesa Substation

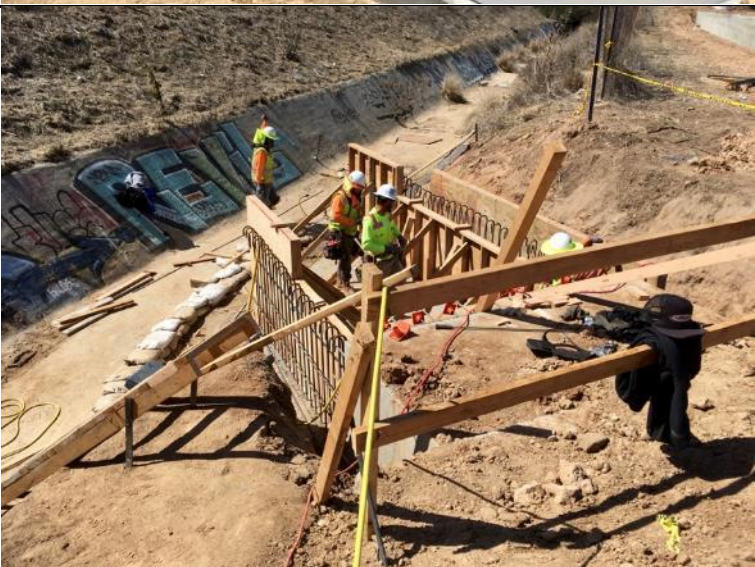
A crew was building concrete forms for the connection point between the storm water drainage system and the existing drainage channel outside of the Mesa Substation site (Photo 9). The crew was using portable generators, which were sitting in plastic-lined containment basins (Photo 10). Portions of the storm water drainage system had been installed, with a concrete slurry mix poured over and around portions of the pipe (Photo 11).

Photo 9 – Concrete forms being built for the storm water runoff pipe tie-in to the existing drainage channel.

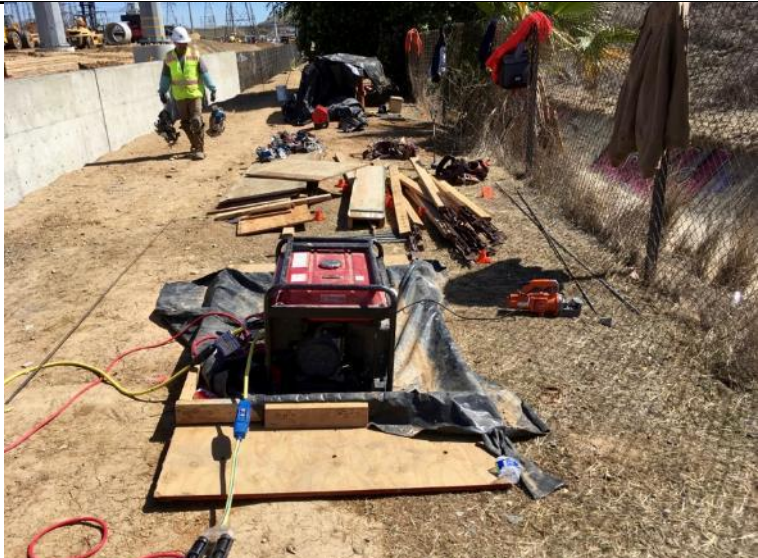
Photo 10 – Generators properly contained.
3/6/18	Mesa Substation

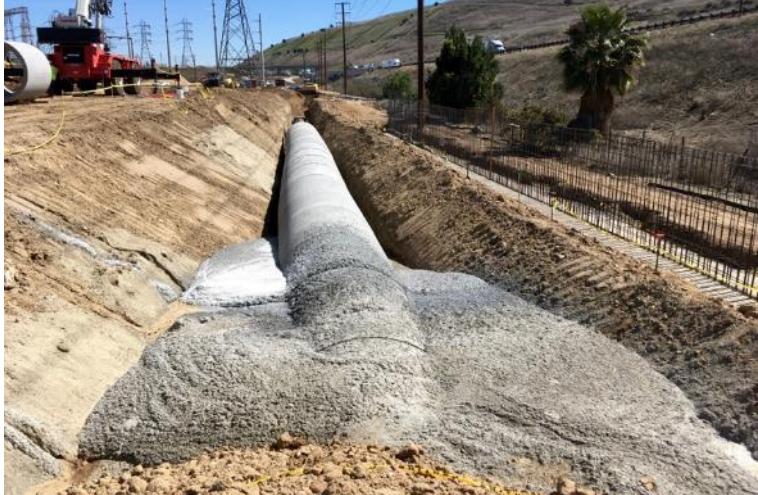
Photo 11 – Storm water pipe installation and backfilling. Photo facing east.
3/6/18	Mesa Substation

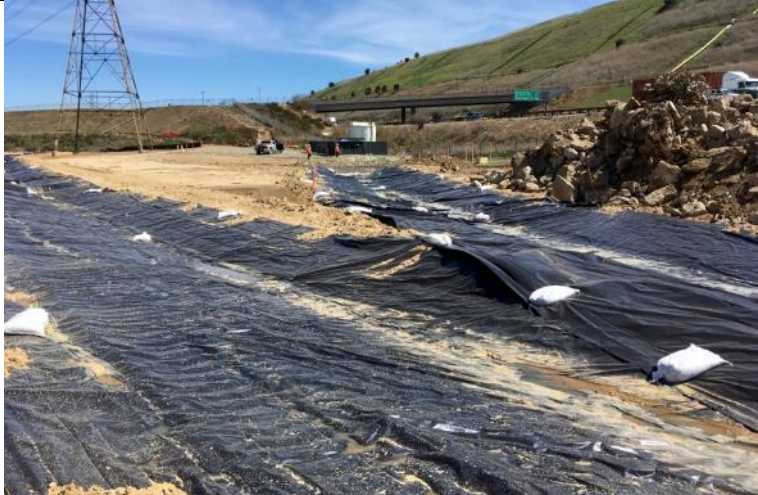
An extensive plastic-lined drainage system had been installed along the southern portion of the Mesa Substation site to transmit offsite storm water runoff across the site and into the existing drainage channel. The plastic-lined channel picks up water from the highway drainage to the south (Photo 12) and from the Market Place development to the east (Photo 13). Because rain was predicted for the weekend, the CASC Engineering and Consulting, Inc., Storm Water Pollution Prevention Plan (SWPPP) inspector Lucy Cortz-Johnson was onsite looking over the best management practices (BMPs) and any storm water runoff issues (MM HY-1).

Photo 12 – Installation of the offsite storm water drainage system. Photo facing east.

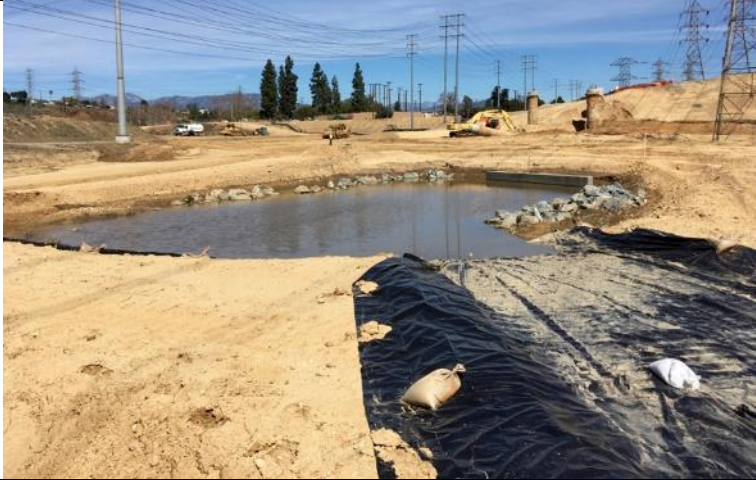
Photo 13 – Storm water runoff from the Market Place development directed into the plastic-lined channel. Photo facing east.
3/6/18	Mesa Substation

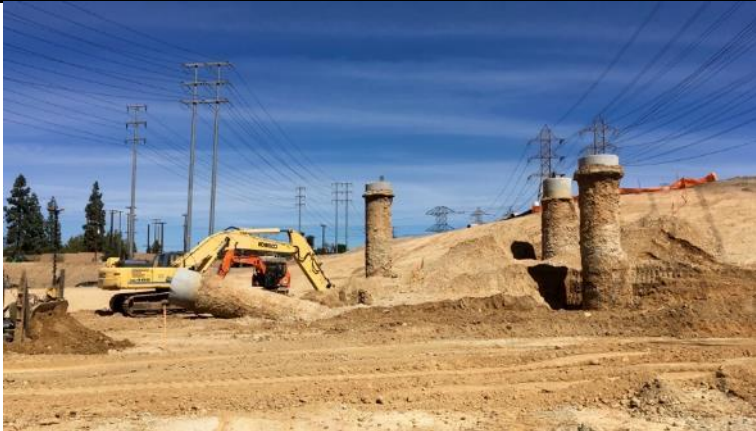
At the east end of the Mesa Substation site, a crew was using an excavator to remove the concrete foundations for an old lattice steel tower (Photo 14).

Photo 14 – Old lattice steel tower foundations being removed. Photo facing east.
3/6/18	Mesa Substation, North of Potrero Grande Drive

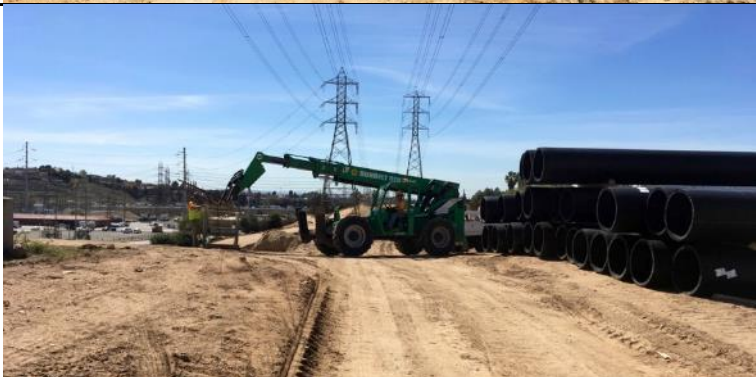
Photo 15 – Stockpiling plastic piping. Photo facing southwest.

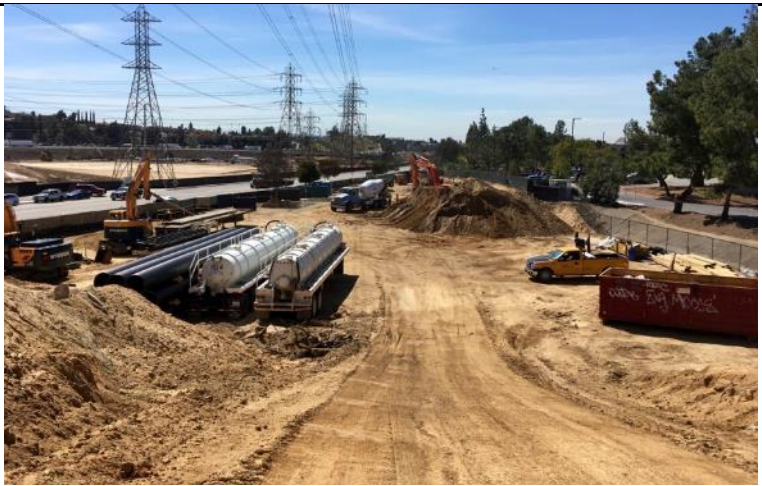
Photo 16 – Backfilling the water line.
3/6/18	Mesa Substation Project north of Potrero Grande Drive

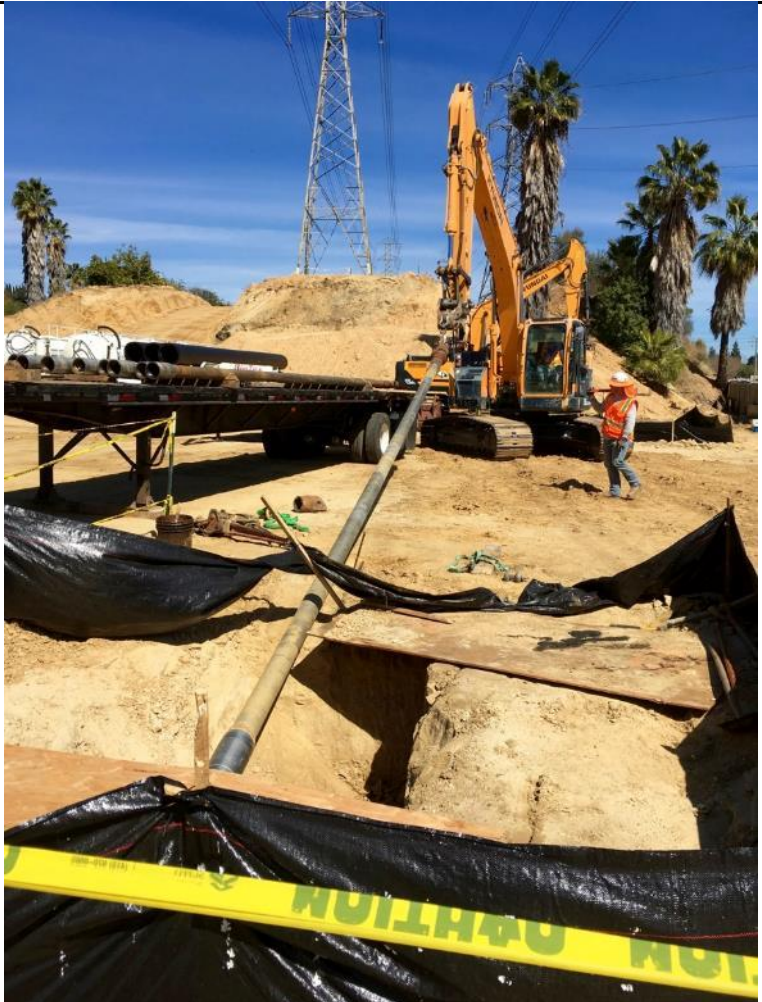
Photo 17 – HDD operation at the exit hole.

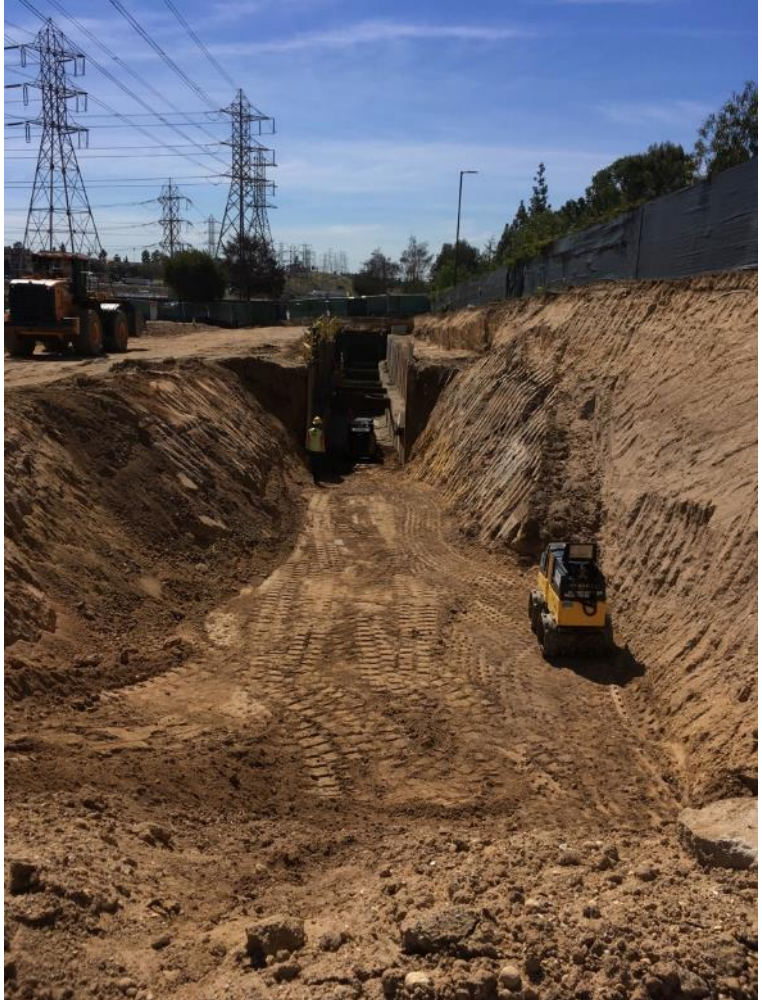
Photo 19 – Backfilling the water line near the exit hole. Photo facing southwest.

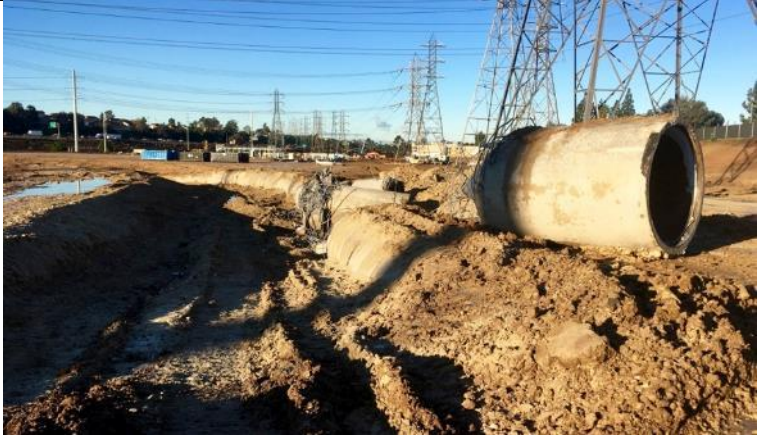
The first construction activity I noted was removal of the old water line (Photo 1).

Photo 1 – Removal of the old water line. Photo facing southwest
3/15/18	Mesa Substation

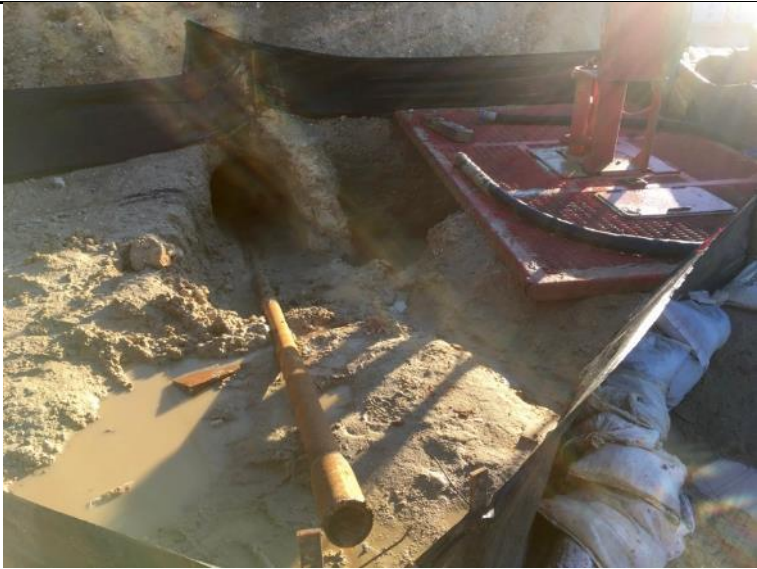
Photo 2 – HDD operation.
3/15/18	Mesa Substation

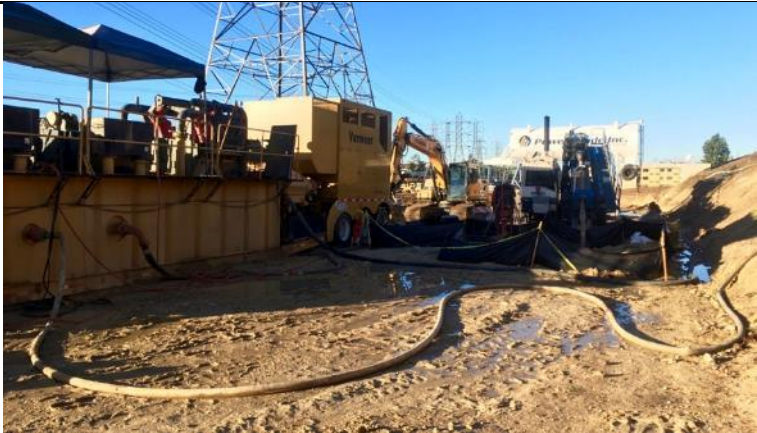
Photo 3 – HDD equipment

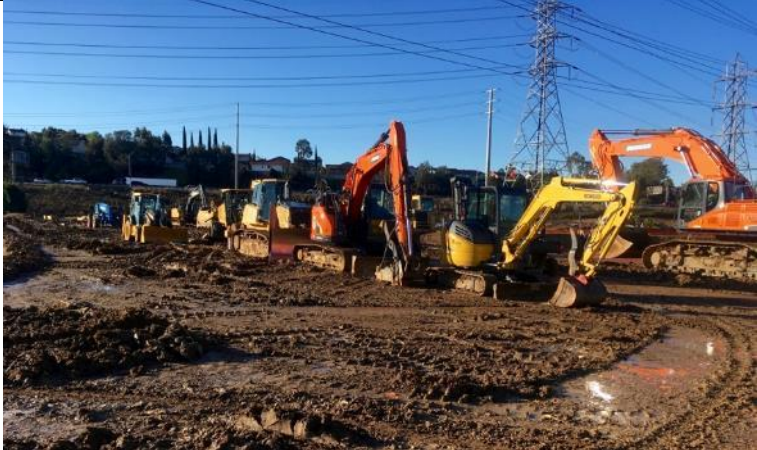
Photo 4 – Parked equipment. Photo facing southwest.
3/15/18	Mesa Substation

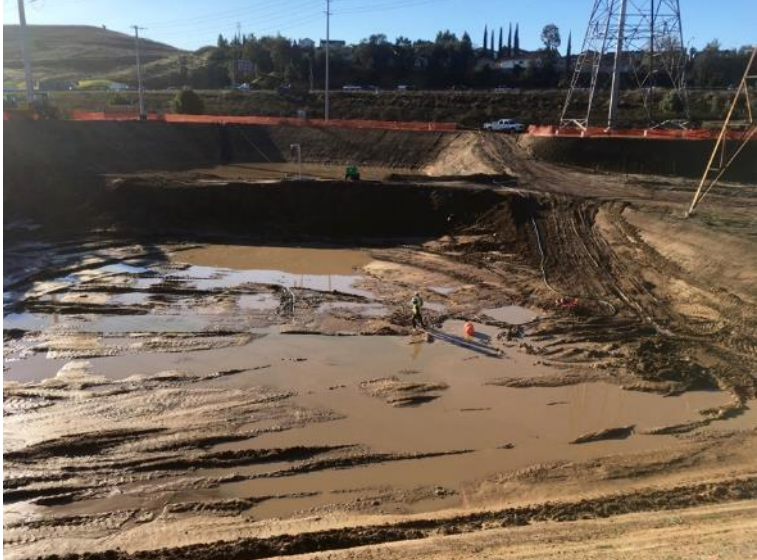
A team was running pumps at several locations throughout the Mesa Substation site to move rainwater runoff into the detention basin (Photo 5).

Photo 5 – Water detention basin near the west end of the Mesa Substation site. Crews are pumping water into the main detention area. Photo facing south.

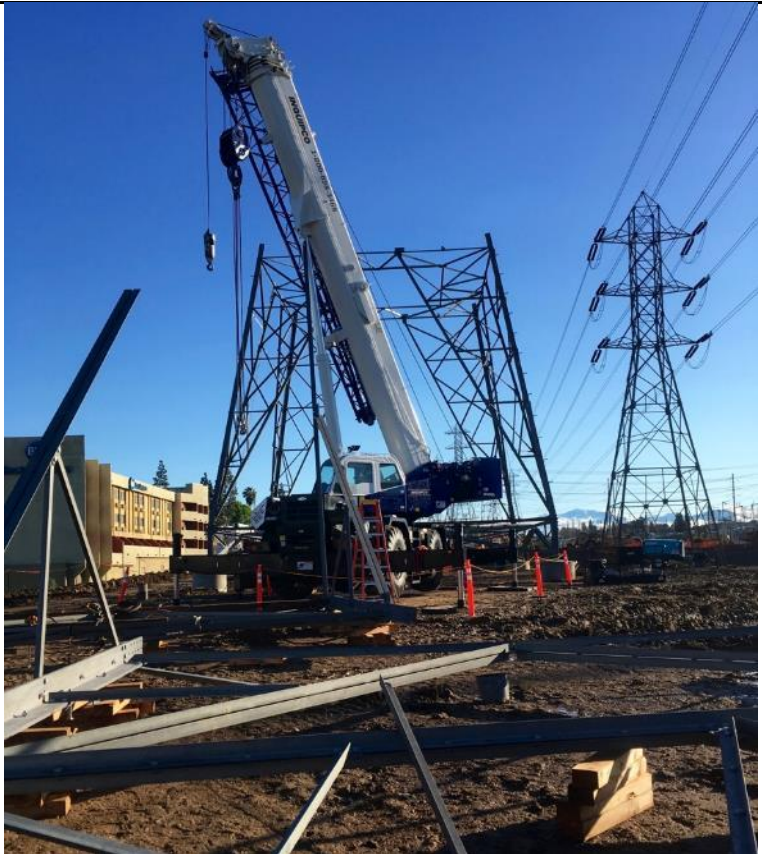
A crew was erecting a lattice steel tower near the western end of the Mesa Substation site near the detention basin (Photo 6).

Photo 6 – Construction of a lattice steel tower. Photo facing east.
3/15/18	Mesa Substation

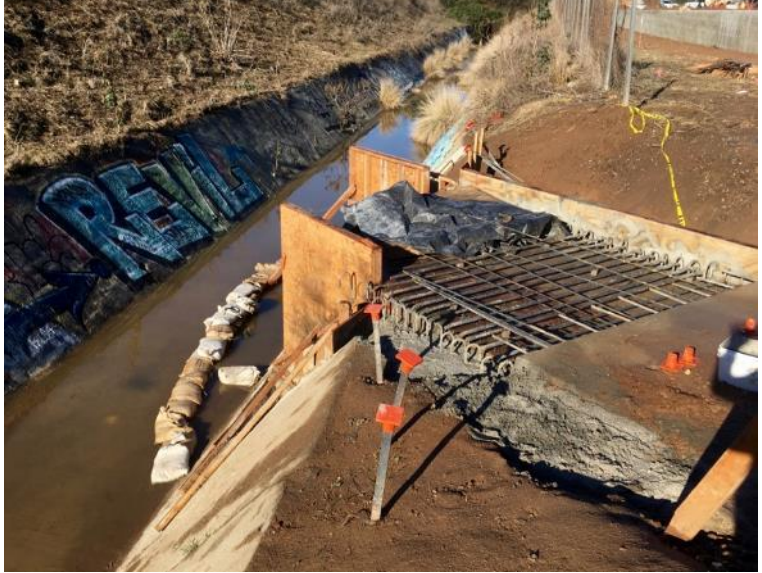
Photo 7 – New storm water drainage system at the connection location to the offsite drain.

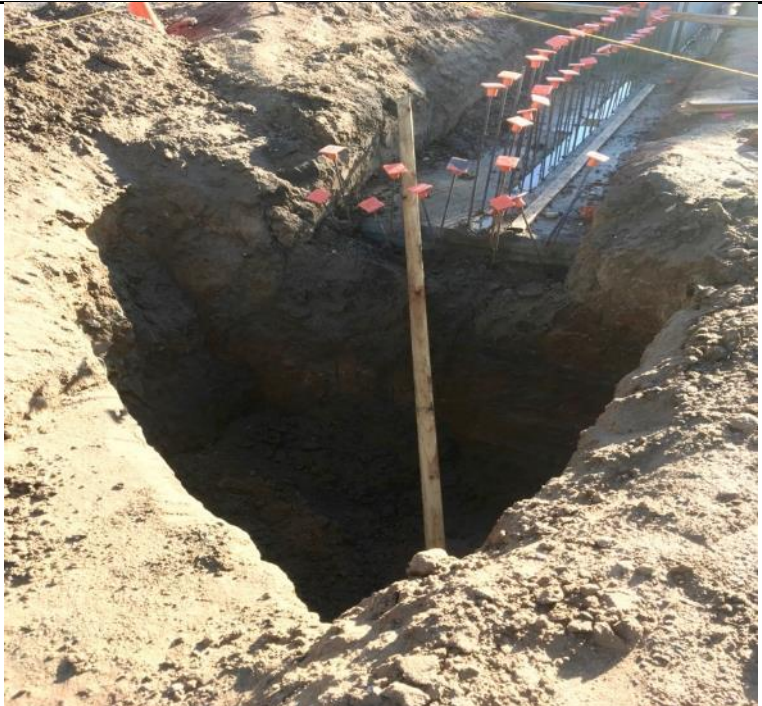
On the day of my site visit, crews were not working on the storm drain system or the border wall, but they had made progress on these portions of the Mesa Substation site along the southern boundary (Photos 7, 8, and 9). At the new wall, I noted an open hole that was approximately 6 feet deep with straight sidewalls (Photo 8). This hole had no barrier fence and it was not covered overnight. I noted a 2x4 placed inside the hole as an exit ramp (MM BR-10).

Photo 8 – Open hole along the perimeter wall with one 2x4 acting as an escape ramp for trapped animals.
3/15/18	Mesa Substation

Before leaving the site, I met with ULM Services, Inc., project coordinator Pete Lubich to discuss possible upgrades to the entry/exit BMPs, and the exit ramp issue. We drove to the open hole location (Photo 8) and agreed to add another board, at a minimum, as a single 2x4 does not provide an adequate exit ramp.

MM BR-10 states that all steep-walled holes shall be covered or fenced, and also states that for open trenches only, wildlife escape ramps may be used. It should be discussed as to whether boards placed in the holes can be considered escape ramps and, if so determined, what are the specifications for these boards.

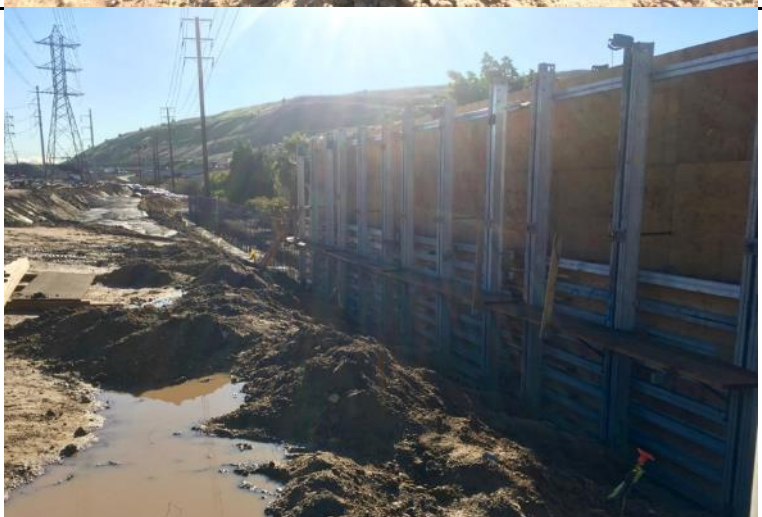
Photo 9 – Perimeter wall construction. Photo facing east.
3/15/18	Mesa Substation	 	Photo 10 – Work on the water line manholes. Photo facing north.

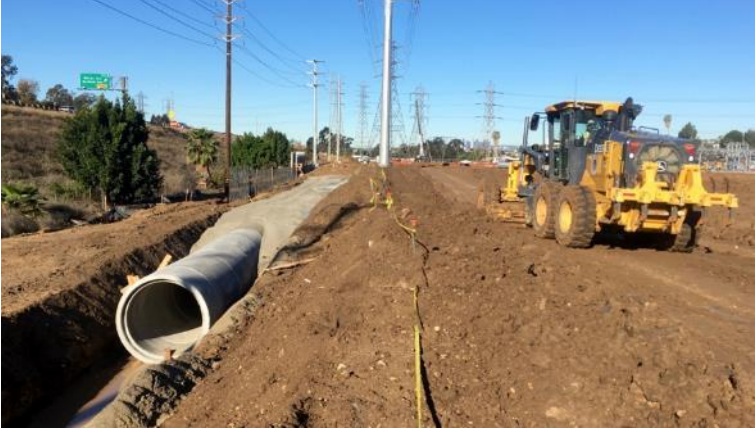
Photo 11 – Storm water drainage pipe installation and backfilling. Photo facing west
3/15/18	Mesa Substation

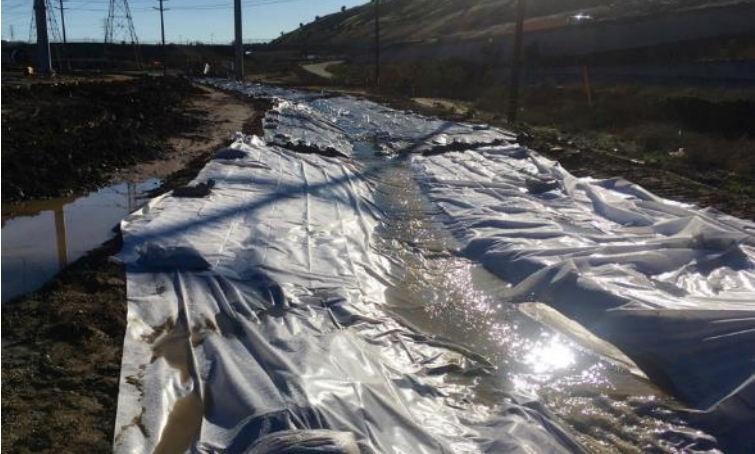
The plastic-lined drainage system appeared to be working well, with onsite storm water runoff passing through the Mesa Substation site and back into the onsite drainage system without picking up any sediment (Photo 12).

Photo 12 – Plastic-lined channel transporting offsite storm water runoff through the Mesa Substation site; note the running water. Photo facing east
3/15/18	Mesa Substation

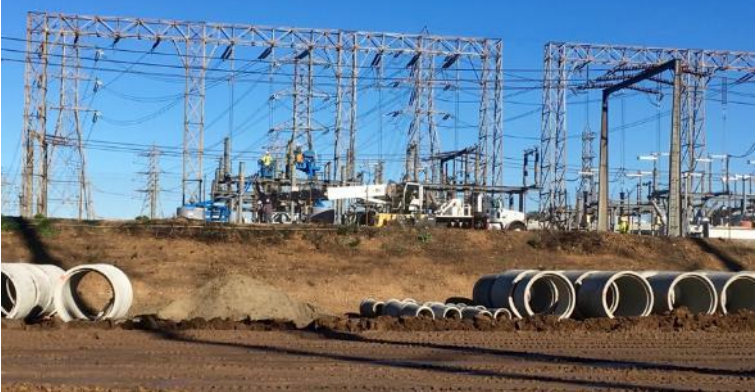
Photo 13 – Crews within the Existing Mesa Substation. Photo facing north.
3/15/18	Mesa Substation

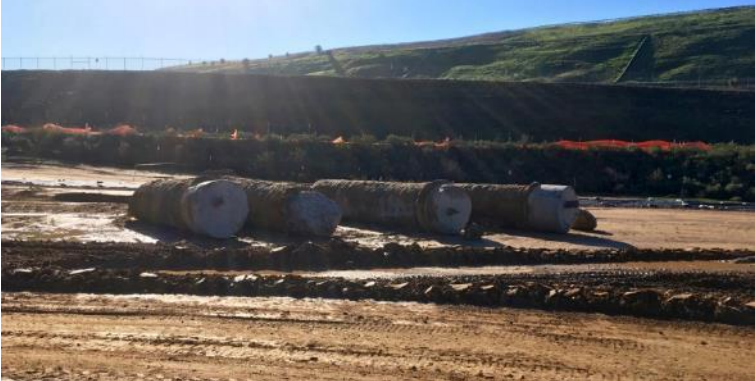
Photo 14 – Old tower foundations stockpiled. Photo facing south.

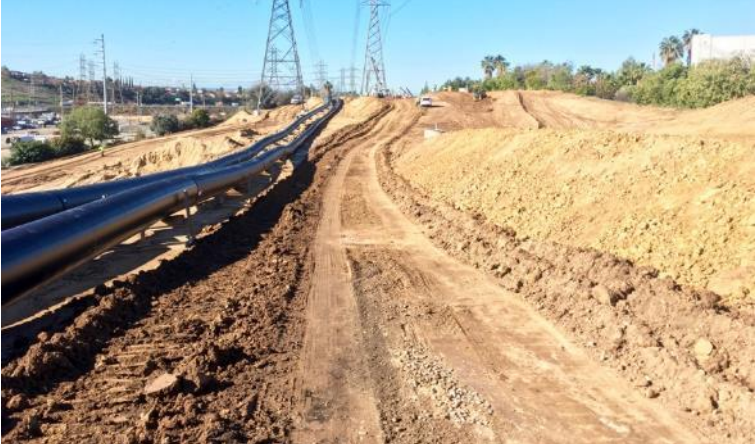
Photo 18 – Welded plastic pipe. Photo facing west
3/15/18	Mesa Substation, North of Potrero Grande Drive

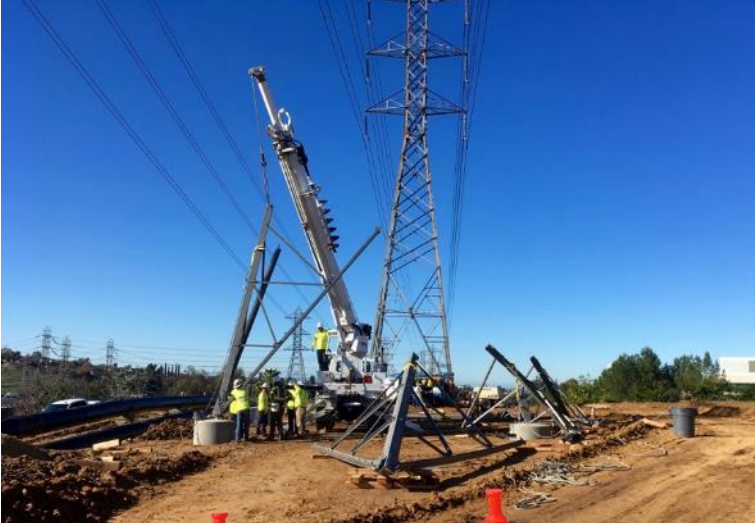
Photo 19 – Lattice steel tower construction. Photo facing southwest.
3/15/18	Mesa Substation, North of Potrero Grande Drive

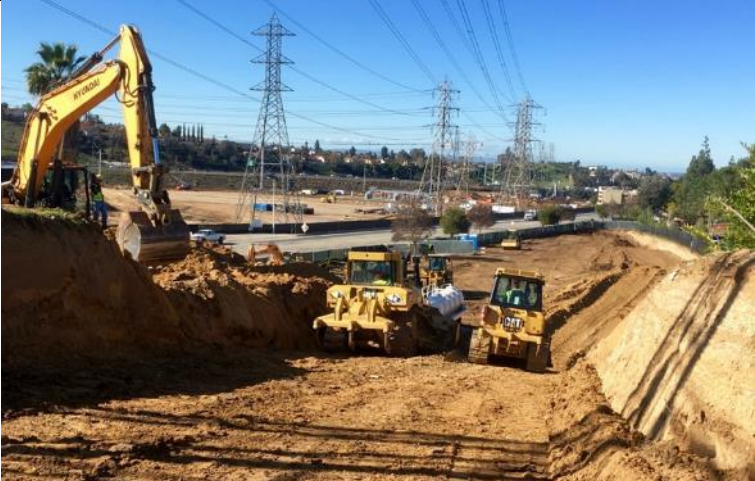
Photo 20 – Backfill and recontour work over the water line. Photo facing southwest.

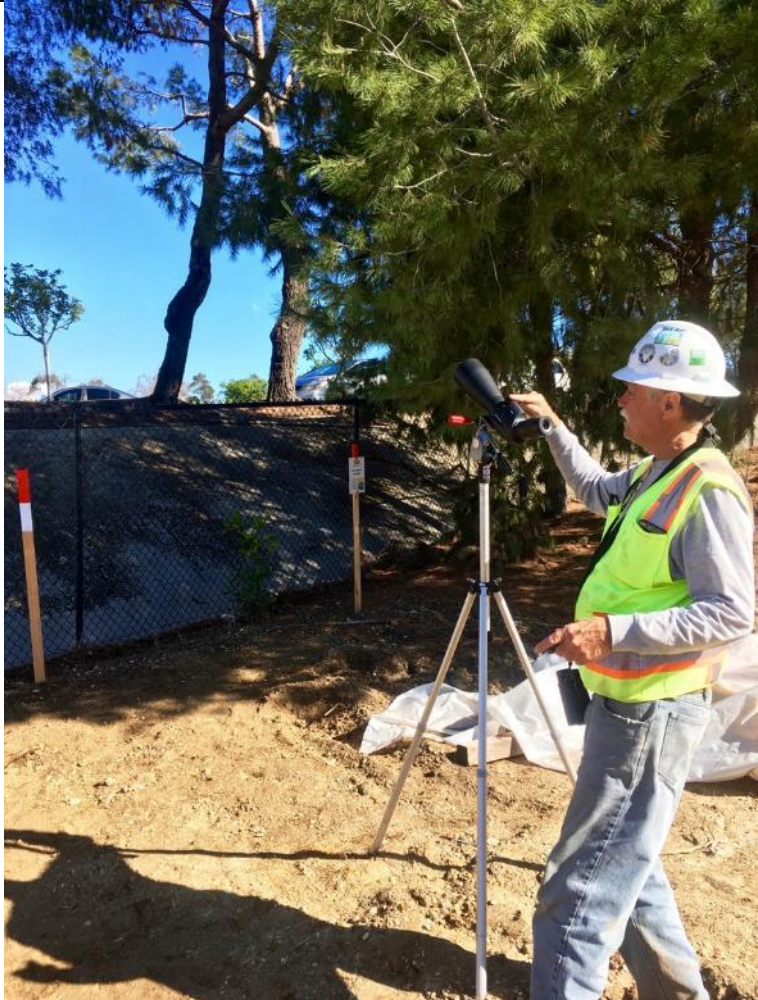
Noreas biological monitor Wayne Woodroof and ICF biological monitor Kristen Klinefelter were observing two different pairs of hummingbirds building nests in the pine trees just north of the New Mesa Substation Boundary (Photo 21). Stakes indicating the Environmentally Sensitive Area (ESA) had been put in place to delineate the nesting buffer. The two bulldozers working nearby seemed to have little effect on the hummingbirds' nesting activities.

Photo 21 – Noreas biological monitor Wayne Woodroof observing two pairs of hummingbirds building nests.
3/15/18	Mesa Substation, North of Potrero Grande Drive

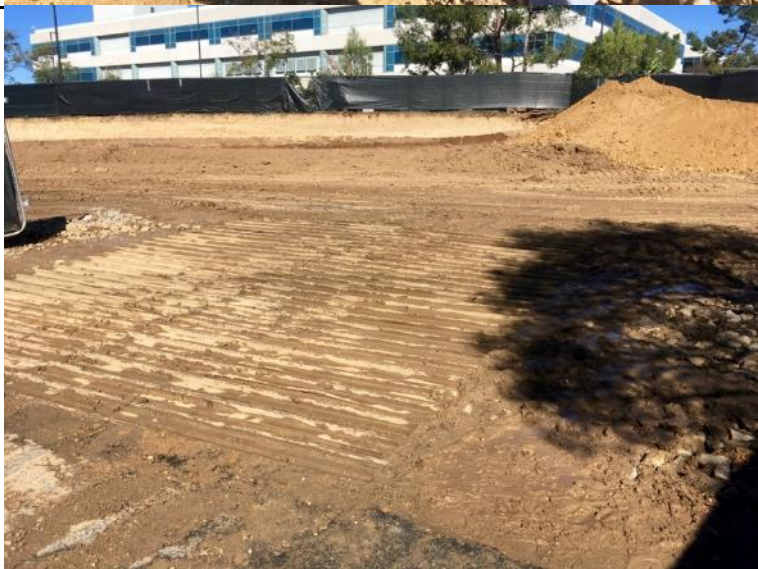
Onsite work vehicles were quite muddy; therefore, tracking mud onto public roads was a concern (MM HY-1). At the Mesa Substation site entry/exit onto Greenwood Avenue, the proper best management practices (BMPs) were not in place and mud was being tracked out onto the road (Photo 16). One of the entry/exits north of Potrero Grande Drive had rumble plates but no rock; therefore, tracking mud was an issue at this location, as well (Photo 22). According to ULM Services, Inc., project coordinator Pete Lubich, crews were shoveling mud, and sweeper trucks would be running regularly after the lunch hour.

Photo 22 – Entry/exit without any rock.
