## PUBLIC UTILITIES COMMISSION

<b>Incident Date:</b>	11/17/2020-3/17/2021 (for MM HY-1 and MM HY-3)	<b>Report No.:</b>	NCR-007
<b>Date Submitted:</b>	5/13/2021	<b>Location:</b>	Basin located on southwest corner of the Mesa Substation site adjacent to Markland Drive
<b>Level:</b>	Level 1	<b>Relevant Plan/Measure:</b>	MM HY-1 (including SWPPP) MM HY-3 (including SWPPP)
<b>Current Land Use:</b>	Mesa Substation	<b>Sensitive Resources:</b>	N/A

NCR-007 Incident Photographs

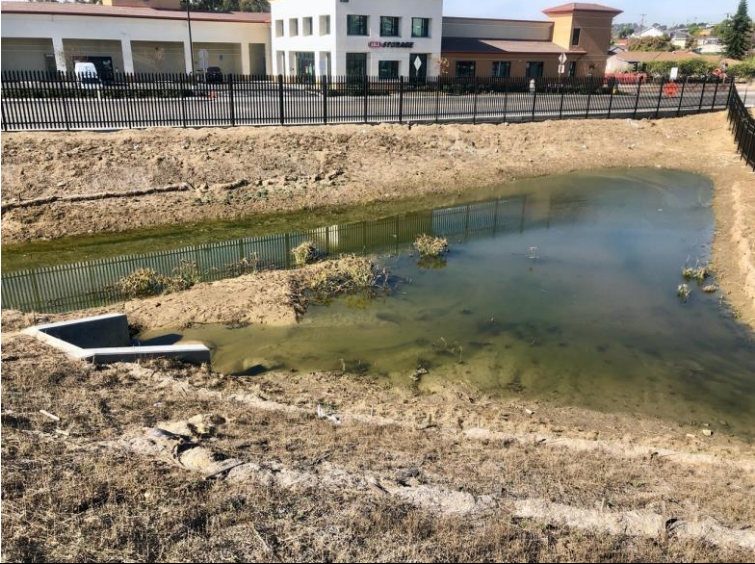
On January 6, 2021, the CPUC Compliance Monitor observed that the small triangular catch basin (far west basin on Markland Drive) was full of water following recent rain events (see photograph dated 1/6/21 in Attachment 1). According to the photograph, the water appeared to be relatively clear – since most of the natural light passing through continues in the original direction. Additionally, a “V” ditch connecting to this basin contained sediment and required maintenance.

Photo 1 – Small triangular (lower) catchbasin full of water. Photo facing northwest
1/6/21	Mesa Substation

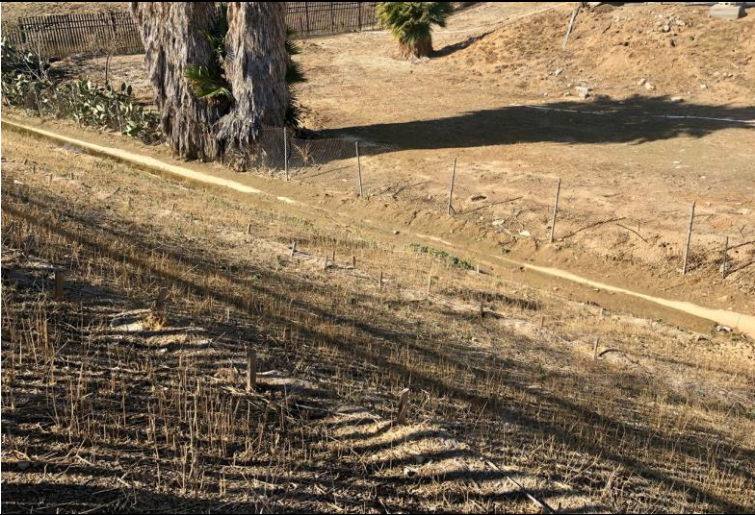
Photo 2 – “V” ditch connecting to the small triangular (lower) catchbasin contains sediment.
1/20/21	Mesa substation

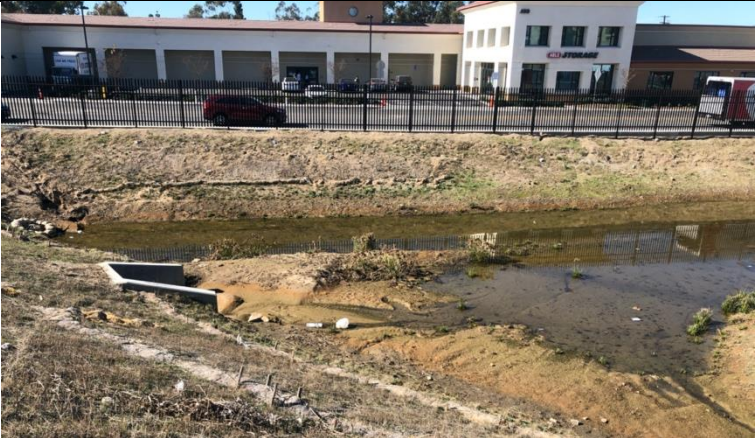
On January 20, 2021, the CPUC Compliance Monitor again observed turbid water in the basin. The “V” ditch still contained sediment and needed maintenance.

Photo 3 – Triangular (lower) catchbasin with water. – This basin is still holding water. Photo facing west

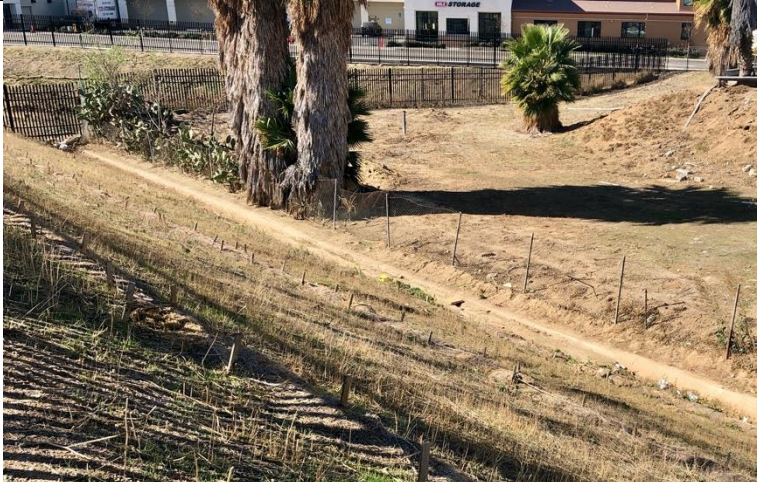
Photo 4 – “V” ditch connecting to the triangular (lower) catchbasin still containing sediment. Photo facing west
2/4/21	Mesa substation

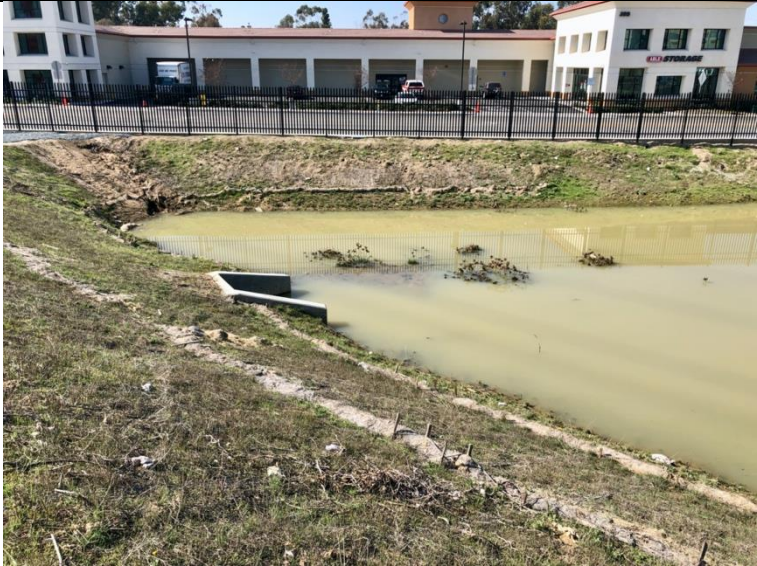
On February 4, 2021, the CPUC Compliance Monitor and Water Quality Manager, observed a significant amount of sediment laden water in the basin. The water appeared cloudy and with a low level of scattered light indicating a high turbidity level. Additionally, a standpipe in the basin appeared to be plugged since the water level was substantially higher than the previous week - indicating inadequate draining.

Although the Contractor's QSP expressed repeated deficiencies of BMP maintenance at the banks of the basin prior to storm events, SCE failed to repair/upgrade the BMPs within 72-hours. Because sediment-polluted water was not adequately draining within 96-hours via the perforations near the base of the standpipe, it is evident that the basin presented a potential vector control issue, which was a previous CPUC concern at the Mesa Substation basin.

Photo 5 – Triangular (lower) catch basin with sediment and water. – The standpipe within the small triangular basin appears to be plugged and water level in the basin was quite high.
3/05/21	Mesa substation

The CPUC requests that SCE develop and incorporate a strategy to ensure that the basin functions to drain within 96-hours. The strategy or design should ensure that onsite wet-weather flow is fully contained within the basin and that the basin shall properly drain within 24 to 96-hours (also referred to as “drawdown time”). The 24-hour limit is specified to provide adequate settling time; the 96-hour limit is specified to mitigate vector control concerns.

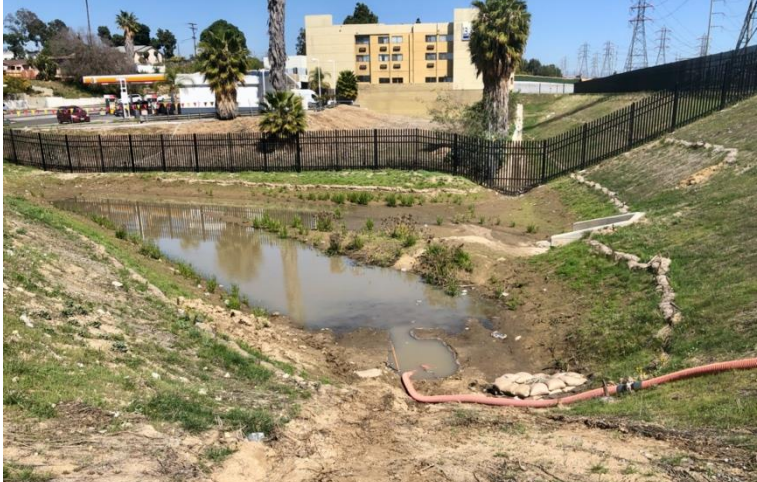
On March 5, 2021, the CPUC Compliance Monitor observed the sediment laden water in the basin being pumped through a filter system (dewatering) and into the larger detention basin at the Mesa Substation.

Photo 6 – Triangular (lower) catchbasin...- The water was being pumped through a filter system and into the detention basin. Photo facing east

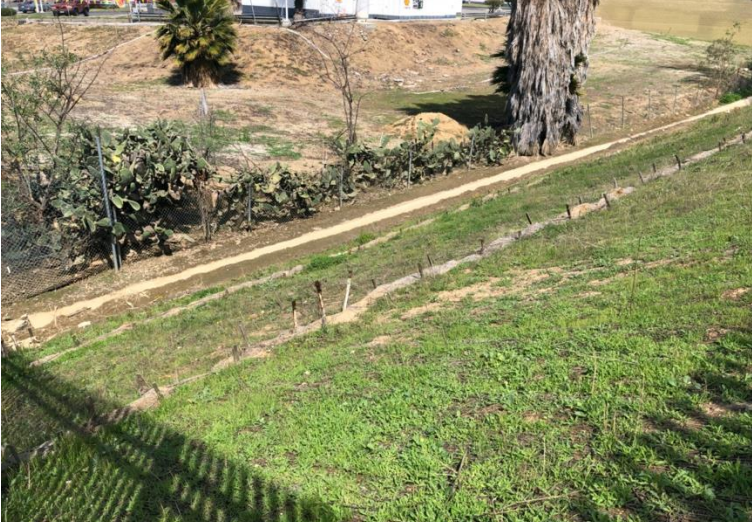
On March 17, 2021, the CPUC Compliance Monitor noted that the basin was almost completely dry. The “V” ditch connecting to the basin, however, remained full of sediment.

Photo 8 – “V” ditch connecting to the triangular (lower) catchbasin remains full of sediment. Photo facing northeast
