Re: Monthly Report Summary #1 for the Sanger Substation Expansion Project

CPUC Compliance Monitoring Reports

Sanger Substation Expansion Project CPUC Compliance Monitoring Report

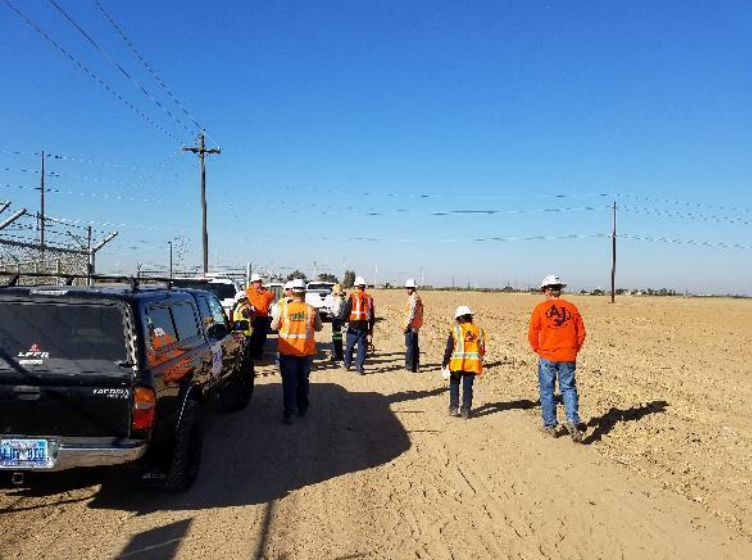
Photo 1 - Crew at the on-site WEAP training. Photo facing west.
11/05/18	Southern part of substation expansion footprint

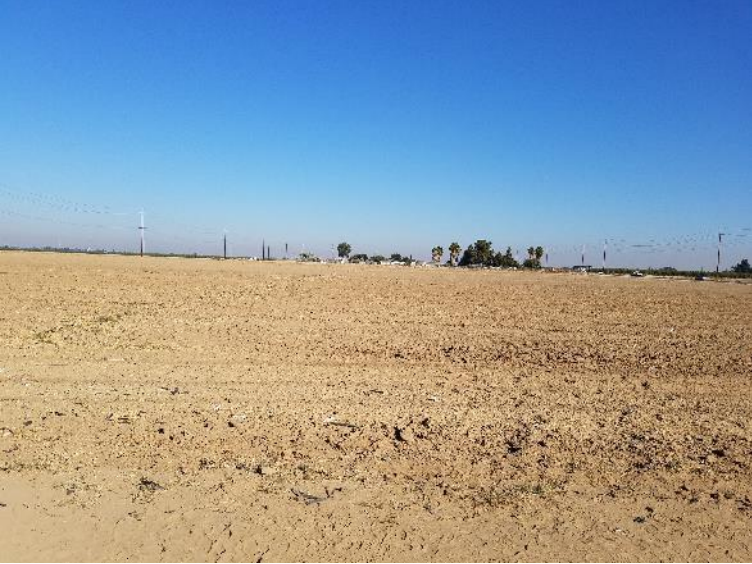
Photo 2 - The substation expansion footprint; ground disturbing activities have not started. Photo facing north.

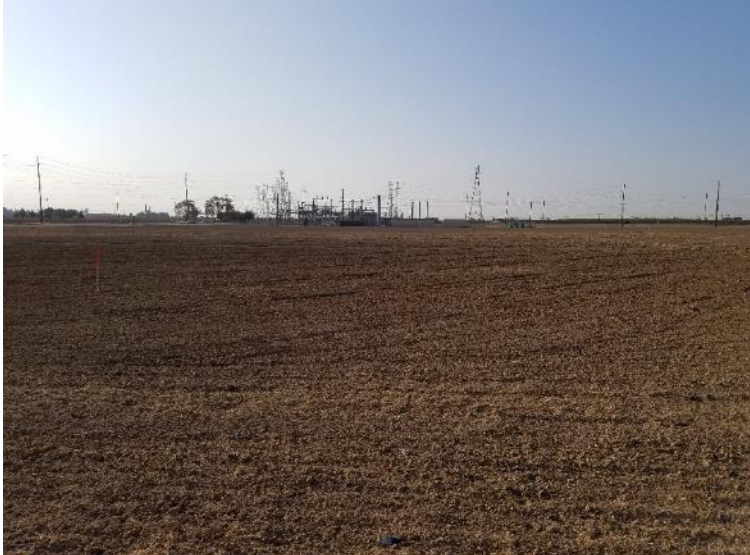
Photo 1 – Agricultural land to be used for the substation expansion. Ground disturbing activities have not started. Photo facing south.
11/08/18	Existing well pipe across irrigation canal, 80 feet north of temporary laydown/staging area

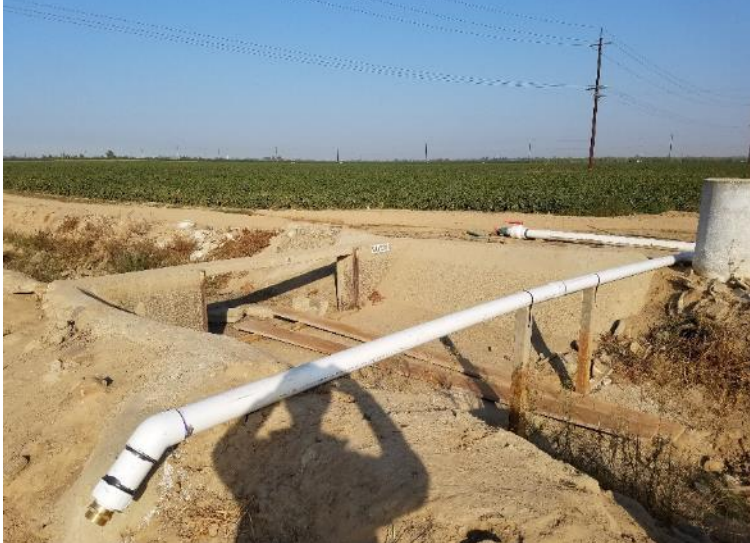
Photo 2 - Water pump on north side of irrigation canal and pipe leading to south side of canal to a spigot. Photo facing northwest.

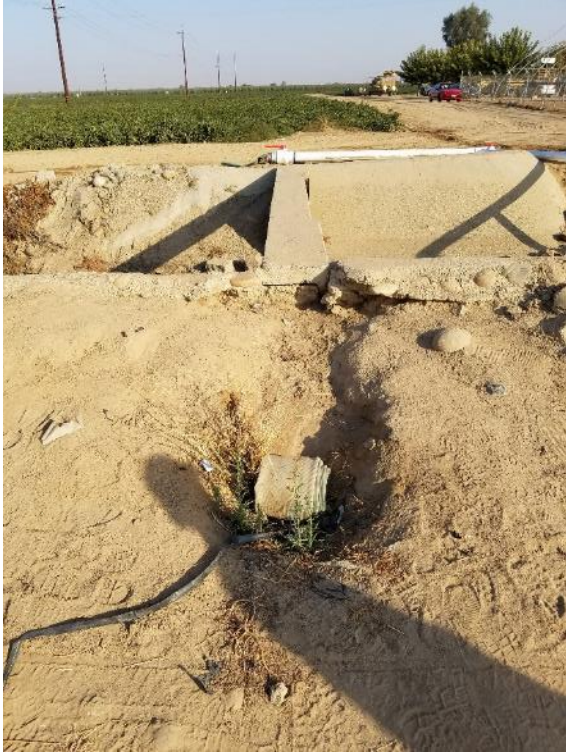
Photo 3 – Concrete footbridge across irrigation canal, leading to existing well. Photo facing north.

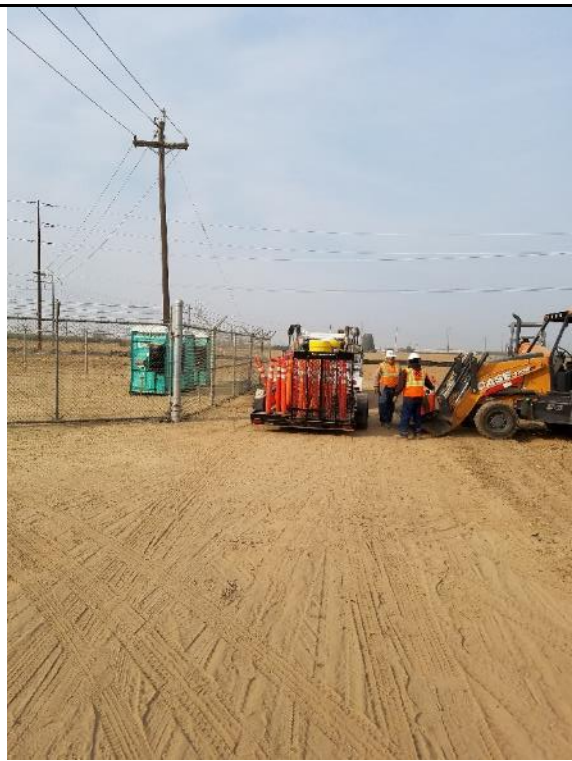
Photo 2 - Construction cones for lane restriction being delivered for traffic direction on McCall Avenue and Jensen Avenue Photo facing west.
11/19/18	Substation expansion footprint, northwest corner.	 	Photo 3 - Silt fence is sagging and detached from the top of stake. Requires repair. Photo facing northwest.

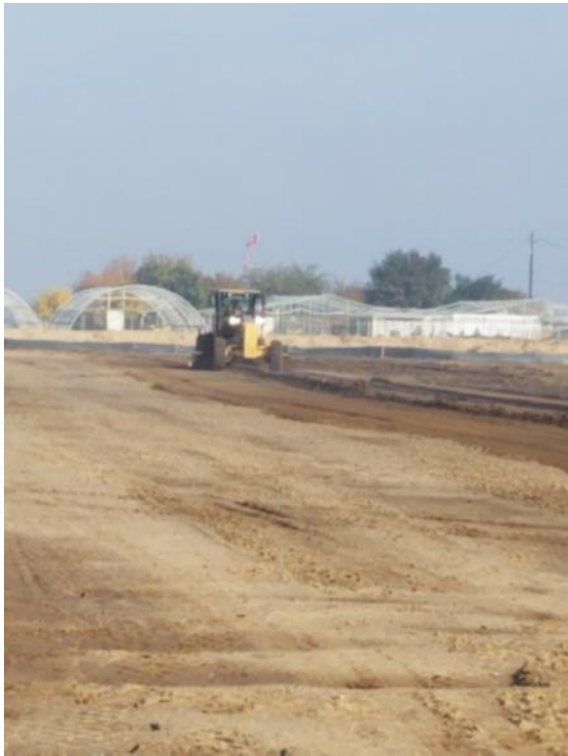
9:30 AM- Arrive on site. Observed that riprap and rumble strips had been installed at the main construction entrance along McCall Avenue (APM AIR-1) (see Photo 1). Met with Jeff Clarkson (PG&E Senior Civil Inspector). Jeff reviewed the substation daily safety tailboard with us. We signed the Job Hazard Analysis form. Jeff notified us about the activities occurring on site today, which included preparing expansion footprint for pulverizing and compacting soil (see Photos 3 and 4). Riprap is covered with soil.

Photo 4 - Grader preparing site for pulverizing and compacting. Photo facing north.
11/26/18	Southern edge of temporary laydown/staging area, immediately north of Jensen Avenue.

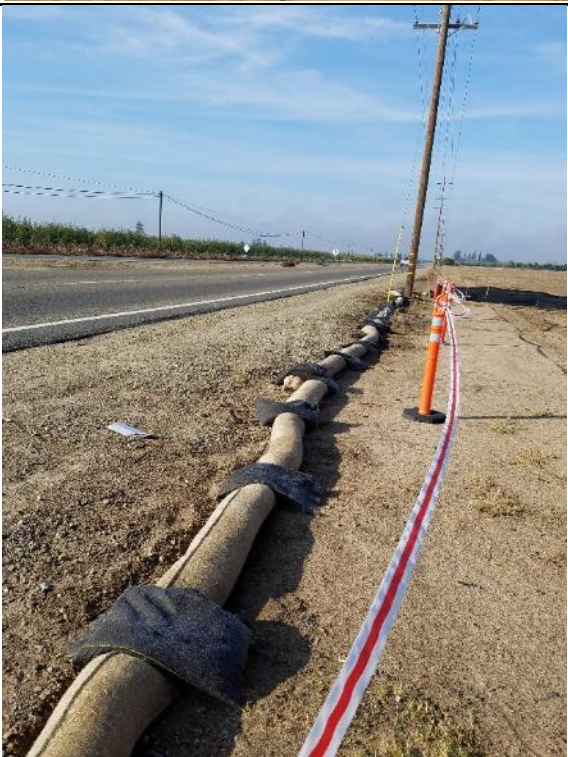
Photo 5 - Wattles set in place to mitigate run-on/run-off. Photo facing west.

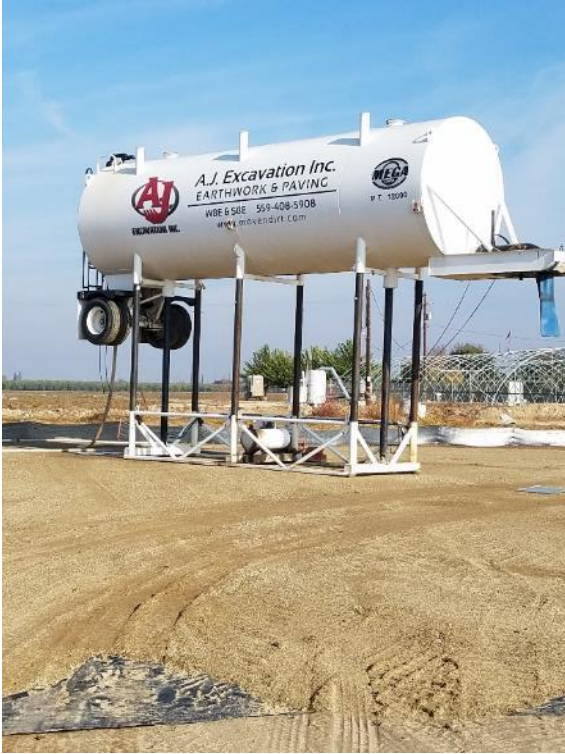
9:50 AM- Performed pedestrian survey of the Project perimeter from McCall Ave towards western Project boundary, then south to Jensen Ave, then to the northern Project boundary, then east to McCall Ave, then south towards Jensen Ave adjacent to McCall Avenue. Silt fence was observed to be installed correctly (see Photo 7). Observed installed erosion control wattles south of Project site along Jensen Avenue (see Photo 5)(APM GEO-2/APM WQ-1) . The water tank in the temporary laydown/storage area is in use, with a drip pan in place to prevent soil beneath the water tower from eroding (see Photos 6 and 8).

Photo 6 - Water tank has been brought on-site and is being used to store water for dust control. Photo facing northwest
11/26/18	Northwest corner of the laydown/staging area, 10 feet west of the water tank.

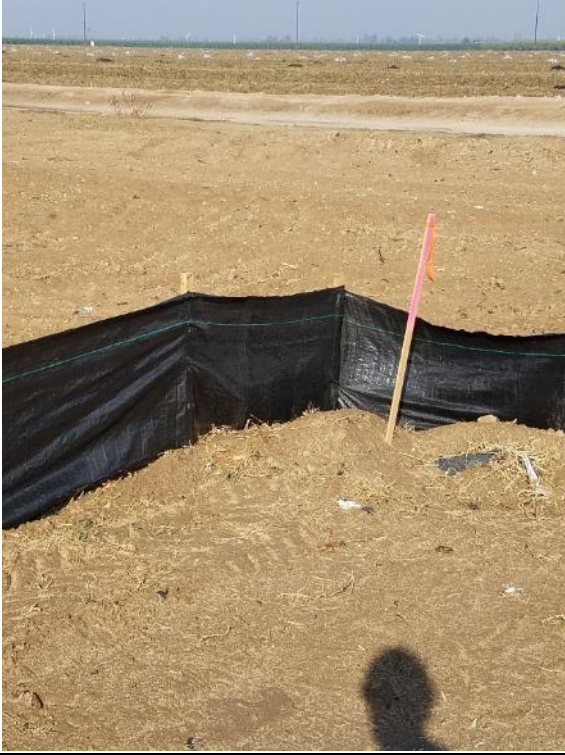
-Silt fence on northwestern corner of project is sagging and is detached from the top of the stake: re-attach silt fence for repair. The silt fence may require additional maintenance, especially after the qualifying storm event this week.

Photo 7 - Portion of formerly sagging silt fence that has been repaired since the previous week. Photo facing northwest.

PREVIOUS COMPLIANCE INCIDENTS OR ITEMS REQUIRING FOLLOW-UP OR RESOLVED TODAY:
Re-inspected silt fence at NW corner of temporary laydown/staging area with recommended follow-up from 11/19 site visit. The silt fence with the sagging issue was resolved.

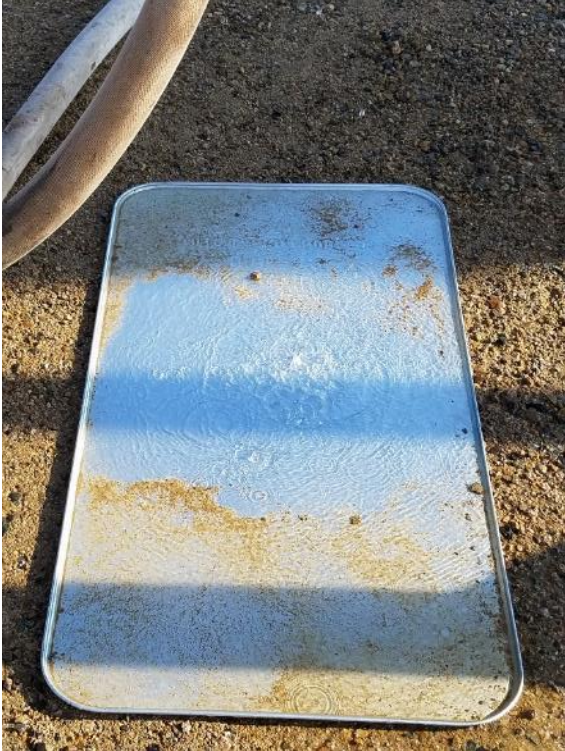
A photograph showing a rectangular, blue-painted metal drip pan resting on a surface of dark, compacted soil. The pan has some brownish residue or dirt on its surface. A portion of a white pipe or hose is visible in the upper left corner of the photo.	Photo 8 - Drip pan in place to prevent water erosion of compacted soil beneath the water tower. Photo facing northeast.
