### Re: Monthly Report Summary #2 for the Sanger Substation Expansion Project

## Sanger Substation Expansion Project CPUC Compliance Monitoring Report

<b>Project Proponent</b>	PG&E	<b>Report No.</b>	CM-BA-120418
<b>Lead Agency</b>	California Public Utilities Commission	<b>Date (mm/dd/yy)</b>	12/05/18
<b>CPUC Project Manager</b>	Billie Blanchard	<b>Monitor(s)</b>	Ben Arax, Evan Studley
<b>CPUC (E &amp; E) Monitoring Manager</b>	Ilja Nieuwenhuizen	<b>AM/PM Weather</b>	Overcast, 55° F, Calm
<b>CPUC (E &amp; E) Monitoring Supervisor</b>	Aileen Cole	<b>Start/End time</b>	3:10 PM – 4:05 PM
<b>Project NTP(s)</b>	NTP #1

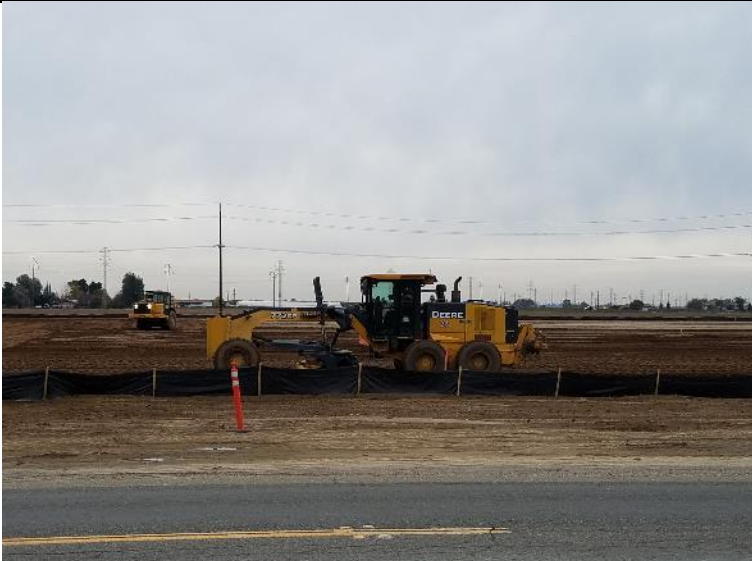
3:10 PM- Arrived on-site with Evan Studley (CPUC compliance monitor). I observed a grader, a scraper and a sheep's foot compactor turning up, grading, and compacting soil (Photo 1, Photo 3).

Photo 1- Grader flattening out soil for compaction. Photo facing west.
12/04/18	Existing substation

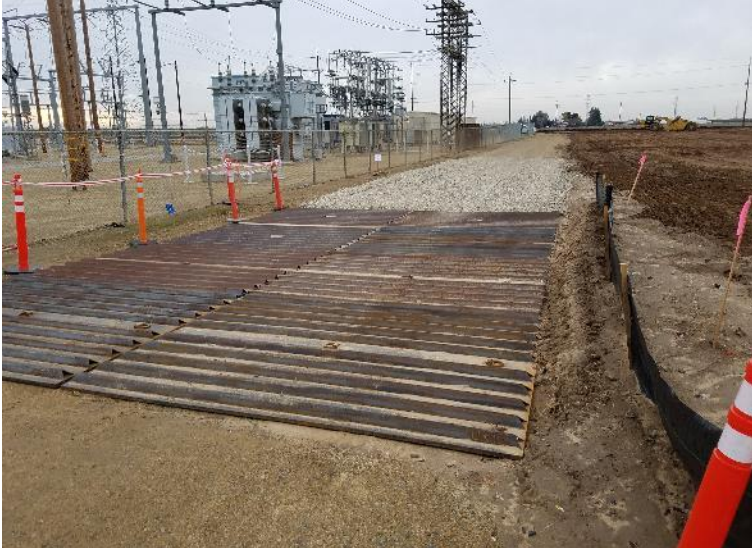
3:15 PM- Observed new, clean riprap and rumble plates installed (APM GEO-1/APM WQ-1) at the egress point (Photo 2).

The previous week, track-out rocks (riprap) and rumble plates were covered in dirt. The riprap was large and spilling close to the roadway. The riprap was replaced with smaller, clean rocks and clean rumble plates. Item of concern has been resolved.

Photo 2-Clean riprap and rumble plates installed at new driveway entrance along McCall Avenue. Photo facing west.

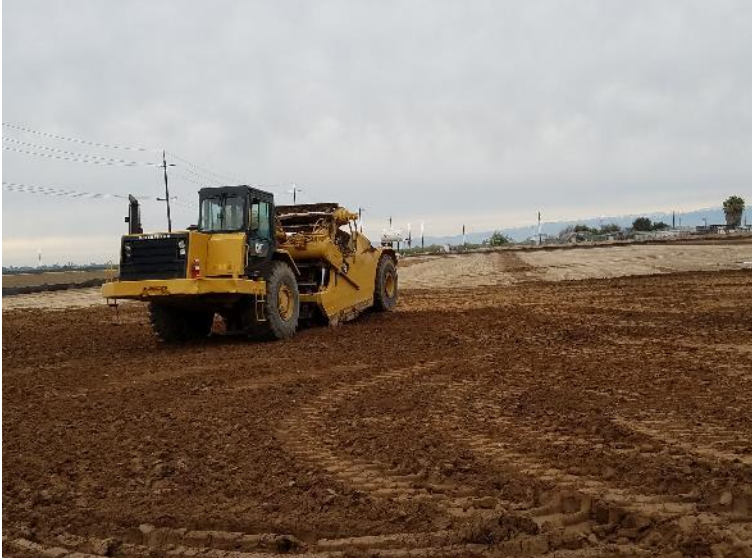
3:20 PM- Conducted pedestrian survey around substation expansion footprint. Observed a scraper not in use (Photo 5). The vehicle was turned off to avoid excess greenhouse gas and noise emissions (APM GHG-1, APM NOI-4). Walked towards the temporary laydown/staging area and observed a pulverizer, two water trucks, and BMPs stored inside the existing substation (Photo 4, Photo 6).

A yellow Caterpillar scraper is parked on a large, muddy construction site. The ground is dark brown and appears to be recently graded. In the background, there are power lines and a clear sky.	Photo 5- Scraper turned off when not in use in compliance with APM GHG-1 and APM NOI-4. Photo facing north.
12/04/18	Temporary Laydown/ staging area

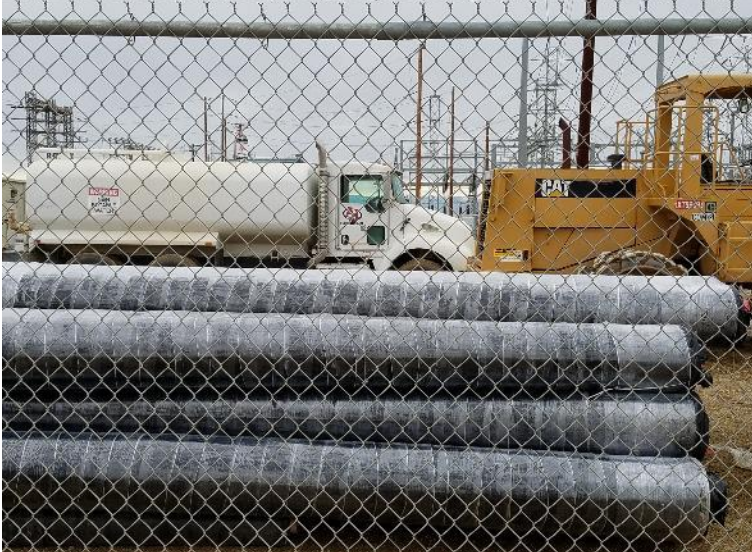
A white water truck and a yellow Caterpillar machine are parked behind a chain-link fence. In the foreground, several large rolls of grey BMP filter fabric are stacked. The background shows a construction site with various structures and equipment.	Photo 6- Water truck and BMP filter fabric being stored inside the existing substation footprint. Photo facing east.

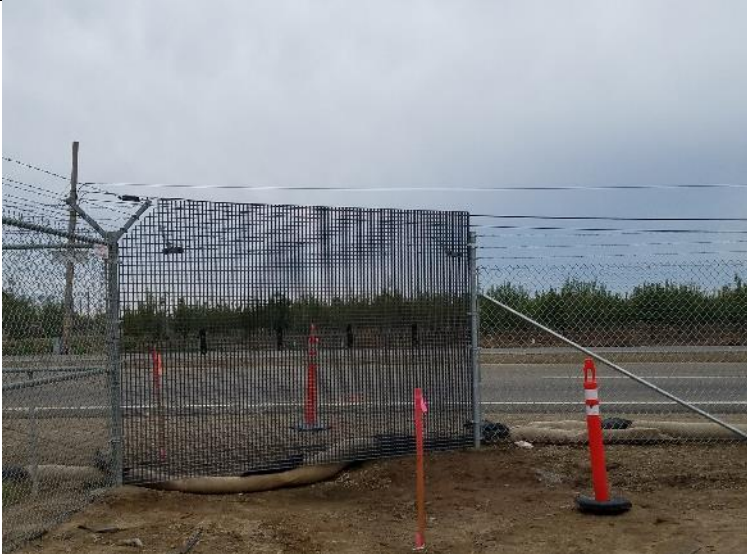
3:25 PM -Observed a new chain-link fence with barbed wire at top and gate installed along Jensen Avenue and the eastern boundary of the substation expansion footprint (Photo 7, Photo 8) to delineate the temporary laydown/staging area and prevent unauthorized access.

Photo 7- Gate installed in the temporary laydown/staging area along Jensen Avenue. Photo facing south.
12/04/18	Temporary laydown/staging area	 	Photo 8- Chain-link fence with barbed wire at top installed along Jensen Avenue. Photo facing west.
