Re: Monthly Report Summary #3 for the Sanger Substation Expansion Project

CPUC Compliance Monitoring Reports
January 3, 10, and 30, 2019

Sanger Substation Expansion Project CPUC Compliance Monitoring Report

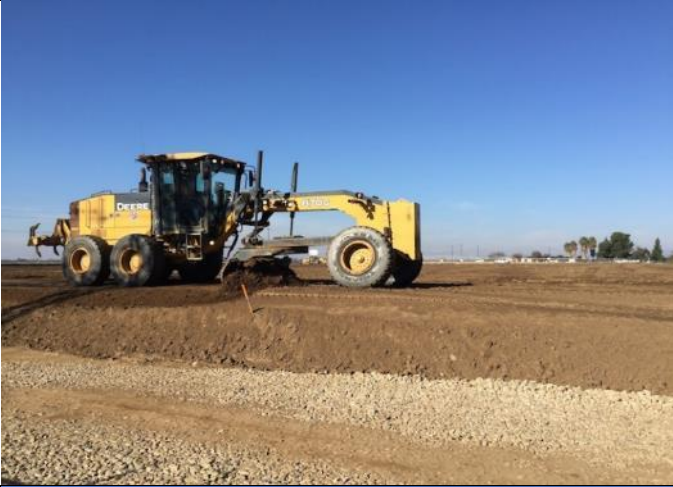
Photo 4 – Grader in use on the substation expansion footprint. Facing north.
01/03/19	Northern edge of expansion footprint.

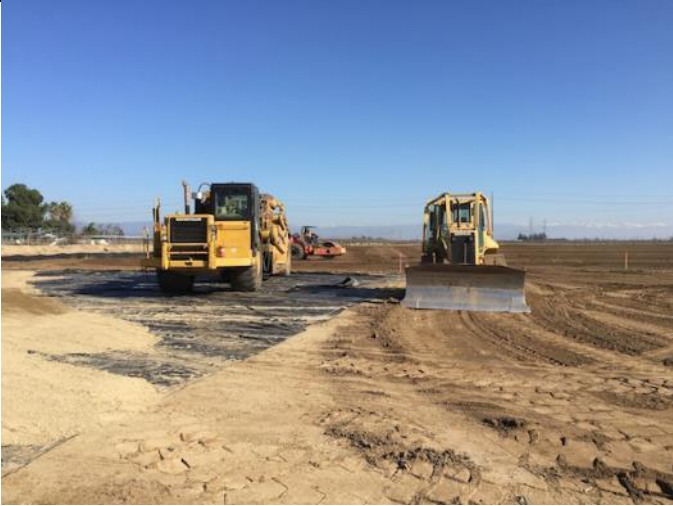
Photo 5 – Broken-down scraper parked on black plastic tarp next to a loader not in use. Facing east.
01/03/19	Southern edge of expansion footprint.

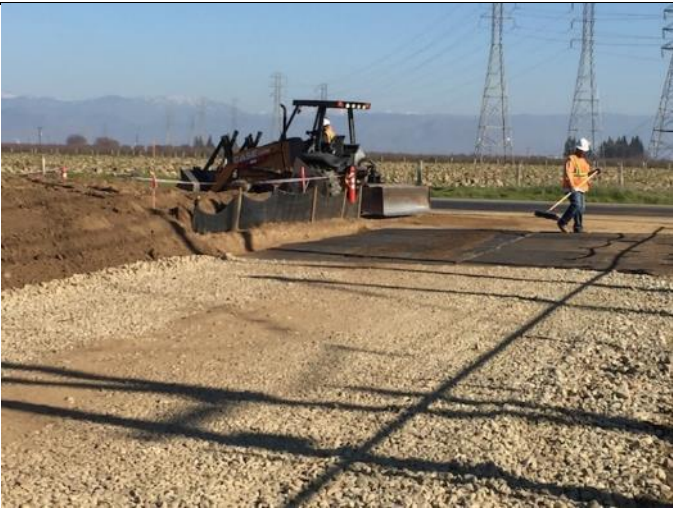
Photo 6 – Southern driveway entrance/exit point along McCall Avenue is neat and well-maintained. Facing east.

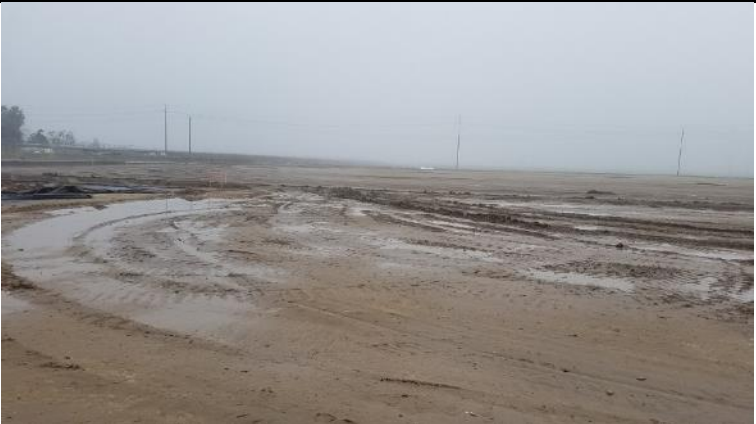
Photo 7- Flooded conditions within the expansion footprint. Photo facing northeast.
1/10/19	Laydown/staging area

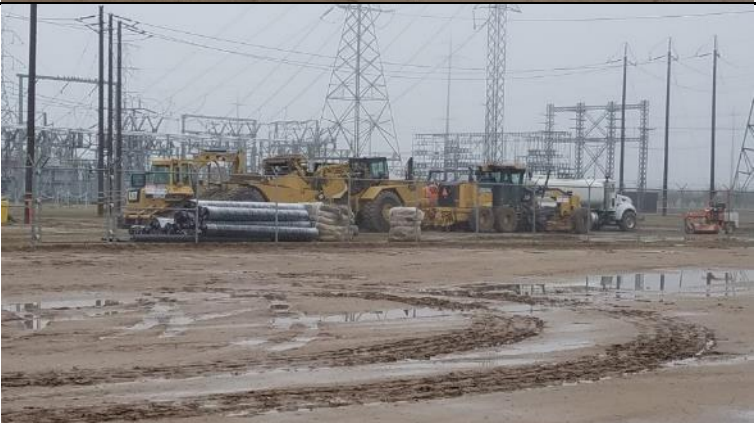
Photo 8- The laydown/staging area is not in use due to muddy and flooded conditions.
1/10/19	Retention Basin

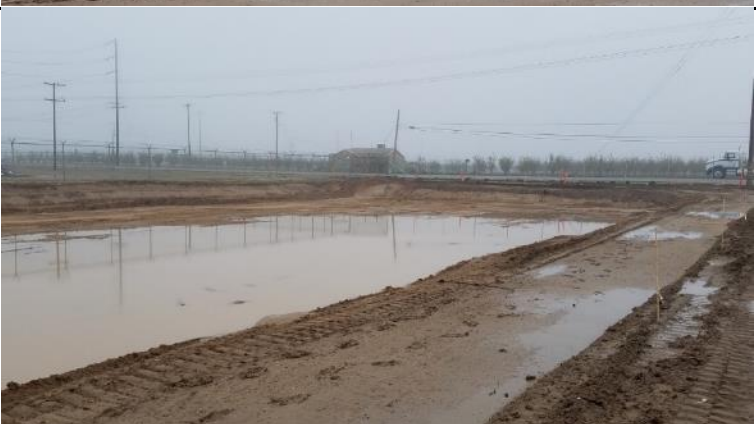
Photo 9- The retention basin is filled with water. Photo facing southeast.

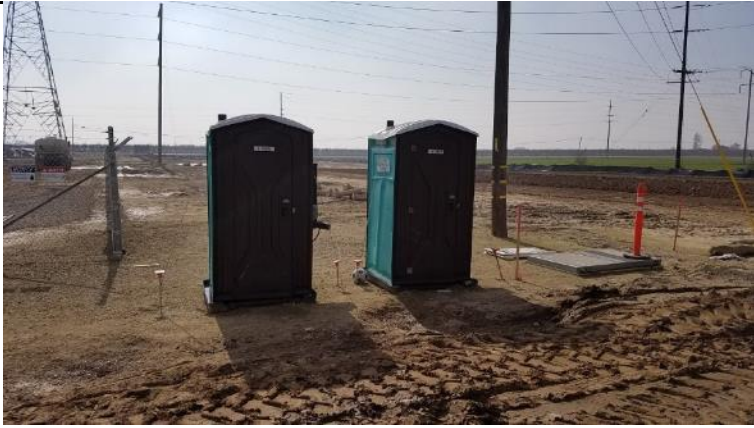
Photo 1- Portable restrooms in the expansion footprint, adjacent to the existing substation, have been moved away from construction vehicles. Photo facing south.
1/30/19	Laydown/staging area

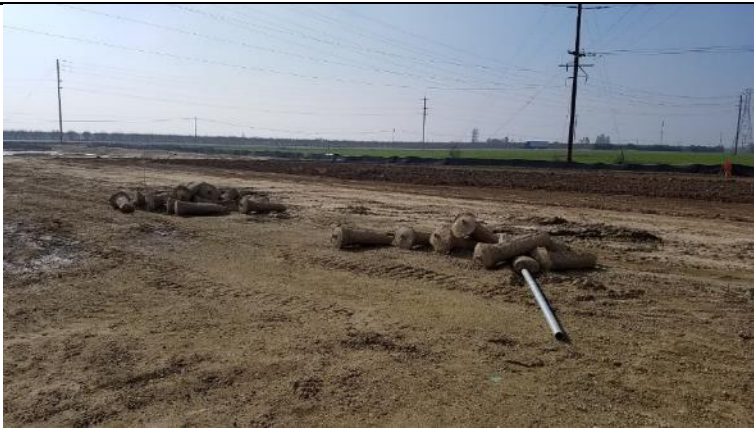
Photo 2- Excavated concrete fence footings piled north of the retention basin, within the staging area. Photo facing southwest.
1/30/19	Laydown/staging area

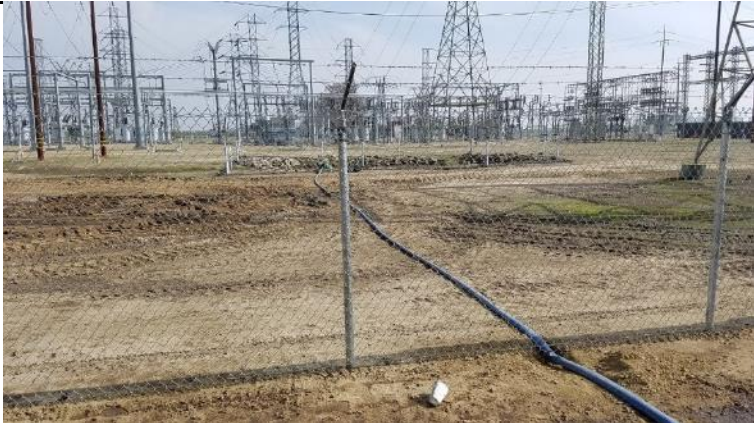
Photo 3- Hose leading from inside the existing substation to the eastern edge of the retention basin. Photo facing east.

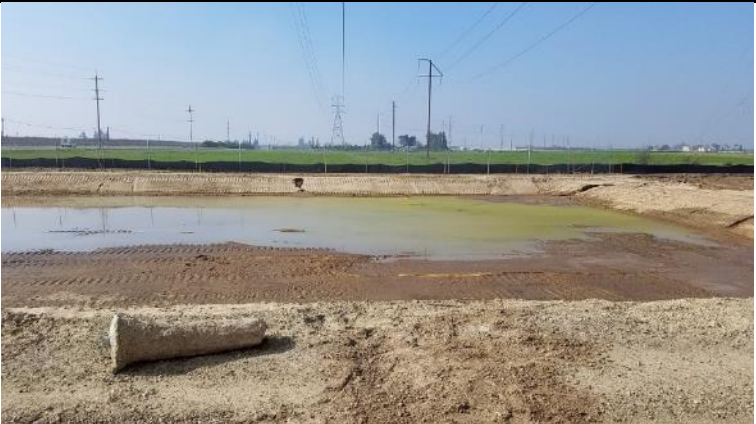
The irrigation pipe had been removed without prior notification.

Photo 4- Excavated irrigation pipe east of the retention basin. Photo facing west.
1/30/19	Retention basin

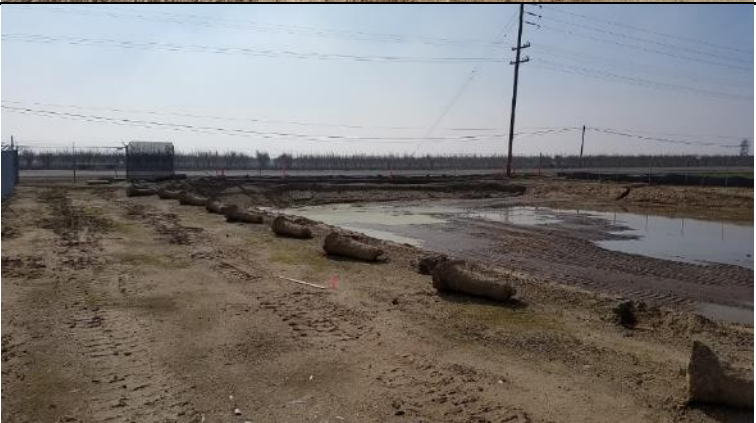
Photo 5- Concrete footings from old fencing has been removed and placed on the eastern side of the retention basin. Photo facing southwest.
1/30/19	Substation expansion footprint

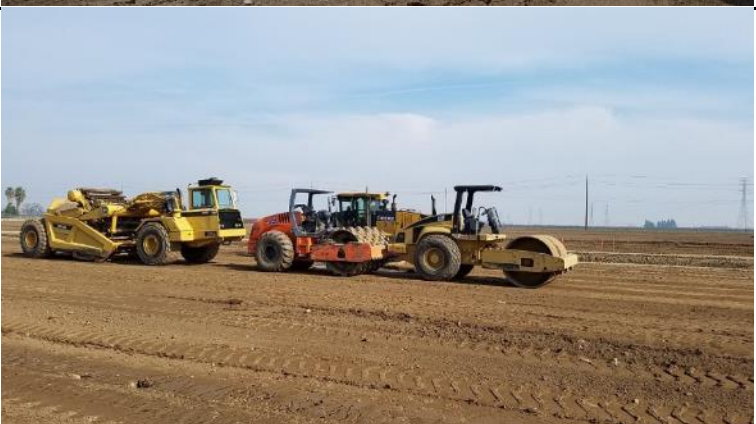
Photo 6- Vehicles are turned off and staged together while the construction workers are on lunch break. Photo facing northeast.
