Re: Monthly Report Summary #15 for the Sanger Substation Expansion Project

CPUC COMPLIANCE MONITORING REPORTS

JANUARY 2, 14, AND 28, 2020

Sanger Substation Expansion Project CPUC Compliance Monitoring Report

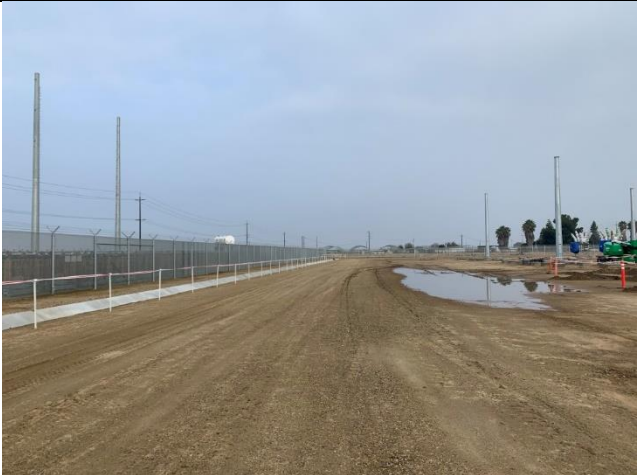
09:45 AM – We exited the construction trailer and proceeded north along the western boundary. I observed large puddles of rainwater within the substation expansion footprint, along the western side (Photo 1). Puddles have accumulated due to the uneven, non-graded ground in the area. Mr. Kacerek explained how the crew would need to grade the area to avoid further puddling.

Photo 1 – Minor rain puddling in the substation expansion footprint.
01/02/20	Existing substation

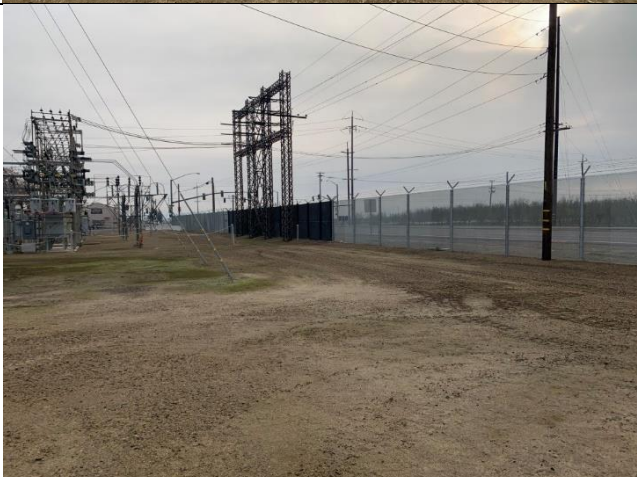
09:25 AM – We observed the completed fence along Jensen Avenue; the fence line is along the original project boundary line (Photo 2). We observed the retention basin and were informed about the good intake of water with no overflow (Photo 3).

Photo 2 – Completed fence along Jensen Avenue.
01/02/20	Detention pond

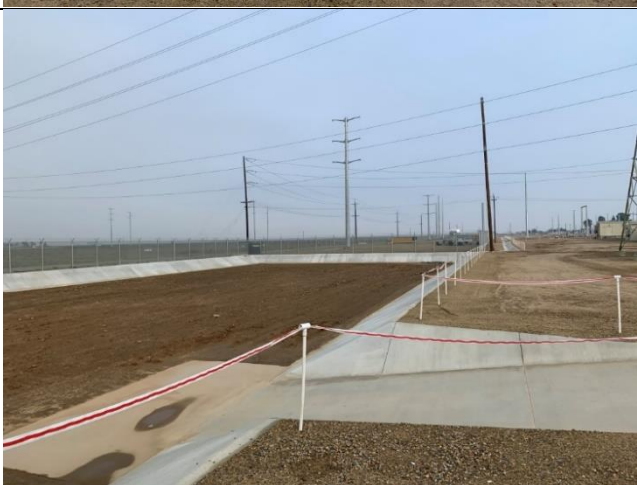
Photo 3 – Detention pond is well drained.

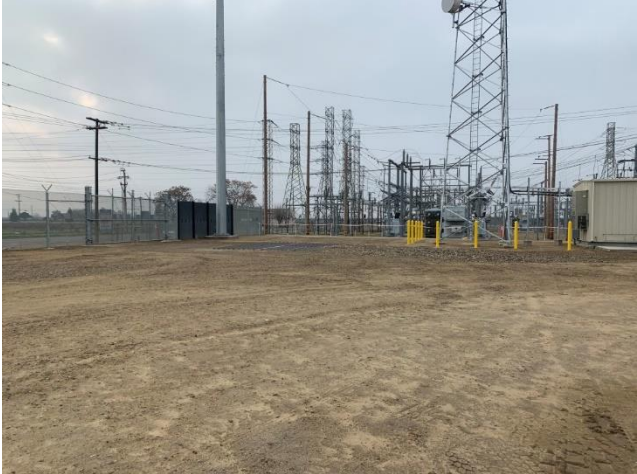
09:15 AM – We observed rumble plates leading to the southern entrance/exit gate to be clean of mud and well kept (Photo 4).

Photo 4 – Rumble plates on the southern entrance are clean of mud and well kept.
01/02/20	Expansion footprint

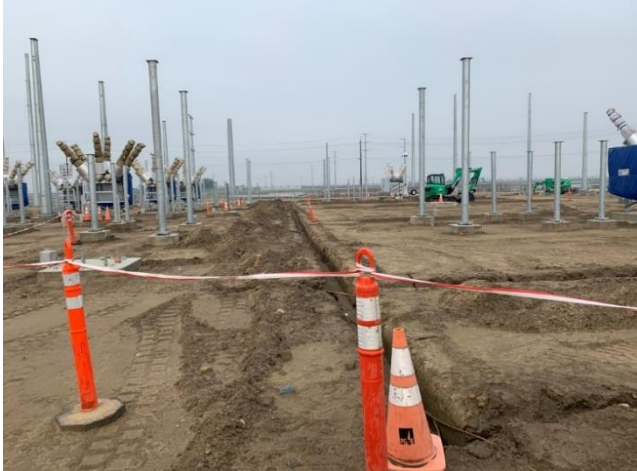
09:55 AM – The trenches within the center of the substation expansion footprint had a small amount of rainwater that would evaporate shortly (Photo 5). The staging area was kept clean and the dumpster was properly covered with a fitted, easy-roll lid. All staged equipment was observed with pans underneath.

Photo 5 – Trench in the center of the expansion substation with small amount of rainwater.

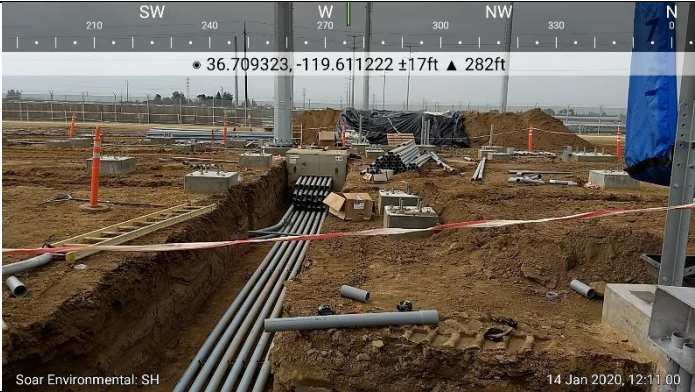
12:35 PM – We proceeded north along the eastern boundary. We observed that trenches were roped off to prevent pedestrian access, and earthen escape ramps were used as necessary for wildlife protection (APM BIO-11) (Photo 1).

Photo 1 – Open trenches are roped off to prevent pedestrian access. Photo facing west.
01/14/20	Expansion footprint

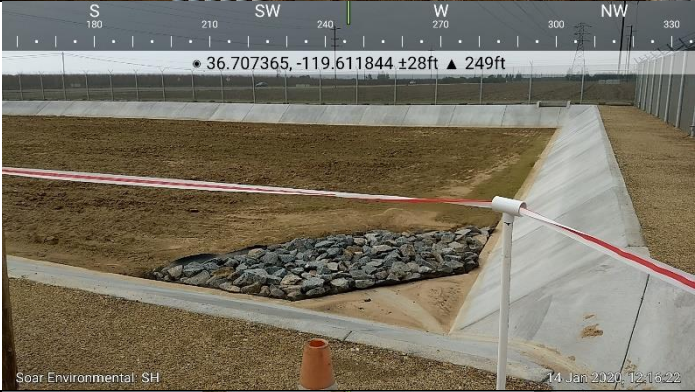
12:10 PM – We walked west along the north boundary to the western swale, observing that the swale drains well (Photo 5) and that no water remained in the swale after the recent storm. The laydown yard was kept in good order and materials were staged neatly. No loose trash was visible in the laydown yard (Photo 3). We proceeded south along the western swale to the southern detention basin. No water remained in the basin; it appeared to drain well (Photo 2).

Photo 2 – Detention basin drains well, and no ponds were present after storm. Photo facing southwest.
01/14/20	Expansion footprint

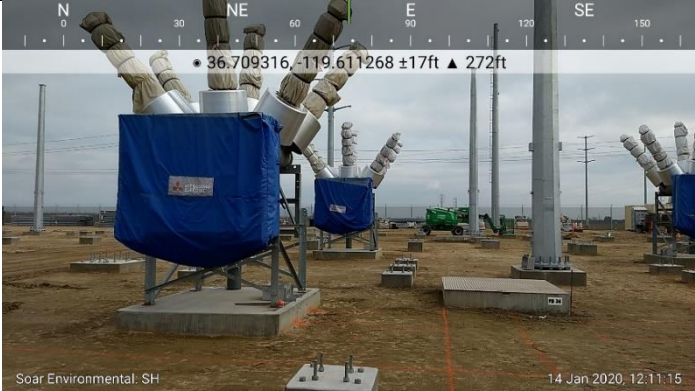
Photo 3 – Product packaging is in good condition; no loose trash is present on the site. Photo facing east.
01/14/20	Expansion footprint

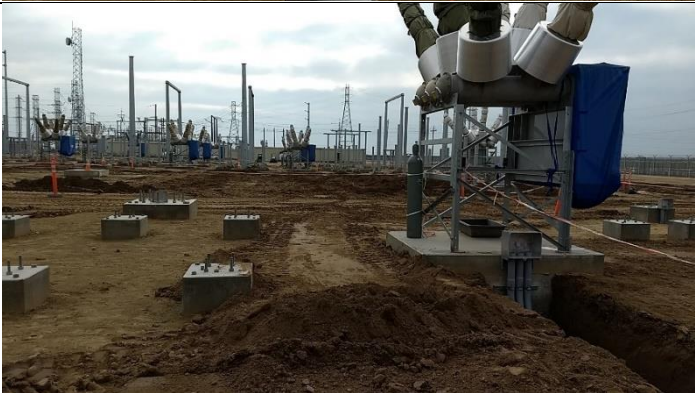
Photo 4 – Transformer tanks are located on an impervious surface and secured to a stationary structure to maximize stability. Photo facing south.
