Re: Monthly Report Summary #16 for the Sanger Substation Expansion Project

Sanger Substation Expansion Project CPUC Compliance Monitoring Report

Project Proponent	Pacific Gas & Electric (PG&E)	Report No.	CM-CPUCDG-021220
Lead Agency	California Public Utilities Commission (CPUC)	Date (mm/dd/yy)	02/12/20
CPUC Project Manager	Billie Blanchard	Monitor(s)	Sam Hopstone
CPUC (E & E) Monitoring Manager	Silvia Yanez	AM/PM Weather	Clear, 41°F, calm
CPUC (E & E) Monitoring Supervisor	Jeff Davis	Start/End time	06:45 AM – 08:15 AM
Project NTP(s)	Notice to Proceed (NTP) #2

Project Proponent	Pacific Gas & Electric (PG&E)	Report No.	CM-CPUCDG-022520
Lead Agency	California Public Utilities Commission (CPUC)	Date (mm/dd/yy)	02/25/20
CPUC Project Manager	Billie Blanchard	Monitor(s)	Sam Hopstone
CPUC (E & E) Monitoring Manager	Silvia Yanez	AM/PM Weather	Clear, 50°F, calm
CPUC (E & E) Monitoring Supervisor	Angelica Oregel	Start/End time	06:45 AM – 07:45 AM
Project NTP(s)	Notice to Proceed (NTP) #2

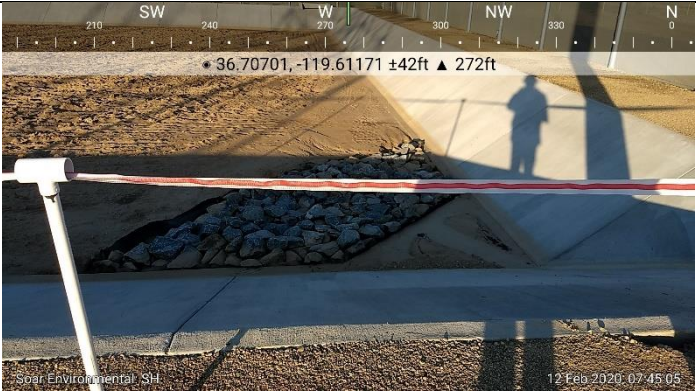
07:30 AM – We began a site walk at the southwest corner of the site. The detention basin appeared to be in good condition (Photo 1). Portable toilets and trash in the existing substation near the construction trailers had drip pans as secondary containment, and the trash was secured shut with a lid. We proceeded north along the west site boundary. The drainage swale was empty of water and sediment, ready to convey storm flows.

Photo 1 – The detention basin has been scarified and sidewalls remain in good condition, ready for the next storm. Photo facing west.	
02/12/20	Detention basin

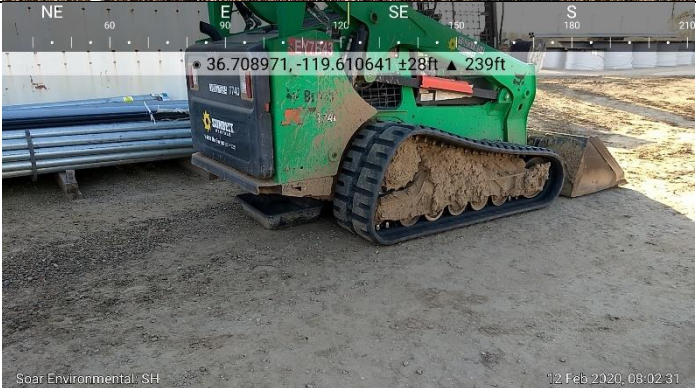
07:50 AM – We observed drip pans under multiple pieces of equipment as precautionary measures (Photo 2), and soil stockpiled near the north site boundary was covered by tarps and secured with sandbags. We proceeded east along the north site boundary, then south along the east site boundary. We observed that trenches that the crew did not plan to backfill at the end of the work day contained wildlife escape ramps (Photo 3). We continued south into the existing substation footprint, to the construction trailers. Handrails have been installed in some staircases behind the permanent structures at the south boundary of the expansion footprint (Photo 4).

Photo 2 – Drip pans are placed under heavy equipment. Photo facing west.	
02/12/20	Expansion footprint

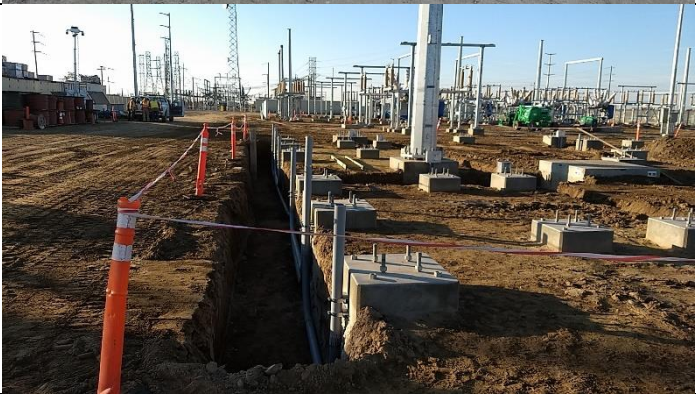
Photo 3 – Excavations that are not backfilled daily contain wildlife escape ramps. All active excavations are roped off to prevent pedestrian access. Photo facing south.

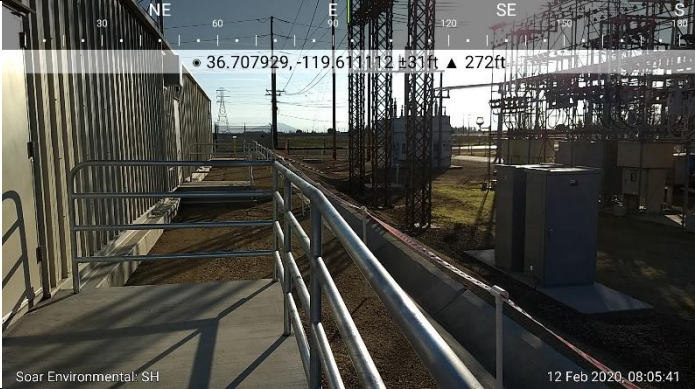
<p>Soar Environmental: SH 12 Feb 2020, 08:05:41</p>	Photo 4 – Staircases on the new buildings had handrails installed. Photo facing east.
02/12/20	East site boundary

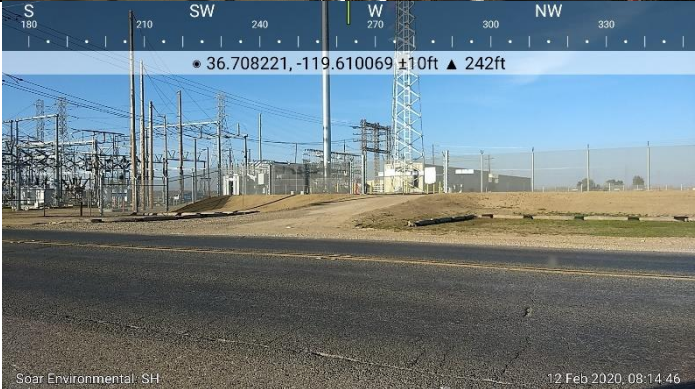
08:15 AM – I checked in with Mr. Davis and Mr. Kacerek with no issues to report. We exited site through southern gate in the existing substation. Upon exiting the site, I observed that fiber rolls and sandbag anchors along the eastern boundary (Photo 5) appear in good condition.

<p>Soar Environmental: SH 12 Feb 2020, 08:14:46</p>	Photo 5 – Fiber rolls and sandbags on east site boundary remain in good condition. Photo facing west.

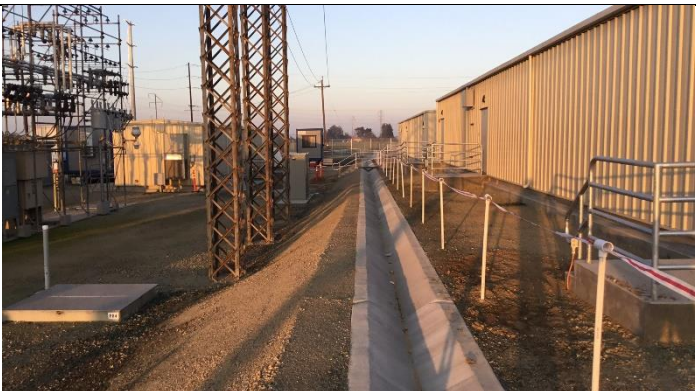
06:55 AM – From the detention basin, we proceeded north into the expansion footprint, and east along the south buildings to the east site boundary. We observed that the stairs behind the permanent buildings have handrails, and the south swale is roped off (Photo 1) to prevent pedestrians that exit the building from entering the swale or existing substation. To the east of the site, we observed that fiber rolls (Photo 2) along the site perimeter remain in good condition (APM GEO-2).

Photo 1 – The swale and slope down to the existing substation are roped off to prevent pedestrians exiting the buildings from falling down. Photo facing west.
02/25/20	Expansion footprint

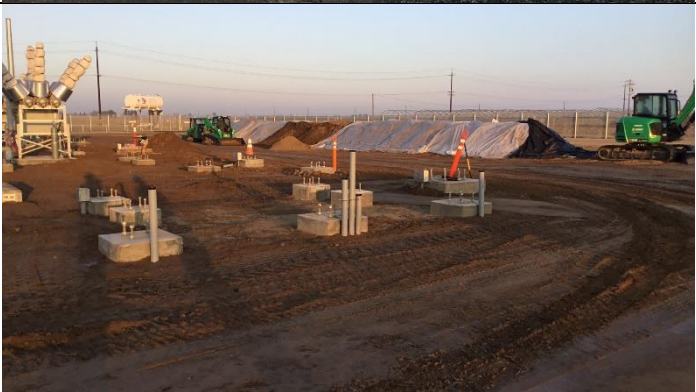
07:00 AM – We proceeded north along the east site boundary and observed that the north soil stockpile (Photo 3) has been covered with plastic tarps and sandbags. We crossed east along the north site boundary and proceeded south along the drainage swale. Both gates to the laydown yard to the west of the expansion footprint were locked to prevent access to the area and materials when not in use (Photo 4) (MM TRAN-1). Further, the dumpster in the south portion of the laydown yard was covered (Photo 5) to prevent wildlife from accessing the dumpster and prevent waste from blowing away (MM HAZ-1).

Photo 3 – Soil stockpile is protected with tarps to prevent erosion. Photo facing northwest.
02/25/20	Expansion footprint
