Re: Monthly Report Summary #17 for the Sanger Substation Expansion Project

Sanger Substation Expansion Project CPUC Compliance Monitoring Report

Project Proponent	Pacific Gas & Electric (PG&E)	Report No.	CM-CPUCDG-031320
Lead Agency	California Public Utilities Commission (CPUC)	Date (mm/dd/yy)	03/13/20
CPUC Project Manager	Billie Blanchard	Monitor(s)	Sam Hopstone
CPUC (E & E) Monitoring Manager	Silvia Yanez	AM/PM Weather	Partly cloudy, 40°F, calm
CPUC (E & E) Monitoring Supervisor	Angelica Oregel	Start/End time	06:45 AM – 07:50 AM
Project NTP(s)	Notice to Proceed (NTP) #2

Project Proponent	Pacific Gas & Electric (PG&E)	Report No.	CM-CPUCDG-032420
Lead Agency	California Public Utilities Commission (CPUC)	Date (mm/dd/yy)	03/24/20
CPUC Project Manager	Billie Blanchard	Monitor(s)	Sam Hopstone
CPUC (E & E) Monitoring Manager	Silvia Yanez	AM/PM Weather	Cloudy, 40°F, calm
CPUC (E & E) Monitoring Supervisor	Angelica Oregel	Start/End time	13:00 PM – 14:00 PM
Project NTP(s)	Notice to Proceed (NTP) #2

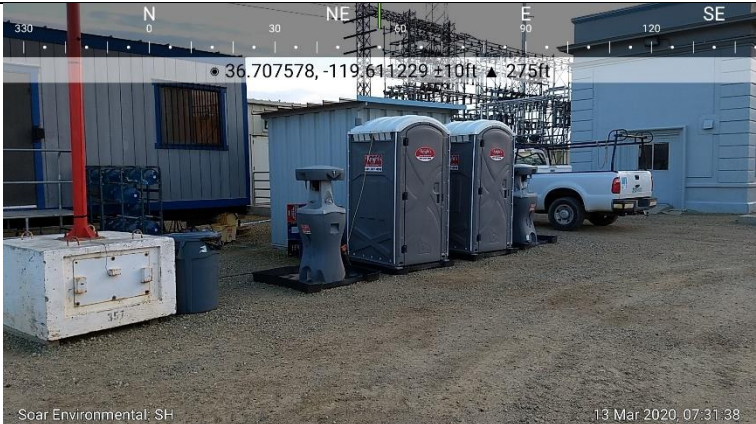
07:00 AM – We began a site walk at construction trailers in the existing substation footprint and observed that portable toilets and handwash station had secondary containment (APM WQ-1) (Photo 1). We proceeded to the detention pond and observed the base to be scarified and that sidewalls were in good condition. We continued north into the expansion footprint and observed that the top of the slope is roped off to prevent people exiting the expansion footprint from stepping into the drainage swale (Photo 2). Additionally, completed vaults by the buildings were covered to prevent access when not actively used (Photo 3).

Photo 1 – Portable toilets and handwash stations have secondary containment. Photo facing northeast.
3/13/20	Expansion footprint

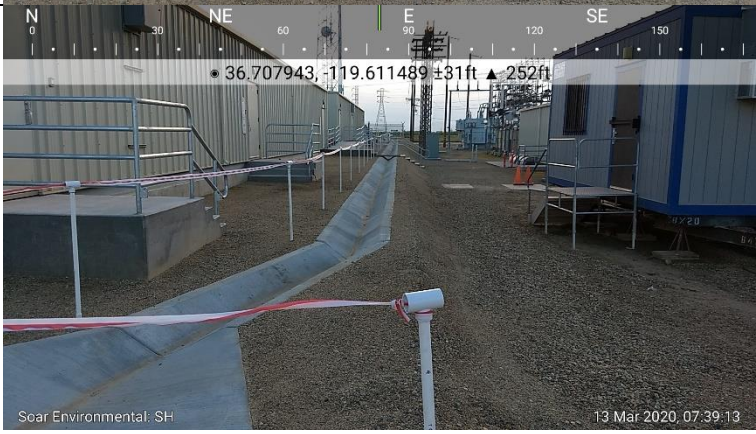
Photo 2 – The rear portions of permanent buildings are roped off from the swale to protect pedestrians. Photo facing east.

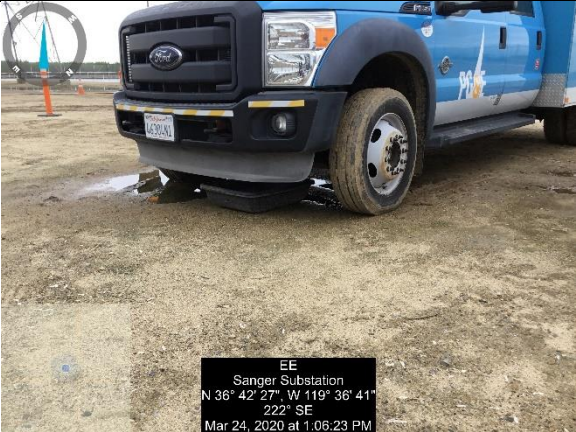
13:00 PM – We arrived onsite and entered through the south gate into the existing substation footprint. We checked in with the SWCA Biologist Angelica Oregel, who conducts daily sweeps for sensitive species before commencement of work (Mitigation Measures [MM] BIO-4, MM BIO-6, and MM BIO-7). We observed drip pans under parked vehicles and equipment (Photo 1) and observed that portable toilets and handwash stations have secondary containment measures in place (Applicant Proposed Measures [APM] WQ-1) (Photo 2). Current activity included installing hardware for breakers and switches and occasional painting activities. Trenching activities were paused since the last rain event and will resume when the trenches dry. Mechanical owls have been installed on some of the vertical structures to deter wildlife. Future planned activities include installing hardware for breakers and switches and trenching when the water dries.

Photo 1 – Drip pans are placed below parked vehicles. Photo facing southwest.	
03/24/20	Existing substation

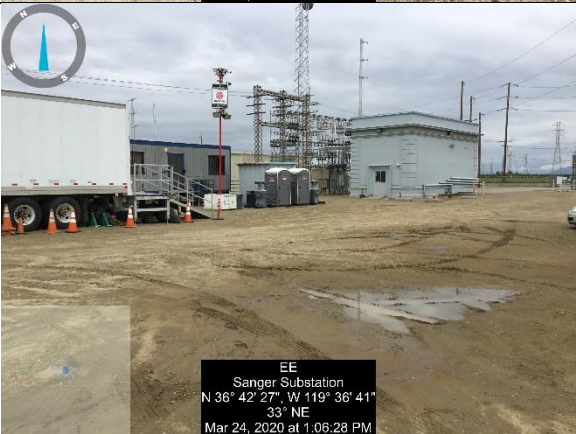
Photo 2 – Portable toilets and handwash stations have secondary containment. Photo facing northeast.
