Re: Monthly Report Summary #18 for the Sanger Substation Expansion Project

Sanger Substation Expansion Project CPUC Compliance Monitoring Report

Project Proponent	Pacific Gas & Electric (PG&E)	Report No.	CM-CPUCDG-040820
Lead Agency	California Public Utilities Commission (CPUC)	Date (mm/dd/yy)	04/08/20
CPUC Project Manager	Billie Blanchard	Monitor(s)	Sam Hopstone
CPUC (E & E) Monitoring Manager	Silvia Yanez	AM/PM Weather	Partly Cloudy, 45°F, calm
CPUC (E & E) Monitoring Supervisor	Angelica Oregel	Start/End time	14:00 PM – 15:00 PM
Project NTP(s)	Notice to Proceed (NTP) #2

Project Proponent	Pacific Gas & Electric (PG&E)	Report No.	CM-CPUCDG-042320
Lead Agency	California Public Utilities Commission (CPUC)	Date (mm/dd/yy)	04/23/20
CPUC Project Manager	Billie Blanchard	Monitor(s)	Sam Hopstone
CPUC (E & E) Monitoring Manager	Silvia Yanez	AM/PM Weather	Partly Cloudy, 70°F, calm
CPUC (E & E) Monitoring Supervisor	Angelica Oregel	Start/End time	14:00 PM – 14:50 PM
Project NTP(s)	Notice to Proceed (NTP) #2

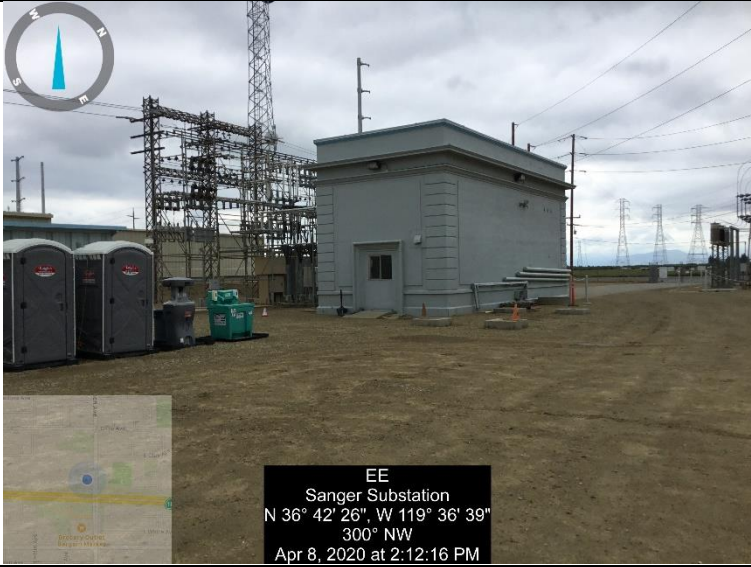
14:00 PM – I arrived onsite and entered through the south gate into the existing substation footprint. I checked in with SWCA Biologist Angelica Oregel. Current activity included installing overhead conductors and wires, and covering grid trenches. Future activities include installing breakers and tubing, and possibly pouring bases for the switches. Ms. Oregel conducted the daily sweeps for sensitive species before commencement of work (Mitigation Measure [MM] BIO-4, MM BIO-6, and MM BIO-7). Since the last compliance inspection, Ms. Oregel monitored evidence of a partial nest in a section of conduit in the north end of the temporary staging area. She determined the nest materials were left by house sparrows (*Passer domesticus*). At the west side of the site, the biologist observed killdeers (*Charadrius vociferous*) and red-tailed hawks (*Buteo jamaicensis*). At the existing substation, a buffer was delineated as a protective buffer around an active mourning dove (*Zenaida macroura*) nest (Photo 1). Additionally, PG&E has installed noisemakers on conex ([storage container](#)) boxes along the east boundary of the expansion footprint that imitate bird calls at regular intervals.

Photo 1 – A wildlife buffer has been installed around the mourning dove nest area. Photo facing northeast.
04/08/20	Existing substation footprint

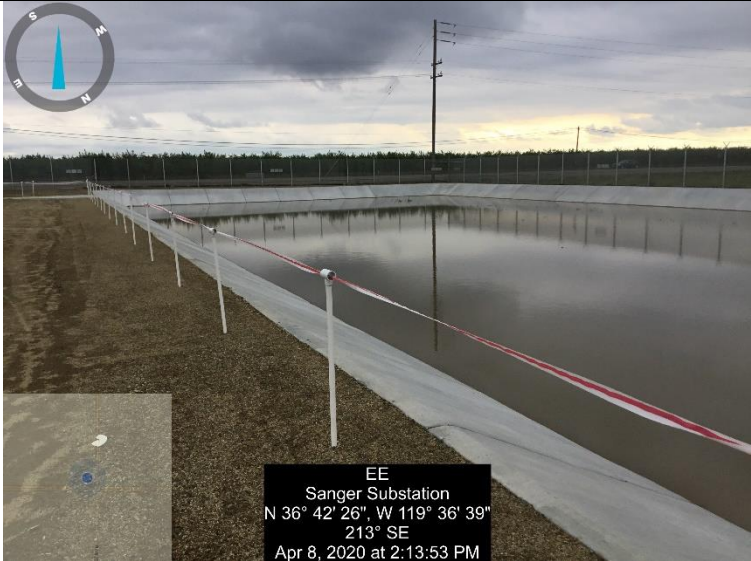
14:10 PM – I proceeded southwest to the detention basin and observed the concrete swales draining properly with ample space for water (Applicant Proposed Measure [APM] WQ-1) (Photo 2). I proceeded north along the west site boundary.

Photo 2 – Detention basin functioning properly during the most recent storm. Photo facing southwest.

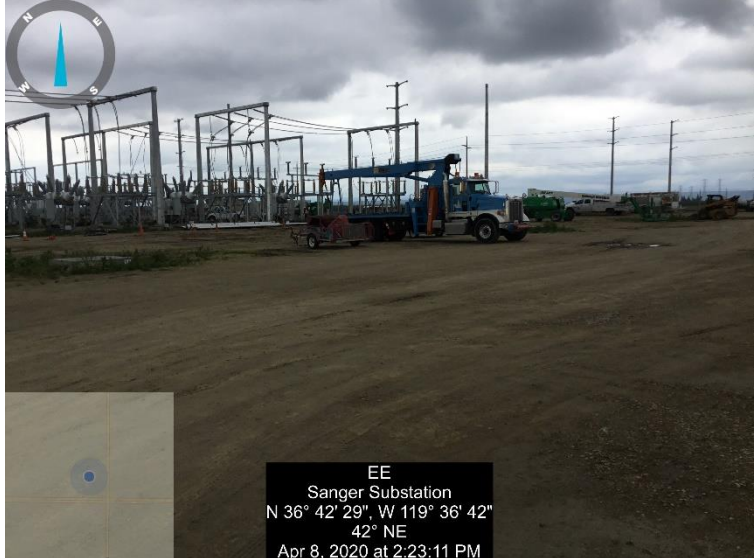
14:20 PM – At the expansion footprint, I observed that equipment and vehicles not in use were parked away from work areas (Photo 3), and all paths of travel around the site were kept open. I proceeded west through the south entrance into the temporary staging area. A red-tailed hawk was present west of the project site and visible to the naked eye (Photo 4). All equipment and materials in the temporary staging area were organized and staged out of the path of travel. No trash or debris was observed (MM HAZ-1). I exited the temporary staging area through the south gate into the expansion footprint and proceeded north into the work area.

<p>EE Sanger Substation N 36° 42' 29", W 119° 36' 42" 42° NE Apr 8, 2020 at 2:23:11 PM</p>	Photo 3 – Equipment and vehicles not in use are parked away from paths of travel and work areas. Photo facing northeast.
04/08/20	Temporary staging area

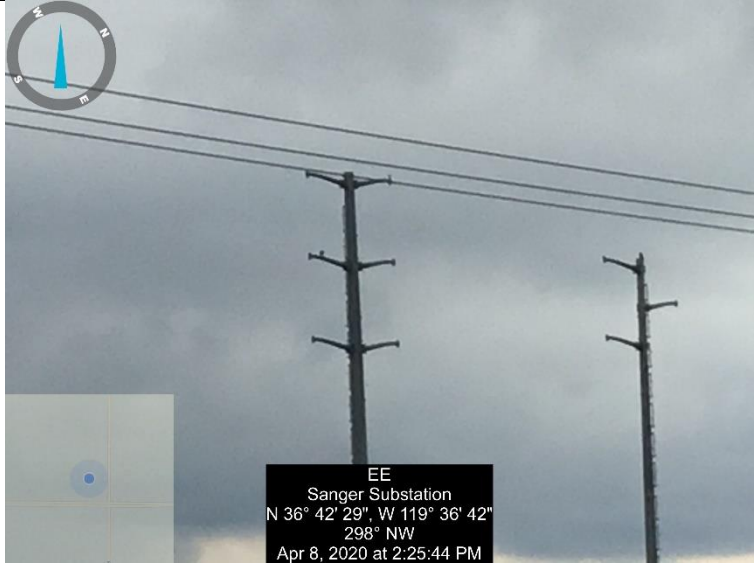
<p>EE Sanger Substation N 36° 42' 29", W 119° 36' 42" 298° NW Apr 8, 2020 at 2:25:44 PM</p>	Photo 4 – Red-tailed hawk is visible on tubular steel pole arm to west of site. Photo facing west.

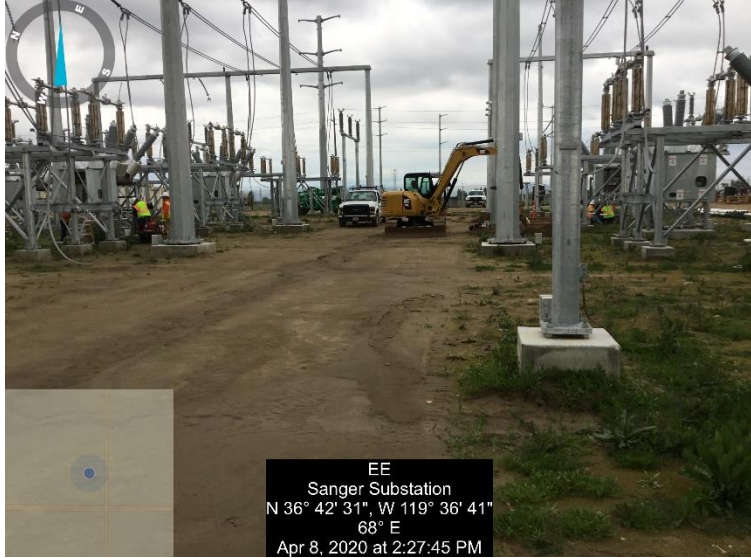
14:30 PM – In the work area, I observed that no trenches were ~~open~~[open](#) and work continues on vertical improvements (Photo 5). Mechanical owls remain in use on top of multiple structures to deter wildlife (Photo 6).

Photo 5 – No trenches were open open and work continued on vertical improvements. Photo facing east.
04/08/20	Expansion footprint

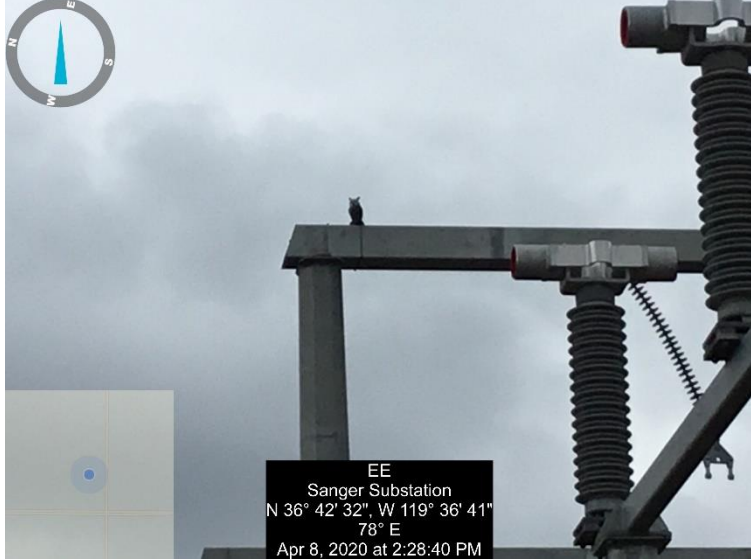
Photo 6 – Mechanical owls have been installed atop multiple structures.

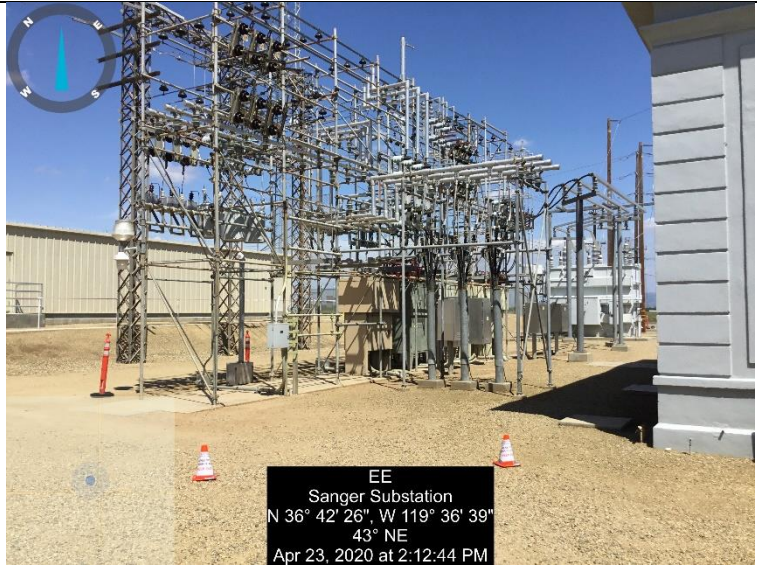
14:00 PM – I arrived onsite and entered through the south gate into the existing substation footprint. I checked in with SWCA Biologist Angelica Oregel. Current activity included installing foundations for switch platforms and installing closed circuit television (CCTV) wiring. Future activities include continuation of switch platform construction, CCTV hookups, and wiring installation. Ms. Oregel conducted the daily sweeps for sensitive species before commencement of work (Mitigation Measure [MM] BIO-4, MM BIO-6), and a Colibri Ecological biologist surveyed the site and surroundings for the Swainson’s hawk (*Buteo swainsoni*) and white-tailed kite (*Elanus leucurus*) (MM BIO-7). At the west of the site, Ms. Oregel observed killdeer (*Charadrius vociferous*) and red-tailed hawks (*Buteo jamaicensis*). At the existing substation, the protective nest buffer remains in place around the mourning dove (*Zenaida macroura*) nest located near the original substation building (Photo 1). Ms. Oregel reported observing American kestrels (*Falco sparverius*) interfering with the mourning dove nest.

Photo 1 – The mourning dove buffer remains in effect. Photo facing northeast.	
04/23/20	Existing substation footprint

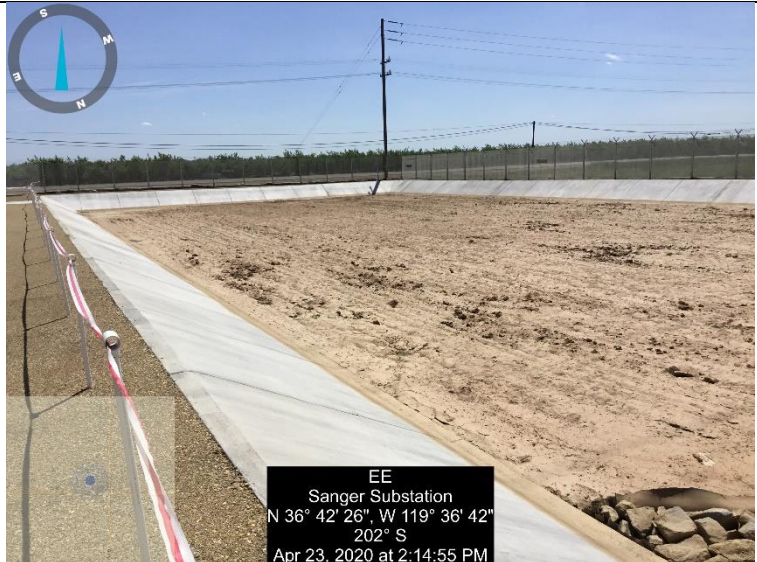
14:10 PM – I proceeded southwest to the detention basin and observed that the basin drained fully since the previous storm with all sidewalks remaining in good condition (Applicant Proposed Measure [APM] WQ-1) (Photo 2).

Photo 2 – The detention basin drained fully and remains in good condition. Photo facing southwest.

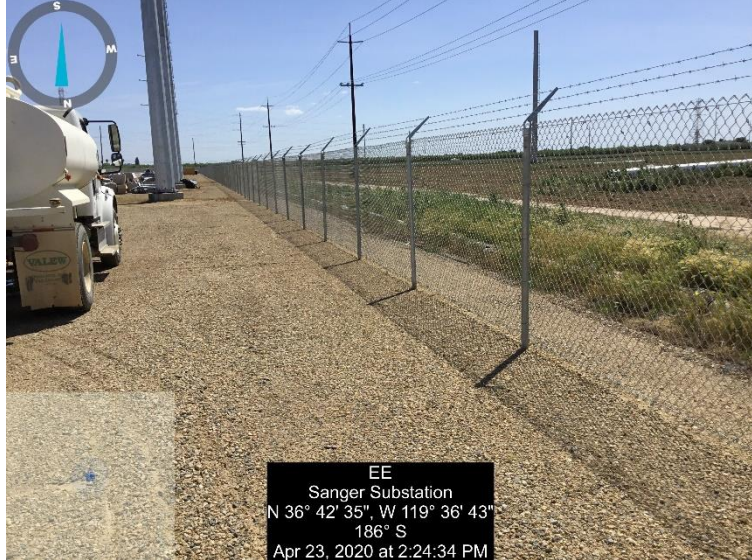
14:20 PM – I proceeded west into the south entrance of the temporary staging area. I observed that equipment, construction materials, and waste were stockpiled neatly away from the path of travel (MM HAZ-1). Vegetation had returned to the site perimeter, creating additional sediment control (Photo 3). I proceeded north through the temporary staging area and exited into the expansion footprint through the north gate.

<p data-bbox="716 730 943 831"> EE Sanger Substation N 36° 42' 35", W 119° 36' 43" 186° S Apr 23, 2020 at 2:24:34 PM </p>	Photo 3 – Vegetation has reestablished around the site perimeter, providing additional erosion control. Photo facing southwest.
04/23/20	Temporary staging area

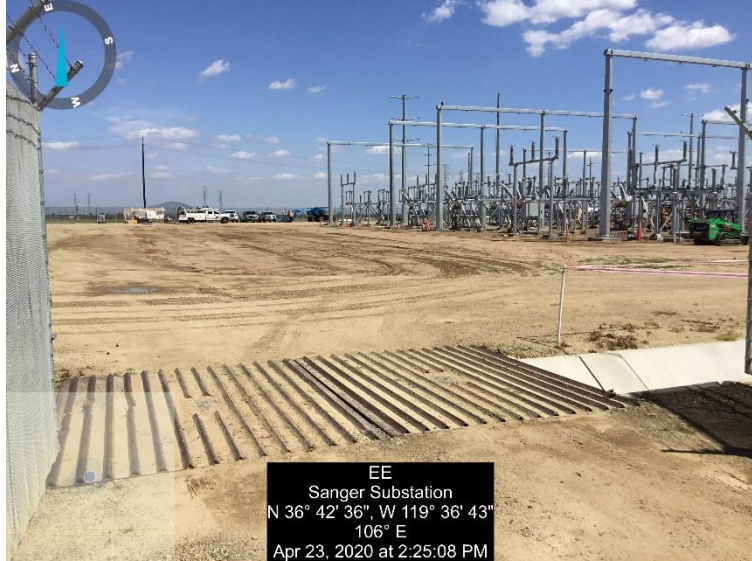
14:30 PM – In the north portion of the expansion footprint, I observed that the soil stockpile was removed and that area was regraded (Photo 4). I continued to the east site boundary and proceeded south along the east boundary. Mechanical owls remained in use on top of multiple structures to repel wildlife. Additional noisemakers were installed on permanent structures (Photo 5). I observed that vehicles and equipment were parked out of the work area and path of travel when not in use (Photo 6).

<p data-bbox="716 1293 943 1394"> EE Sanger Substation N 36° 42' 36", W 119° 36' 43" 106° E Apr 23, 2020 at 2:25:08 PM </p>	Photo 4 – Stockpiled soil was removed and the area was regraded. Photo facing east.

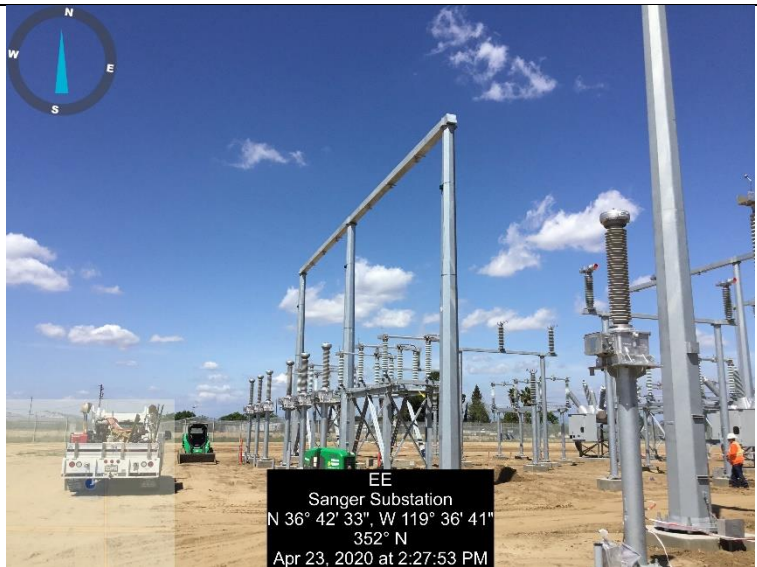
Photo 5 – Noisemakers were installed on multiple structures to repel wildlife. Photo facing north.
04/23/20	Expansion footprint

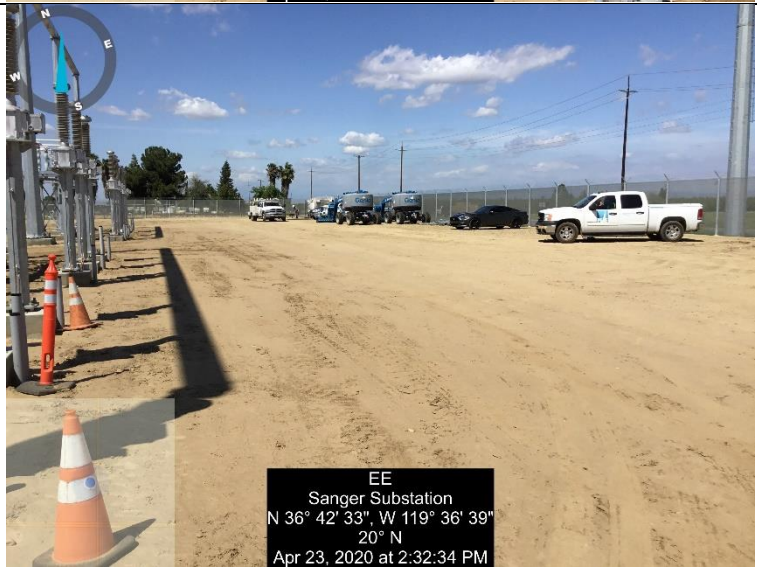
Photo 6 – Vehicles and equipment were parked away from the path of travel when not in use. Photo facing north.
