**Re: Monthly Report Summary #19 for the Sanger Substation Expansion Project**

## Sanger Substation Expansion Project CPUC Compliance Monitoring Report

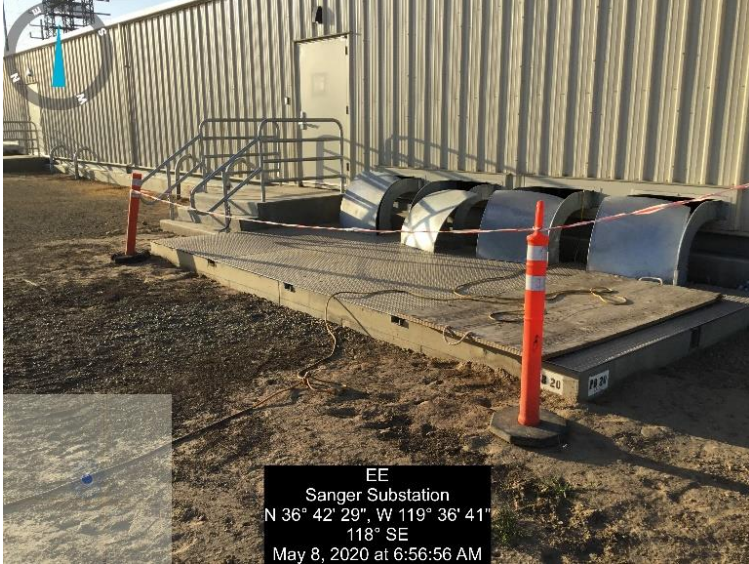
07:00 AM – A new civil crew commenced work onsite. Facilities had secondary containment (Photo 4). I proceeded north into the expansion footprint. I observed that vegetation management had commenced to reduce weeds (Photo 2). Additionally, I observed ducts were installed to connect the control buildings with the vaults directing conduit throughout the expansion footprint (Photo 3).

Photo 3 – Crews have installed ducting to connect vaults to control buildings. Photo facing east.
05/08/20	Expansion footprint

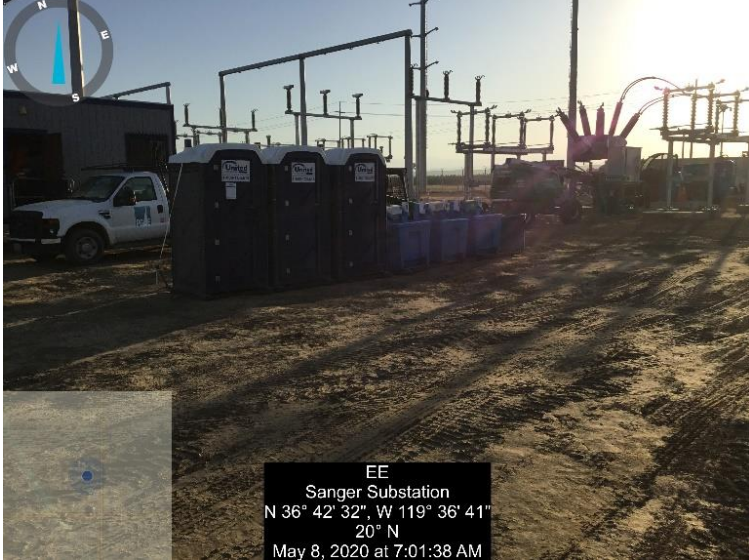
Photo 4 – A new civil crew commenced work onsite. Facilities have secondary containment. Photo facing northeast.

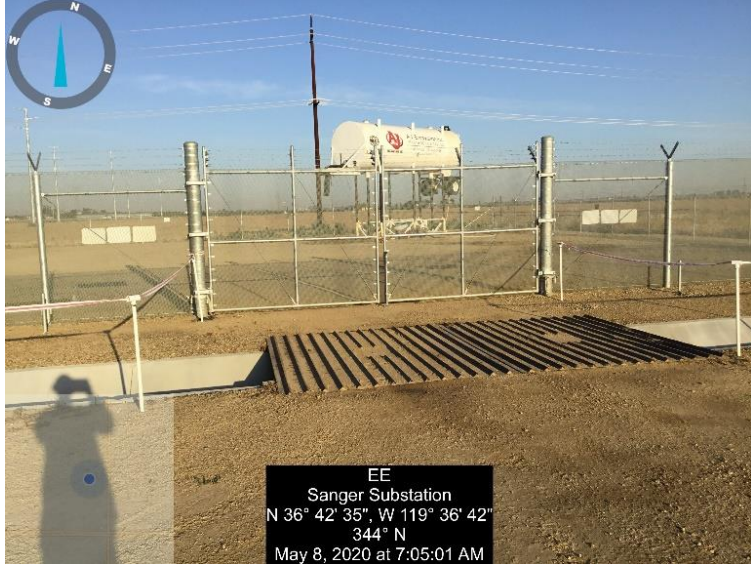
07:10 AM – I continued north along the west drainage swale. Both gates of the temporary staging area remained locked while the area was not in use (Photo 5).

Photo 5 – The temporary staging area was locked while not in use. Photo facing west.
05/08/20	Existing substation footprint

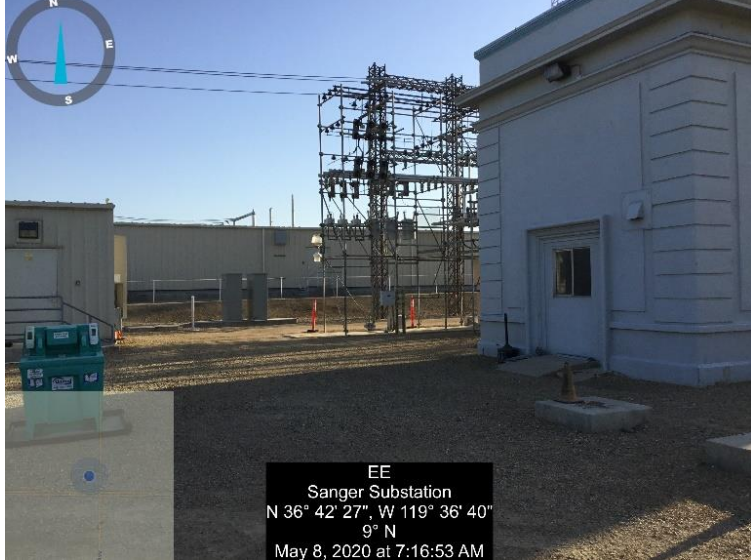
Photo 6 – Mourning dove nest buffer was removed. Photo facing north.

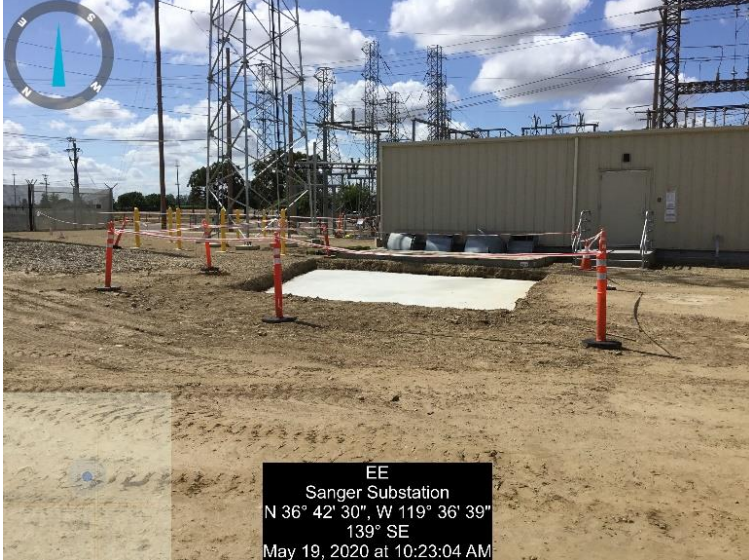
10:15 AM – I proceeded north into the expansion footprint and observed crews feeding wires into the conduit banks in the vaults north of the control buildings, at the southern end of the expansion footprint. In previous weeks, crews installed concrete foundations above conduit bundles that cross under future paths of vehicular travel (Photo 2), and these areas were delineated to prevent pedestrian and vehicular access while the concrete cures. I travelled east toward the expansion footprint fence. At the southeast entrance of the expansion footprint, I observed the nest buffer for the western kingbird partial nest in the microwave tower (Photo 3).

<p>EE Sanger Substation N 36° 42' 30", W 119° 36' 39" 139° SE May 19, 2020 at 10:23:04 AM</p>	Photo 3 – A protective buffer was installed around the microwave tower housing western kingbird nesting materials. Photo facing south.
05/19/20	Expansion footprint

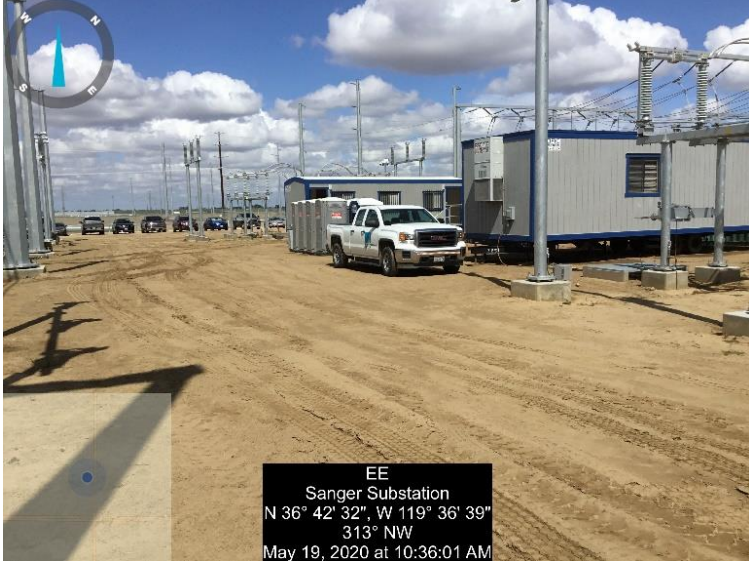
10:20 AM – I continued north through the edge of the work area and observed the new crew trailers located in a central position, vehicles parked out of the path of travel, and portable toilets and wash stations were secondarily contained (MM HAZ-1) (Photo 4). I continued to the north boundary of the expansion footprint.

<p>EE Sanger Substation N 36° 42' 32", W 119° 36' 39" 313° NW May 19, 2020 at 10:36:01 AM</p>	Photo 4 – A new civil crew commenced work onsite where facilities had secondary containment. Photo facing northwest.

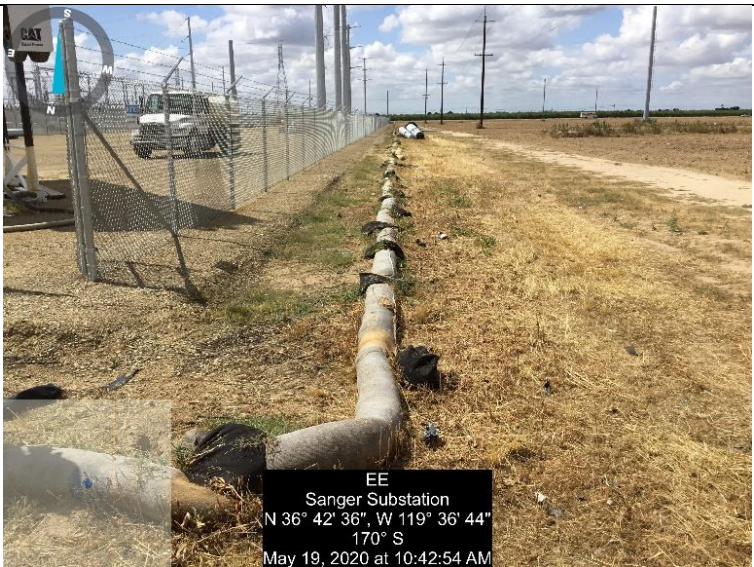
10:30 AM – I followed the north boundary, passed through the temporary staging area, through the northwest gate of the temporary staging area to the northeast corner of the project footprint. I observed fiber rolls and sandbags were maintained or replaced, as necessary, during vegetation management (Photo 5).

Photo 5 – Fiber rolls were replaced, as necessary, and vegetation established on both sides, providing extra sediment control. Photo facing south.
05/19/20	Expansion footprint

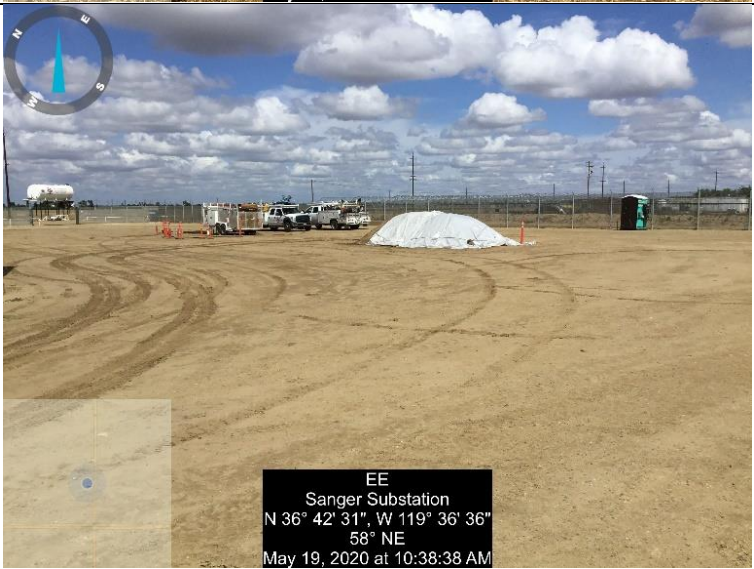
10:40 AM – I returned through the northwest gate into the expansion footprint and documented the soil stockpile covered near the north boundary of the expansion footprint (Photo 6).

Photo 6 – Earthmoving commenced, and the soil stockpiled was covered when not actively used. Photo facing northwest.
