Re: Monthly Report Summary #21 for the Sanger Substation Expansion Project

Sanger Substation Expansion Project CPUC Compliance Monitoring Report

Project Proponent	Pacific Gas & Electric (PG&E)	Report No.	CM-CPUCDG-071020
Lead Agency	California Public Utilities Commission (CPUC)	Date (mm/dd/yy)	07/10/20
CPUC Project Manager	Billie Blanchard	Monitor(s)	Sam Hopstone
CPUC (E & E) Monitoring Manager	Silvia Yanez	AM/PM Weather	Clear, 90°F, calm
CPUC (E & E) Monitoring Supervisor	Angelica Oregel	Start/End time	1030 AM – 1115 AM
Project NTP(s)	Notice to Proceed (NTP) #2

Project Proponent	Pacific Gas & Electric (PG&E)	Report No.	CM-CPUCDG-072220
Lead Agency	California Public Utilities Commission (CPUC)	Date (mm/dd/yy)	07/22/20
CPUC Project Manager	Billie Blanchard	Monitor(s)	Sam Hopstone
CPUC (E & E) Monitoring Manager	Silvia Yanez	AM/PM Weather	Clear, 81°F, calm
CPUC (E & E) Monitoring Supervisor	Angelica Oregel	Start/End time	0800 AM – 0845 AM
Project NTP(s)	Notice to Proceed (NTP) #2

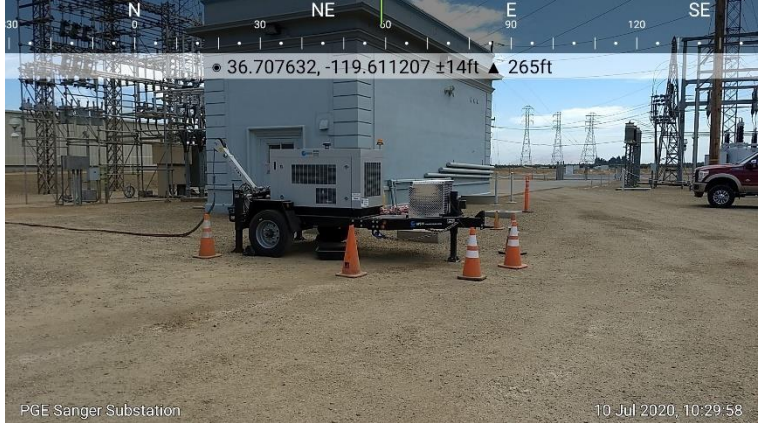
Photo 1- Generator with secondary containment. Photo facing northeast.
07/10/20	Existing Substation Footprint

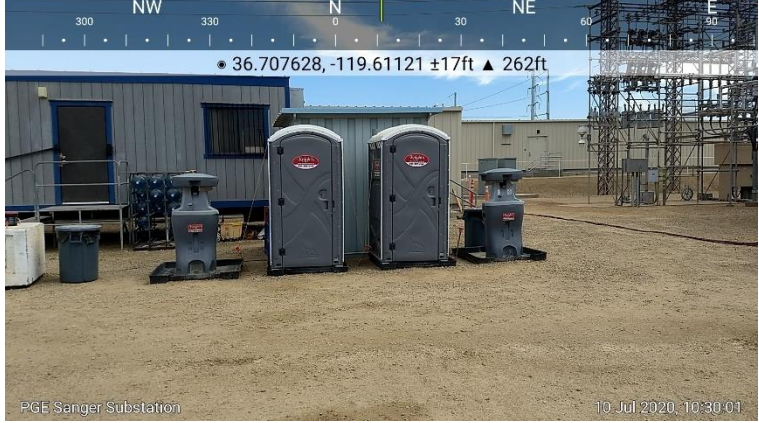
1030 AM – I arrived onsite and entered through the south gate into the existing substation footprint. I checked in with the SWCA biologist Angelica Oregel. Current activity included wiring in breaker boxes and pulling wire through underground conduit. Future activities included the same including line crews hand wiring in upper connections and poles. Ms. Oregel reported that there were no buffers in use on site, and the primary species observed were red tailed hawks (*Buteo jamaicensis*) and house sparrows (*Passer domesticus*). Ms. Oregel conducted daily sweeps for sensitive species before commencement of work (MM BIO-2, MM BIO-3). I observed that a new generator was in place near the construction trailers with secondary containment in place (Photo 1) and the portable toilets containment remained in good condition (Photo 2).

Photo 2- Portable toilets and handwash station with secondary containments in place. Trash receptacles were covered with sturdy lids. Photo facing north.

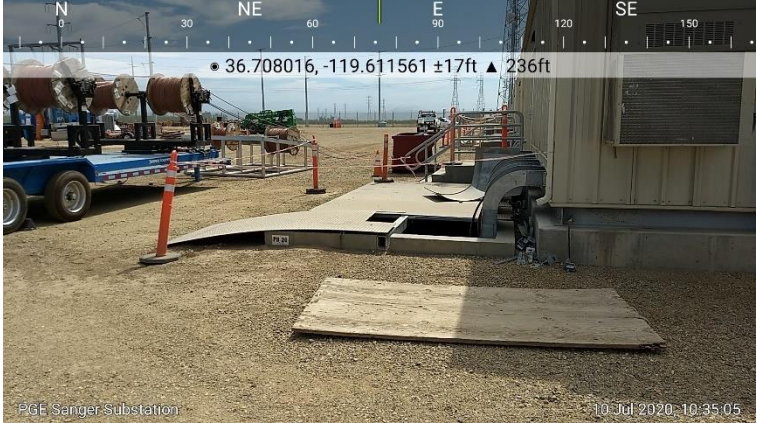
1040 AM – I proceeded southwest to the detention basin and observed that the entire basin remained in good condition (APM GEO-2). I headed north into the expansion footprint where crews were pulling wire through the conduit entries in the vaults at the south of the expansion footprint. All vaults with the lids removed for the day were delineated and roped off to prevent pedestrian access (Photo 3). I headed east to the east boundary fence.

<p>Photo 3 shows a construction site at PGE Sanger Substation. A blue truck is on the left, and a large metal structure is in the center. The photo is facing east. The top of the photo has a compass overlay with directions N, NE, E, SE and a scale from 0 to 150. The coordinates are 36.708016, -119.611561 ±17ft ▲ 236ft. The bottom left corner says 'PGE Sanger Substation' and the bottom right corner says '10 Jul 2020, 10:35:05'.</p>	Photo 3- Crews were pulling wire through underground conduits. Photo facing east.
07/10/20	Expansion Footprint

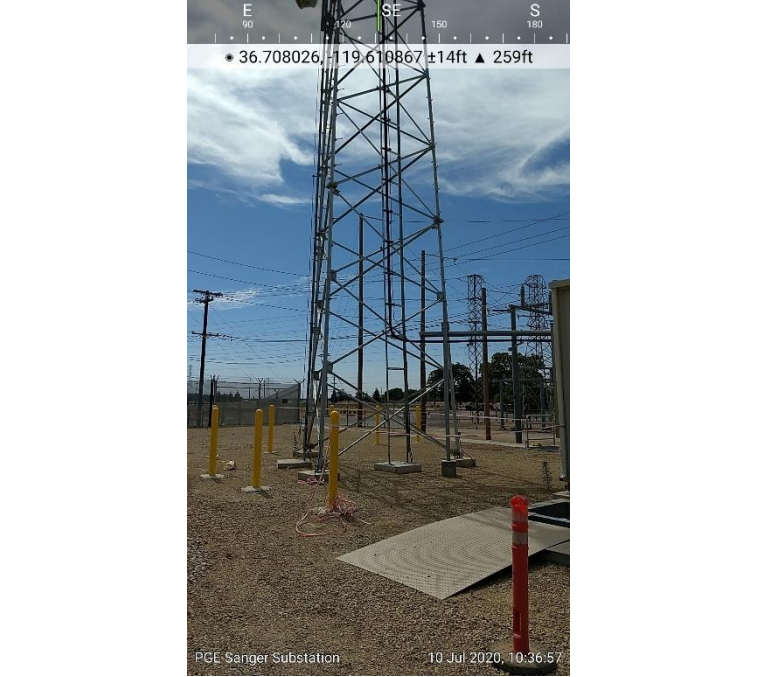
1050 AM – I observed that the buffer previously arranged around the microwave tower had been removed after CPUC approval (Photo 4). I observed that heavy equipment in the expansion footprint had drip pans placed below oil sumps (Photo 5). I proceeded north along the east boundary.

<p>Photo 4 shows a microwave tower at PGE Sanger Substation. The tower is a lattice structure. The photo is facing southeast. The top of the photo has a compass overlay with directions E, SE, S and a scale from 0 to 180. The coordinates are 36.708026, -119.610867 ±14ft ▲ 259ft. The bottom left corner says 'PGE Sanger Substation' and the bottom right corner says '10 Jul 2020, 10:36:57'.</p>	Photo 4- Fledglings had left the nest in the microwave tower; buffer removal was approved and completed. Photo facing southeast.

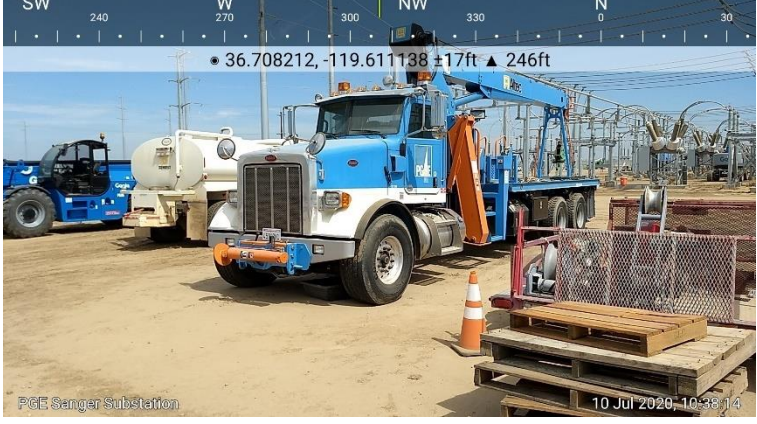
<p>Photo 5 shows heavy equipment at PGE Sanger Substation. A blue truck with a crane is the main focus. The photo is facing northwest. The top of the photo has a compass overlay with directions SW, W, NW, N and a scale from 0 to 300. The coordinates are 36.708212, -119.611138 ±17ft ▲ 246ft. The bottom left corner says 'PGE Sanger Substation' and the bottom right corner says '10 Jul 2020, 10:38:14'.</p>	Photo 5- Heavy equipment had drip pans below oil sumps. Photo facing northwest.

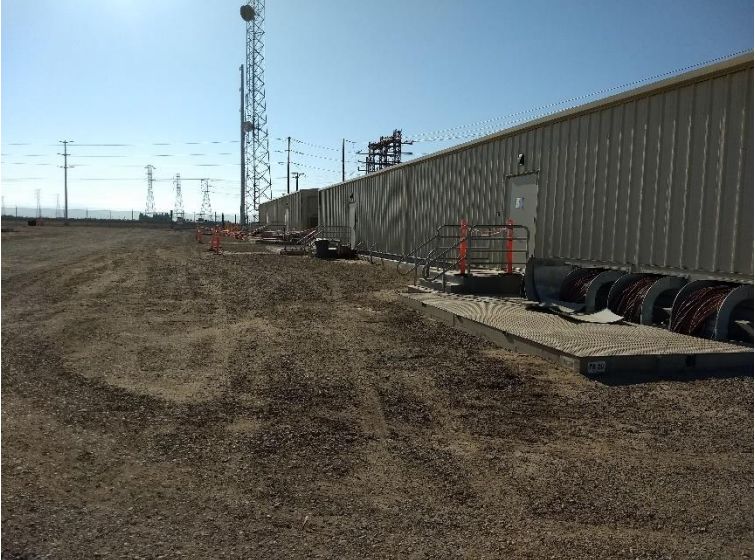
0820 AM – I observed equipment and materials to pull wire into the vaults in the southern portion of the expansion footprint, and into the underground conduits extending into the expansion footprint (Photo 2). I turned left and proceeded east through the southern gate of the temporary staging area. No construction activities were ongoing in the temporary staging area, and most equipment and materials had been removed (Photo 3). Ms. Oregel confirmed she included the temporary staging area in her wildlife sweeps. I exited the area through the south gate and proceeded into the southwest corner of the expansion footprint.

Photo 2- The westernmost vault conduits had been filled, and the vault covered. Photo facing east.
07/22/20	Temporary Staging Area

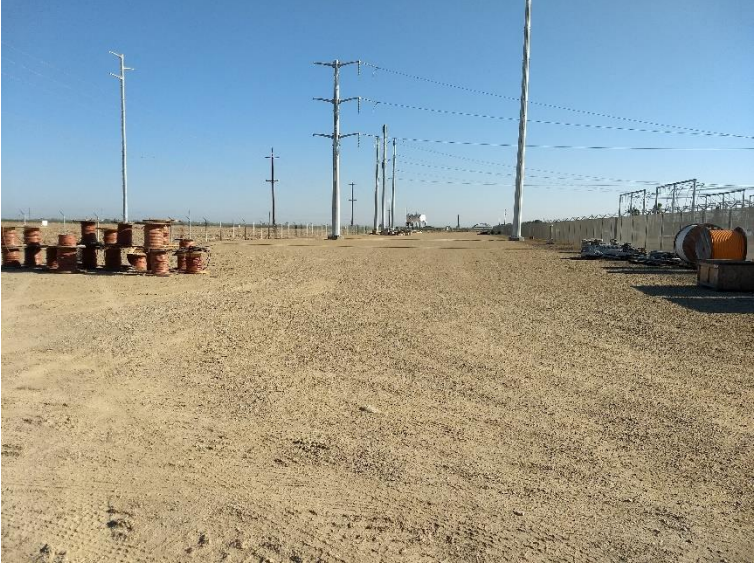
Photo 3- Most equipment and materials had been removed from temporary staging area, except the wire spools. No activity was underway in the temporary staging area. Photo facing north.
