**Re: Monthly Report Summary #22 for the Sanger Substation Expansion Project**

## Sanger Substation Expansion Project CPUC Compliance Monitoring Report

<b>Project Proponent</b>	Pacific Gas & Electric (PG&E)	<b>Report No.</b>	CM-CPUCDG-080420
<b>Lead Agency</b>	California Public Utilities Commission (CPUC)	<b>Date (mm/dd/yy)</b>	08/04/20
<b>CPUC Project Manager</b>	Billie Blanchard	<b>Monitor(s)</b>	Sam Hopstone
<b>CPUC (E &amp; E) Monitoring Manager</b>	Silvia Yanez	<b>AM/PM Weather</b>	Clear, 74°F, calm
<b>CPUC (E &amp; E) Monitoring Supervisor</b>	Angelica Oregel	<b>Start/End time</b>	0800 AM – 0900 AM
<b>Project NTP(s)</b>	Notice to Proceed (NTP) #2

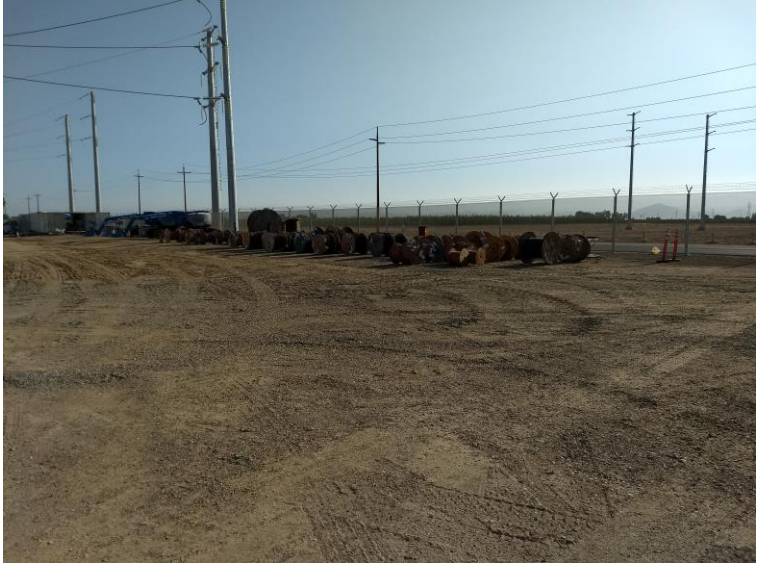
0810 AM – I headed south along the eastern boundary of the stormwater detention basin to the south fence. I observed no ongoing construction activities in the existing substation footprint. The stormwater detention basin was dry, and concrete sidewalls remained in good condition. I proceeded north into the southwest corner of the expansion footprint. I observed that vaults and conduit paths were covered when wire pulling was completed (Photo 1). I proceeded east along the south boundary of the expansion footprint to the east boundary fence. I travelled north along the east boundary fence and observed that equipment and materials were staged out of the path of travel (Photo 2).

Photo 2- Equipment and materials were staged out of the path of travel. Photo facing northeast.
08/04/20	Expansion Footprint

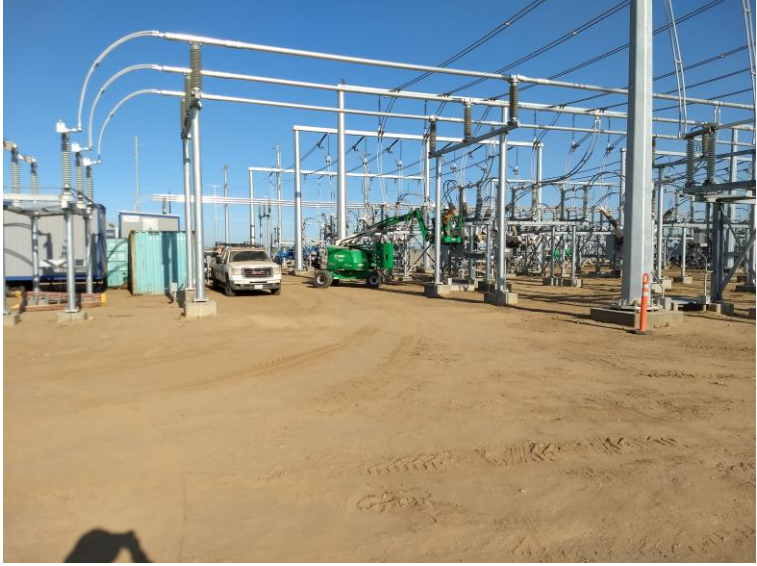
0820 AM – I observed crews on the ground and in manlifts setting switches in the expansion footprint (Photo 3). Equipment not currently used was parked out of the path of travel and engines turned off (APM GHG-1). I continued north to the northeast corner of the project footprint. I turned left and proceeded west along the north boundary fence to the west swale. I observed that where soil was stockpiled in the northern open area for several months that the ground surface remained compacted and no vegetation had established. I travelled south along the west swale.

Photo 3- Crews set switches in the expansion footprint. Photo facing west.

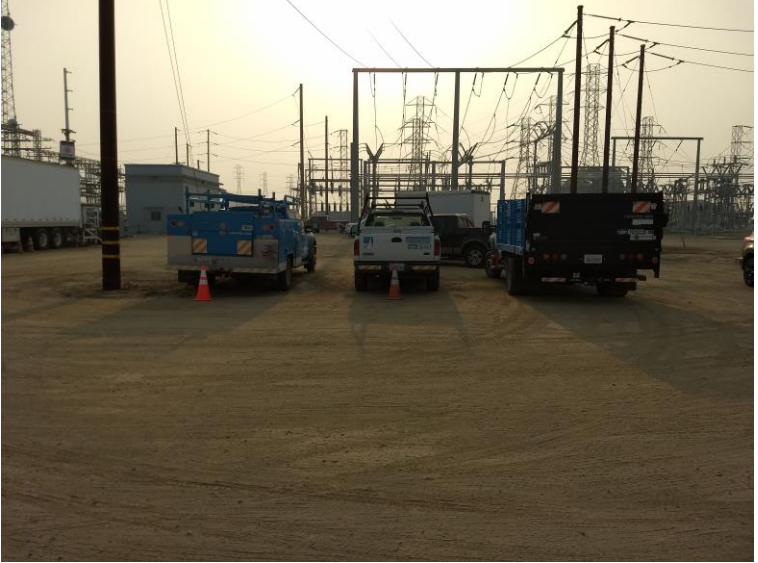
Photo 1- Vehicles turned off when not in use. Photo facing east.
08/21/20	Expansion Footprint

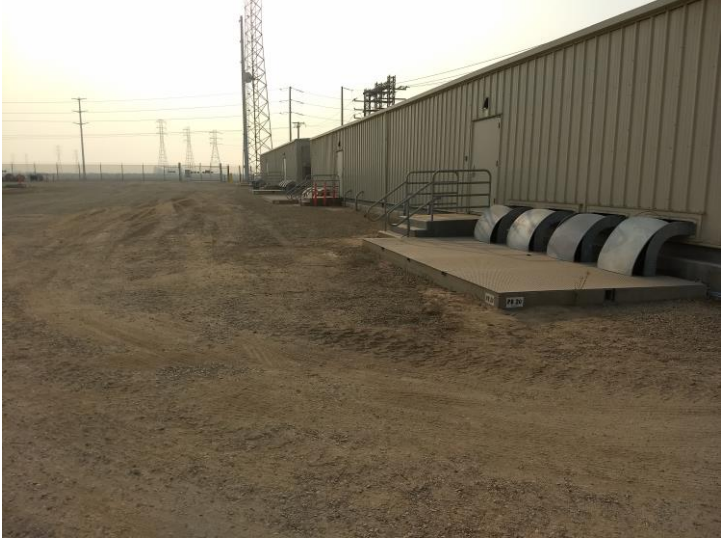
0805 AM – I headed south along the western site boundary to the south fence and observed no ongoing construction activities in the existing substation footprint. The stormwater detention basin was dry, and the concrete sidewalls remained in good condition. Vehicles were parked out of the path of travel, delineated when needed, and turned off when not in use (Photo 1) (APM NOI-4). I proceeded north into the expansion footprint and observed that vaults and conduit paths were covered (APM HAZ-3) (Photo 2). I turned left and headed west into the temporary staging area.

Photo 2- Control room transfer conduits and vaults were covered and protected. Photo facing east.

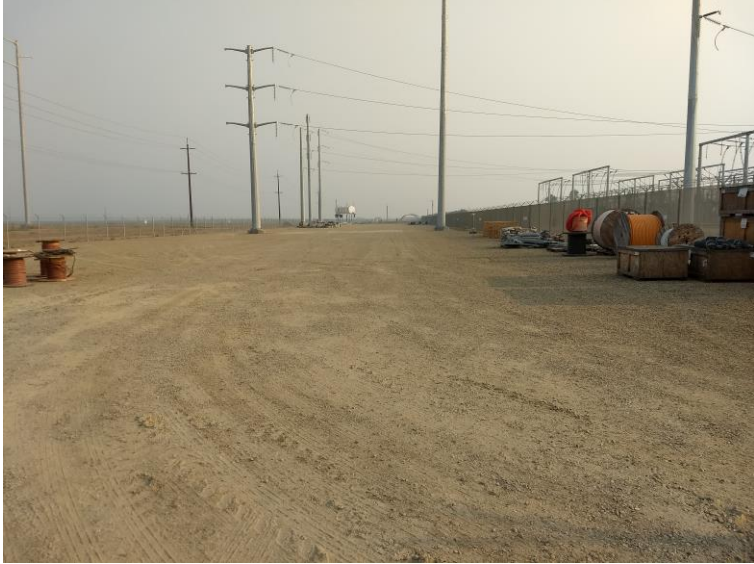
0810 AM – I observed no activity in the temporary staging area. Ms. Oregel confirmed that the gates were usually locked, and the yard was used for material storage (Photo 3). I returned to the south gate of the staging area and proceeded east into the expansion footprint. I observed that most interior cables had been hung between transformers and switch stations. Some connections had been hung to the surrounding tubular steel poles (TSP) (Photo 4).

Photo 3- No activity occurred in the temporary staging area. Photo facing north.
08/21/20	Expansion Footprint

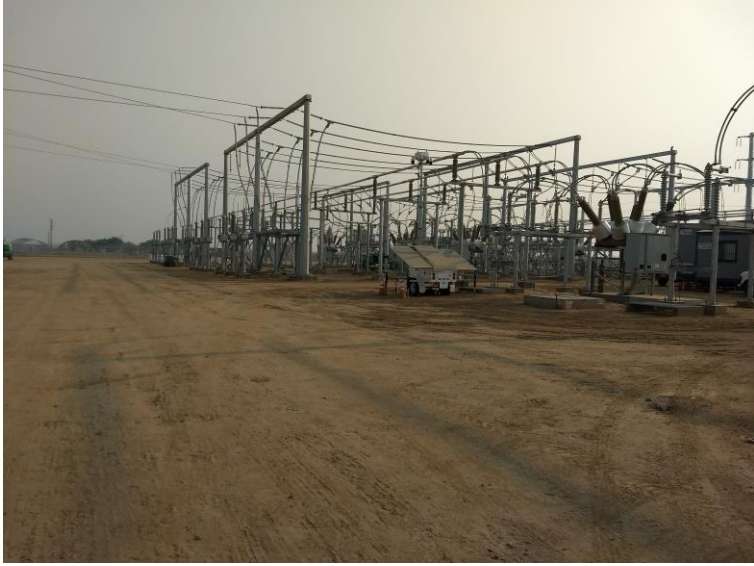
Photo 4- Most interior cables were hung within the station. Photo facing northeast.
