Re: Monthly Report Summary #5 for the Sanger Substation Expansion Project

Sanger Substation Expansion Project CPUC Compliance Monitoring Report

Project Proponent	Pacific Gas & Electric (PG&E)	Report No.	CM-CPUCBA-031419
Lead Agency	California Public Utilities Commission (CPUC)	Date (mm/dd/yy)	03/14/19
CPUC Project Manager	Michael Rosauer	Monitor(s)	Ben Arax
CPUC (Ecology and Environment, Inc., member of WSP [E & E]) Monitoring Manager	Ilja Nieuwenhuizen	AM/PM Weather	57° F, Sunny, Wind SSE 5 miles per hour (mph)
CPUC (E & E) Monitoring Supervisor	Aileen Cole	Start/End Time	11:00 AM – 12:25 PM
Project Notices to Proceed NTP(s)	NTP #1

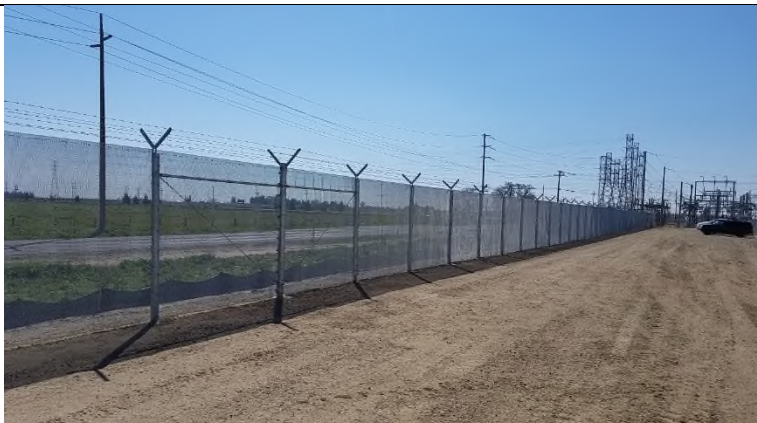
Photo 1- Permanent fencing installed along McCall Avenue. Photo facing southeast.	
03/14/19	Expansion footprint

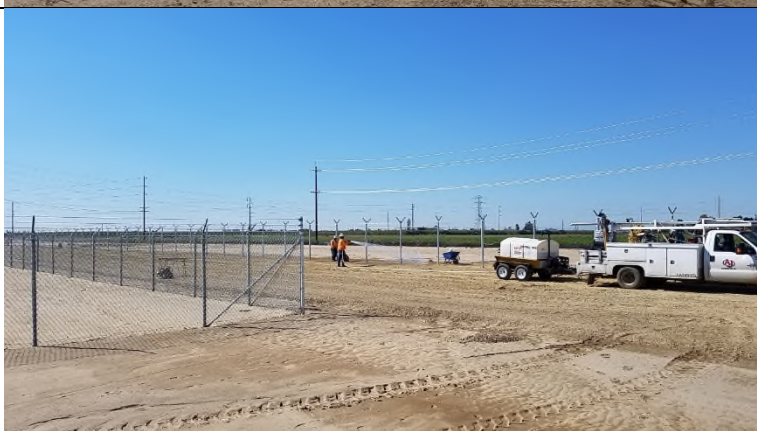
Photo 2- An AJ Excavation crew watering and compacting soil to install fence posts. Photo facing southwest.

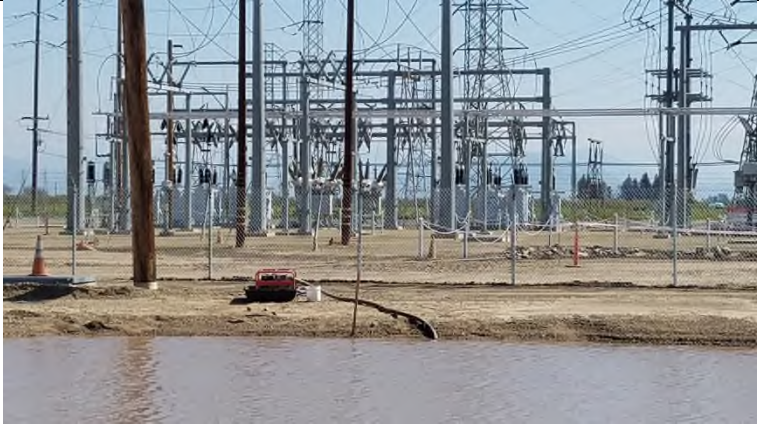
11:28 AM- At the start of the inspection, I observed a crew installing permanent fencing and the foundations for the substation structures (Photos 1, 2, 4, 5, 6, and 7). I also observed a pump diverting water from the substation expansion footprint retention basin into the retention basin within the existing substation footprint (Photo 3).

Photo 3- Pump and hose diverting water from the retention basin into the existing substation. Photo facing east.
03/14/19	Expansion footprint

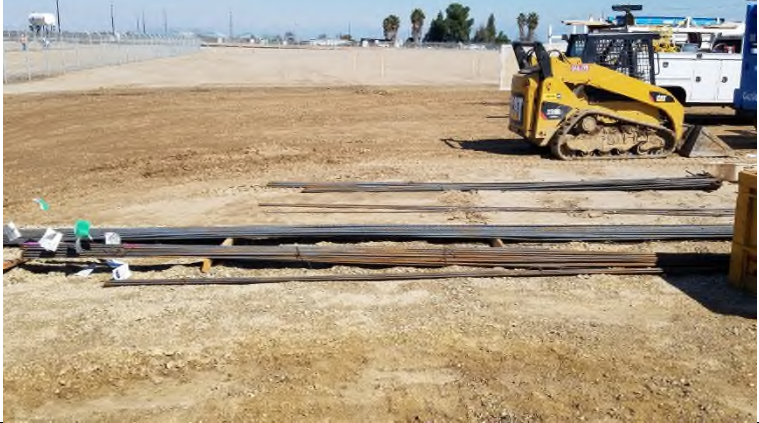
Photo 4- Rebar for foundation installations. Photo facing north.
03/14/19	Expansion footprint

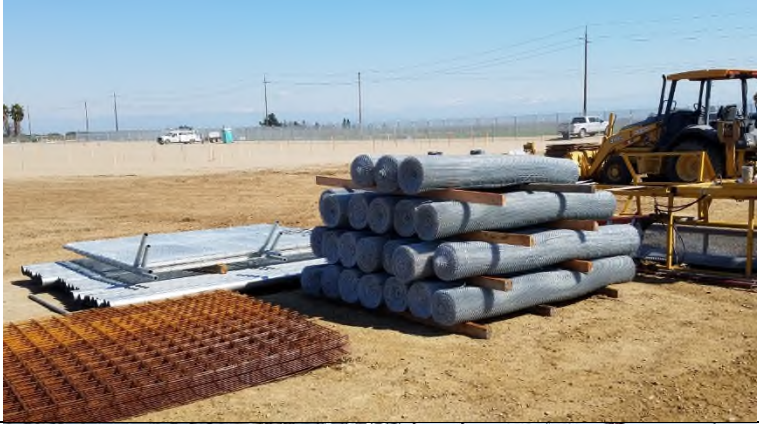
Photo 5- Materials for fence and foundation installations. Photo facing northeast.
03/14/19	Expansion footprint

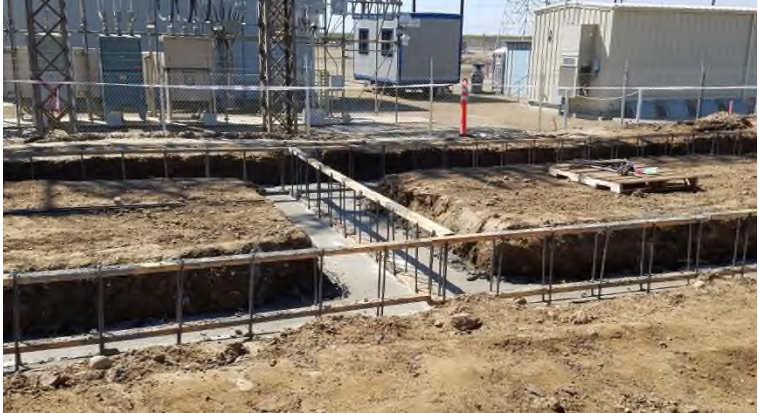
Photo 6- Concrete poured for the foundations. Photo facing south.

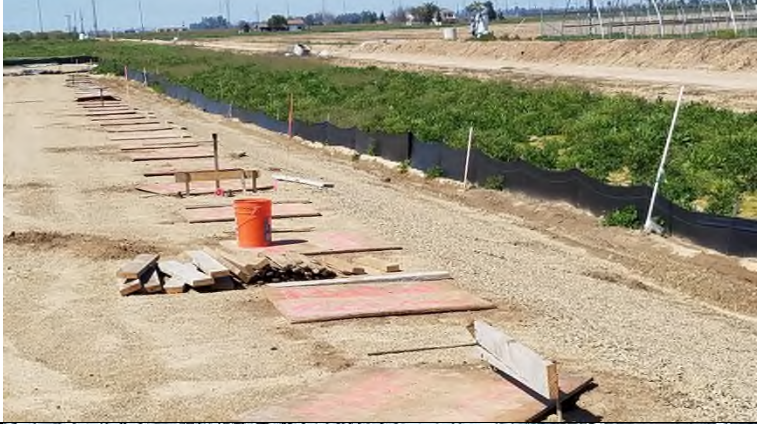
Photo 7- Covered holes/excavations for permanent fence installation. Photo facing northwest.
03/14/19	Existing substation

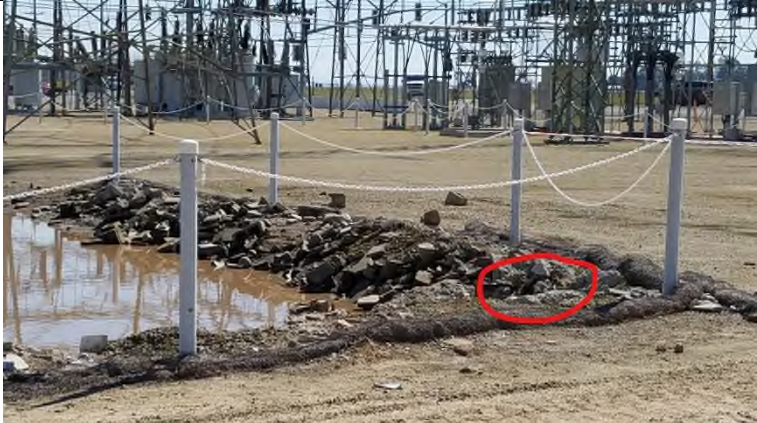
11:46 AM- I requested that Ms. Castañon escort me to the Killdeer nest buffer boundaries. Ms. Castañon stated that one nest buffer reduction was approved by the CPUC (Photo 8), while the other (the nest south of the northern access road) does not currently have a reduced buffer. At the Killdeer nest within the existing substation footprint (nest KILL02), the adult killdeer was a few feet away from the nest (not on it). At the other Killdeer nest (nest KILL01, located south of the northern access road), the adult killdeer was observed sitting on the nest (Photo 9). Appropriate signage and buffers were observed for both nests (Photo 10). Neither sensitive resource was impacted by project-related activities (MM BIO-4).

Photo 8- Killdeer immediately south of its nest (KILL02), located on the edge of the existing substation retention basin. Photo facing southeast.
03/14/19	Expansion footprint

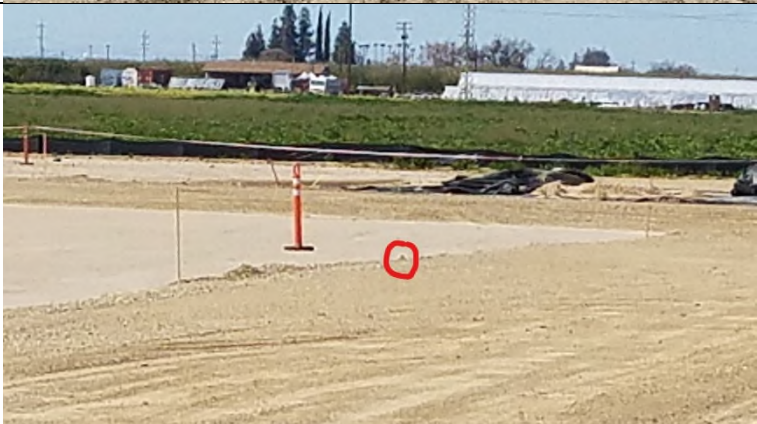
Photo 9- Killdeer sitting on nest (KILL01) immediately south of northern access road. Photo facing southwest.
03/14/19	Expansion footprint

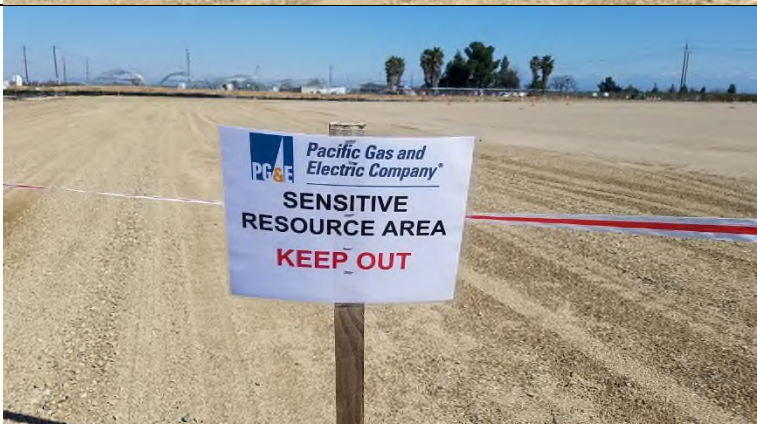
Photo 10- Signage designating sensitive resources (Killdeer nest). Photo facing north.

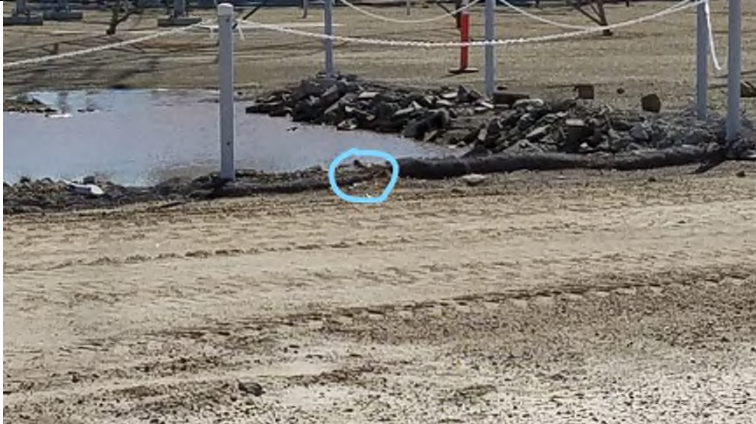
Photo 5- Killdeer observed on nest (KILL02). Photo facing east.
03/29/19	Temporary staging area

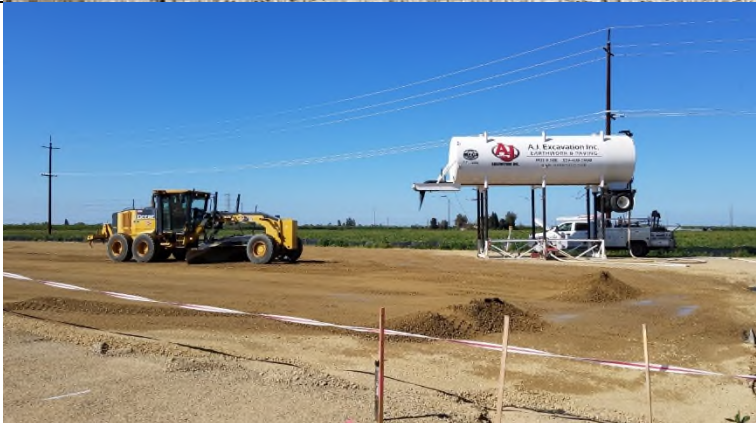
Photo 6- Blade grading staging area. Photo facing southwest.
03/29/19	Expansion footprint

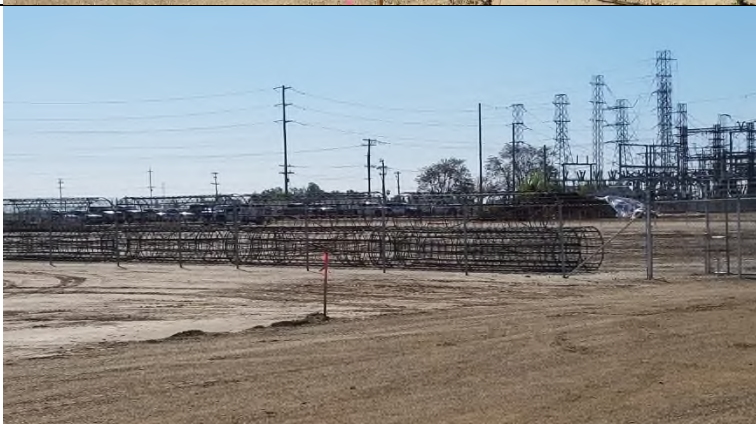
Photo 7- Rebar and other construction materials being stored for future use. Photo facing southeast.
03/29/19	Temporary staging area

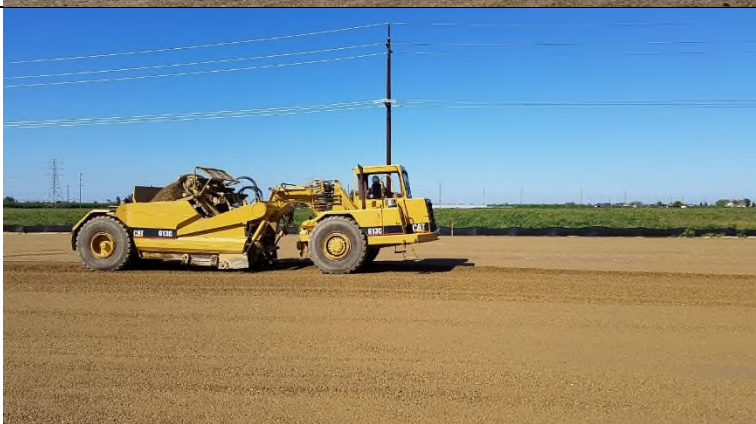
Photo 8- Scraper grading within the future staging area. Photo facing west.

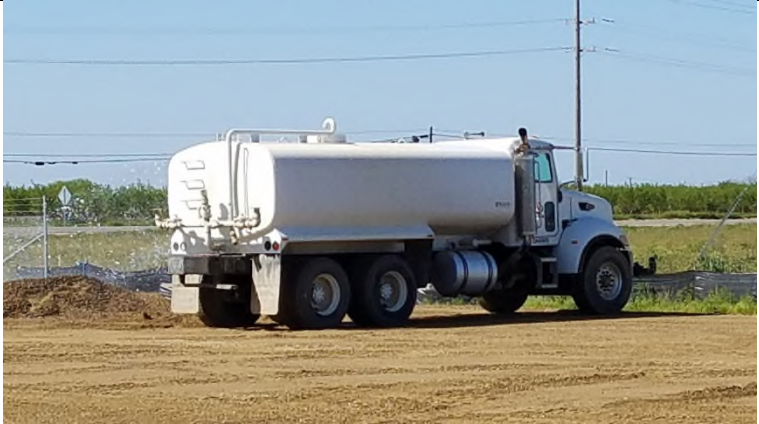
Photo 9- Water truck spraying water on soil. Photo facing southwest.
03/29/19	Temporary staging area

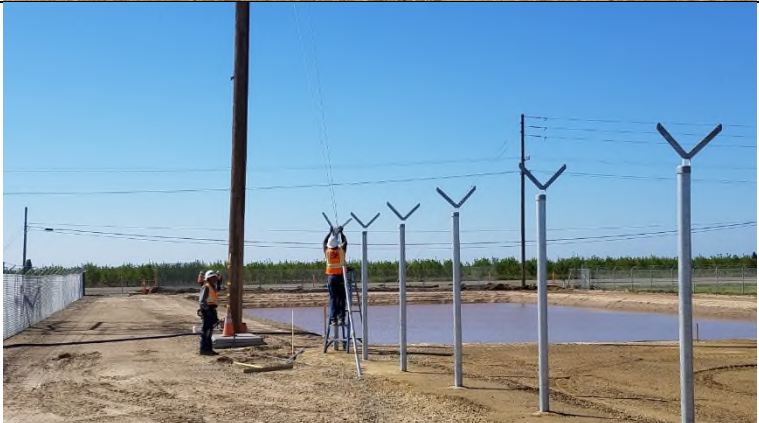
Photo 10- AJ excavation workers installing fence posts. Photo facing south.
03/29/19	Expansion footprint

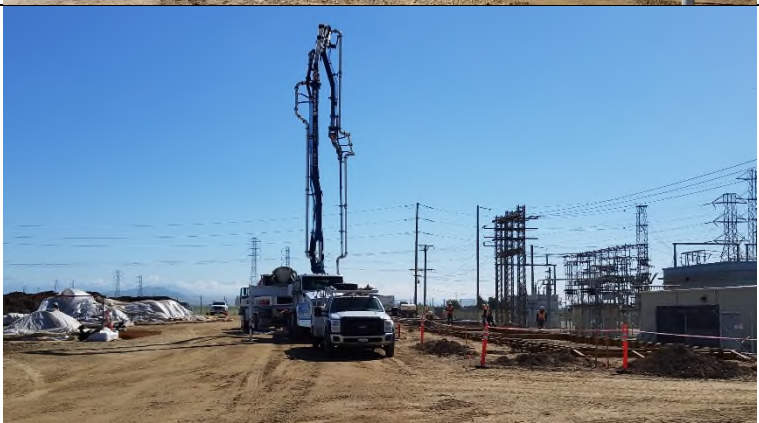
Photo 11- Crew pouring concrete for substation impact building. Photo facing east.
