Re: Monthly Report Summary #7 for the Sanger Substation Expansion Project

Sanger Substation Expansion Project CPUC Compliance Monitoring Report

| Project Proponent | Pacific Gas & Electric (PG&E) | Report No. | CM-CPUCBA-050919 |

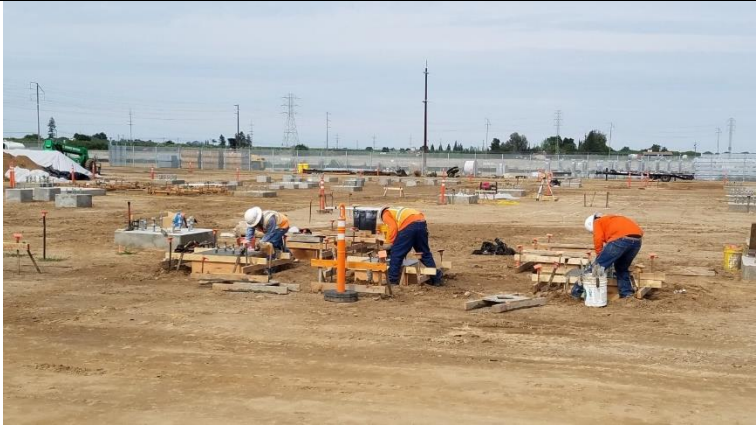
| REPRESENTATIVE SITE PHOTOGRAPHS | | | |
|---|---|--|--|
| 05/23/19 | Expansion footprint | | Photo 5- AJ crew working on freshly poured pole boxes. Photo facing southwest. |

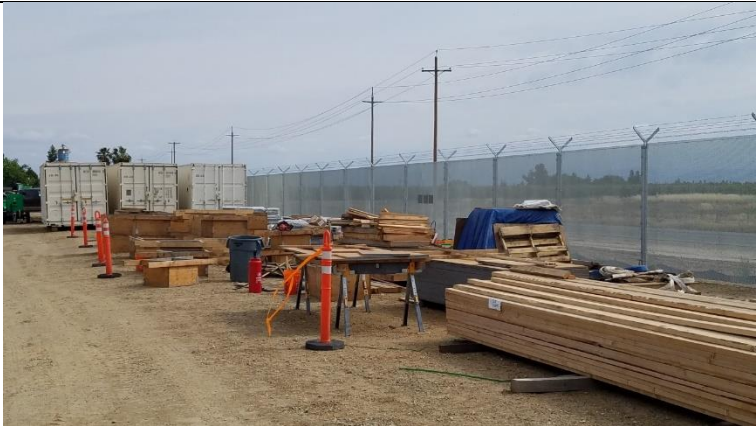
| REPRESENTATIVE SITE PHOTOGRAPHS | | | |
|---|---|--|--|
| 05/23/19 | Expansion footprint | | Photo 6- Materials kept away from work area. Photo facing northeast. |

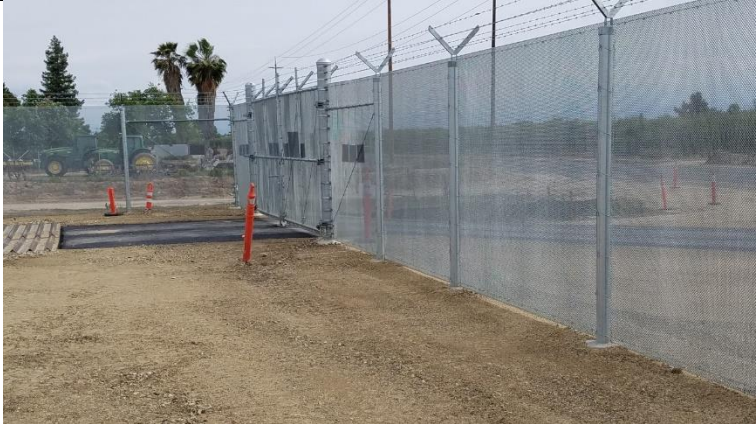
| REPRESENTATIVE SITE PHOTOGRAPHS | | | |
|---|---|--|---|
| 05/23/19 | Expansion footprint | | Photo 7- Newly paved road for egress point. Photo facing north. |

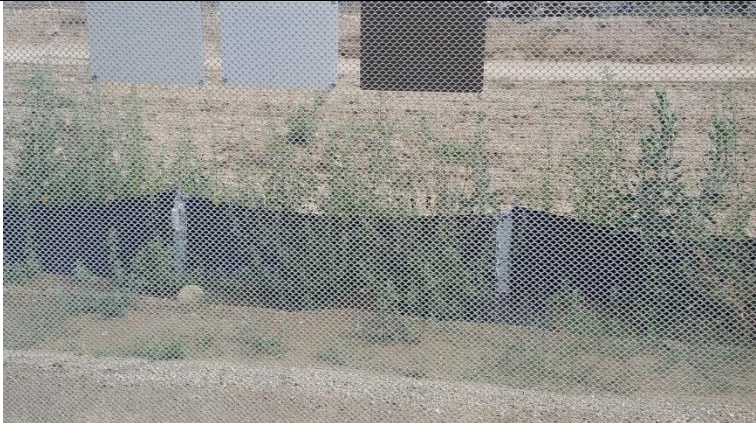
| REPRESENTATIVE SITE PHOTOGRAPHS | | | |
|---|---|--|---|
| 05/23/19 | Expansion footprint | | Photo 8- Silt fence weathered but maintained. Photo facing north. |

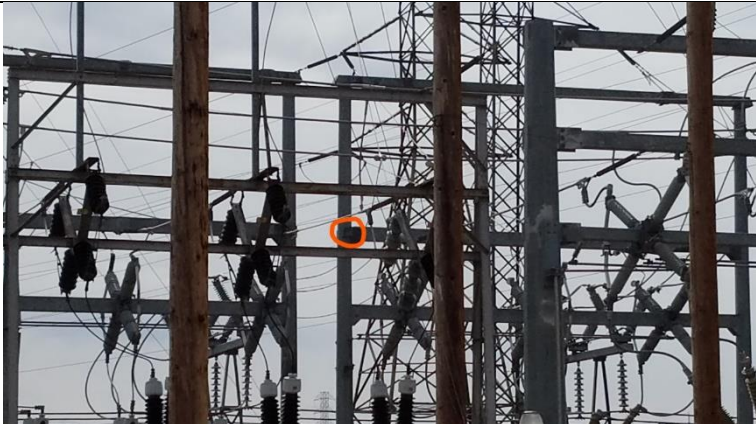
| REPRESENTATIVE SITE PHOTOGRAPHS | | | |
|---|---|--|---|
| 05/23/19 | Existing substation | | Photo 9- Kestrel nest located in existing substation; entrance is on top of the second beam. Photo facing east. |

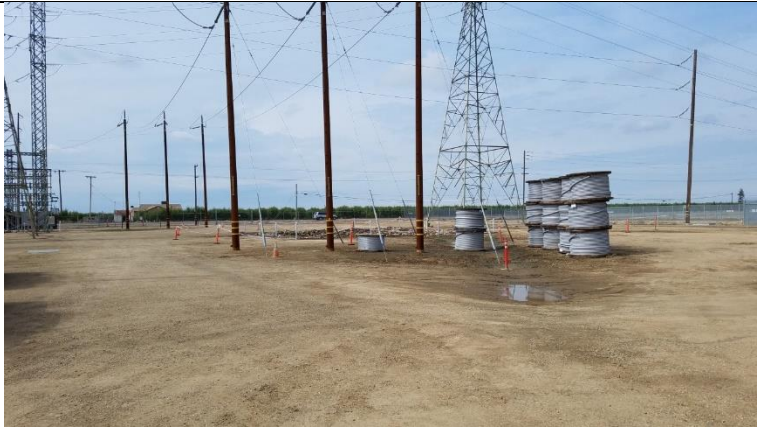
A Killdeer has built a nest on the outside of the northern fence of the substation expansion footprint. A buffer was placed around the resource, with only 13 feet of it entering the expansion footprint.

| REPRESENTATIVE SITE PHOTOGRAPHS | | | |
|--|---|---|---|
| 05/23/19 | Existing substation | | Photo 10- KILL 04 buffer still up; nest still active. Photo facing southwest. |

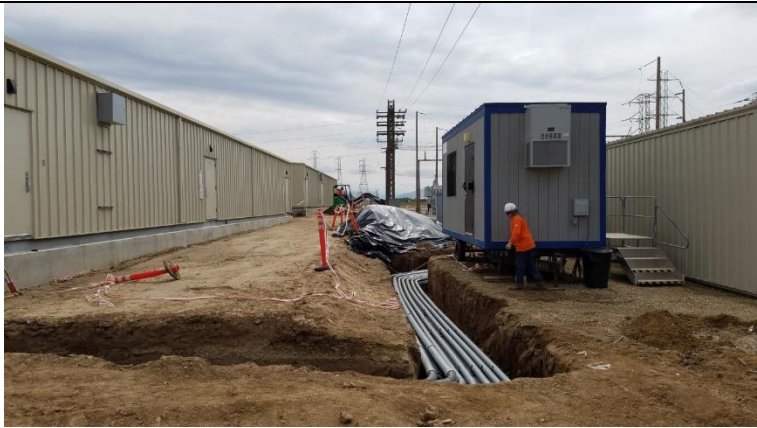
| REPRESENTATIVE SITE PHOTOGRAPHS | | | |
|--|---|---|---|
| 05/23/19 | Existing substation | | Photo 11- AJ crew performing utility relocation. Photo facing east. |
