Re: Monthly Report Summary #8 for the Sanger Substation Expansion Project

Sanger Substation Expansion Project CPUC Compliance Monitoring Report

Project Proponent	Pacific Gas & Electric (PG&E)	Report No.	CM-CPUCBA-060619
Lead Agency	California Public Utilities Commission (CPUC)	Date (mm/dd/yy)	06/06/19
CPUC Project Manager	Michael Rosauer	Monitor(s)	Ben Arax
CPUC (Ecology and Environment, Inc., member of WSP [E & E]) Monitoring Manager	Silvia Yanez	AM/PM Weather	Partly cloudy, 77°F, wind 10 miles per hour (mph)
CPUC (E & E) Monitoring Supervisor	Fernando Guzman	Start/End Time	8:56 AM – 9:30 AM
Project Notices to Proceed NTP(s)	NTP #2

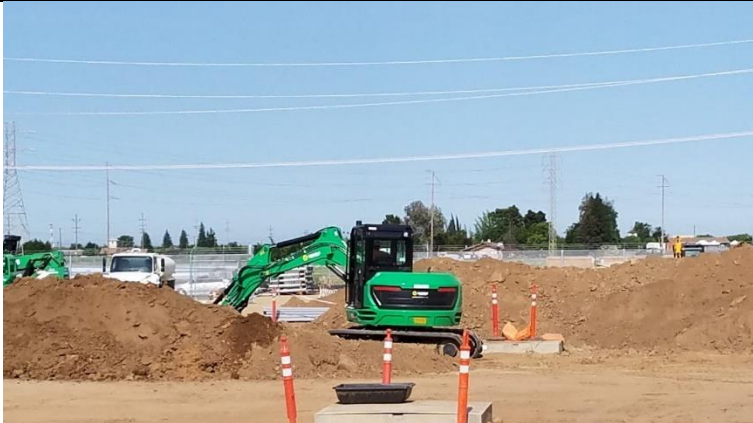
Photo 1- Crew excavating trenches for utility line. Photo facing west.
06/06/19	Expansion footprint

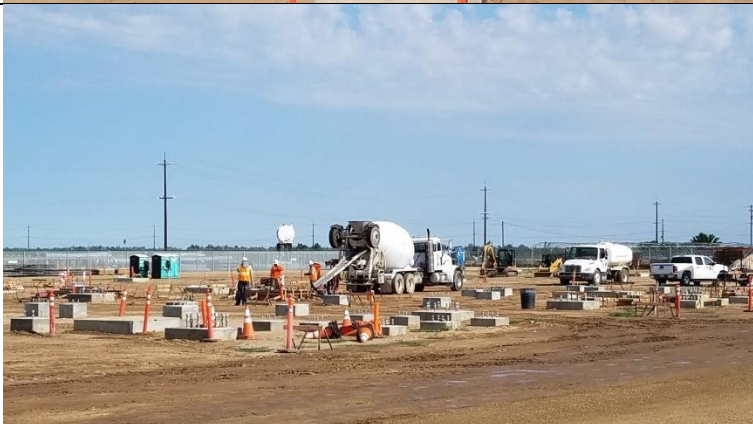
Photo 2- Crew constructing breaker pads. Photo facing northwest.
06/06/19	Expansion footprint

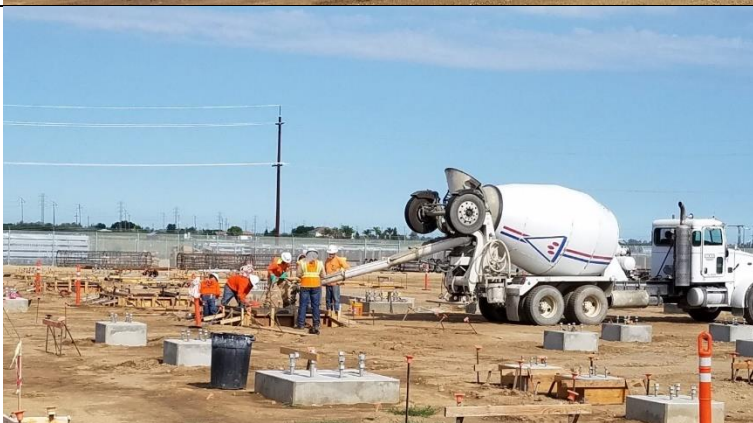
Photo 3- Crew pouring concrete for breaker pads. Photo facing northwest.
06/06/19	Expansion footprint

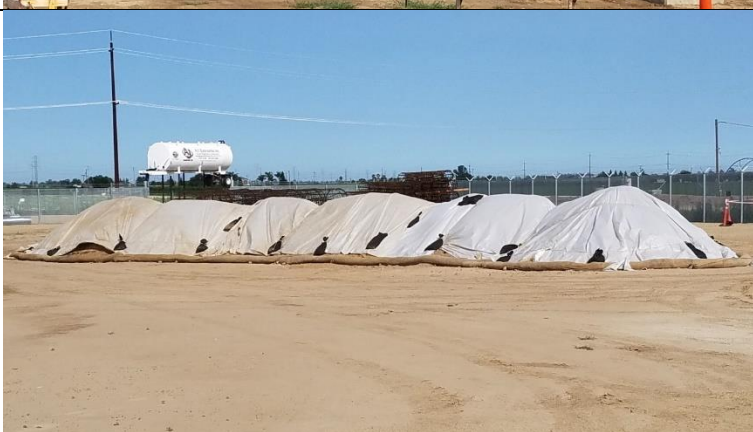
Photo 4- Soil temporarily stored. Photo facing northwest.

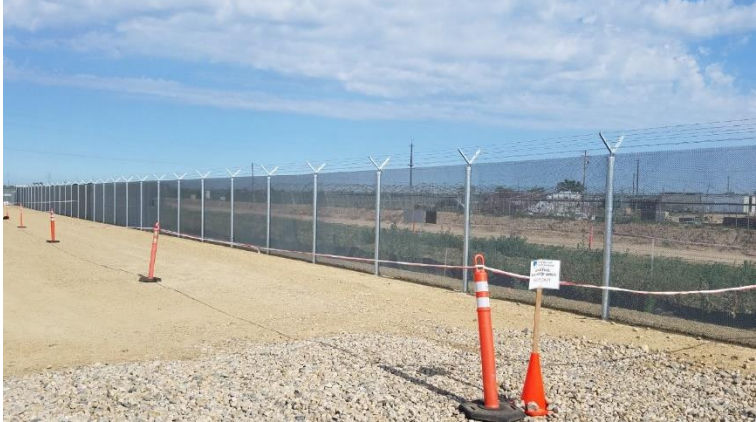
A Killdeer built a nest on the outside of the northern fence of the substation expansion footprint. A buffer was placed around the resource, with only 13 feet of it entering the expansion footprint.

Photo 5- Buffer reduced for KILL 05. Photo facing northwest.
06/06/19	Expansion footprint

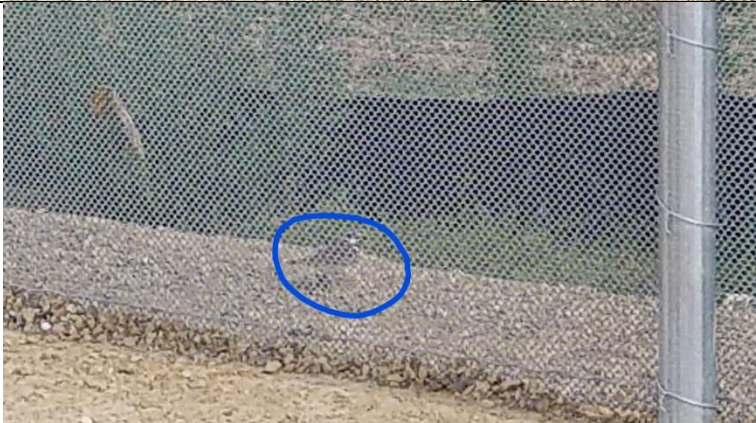
Photo 6- Killdeer adult inside the buffer, outside the fence. Photo facing northwest.
06/06/19	Temporary staging area

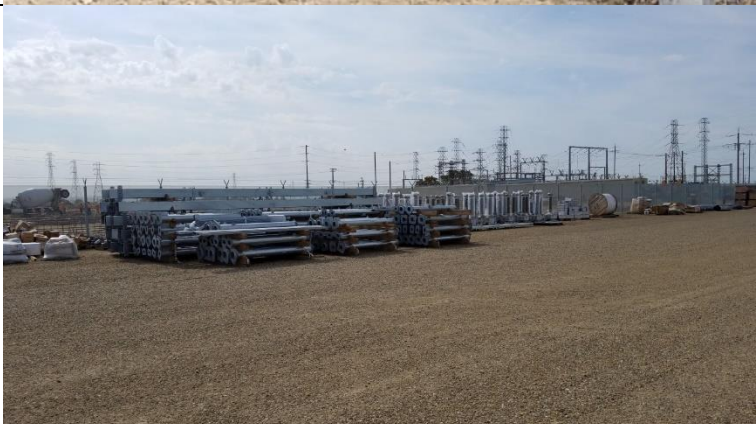
Photo 7- Substation parts stored for future construction. Photo facing southeast.
06/06/19	Expansion footprint

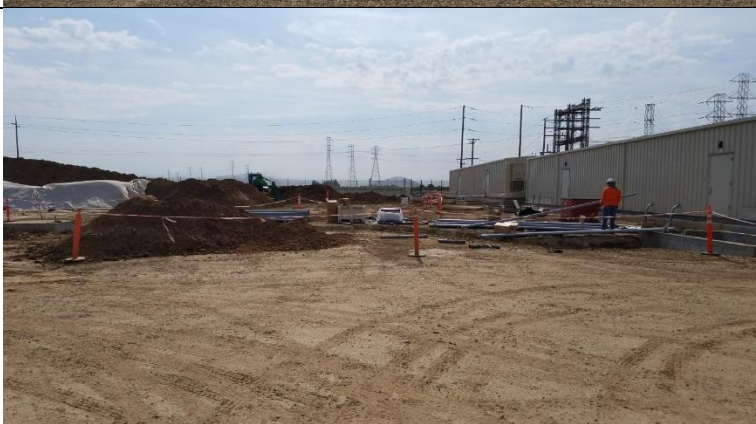
Photo 8- AJ Excavation crew working on utility lines. Photo facing east.

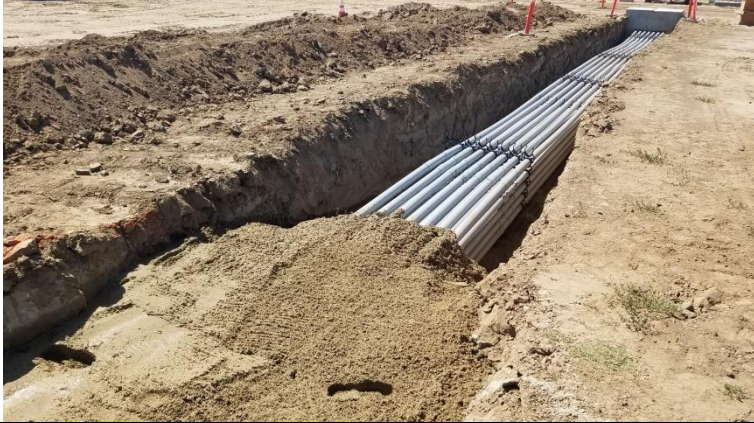
9:15 AM- I arrived onsite. I met with Jeff Clarkson (PG&E Senior Civil Inspector) and Chennie Castañon (PG&E Environmental Inspector). Mr. Clarkson explained construction activities included placement of sand slurry in trenches with banks of polyvinyl chloride (PVC) conduit for future electrical connectivity (Photo 1) and placement of concrete for pole boxes and breaker pads within the expansion footprint (Photos 2 and 4).

Photo 1 -Trench with PVC for utility line. Photo facing southeast.
06/21/19	Expansion footprint

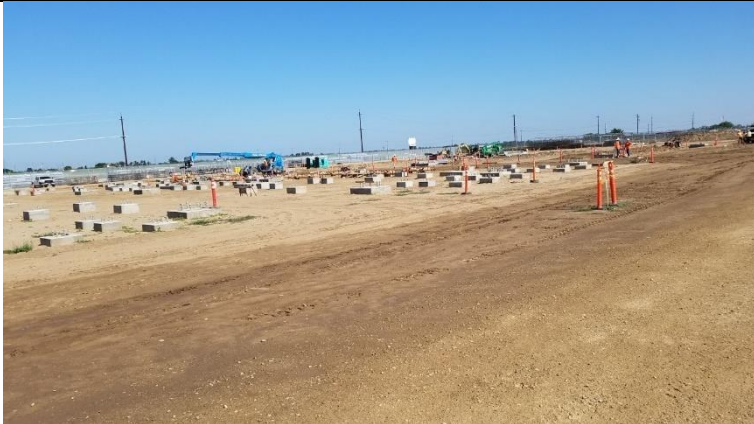
Photo 2- Crew installing structure foundation. Photo facing northwest.
06/21/19	Existing substation

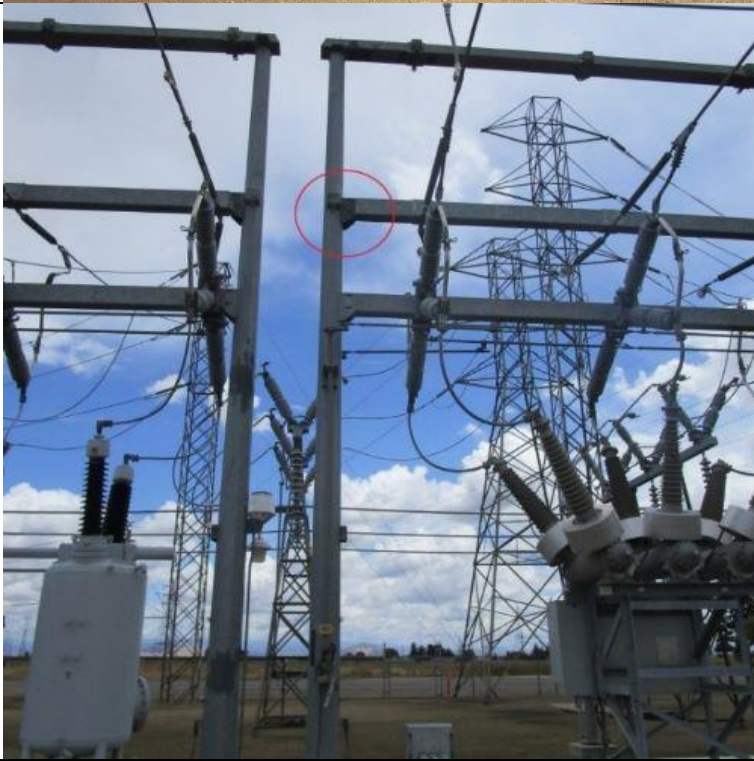
9:40 AM- Along with Ms. Castañon, I observed the American kestrel (*Falco sparverius*) nest located in Dead End 421 within the existing substation (Photo 3). The nest could not be seen as the nest was inside a joint of the steel structure. No activity was observed at the nest or in the project areas.

Photo 3- Kestrel nest in Dead End 421. Photo facing east.
