Re: Monthly Report Summary #28 for the Sanger Substation Expansion Project

CPUC COMPLIANCE MONITORING REPORTS

FEBRUARY 10 AND 24, 2021

## Sanger Substation Expansion Project CPUC Compliance Monitoring Report

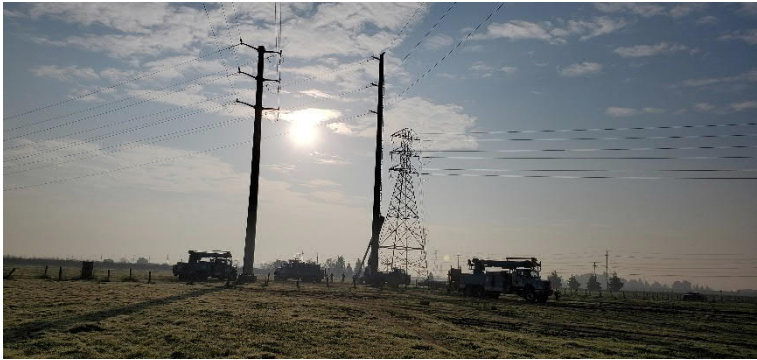
Photo 1- Crew working on TSPs/power poles. Photo facing southeast.
2/10/2021	East of existing substation

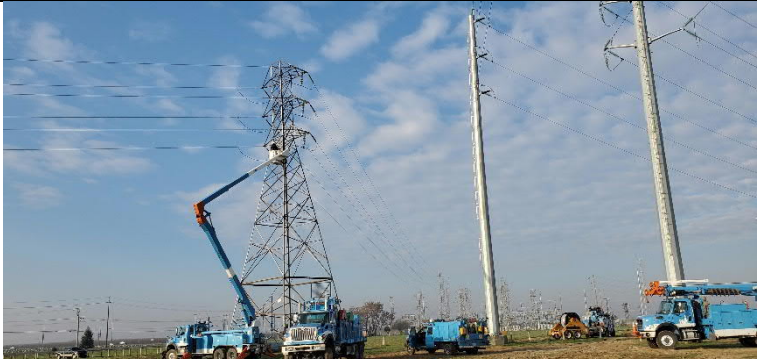
Photo 2- Crew removing old power lines. Photo facing southwest.
2/10/2021	McCall Avenue

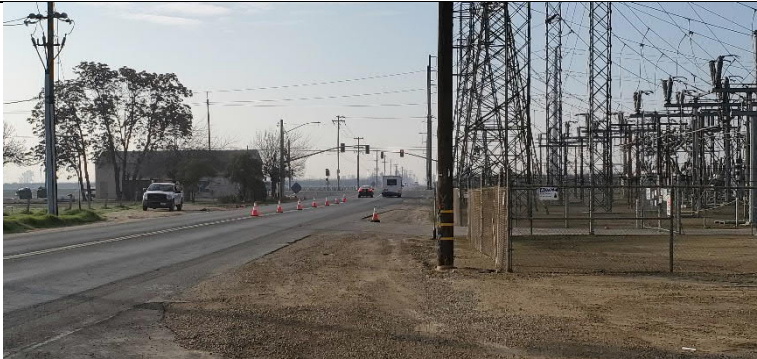
Photo 3- Traffic cones in place to mitigate accidents, etc. Photo facing south.

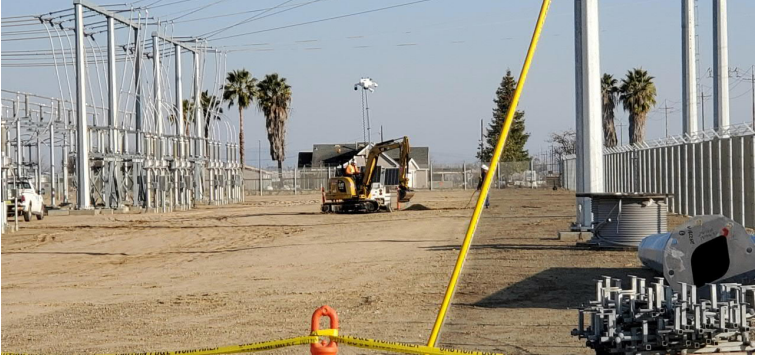
Photo 1- Crew pulling grounding wires. Photo facing north.
2/24/2021	Substation expansion footprint

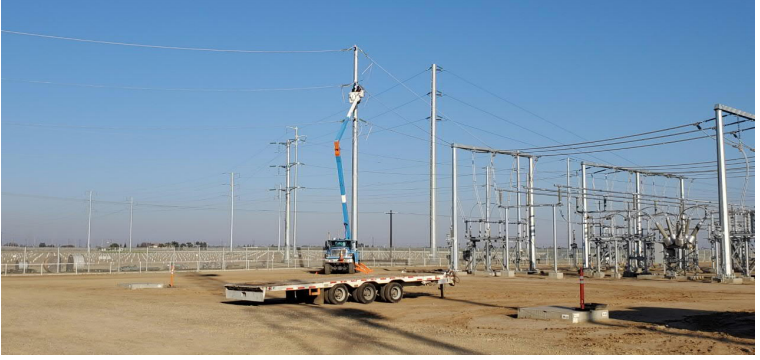
Photo 2- Crew connecting jumpers. Photo facing northwest.
2/24/2021	Staging Area

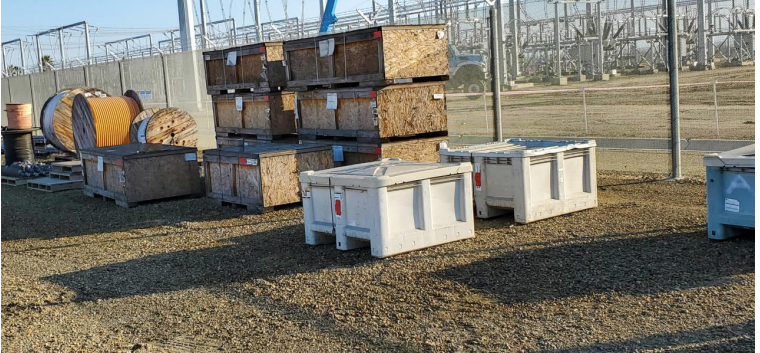
Photo 3- Equipment redtagged for removal. Photo facing northeast.
2/24/21	Existing substation footprint

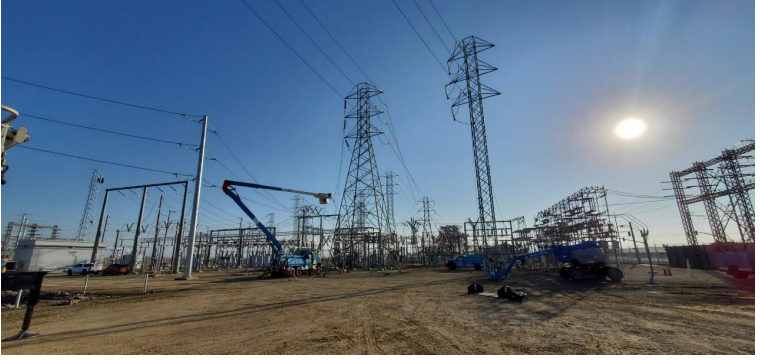
Photo 4- Crew removing and replacing conductors. Photo facing east.
