Re: Monthly Report Summary #29 for the Sanger Substation Expansion Project

Sanger Substation Expansion Project CPUC Compliance Monitoring Report

Project Proponent	PG&E	Report No.	CM-CPUCDG-031221
Lead Agency	California Public Utilities Commission	Date (mm/dd/yy)	3/12/21
CPUC Project Manager	Mike Rosauer	Monitor(s)	Ben Arax
CPUC (E & E) Monitoring Manager	Silvia Yanez	AM/PM Weather	Partly cloudy, 45°F, wind 7 mph
CPUC (E & E) Monitoring Supervisor	Angelica Oregel	Start/End time	8:00 – 8:30 AM
Project NTP(s)	NTP #2

Project Proponent	PG&E	Report No.	CM-CPUCDG-032421
Lead Agency	California Public Utilities Commission	Date (mm/dd/yy)	3/24/21
CPUC Project Manager	Mike Rosauer	Monitor(s)	Ben Arax
CPUC (E & E) Monitoring Manager	Silvia Yanez	AM/PM Weather	Sunny, 40°F, wind 4 mph
CPUC (E & E) Monitoring Supervisor	Angelica Oregel	Start/End time	8:00 – 8:30 AM
Project NTP(s)	NTP #2

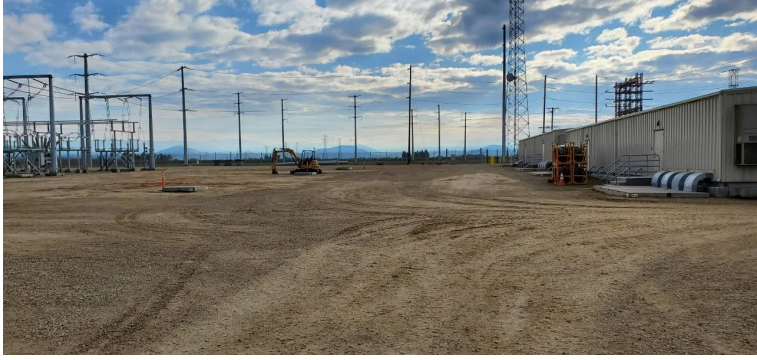
Photo 1- Excavator not idling and staged when not in use. Photo facing east.
3/12/2021	Staging Area

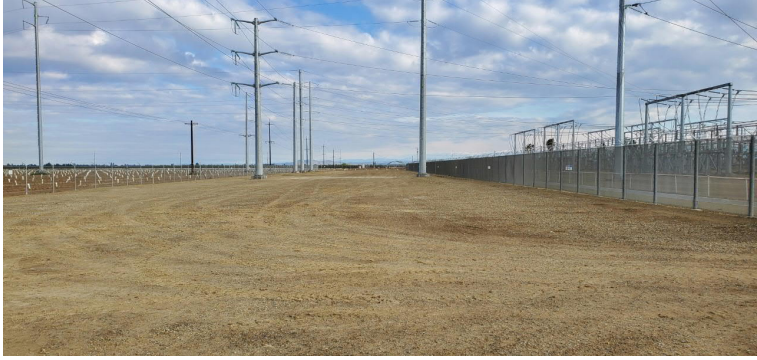
Photo 2- Empty staging area; crew had previously demobilized materials. Photo facing north.

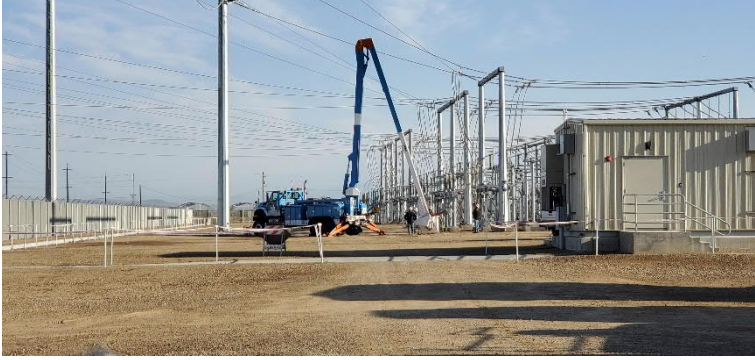
Photo 1- Crew attaching drop lines. Photo facing north.
3/24/2021	Subststion expansion footprint

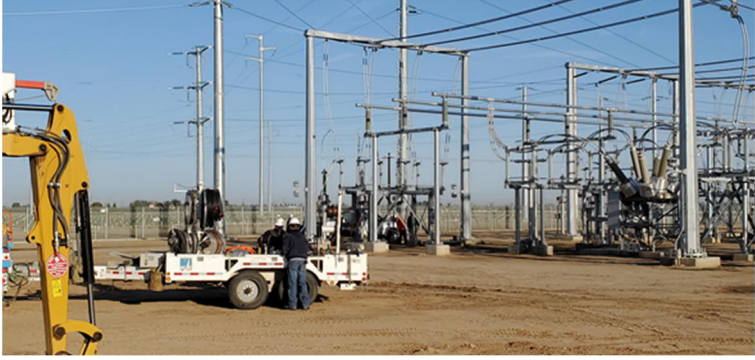
Photo 2- Crew working on power lines. Photo facing northwest.
3/24/2021	Existing substation footprint

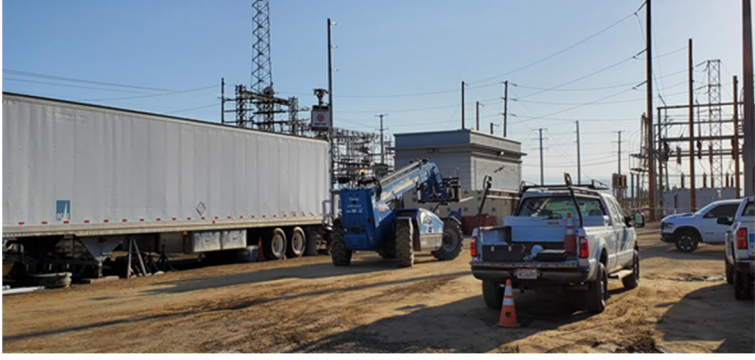
Photo 3- Crew moving materials with forklift. Photo facing northeast.
3/24/2021	Subststion expansion footprint

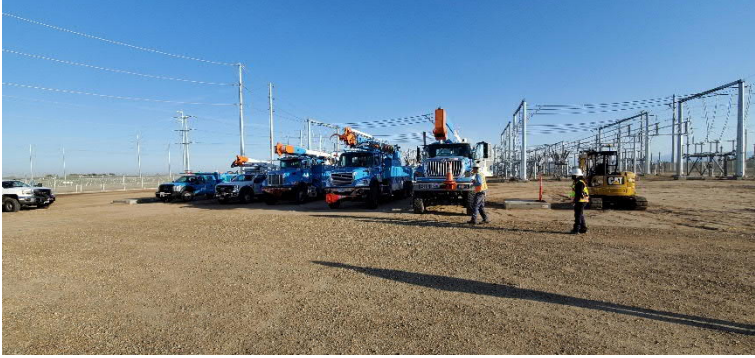
Photo 4- Excavator and work trucks staged in expansion footprint. Photo facing north.
