### **Re: Monthly Report Summary #10 for the Santa Barbara County Reliability Project**

CPUC Site Inspection Reports  
July 11 and 27, 2018

## Santa Barbara County Reliability Project CPUC Site Inspection Form

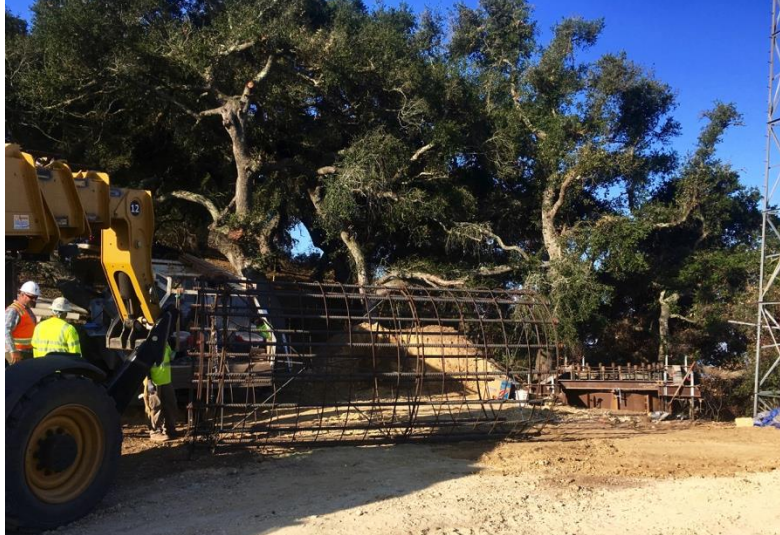
At TSP 71, an H&M crew was setting up to lower additional sections of the rebar cage into the foundation hole (Photos 1 and 2). The hole had been drilled the previous day and was covered overnight with a heavy tarp to prevent animals from falling in (MM BIO-6). The foundation pour was scheduled to take place within the next several days.

Photo 1 – H&M crew setting additional rebar cage in the drilled hole. Photo facing south.
7/11/18	SBCRP – Segment 3B, TSP 71

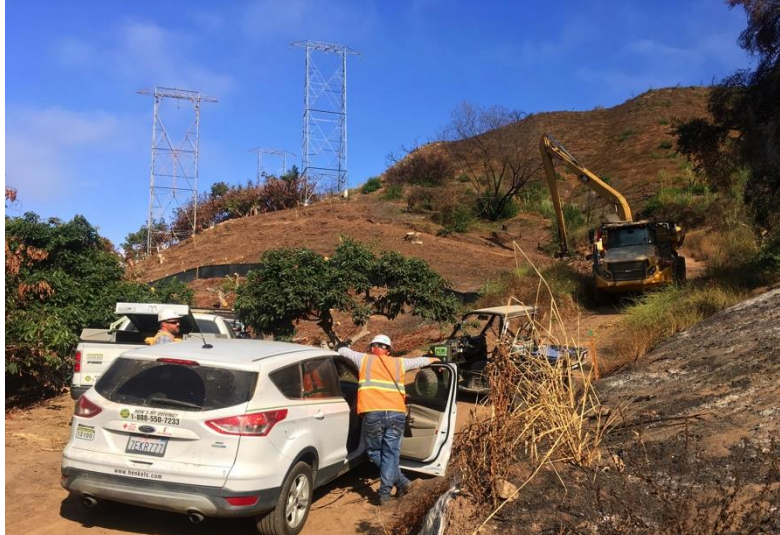
Along Segment 4 at TSP 97, a crew had removed vegetation near the tower location and were beginning to grade a new road to the tower site (Photos 3 and 4). Best management practices (BMPs) were in place and appeared to be in good condition, but the construction zone needed dust control.

Photo 3 – Vegetation clearing and road construction to the tower location. Photo facing northwest.

Verify oversight and compliance with nesting buffers and follow up on dust control.

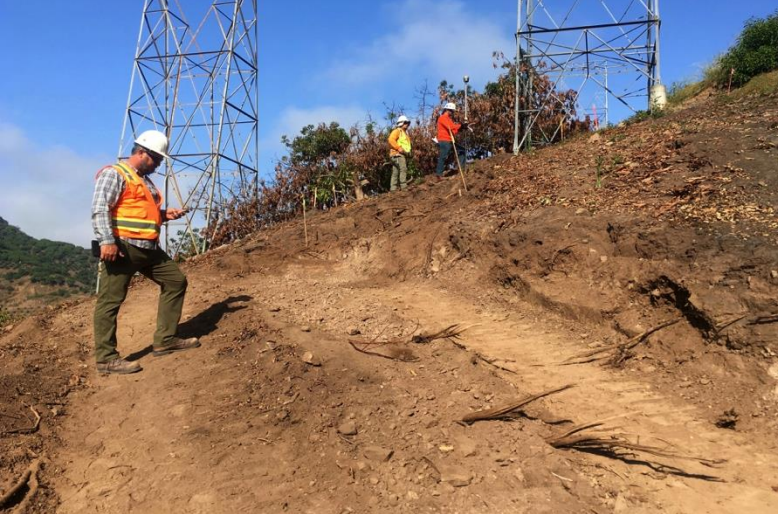
Photo 4 – Initial road construction. Photo facing south.
7/11/18	SBCRP – Segment 4, the “Y” Yard

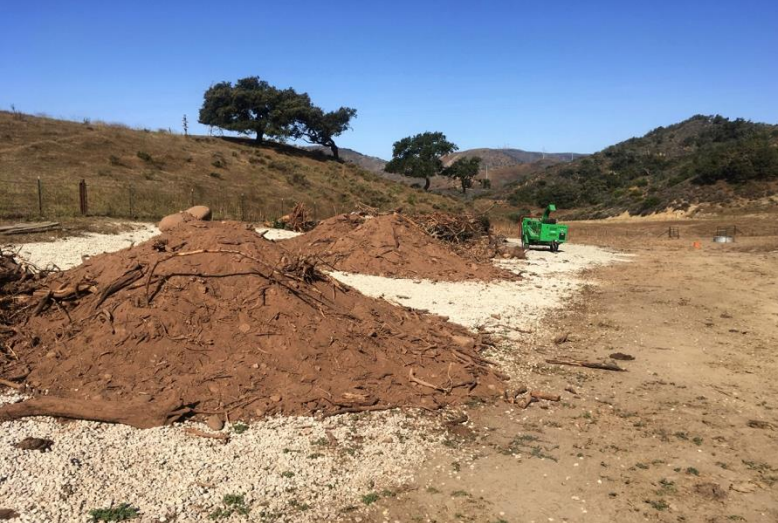
Lead biological monitor Mike Moss (Rincon) drove to the "Y" Yard where some of the material (i.e., soil and vegetation) from the TSP 97 work was being stockpiled (Photo 5). These stockpiles and portions of the access road near the "Y" Yard needed dust control (APM AQ-1). I inquired as to whether the this material was covered when it was being transported in trucks; Mike Moss was not sure (APM AQ-1). We encountered biological monitor Peter Gaede (BRC) near the "Y" Yard doing nesting bird surveys.

Photo 5 – Stockpiled soil and vegetation.
7/11/18	SBCRP – Segment 3B, TSP 60	 	Photo 6 – H&M crew removing wire from the old towers M6/T1-M4/T4. Photo facing east.

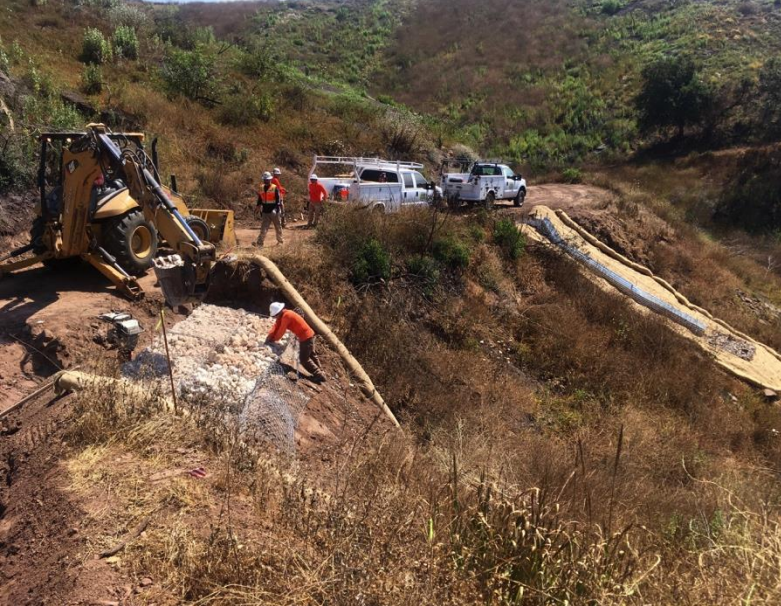
An H&M crew was installing McCarthy drains along the access road between TSPs 87 to 90, specifically at Civil ID #65 and #66 (Photo 7). Support equipment was parked at TSP 88; biological monitor Dave Wappler (BRC) had moved to this area and was spot-checking the work. There were no concerns, and Mike and I signed into the Job Safety Analysis (JSA).

Photo 7 – McCarthy drain installation at Civil ID #65-67. Photo facing east.
7/11/18	SBCRP – Segment 4, TSP 112

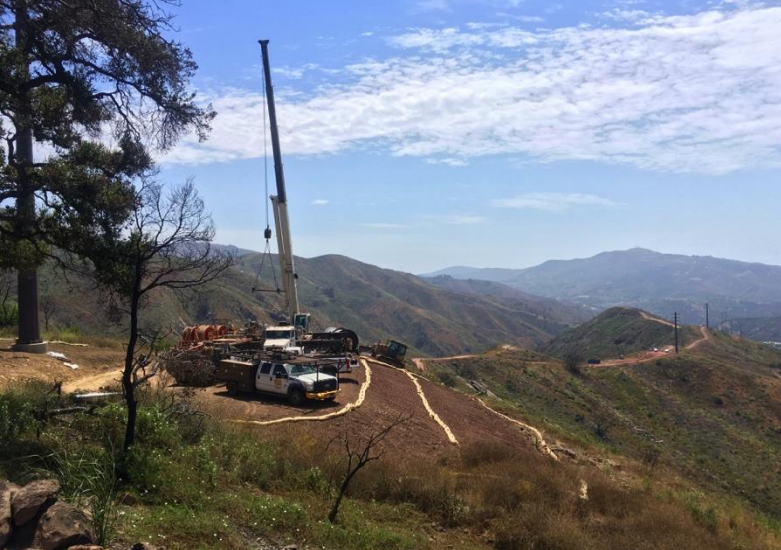
At the Vedder property, I checked on the wire pulling crew setting up at TSP 112 (Photo 8). Biological monitor Asher Dietch (BRC) was stationed along this portion of the site. Dust control from multiple water trucks was needed near TSP 112. Lead biological monitor Mike Moss (Rincon) made some calls to get this accomplished and then spoke with a water truck driver on

Photo 8 – Wire pull crew setting up at TSP 112. Photo facing southeast.
7/11/18	SBCRP – Segment 4, TSP 114

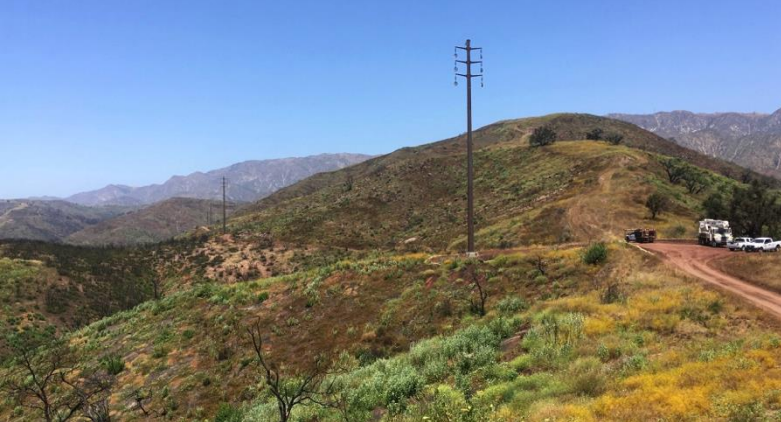
our way off the property. I noted that a truck was left idling and I mentioned this to Asher Dietch (APM AQ-2). Photo 9 looks west from TSP 112 toward newly installed TSPs 114 and 115.

Photo 9 – Newly installed TSPs 114 and 115. Photo facing west.

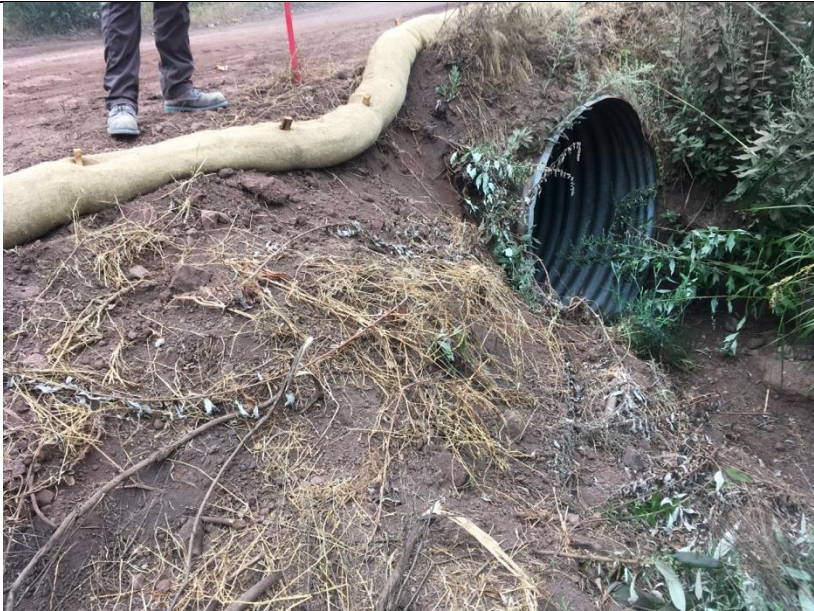
- July 17, 2018: A water truck backed off an access road onto the bank of Franklin Creek on Segment 4 near Construct 130. The truck disturbed an area of approximately 10 feet by 12 feet (0.003 acre) outside the approved disturbance area, some within California Department of Fish and Wildlife (CDFW) jurisdiction, and caused approximately 3 gallons of soil from the road berm to slough into Franklin Creek. Franklin Creek is protected under Fish and Game Code Section 1602 and MM BIO-1 and MM BIO-8. The incident violated the 1602 permit because it caused temporary impacts in excess of what was authorized for Franklin Creek at this location. MM BIO-1 requires sensitive areas, including drainages such as Franklin Creek, to be clearly marked and limits construction activities from occurring within these sensitive areas. By encroaching into a delineated sensitive area, SCE violated MM BIO-1. MM BIO-8 requires that SCE establish and maintain a minimum exclusionary buffer of 50 feet from the delineated extent of all jurisdictional features during construction and restoration. SCE received a 1602 permit, which authorized approved construction activities to occur within 50 feet of the jurisdictional feature; however, the permit does not allow for encroachment into the jurisdictional features for unapproved activities. Because the incident deviated from permit requirements and mitigation measures and had the potential to cause minor impacts on environmental resources, the CPUC issued a Level 2 Non-Compliance Report (NCR-002).

We traveled up the Franklin Trail access road along Segment 4 toward tubular steel pole (TSP) 120. At one of the creek crossings along the way, I noted the location where, on July 17, 2018, a water truck had attempted to turn around and slid off the road. A portion of the road berm next to the culvert was impacted (Photo 1). Vegetation impacted by the truck appeared to be mostly weeds in addition to some mugwort. Best management practices (BMPs) were installed, but additional BMPs, and possibly some seed, will be needed to stabilize this area.

Photo 1 – Impacts to creek area next to the access road culvert resulting from a truck leaving the roadway.
7/27/18	SBCRP – Segment 4, TSP 123

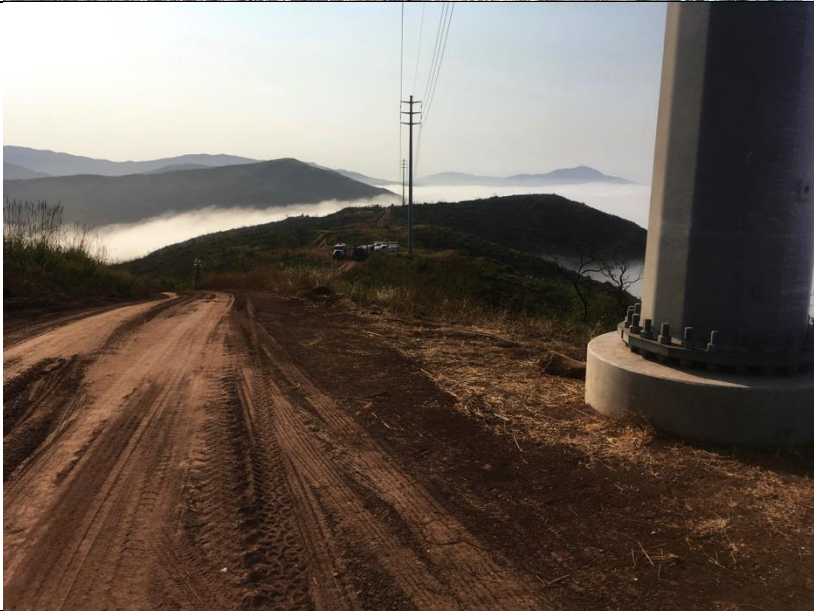
Photo 2 – Access road looking east from TSP 123 toward TSPs 122 and 121.
7/27/18	SBCRP – Segment 4, TSP 120

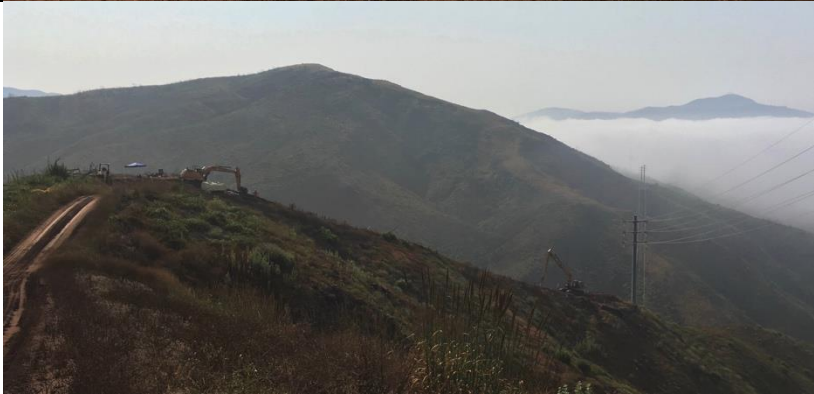
Photo 3 – Work at TSP 120 included upgrading the access road and excavation for a Hilfiker wall. Photo facing east.

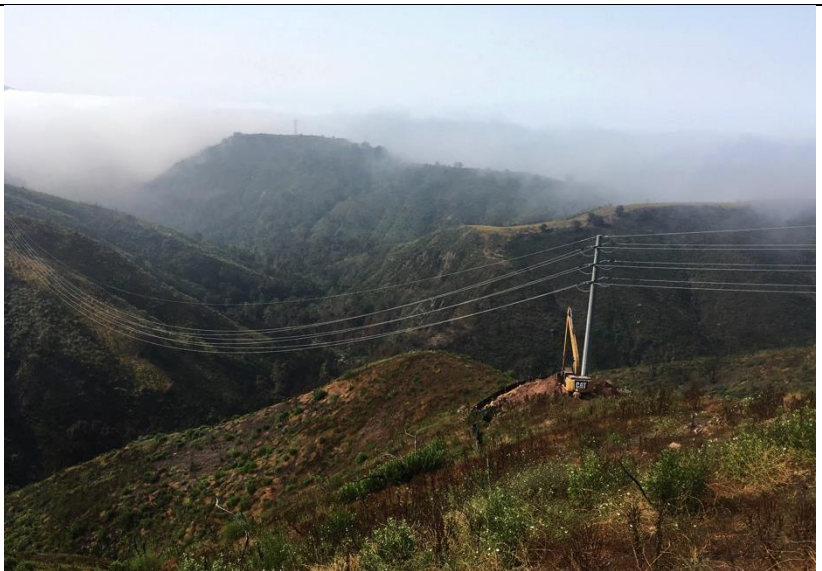
TSP 120 is located at the very end of the access road; from this location, the wires span a deep creek canyon to TSP 119 and the Vedder property (Photos 2, 3, and 4). Parking was very limited at this location; therefore, equipment and vehicles were stockpiled and parked at a number of staging areas along the access road (Photo 9). BMP installation and maintenance was needed at all of these staging areas. One construction vehicle had a fuel spill in the bed of the truck that was leaking from the tailgate. Lead biological monitor Mike Moss (Rincon) and avian biological monitor Brody Olson (BRC) spoke with the construction crew about this.

Photo 4 – TSP 120 is at the end of the access road; wire spans a deep canyon over to TSP 119. Photo facing southeast.
7/27/18	SBCRP – Segment 4, TSP 121

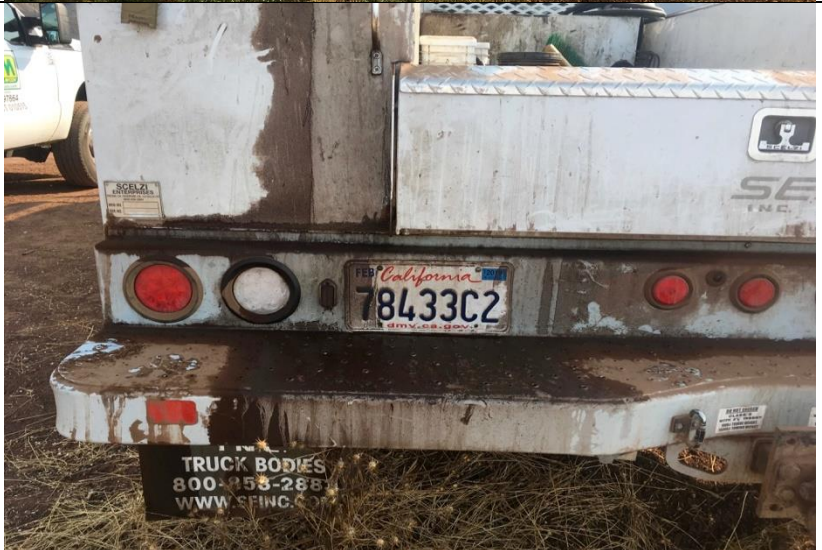
Photo 5 – Fuel spill in the bed of a construction vehicle is leaking out the back.
7/27/18	SBCRP – Segment 4, TSP 120

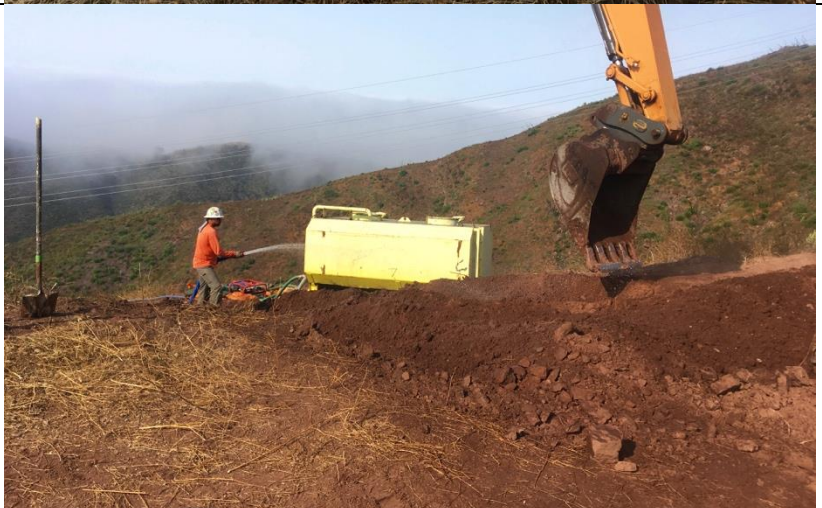
Photo 6 – H&M crew preparing the access road to TSP 120. Photo facing south.

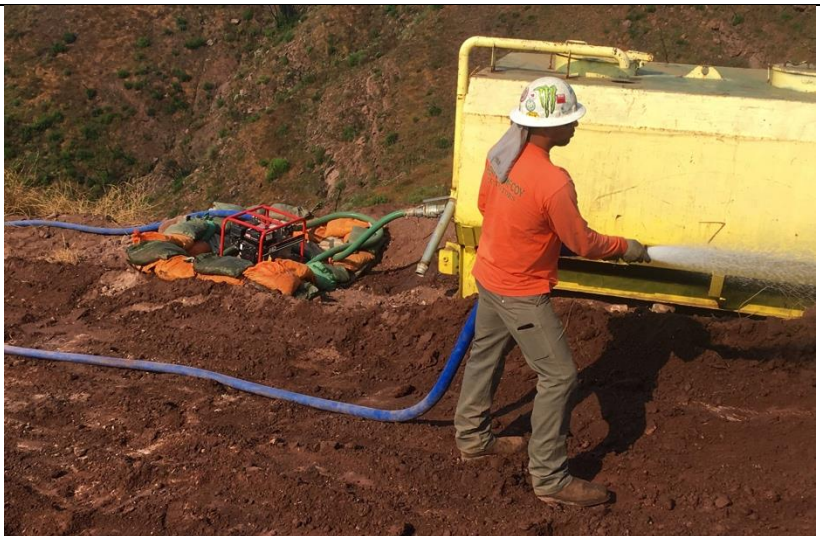
Photo 7 – The water pump is well contained.
7/27/18	SBCRP – Segment 4, TSP 120

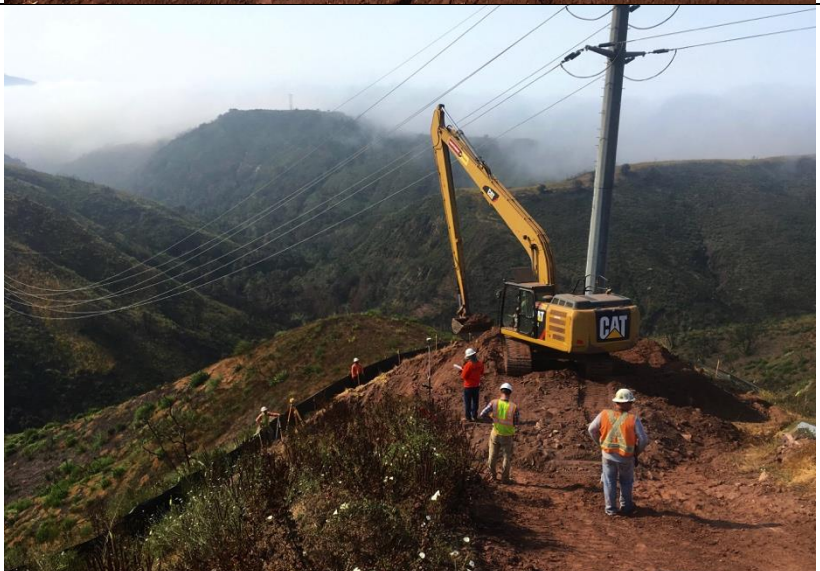
Two crews were using excavators at TSP 120; one crew was at the site, itself, and working on the Hilfiker wall, and the other crew was improving the access road (Photos 6 and 8). Water was being used at both locations for dust control and to stabilize the soil. A gas-powered water pump was being used and was well-contained with plastic and gravel bags (Photo 7). A paleontological monitor was scheduled on the day of my site visit at this location, but did not arrive in time for me to meet them. Lead biological monitor Mike Moss (Rincon) informed me that the paleontological monitor was spot-checking several locations on that day (MM CR-13).

Photo 8 – Excavator is prepping the site for installation of a Hilfiker wall. Photo facing southeast.
7/27/18	SBCRP – Segment 4, TSP 121

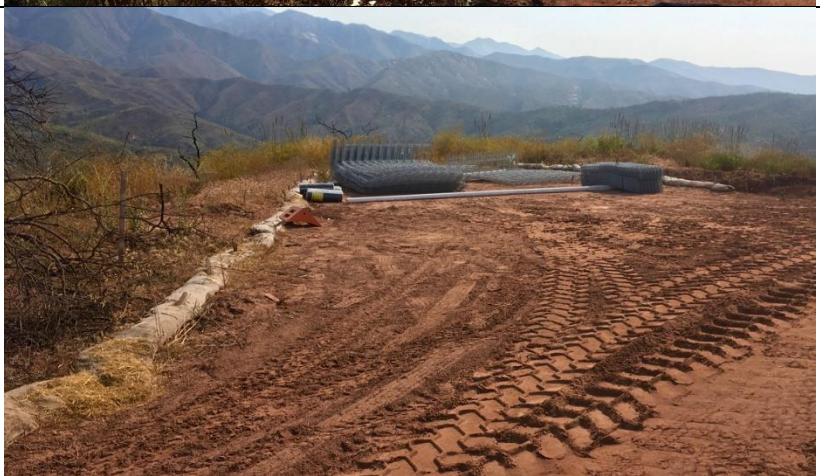
Photo 9 – Staging area along the access road; BMPs need maintenance. Photo facing northeast.

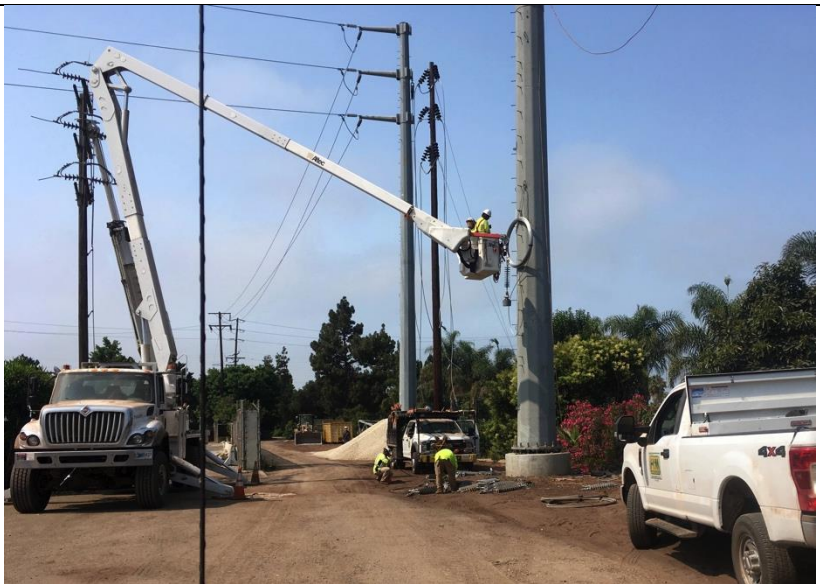
At the Carpinteria Substation, crews were working on the TSPs and wiring both inside and outside of the Carpinteria Substation (Photo 10). Biological monitor Dave Wappler (BRC) was stationed at this location.

Photo 10 – Crews are working on the TSPs in and outside of the Carpinteria Substation. Photo facing south.
7/27/18	SBCRP – Segment 3B, Access Road near TSP 62

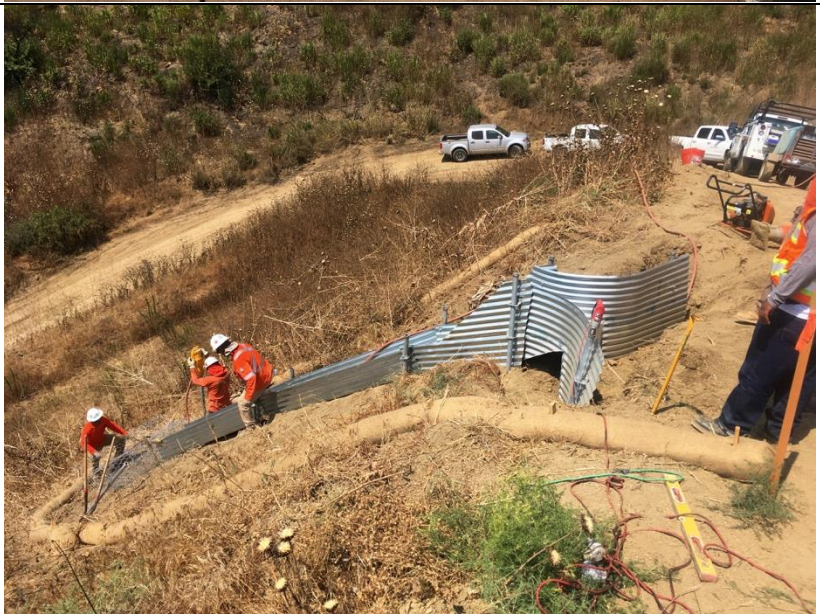
Lead biological monitor Mike Moss (Rincon) drove me to Segment 3B and up the access road to near TSP 62. A crew was installing a McCarthy drain

Photo 11 – McCarthy drain installation near TSP 62.
