Re: Monthly Report Summary #11 for the Santa Barbara County Reliability Project

CPUC Site Inspection Reports
September 7 and 18, 2018

Santa Barbara County Reliability Project CPUC Site Inspection Form

Project:	Santa Barbara County Reliability Project	Date:	September 7, 2018
Project Proponent:	Southern California Edison	Report #:	VS029
Lead Agency:	California Public Utilities Commission	Monitor(s):	Vince Semonsen
CPUC PM:	Jensen Uchida, Energy Division	AM/PM Weather:	Thick fog clearing late morning, cool & calm
E & E CM:	Caitlin Barns	Start/End time:	0700 hrs – 1230 hrs
Project NTP(s):	NTP-1, NTP-2, NTP-3, NBMP, NIWCP

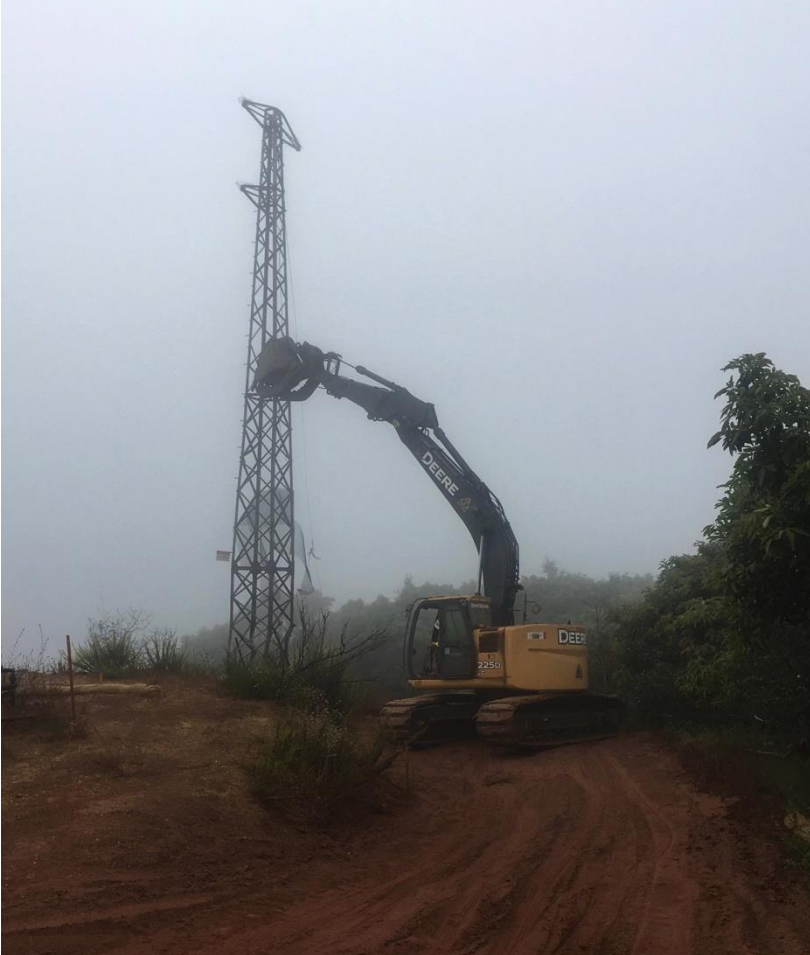
It was a very foggy up at TSP 108 – Photo 2. We watched as the excavator brought down the one remaining old latticework tower near TSP 108 – Photo 4. They slowly dropped the tower into the existing roadway so there was no damage to any existing vegetation.

Photo 4 – Excavator preparing to bring down an old tower.
9/07/18	SBCRP – Segment 4

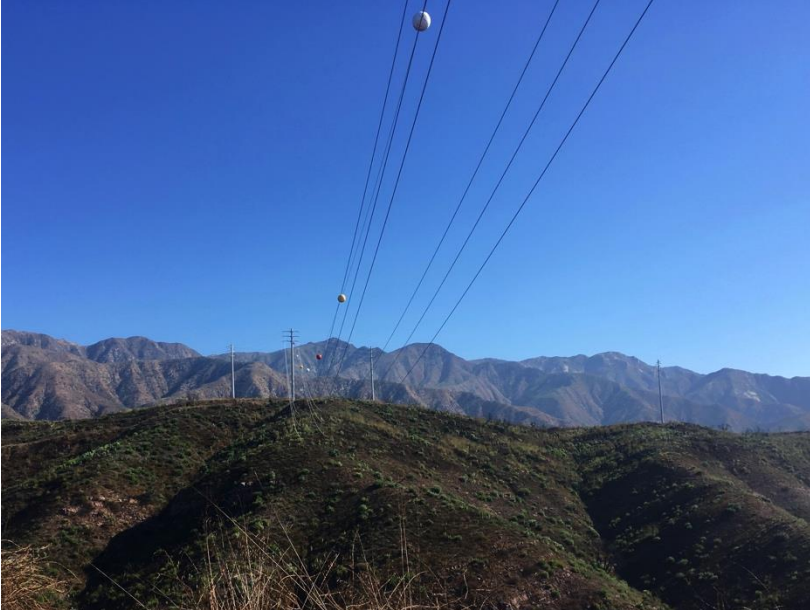
Matt and I drove up the Franklin trail access road and out to TSP 120. Crews had already hung the indicator balls on the wires crossing some of the larger canyons – Photo 5. We met Mike Moss and walked out to the 120 work area. Dirt stockpiled on the access road was now being collected by an excavator – Photo 6 - and transported back down to the 120 site for backfilling the Hilfiker wall – Photo 8. This was some of the last work to be done in this area and it will continue for awhile. The staging area just up the hill from the 120 work area looked to be well contained with silt fencing installed around the gravel pile – Photo 7.

Photo 5 – Marker balls installed on the wire. Photo facing north

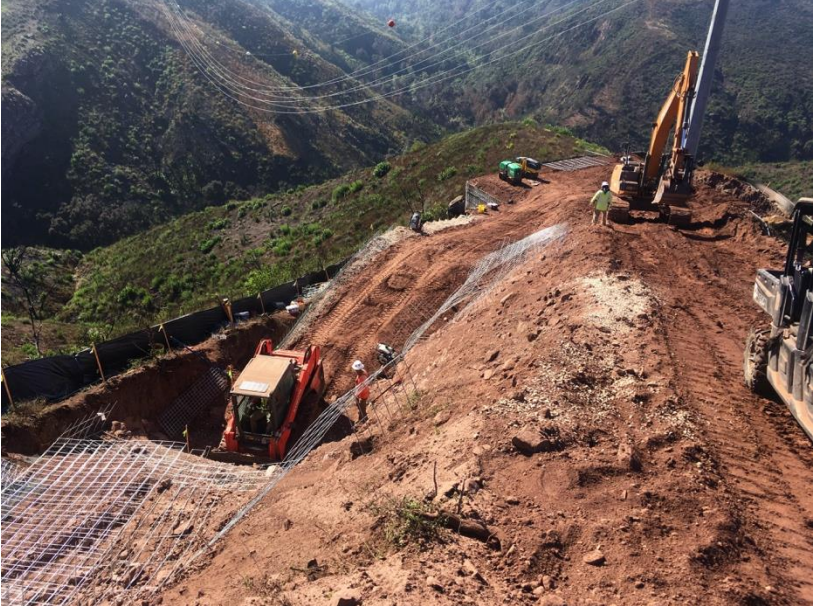
At TSP 97 an excavator continued to work on the Hilfiker wall – Photos 9 & 10. They had installed rumble plates and rock on the access road, which made a big difference in keeping down the dust and keeping mud off of the public roadway (APM AQ-1). Bio monitor Zeph was onsite at this location.

Photo 8 – Hilfiker wall work
9/07/18	Segment 3B, TSP 97

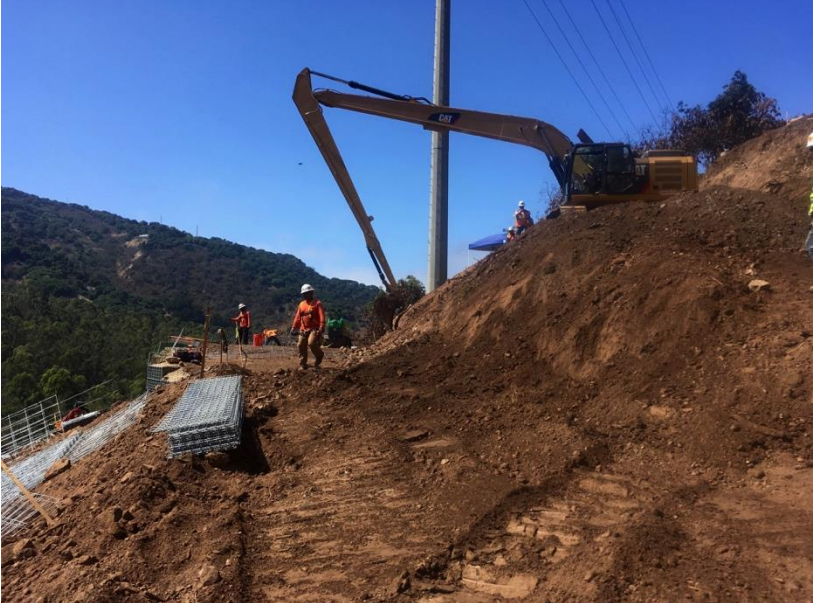
Photo 9 – Hilfiker wall work. Photo facing south

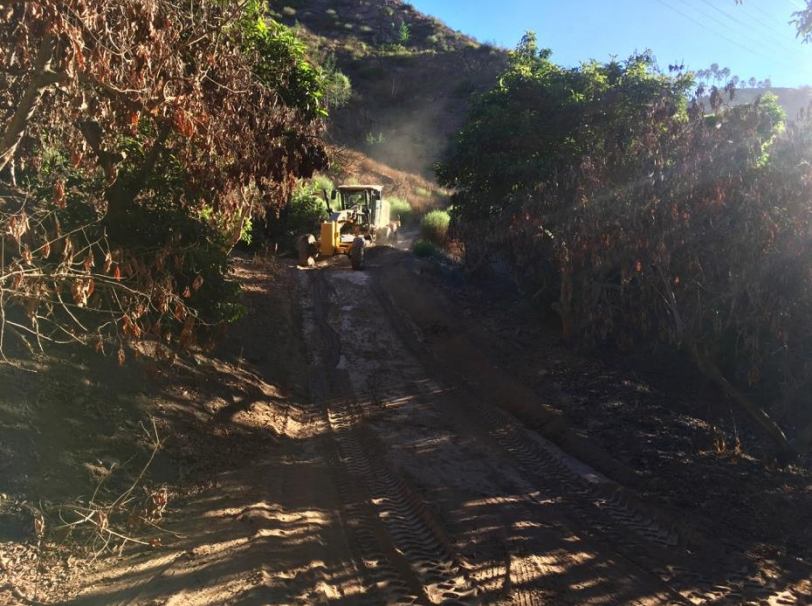
At C96 a crew was using a motorgrader to regrade the access road, we saw Zeph at this location – Photo 3. They will be bringing in some road base to improve the road. There was some track out onto Hwy 150, Mike made note of it. A sweeper regularly cleans the Hwy 150 roadway (APM AQ-1). Traffic control was in place along Hwy 150 due to the ongoing construction activities at C76, C96 and C99.

Photo 3 – Regrading the access road.
9/18/18	SBCRP – Segment 4, TSP 119 and 120

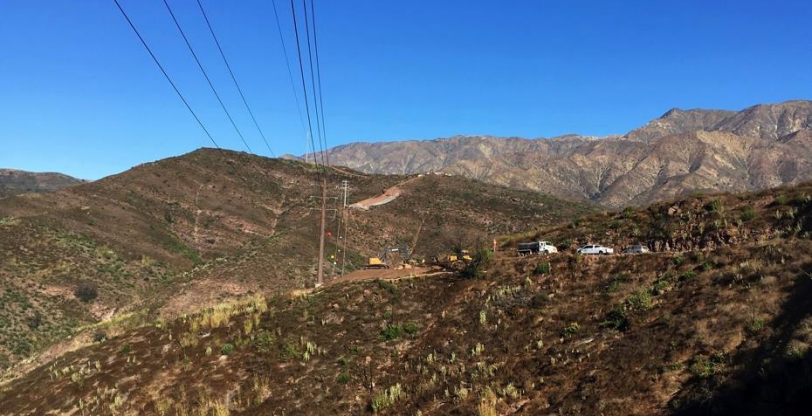
Photo 4 – Overview of TSPs 119 and 120 looking west from the access road.
9/18/18	SBCRP – Segment 4, TSP 119

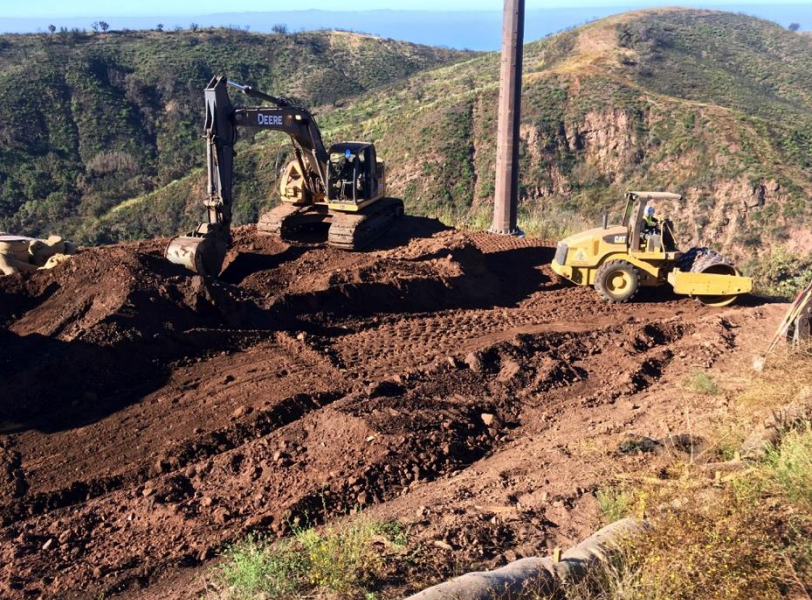
We headed up onto the Vedder property where work was being done at TSP 119. There were some compaction issues at the tower so a crew was excavating the pad and recompacting the dirt using a water truck and a vibrating compactor – Photo 5. Peter Gaede was overseeing the work up along the Vedder property. Hilfiker wall work continued at TSP 120, visible just across the canyon from 119 – Photo 4. I looked at the construction activities with my binoculars; it all looked good so we decided not to make the trek out to this location. While walking back to our vehicle we saw a ringneck snake crossing the access road – Photo 6. Peter took photos of the snake and released it away from the road.

Photo 5 – Excavation and recompaction of the tower pad. Photo facing south

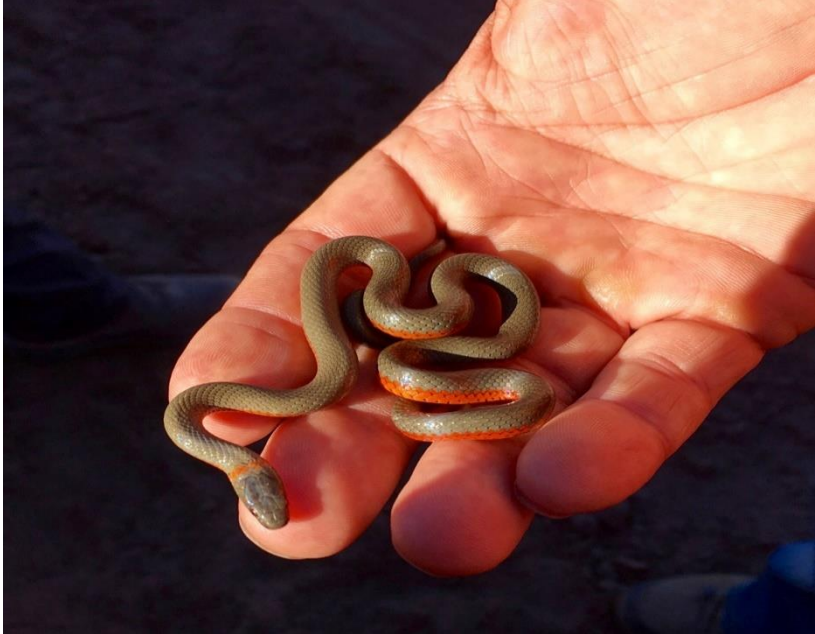
Photo 6 – Ringneck snake found crossing the access road between TSP 118 & 119.
9/18/18	SBCRP – Segment 3B, TSP 67

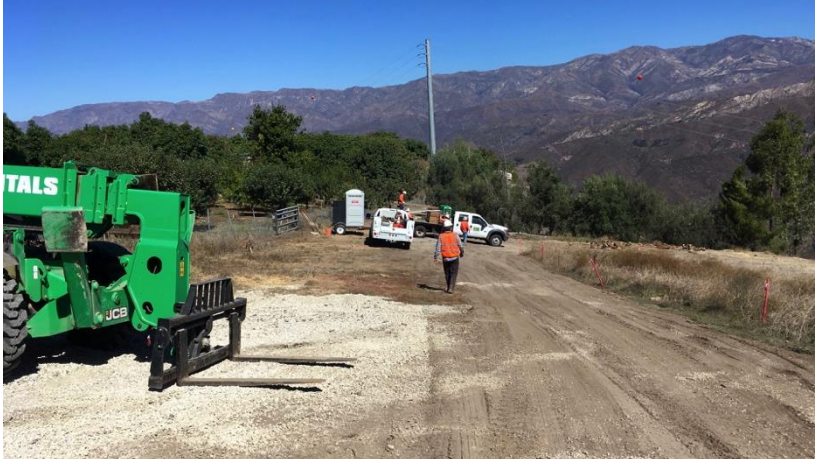
Next stop was up at TSP 67 along segment 3B where a crew was doing cleanup work – Photo 7. A MacDrain had been newly installed and needed some BMPs – Photo 8. A number of areas along the access road and around the TSP needed some regrading and BMP installation – Photo 9.

Photo 7 – Cleanup work along the access road and staging area. Photo facing northwest
9/18/18	SBCRP – Segment 3B, TSP 67

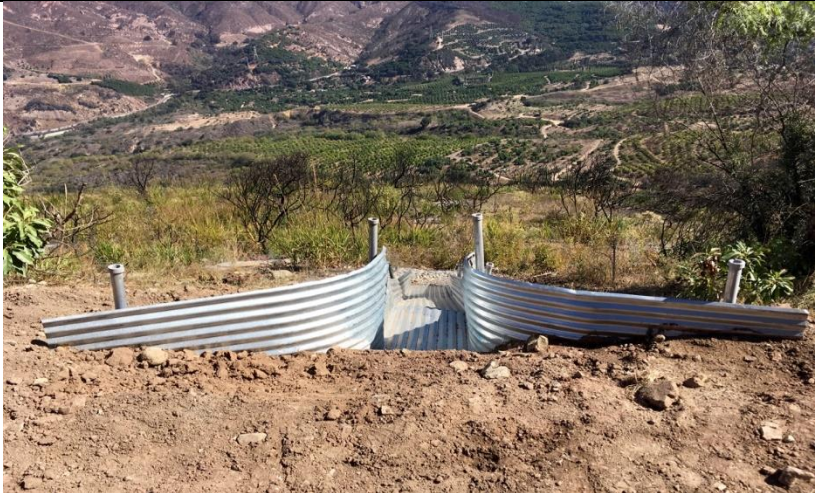
Photo 8 – MacDrain installation
