Re: Monthly Report Summary #14 for the Santa Barbara County Reliability Project

CPUC Site Inspection Reports November 16 and 28, 2018

Santa Barbara County Reliability Project CPUC Site Inspection Form

| Project Proponent: | Southern California Edison | Report #: | VS034 |

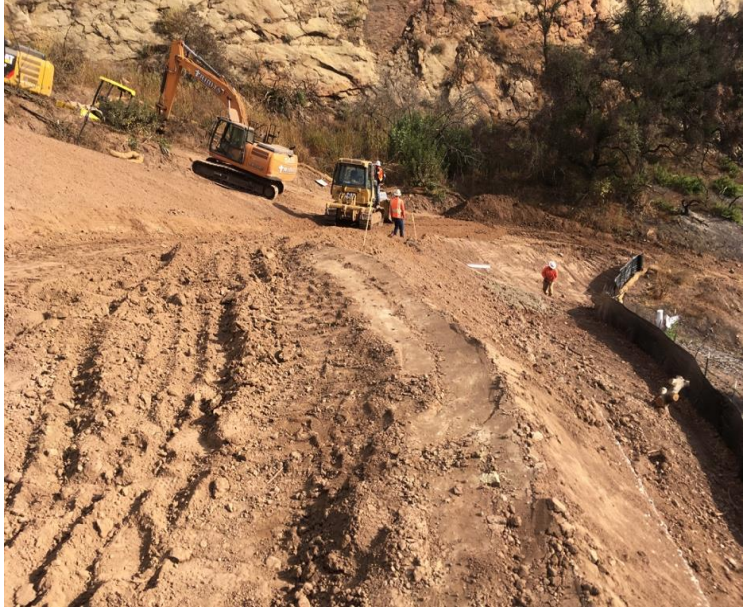
We traveled to Segment 4 and TSP 97. A crew was working on the final grading of the access road. The H&M foreman anticipated completion in one to two days – Photo 5. Crews still needed to install BMPs and hydroseed the area. Dave Wappler was the onsite biological monitor at this location. The access road toward the TSP and the small parking area along Highway 150 was extremely dusty. I noted several inches of "moon dust" – Photo 4. I discussed dust control issues with both the Rincon monitors and the H&M foreman.

| Date | Location | Photo | Description |
|---|---|--|--|
| 11/16/18 | SBCRP – Segment 4, TSP 97 | | Photo 5 – Final grading work being completed near TSP 97. Photo facing east. |

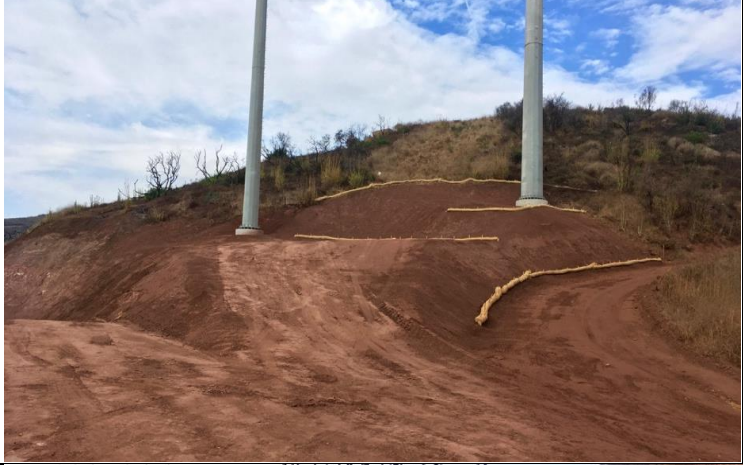
| Date | Location | Photo | Description |
|---|---|--|--|
| 11/16/18 | SBCRP – Segment 4, TSP 127 | | Photo 6 – BMP installation around TSP 127. Photo facing west. |

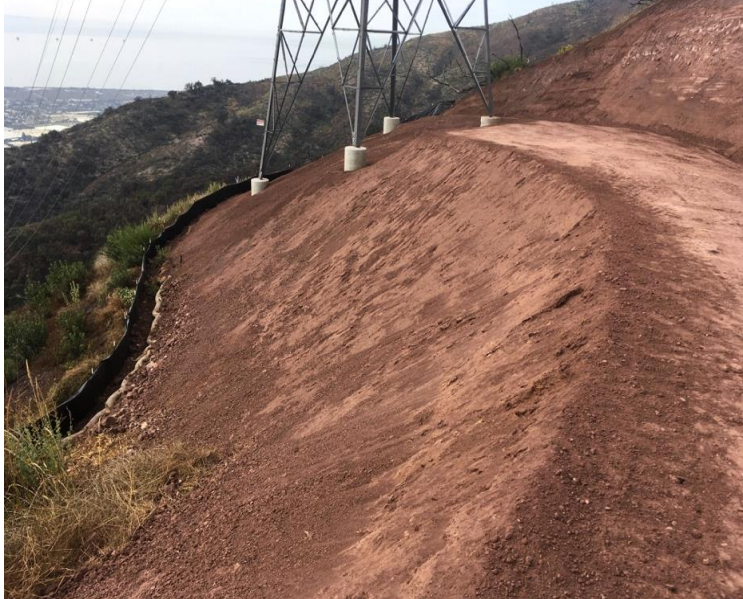
| Date | Location | Photo | Description |
|---|---|--|--|
| 11/16/18 | SBCRP – Segment 4, TSP 128 | | Photo 7 – BMPs needed at TSP 128. Photo facing southwest. |

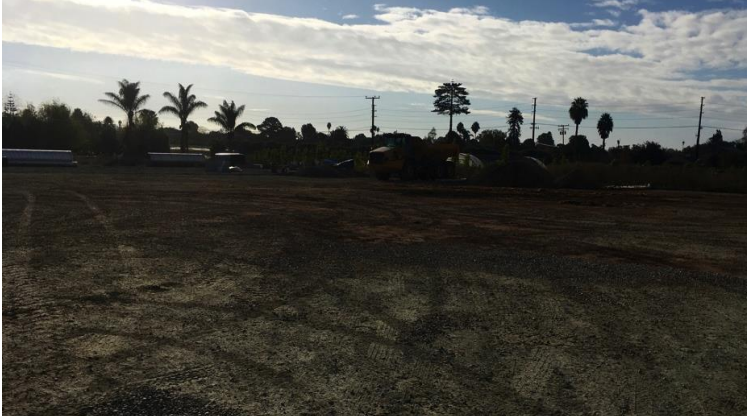
I met with lead environmental biologist Mike Moss at 0830 at the Carpinteria Yard. This yard was still being dismantled – Photo 1. A storm system was predicted to move through the area over the next two days.

| Date | Location | Photo | Description |
|---|---|--|---|
| 11/28/18 | SBCRP – Carpinteria Yard | | Photo 1 – Carpinteria yard being dismantled. Photo facing south. |

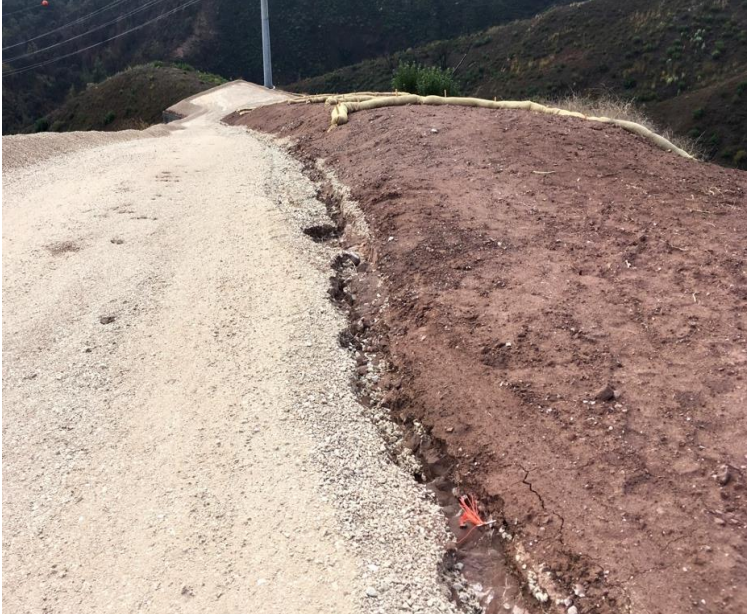
We drove to the end of the access road near TSP 120. The access road was very steep and best management practices (BMPs) were installed where needed – Photo 2. Mike Moss was one of the Storm Water Pollution Prevention Plan (SWPPP) inspectors and we discussed the need for additional BMPs. It appeared that gravel check dams, additional straw wattles, and hydroseeding were needed.

| Date | Location | Photo | Description |
|---|---|--|---|
| 11/28/18 | SBCRP – Segment 4, TSP 120 | | Photo 2 – Steep access road down to TSP 120. |

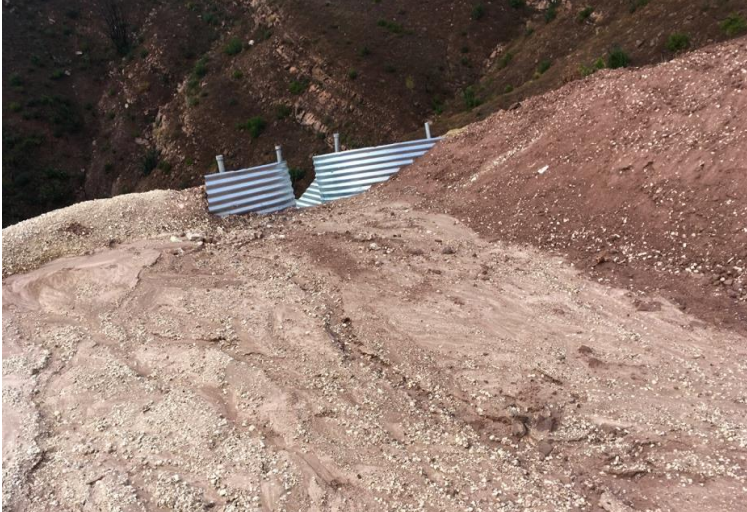
Water was channeling correctly into the McCarthy drain at the bottom of the TSP 120 access road – Photo 3, and the McCarthy drain itself appeared to be properly installed – Photo 4.

| Date | Location | Photo | Description |
|---|---|--|---|
| 11/28/18 | SBCRP – Segment 4, TSP 120 | | Photo 3 – McCarthy drain near TSP 120. |

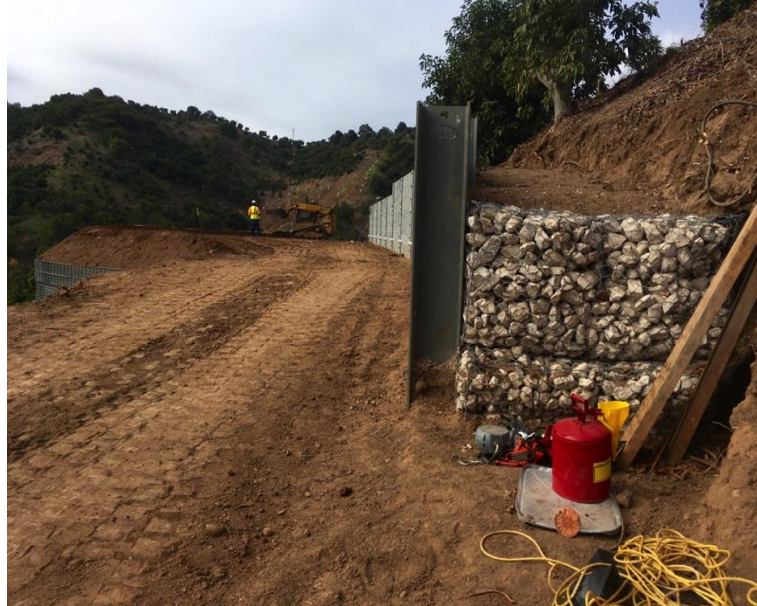
We traveled toward TSP 99 where an H&M crew was completing the finishing touches to the access road – Photo 5. The foreman mentioned that a completion date was dependent on the weather. Some excess soil was being used to build a berm around the edge of the Hilfiker wall – Photo 6. Dave Wappler was the onsite biologist for that area.

| Date | Location | Photo | Description |
|---|---|---|--|
| 11/28/18 | SBCRP – Segment 4, TSP 99 | | Photo 6 – Final dirt work around the TSP 99 Hilfiker wall. Photo facing southwest. |

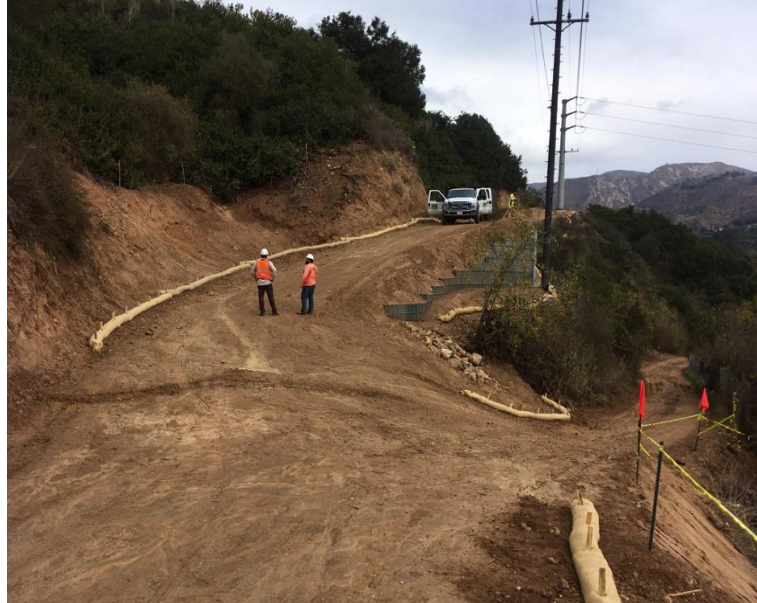
Our last stop was along Segment 3 at TSP 76 where a crew was installing additional BMPs – Photo 7.

| Date | Location | Photo | Description |
|---|---|---|--|
| 11/28/18 | SBCRP – Segment 3, TSP 76 | | Photo 7 – BMP work along the TSP 76 access road. Photo facing east. |
