Re: Monthly Report Summary #17 for the Santa Barbara County Reliability Project

CPUC Site Inspection Report

Santa Barbara County Reliability Project CPUC Site Inspection Form

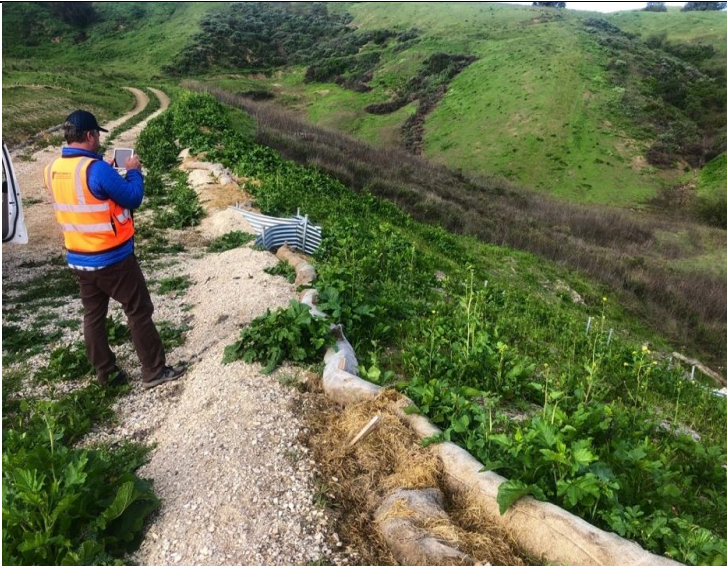
We inspected the revegetation on the slope located below the access road and around the McCarthy drain at tubular steel pole (TSP) 55 on segment 3B – Photo 1. The disturbed area contained a significant amount of new growth. Unfortunately, most of it was black mustard, which is a non-native plant.

Photo 1 – Restoration evaluation. Photo facing south.
03/26/19	SBCRP – Segment 3B TSP 56

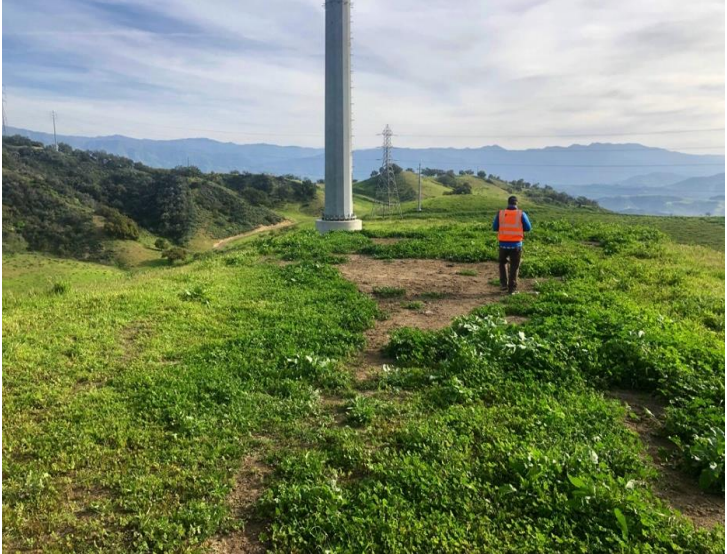
We stopped at the next tower near TSP 56, where Mike Moss took photos at fixed point locations – Photo 2. This location did not appear to require additional grading, since the tower's location was readily accessible and flat.

Photo 2 – Restoration evaluation. Photo facing east.
03/26/19	SBCRP – Segment 4

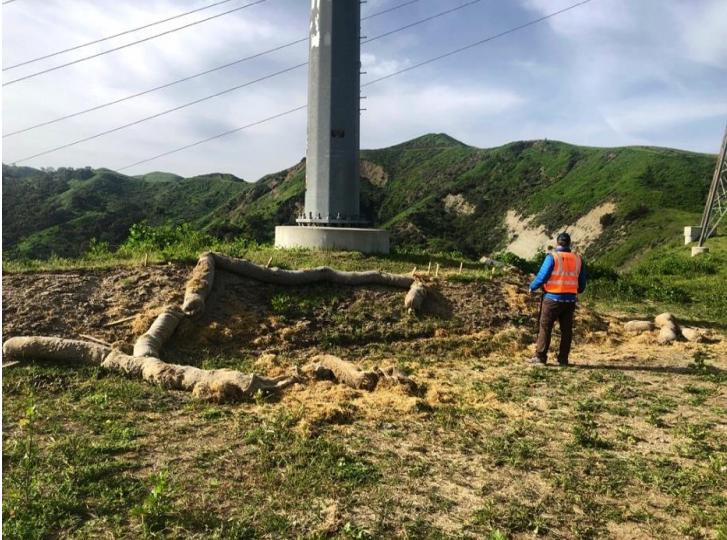
Cattle grazing on Hailey Ranch overwhelmed the BMPs installed as well as the previous restoration efforts – Photo 3.

Photo 3 – Grazing activities impacted the BMPs. Photo facing south.

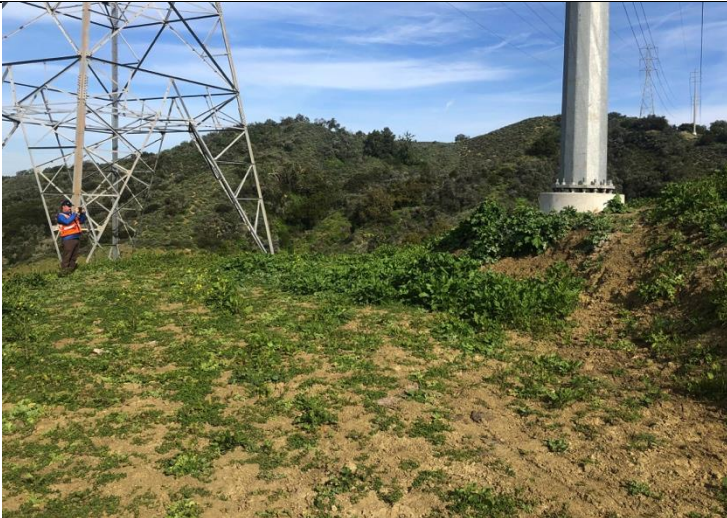
I noted extensive vegetation coverage at TSP 78 on Segment 4; however, it was mostly mustard and milk thistle – Photo 4.

Photo 4 – Restoration photos taken by Mike Moss. Photo facing west.
03/26/19	SBCRP – TSP 80, Segment 4

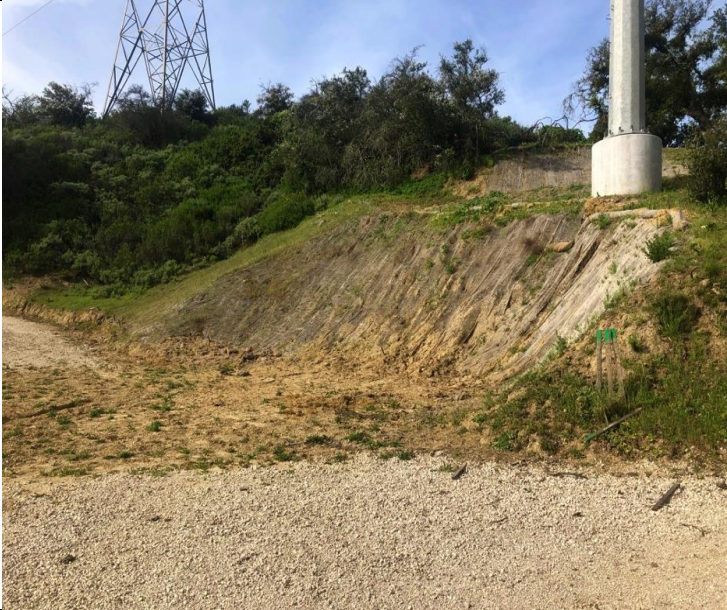
At TSP 80, along Segment 4, there were restoration issues regarding cattle grazing and stormwater runoff erosion – Photo 5. Some well-placed water bars and additional BMPs would help the restoration effort.

Photo 5 – Erosion and grazing impacted the restoration efforts at this tower location. Photo facing southwest.
03/26/19	SBCRP – TSP 98, Segment 4

- On March 26, 2019, the CPUC Compliance Monitor noted restoration issues regarding non project-related cattle grazing and stormwater runoff erosion along Segment 4. The CPUC Compliance Monitor recommended installing well-placed water bars and additional BMPs to support restoration efforts.

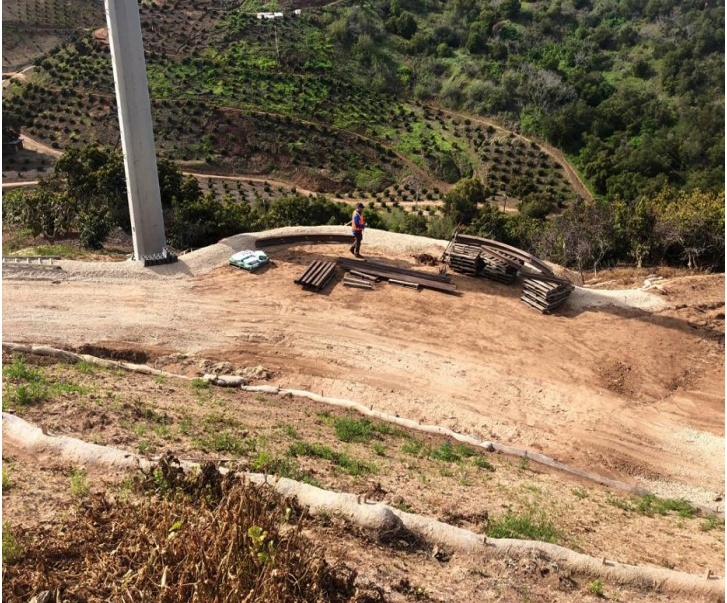
At TSP 98, materials were placed to build a guard rail around a portion of the tower pad – Photo 6.

Photo 6 – Guard rail installation work would begin soon.
