Re: Monthly Report Summary #19 for the Santa Barbara County Reliability Project

CPUC Site Inspection Report

Santa Barbara County Reliability Project CPUC Site Inspection Form

Project:	Santa Barbara County Reliability Project	Date:	August 21, 2019
Project Proponent:	Southern California Edison	Report #:	VS041
Lead Agency:	California Public Utilities Commission	Monitor(s):	Vince Semonsen
CPUC PM:	Connie Chen, Energy Division	AM/PM Weather:	Clear and warm temperatures with a light breeze
E & E CM:	Fernando Guzman	Start/End Time:	0900 to 1200
Project NTP(s):	NTP-1, NTP-2, NTP-3, NBMP, NIWCP

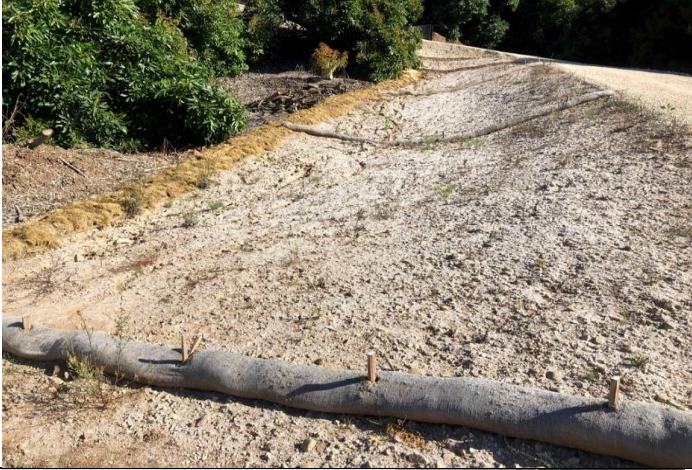
Our first stop was at tubular steel pole (TSP) 99, where the BMP restoration was completed. Crews were removing the old BMPs and installing straw wattles around the impacted areas – Photo 1. Afterward, crews installed new straw wattles where necessary. The areas to be upgraded were determined by site visits by Mike Moss and the Rincon Stormwater Pollution Prevention Plan (SWPPP) inspector Caitlyn Teague.

Photo 1 – BMP upgrades at TSP 99. Photo facing north.
08/21/19	SBCRP

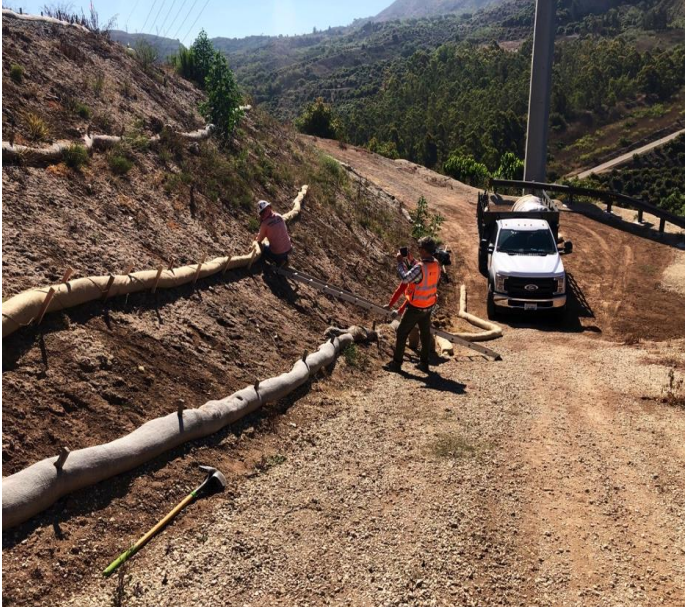
At TSP 98, we encountered the BMP installation crew conducting repair/upgrade work – Photo 2. Mike informed the crew that they could move to TSP 100 after they completed that work. The crew was completing a “Type 2” straw wattle installation that did not require digging a shallow trench for the wattle. In addition, the stakes would not be driven through the wattle to anchor it. The wattle was placed on the slope and anchored using stakes on both sides and twine to cinch it down to the ground. This appeared to be a better way of anchoring the wattle to the ground.

Photo 2 – BMP work at TSP 98. Photo facing east.
08/21/19	SBCRP

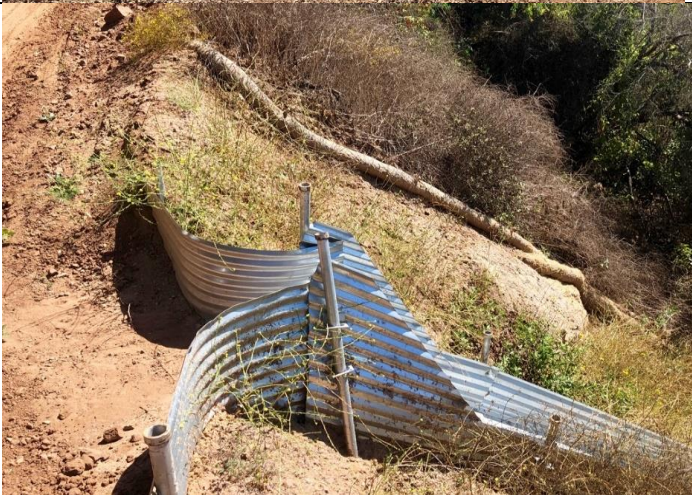
We drove toward the Franklin Trail access road to inspect several locations scheduled for BMP upgrades. We stopped at one of the McCarthy drains along the access road where crews may remove the wattles since they were installed parallel to the slope. This area tends to focus the rainwater runoff instead of slowing it – Photo 3.

Photo 3 – McCarthy drain along the Franklin Trail access road.

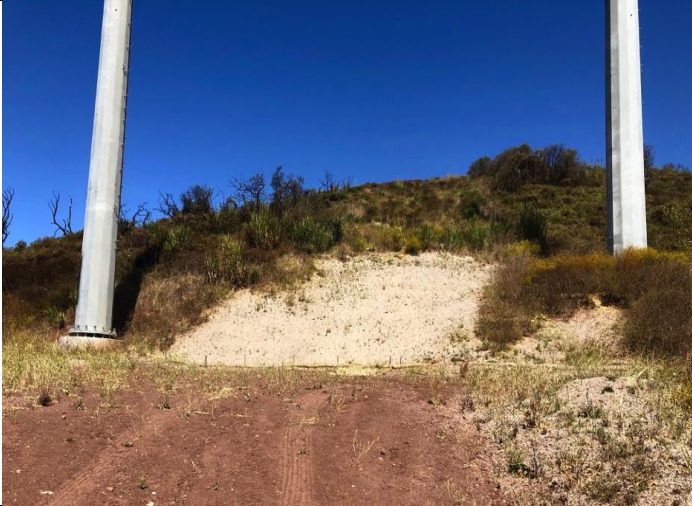
We stopped at TSPs 126, 127 and 128 where additional wattle installations were planned – Photo 4. The McCarthy drain at TSP 128 appeared to be in good condition, despite most of the vegetation growing on the disturbed slope being weeds – Photo 5. Mike Moss noted that the old tower foundations remained in place below the new TSP 128 towers. In several areas crews removed the old foundations and in others the foundations were left in place; neither Mike Moss nor I understood the reason for this inconsistency.

Photo 4 – Restored slope between TSPs 126 and 127. Photo facing west.
08/21/19	SBCRP

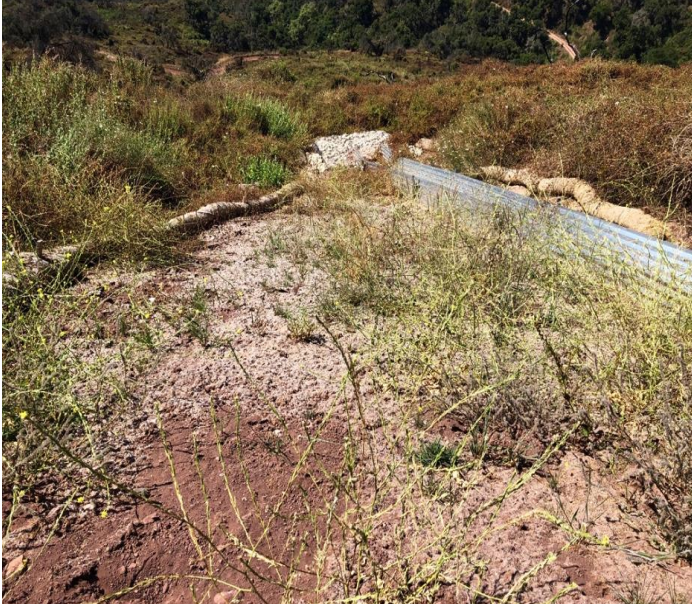
Photo 5 – McCarthy drain below TSP 128. Photo facing south.

Removal of the old tower foundations at TSP 128.
 Clarification of the determination for work considered to be “Non-Project Related.”

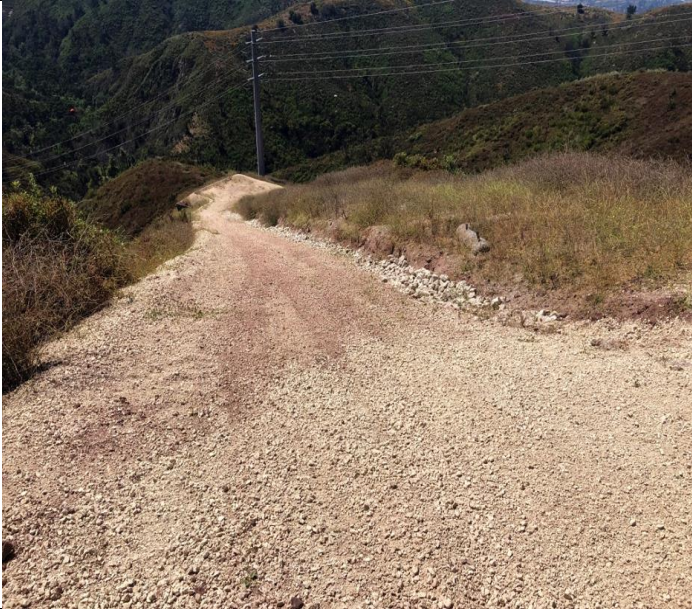
We drove out to the end of the road at TSP 120, where the BMPs appeared to be in good condition on the steep access road – Photo 8.

Photo 8 – Steep access road down to TSP 120. Photo facing southeast.
