## ecology and environment, inc.

May 17, 2018

### **Re: Monthly Report Summary #7 for the Santa Barbara County Reliability Project**

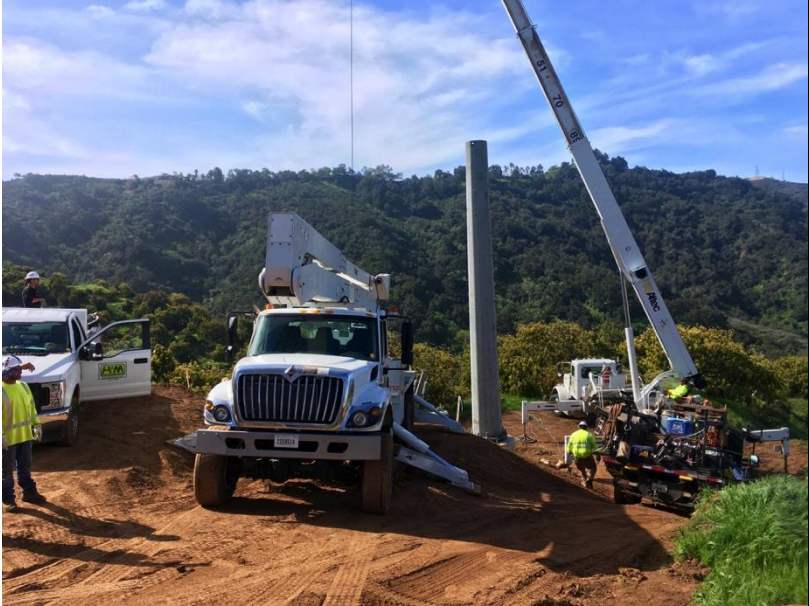
REPRESENTATIVE SITE PHOTOGRAPHS			
Date	Location	Photo	Description
4/5/18	Segment 4, Construct 83

Photo 5 – New TSP installation. Photo facing south.
4/5/18	Segment 4, Construct 80

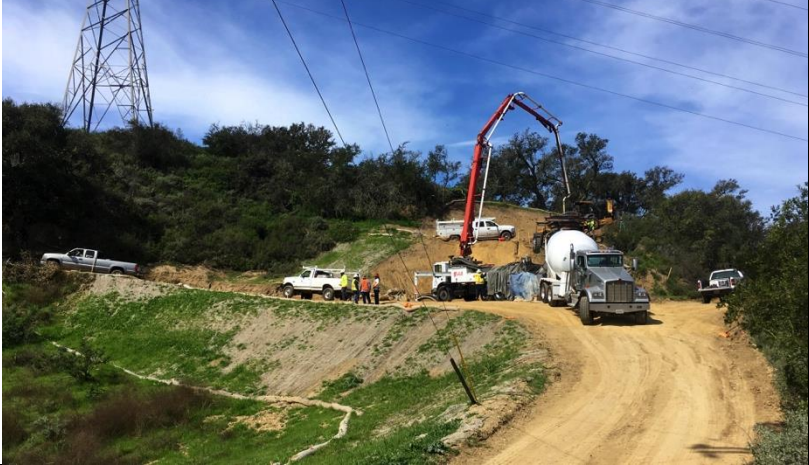
Crews were pouring the TSP foundation at Construct 80. It was a large pour, and five concrete trucks were lined up with crews ready to begin the work (Photo 6).

Photo 6 – Concrete pour of the TSP foundation. Photo facing northwest

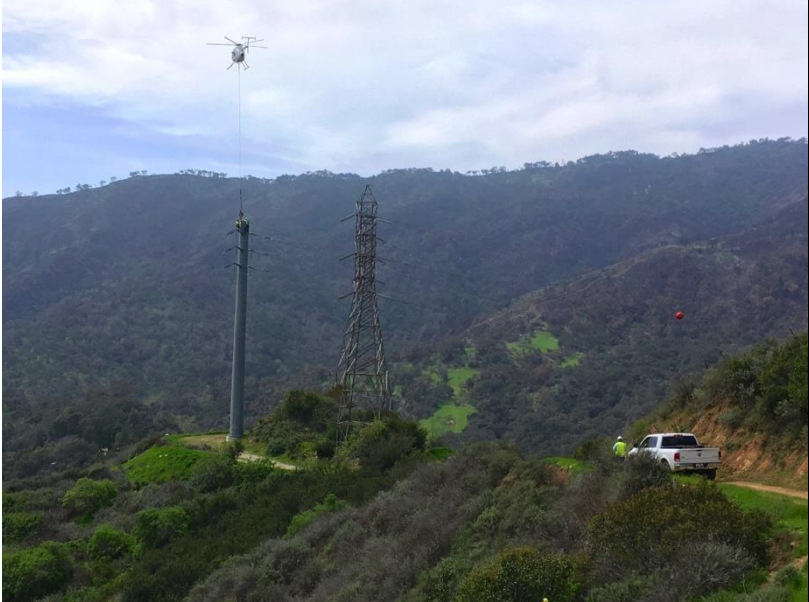
REPRESENTATIVE SITE PHOTOGRAPHS			
Date	Location	Photo	Description
4/5/18	Segment 2, Tower 445239

Along Segment 2, near the Casitas Substation, a helicopter crew was working. At the time of my site visit, they were dropping a crew member onto Tower 445239 to remove the fire-damaged marker balls from the wires (Photo 7). BRC biological monitors Peter Gaede and Asher Dietch were observing the various helicopter activities and watching for California condors.

Photo 7 – Helicopter dropping off workers on the new TSPs. Photo facing south.
4/5/18	Segment 4, Construct 98

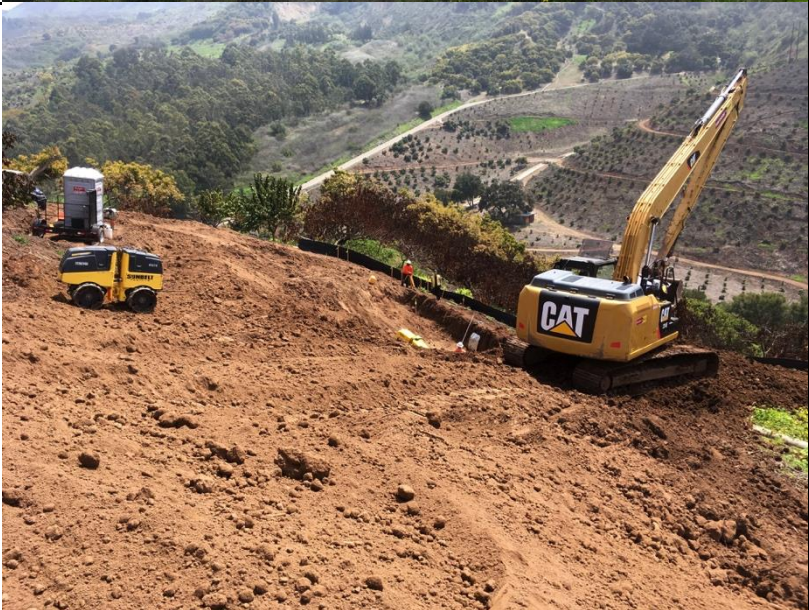
Photo 8 – Excavation for a Hilfiker wall. Photo facing east.

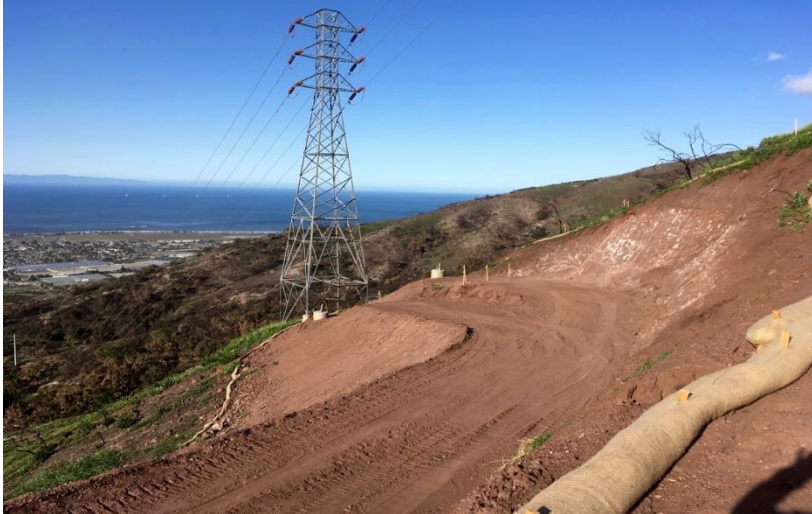
Date	Location	Photo	Description
4/12/18	Segment 4, TSP 129

We drove to tubular steel poles (TSPs) 128 and 129 where crews were attempting to install the tower foundations (Photo 1). Crews were at the site, but it was a very windy morning and they were unsure if they could work in the current conditions (Photo 2). It was very dusty at the site due to the winds and lack of dust control around the work areas. BRC lead biological monitor Matt Schaap said they had to relocate a rattlesnake from this area; he had moved the snake several miles up into the mountains. Large patches of wildflowers were growing within the burned areas along the access road.

Photo 1 – Crane pad construction. Photo facing south.
4/12/18	Segment 4, TSP 128

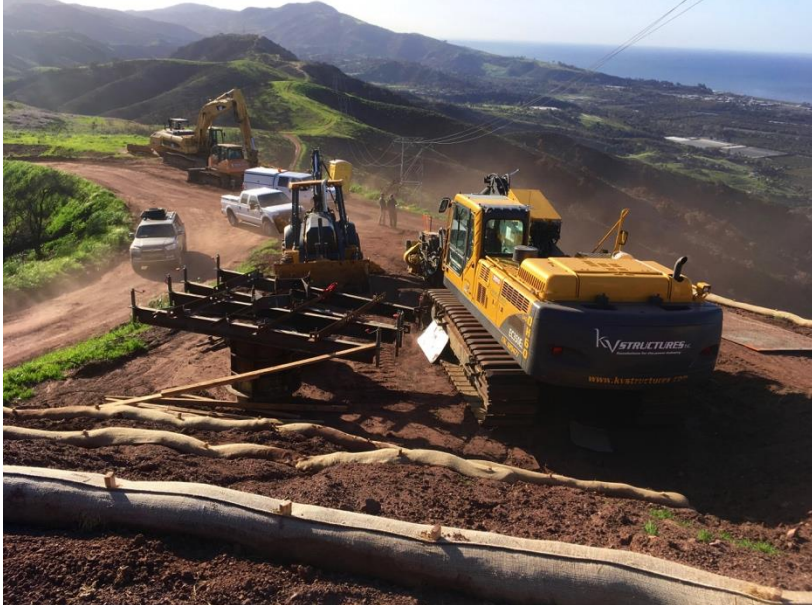
Photo 2 – Windy conditions at TSP 128. Photo facing southeast
4/12/18	Segment 4, Construct 101

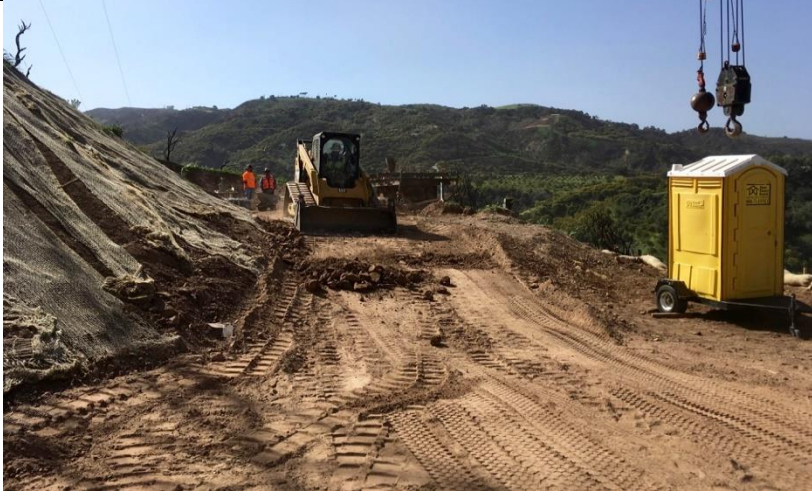
At TSP 101, a crew was preparing to pour the tower foundation, and a crew with a small piece of equipment was prepping the pad for the cement trucks (Photo 3). The crew said the hole was 7 feet in diameter by 42 feet deep and would require 64 cubic yards of concrete, or approximately eight to nine cement trucks. Due to the windy conditions, it was dusty; however, crews did not want to put water on the access road because it could make the road too slippery for the concrete trucks (APM AQ-1, MM HZ-2). I spoke with BRC lead biological monitor Matt Schaap about the dust and recommended that a water truck should wet down these areas first thing in the morning before the crews arrive.

Photo 3 – Final earthwork before concrete trucks arrive to pour the foundation. Photo facing southeast

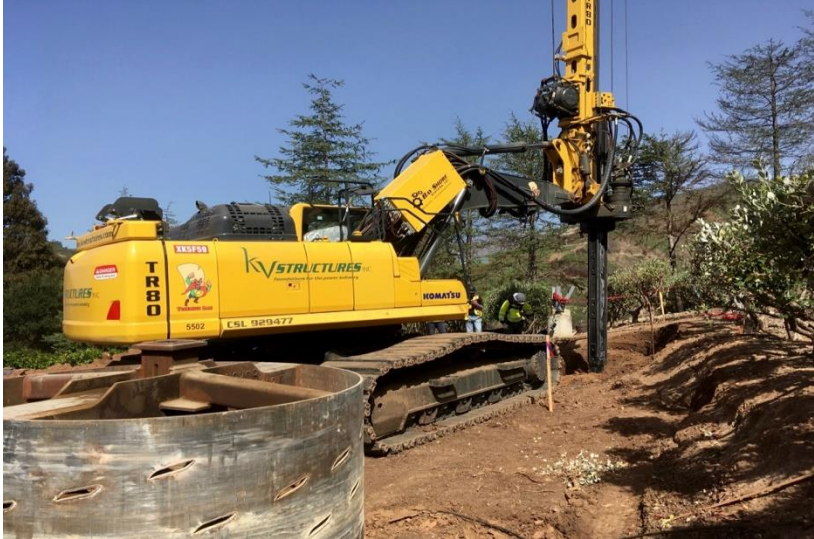
Date	Location	Photo	Description
4/12/18	Segment 4, TSP 102

A crew was drilling the foundation hole at TSP 102 (Photo 4). Drilling was progressing slowly, as the crew was now drilling into rock; however, the crew hoped to finish before the end of the day. GANDA paleontological monitor Andrew Paden was monitoring the tailings (MM CR-13). The previously identified red-shouldered hawk nest in the nearby sycamore tree was abandoned during the nest-building phase and was no longer an issue.

Photo 4 – Drilling rig is onsite and working. Photo facing west.
4/12/18	Segment 4, TSP 81

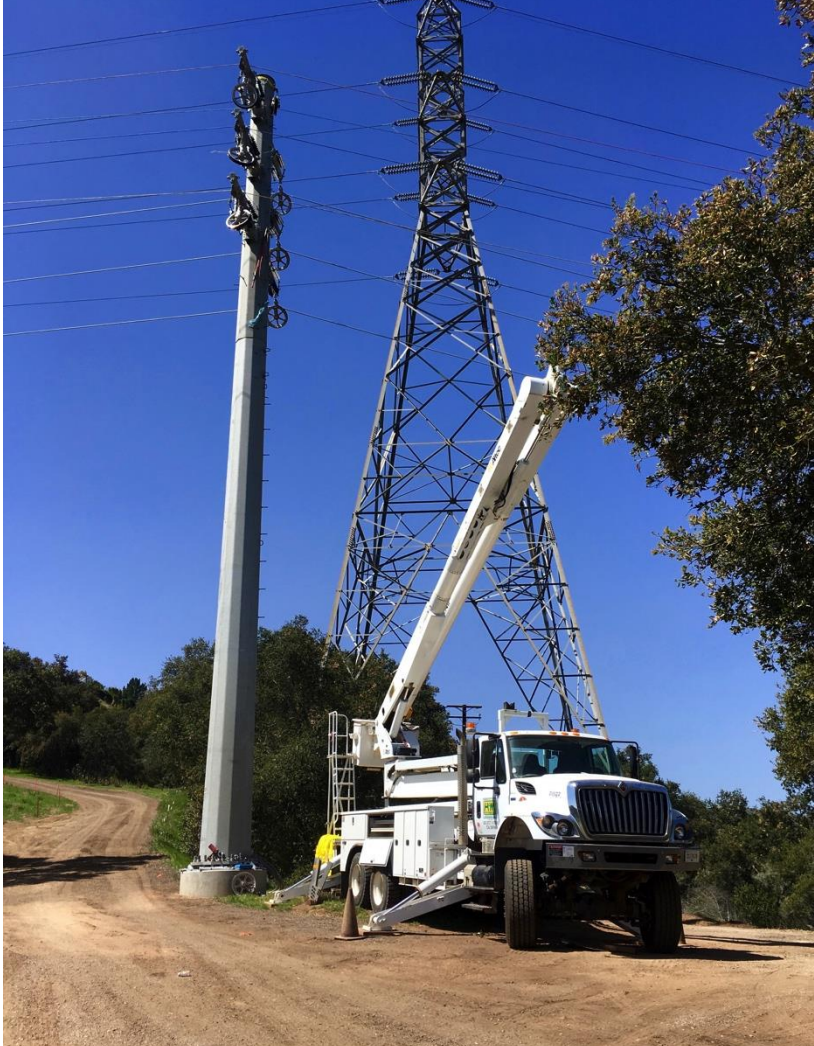
Photo 5 – Wire pulling work.

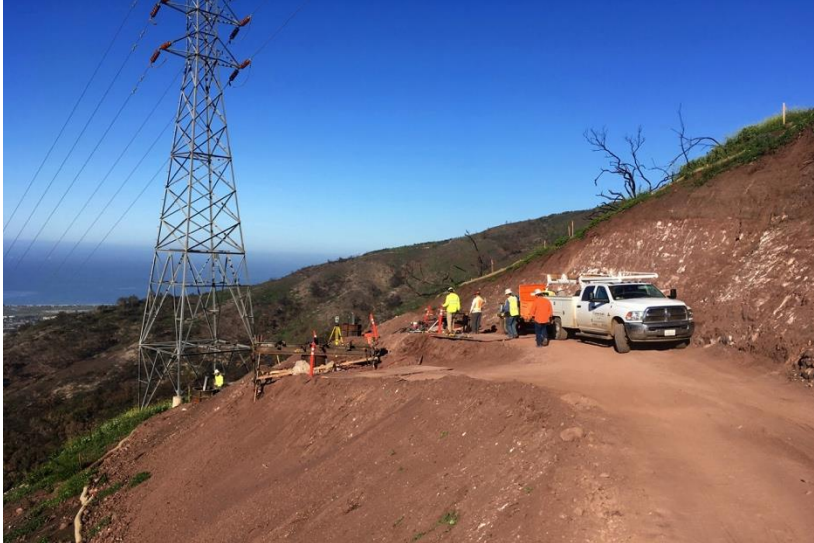
REPRESENTATIVE SITE PHOTOGRAPHS			
Date	Location	Photo	Description
4/20/18	Segment 4, Construct 129

Photo 1 – Foundation work continues. Photo facing southwest.
4/20/18	Segment 4, TSP 132

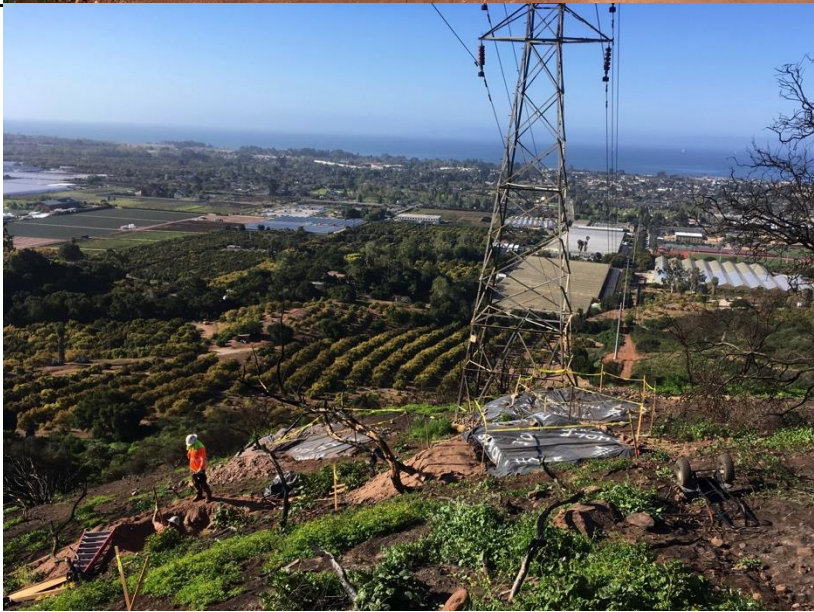
BRC biological monitor Dave Wappler was stationed at the Franklin Trail. We walked to TSP 132 where a two-person excavation team continued to chip away at the rock within the last foundation hole (Photo 2). This crew had finished three foundation holes and had nearly completed the fourth (Photo 3). All of the holes were well covered and had caution tape around them. The rocks from the foundation excavation were piled next to the holes; I asked BRC lead biological monitor Matt Schaap about their plan for the tailings and he was not sure at that time. During the day of my site visit, Dave Wappler would be headed up the hill to check on the work at TSP 128 (APM BIO-3, APM BIO-4).

Photo 2 – Hand crews have dug three of the four foundation holes. Photo facing south.

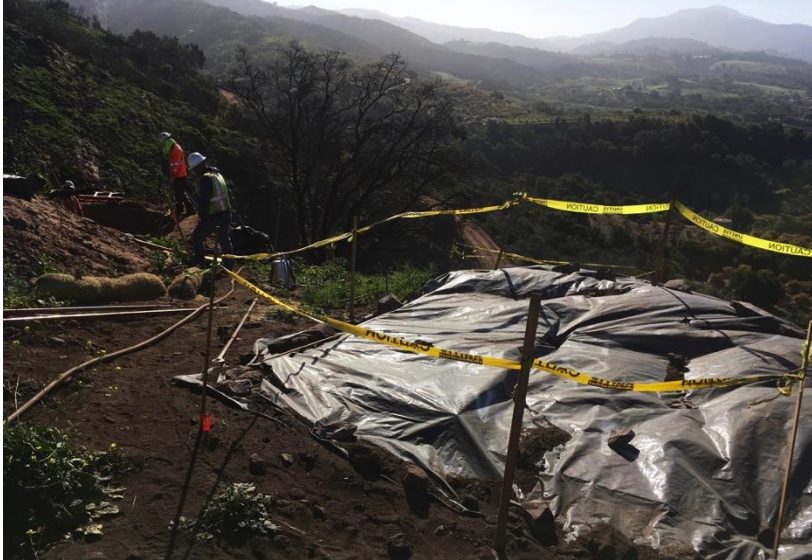
Date	Location	Photo	Description
4/20/18	Segment 4, TSP 132

Photo 3 – A hand crew excavating the last foundation hole; other holes have been dug and sealed. Photo facing east
4/20/18	Segment 4 TSP 99

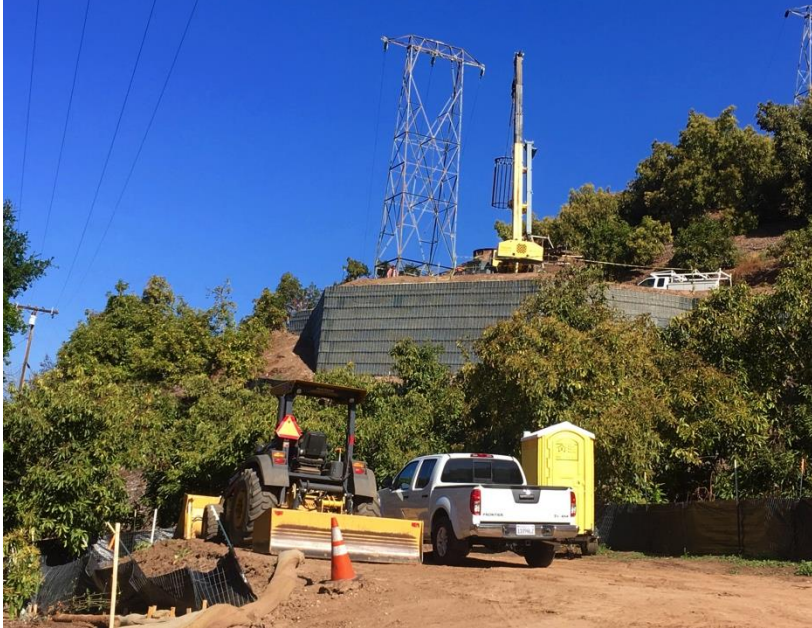
At TSP 99, crews were preparing to set the cage in the foundation hole and planned to pour the foundation on the day of my site visit (Photo 4). Rincon biological monitor Emily Chase was onsite and said that the work was going well. BRC lead biological monitor Matt Schaap and I noticed that the parked drill rig was leaking an oily fluid. Pans had been placed under the equipment, but it was parked on a slope and the fluid was running off the pans into the soil. Matt Schaap spoke with the foreman who said they had a mechanic in route to fix the leak but that he would assign someone to clean up the impacted soil.

Photo 4 – A crane is setting the foundation cage.

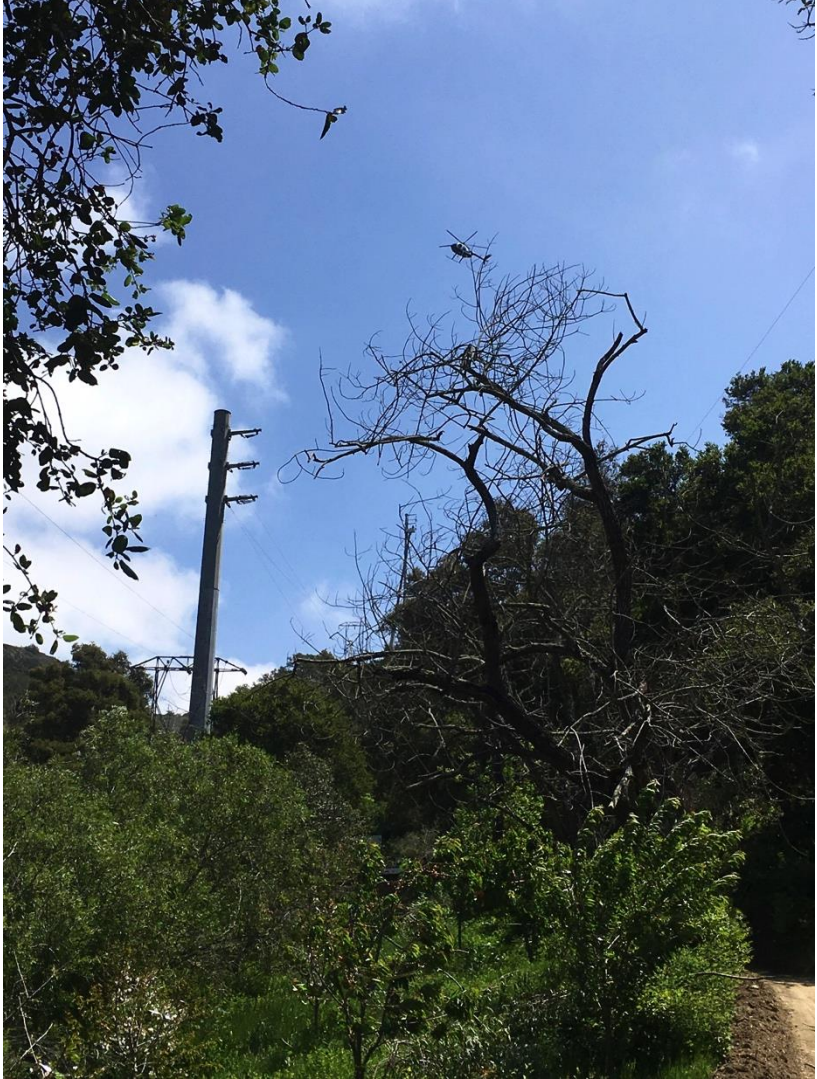
REPRESENTATIVE SITE PHOTOGRAPHS			
Date	Location	Photo	Description
4/27/18	Segment 4, TSP 61

A photograph showing a small helicopter pulling a wire near a utility tower in a wooded area. The scene is outdoors with a clear blue sky and some clouds. A utility tower is visible in the background, and a large, leafless tree is in the foreground. The helicopter is positioned near the top of the frame, pulling a wire that extends towards the tower.	Photo 4 – A small helicopter is pulling wire near the new towers.

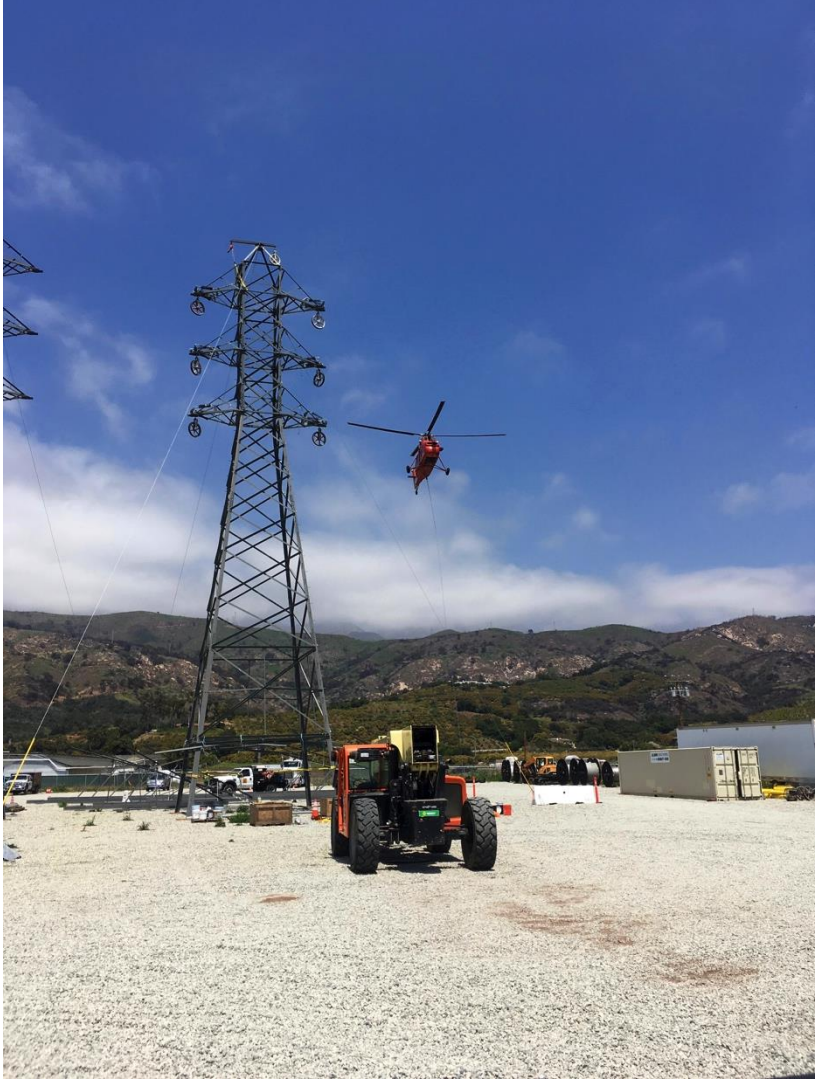
REPRESENTATIVE SITE PHOTOGRAPHS			
Date	Location	Photo	Description
4/27/18	Carpinteria Yard B

We returned to Carpinteria Yard B where we watched the large helicopter carrying concrete to TSP 132 (Photo 5). Conditions were still fairly calm and the work appeared to be going smoothly.

Photo 5 – A large helicopter returning to Carpinteria Yard B for fuel. Photo facing north.
