**Re: Monthly Report Summary #9 for the Santa Barbara County Reliability Project**

CPUC Site Inspection Report

## Santa Barbara County Reliability Project CPUC Site Inspection Form

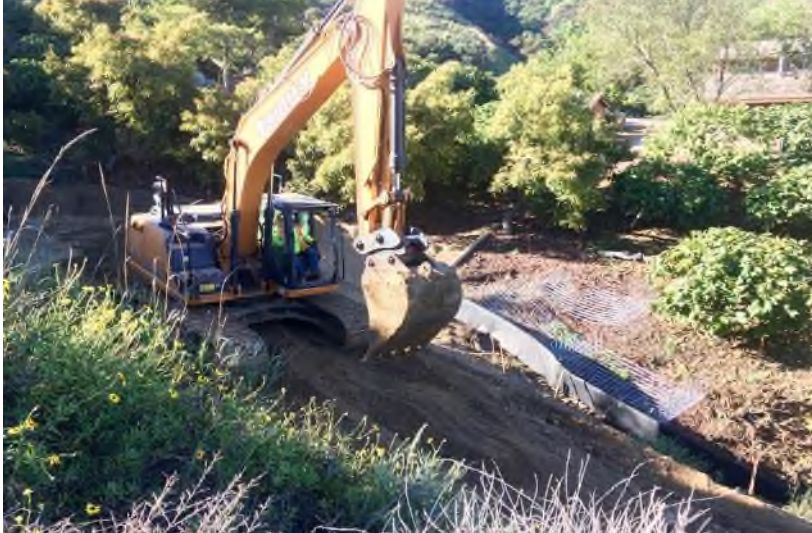
Photo 1 – Construction of the Hilfiker wall. Photo facing southeast.
6/1/18	SBCRP – Construct 72

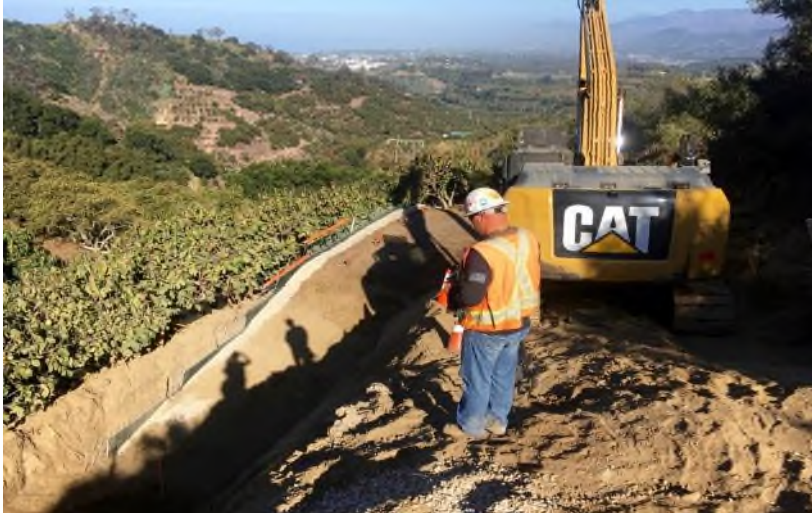
Photo 2 – Construction of the Hilfiker wall. Photo facing west.
6/1/18	SBCRP – Construct 72

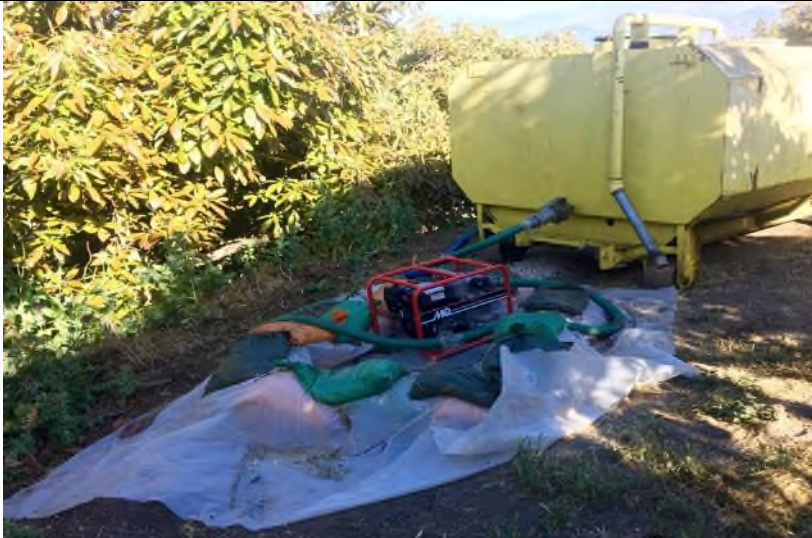
Photo 3 – Water delivery system with a tank and pump.

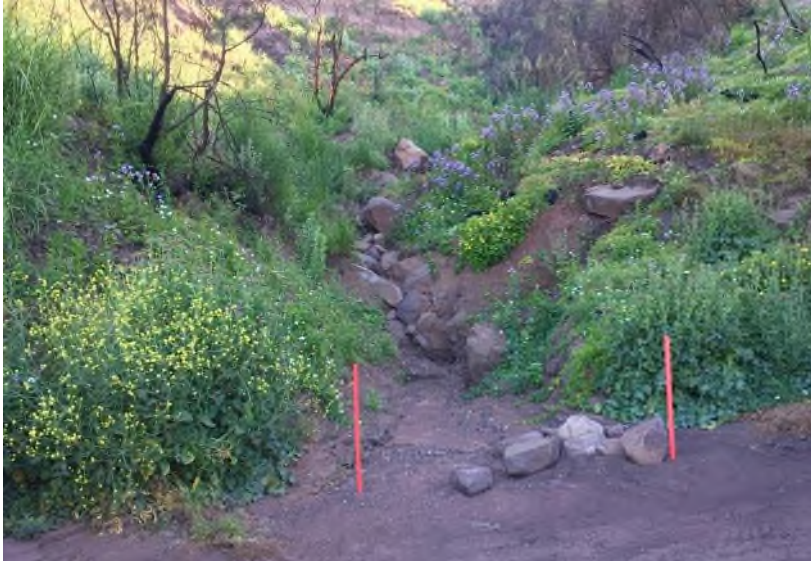
Photo 1 – A drainage coming down onto the access road located between Constructs 116 and 119.
6/13/18	SBCRP – Construct 119

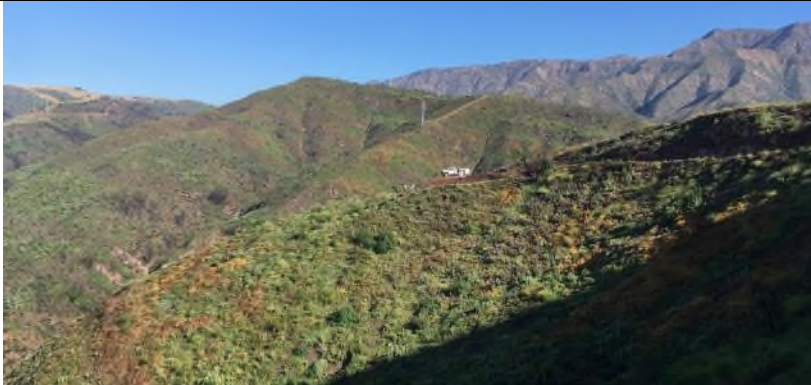
Photo 2 – Looking northwest toward Construct 119 (where the vehicles are) and 120 in the distance.
6/13/18	SBCRP – Segment 4, Vedder Property, Construct 119

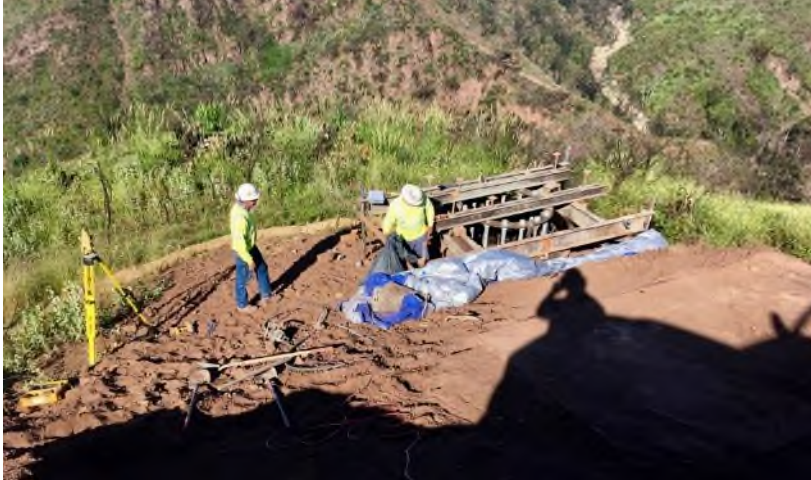
Photo 3 – Foundation set to pour.

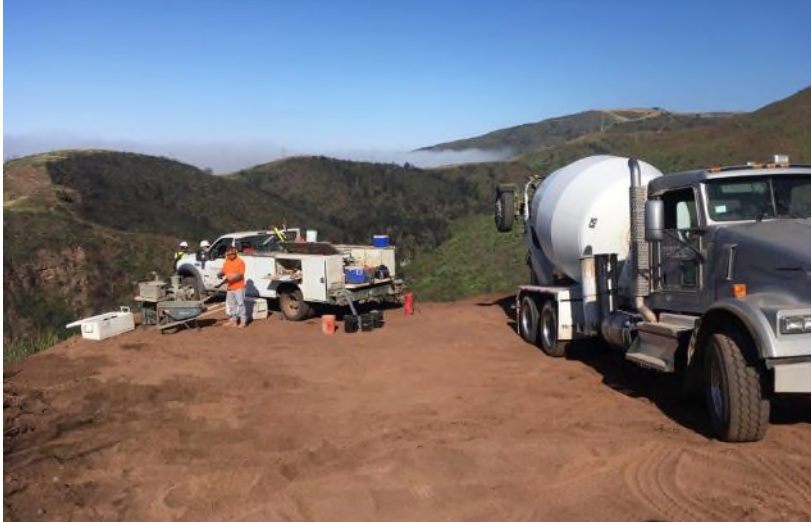
Since access was an issue, I rode with Rincon lead biological monitor James Rasico to Construct 119 before the concrete trucks arrived. This was my first site visit to the Vedder property. On the way in, we noted water trucks conducting dust control (APM AQ-1) and a crew coordinating traffic. Parking was very limited, so we stopped at Construct 116 and walked to Construct 119, which was at the end of the access road. The access road crosses a number of steep drainages (Photo 1) that James Rasico said will be "upgraded" after most of the tubular steel pole (TSP) installation work is completed. This could include culverts, riprap, and McCarthy drain installation. Photo 2 is looking northwest toward Construct 119 where the vehicles were located. Behind the vehicles and across the canyon is Construct 120, which is another tower location at the end of an access road. At Construct 119, the hole had been drilled, the rebar was installed, and the concrete forms were in place (Photo 3). Barrett Holland (BRC) was the biological monitor onsite, and he had cleared the area and would be monitoring construction activities between Constructs 116 and 119 throughout the day (APM BIO-3, APM BIO-4). The first concrete truck arrived at 0845, with seven additional concrete trucks scheduled to follow (Photo 4).

Photo 4 – Concrete truck arrives at Construct 119 to pour the pole foundation. Photo facing west
6/13/18	SBCRP – Segment 4, Vedder Property, Construct 118

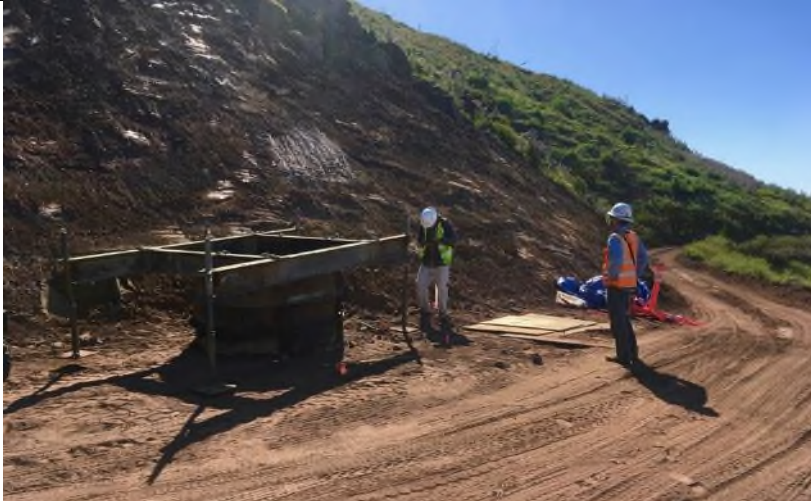
At Construct 118, some site preparation had been completed, including cutting back the slope north of the TSP site. Some foundation equipment had been staged at this location (Photo 5), but no drilling work had been conducted, yet.

Photo 5 – Stockpiled equipment at Construct 118.
6/13/18	SBCRP – Segment 4, Vedder Property, Construct 116

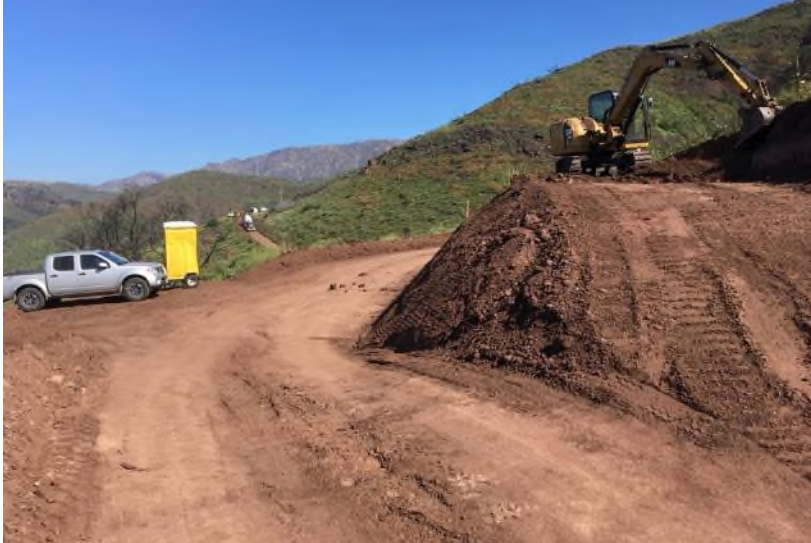
Photo 6 – Small excavator digging out the pad at Construct 116. Photo facing northwest.

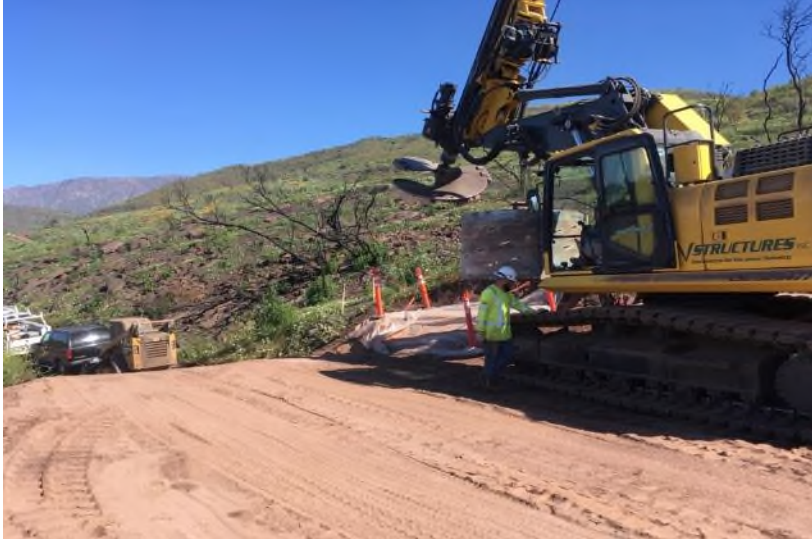
Photo 7 – Drill rig sitting at the Construct 115 site. Photo facing northwest.
6/13/18	SBCRP – Segment 4, Vedder Property, Construct 114

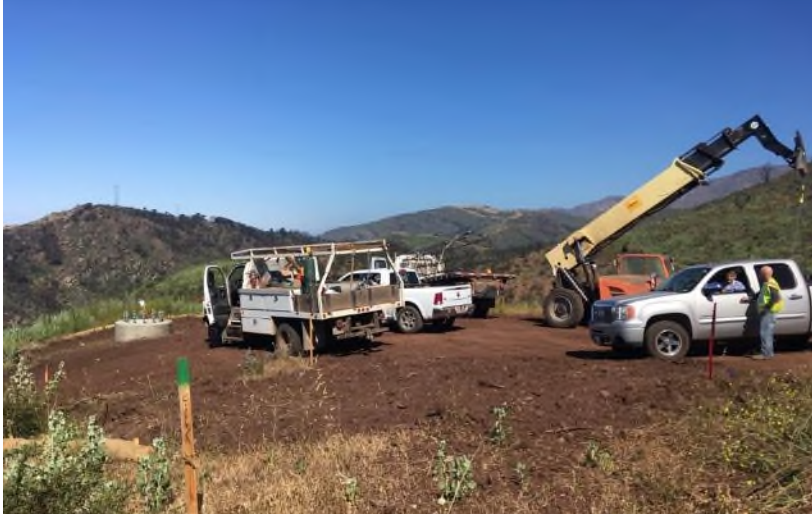
The Construct 114 location had the pole foundation poured. Because this location provided more space, a number of vehicles were parked there; it is also documented as a helicopter landing area (Photos 8 and 11).

Photo 8 – Equipment staged at Construct 114, which has already been poured. Photo facing west.
6/13/18	SBCRP – Segment 4, Vedder Property, Construct 112

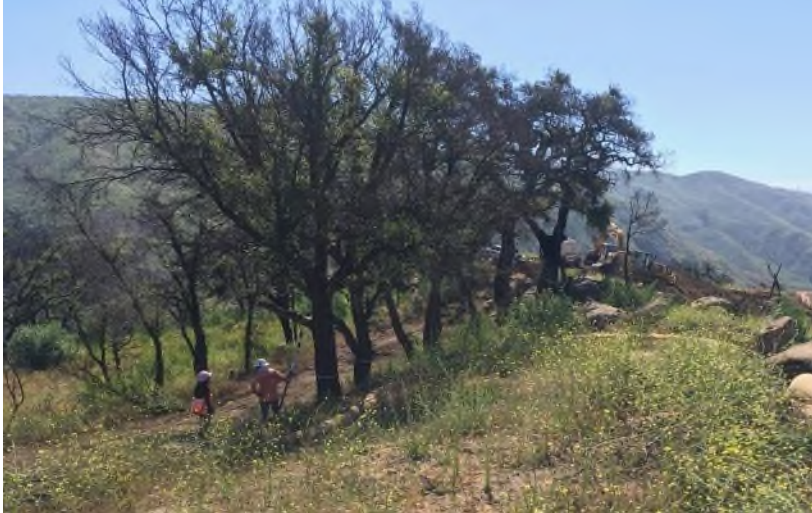
Photo 9 – Tree trimming along the Construct 112 access road. Photo facing east.

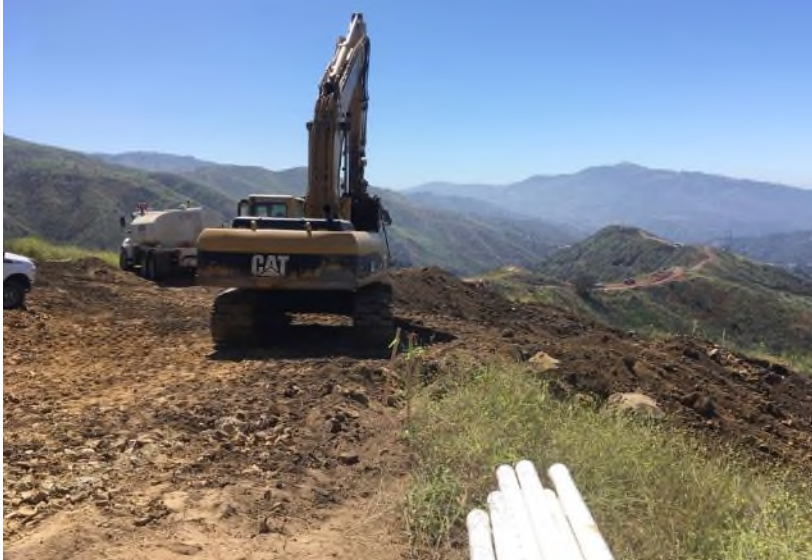
Photo 10 – Earthwork at the Construct 112 site. Photo facing east.
6/13/18	SBCRP – Segment 4, Vedder Property, Construct 114	 	Photo 11 – Looking back at the Construct 114 site, which is an approved helicopter landing area. Photo facing northwest.
6/13/18	SBCRP – Segment 4, Vedder Property, Construct 110

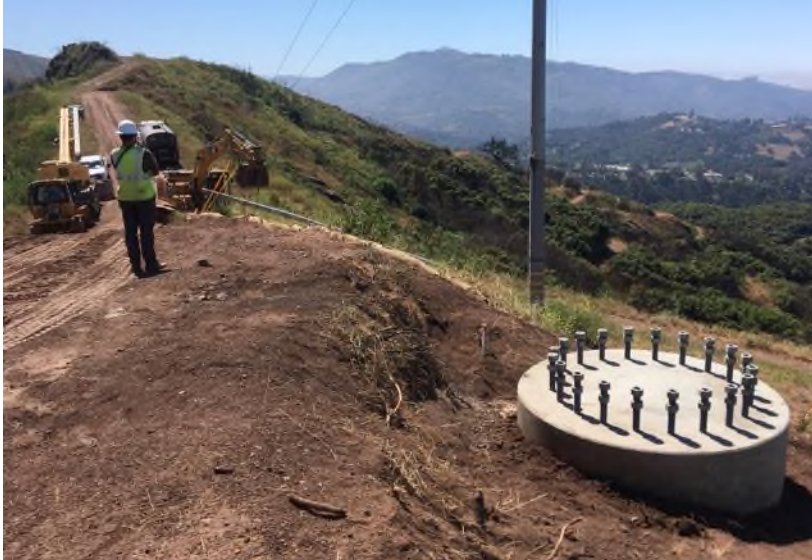
Photo 12 – TSP foundation has been poured; equipment is being used to remove an old metal pole.

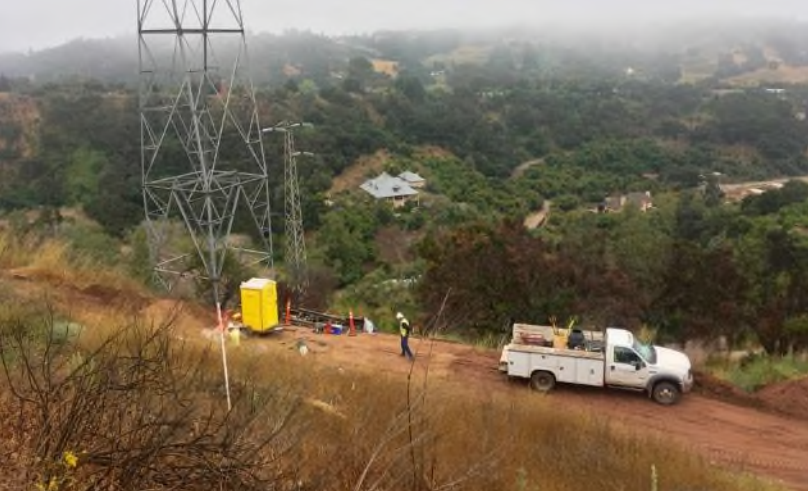
Rincon lead biological monitor James Rasico said they had installed tubular steel poles (TSPs) 119, 118, and 117 on the Vedder property and were pouring the foundation for Construct 107 on the day of my site visit (Photo 1). We drove to Construct 107 where the crews had set up the forms and were waiting for concrete trucks (Photo 2). The pour was expected to take a while to complete, as it was a large (7 feet in diameter) and deep hole. BRC biological monitor Dave Wappler was stationed at this location and would be overseeing the concrete pour and other work in this area.

Photo 1 – Setting up for a foundation pour at Construct 107. Photo facing south.
6/27/18	SBCRP – Construct 107

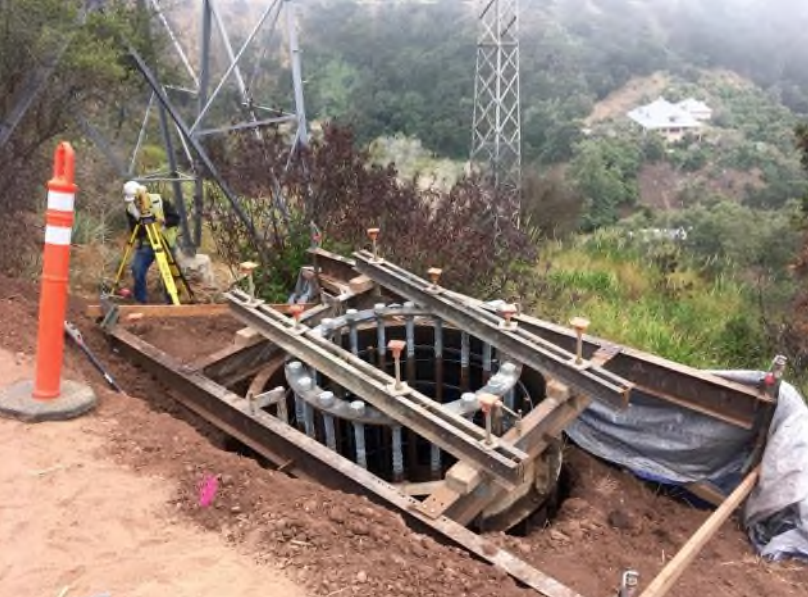
Photo 2 – Rebar cage installed and concrete forms in place.
6/27/18	SBCRP – Segment 4, Vedder Property, Construct 108

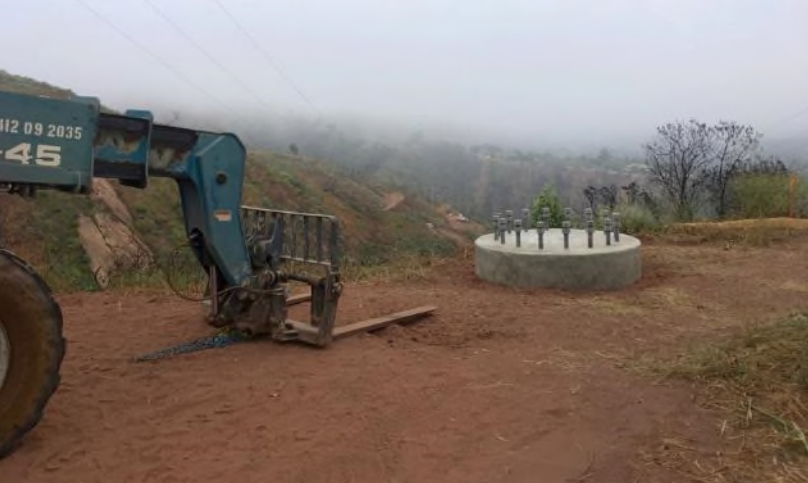
Photo 3 – Tower foundation poured at TSP 108. Photo facing southwest.

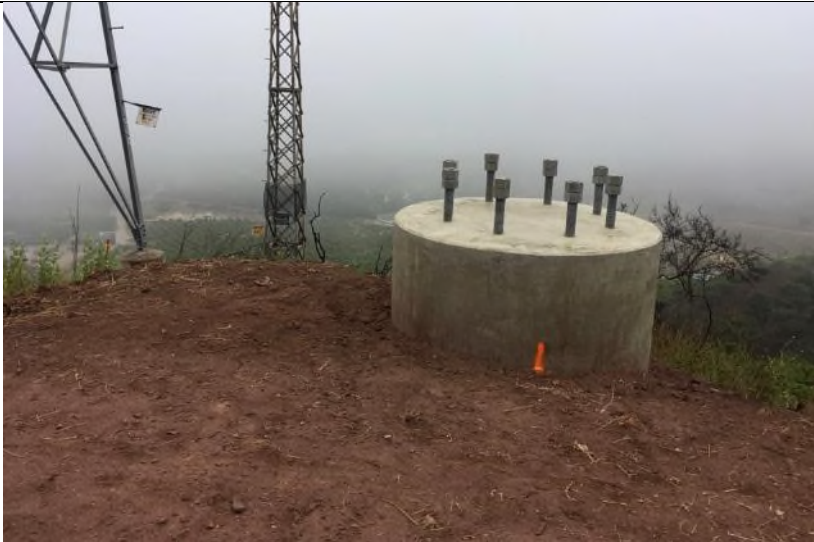
Photo 4 – Concrete foundation has been poured. Photo facing south.
6/27/18	SBCRP – Segment 4, Vedder Property Access Road to Construct 112

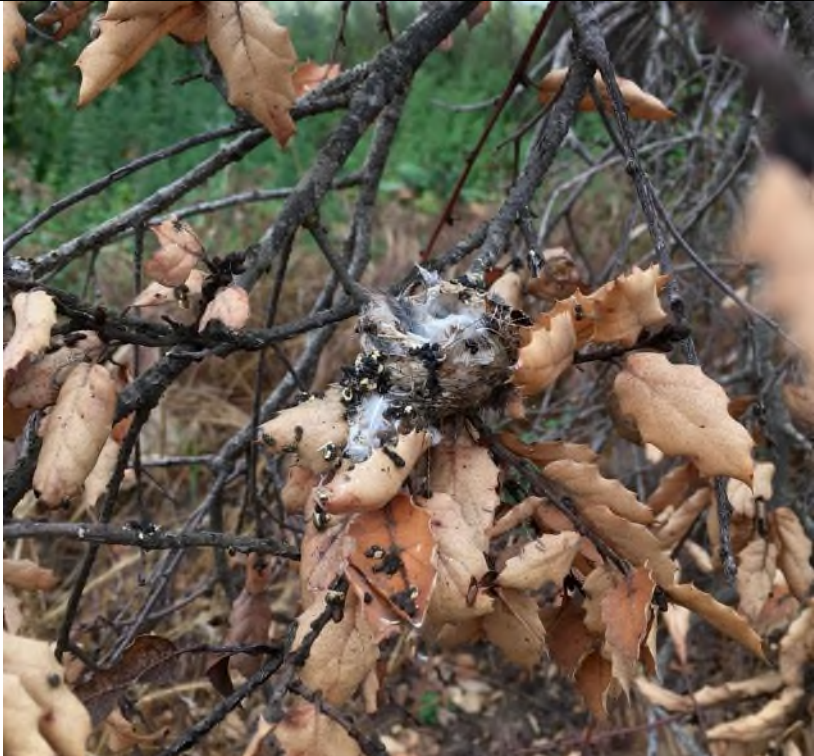
Photo 5 – Old hummingbird nest.

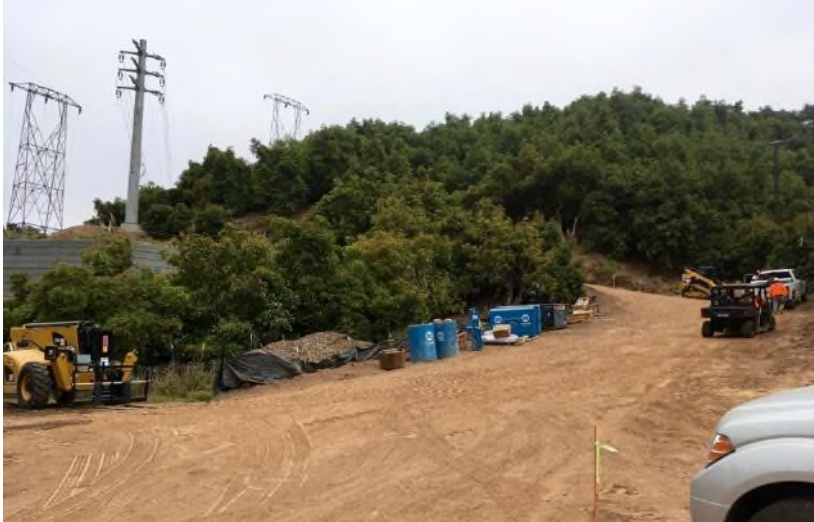
At Construct 99, a new crew was mobilizing for work on the access road; the crew was bringing materials to the site (Photo 9). Rincon biological monitor Paulette Loubet was onsite and she had talked with the crew about the environmental conditions, emphasizing dust control and drip pans (APM AQ-1). This crew will be driving sheet pile to stabilize the steep slopes above the access road (Photo 10).

Photo 9 – A new crew is mobilizing at this site. Photo facing west.
6/27/18	SBCRP – Construct 99

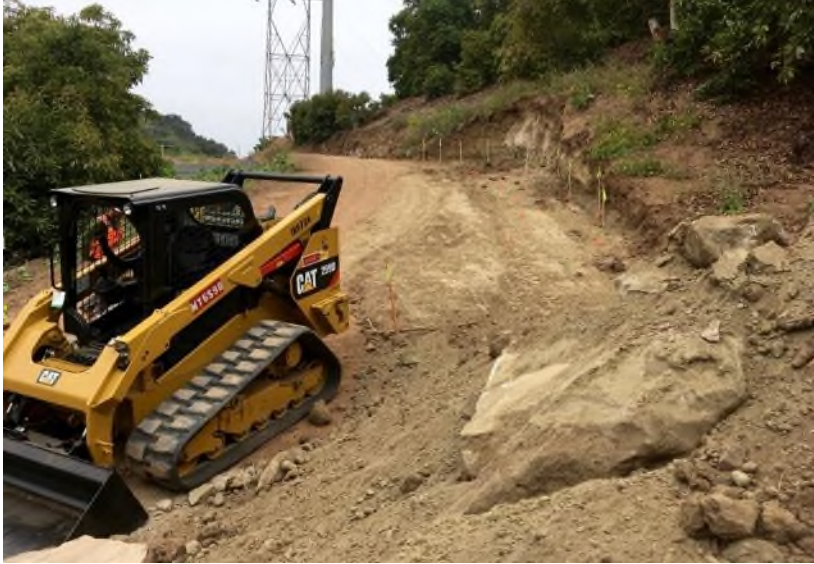
Photo 10 – Access road where sheet pile will be driven. Photo facing west.
6/27/18	SBCRP – Civil ID #69 along Access Road to Construct 90

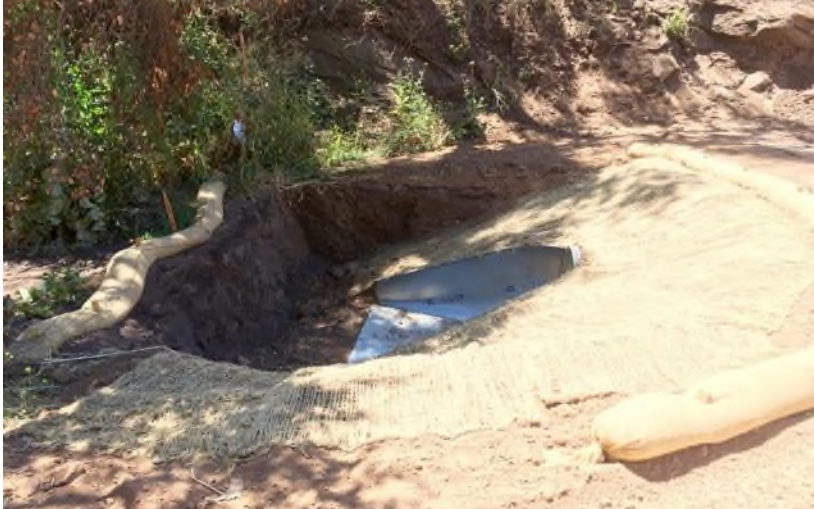
Photo 11 – Culvert intake apron installed approximately 3 feet below the drainage.

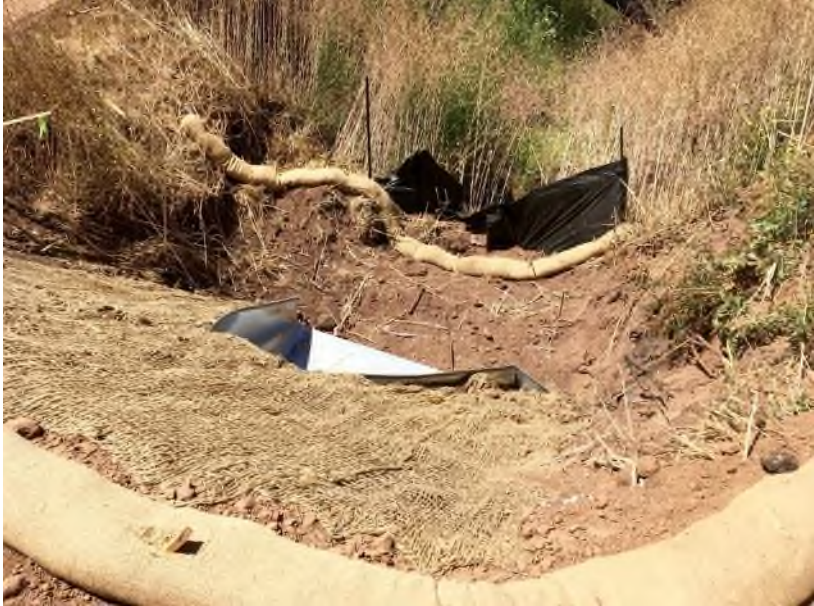
Photo 12 – Downstream portion of the newly installed culvert.
6/27/18	SBCRP – Access Road to Constructs 90 and 91

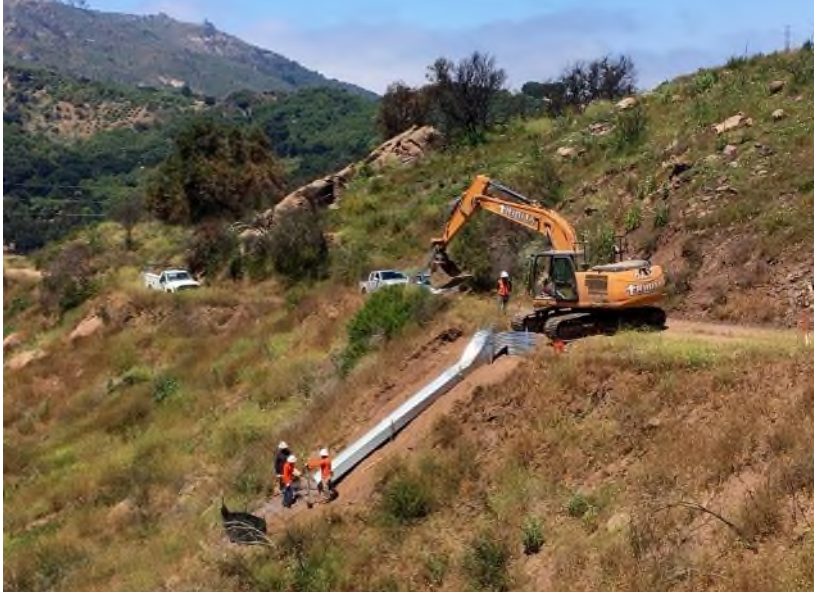
Photo 13 – McCarthy drain installation along the access road. Photo facing southwest.
