Re: Monthly Report Summary #11 for the South Orange County Reliability Enhancement (SOCRE) Project

CPUC Site Inspection Reports
September 6, 13, 20, and 27, 2018

South Orange County Reliability Enhancement Project CPUC Site Inspection Form

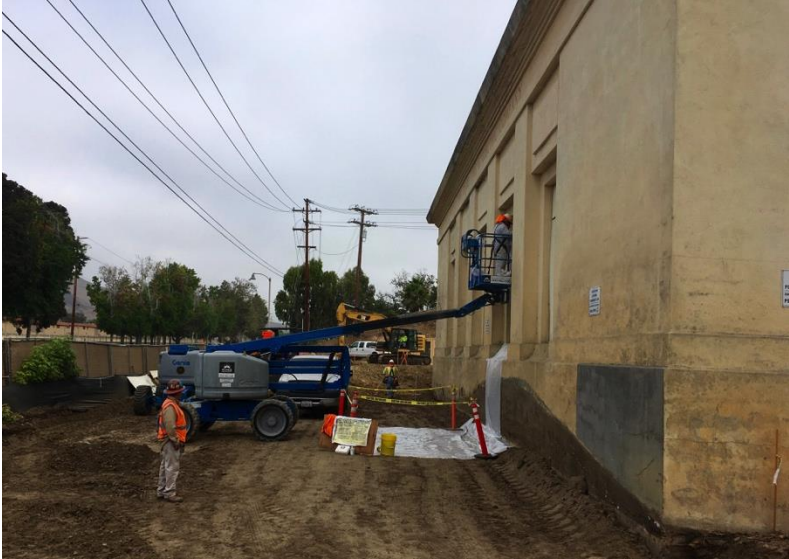
A crew continued to remove lead paint from the former utility structure's windows (Photo 7). Air sampling equipment was being used during lead paint removal (Photo 8).

Photo 7 – Lead paint removal at the former utility structure. Photo facing north.
9/13/18	San Juan Capistrano Substation

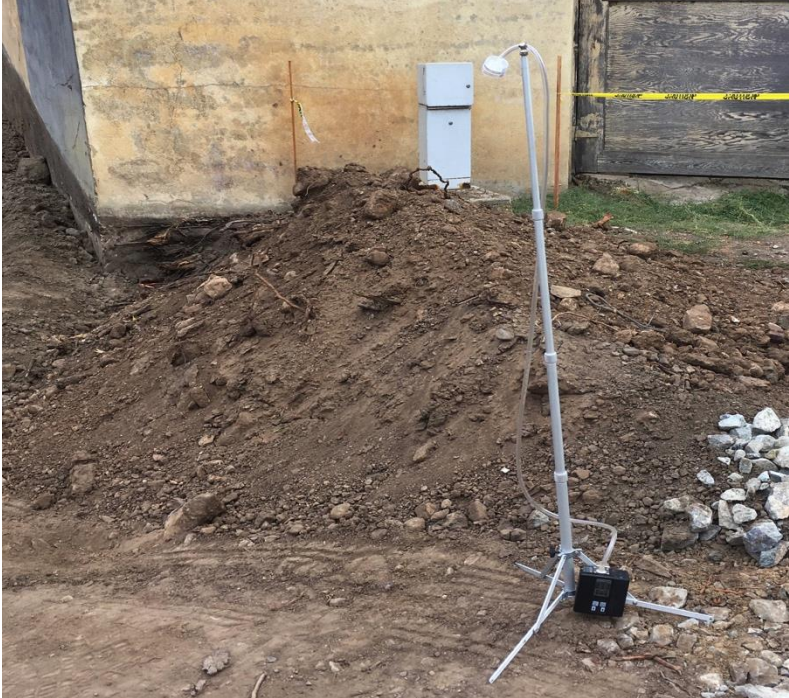
Photo 8 – Air sampling equipment at the former utility structure.

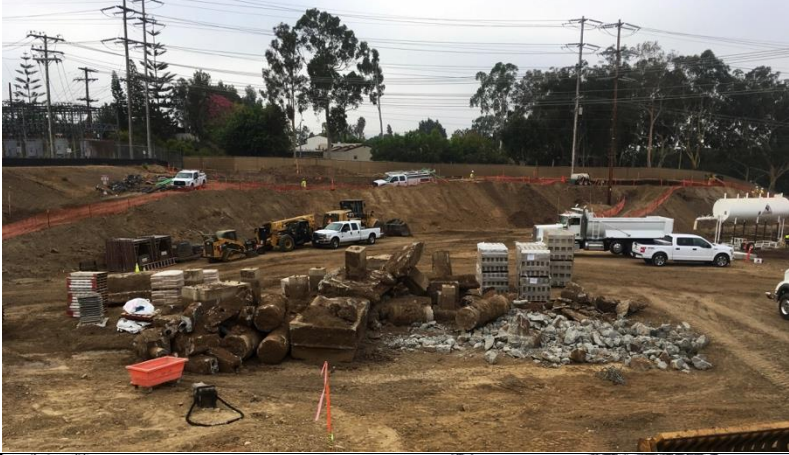
Tower and rack foundations have been excavated from within the San Juan Capistrano Substation site. These materials will be stockpiled onsite until it can be broken up and recycled (Photo 2). Some foundations remain within the San Juan Capistrano Substation site (Photo 5).

Photo 2 – Old tower foundations stockpiled onsite. Photo facing south.
9/27/18	San Juan Capistrano Substation

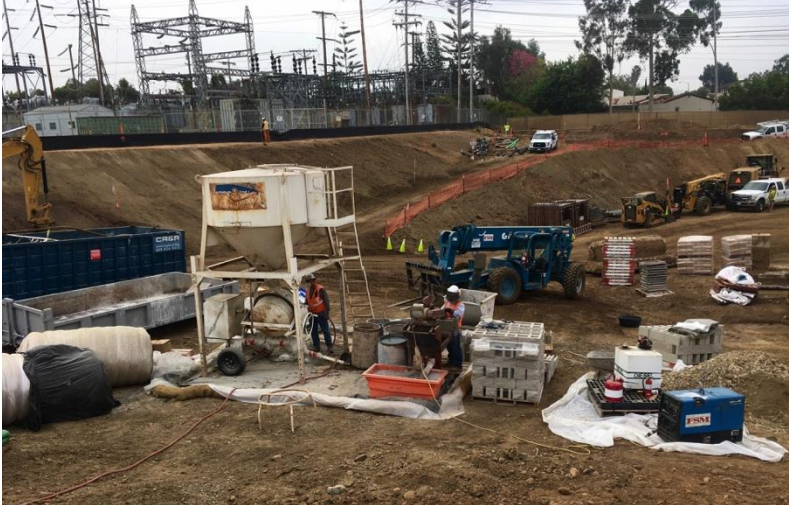
Photo 3 – Grout mixing station. Photo facing south.

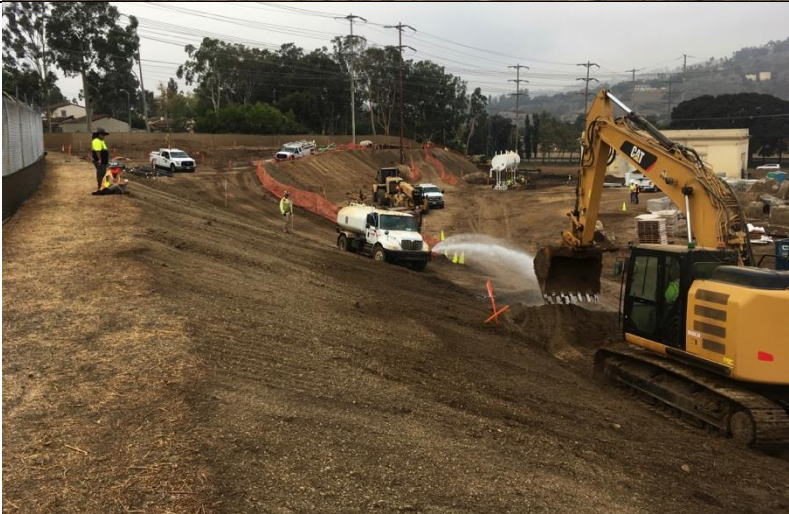
Photo 6 – Over-excitation work. Photo facing southwest.
