Re: Monthly Report Summary #16 for the South Orange County Reliability Enhancement (SOCRE) Project

South Orange County Reliability Enhancement Project CPUC Site Inspection Form

Project:	South Orange County Reliability Enhancement (SOCRE) Project	Date:	February 6, 2019
Project Proponent:	San Diego Gas & Electric (SDG&E)	Report #:	VS024
Lead Agency:	California Public Utilities Commission (CPUC)	Monitor(s):	CPUC/Ecology and Environment (E & E) Compliance Monitor
CPUC PM:	Andrew Barnsdale, Energy Division	AM/PM Weather:	Sunny, cool, and calm
CPUC CM (E & E):	Joe Donaldson	Start/End Time:	1200 to 1315
Project NTP(s):	NTP-1, NTP-2, NTP-2 Addendum 1, NTP-3, and NTP-4

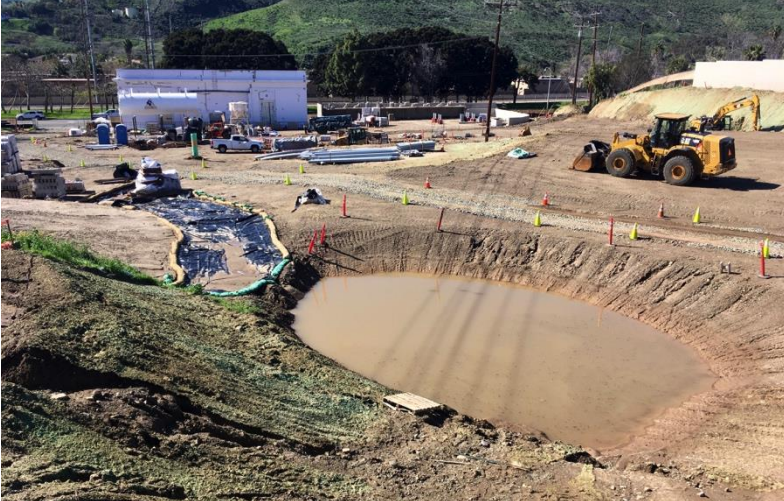
The catch basin located below the existing 138/12-kilovolt (kV) substation was fairly full (Photo 3). As directed by the SDG&E Lead Environmental Coordinator, construction crews installed a plastic-lined overflow channel to direct rainwater runoff to the rock-lined access road and then into the rock-lined channel at the southwest corner of the San Juan Capistrano Substation site. From there, rainwater runoff enters the exit culvert (Photo 4). According to the SDG&E Lead Environmental Inspector, the pipe redirecting runoff from the existing 138/12-kV substation was damaged and more water had flowed into the catch basin. Construction crews repaired the pipe soon after discovering it was damaged.

Photo 3 – Catch basin below the existing 138/12-kV substation. Photo facing west.
2/6/19	San Juan Capistrano Substation

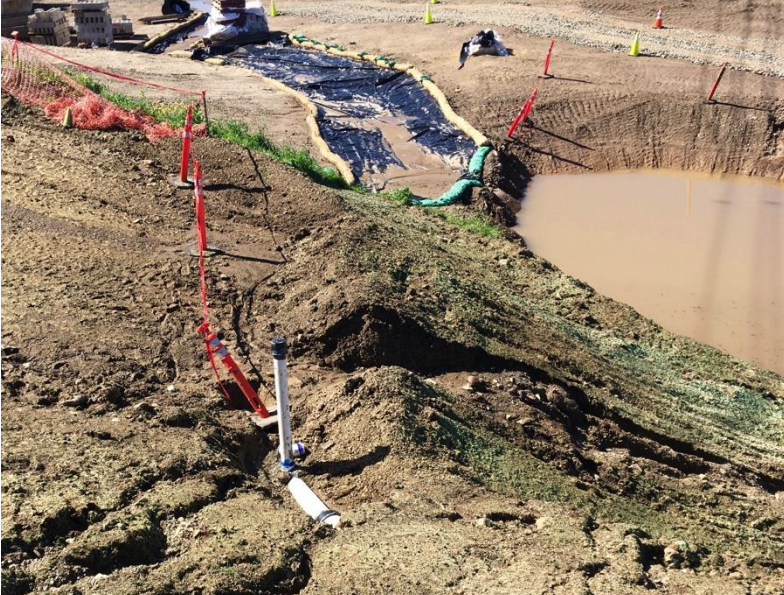
Photo 4 – Piping bringing water from the existing 138/12-kV substation down to the exit culvert.
2/6/19	San Juan Capistrano Substation

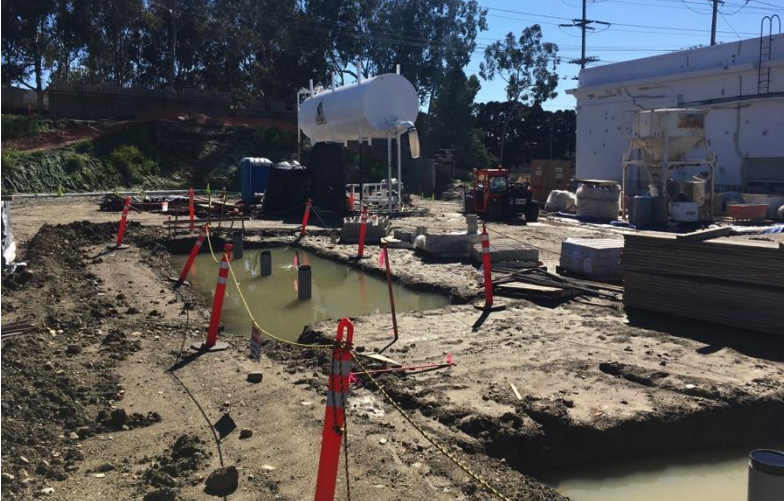
Some of the open conduit excavations were full of water (Photo 5). A truck had parked in a muddy portion of the site and the Lead SDG&E Environmental Coordinator directed that the tires be hosed off before the vehicle exited the site (Photo 6).

Photo 5 – Conduit trenches full of water. Photo facing south.

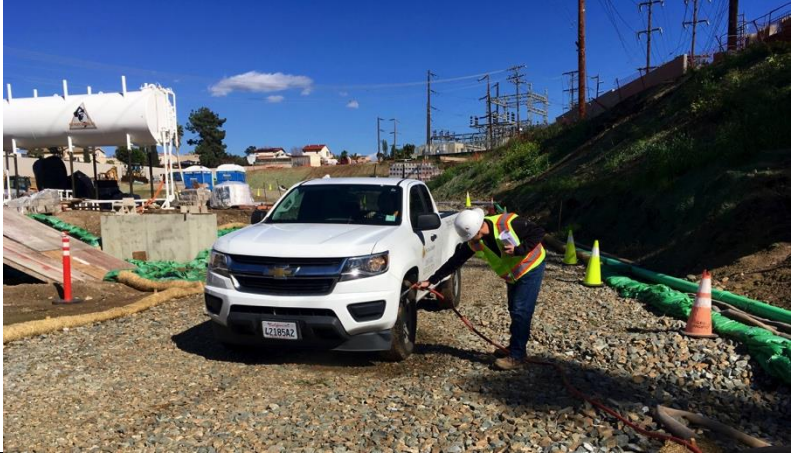
Photo 6 – Washing off vehicle tires before exiting the site. Photo facing east

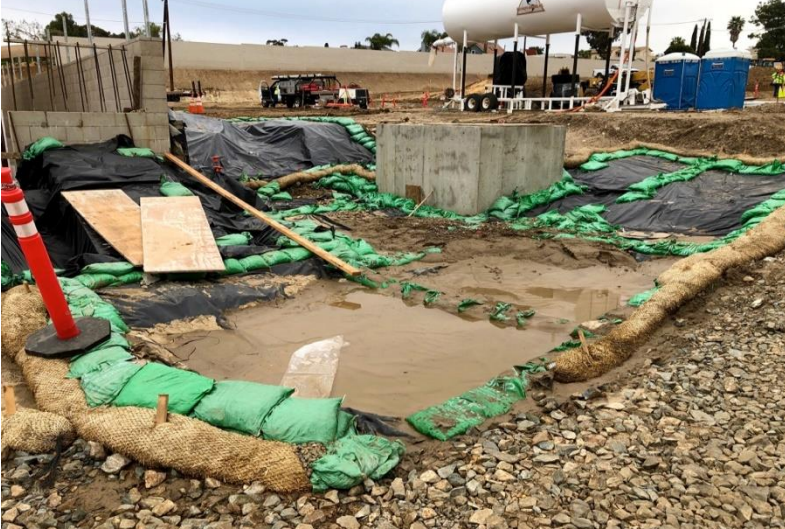
According to the Lead SDG&E Environmental Coordinator, upgrades to the existing best management practices (BMPs) were scheduled to be completed as soon as possible (Photo 1). The piping bringing rainwater runoff from the existing 138/12-kilovolt (kV) substation was scheduled to be reconnected by the end of the day (Photo 2).

Photo 1 – BMPs near the San Juan Capistrano Substation site entrance. Photo facing north.
2/28/19	San Juan Capistrano Substation

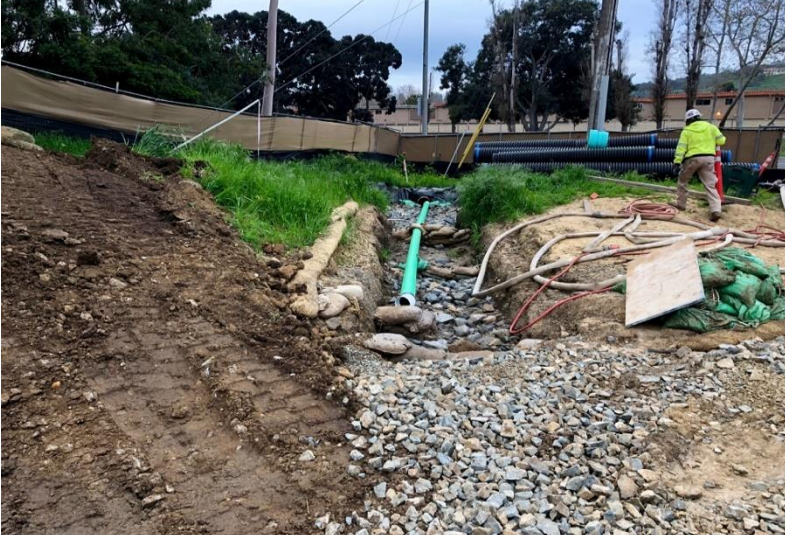
Photo 2 – Rock lined trench and piping leading to the offsite drain. Photo facing southwest.
2/28/19	San Juan Capistrano Substation

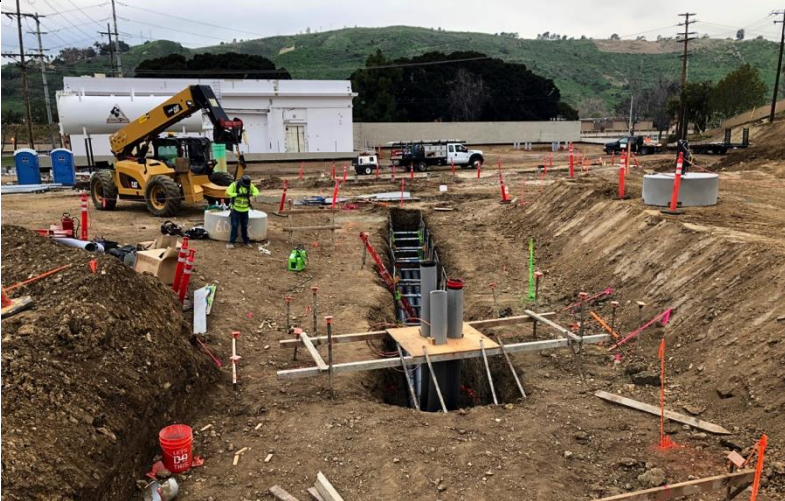
A construction crew was working on conduit and was expecting to slurry the trench later in the day (Photo 3). The crew had rerouted wiring around the site earlier and removed the poles from inside the San Juan Capistrano Substation site.

Photo 3 – Conduit work. Photo facing west.

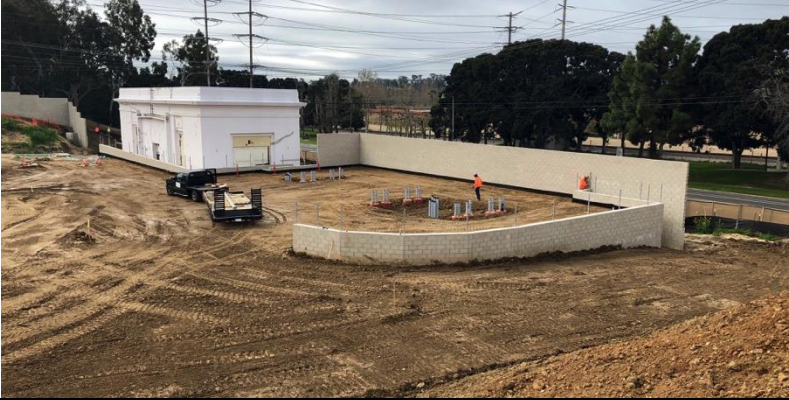
Earthwork continued at the San Juan Capistrano Substation site; the slope below the northern wall had been cut back to grade (Photo 4). Soil was used to backfill the area behind the western boundary wall (Photo 7), but there was still a fair amount of soil stockpiled onsite (Photo 5). The catch basin below the existing 138/12-kV substation was filled with water; this was a concern, given the amount of stockpiled soil onsite. The SDG&E Lead Environmental Coordinator indicated that the slopes had been sprayed with a soil binder and that they were going to construct a catch basin downslope near the northwest corner of the site. The SDG&E Lead Environmental Coordinator will be monitoring this area during rain events.

Photo 7 – The western boundary wall is now finished and backfilled. Photo facing southwest.
