Re: Monthly Report Summary #20 for the South Orange County Reliability Enhancement (SOCRE) Project

South Orange County Reliability Enhancement Project CPUC Site Inspection Form

Project:	South Orange County Reliability Enhancement (SOCRE) Project	Date:	June 7, 2019
Project Proponent:	San Diego Gas & Electric (SDG&E)	Report #:	VS036
Lead Agency:	California Public Utilities Commission (CPUC)	Monitor(s):	CPUC/Ecology and Environment (E & E) Compliance Monitor
CPUC PM:	Andrew Barnsdale, Energy Division	AM/PM Weather:	Overcast, cool, and calm
CPUC CM (E & E):	Joe Donaldson	Start/End time:	0645 to 0845
Project NTP(s):	Notice to Proceed (NTP) -1, NTP-2, NTP-2 Addendum 1, NTP-3, and NTP-4; Minor Project Refinement (MPR) -1, MPR-1 Addendum 1, and MPR-3.

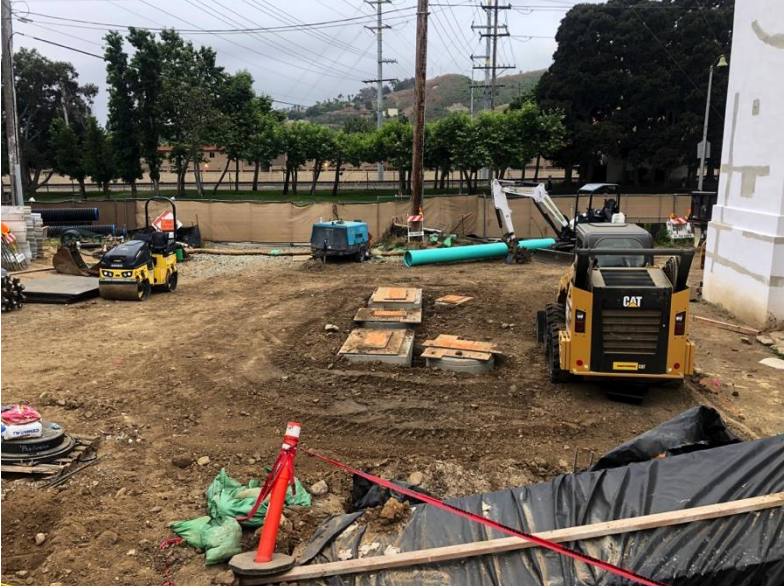
Part of the modular wetland system has been installed near the southern entrance to the San Juan Capistrano Substation site (Photo 1). Conduit work was being conducted within the 138-kV GIS building pad (Photo 2).

Photo 1 – Installation of a portion of the modular wetland system. Photo facing west.
6/7/19	San Juan Capistrano Substation

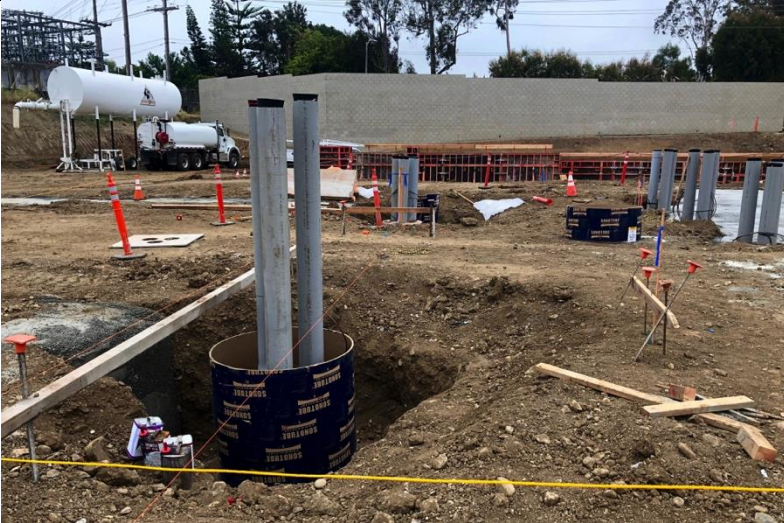
Photo 2 – Conduit work within the 138-kV GIS building pad. Photo facing south.
6/7/19	San Juan Capistrano Substation

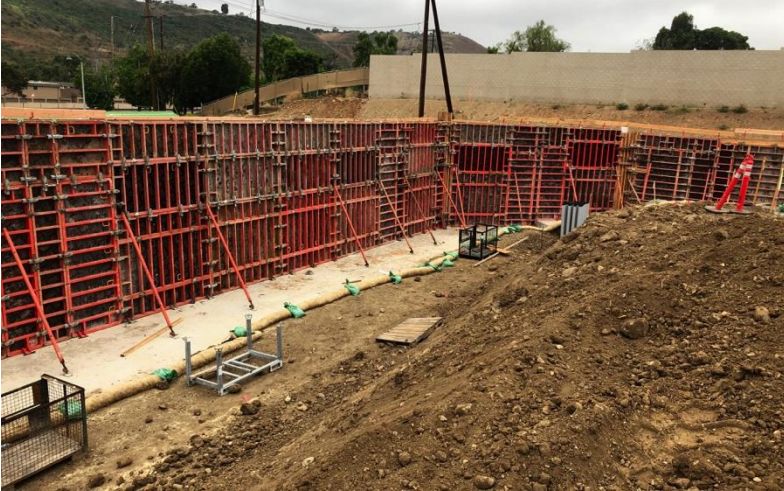
Photo 3 – Western portion of the 138-kV GIS building retaining wall. Photo facing north.

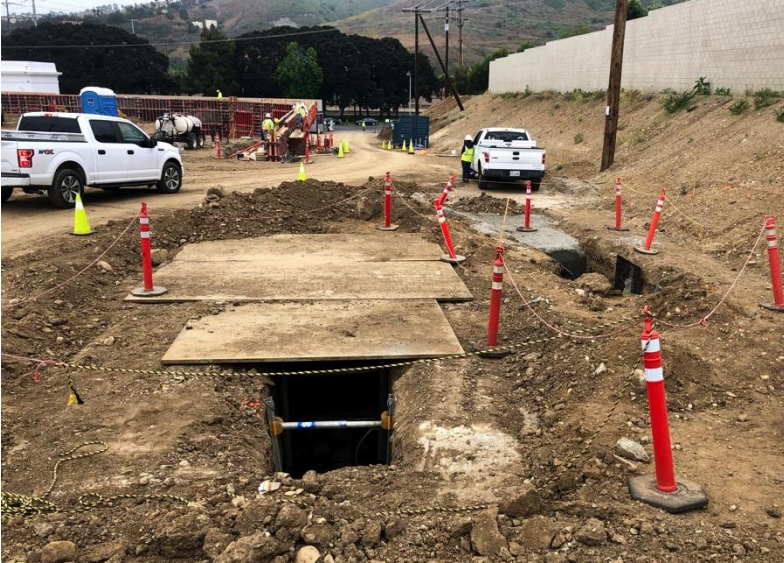
Two conduit trenches near the northern edge of the site remained partially open (Photo 5). The conduit pipes were capped, but neither trench had an exit ramp (Photo 6). I pointed this out to the SDG&E Lead Environmental Inspector and we discussed whether to install escape ramps or cover the trench openings. Later in the day, the SDG&E Lead Environmental Inspector sent a photo showing the two trenches covered with metal plates and sheets of plywood (Photo 7).

Two open conduit trenches are visible, each with a concrete cover. The area is marked with orange traffic cones and caution tape. A white pickup truck is parked in the background.	Photo 5 – Two open conduit trenches. Photo facing west.

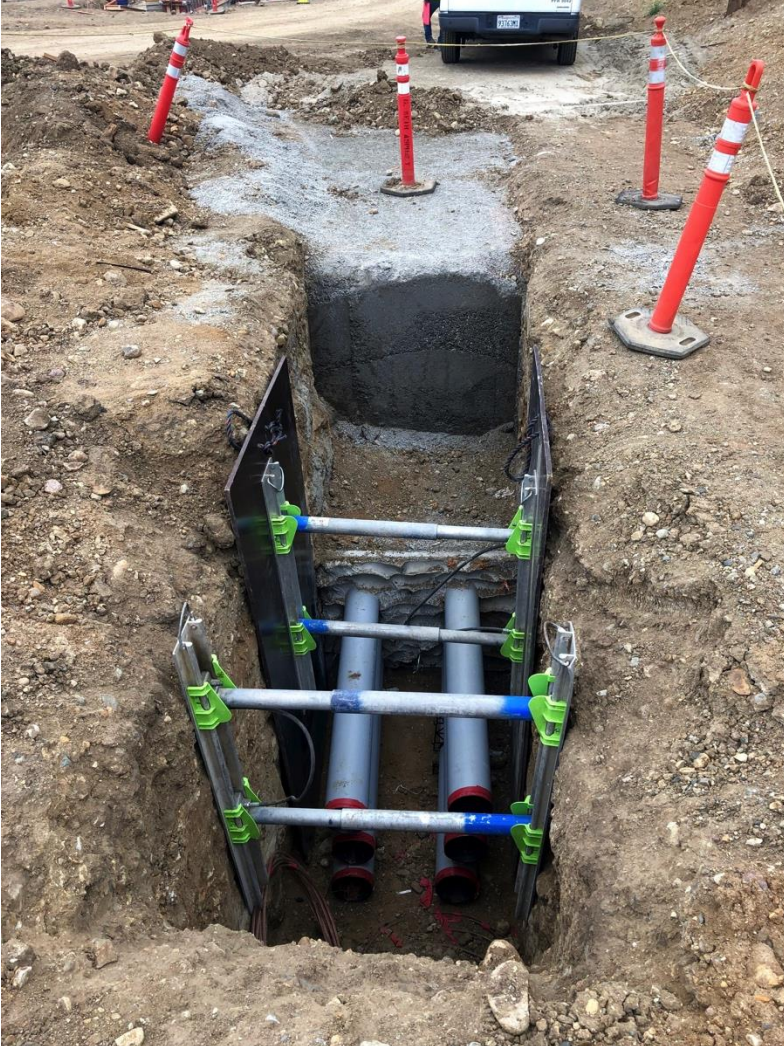
Photo 6 – Open conduit trench with no escape ramp.
6/7/19	San Juan Capistrano Substation

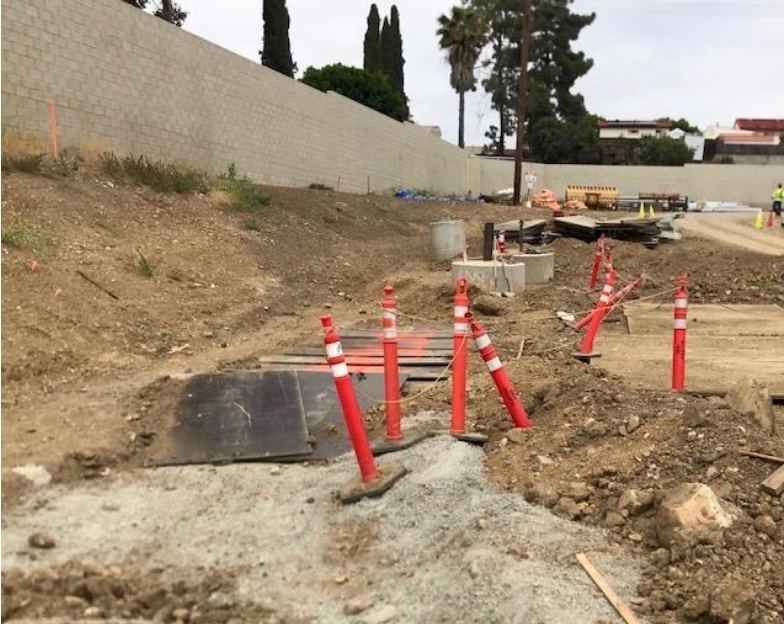
Photo 7 – Photo taken by the SDG&E Lead Environmental Inspector later in the day showing the covered conduit trenches. Photo facing east.

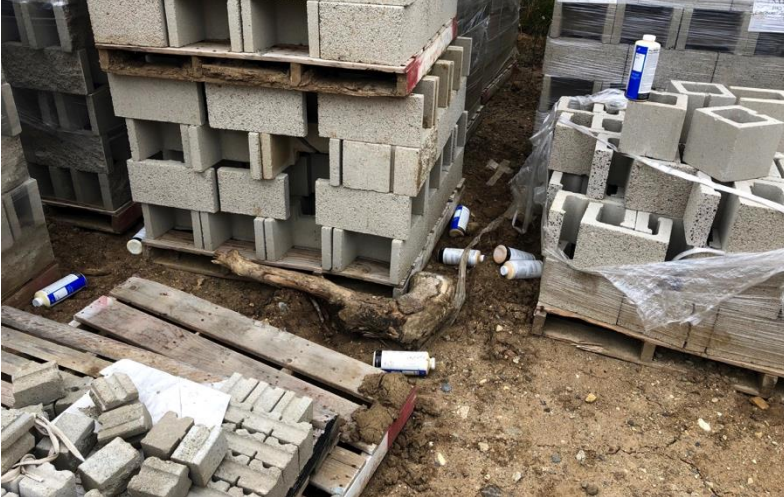
In the staging area near the east end of the San Juan Capistrano Substation site, I noted plastic bottles on the ground (Photo 8). I spoke with the SDG&E Lead Environmental Inspector about cleaning up this area.

Photo 8 – Plastic containers of brick sealant that need to be cleaned up.
6/7/19	San Juan Capistrano Substation

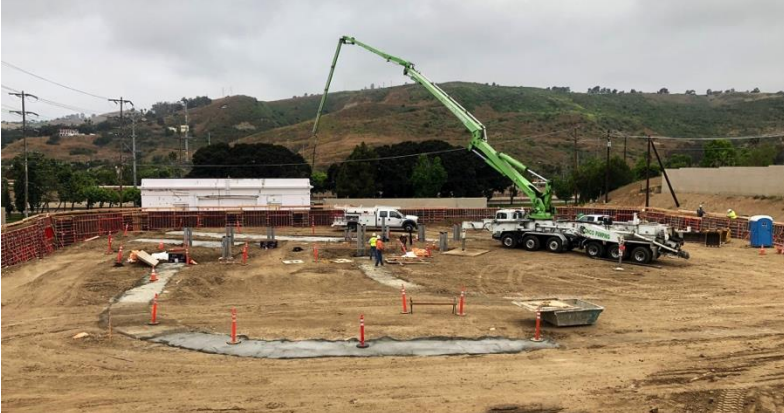
Photo 9 – Pumping unit in place for pouring concrete for the retaining wall. Photo facing west.
6/7/19	San Juan Capistrano Substation

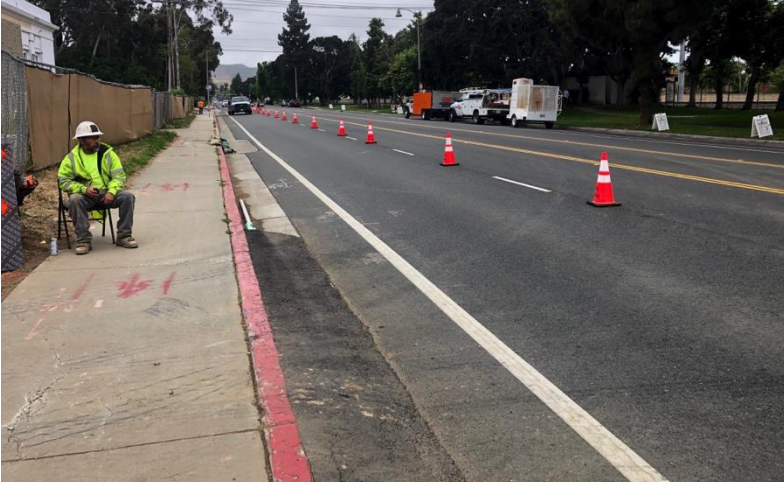
Work within Camino Capistrano continued on the day of my site visit. Traffic control crews were setting up in the roadway (Photo 10). The crew planned to saw-cut the asphalt and concrete for the northern piping. The southern piping has been installed and the road has been repaved (Photo 11).

Photo 10 – Traffic control procedures in place on Camino Capistrano for cutting the pavement for the northern crossing.

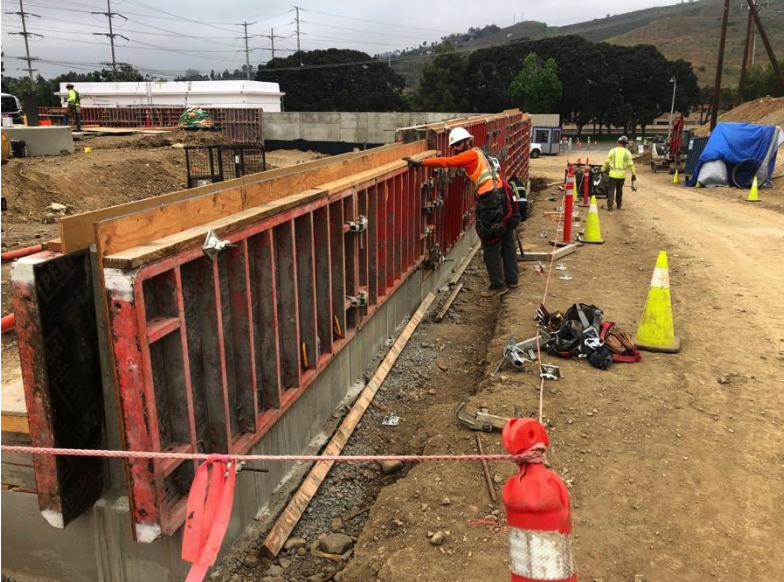
The retaining wall had been poured with concrete, and crews were stripping off the foundation forms (Photos 3 & 4).

Photo 4 – Stripping forms off of the retaining wall. Photo facing west.
6/13/19	San Juan Capistrano Substation

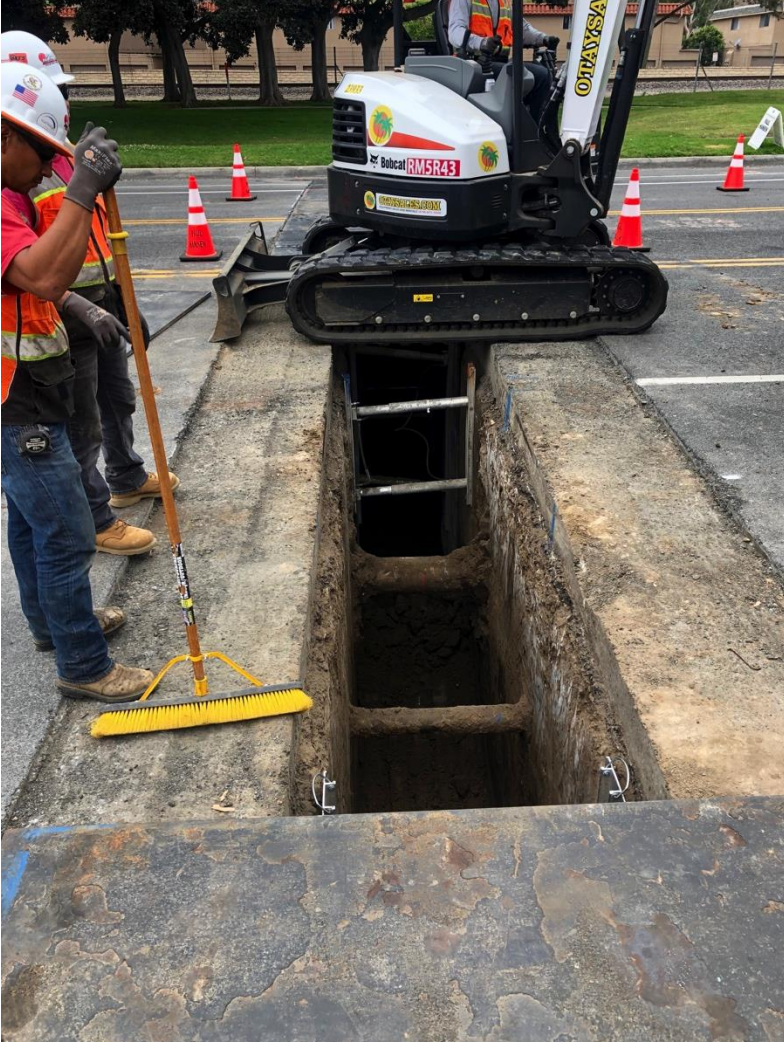
Photo 5 – Pipe trench across Camino Capistrano. Photo facing west.

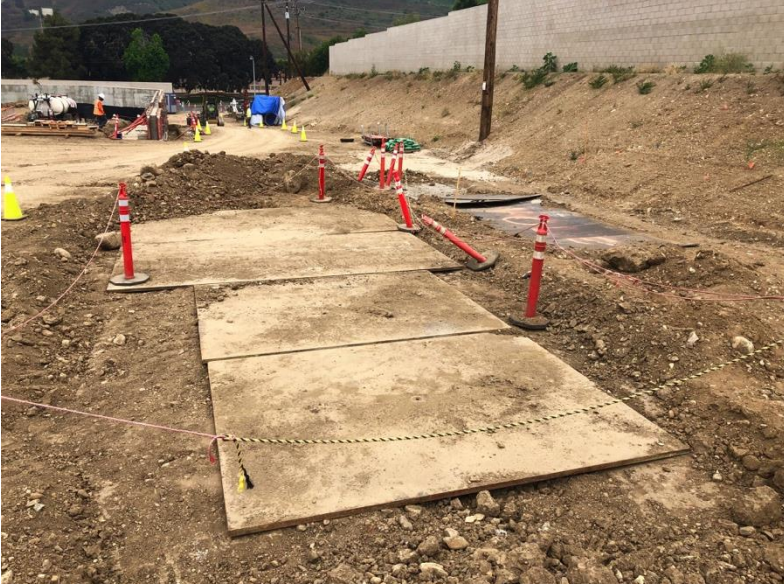
I looked at the covered conduit trenches and they were sufficiently sealed (Photo 6). Construction crews were working on sealing the retaining wall and were installing the water piping (Photo 7).

Photo 6 – Covered conduit trench. Photo facing west.
6/13/19	San Juan Capistrano Substation	 	Photo 7 – Moisture sealant work on the wall; conduit work. Photo facing north.

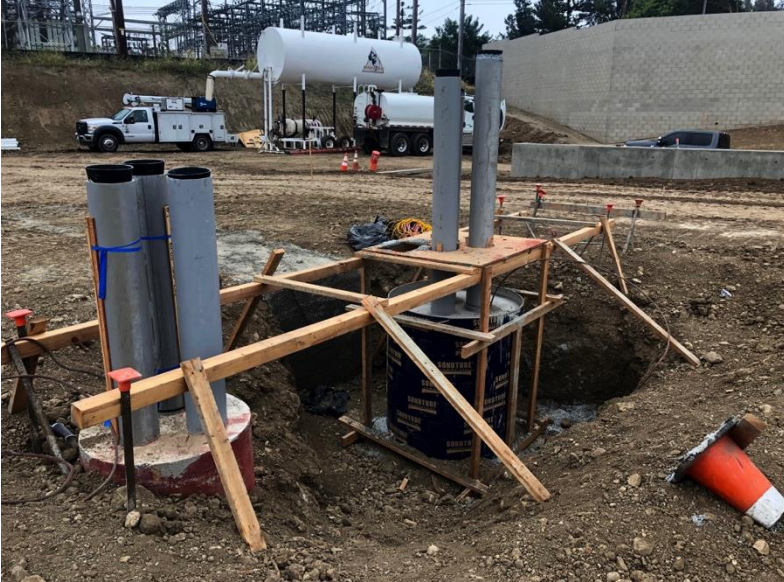
Conduit work was being conducted within the 138-kilovolt (kV) gas-insulated substation (GIS) building pad (Photo 4), along with ongoing installation of the moisture barrier on the retaining wall (Photo 5).

Photo 4 – Conduit work continues at the GIS building pad. Photo facing south.
6/20/19	San Juan Capistrano Substation

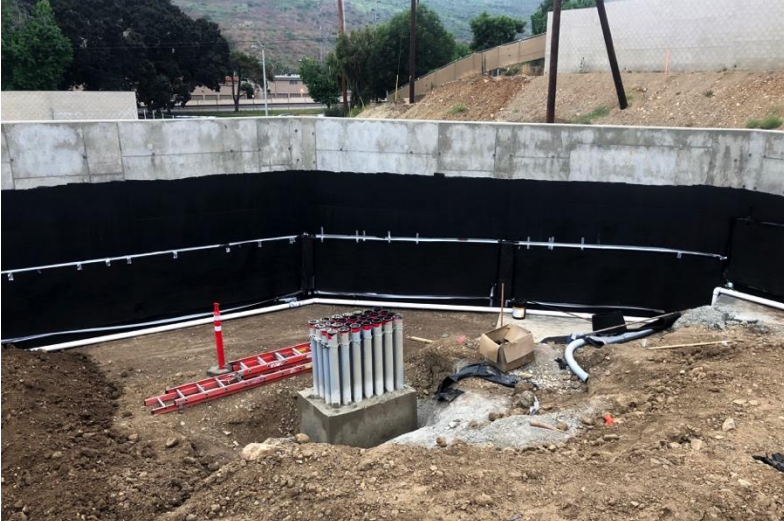
Photo 5 – Moisture protection work continues on the retaining wall. Photo facing northwest.
6/20/19	San Juan Capistrano Substation

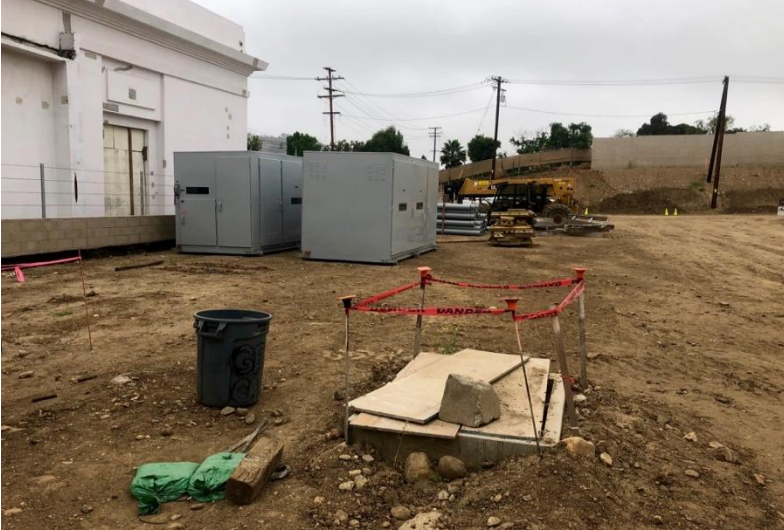
Photo 6 – Equipment staged onsite. Photo facing north.

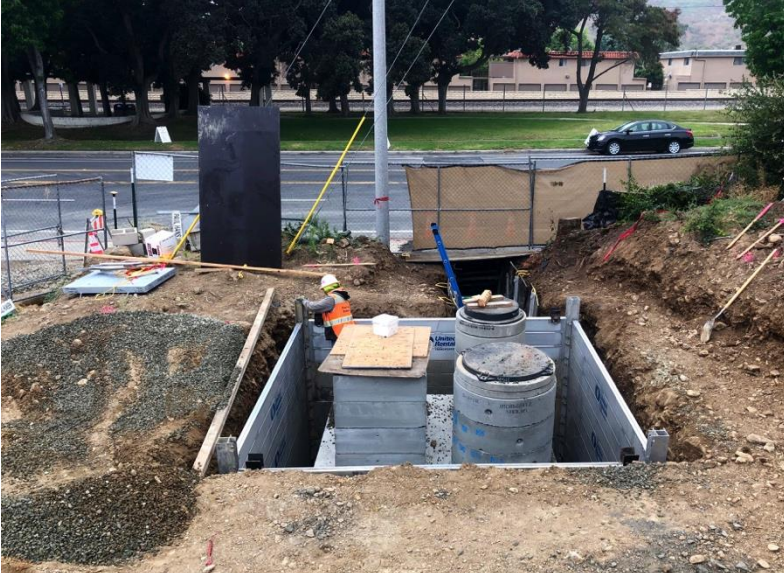
Photo 8 – Northern modular wetland system has been installed. Photo facing west.
6/20/19	San Juan Capistrano Substation

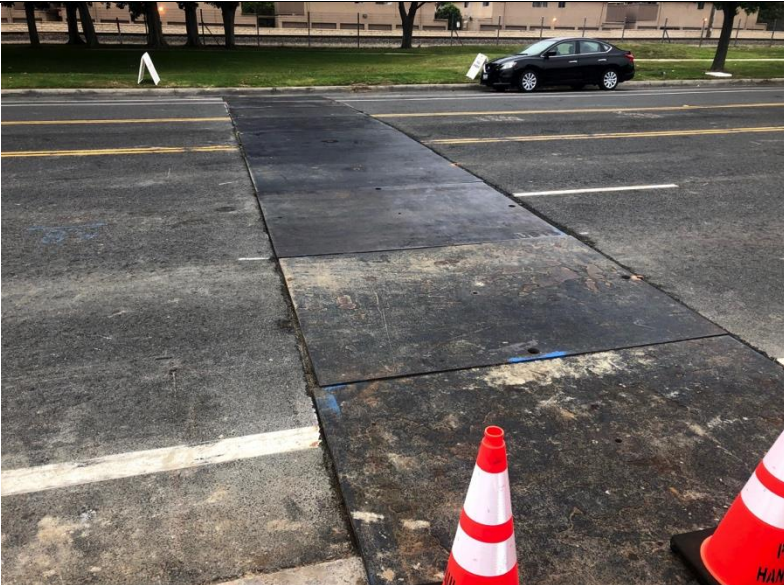
Photo 9 – Camino Capistrano has been trenched and covered with steel plates. Photo facing west.

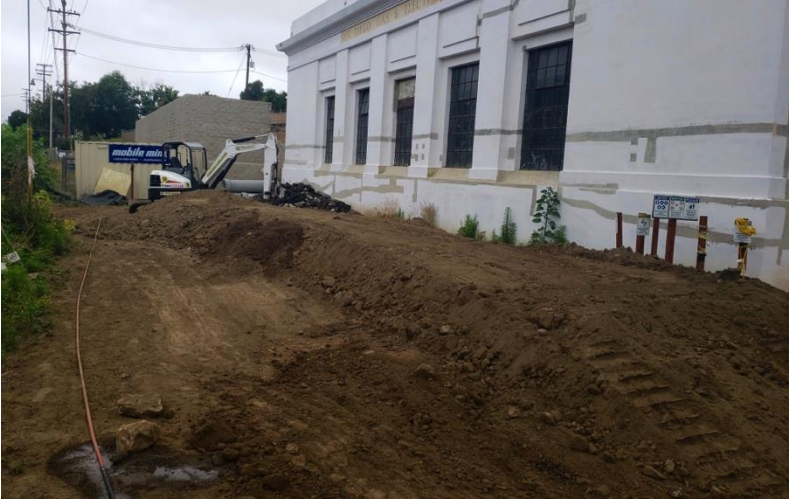
Photo 11 – This photo was provided by the SDG&E Lead Environmental Inspector showing the actions taken to minimize dust from the spoil piles. Photo facing north.

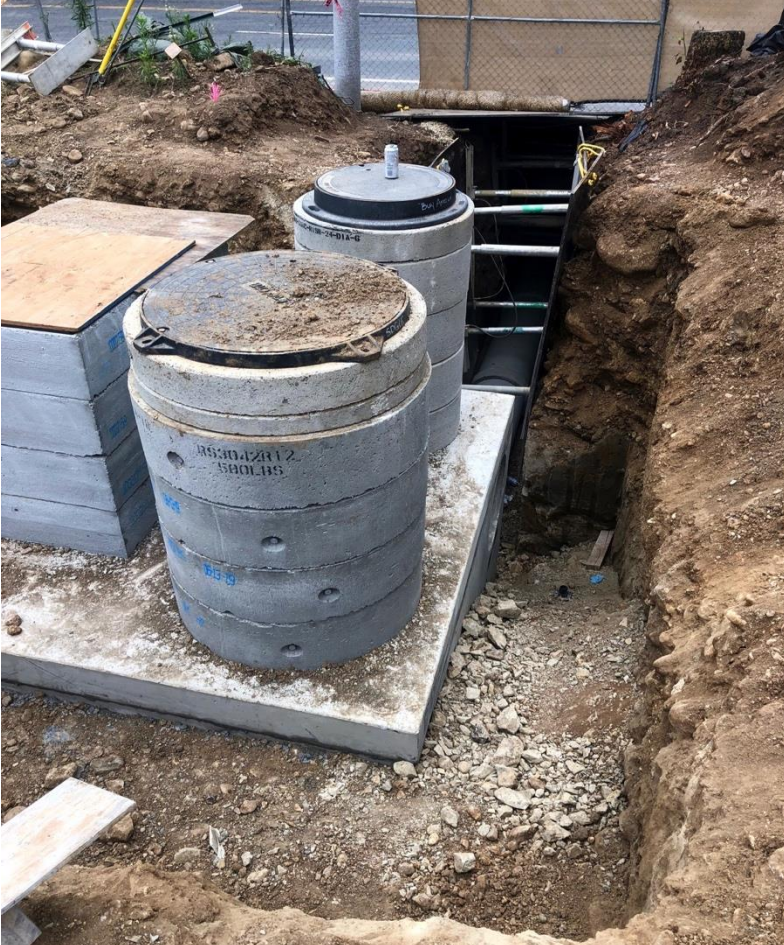
<p>Photo 1 – Modular wetland system at the northwest corner of the San Juan Capistrano Substation site. Photo facing west.</p>
6/27/19	San Juan Capistrano Substation

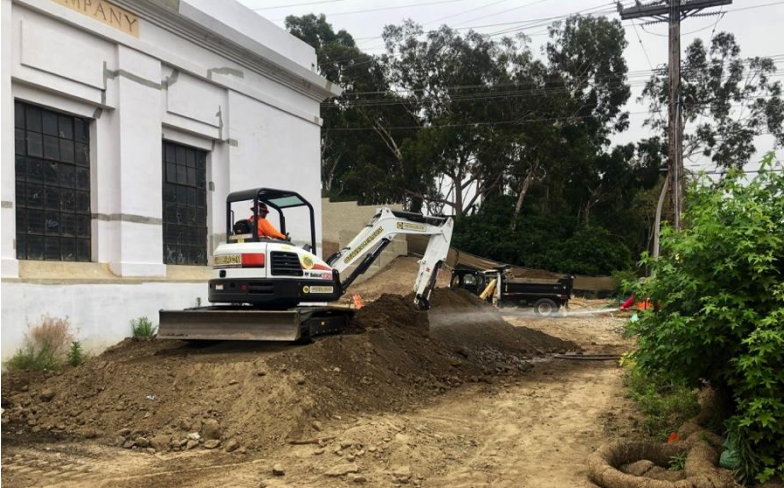
<p>Photo 2 – Small backhoe mixing soil with water in preparation for backfilling work. Photo facing south.</p>

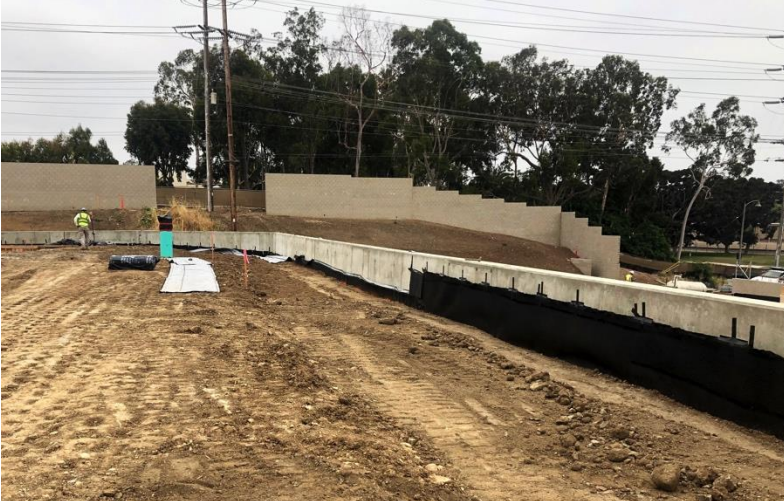
A variety of work was being conducted on the 138-kilovolt (kV) gas-insulated substation (GIS) building pad in anticipation of the building contractor mobilizing to begin work. A crew with a small bulldozer was working along the southern end of the building pad (Photo 3). One trench was still open at the northwest corner of the building pad (Photo 4), and some final moisture barrier was being installed on the retaining wall (Photo 5).

Photo 5 – Moisture protection work continues on the retaining wall. Photo facing south.
6/27/19	San Juan Capistrano Substation	 	Photo 6 – Excavation activities. Photo facing southwest.
6/27/19	San Juan Capistrano Substation	 	Photo 7 – Trash in the staging area.
