**Re: Monthly Report Summary #23 for the South Orange County Reliability Enhancement (SOCRE) Project**

CPUC Site Inspection Reports  
September 5, 13, 19, and 25, 2019

## South Orange County Reliability Enhancement Project CPUC Site Inspection Form

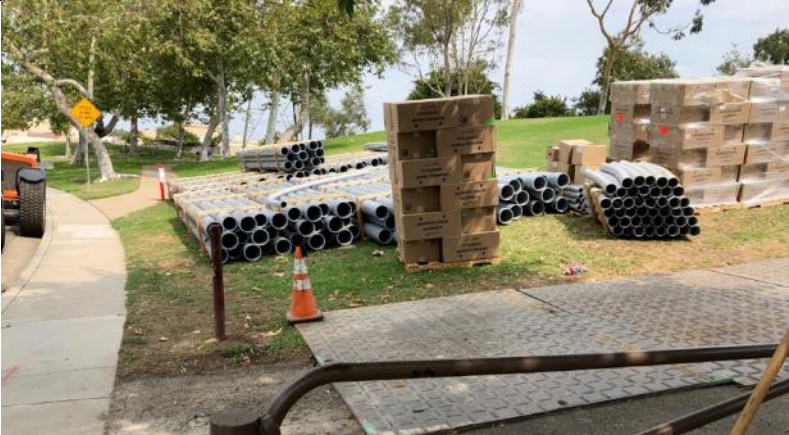
I arrived onsite at the San Capistrano Substation at 1100. I met with the SDG&E Lead Environmental Inspector (LEI) and we walked to Serra Park to check on the work activities. Plastic conduit pipe and other items were stockpiled on the lawn by Calle Santa Rosalia at the western end of the park (Photo 1). Metal plates were placed at the narrow, paved access road where trenching will be conducted (Photo 2).

Photo 1 – Stockpiled materials on the lawn at the western side of Serra Park. Photo facing north.
09/05/19	Serra Park, near San Juan Capistrano Substation

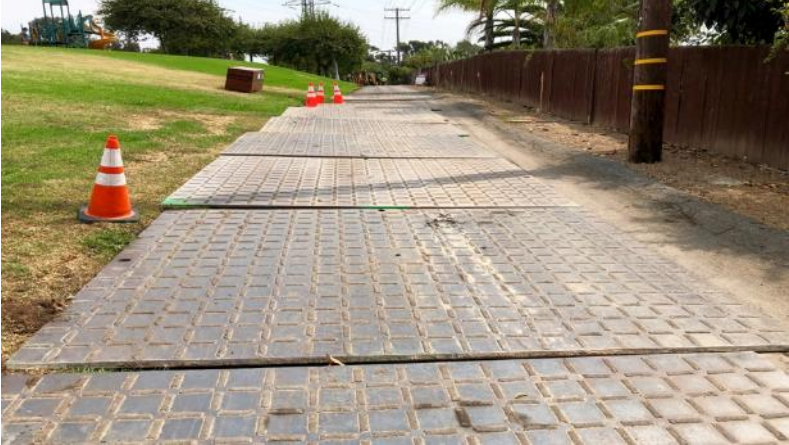
Photo 2 – Metal plates placed at the access road where trenching will occur. Photo facing east.
09/05/19	Serra Park, near San Juan Capistrano Substation

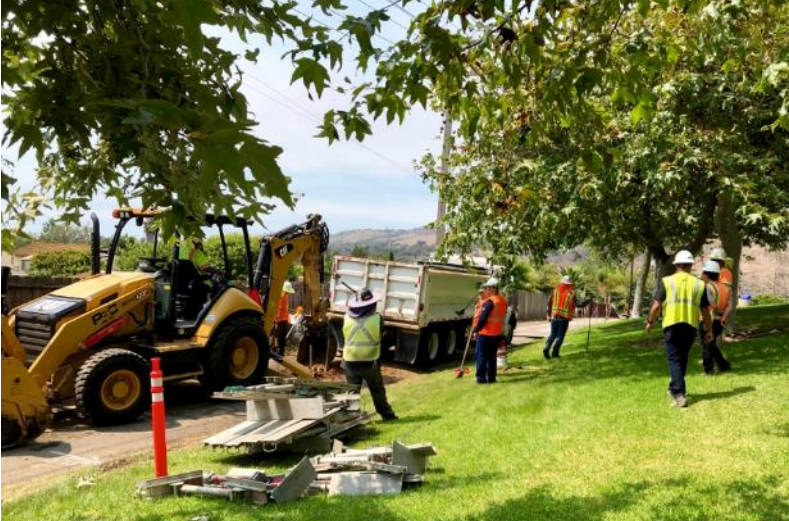
The crew was using a backhoe to perform excavation work near the existing towers at the eastern end of Serra Park (Photo 3). The trench spoil was being placed in a dump truck for transporting offsite. An environmental resource monitor was overseeing this work, along with a paleontological resource monitor, a Native American monitor, and a cultural resource monitor. No new bird nests had been found in the area since the previous site visit.

Photo 3 – Excavation work with various monitors onsite. Photo facing west.

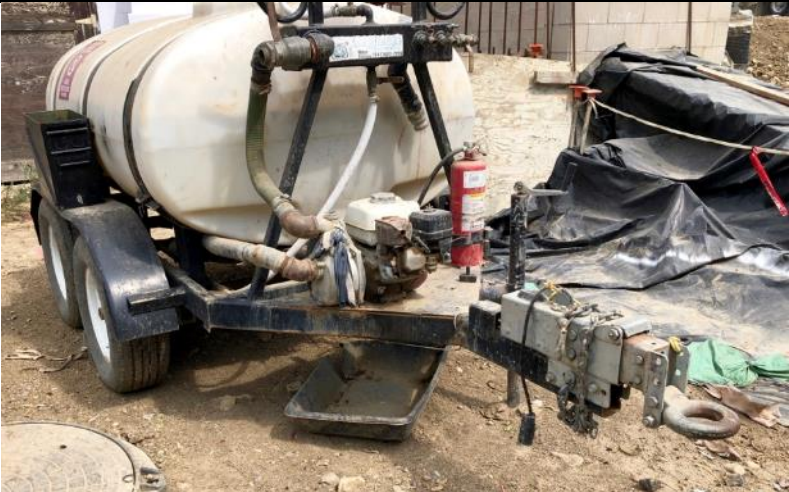
At the San Juan Capistrano Substation site, I noted a broken drip pan beneath the gas pump on the "water buffalo" (i.e., a mobile water tank) (Photo 4). The SDG&E LEI said he would speak with the contractor about replacing the pan.

Photo 4 – Water buffalo (i.e., mobile water tank) parked near the southwestern entrance with a broken drip pan.
09/05/19	San Juan Capistrano Substation

Ensure drip pans under construction equipment are in proper condition, even if the equipment is only parked for a short time.

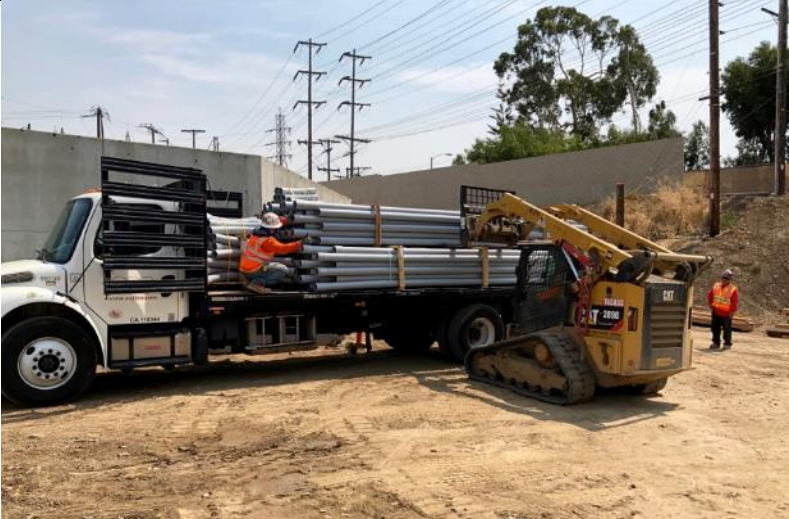
More plastic conduit pipe was being offloaded at the San Juan Capistrano Substation site near the former utility structure (Photo 5).

Photo 5 – Conduit pipe being unloaded onsite. Photo facing southeast.
09/05/19	San Juan Capistrano Substation

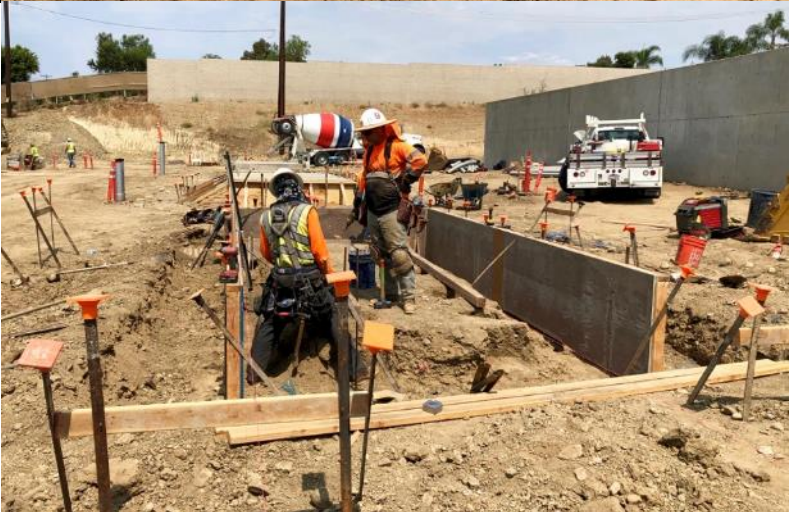
Two transformer foundations had been poured and a crew was working on a third transformer foundation (Photo 6).

Photo 6 – Work on the transformer foundations located west of the 138-kV GIS building pad retaining wall. Photo facing north.

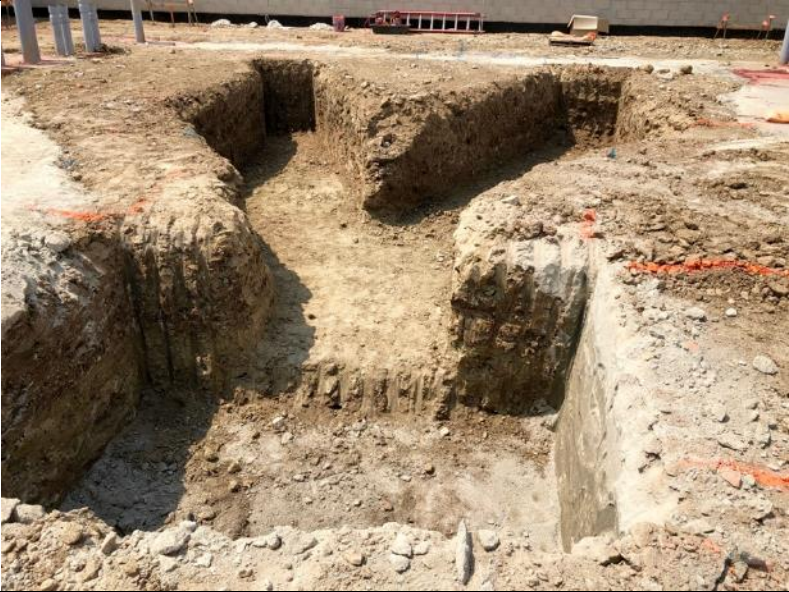
Some additional trenching has been conducted in the switch rack area; however, none of the trench walls have been laid back, and no boards/climbing structures were installed for wildlife escape ramps (Photo 7). The SDG&E LEI said he was comfortable with the effectiveness of their early morning surveys of open trenches, noting that they had not found any trapped animals thus far.

Photo 7 – Excavation within the switch rack area; trench walls are not laid back and there are no climbing structures/boards installed for wildlife escape ramps..
09/05/19	San Juan Capistrano Substation

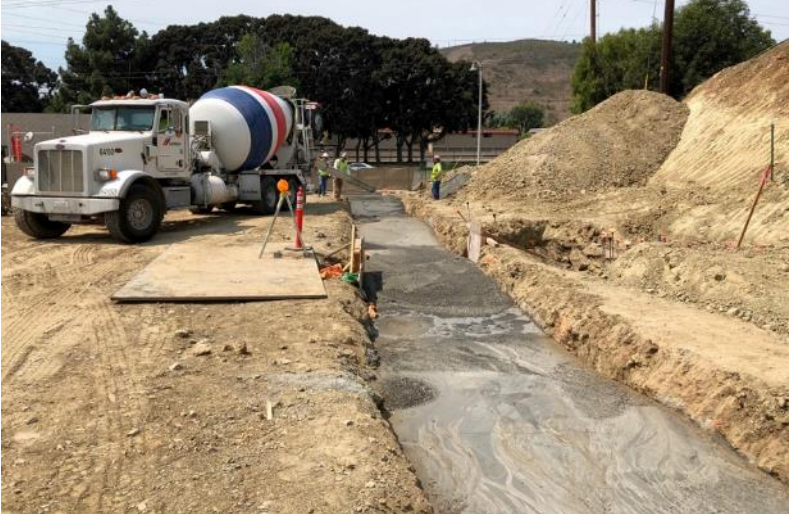
Photo 8 – Concrete slurry poured in a conduit trench. Photo facing west
09/05/19	San Juan Capistrano Substation

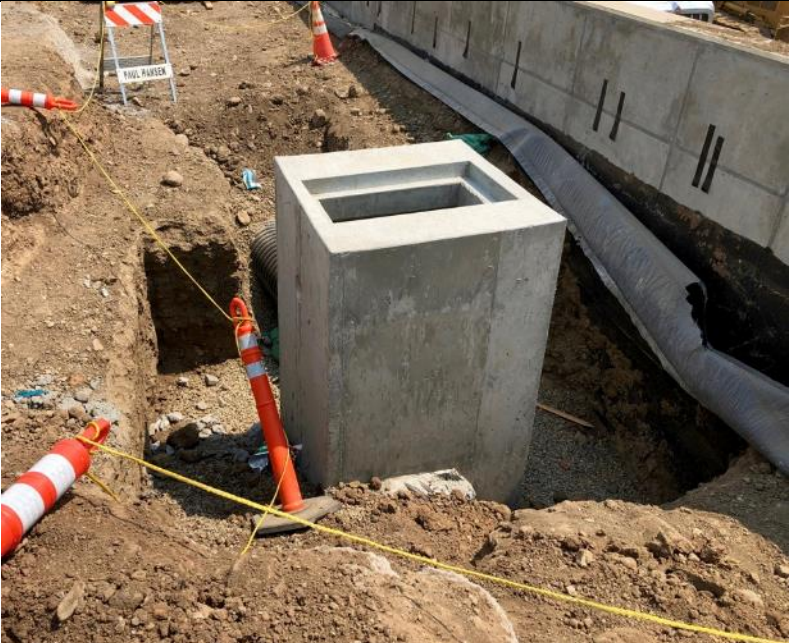
Photo 9 – Storm drain vaults recently poured within the 138-kV GIS building pad.

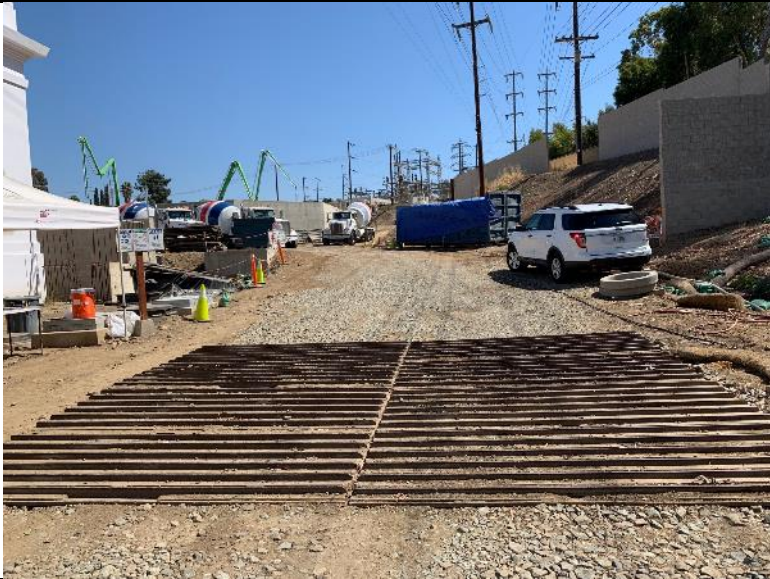
I contacted the Lead Environmental Inspector (LEI) at approximately 1045 to notify him that I had arrived at the San Juan Capistrano Substation site. He met me at the northern entrance gate where we observed trucks moving on and off the site for concrete pouring work. Both the northern and southern entrances at the San Juan Capistrano Substation were being utilized for concrete truck ingress and egress. The rumble plates at the northern and southern gate entrances remained clean (Photo1).

Photo 1 – Rumble plates at the southern entrance to the site remain clean. Photo facing east.
09/13/19	San Juan Capistrano Substation

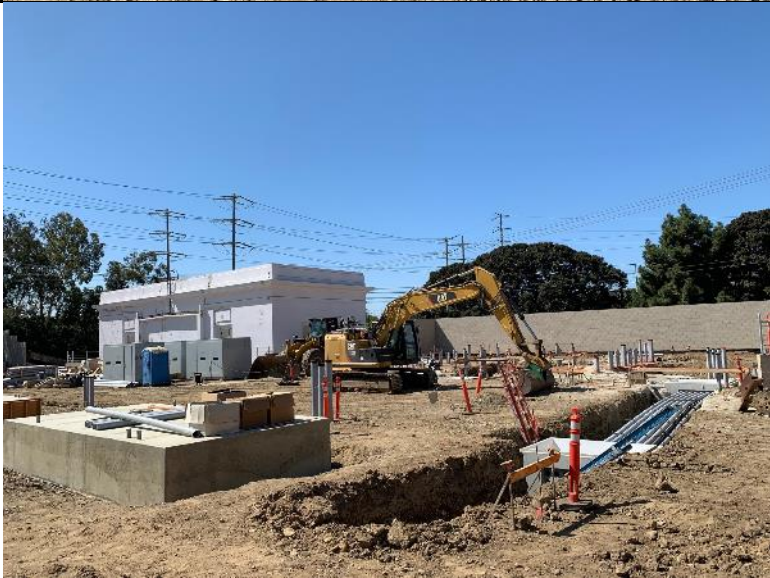
Photo 2 – Open conduit trench in a closed area. Photo facing west.
09/13/19	San Juan Capistrano Substation

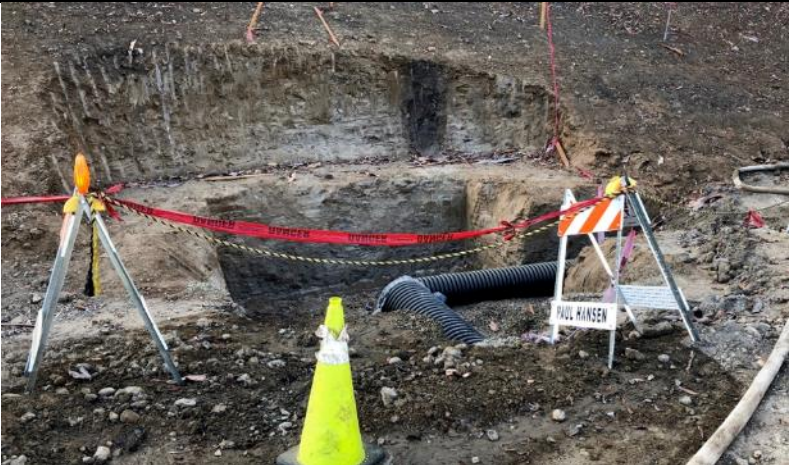
Photo 1 – Storm drain pipe excavation remaining open near the southwestern portion of the site. Photo facing south.
9/19/19	San Juan Capistrano Substation

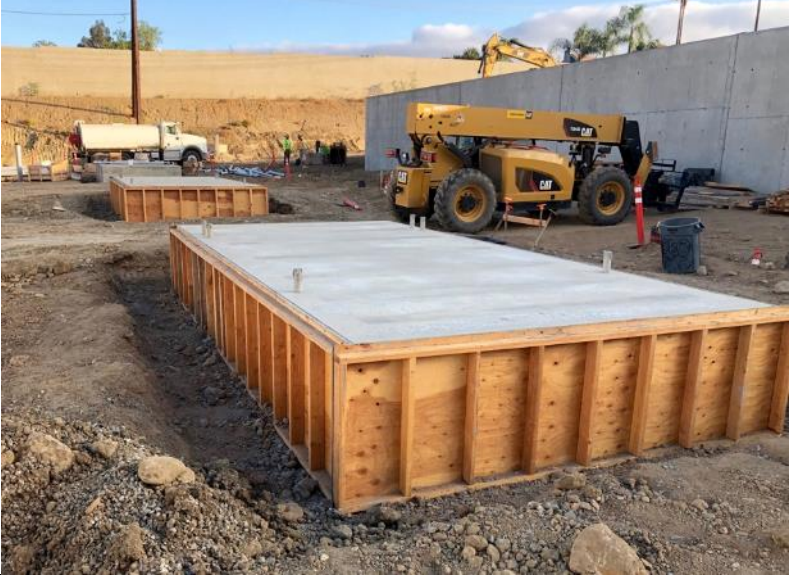
All three transformer foundations had been poured and crews were beginning to strip off the forms (Photo 2).

Photo 2 – Transformer foundations. Photo facing north.
9/19/19	San Juan Capistrano Substation

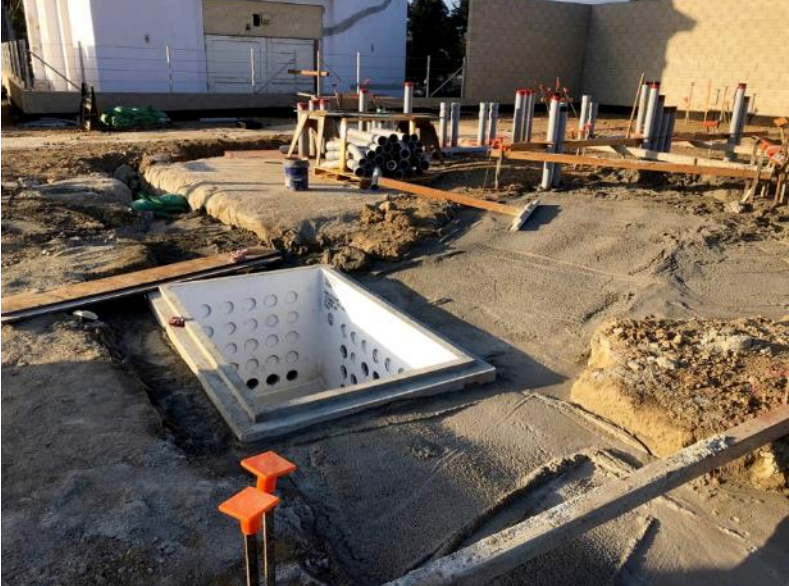
Conduit vaults had been installed within the switch rack area (Photo 3) and conduit had been installed in a new trench exiting the northwest corner of the substation retaining wall (Photo 4). A conduit trench near the northern side of the switch rack area had been covered with metal plates (Photo 5). None of these excavations had any wildlife escape ramps and I, again, inquired about routine checks for these locations before work begins each day. The SDG&E LEI confirmed that surveys are conducted every morning. It proved difficult to check the plate-covered hole (Photo 5), so I recommended that the small opening that remained be closed off.

Photo 3 – Conduit vault within the switch rack area with no climbing structures in place. Photo facing southwest.

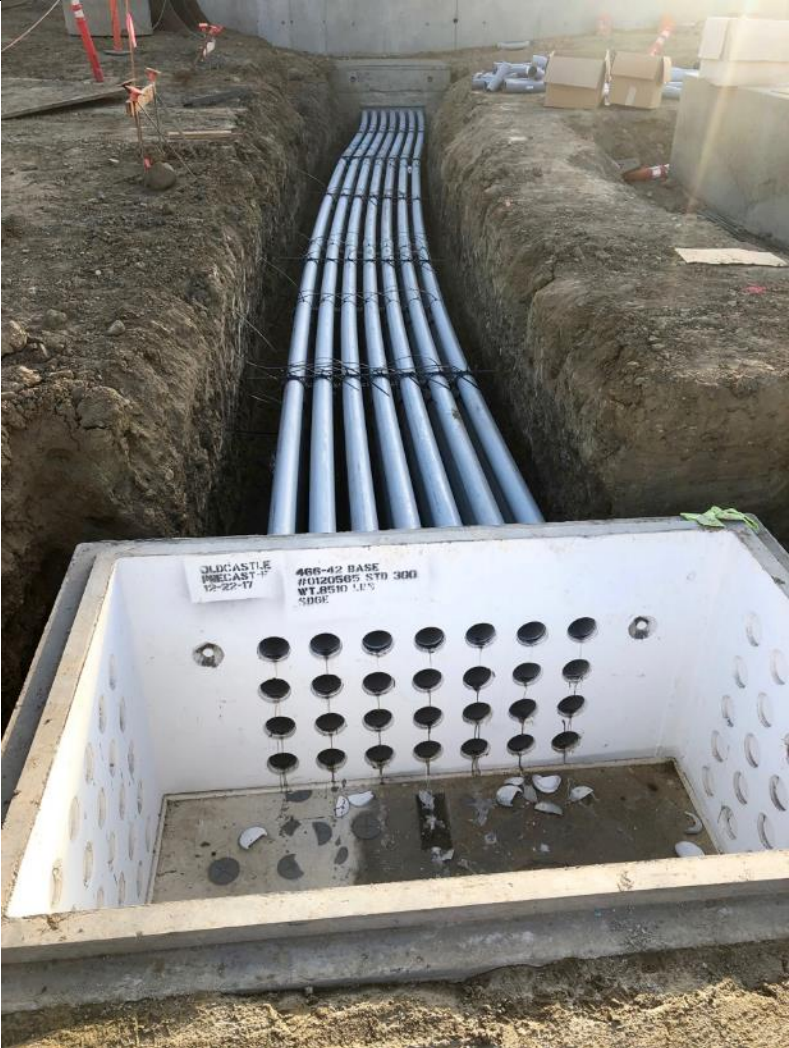
Photo 4 – Conduit trench, conduit, and conduit vault near the northwest corner of the 138-KV GIS building pad. Photo facing east.
9/19/19	San Juan Capistrano Substation

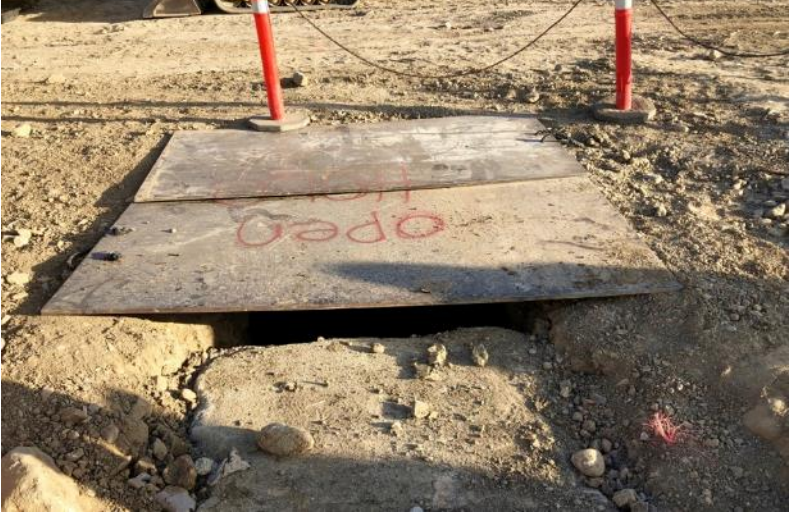
Photo 5 – Conduit pipe excavation partially covered.

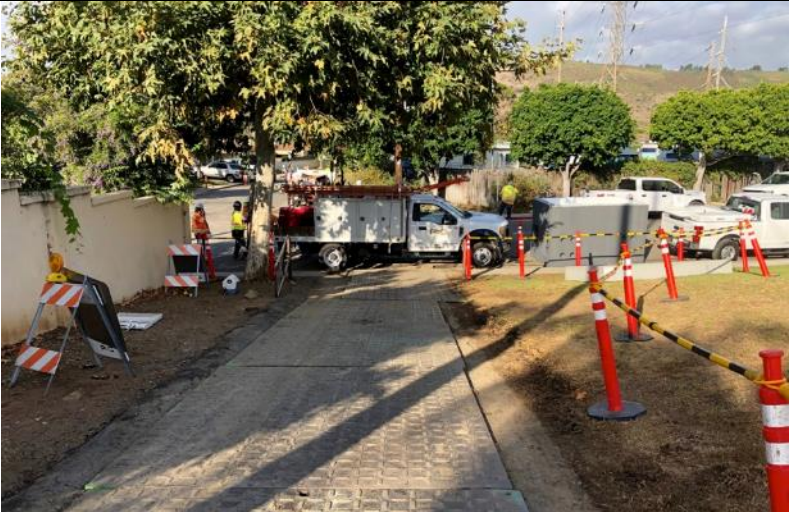
Work continued at Serra Park, with trenching in the public roadway and placement of a conduit vault near the eastern edge of the park (Photo 13). Drip pans were in place under the parked equipment (Photo 14). I noted that the staging area was muddy. The SDG&E LEI indicated this was due to a broken irrigation line (Photo 15).

Photo 13 – Trenching for the underground conduit continues along the public road toward the substation. Photo facing west.

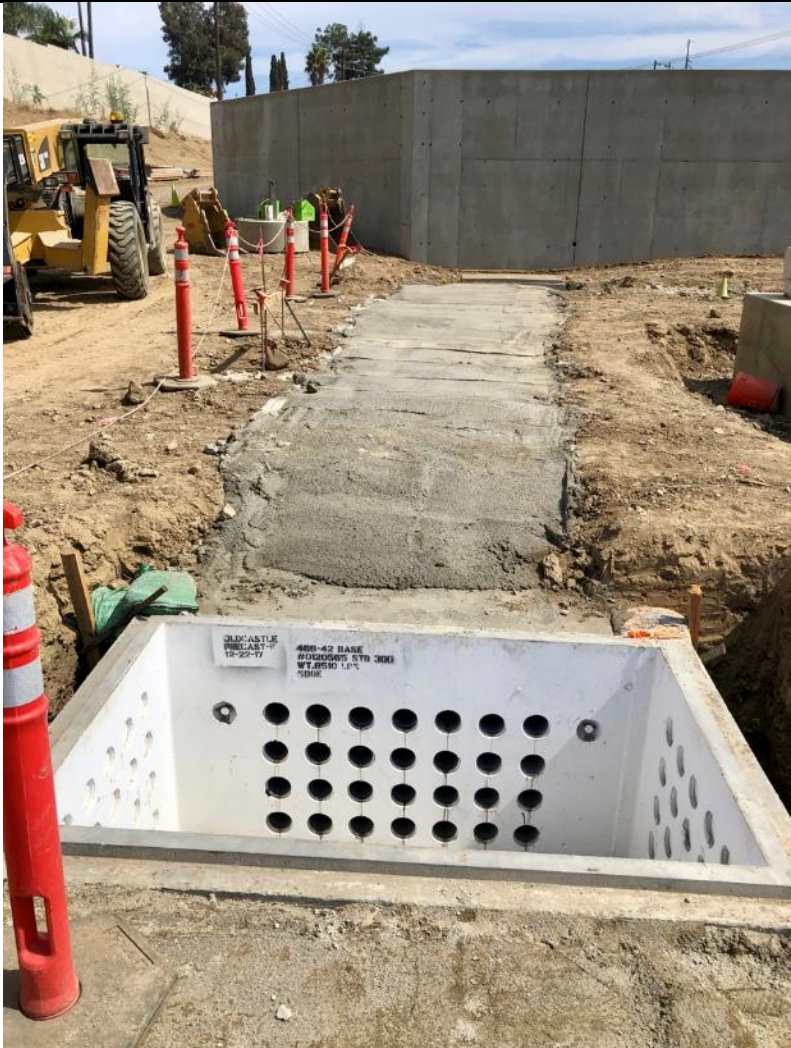
Photo 3 – Conduit trench has been poured; the conduit vault remains open. Photo facing east.
9/25/19	San Juan Capistrano Substation

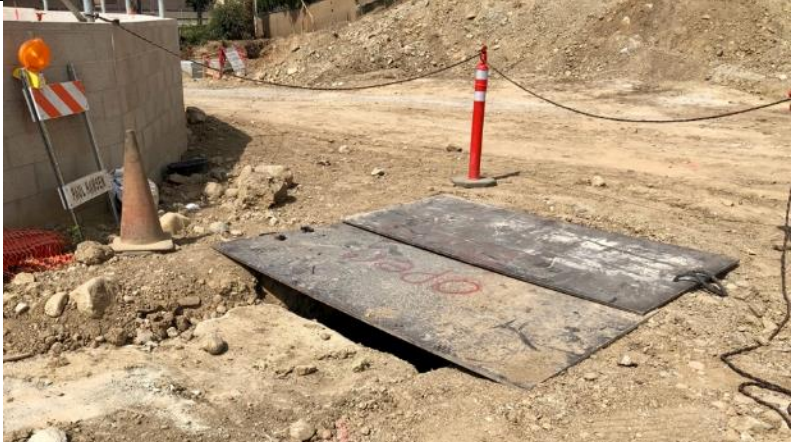
Photo 4 – A partially covered conduit trench. Photo facing northwest.
