February 20, 2020

Re: Monthly Report Summary #26 for the South Orange County Reliability Enhancement (SOCRE) Project

CPUC Site Inspection Reports
December 5, 12, and 19, 2019

South Orange County Reliability Enhancement Project CPUC Site Inspection Form

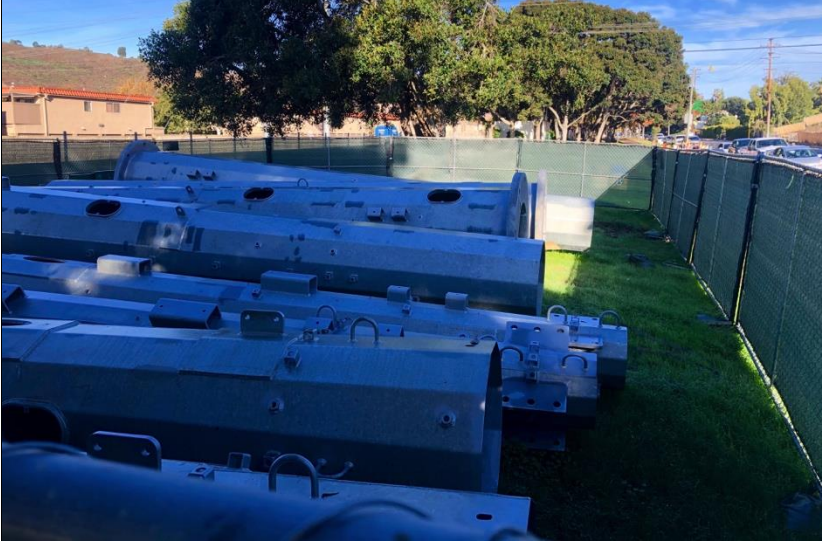
I arrived onsite at the San Juan Capistrano Substation at 0830. I examined the fenced staging area across the street (Camino Capistrano) from the substation site (Photo 1). The area contained segments of several tubular steel poles (TSPs).

A photograph showing several large, blue, cylindrical tower segments stacked in a staging area. The area is enclosed by a green chain-link fence. In the background, there are trees and a building under a clear blue sky.	Photo 1 – Tower segments in a staging area west of Camino Capistrano. Photo facing north.
12/05/19	San Juan Capistrano Substation	  A photograph of a construction site at a substation. The ground is covered in dark mud and gravel. In the background, there is a large metal structure under construction and several utility poles with power lines. Orange safety cones and pipes are visible in the foreground.	Photo 2 – Cleanup of mud and BMPs along the south side of the substation. Photo facing east.
12/05/19	San Juan Capistrano Substation	  A photograph of a catch basin near an offsite drain. The basin is filled with dark gravel. A large white pipe runs through the basin, and there are green sandbags or silt bags placed around it. The background shows a fence and some trees.	Photo 3 – Catch basin near the offsite drain. Photo facing southwest.

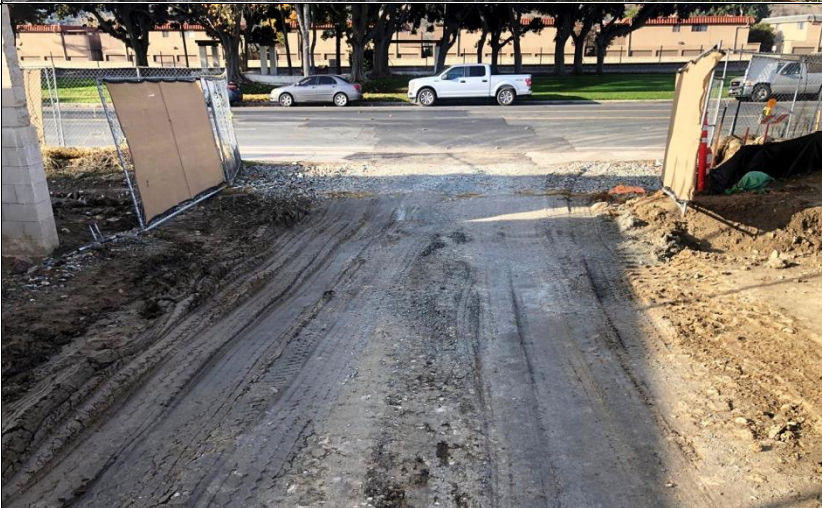
The southwestern entrance was closed, and the exit/entry needed some upgrades (Photo 1). The access road to the substation was muddy (Photo 2), so crews had shifted to using the northwestern entrance. The northern entrance had some rock, but no rumble plates (Photo 5). When switching entrances, crews have typically shifted the entry/exit BMPs, but that did not occur this time. Since they regularly shift back and forth between entrances, I suggested they set up both locations with the proper entry/exit BMPs. The EI discussed this with the construction supervisor. Rumble plates were ordered and arrival was anticipated for the following Monday. A sweeper truck was maintaining the public roads, but, ideally, mud should not be tracked onto the roads.

<p>A photograph of a dirt road or path leading into a substation area. In the background, there is a paved road with a white pickup truck and a silver car. A fence is visible on the left side.</p>	Photo 5 – The northern entry into the substation. Photo facing west.
12/12/19	San Juan Capistrano Substation

The BMPs at the southwestern exit/entry to the substation require some upgrades.

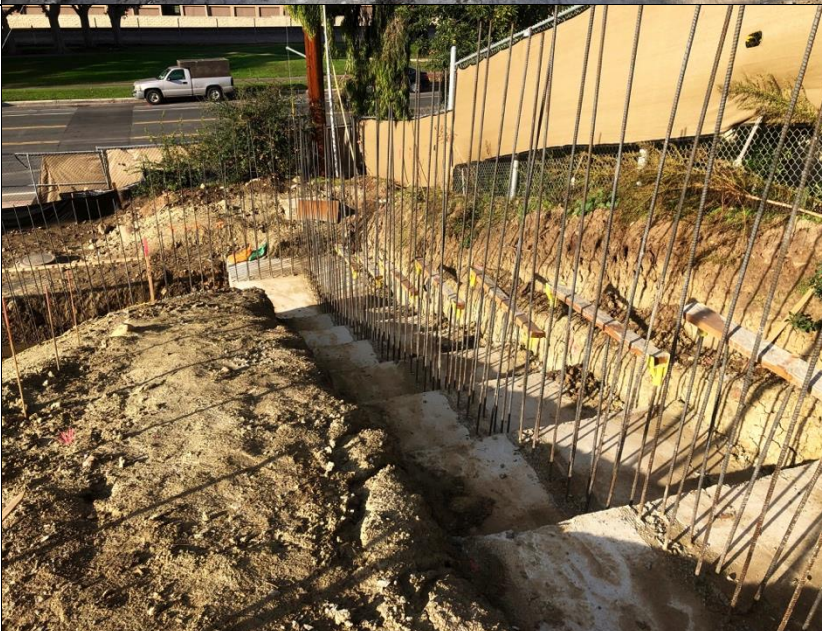
No additional work activity was observed on the wall at the northwestern corner of the substation (Photo 6).

<p>A photograph showing the foundation and rebar structure for a wall. The rebar is visible in the foreground, and a concrete foundation is being laid. In the background, there is a road with a white pickup truck and a fence.</p>	Photo 6 – Foundation for the northern wall. Photo facing west.

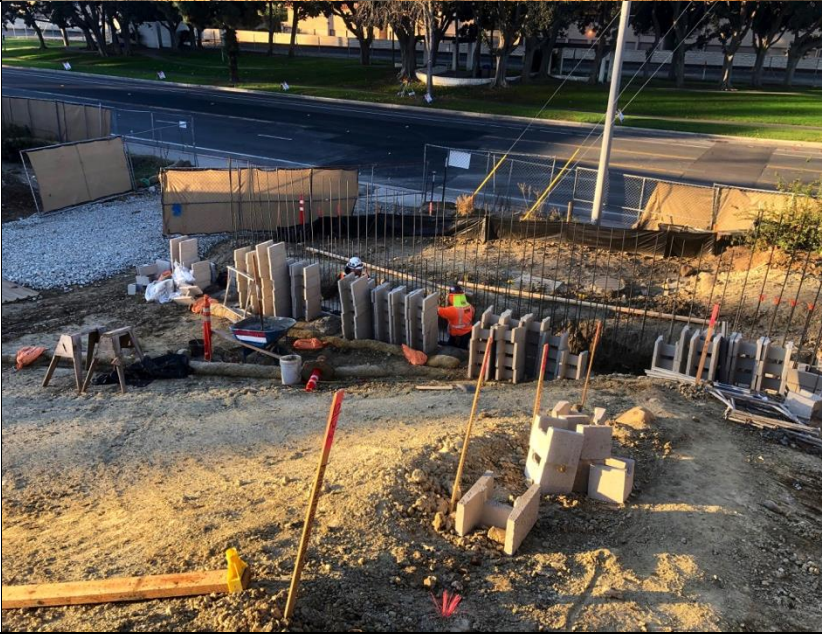
Brick installation was occurring on the wall at the northwestern corner of the substation site (Photo 4). The mortar mixing station had been relocated next to the wall work (Photo 5).

Photo 4 – Brick installation on the boundary wall. Photo facing south.

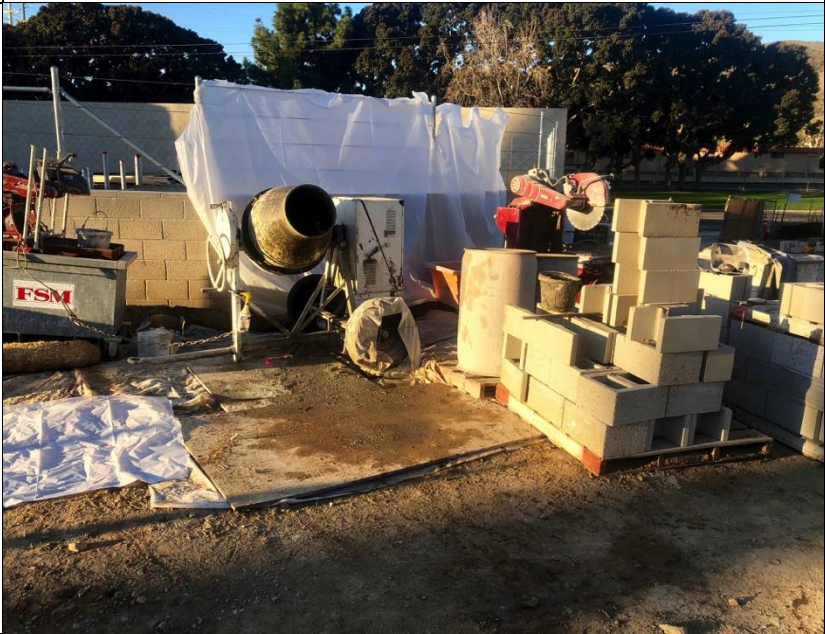
Photo 5 – Mortar mixing station near the wall work. Photo facing west.
12/19/19	San Juan Capistrano Substation

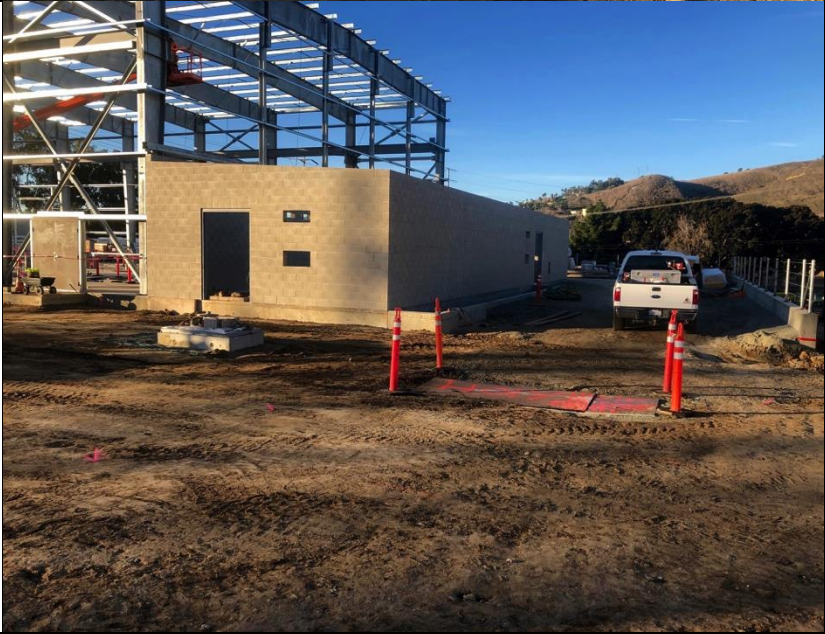
The brickwork for the control room adjacent to the 138-kilovolt (kV) gas-insulated substation (GIS) building had been completed (Photo 6). Installation of the metal framing continued for the 138-kV GIS building (Photo 7).

Photo 6 – Brick control room. Photo facing west.

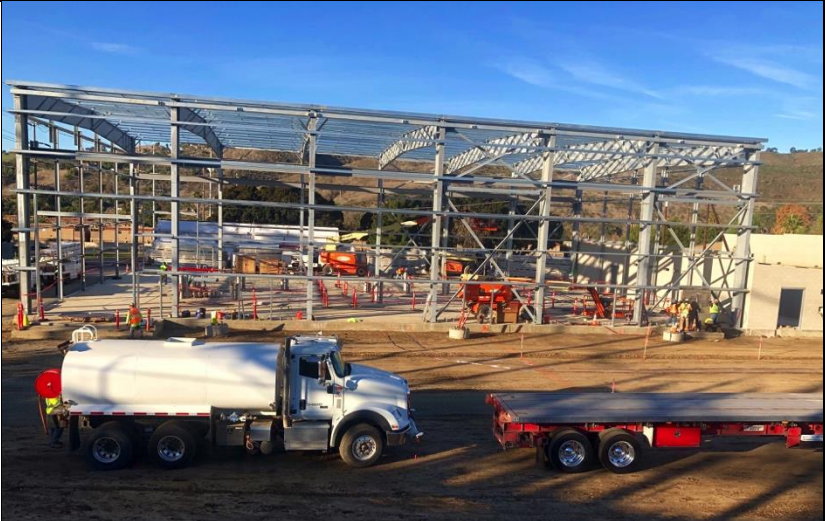
Photo 7 – Work on the 138-kV GIS building. Photo facing west.
12/19/19	San Juan Capistrano Substation

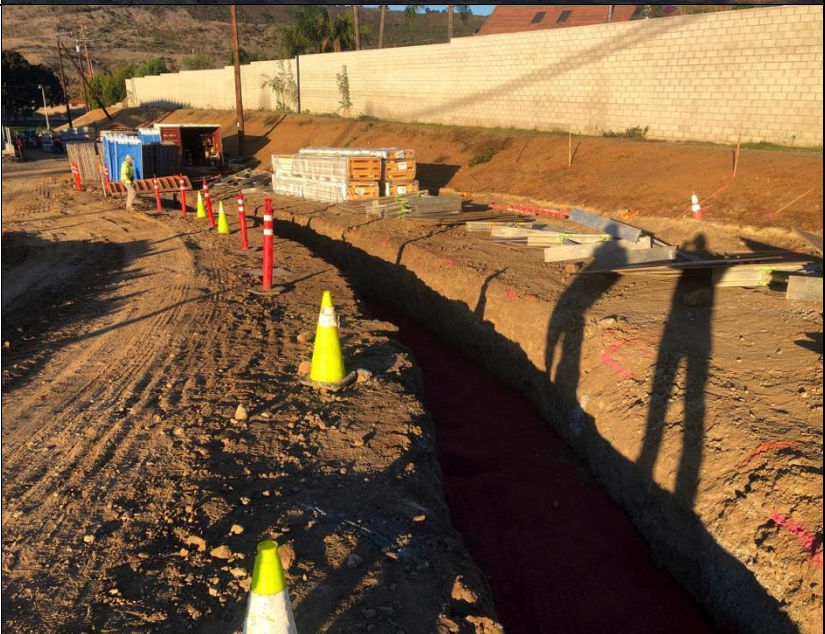
Another conduit trench had been excavated, conduit laid down, and slurry poured (Photo 8). This trench runs east to west along the northern portion of the substation site and adjacent to another conduit trench installed the previous week.

Photo 8 – Conduit trench with newly installed piping and poured concrete. Photo facing west.
