Re: Monthly Report Summary #29 for the South Orange County Reliability Enhancement (SOCRE) Project

South Orange County Reliability Enhancement Project CPUC Site Inspection Form

| Project: | South Orange County Reliability Enhancement (SOCRE) Project | Date: | March 4, 2020 |
| Project Proponent: | San Diego Gas & Electric (SDG&E) | Report #: | VS071 |

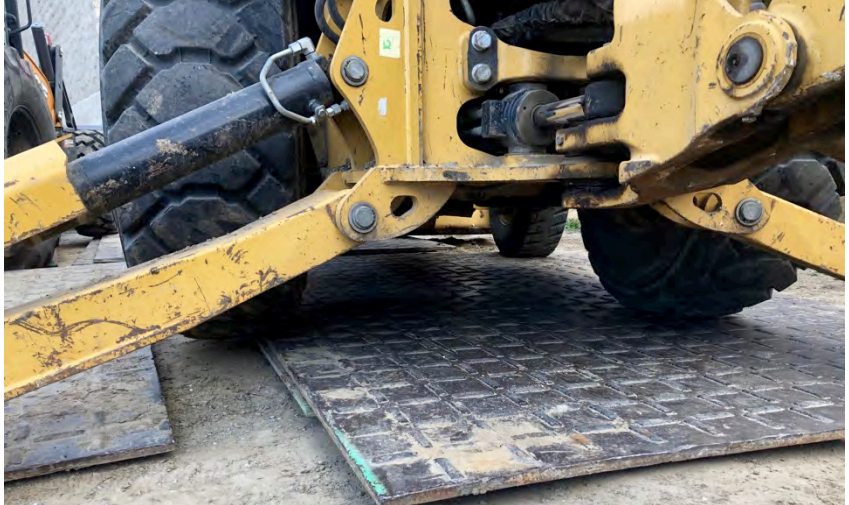
I arrived onsite at the San Juan Capistrano Substation at 0715. Some of the equipment parked along Camino Capistrano did not have a drip pan in place (Photo 1). I met with the onsite Environmental Inspector (EI) and showed him the equipment. Trenching and conduit installation in the roadway began later in the morning (Photo 2).

| Date | Location | Photo | Description |
|---|---|---|---|
| 03/04/20 | San Juan Capistrano Substation | | Photo 1 – No drip pan under equipment parked along Camino Capistrano. |

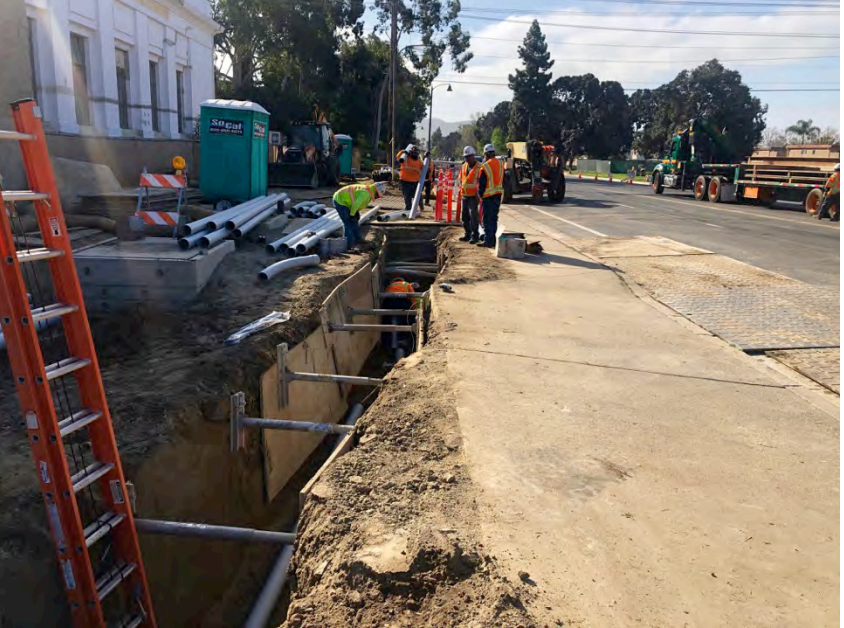
| Date | Location | Photo | Description |
|---|---|--|---|
| 03/04/20 | San Juan Capistrano Substation | | Photo 2 – Conduit trenching and installation along Camino Capistrano. Photo facing south. |

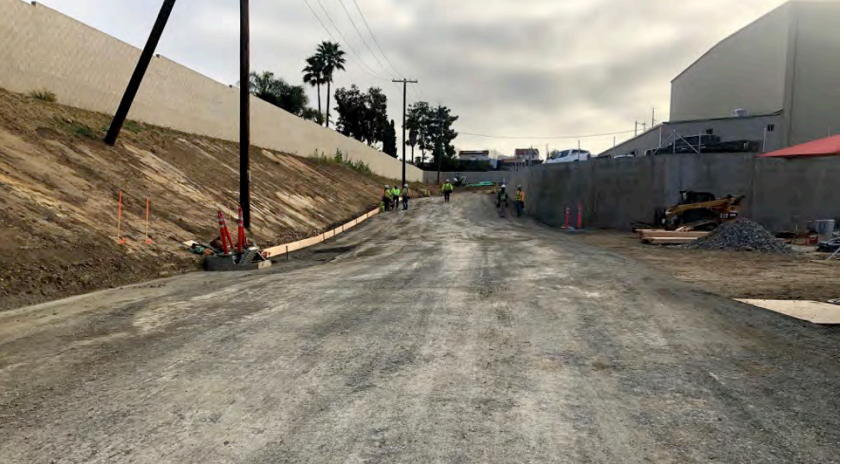
The road base has been installed along the project access road and a crew was working on the forms to pour concrete for the curb (Photo 3). Crews continue to work around the transformer locations (Photo 4).

| Date | Location | Photo | Description |
|---|---|--|---|
| 03/04/20 | San Juan Capistrano Substation | | Photo 3 – Road base has been laid and curb work is underway. Photo facing east. |

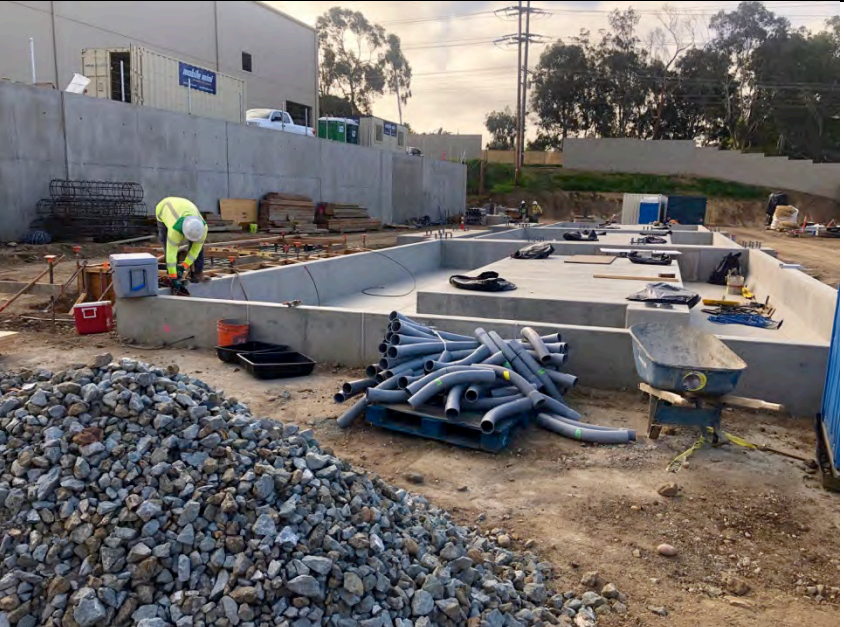
| Date | Location | Photo | Description |
|---|---|--|---|
| 03/04/20 | San Juan Capistrano Substation | | Photo 4 – Transformer foundations. Photo facing south. |

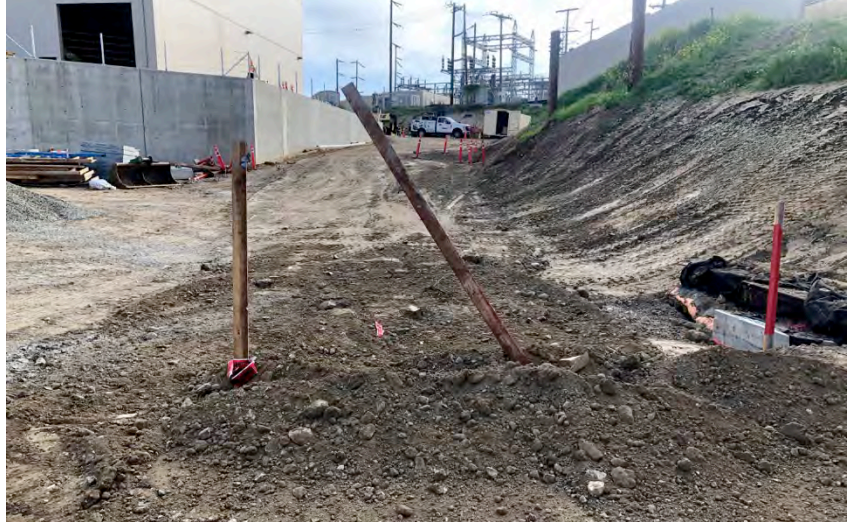
The open conduit hole along the south side of the site has been backfilled and pieces of wood were placed to indicate where the conduit ends (Photo 5). Additional installation work will be performed when jack and bore work begins.

| Date | Location | Photo | Description |
|---|---|---|---|
| 03/04/20 | San Juan Capistrano Substation | | Photo 5 – The end of the conduit trench has now been backfilled. Photo facing east. |

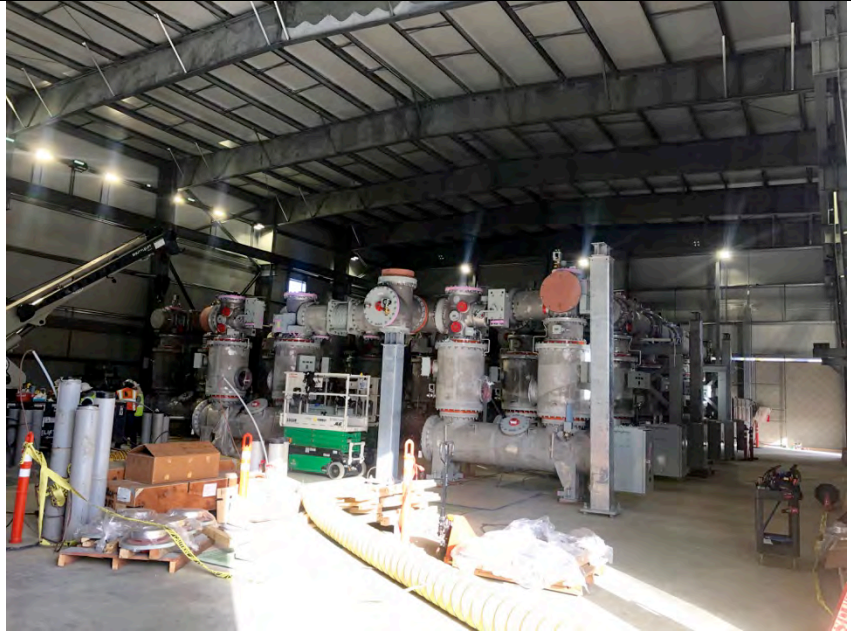
Equipment installation continues within the 138-kV gas-insulated substation (GIS) building (Photo 6). Several pieces of remaining equipment need to be removed from the packing material and delivered into the building (Photo 7). A small fueling location has been set up near the equipment staging area.

| Date | Location | Photo | Description |
|---|---|---|---|
| 03/04/20 | San Juan Capistrano Substation | | Photo 6 – Inside the 138-kV GIS building. |

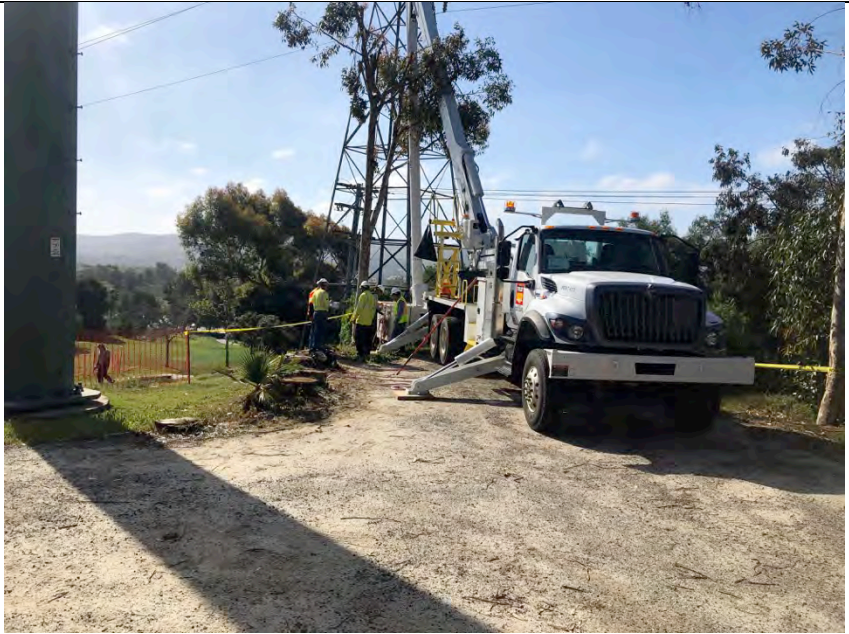
| Date | Location | Photo | Description |
|---|--|---|---|
| 03/04/20 | Transmission line route, tower location 5 | | Photo 9 – Tower location 5, with a grounding crew onsite. Photo facing south. |

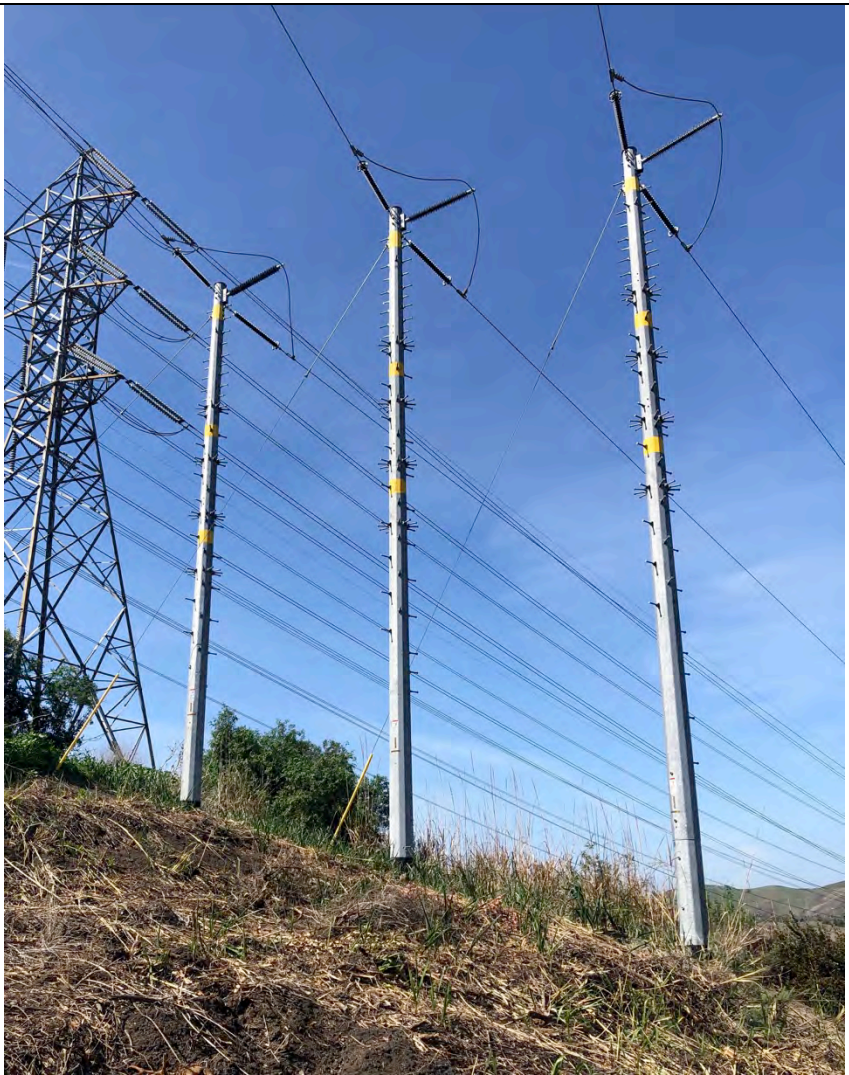
We travelled to tower location 36 where vegetation clearing was taking place (Photo 10). The vegetation around the tower location had already been cleared and crews were using weedwhackers, chain saws, and a brush hog to clear the area west of the tower site (Photo 11). The pull site was staked and flagged while an EI oversaw the work (Photo 12). Two very young brush rabbits (*Sylvilagus bachmani*) were observed; they had some fur and their eyes were open (Photo 13). The EI and I moved the rabbits outside of the flagged area. I confirmed with the EI that a morning walk-through had been performed by biologists to check for wildlife at the sites.

| Date | Location | Photo | Description |
|---|--|---|---|
| 03/04/20 | Transmission line route, tower location 36 | | Photo 10 – Tower location 36. Photo facing west. |

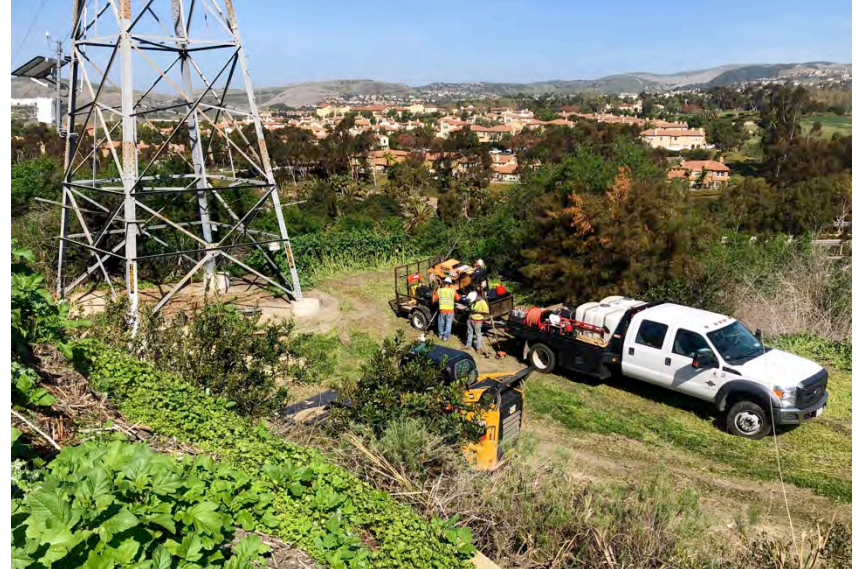
| Date | Location | Photo | Description |
|---|--|---|--|
| 03/04/20 | Transmission line route, tower location 36 | | Photo 11 – Vegetation clearing crew at tower location 36. Photo facing north. |

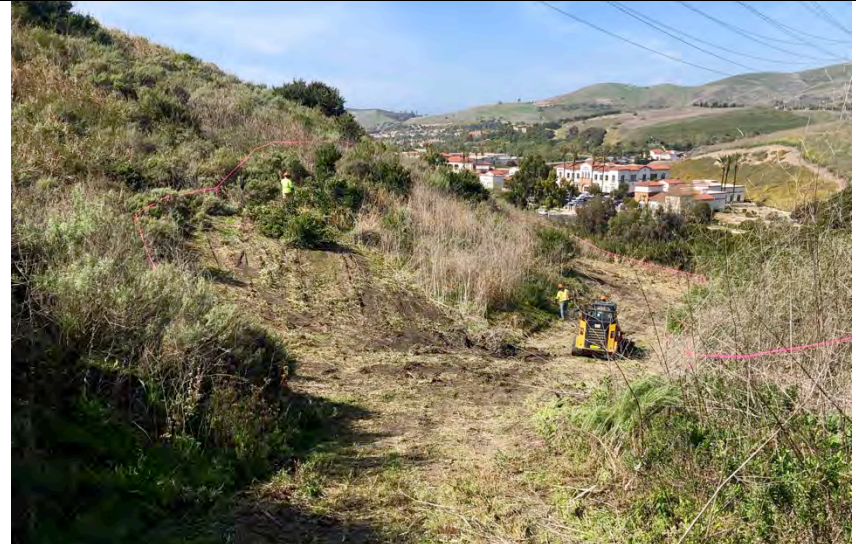
| Date | Location | Photo | Description |
|---|--|---|--|
| 03/04/20 | Transmission line route, tower location 36 | | Photo 12 – Clearing the stringing/wire pulling location west of tower location 36. Photo facing northwest. |

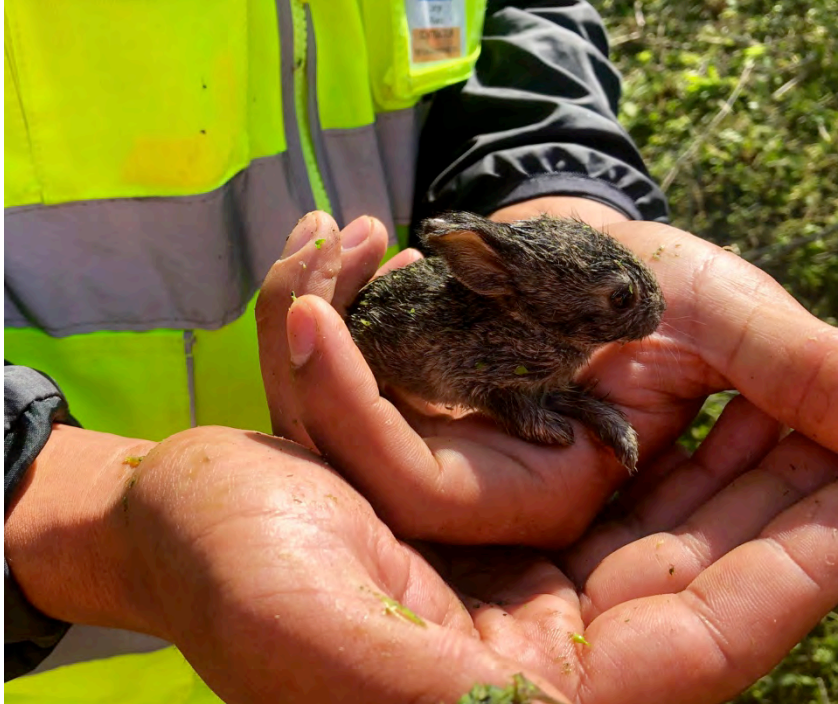
| Date | Location | Photo | Description |
|---|--|---|---|
| 03/04/20 | Transmission line route, tower location 36 | | Photo 13 – Baby brush rabbit (<i>Sylvilagus bachmani</i>) captured and moved out of the construction impact area. |

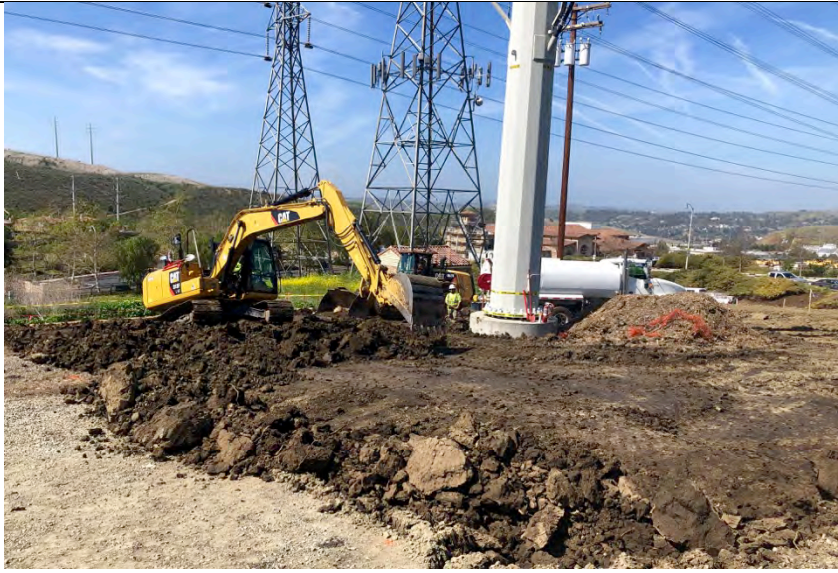
At tower locations 18 and 19, equipment was onsite and grading had begun for the workspace around the towers (Photo 14). This is the first grading work along the transmission corridor and a paleontology monitor was onsite with another EI. The ground contains high amounts of clay that becomes very sticky when wet. No entry/exit BMPs within the short access road to the site (i.e., rock or rumble plates) were observed, but this has not been an issue. While rain was predicted for the upcoming weekend, the grading work was anticipated to be completed by the end of the week.

| Date | Location | Photo | Description |
|---|--|---|---|
| 03/04/20 | Transmission line route, tower locations 18 and 19 | | Photo 14 – Grading work at tower locations 18 and 19. Photo facing northwest. |

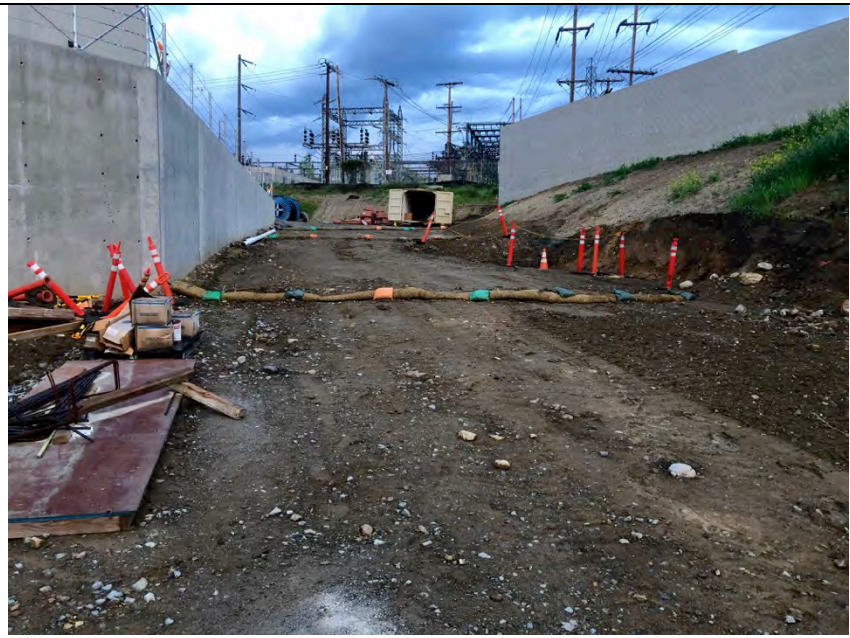
I observed a stormwater drain inlet located at the top of the southern access road that appears to drain the staging area east of the 138-kV gas-insulated substation (GIS) building (Photo 7). The staging area is muddy, so I discussed possible sediment control measures that could be placed around the drain inlet with the EI onsite. A fueling tank/station is present at the staging area (Photo 8).

| Date | Location | Photo | Description |
|---|---|--|--|
| 03/12/20 | San Juan Capistrano Substation | A photograph of a dirt access road at a substation. The road is lined with concrete walls on both sides. Orange traffic cones and safety barriers are placed along the edges of the road. In the background, there are power lines and a utility structure under a cloudy sky. | Photo 5 – BMPs installed along the southern access road. Photo facing east. |

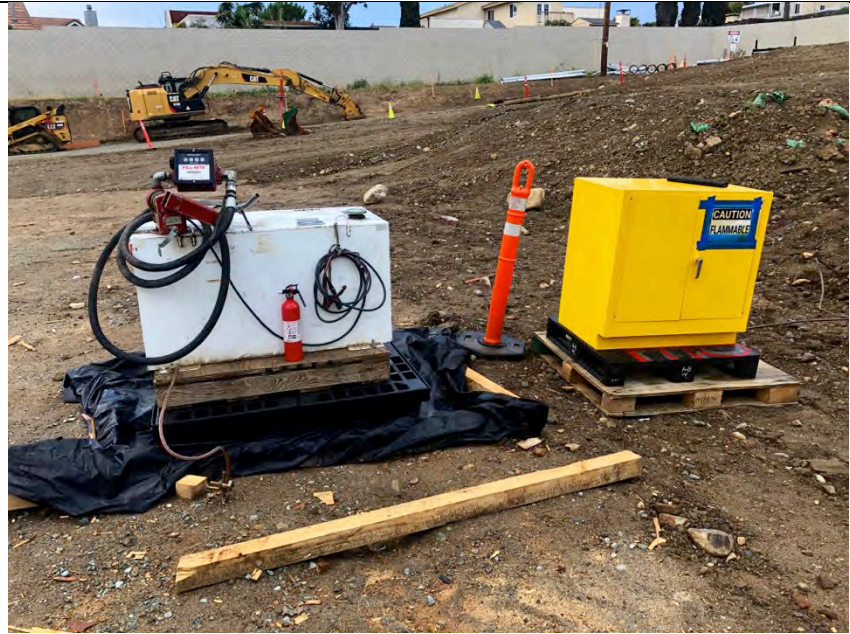
| Date | Location | Photo | Description |
|---|---|---|--|
| 03/12/20 | San Juan Capistrano Substation | | Photo 8 – Fueling station within the staging area outside of the 138-kV GIS building. Photo facing west. |

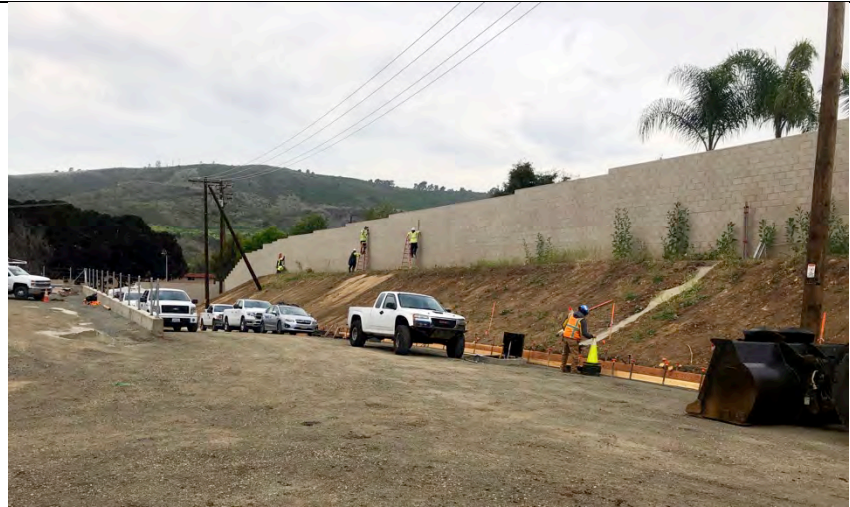
A crew was observed working on the northern boundary wall installing grounding wire (Photo 10).

| Date | Location | Photo | Description |
|---|---|---|--|
| 03/12/20 | San Juan Capistrano Substation | | Photo 10 – Grounding work conducted on the northern boundary wall. Photo facing northwest. |

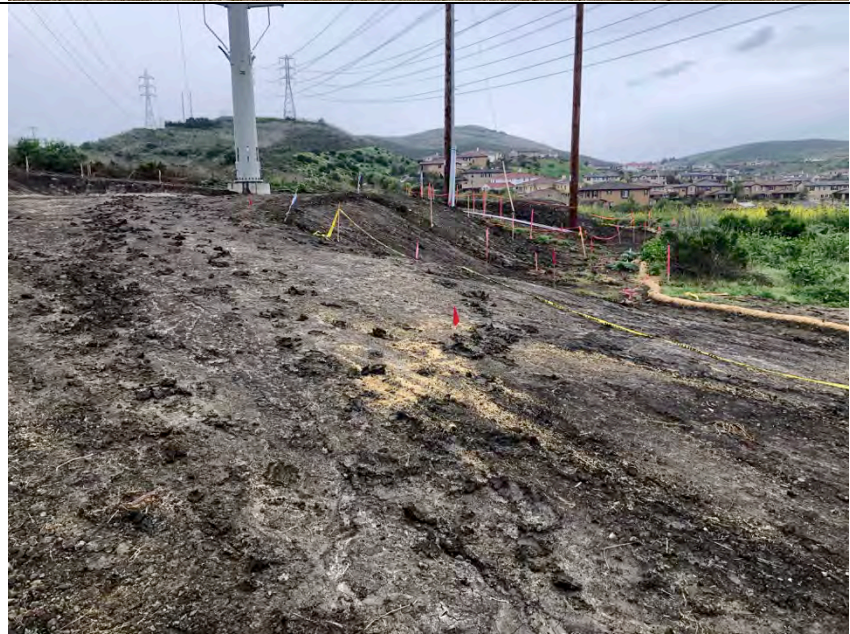
No work was being conducted along the transmission line, but I made a brief stop at tower locations 18 and 19 where grading had begun last week. The work was completed and BMPs were in place for both the access road (Photo 11) and the graded area (Photo 12). The area is quite muddy, but there was no sign of runoff problems, and no track-out mud was observed on the public roadway.

| Date | Location | Photo | Description |
|---|---|---|--|
| 03/12/20 | SOCRE transmission corridor | | Photo 11 – Access road into tower locations 18 and 19. Photo facing south. |

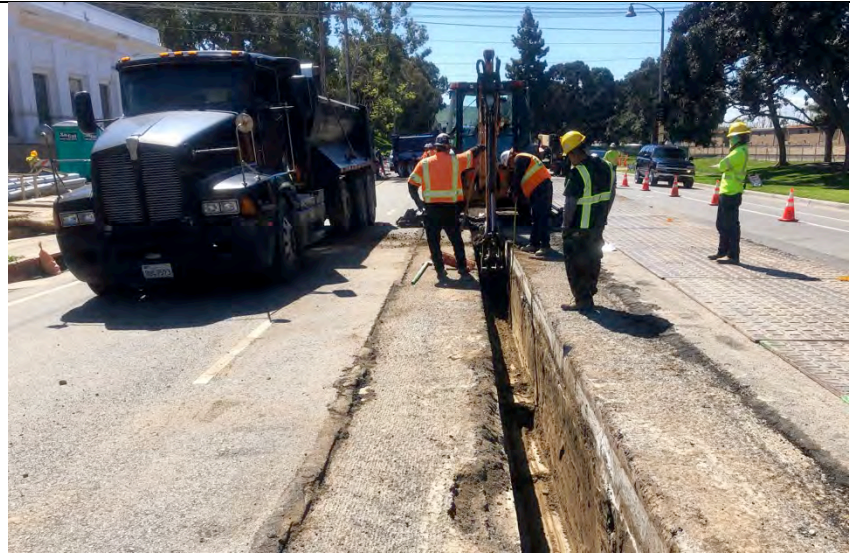
I observed widespread construction activity within Camino Capistrano near the San Juan Capistrano Substation (Photo 1). One backhoe was removing asphalt, and another was trenching within the street (Photo 2). Cultural resource monitors were observing the excavation activities while trucks hauled out the excavated material. All the work was being completed within the approved time frame.

| Date | Location | Photo | Description |
|---|---|--|---|
| 03/26/20 | San Juan Capistrano Substation | | Photo 2 – Trenching within Camino Capistrano with cultural resource monitors present. Photo facing south. |

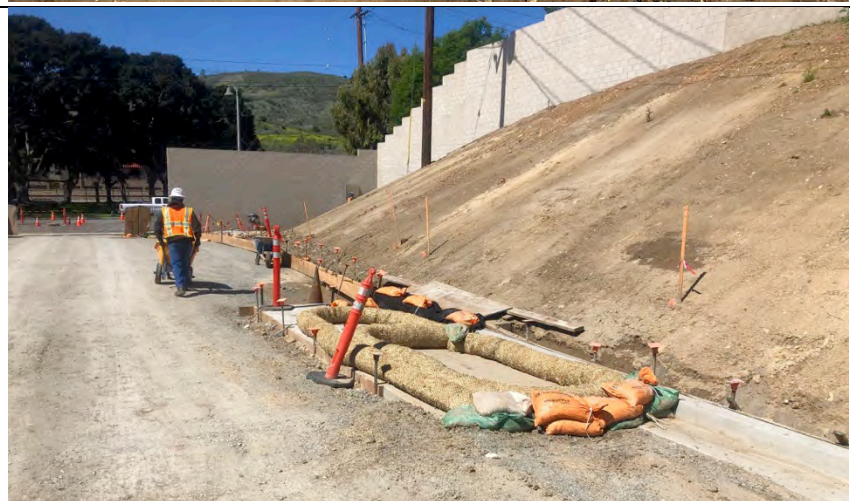
Within the substation, crews continued to work on installation of the grounding wire around the transformer foundations (Photo 3). Work also continued with pouring the curbs along the main access road (Photo 4). The straw wattle in Photo 4 was recommended for installation around the storm drain. Straw wattle recommendations were also implemented around a drain inlet near the 138-kV gas-insulated substation (GIS) building (Photo 6).

| Date | Location | Photo | Description |
|---|---|--|---|
| 03/26/20 | San Juan Capistrano Substation | | Photo 4 – BMPs installed around a storm drain inlet along the new road curb. Photo facing west. |

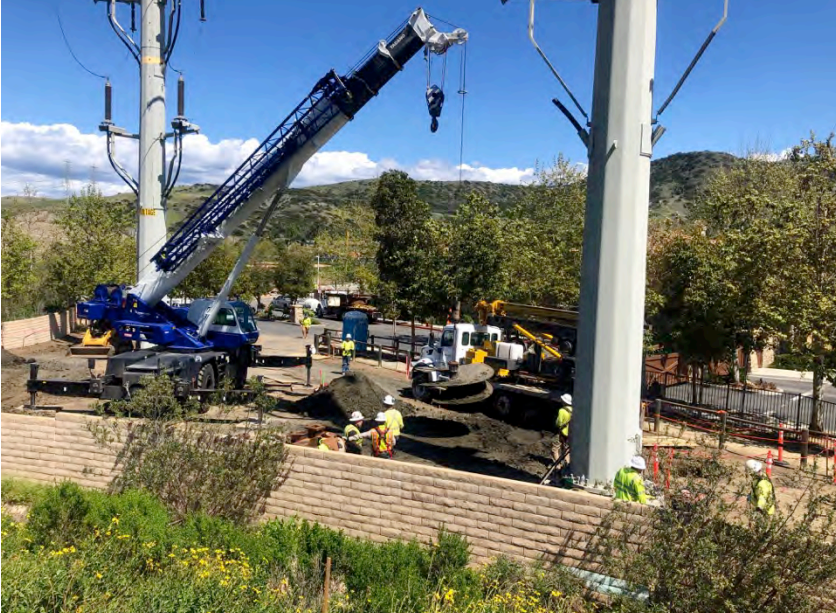
The first tower foundation drilling was being performed at tower location 16, south of Stallion Ridge Road (Photo 10). The hole had been excavated and crews were preparing to place the foundation cage; concrete pouring was anticipated for the following day. The crew will seal the hole overnight to prevent anything from falling in. The foundation hole is 8 feet in diameter and 50 feet deep; the tailings were loaded onto trucks and removed from the site. Cultural resource monitors were onsite earlier, during the initial phase of drilling.

| REPRESENTATIVE SITE PHOTOGRAPHS | | | |
|---|--|---|---|
| 03/26/20 | Transmission line route, tower location 16 | | Photo 10 – Foundation drilling at tower location 16. Photo facing east. |

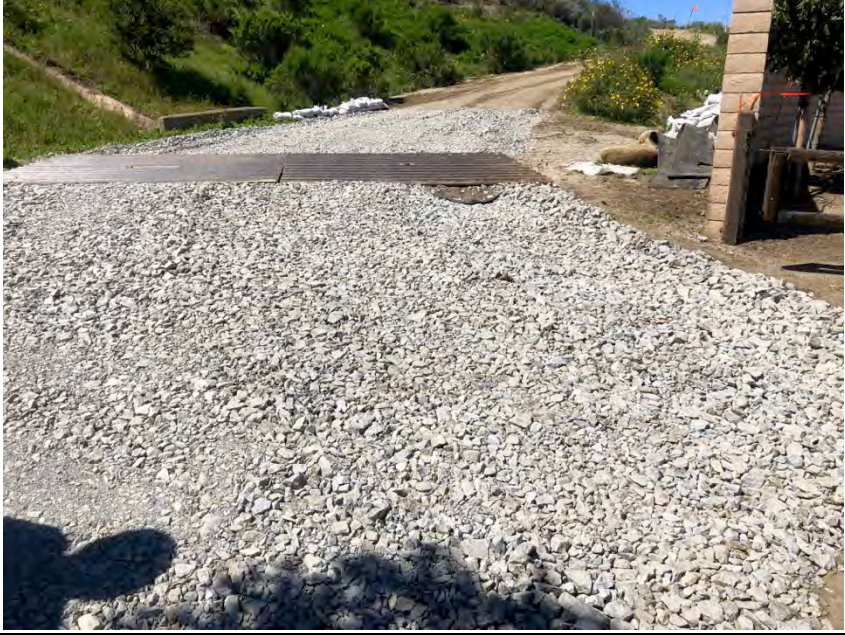
| REPRESENTATIVE SITE PHOTOGRAPHS | | | |
|---|--|---|---|
| 03/26/20 | Transmission line route, tower location 15 | | Photo 11 – BMPs installed at the entrance to the access road at tower location 15. Photo facing north. |

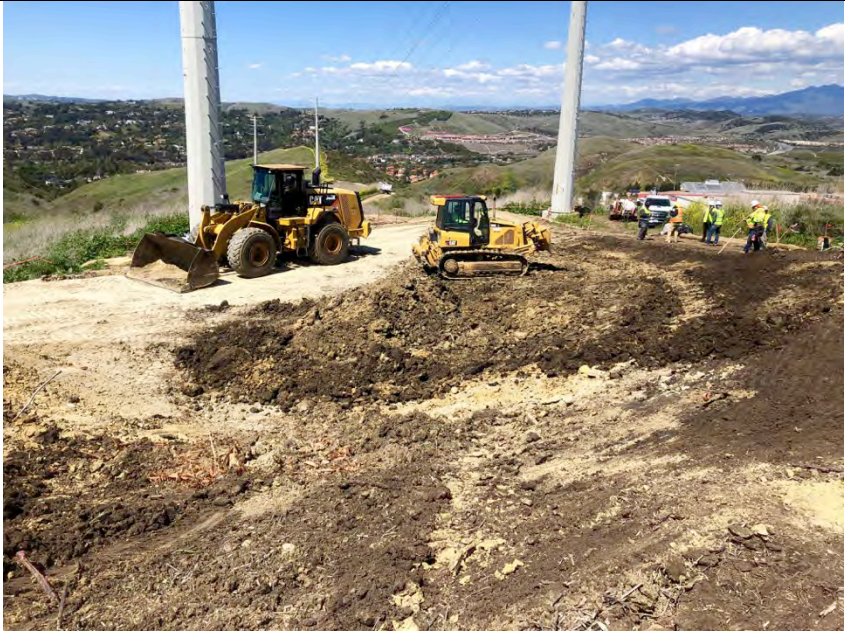
Grading work was being performed at tower location 15 (Photo 12). A biological monitor and cultural resource monitors were onsite observing the work. Thus far, no wildlife has been disturbed and no cultural resource materials have been found. According to the LEI, the area is near a culturally sensitive area. The work area has been delineated by lath stakes with BMPs installed. Equipment operating here included a bulldozer and a front-end loader. Grading is near completion at this location.

| REPRESENTATIVE SITE PHOTOGRAPHS | | | |
|---|--|---|---|
| 03/26/20 | Transmission line route, tower location 15 | | Photo 12 – Grading work at tower location 15. Biological and cultural resource monitors were present. Photo facing north. |
