Re: Monthly Report Summary #31 for the South Orange County Reliability Enhancement (SOCRE) Project

This report provides a summary of the compliance monitoring activities that occurred during the period from **May 1 to 31, 2020**, for the South Orange County Reliability Enhancement (SOCRE) Project in Orange County, California. Compliance monitoring was performed four times between May 1 and 31, 2020, to ensure all project-related activities conducted by San Diego Gas and Electric (SDG&E) and its contractors were in compliance with the Final Environmental Impact Report (Final EIR) for the SOCRE Project, as adopted by the California Public Utilities Commission (CPUC) on December 15, 2016.

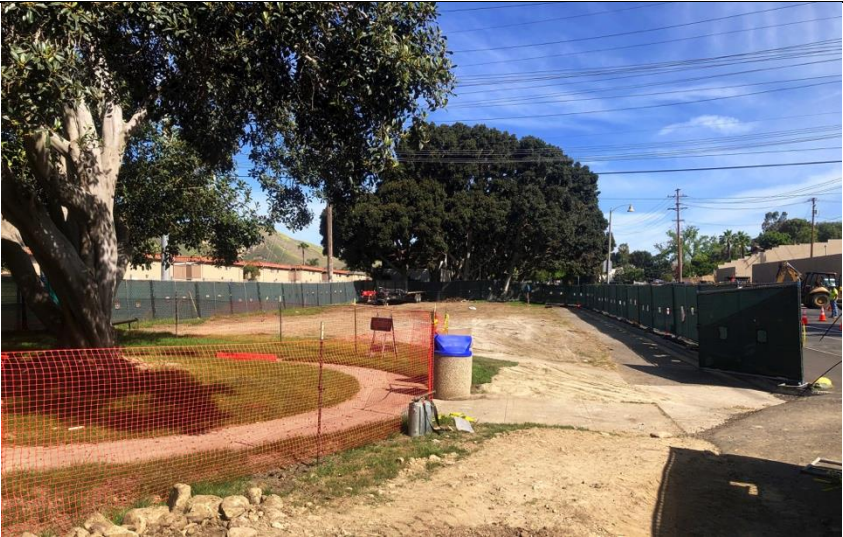
Photo 1 – The jack and bore site near the railroad tracks was fenced off. Photo facing north.

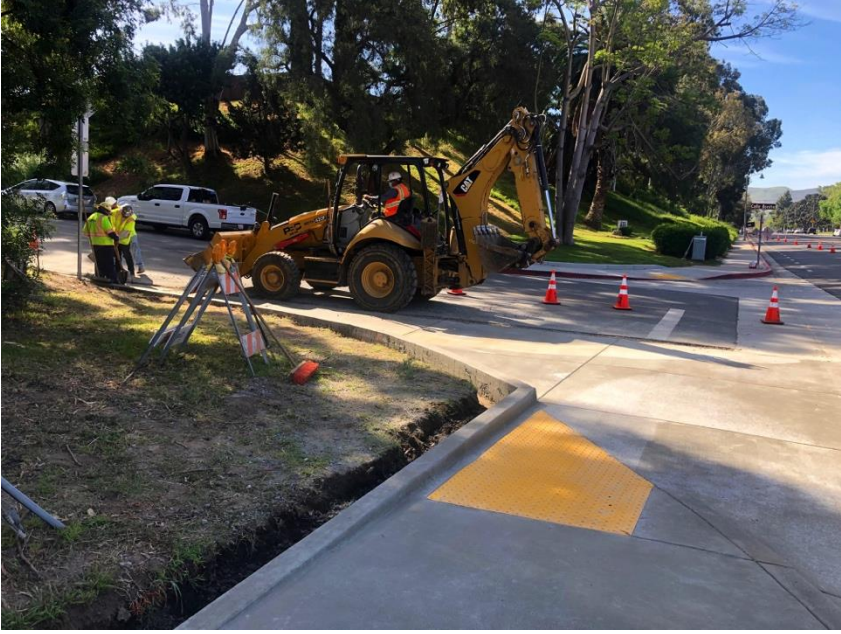
Photo 4 – Trench work was underway while a new sidewalk was being installed. Photo facing south.
05/06/20	San Juan Capistrano Substation

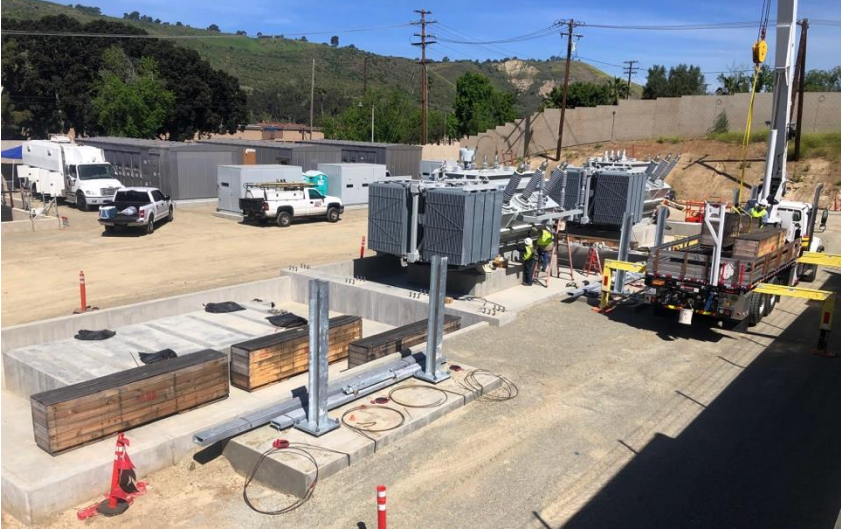
Photo 5 – Transformer unit installation. Photo facing northwest.
05/06/20	San Juan Capistrano Substation

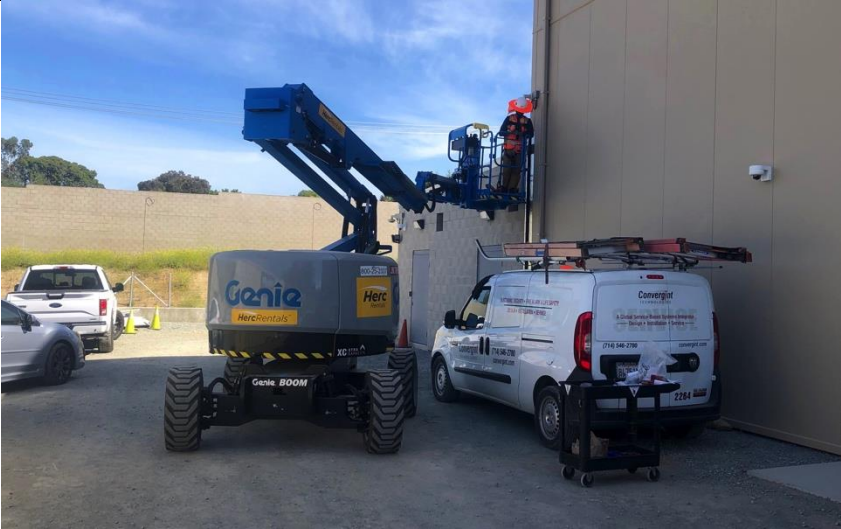
Photo 6 – Installation of lights and cameras on the 138-kV GIS building. Photo facing north.

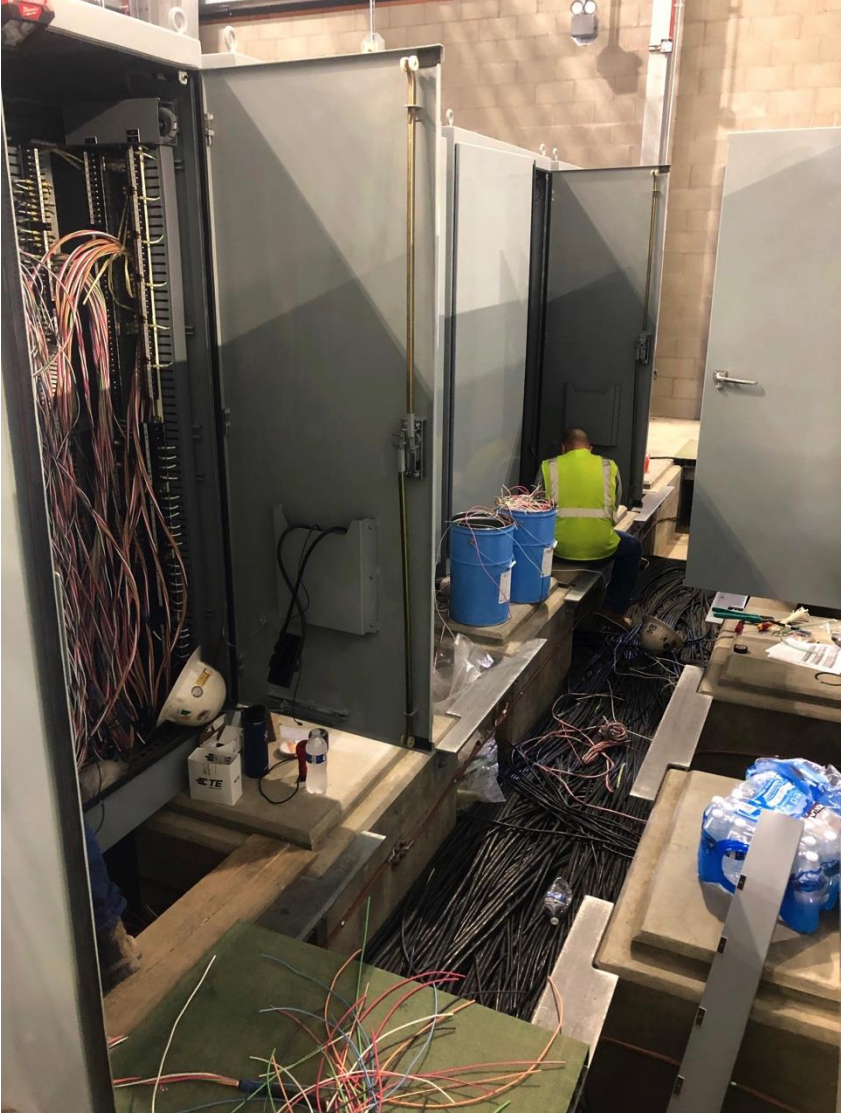
Photo 8 – Wiring inside of the 138-kV GIS building.

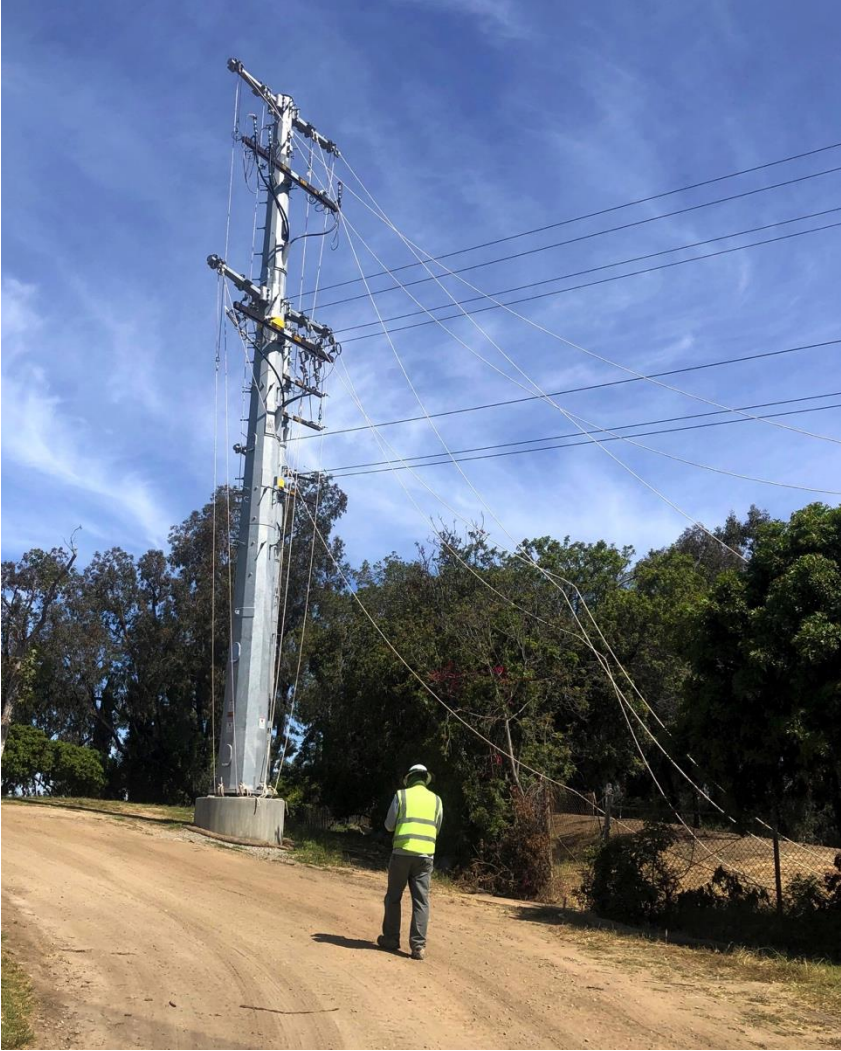
Photo 9 – Wire stringing to the tubular steel pole west of Interstate 5. Photo facing north.
05/06/20	SOCRE transmission corridor

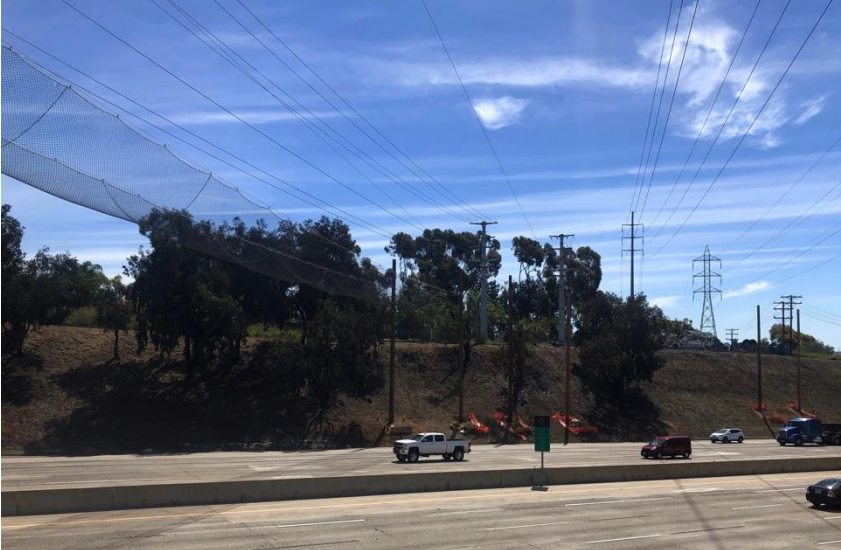
Photo 10 – Netting installed over Interstate 5. Photo facing east.

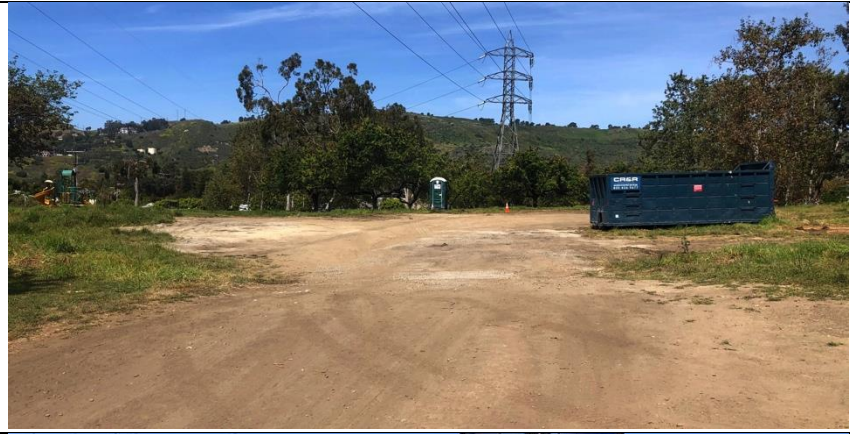
Photo 11 – The Serra Park laydown yard. Photo facing west.
05/06/20	SOCRE transmission corridor

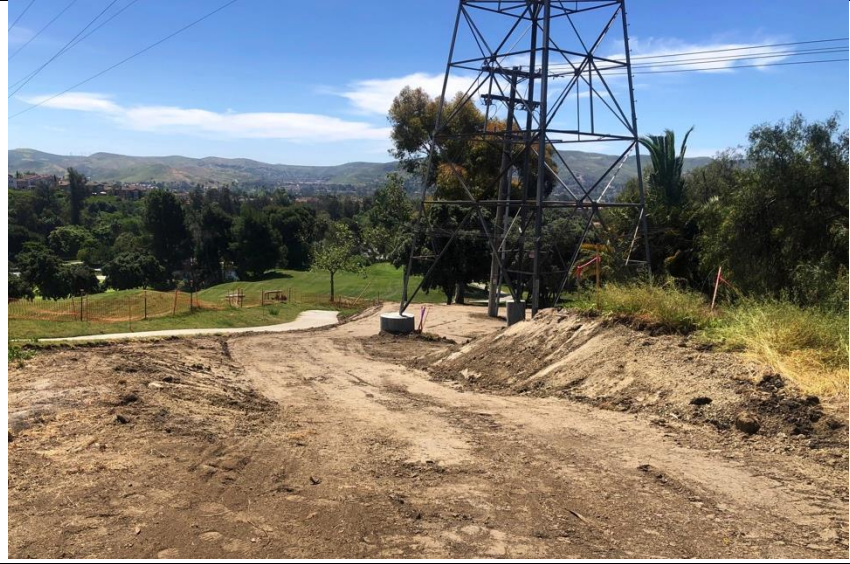
Photo 12 – The access road to tower location 5. Photo facing south.
05/06/20	SOCRE transmission corridor

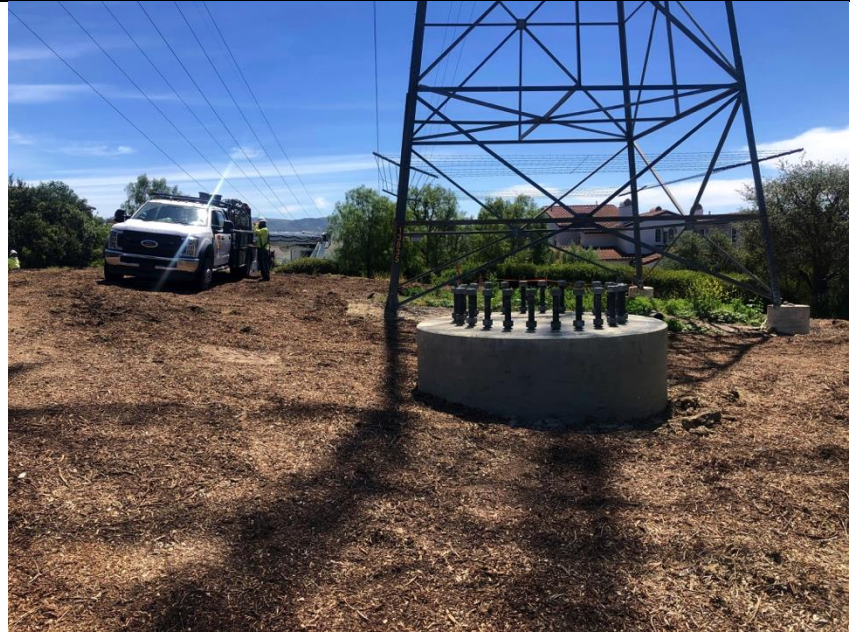
The LEI and I traveled to tower location 6; the new tower foundation was drilled and poured (Photo 13). A line crew was onsite performing wirework.

Photo 13 – The new foundation at tower location 6. Photo facing south.

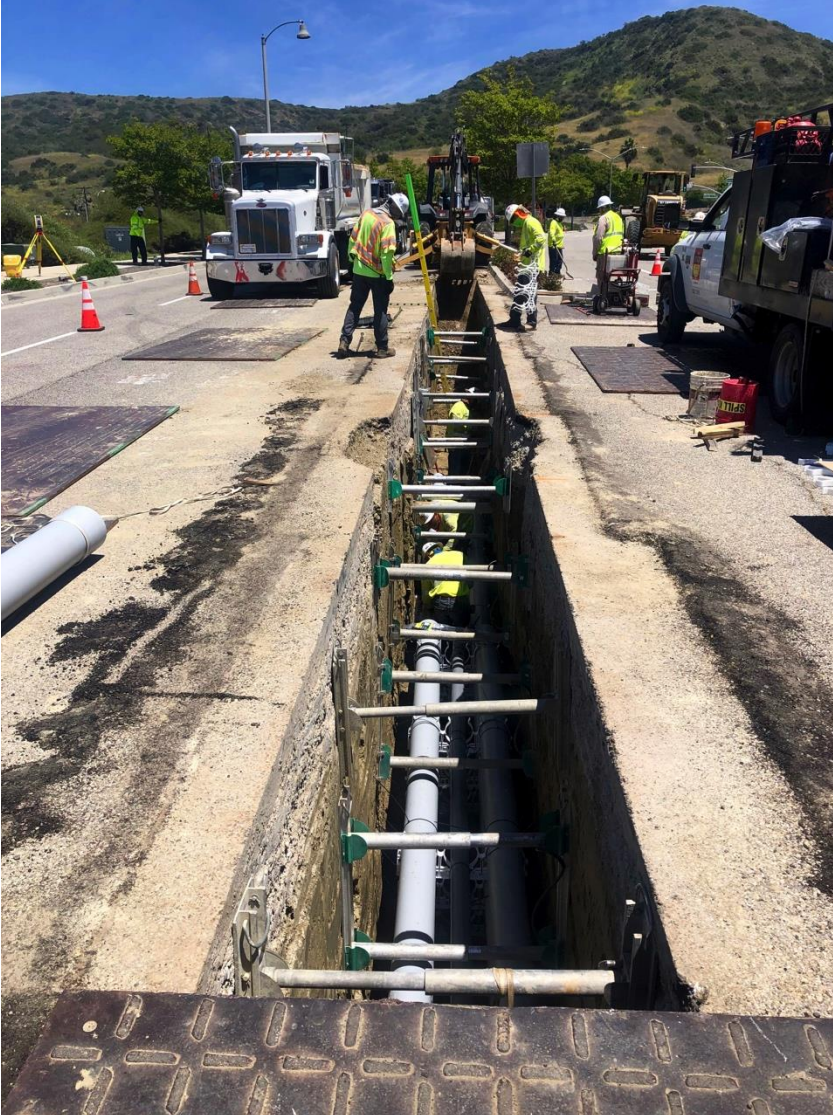
Photo 21 – Conduit installation within Stallion Ridge Road. Photo facing east.

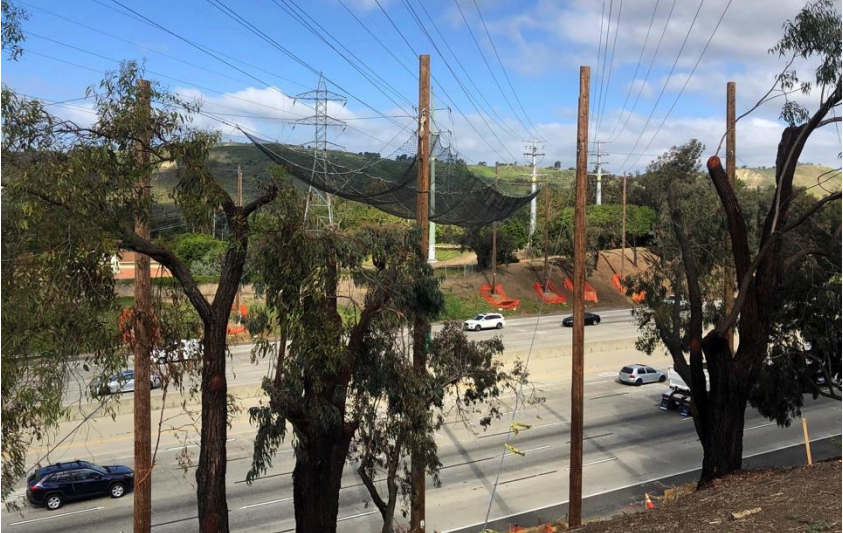
Photo 1 – Netting strung across Interstate 5. Photo facing northwest.

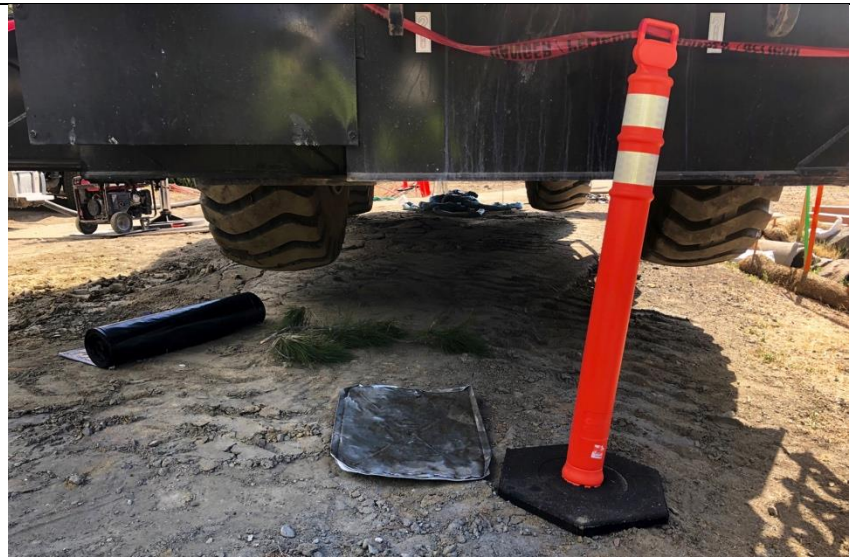
At tower location 9, the foundation drilling had been completed (Photo 4). The remaining drilling solution was pumped into a water truck where it was transferred to baker trucks at tower location 10. After the fluid was removed, the remaining 9 feet were slurried to stabilize the culvert. The concrete washout basin was in good condition (Photo 5); however the secondary containment under the large crane was insufficient (Photo 6). The LEI and I discussed the drip pan issue, which will be communicated to the contractor.

Photo 6 – Inadequate drip pan under a large crane at tower location 9.

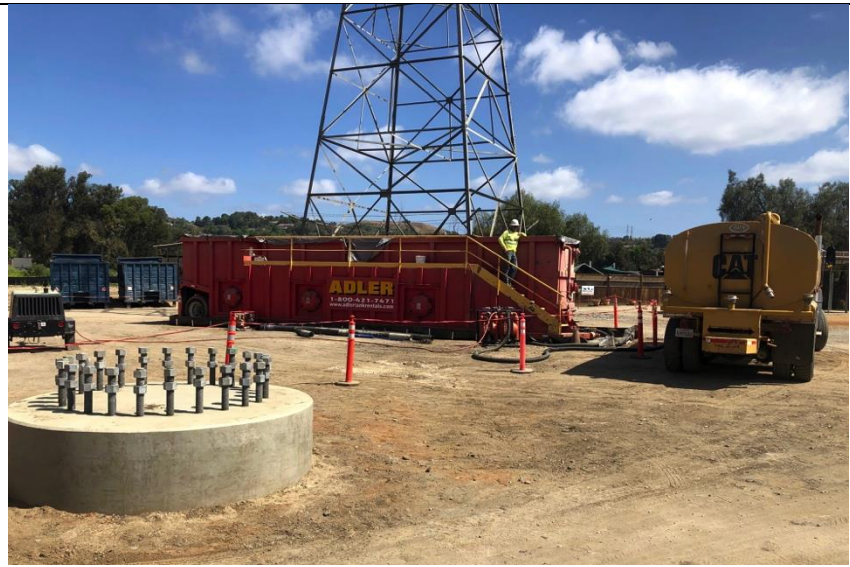
Photo 7 – Equipment remaining at tower location 10. Photo facing north.
05/15/20	SOCRE transmission corridor

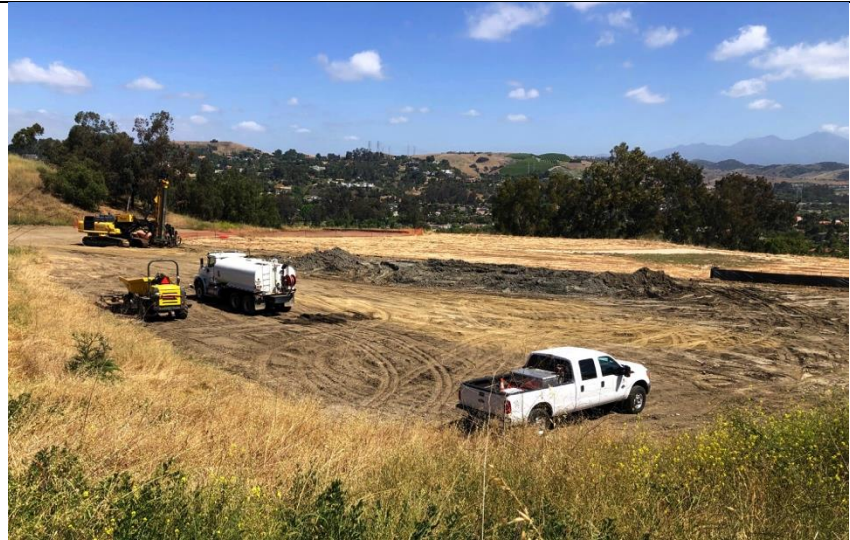
The tailings from tower foundation drilling at tower locations 9 and 10 were transported to the staging area near tower location 12 (Photo 8). The nest buffer boundary near the tower location 12 access road had additional signage and new lath and flagging to give notice to the crews (Photo 9). The tower foundation for location 12 had been drilled and poured (Photo 10).

Photo 8 – Soil stockpile area near tower location 12. Photo facing north.
05/15/20	SOCRE transmission corridor

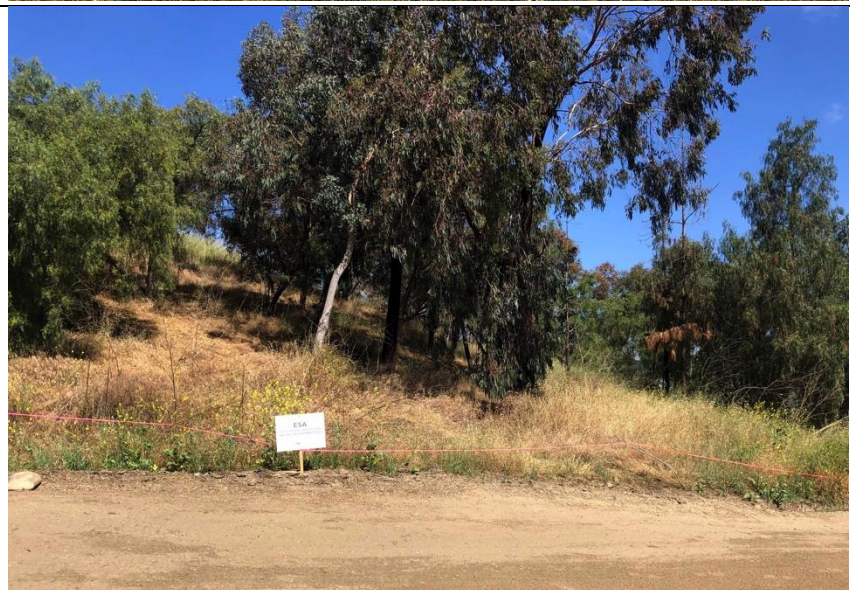
Photo 9 – Nest buffer boundary along the access road to tower location 12. Photo facing north.

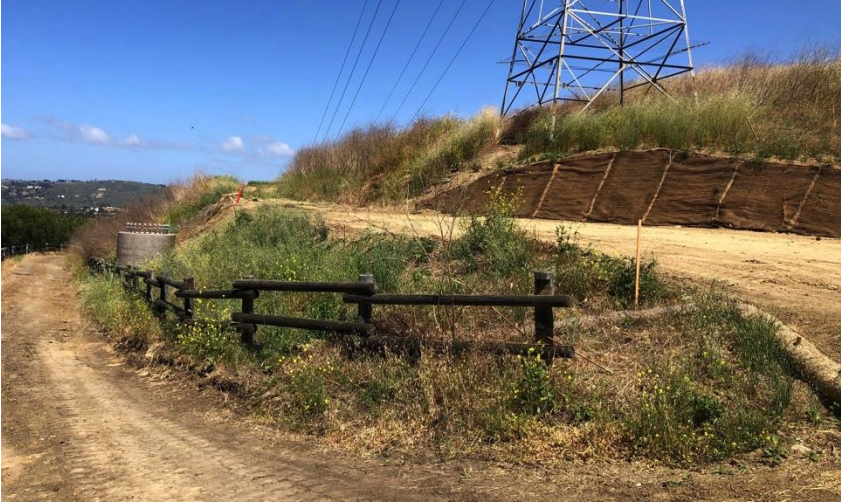
Photo 10 – Tower location 12 with newly poured foundation. Photo facing north.
05/15/20	SOCRE transmission corridor

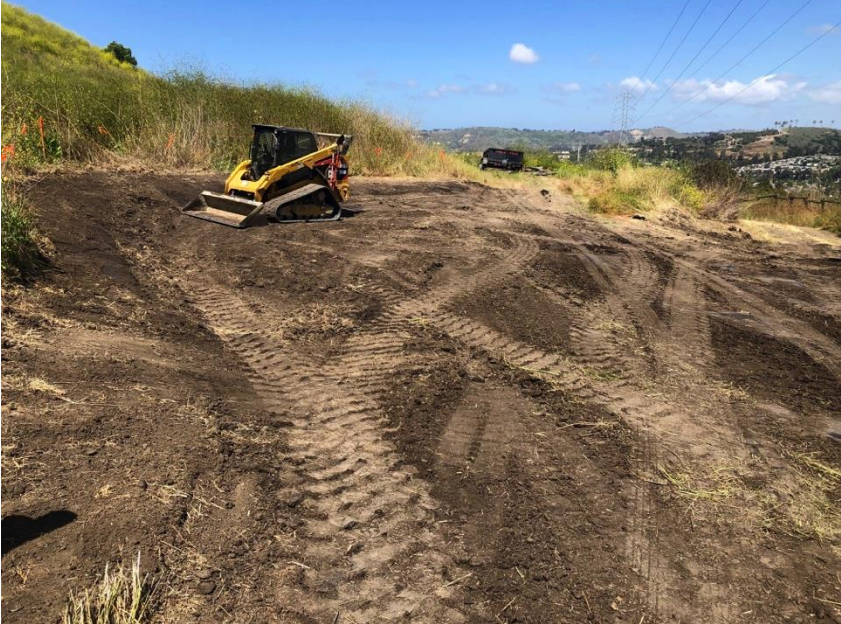
Photo 11 – Small graded area along the access road to tower location 13. Photo facing northwest.
05/15/20	SOCRE transmission corridor

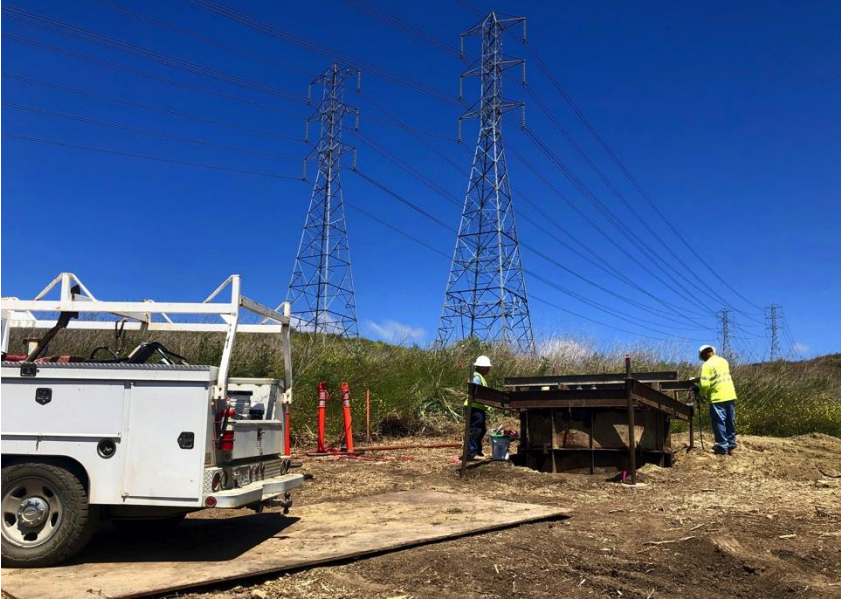
My final stop along the transmission corridor was at tower location 29. The foundation had been drilled and the rebar cage installed; the crew was waiting for concrete trucks to pour the foundation (Photo 12). An avian biologist was monitoring the work due to a nearby red-tailed hawk (*Buteo jamaicensis*) nest where the chicks appeared to be close to fledging. A pair of Cassin's kingbirds (*Tyrannus vociferans*) was nesting in an adjacent lattice tower and did not appear to be disturbed by the construction effort. The environmental coordinator for the contractor was onsite and watering the access road ahead of the concrete trucks for dust control.

Photo 12 – The recently drilled foundation at tower location 29, with crews waiting for concrete trucks to arrive. Photo facing south.

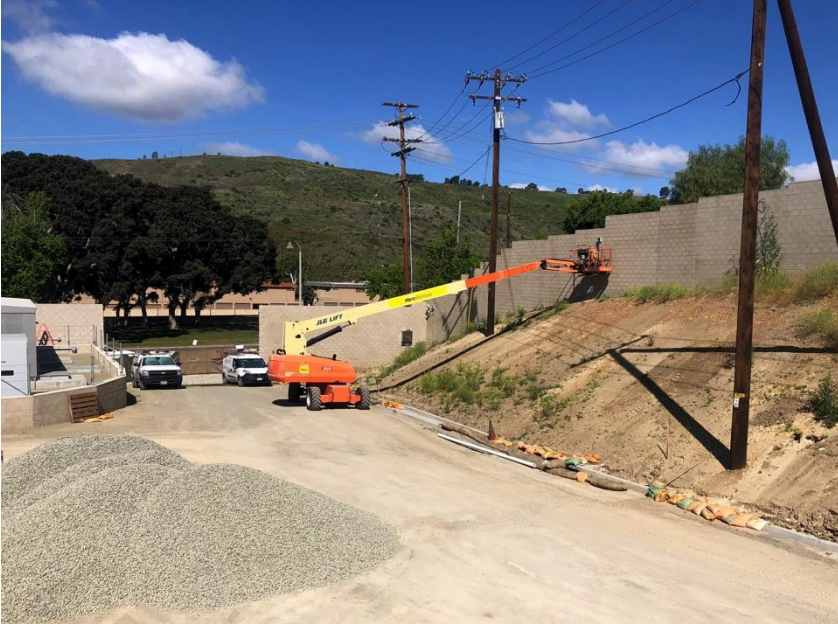
Photo 4 – Work on the northern boundary wall. Photo facing west.
05/20/20	San Juan Capistrano Substation

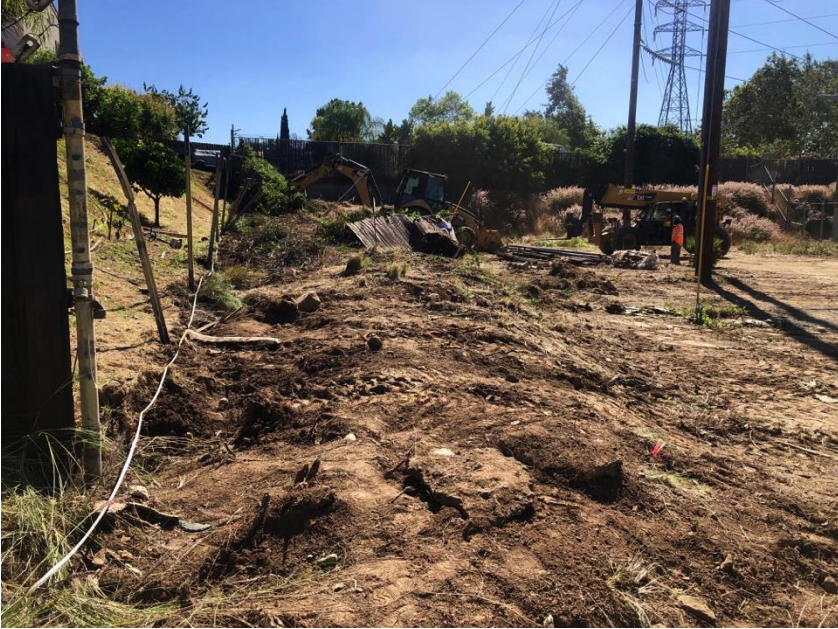
Photo 5 – Removal of fencing in the northeast corner of the substation. Photo facing east.
05/20/20	SOCRE transmission corridor

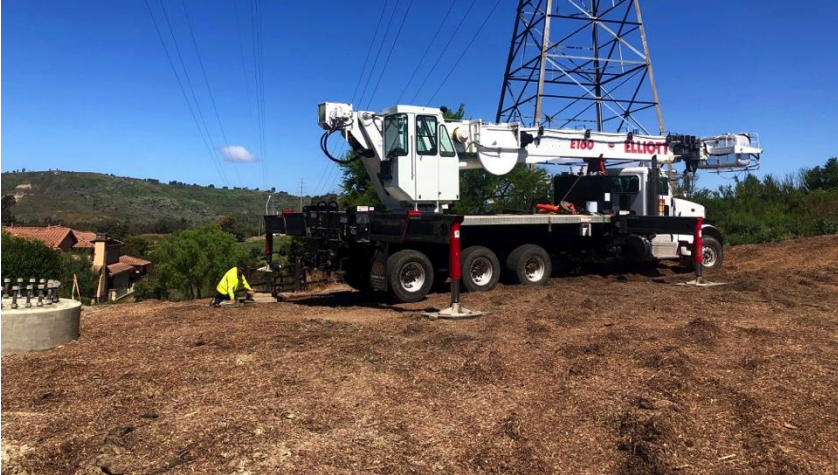
Photo 6 – Line crew setting up near tower location 6. Photo facing northwest.

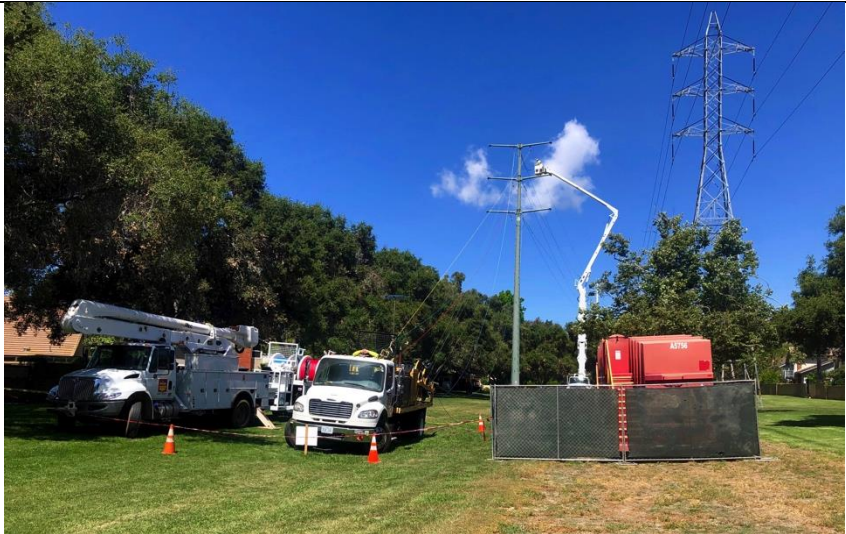
Photo 7 – Wire being reeled at tower location 8. Photo facing north.
05/20/20	SOCRE transmission corridor

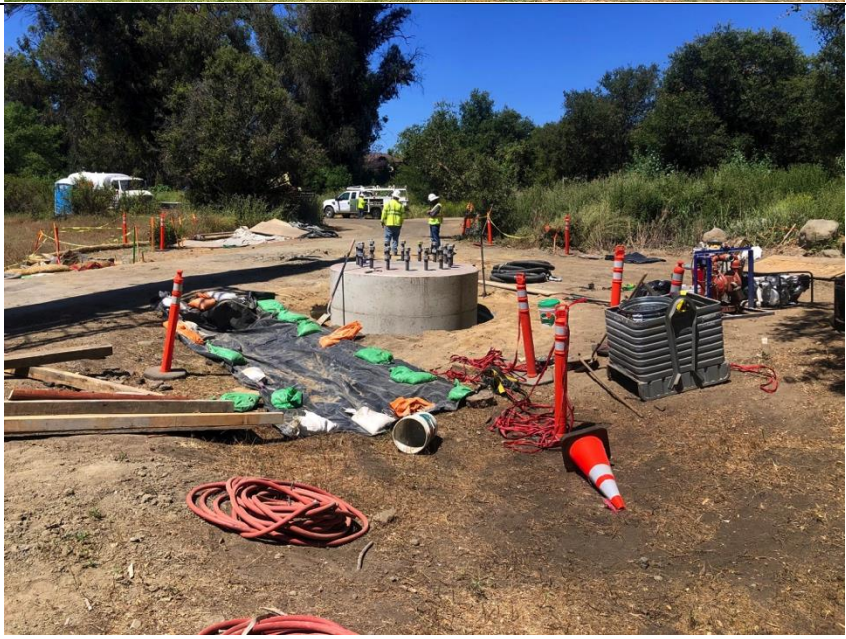
Crews continued to demobilize the equipment at tower location 9 (Photo 8), with most of the construction moved to tower location 8. The large crane remained at tower location 9 with adequate drip pans beneath it. The EI said work would begin quickly to repair the asphalt bike path at tower location 9 so that it could be opened to the public.

Photo 8 – Cleanup and demobilization of the work at tower location 9. Photo facing west.

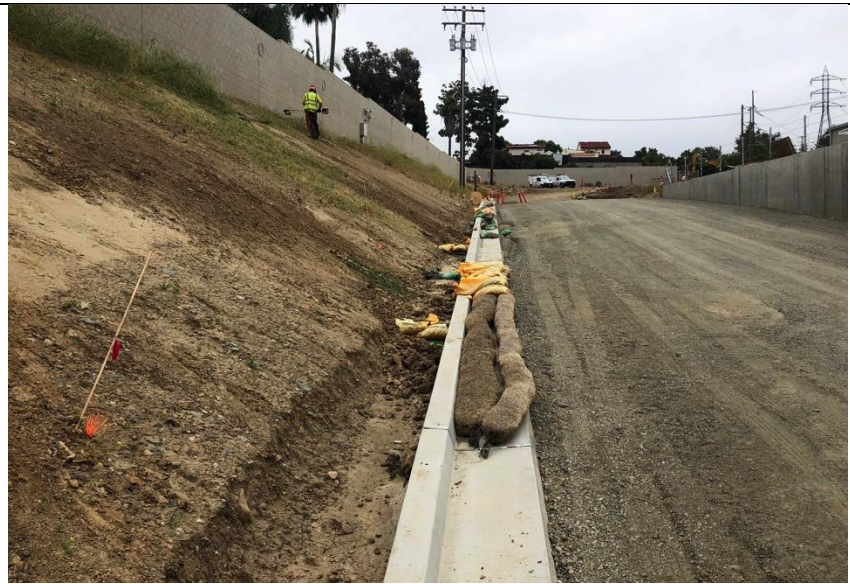
Photo 2 – Preparation work on the northern slope. Photo facing east.
05/27/20	San Juan Capistrano Substation

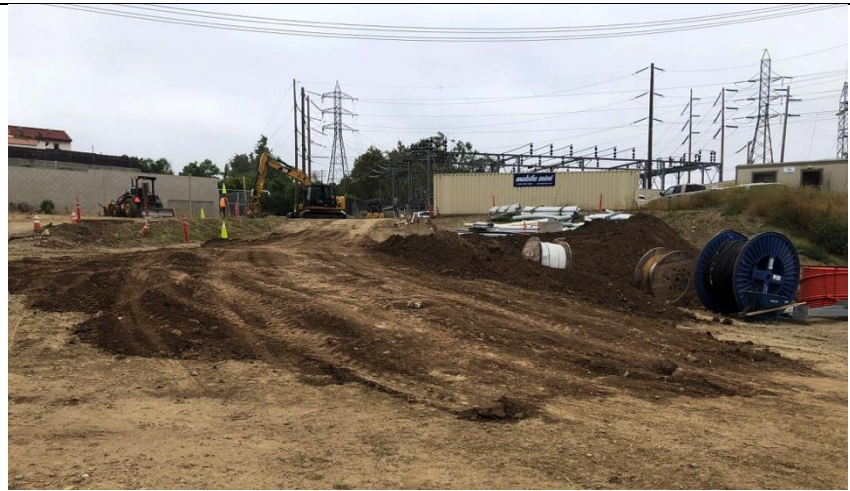
Photo 3 – Excess soil stockpiled onsite. Photo facing east.
05/27/20	San Juan Capistrano Substation

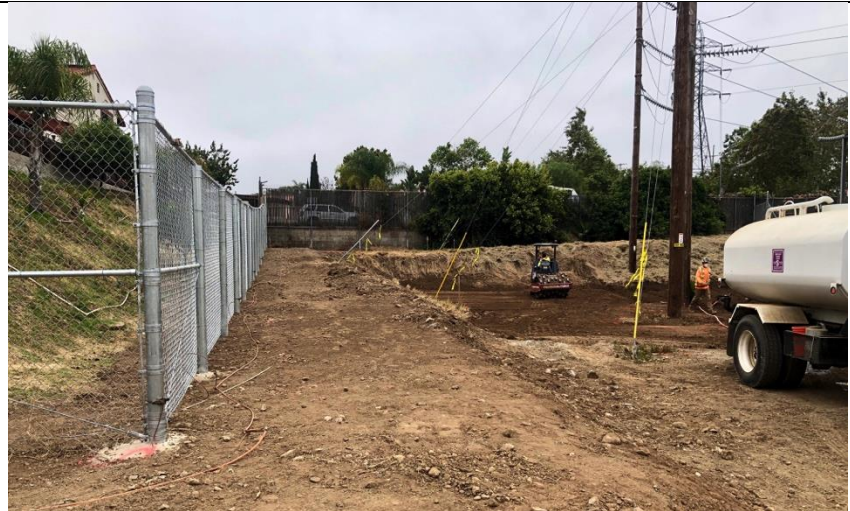
Photo 4 – A new fence and soil compaction work south of the northern boundary of the substation. Photo facing east.

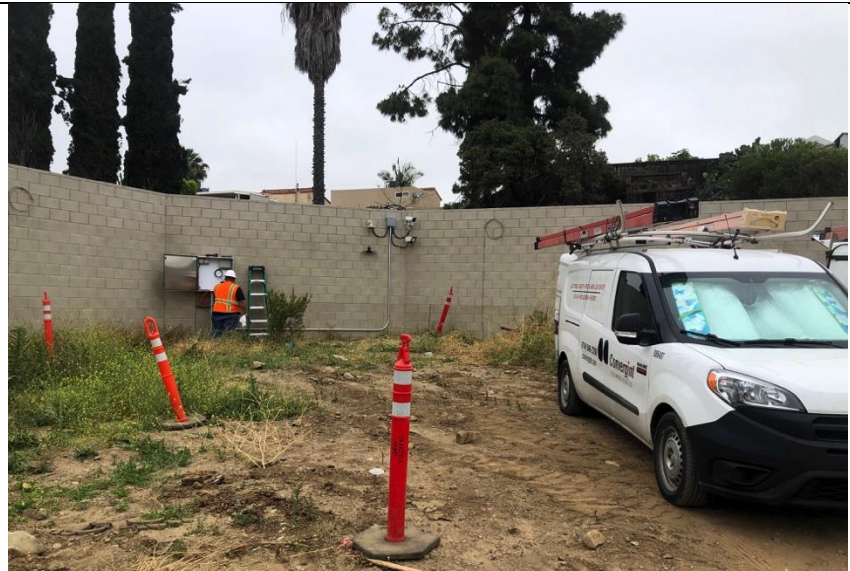
Photo 5 – Electrical work on the northern boundary wall. Photo facing northeast.
05/27/20	Long Park, west of the San Juan Capistrano Substation

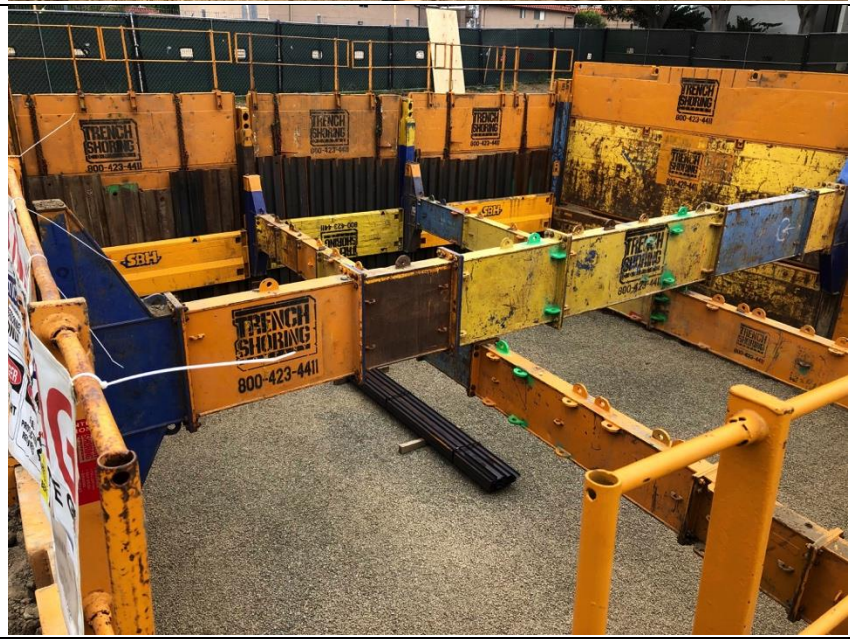
Photo 6 – The jack and bore hole east of the railroad tracks. Photo facing northwest.

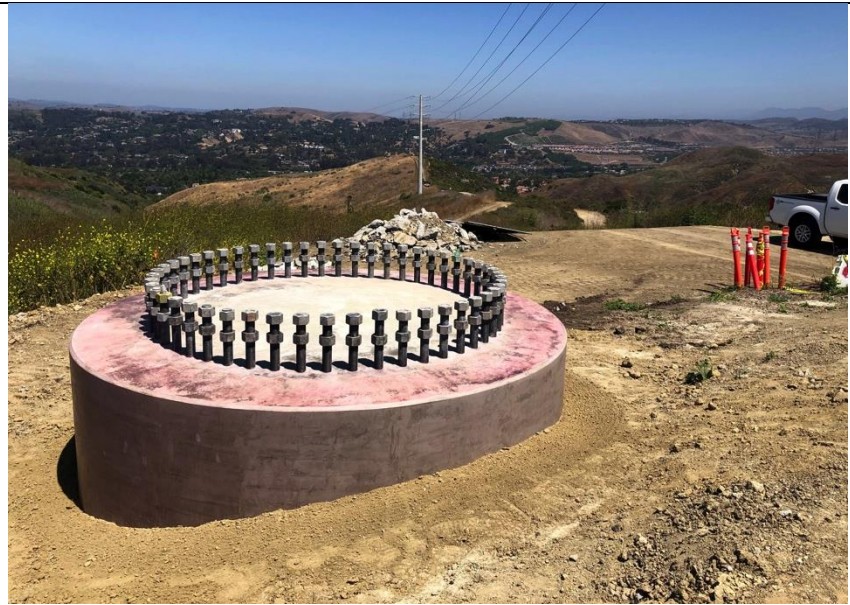
At tower location 15, the new tower foundation had been drilled and poured (Photo 12). This foundation is larger than others because the transmission line turns at this location. Work was being performed to remove the existing tower foundation. A pair of American kestrels (*Falco sparverius*) was observed near the existing tower and an avian biologist will monitor their activity to determine if they are nesting.

Photo 12 – New tower foundation at tower location 15. Photo facing north.
05/27/20	SOCRE transmission corridor

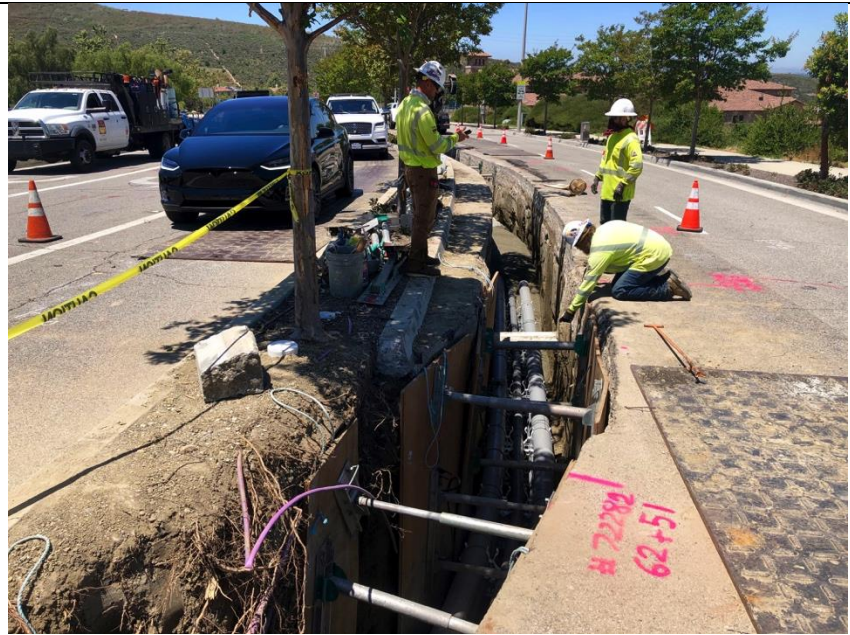
Photo 13 - Conduit installation within Stallion Ridge Road. Photo facing west.
