Re: Monthly Report Summary #37 for the South Orange County Reliability Enhancement (SOCRE) Project

South Orange County Reliability Enhancement Project CPUC Site Inspection Form

Project:	South Orange County Reliability Enhancement (SOCRE) Project	Date:	November 5, 2020
Project Proponent:	San Diego Gas & Electric (SDG&E)	Report #:	VS102
Lead Agency:	California Public Utilities Commission (CPUC)	Monitor(s):	CPUC/WSP (formerly Ecology and Environment, Inc.) Compliance Monitor
CPUC PM:	Andrew Barnsdale, Energy Division	AM/PM Weather:	Partly cloudy, mild, and calm
CPUC CM (WSP):	Joe Donaldson	Start/End time:	0630 to 1130
Project NTP(s):	Notice to Proceed (NTP)-3 and NTP-6

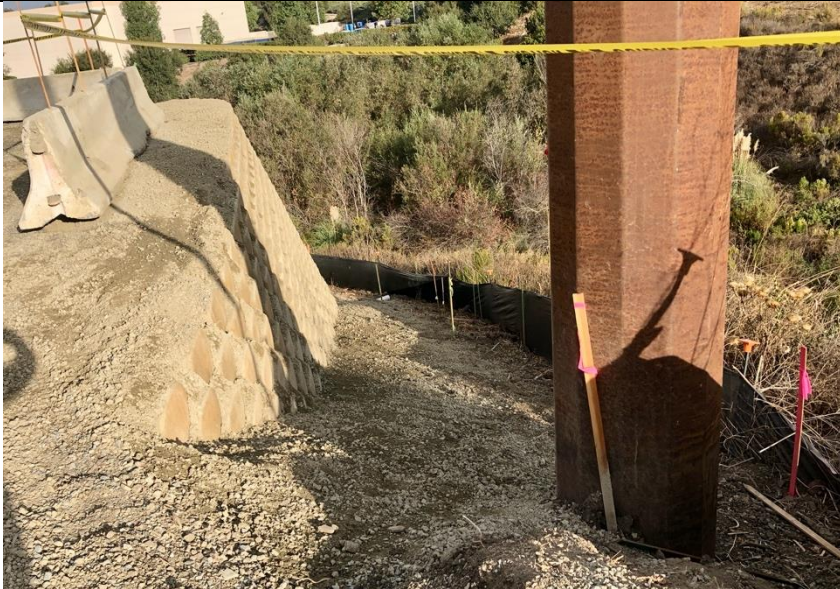
Our first stop was at tower location 39 where the retaining wall had been completed and the additional workspaces cleaned (Photos 1 and 2). The KV Structures crew expected to begin drilling the tower foundation hole once the survey crews completed the inspection. The paleontology monitor was onsite with a biological monitor.

Photo 1 – New retaining wall at tower location 39. Photo facing north.

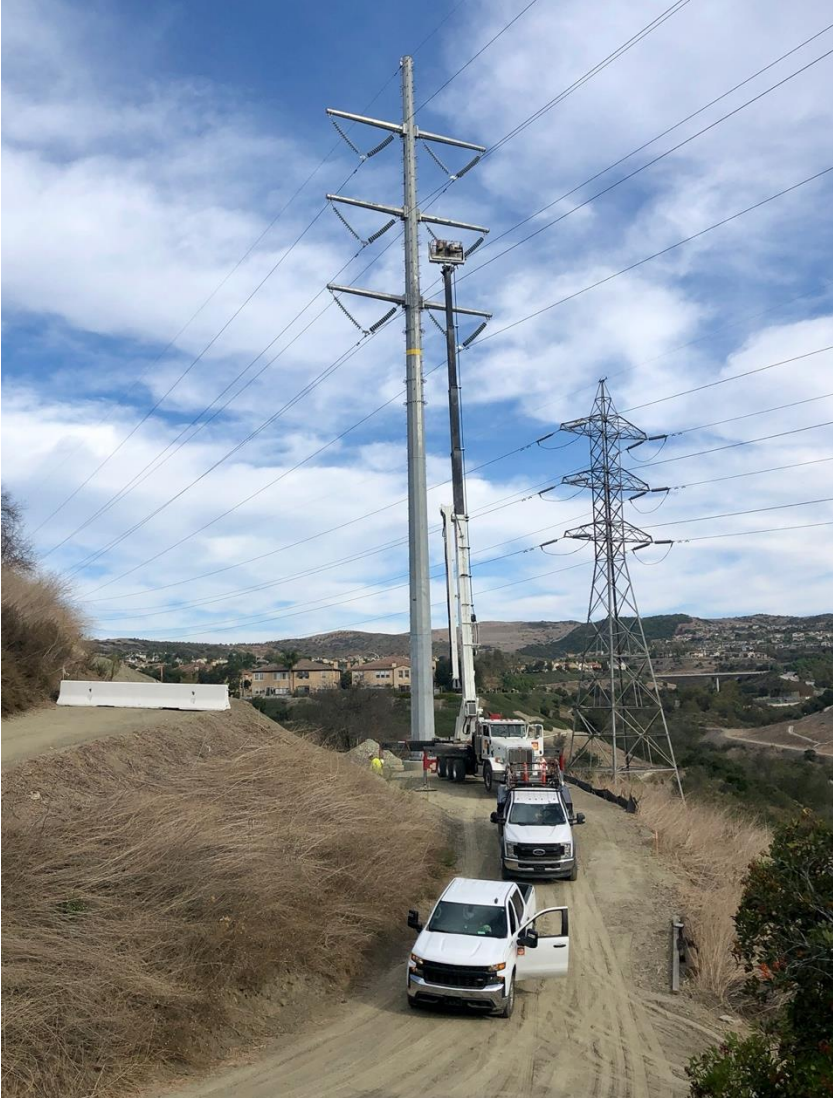
Crews were working on the tubular steel poles (TSP) at tower locations 32 and 33 (Photo 5).

Photo 5 – TSP work at tower location 32. Photo facing north.
11/05/20	SOCRE transmission corridor

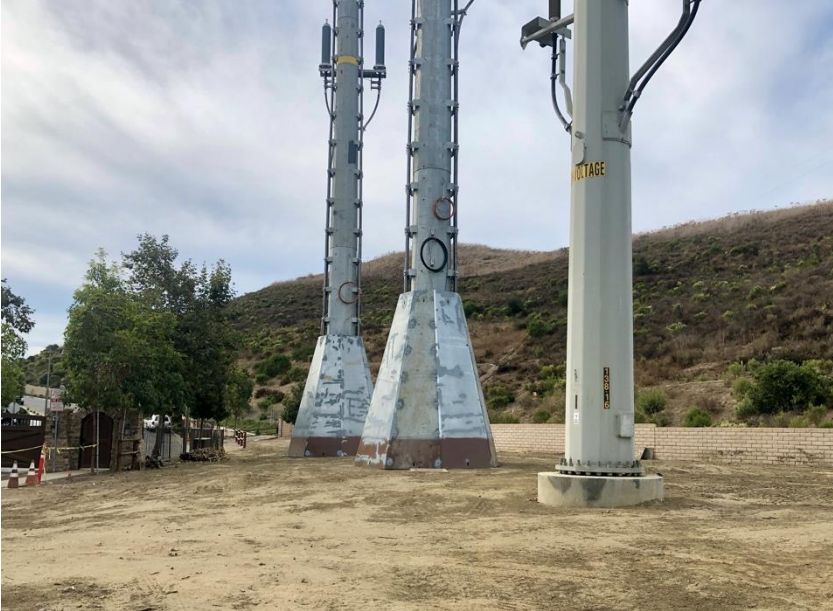
Work at tower locations 18 and 19 appeared to be completed and the area was closed off. Tower locations 16 and 17 were also closed, but some trash remained within the work site (Photo 6).

Photo 6 – TSPs at tower locations 16 and 17. Photo facing southwest.

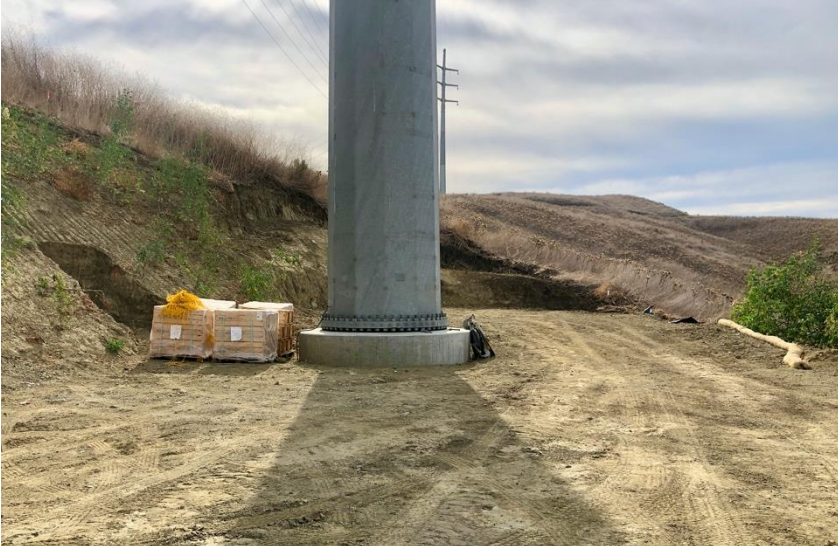
Photo 7 – Workspace at tower location 14. Photo facing southwest.
11/05/20	SOCRE transmission corridor

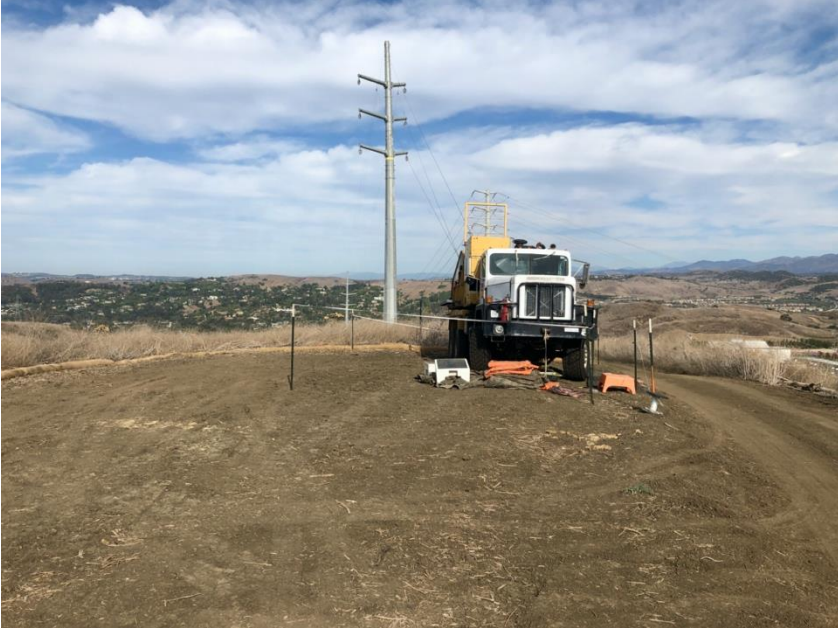
Photo 8 – A pulling site along the access road south of tower location 15. Photo facing north.

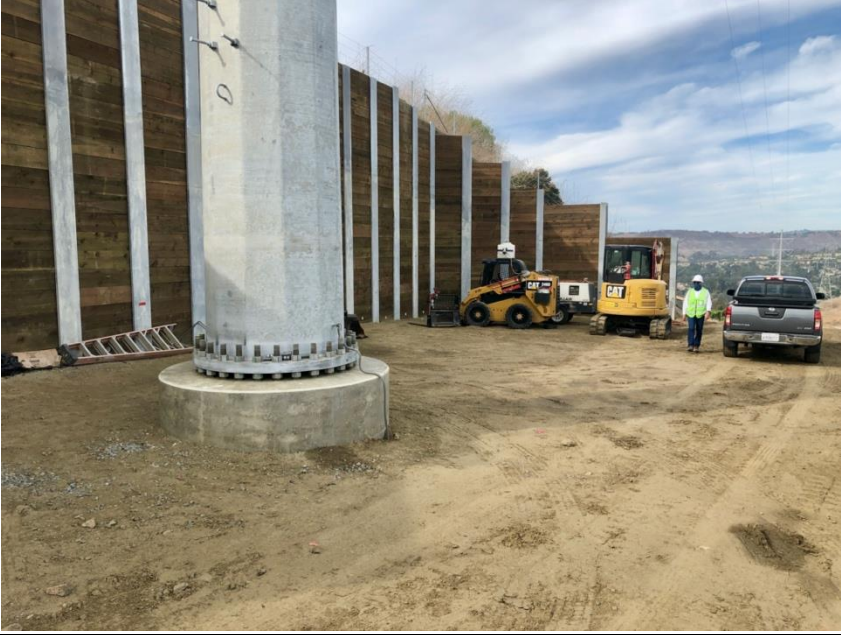
We drove the access road from tower locations 16 and 17 to tower location 13. I stopped at tower location 14 to inspect the work area (Photo 7). A pulling site had been graded along the access road north of tower location 15, and some pulling equipment was parked (Photo 8). At tower location 13, a crew was scheduled to begin working on the brow ditch above the new wall (Photo 9).

Photo 9 – Work continued at tower location 13, installing a brow ditch above the wall. Photo facing northwest.
11/05/20	SOCRE transmission corridor – Arroyo Park

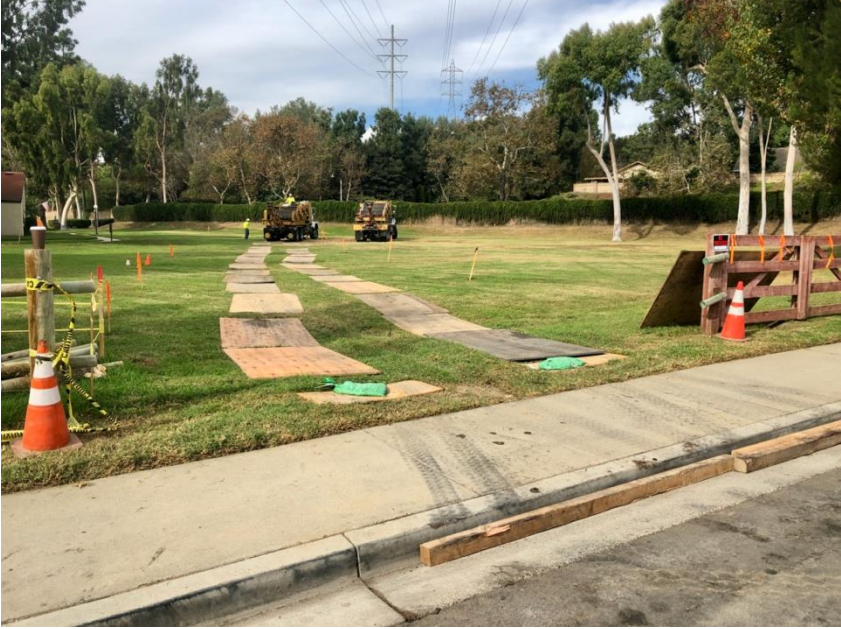
At tower location 8, the wire pulling equipment had been moved to the north side of the tower as they would be pulling wire to the south. Crews placed wooden mats in Arroyo Park to prevent damage to the grass and prevent mud from adhering to vehicle tires (Photo 10). The area of the park north of the tower remained wet and muddy (Photo 11). According to the onsite inspector, the crews had to use shovels and hammers to remove the mud from the truck tires.

Photo 10 – Pulling equipment setting up in Arroyo Park north of tower location 8 with wooden mats placed to prevent damage to the grass and prevent mud from adhering to vehicle tires. Photo facing northwest.

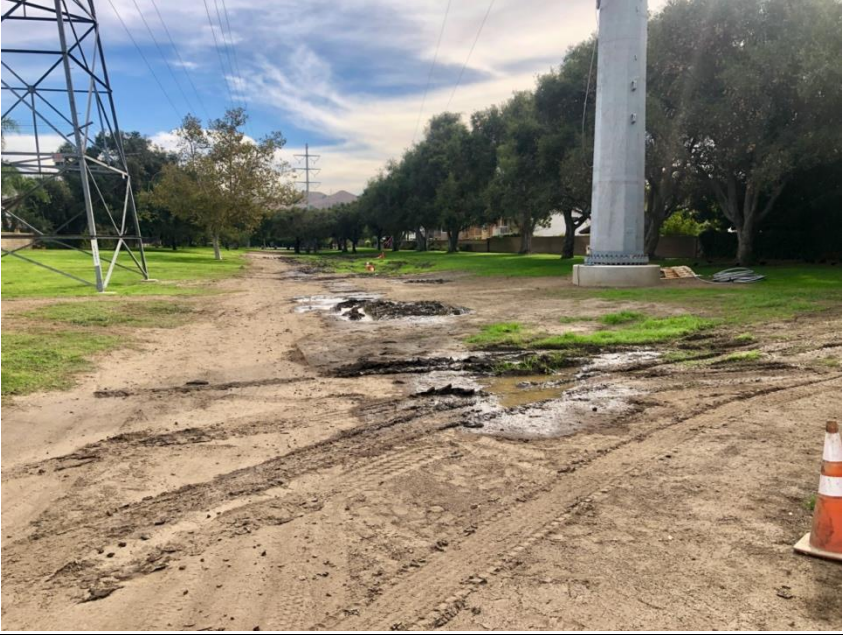
Photo 11 – Wet and muddy conditions around tower location 8 in Arroyo Park. Photo facing south.
11/05/20	San Juan Capistrano Substation

Monitor mud track-out from the park at tower location 8.

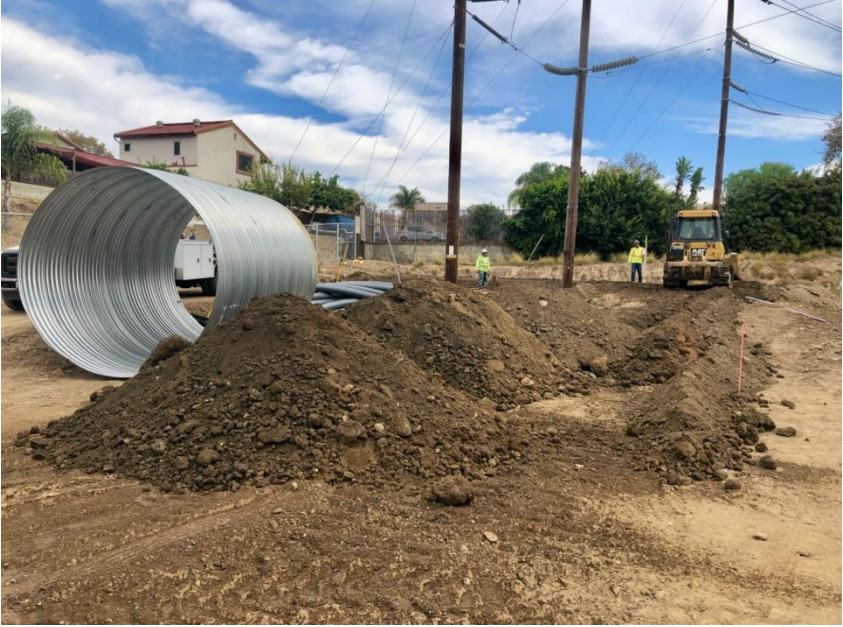
At the substation, I met with the EI and we walked the site. Some soil work was being performed near the existing substation in preparation for new TSP foundation work (Photo 12).

Photo 12 – Soil work being done in the northeast portion of the substation. Photo facing east.

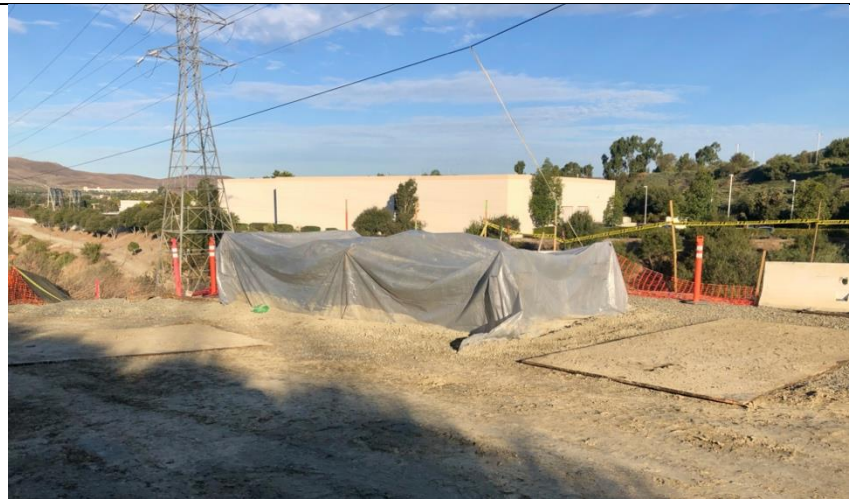
The EI and I drove to tower location 39 where the foundation for the tubular steel pole (TSP) was to be poured. The access road had dried out, so there were no track-out issues. The additional work area along the access road had been fenced off (Photo 1). The foundation hole had been drilled and the rebar cage installed; the hole was well covered with plastic (Photo 2). A concrete washout bin was in place for the pouring activity (Photo 3).

Photo 2 – The foundation hole at tower location 39 had been drilled and covered with plastic. Photo facing northwest.
11/12/20	SOCRE transmission corridor

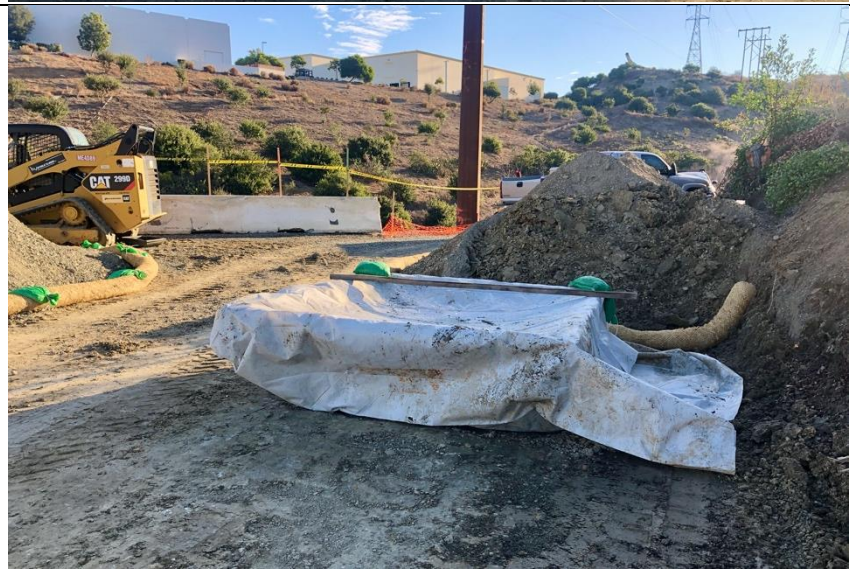
Photo 3 – A concrete washout bin at tower location 39 was set up. Photo facing east.
11/12/20	SOCRE transmission corridor

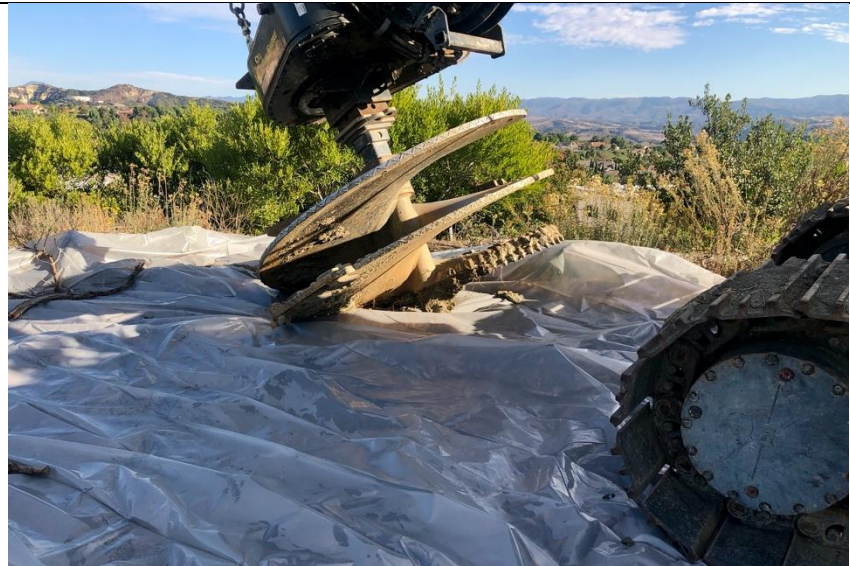
Photo 4 – The drilling rig was parked at tower location 40. Photo facing northeast.

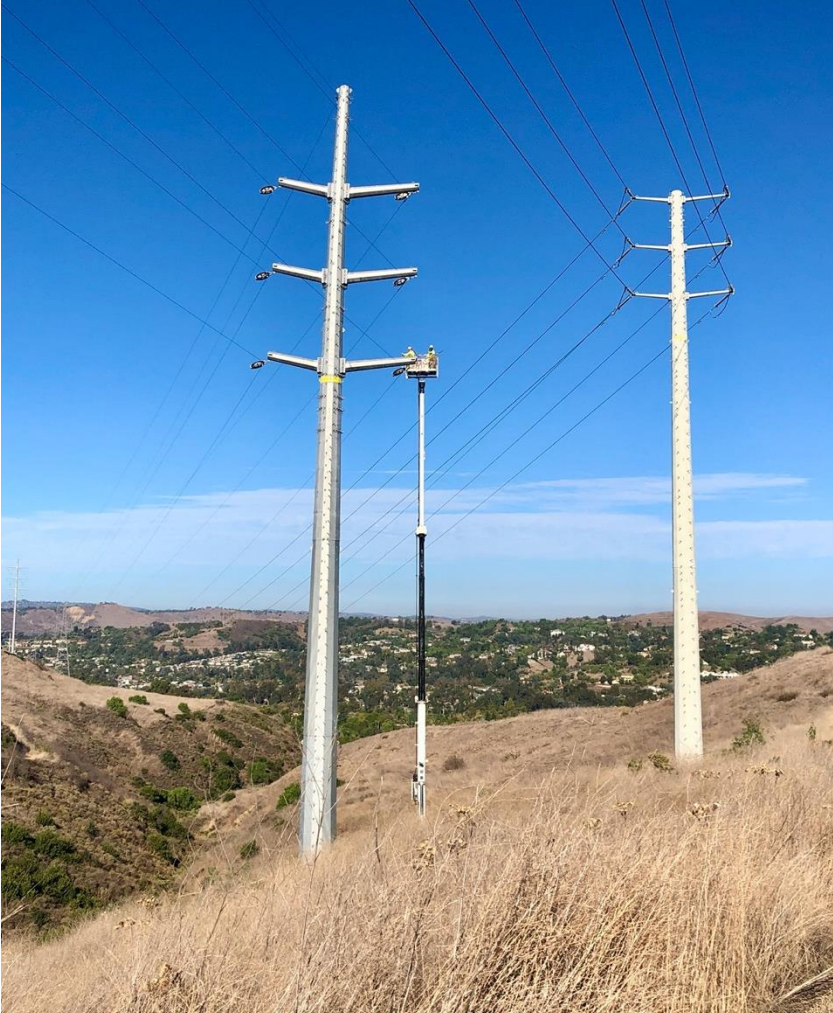
Photo 5 – Wire pulling crew at tower location 14. Photo facing north.
11/12/20	SOCRE transmission corridor

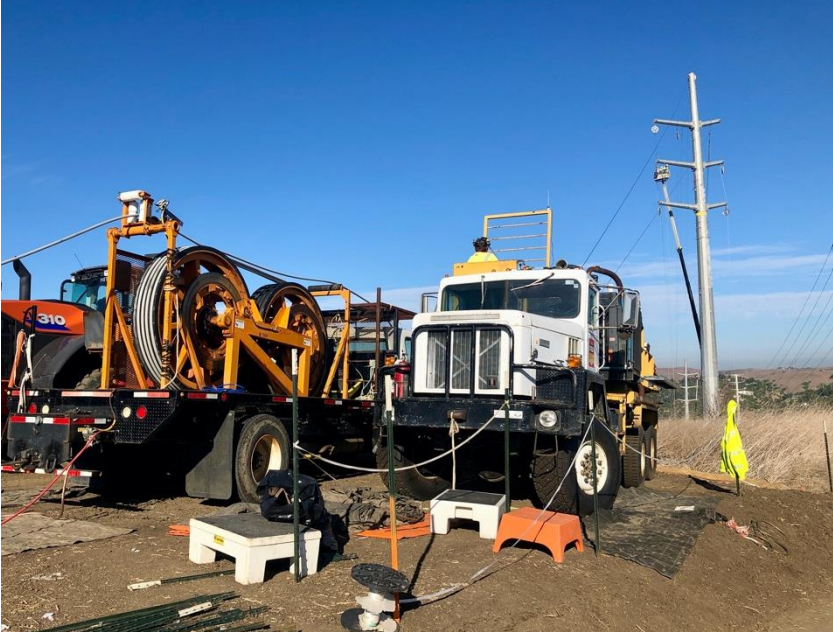
Photo 6 – Wire pulling equipment set up north of tower location 15. Photo facing north.

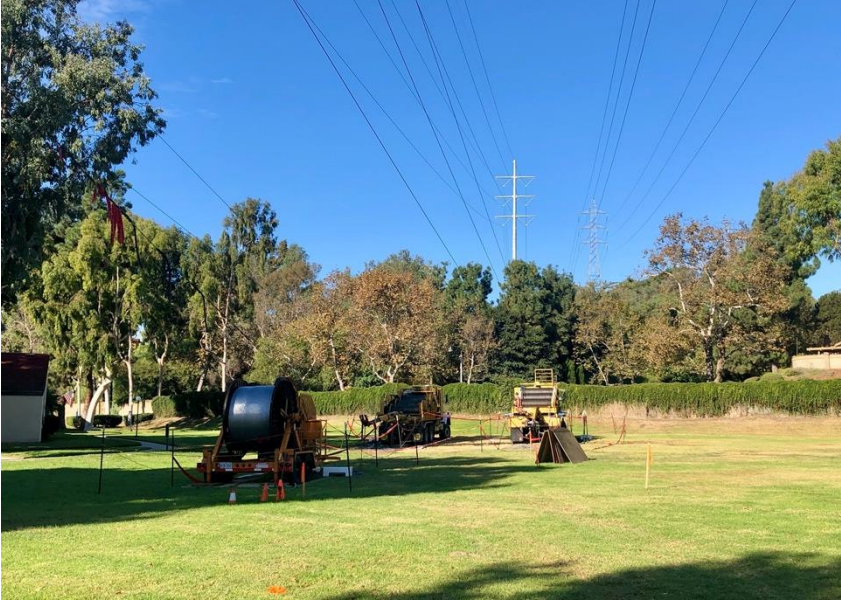
At tower location 8, the wire pulling crew was set up in Arroyo Park, north of the tower (Photo 7). A manlift was set up at tower location 8 (Photo 8), but a hydraulic line was damaged before we arrived (Photo 9). The leaked hydraulic fluid appeared to be well contained and crews were cleaning it up with oil absorbent pads. The wire pulling operation was slowed due to this incident.

Photo 7 – Wire pulling equipment set up in Arroyo Park, north of tower location 8. Photo facing northwest.
11/12/20	SOCRE transmission corridor – Arroyo Park

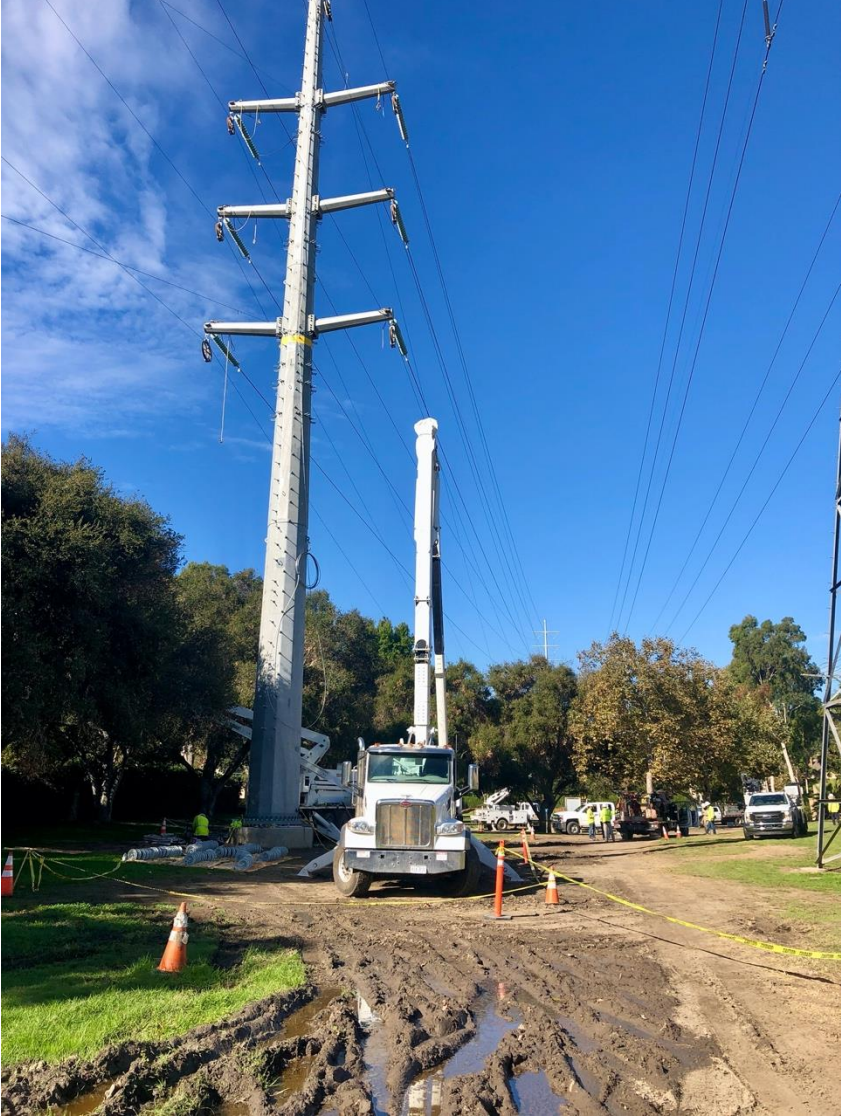
Photo 8 – A manlift set up near tower location 8 in muddy conditions. Photo facing north.

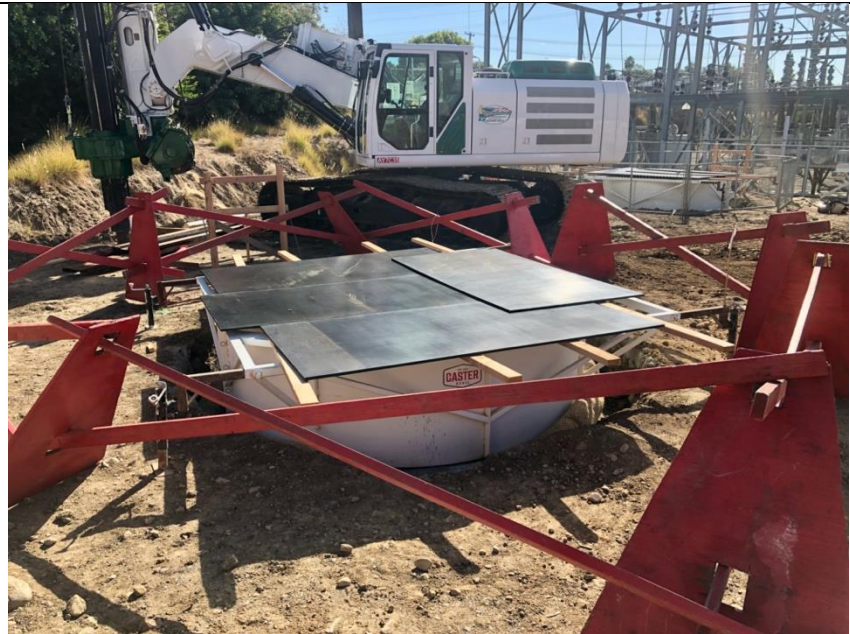
Some tower foundation drilling had been done for the two TSPs to be installed near the 12-kV substation facility at the substation (Photo 11). The rebar cages were delivered and would be installed once work on the foundations was complete. The EI and I discussed how best to cover these holes to comply with project requirements.

Photo 11 – Tower foundation holes for the TSPs had been drilled near the 12-kV substation facility. Photo facing southeast.
11/12/20	San Juan Capistrano Substation

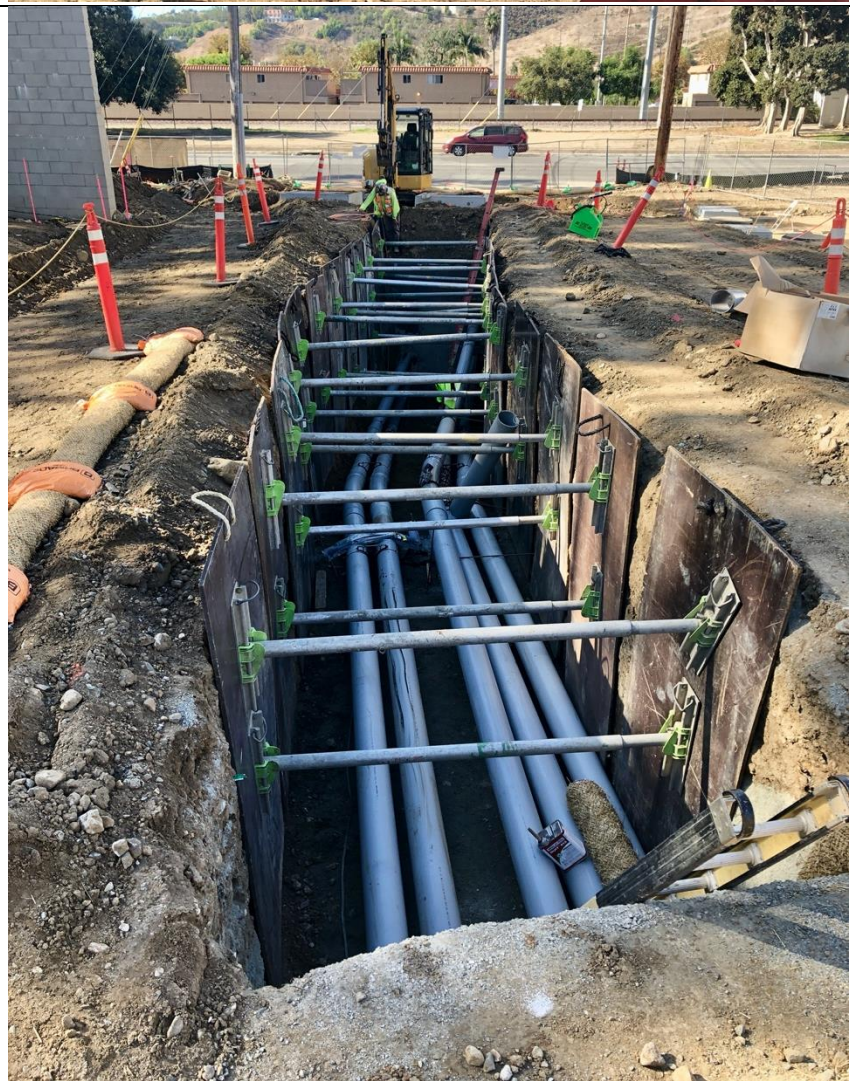
Photo 12 – Conduit installation into the new vault. Photo facing west.

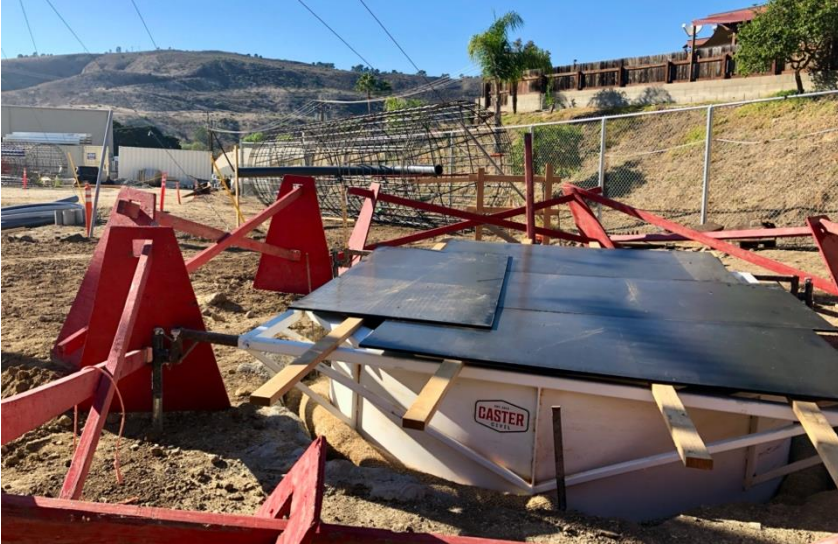
The two tower foundation holes near the 12-kV substation facility at the substation remained open and were cordoned off and covered (Photos 1 and 2). I asked why they were not covered with plastic and the EI said that SDG&E advised against installing plastic so close to an energized substation. Straw wattles had been placed around the forms sealing off all openings.

Photo 2 – A second drilled tower foundation hole near the 12-kV substation facility. The foundation rebar cage is visible in the background. Photo facing west.
11/18/20	San Juan Capistrano Substation

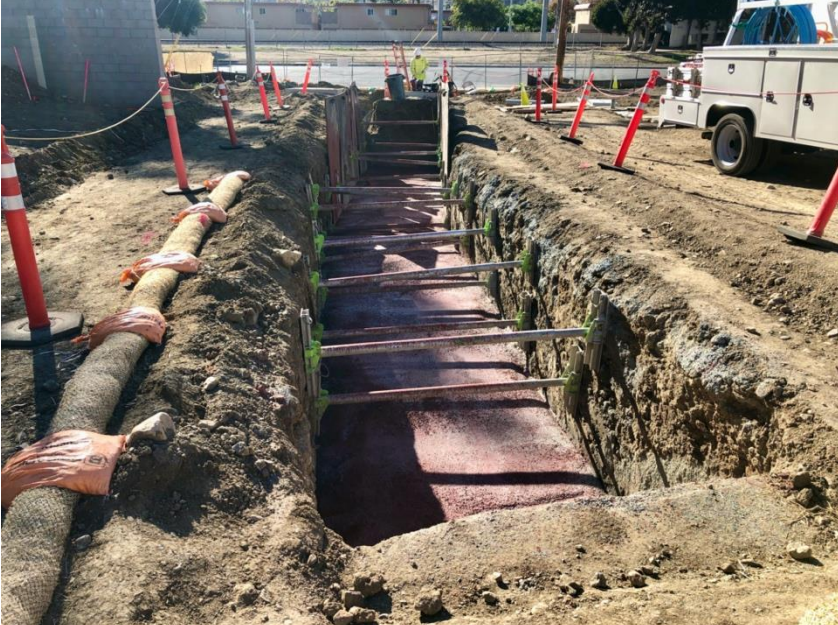
Photo 3 – The conduit trench near the southern entrance to the substation had been partially filled with colored slurry. Photo facing west.

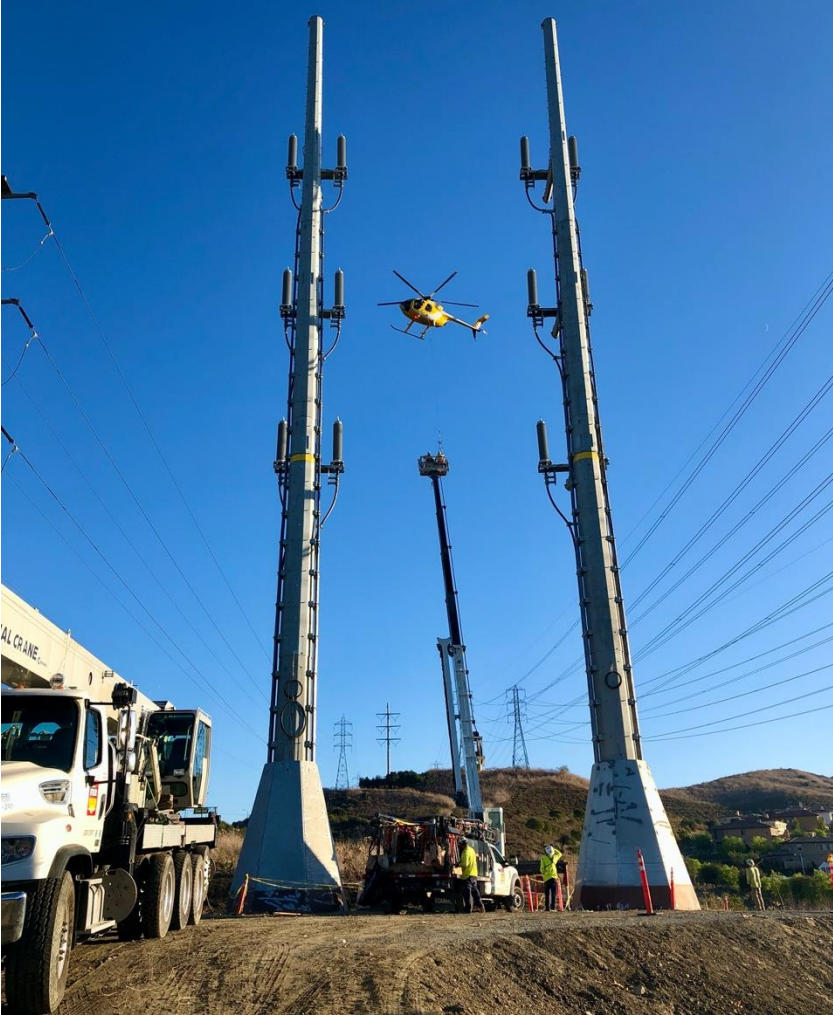
Photo 9 – The helicopter working with the pulling crew at tower locations 18 and 19. Photo facing south.
11/18/20	SOCRE transmission corridor

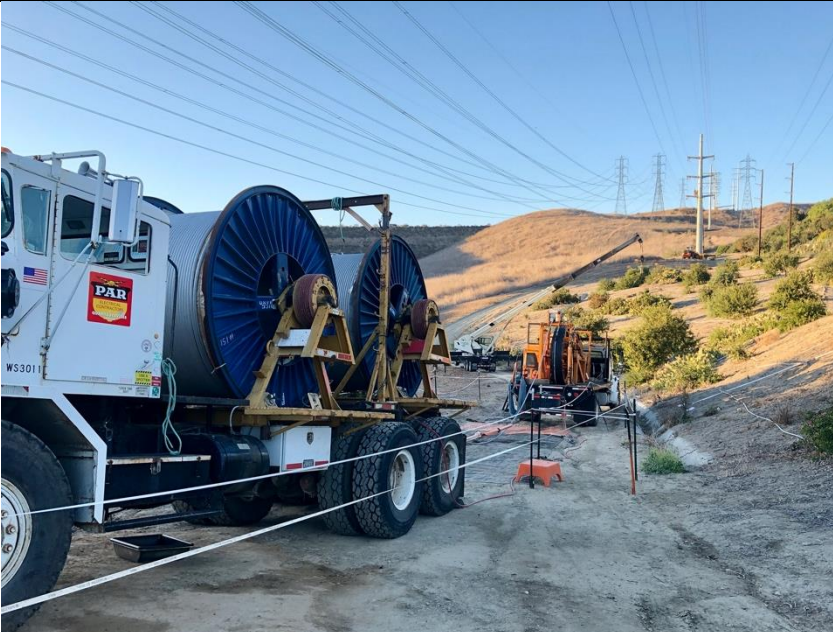
Photo 10 – Wire pulling equipment set up south of tower location 30. Photo facing north.

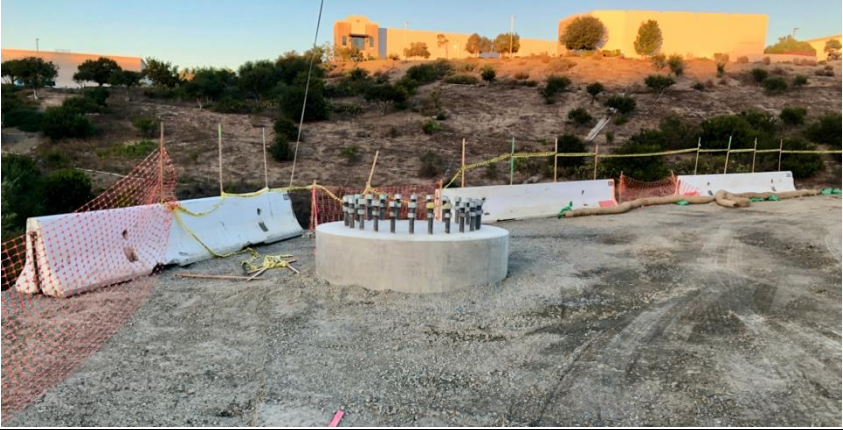
I stopped at tower location 39 to inspect the newly poured tower foundation (Photo 11). The work area was well contained with no trash present. The drill rig remained at tower location 40 with secondary containment under the leaky drilling attachment.

Photo 11 – Tower foundation at tower location 39. Photo facing northeast.
