January 28, 2021

Re: Monthly Report Summary #38 for the South Orange County Reliability Enhancement (SOCRE) Project

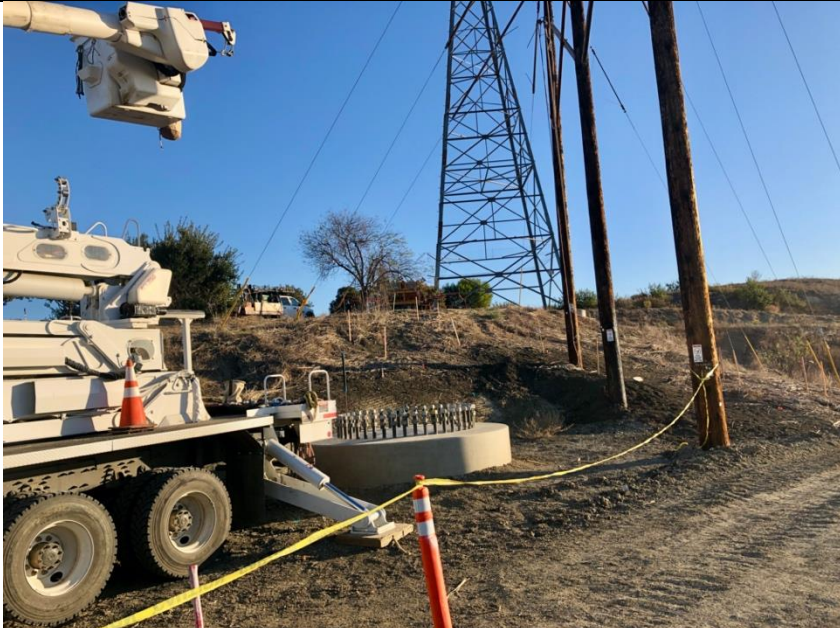
We walked to tower location 42 where a large TSP foundation was in place (Photo 2). The wire crew was set up at this location to remove wire and the existing wooden poles between tower locations 36 and 42 (Photo 3).

Photo 2 – Tower location 42 where the TSP foundation was poured. Photo facing east.
12/02/20	SOCRE transmission corridor

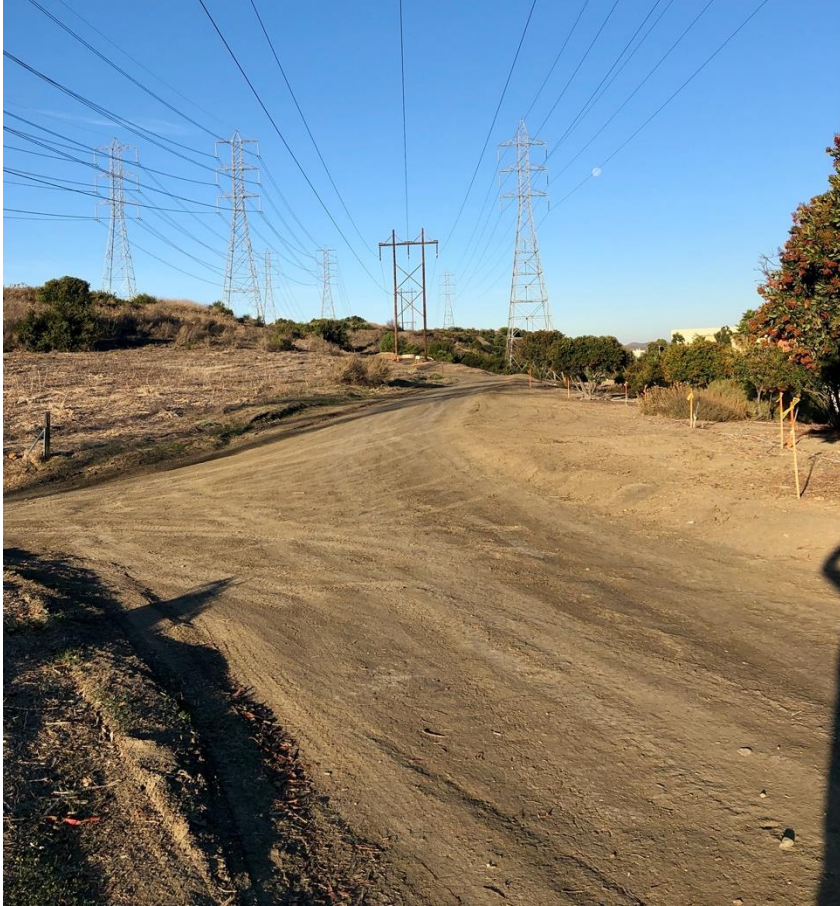
Photo 3 – Wire and poles to be removed at tower locations 36 and 42. Photo facing west.

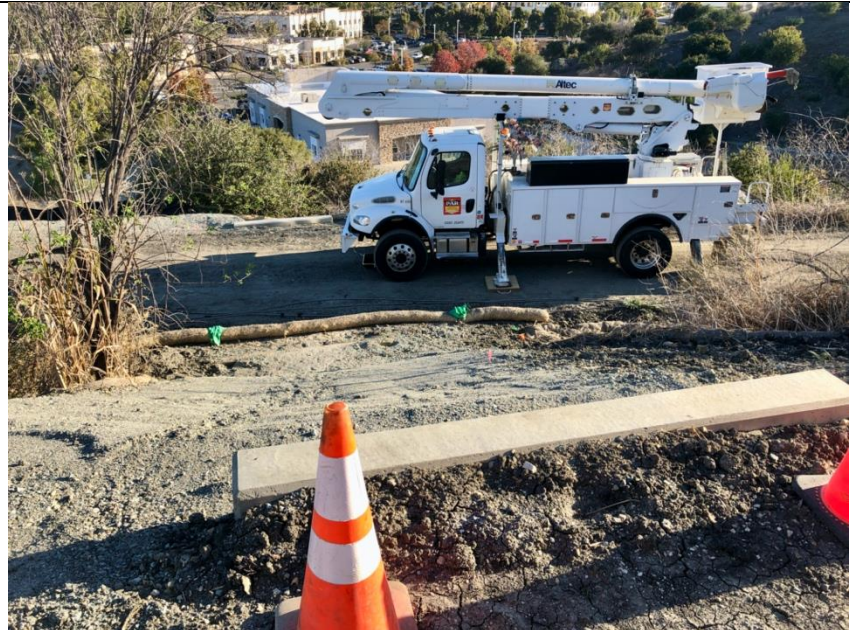
Photo 6 – V ditch drainage work at tower location 36. Photo facing northeast.
12/02/20	SOCRE transmission corridor

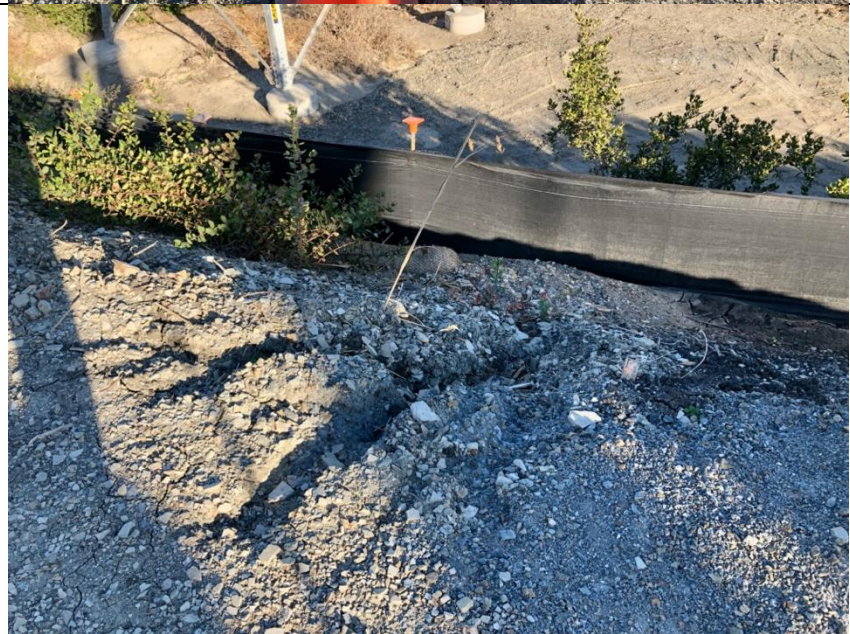
We traveled to tower location 36 where a tailboard meeting was underway for the wire crew (Photo 4). I spoke to the foreman about him and his crew not wearing masks. The wire pulling trucks were set and ready to remove the existing wire (Photo 5). Some V ditch work remained to be completed (Photo 6), and additional BMPs were needed around the tower pad (Photo 7).

Photo 7 – Erosion evident along the edge of the pad at tower location 36 required additional BMPs. Photo facing north.

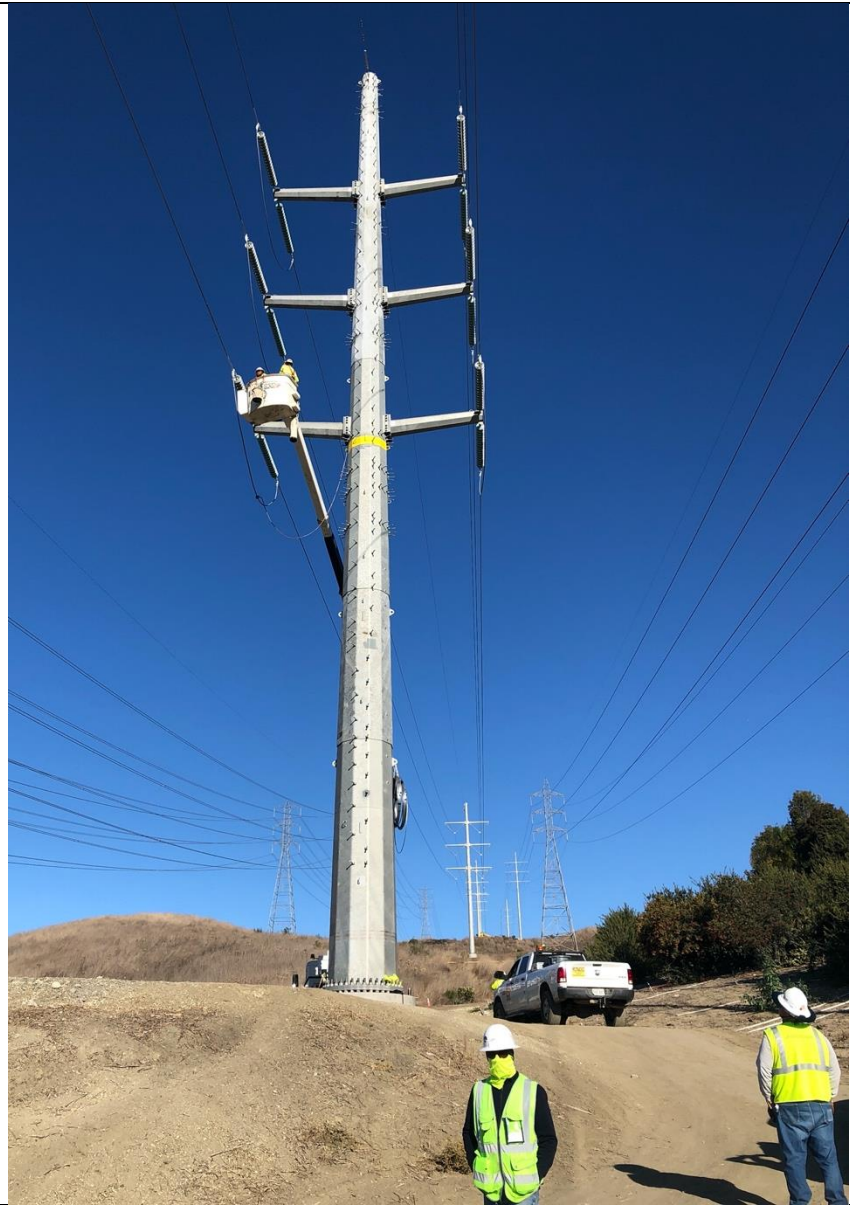
At tower location 30, a crew was working in the new tower (Photo 8). This crew was also not wearing masks. I called and talked with SDG&E's Project Manager about SDG&E's mask wearing policy.

Photo 8 – Crews working in the new tower at tower location 30. Photo facing north.

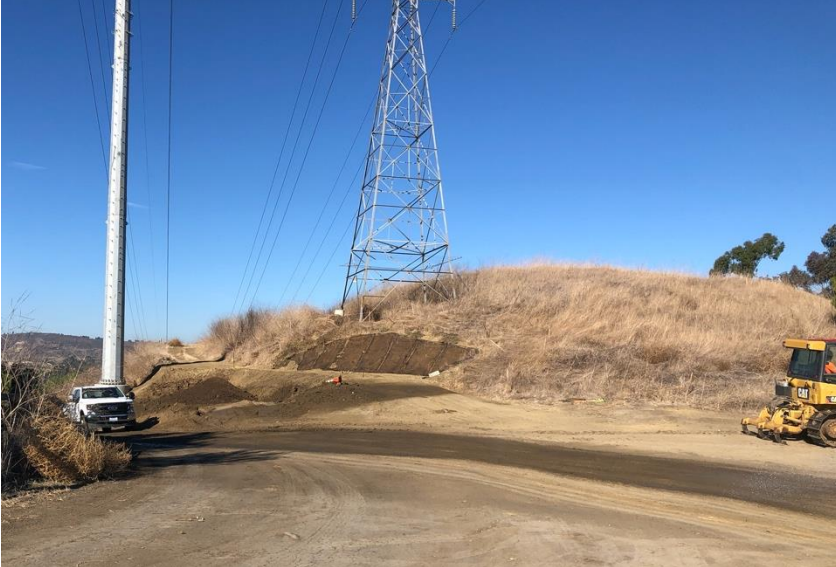
Photo 11 – Minor grading work underway at tower location 12. Photo facing northwest.
12/02/20	SOCRE transmission corridor – Serra Park

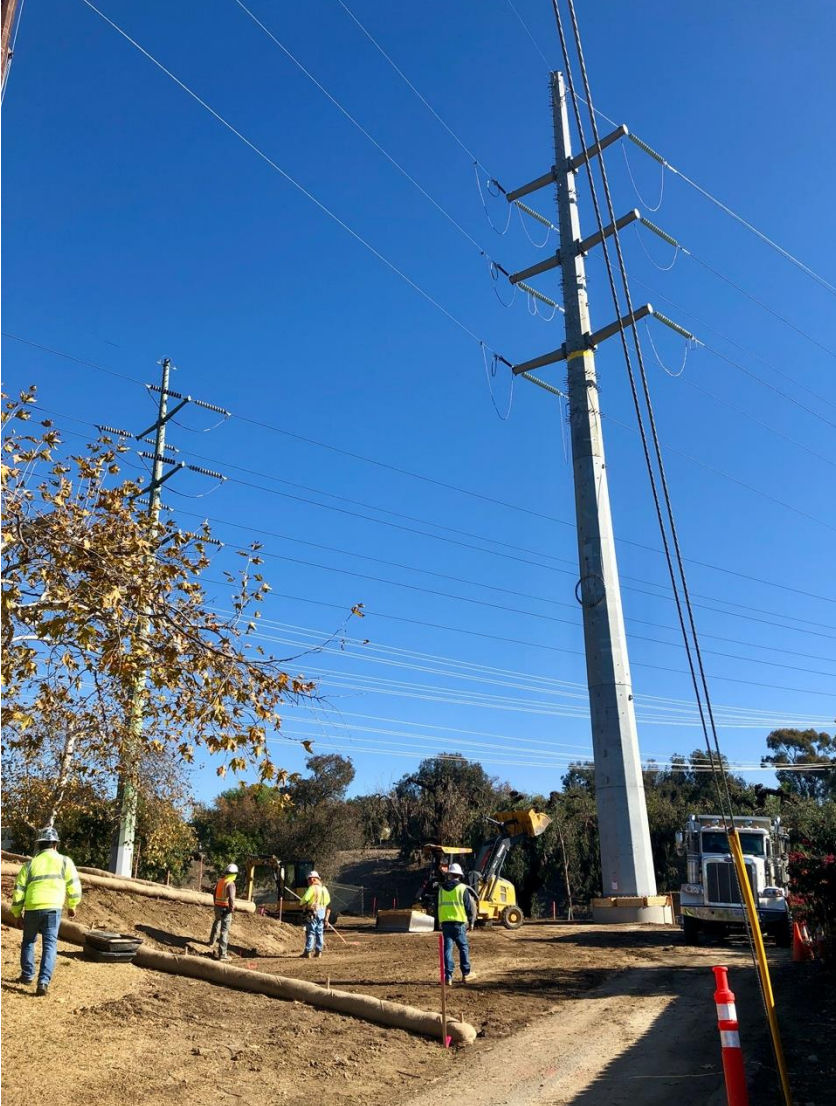
Grading was being performed at tower location 4 at the east end of Serra Park (Photo 12). A paleontology monitor was onsite and reported that nothing of significance had been found. The grading was almost completed and BMPs were installed.

Photo 12 – Grading work being performed at tower location 4. Photo facing east.

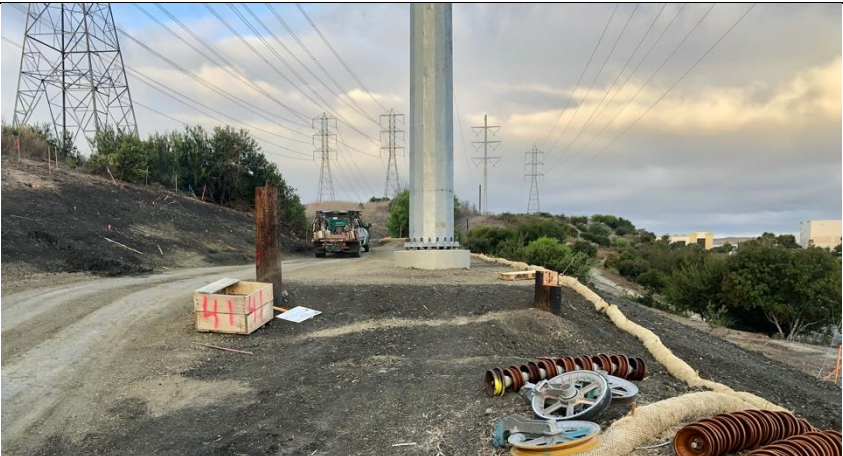
Photo 1 – The new TSP was installed at tower location 41. The existing wooden poles had been partially removed. Photo facing west.

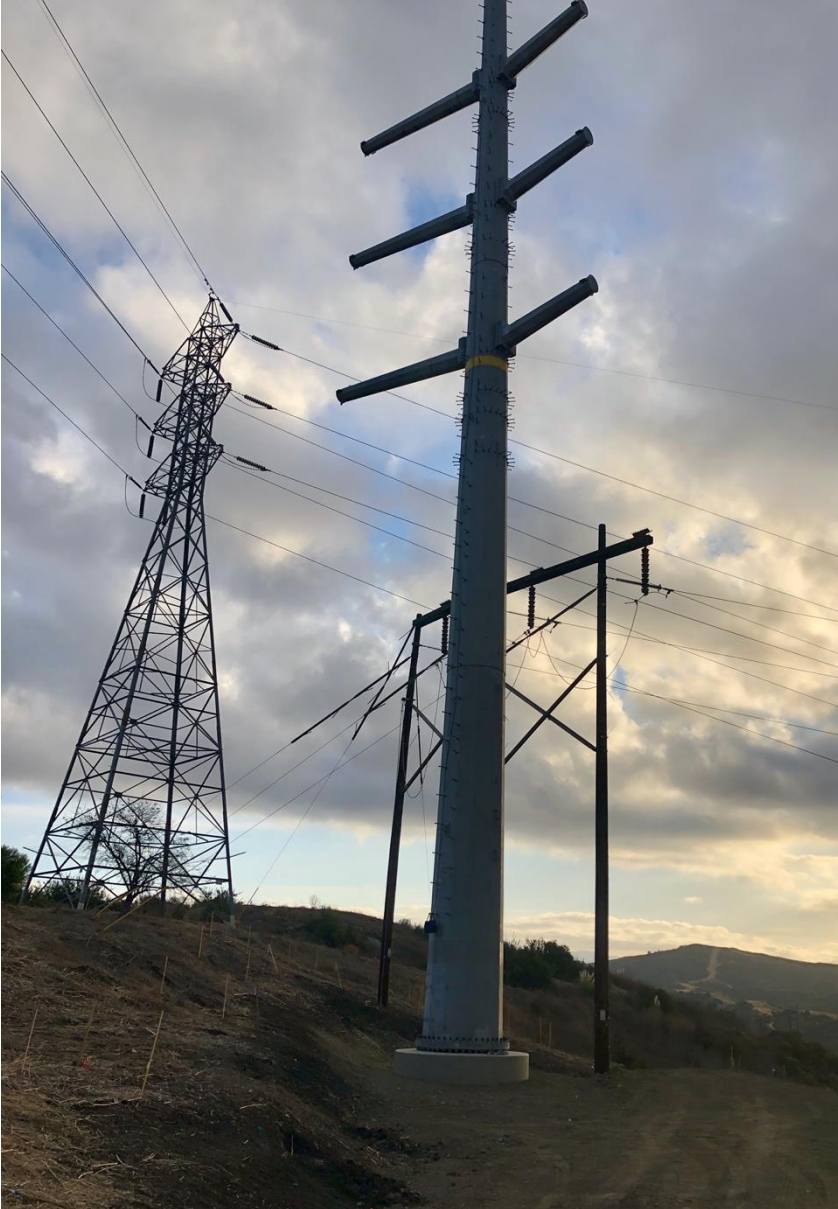
The TSP at tower location 42 had been installed (Photo 2). A crew arrived to clear the area around the pulling location south of tower location 42. An EI had cleared the area prior to the crew beginning work, and a paleontology monitor was onsite to observe the mowing and grading work. The onsite EI said monitoring was being conducted regularly and no wildlife had been observed. The crew sprayed down the area for fire prevention and dust control prior to any mowing or grading (Photo 3).

Photo 2 – The TSP was installed at tower location 42. Photo facing east.

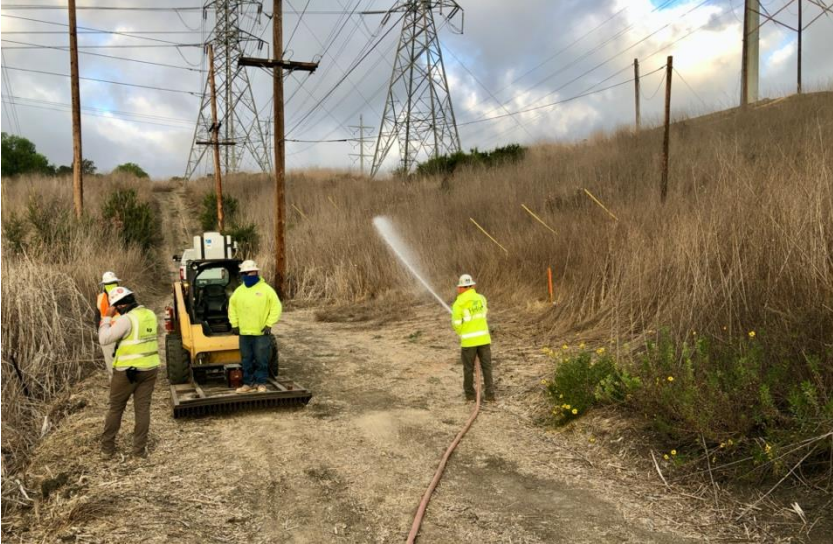
Photo 3 – Crews watering down the pulling site below tower location 42 prior to mowing and grading. Photo facing west.
12/10/20	SOCRE transmission corridor

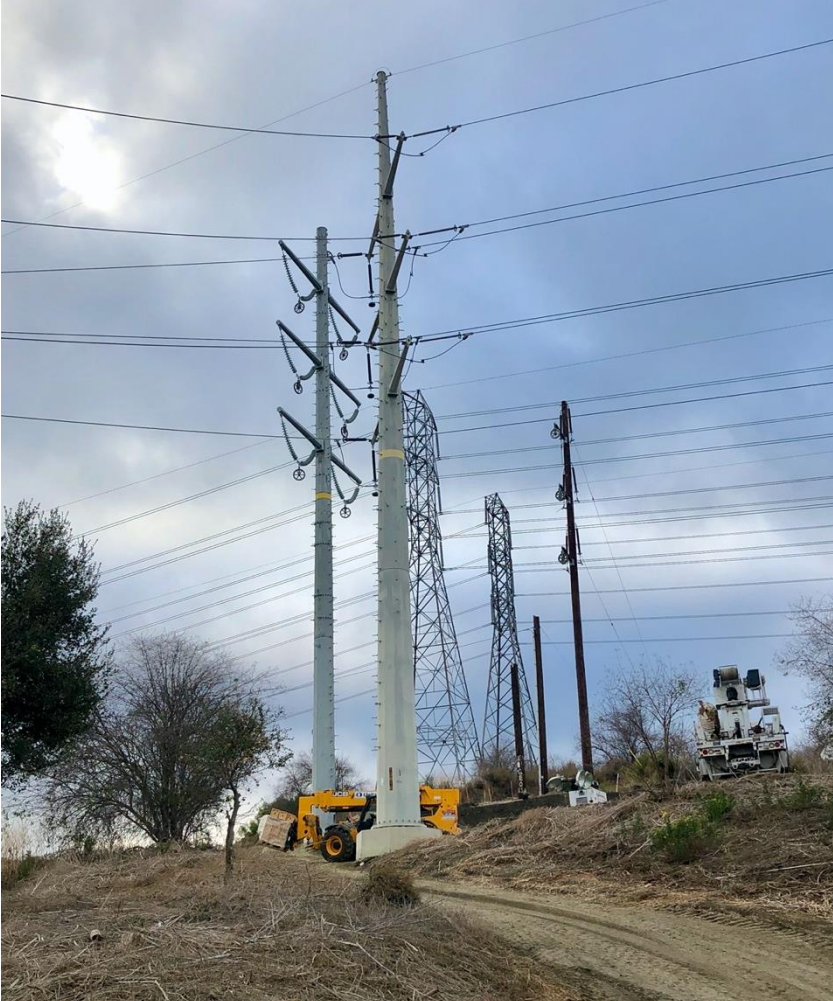
Photo 4 – The new TSP at tower location 38. Photo facing south.

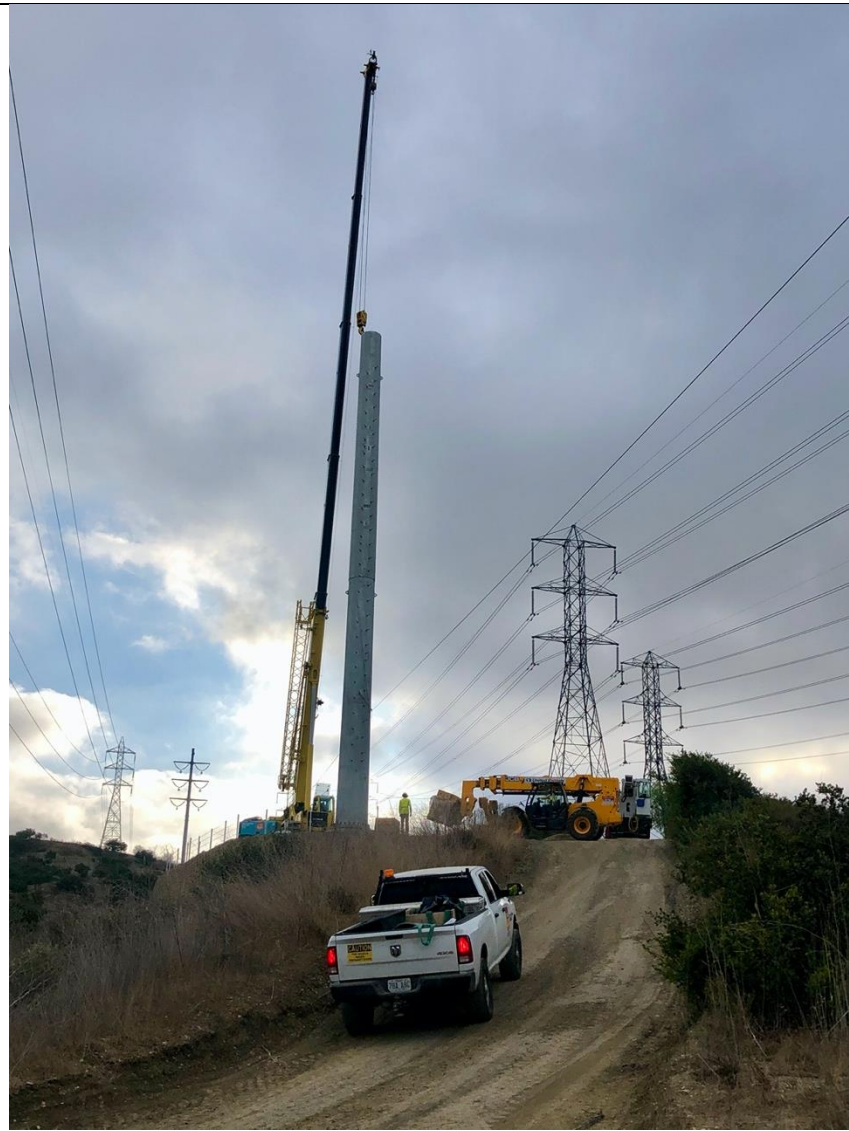
At tower location 39, a crane was onsite to install the last segment of the TSP (Photo 5). Crews were preparing equipment to be attached to the segment before it was installed (Photo 6). Some of the tower pad drainage ditches had not yet been installed (Photo 7). As we left the area, we observed the last segment of the TSP being offloaded from a truck (Photo 8).

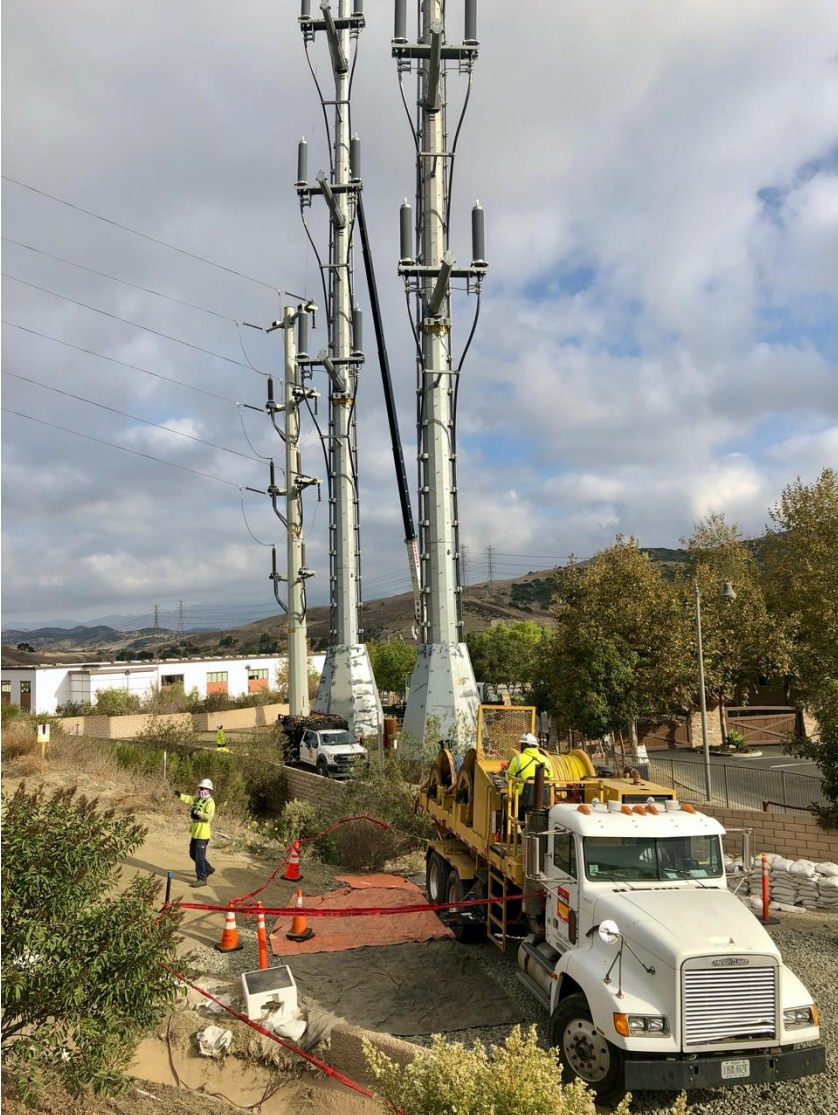
Photo 9 – Pulling crews and equipment setting up at tower locations 16 and 17. Photo facing northeast.

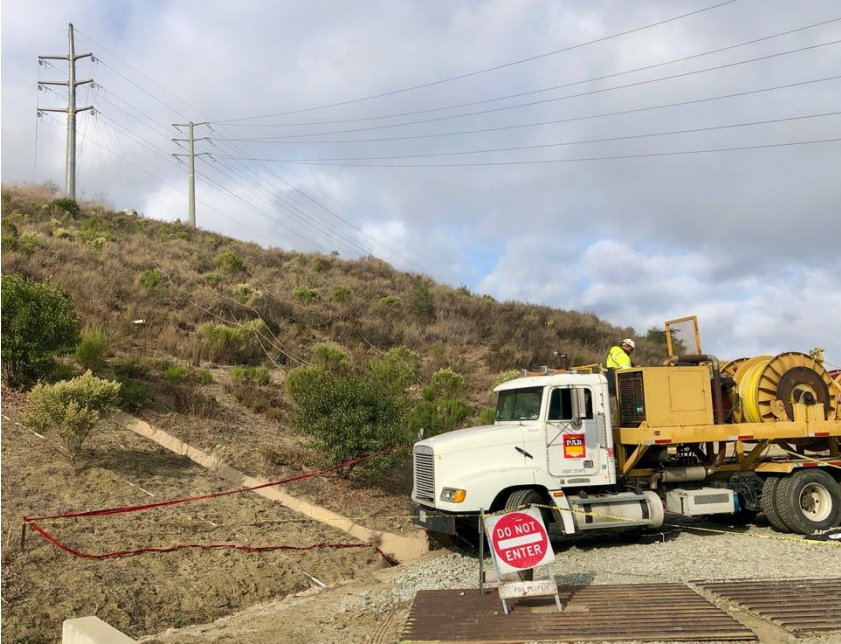
Photo 10 – A pulling truck parked in the access road with ropes running up the slope to tower location 15. Photo facing northwest.
12/10/20	SOCRE transmission corridor

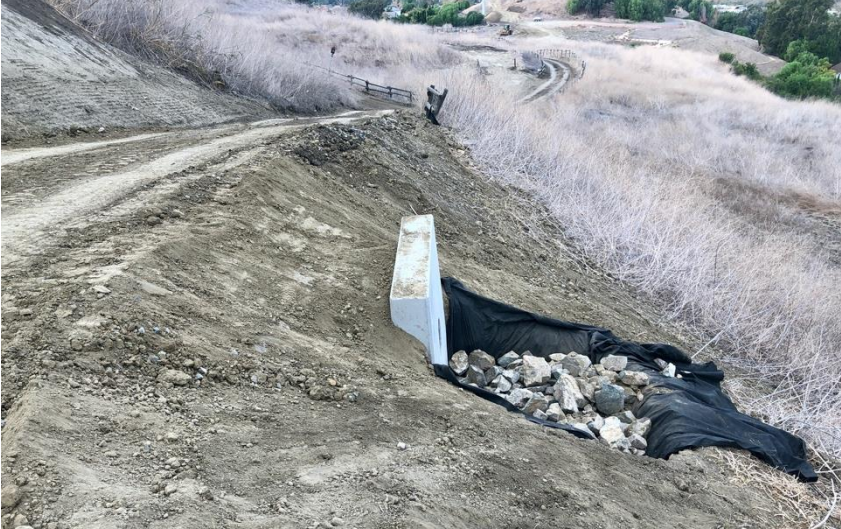
Photo 11 – Tower pad drainage work at tower location 13. Photo facing northwest.

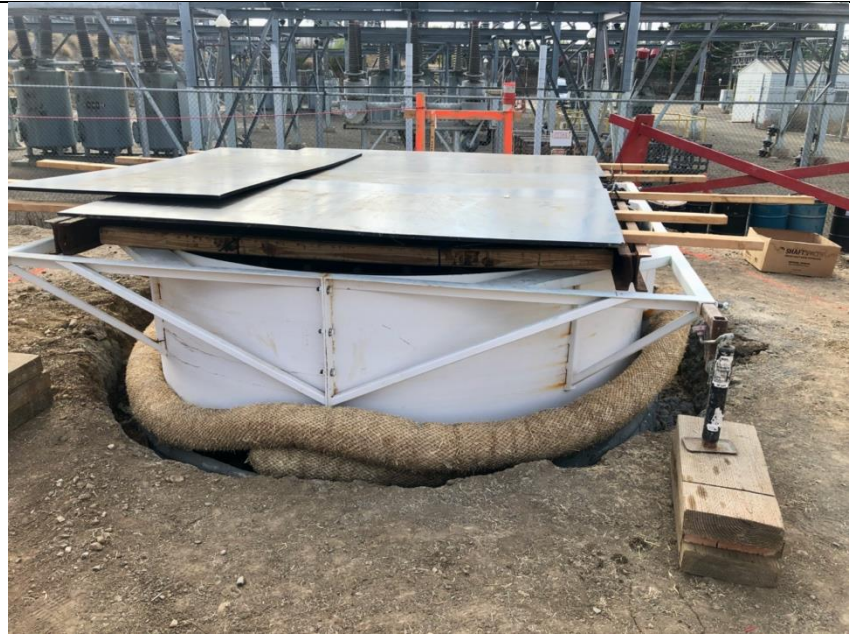
I drove to the San Juan Capistrano Substation and met with the EI assigned there. Rebar cages were set up in the two TSP foundation holes near the 12-kilovolt (kV) substation facility (Photo 12). Trenching work was underway for conduit to run through the foundation and into the TSP (Photo 13). The foundations were expected to be poured in the following days. The holes would be covered overnight until then. The EI and I discussed ways to cover the holes to prevent animals from falling in.

<p>Photo 12 – Foundation work and rebar installation continued on the TSPs located near the 12-kV substation facility. Photo facing south.</p>
12/10/20	San Juan Capistrano Substation	 	<p>Photo 13 – Trenching work on the TSP foundation near the 12-kV substation facility. Photo facing south.</p>

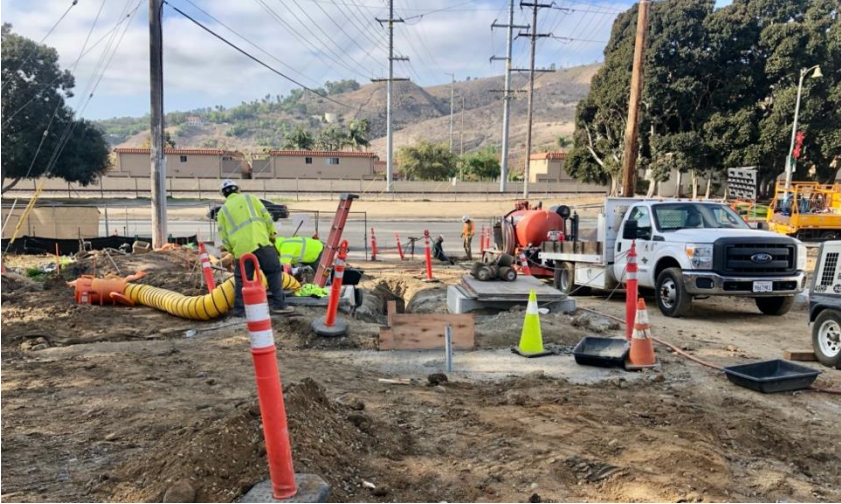
Photo 14 – Vault work and conduit installation continued near the southern entrance to the substation. Photo facing west.
12/10/20	San Juan Capistrano Substation

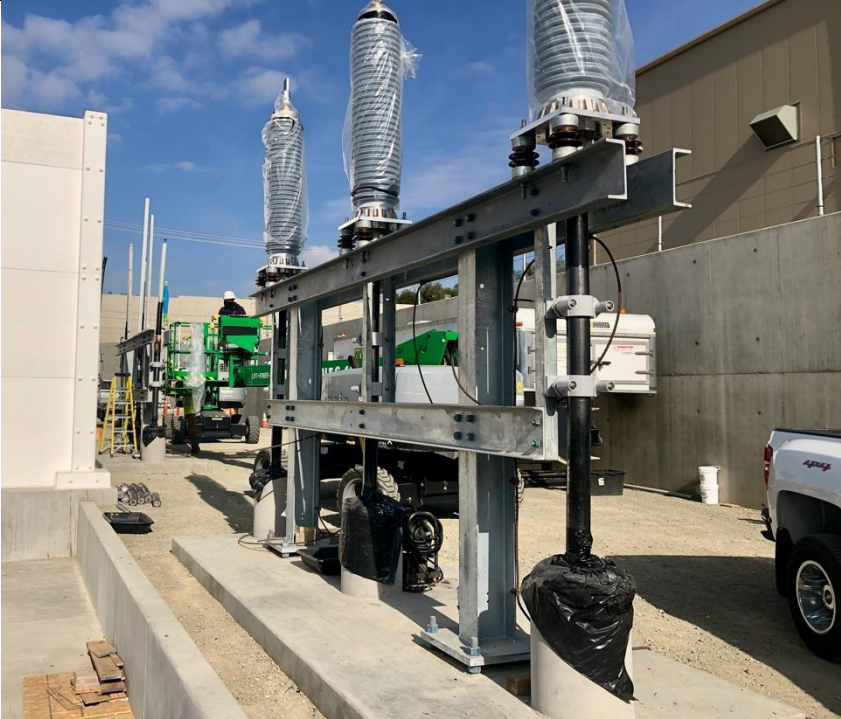
Photo 15 – Installation of equipment around the transformers continued. Photo facing north.

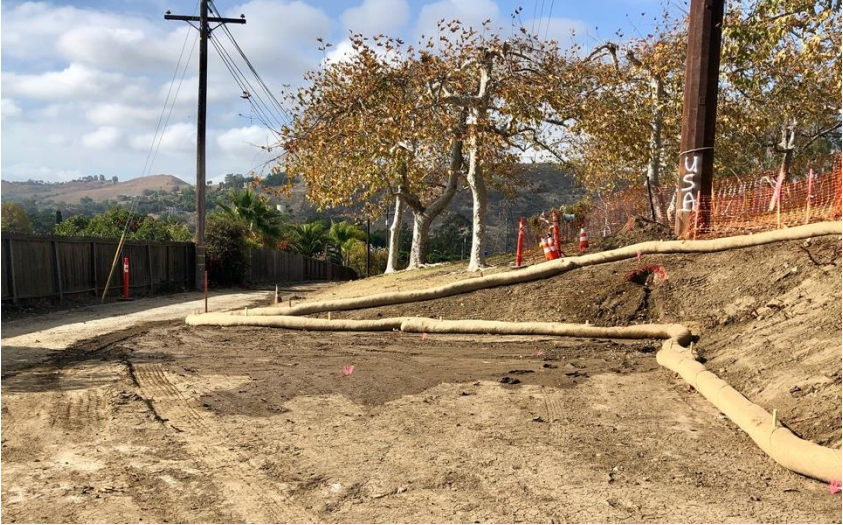
The grading had been completed in Serra Park; however, one or two irrigation lines were damaged with water running down the access way to the public roadway (Photo 16). Mud and sediment were being collected from the graded area and washed onto the access road. I suggested the sediment be cleaned before another leak or rain event occurred that would wash it onto the public roadway. Later in the day, the Lead Environmental Inspector (LEI) sent me a photo of the cleanup effort.

Photo 16 - Grading work around tower location 4 where irrigation lines were damaged and caused water to run into the roadway. Photo facing west.

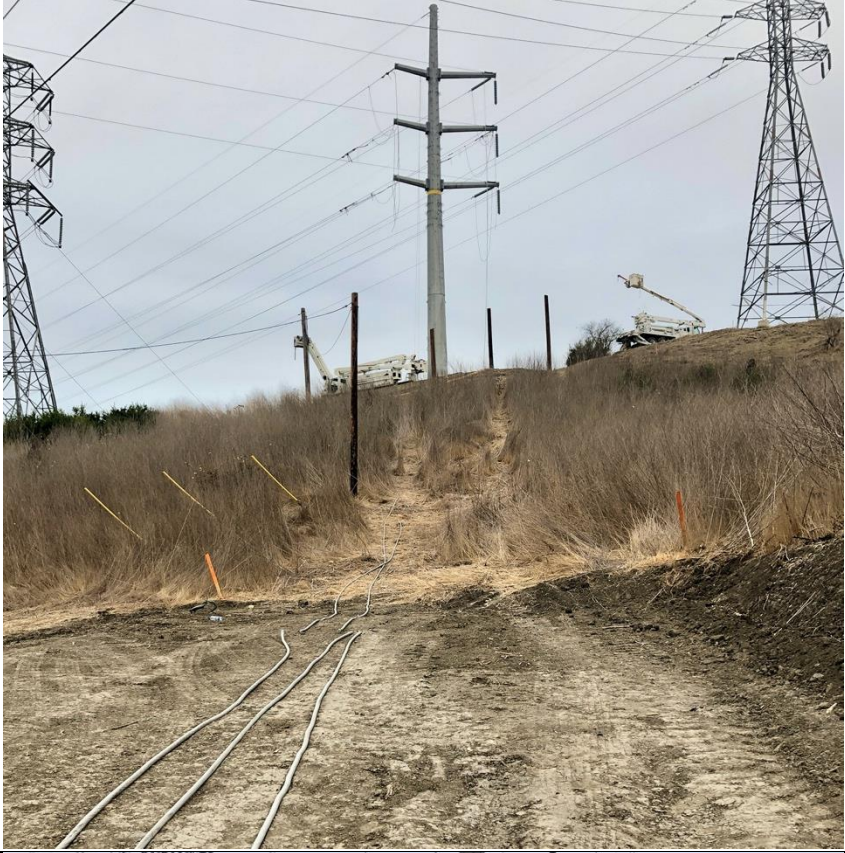
Photo 2 – Wire remained on the ground between tower location 42 and the nearby pulling station. Photo facing northwest.
12/17/20	SOCRE transmission corridor

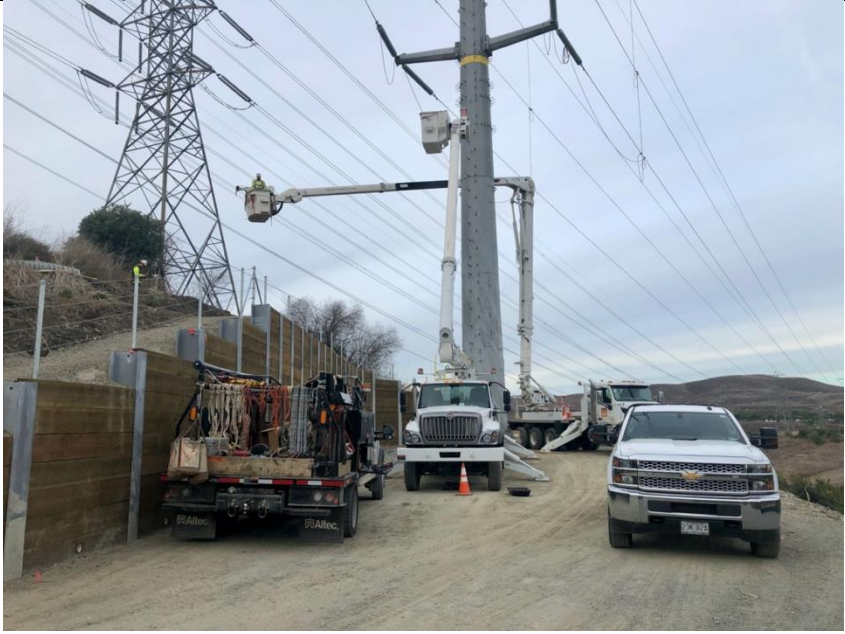
We stopped at tower location 36 where another crew was building jumpers (Photo 3). Some of the existing wooden poles remained in the ground and some of the cut pieces remained onsite (Photo 4). There was minor erosion at this site from water running off the tower pad; the sediment was captured by the silt fence below the pad. I discussed the addition of some BMPs with the EI and he said a crew was doing BMP upgrades and hydroseeding throughout the transmission corridor. They would be replacing all of the plastic covered straw wattles with burlap covered ones, so they could be left to degrade in place. Instead of hauling off and throwing away the existing wattles I suggested that they cut and remove the plastic and spread the straw out onsite.

Photo 3 – Crews installing jumpers at tower location 36. Photo facing west.

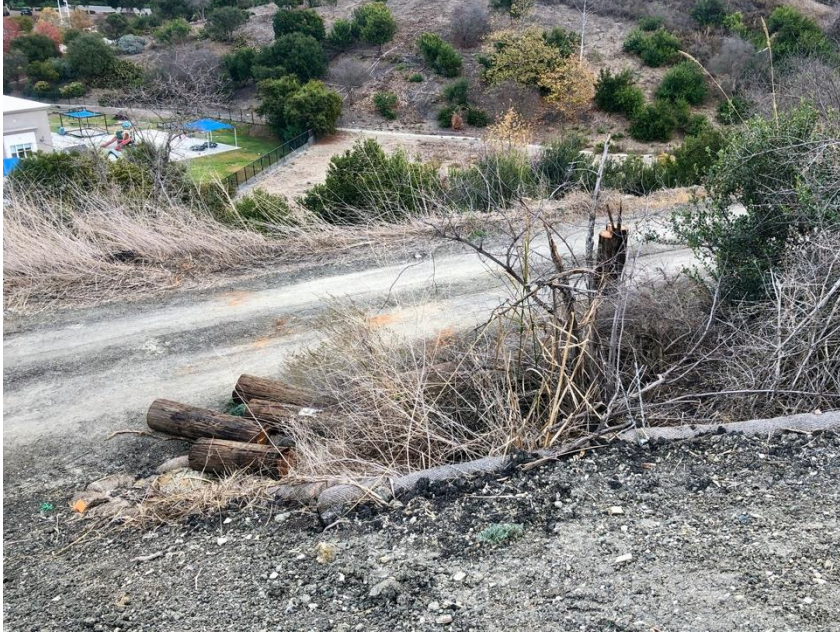
<p>Photo 4 – Segments of the existing wooden poles remained near the new TSP at tower location 36. Photo facing east.</p>
12/17/20	SOCRE transmission corridor

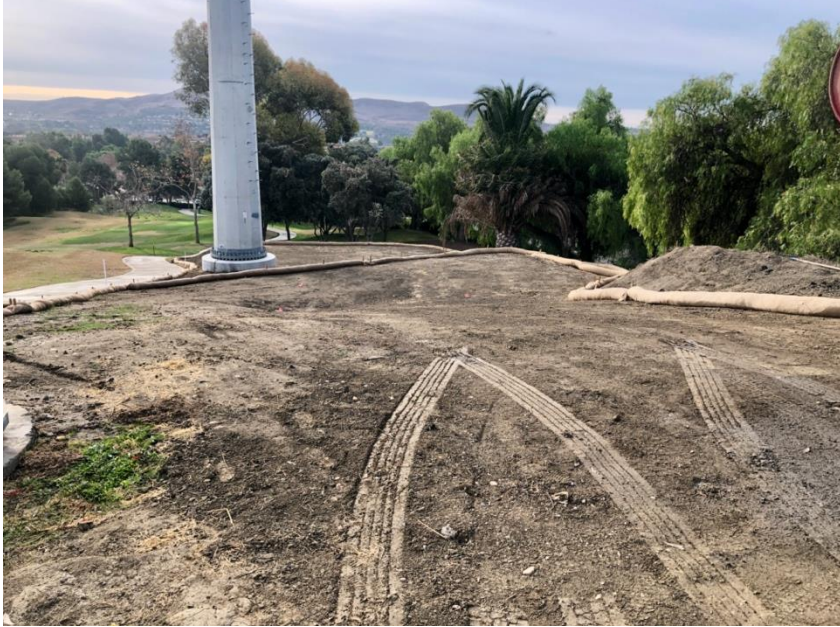
<p>Photo 5 – At tower location 5, BMPs in place and the area was prepared for hydroseeding. Photo facing south.</p>

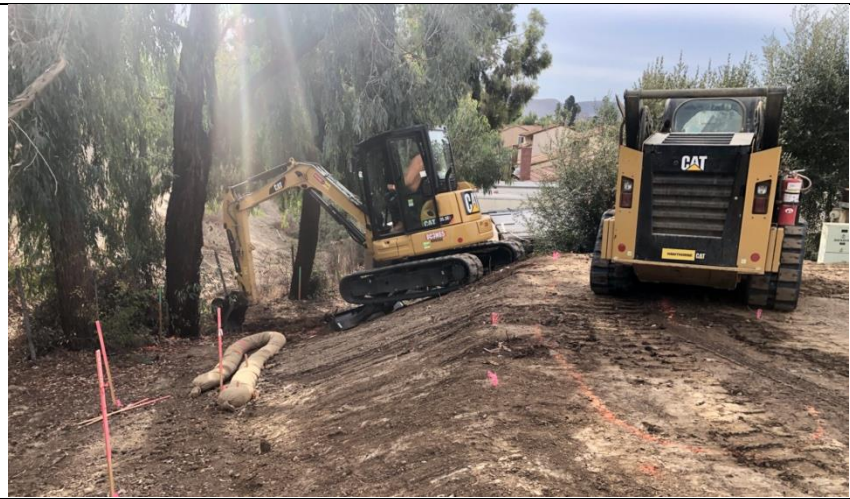
Photo 8 – A crew was digging out the energy dissipater near tower location 4. Photo facing south.
12/17/20	San Juan Capistrano Substation

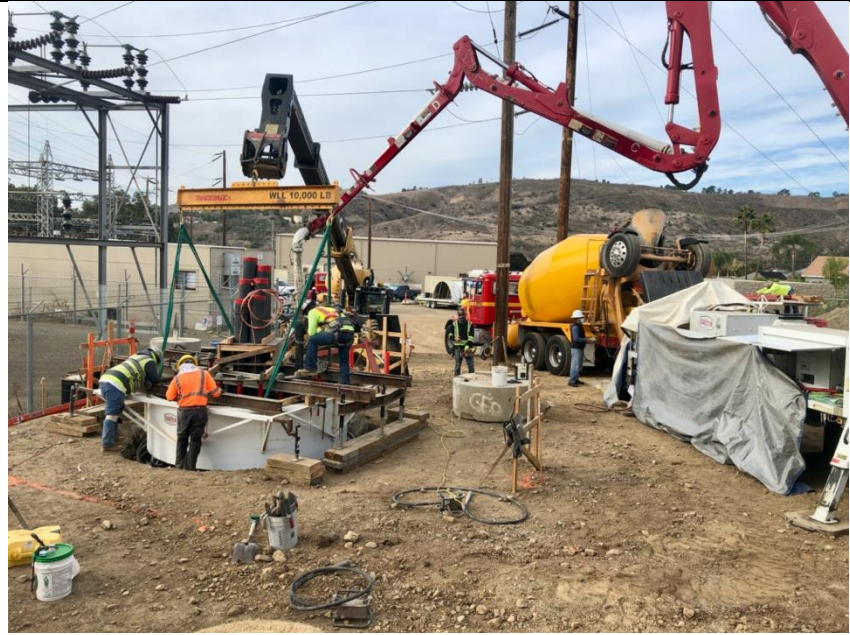
At Serra Park, I met with the EI assigned to the San Juan Capistrano Substation and we headed back to the substation. Concrete trucks were entering the substation to pour the two TSP foundations near the 12-kilovolt (kV) substation facility (Photo 9). Several bins had been placed near the work area for the concrete trucks to wash out their equipment (Photo 10). The conduit trench to the tower foundations would remain open until additional conduit was installed (Photo 11). The EI and I discussed the importance of sealing the trenches, especially over the two long holiday weekends.

Photo 9 – Concrete trucks were onsite to pour the foundations for the TSPs near the 12-kV substation facility. Photo facing west.
12/17/20	San Juan Capistrano Substation

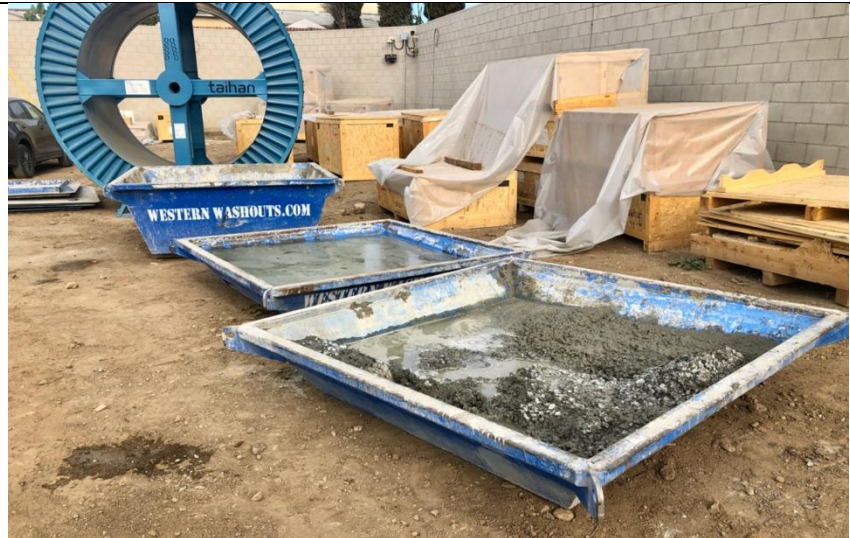
Photo 10 – The concrete washout station. Photo facing northeast.

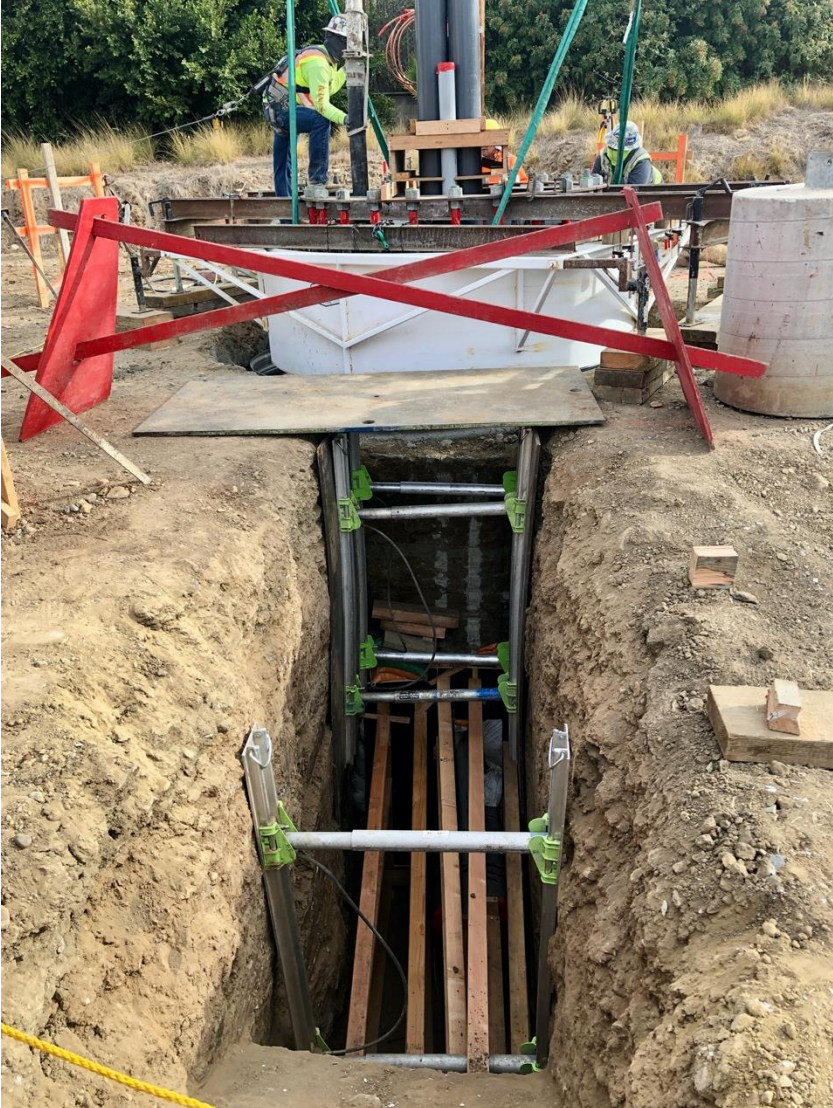
Photo 11 – Conduit trench to the tower foundation. Photo facing east.
12/17/20	San Juan Capistrano Substation	 	Photo 12 – Muddy water from the potholing was dumped into the soil stockpile area. Photo facing south.

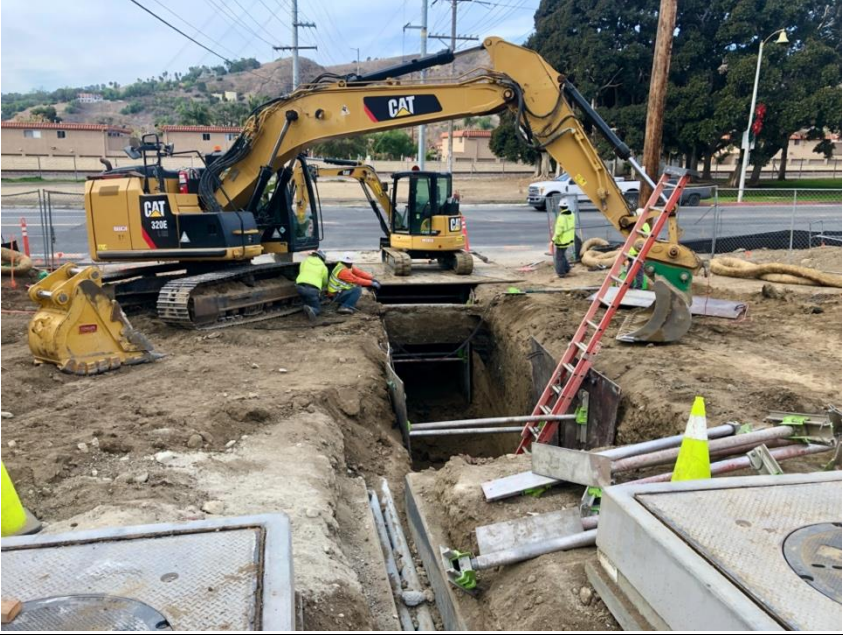
Photo 13 – Vault work and conduit installation continued near the southern entrance to the substation. Photo facing west.
12/17/20	San Juan Capistrano Substation

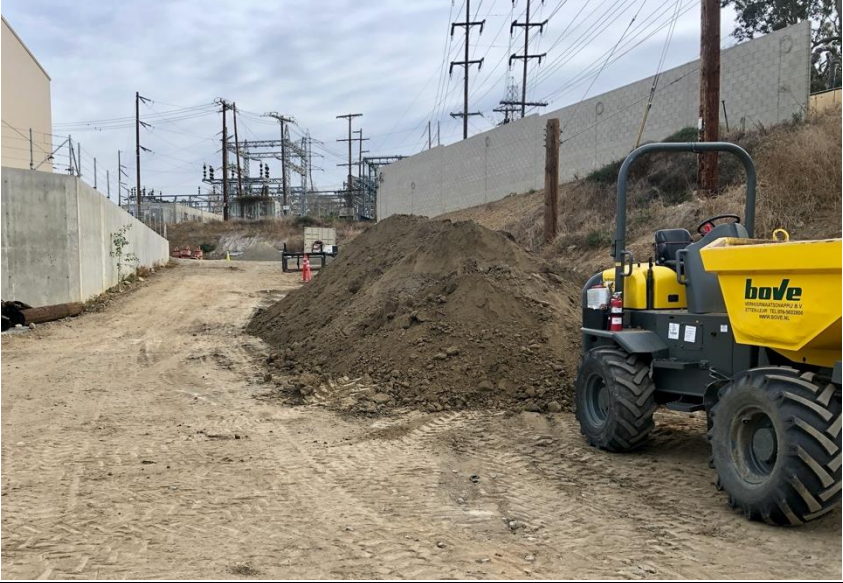
Photo 14 – Excess soil stockpiled along the project access road. Photo facing east.

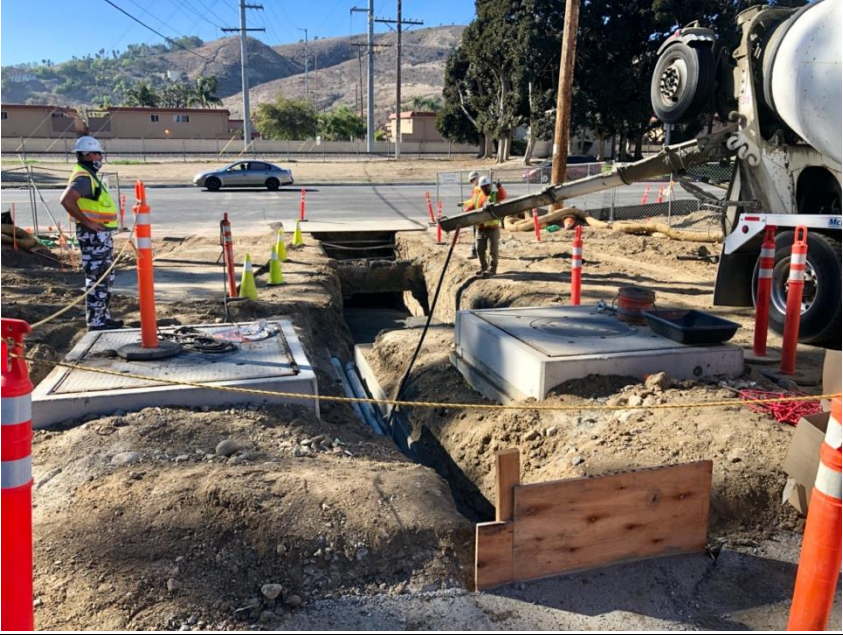
Photo 2 – A crew pouring slurry near the southern entrance to the substation. Photo facing west.
12/21/20	SOCRE transmission corridor – Serra Park

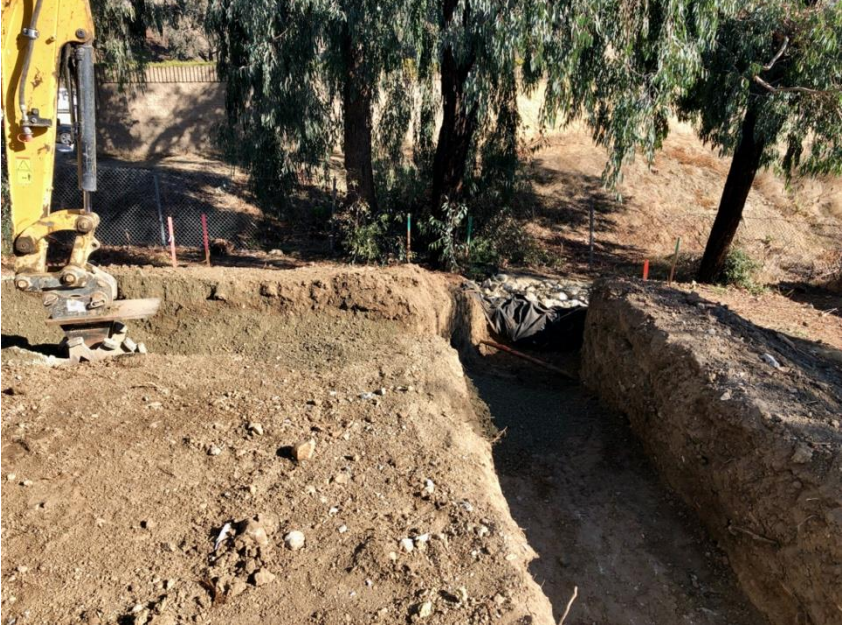
Photo 3 – Excavation work for the brow ditch around tower 4. Photo facing east.

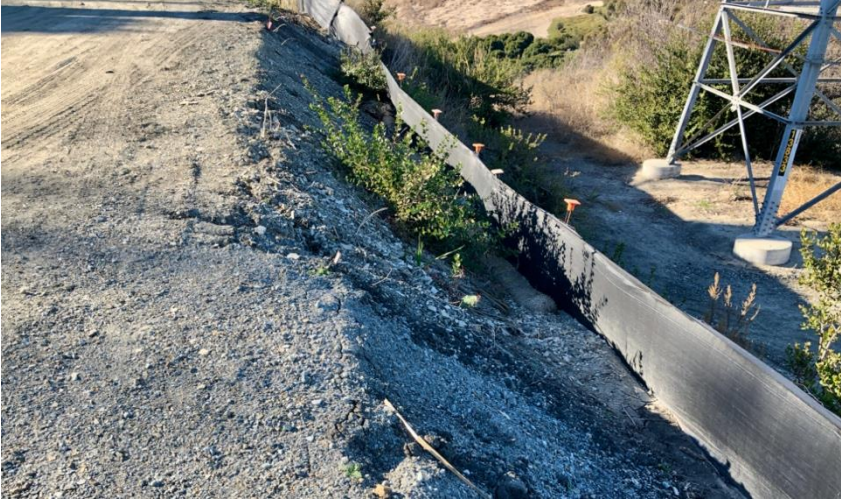
Photo 4 – An erosion area at tower location 36 that required additional BMPs. Photo facing northwest.
12/21/20	SOCRE transmission corridor

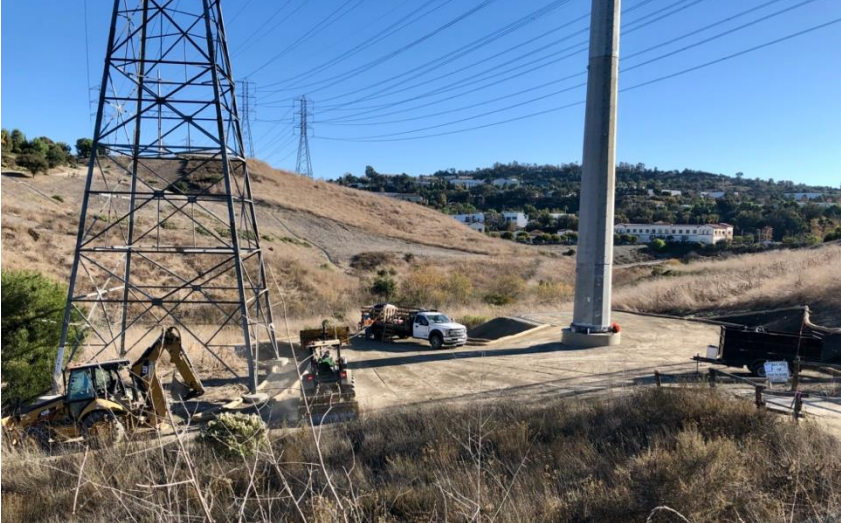
Photo 5 – Completion of final groundwork at tower location 34 before hydroseeding. Photo facing south.
12/21/20	SOCRE transmission corridor

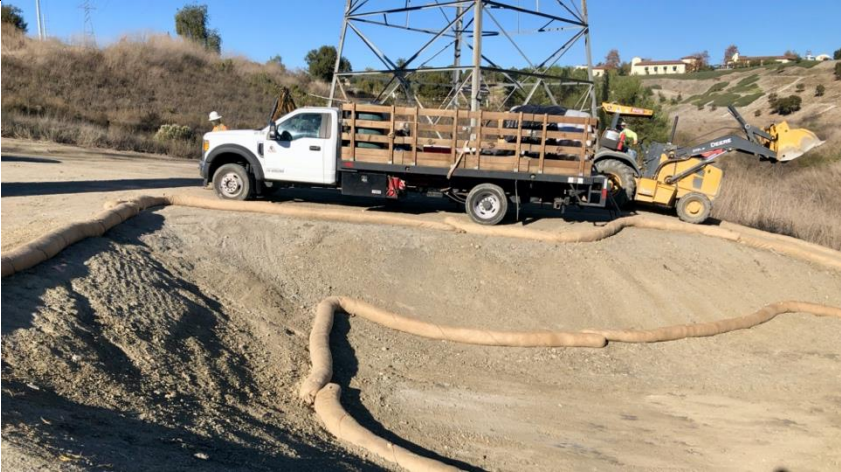
Photo 6 – Additional BMPs in place in preparation for hydroseeding at tower location 34. Photo facing northeast.
