January 28, 2021

Re: Monthly Report Summary #38 for the South Orange County Reliability Enhancement (SOCRE) Project

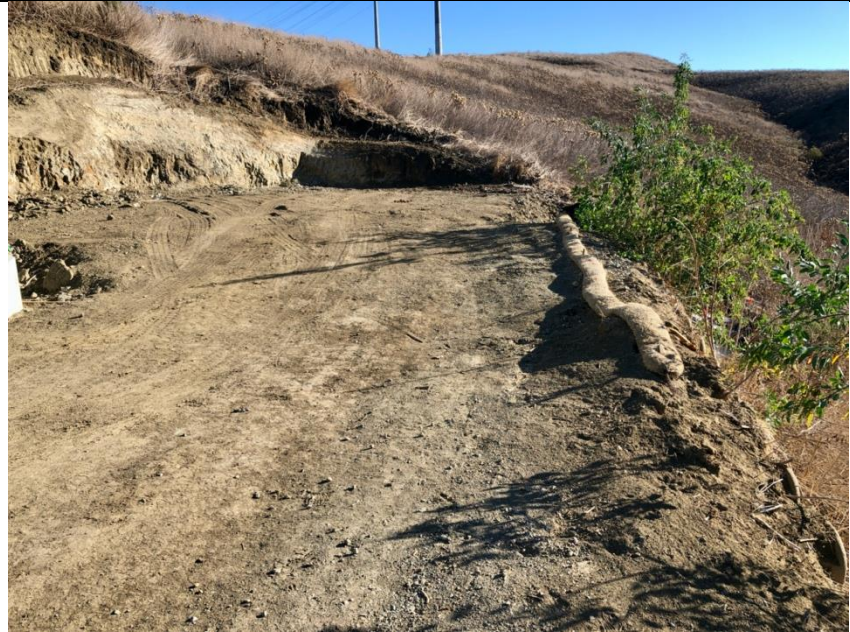
A photograph of a dirt road or construction site on a hillside. The ground is uneven and appears to be a mix of dirt and gravel. There are some sparse green plants and a large tree root in the foreground. The background shows a steep, eroded hillside under a clear blue sky.	Photo 8 – The tower pad at tower location 14 where additional BMPs were needed. Photo facing south.
