**Re: Monthly Report Summary #40 for the South Orange County Reliability Enhancement (SOCRE) Project**

CPUC Site Inspection Reports

## South Orange County Reliability Enhancement Project CPUC Site Inspection Form

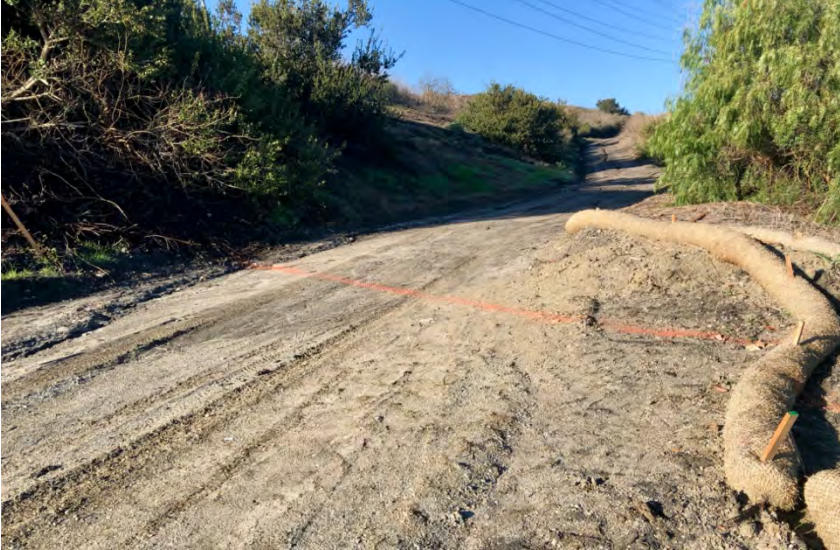
My first stop was at tower location 41, where water runoff was a known issue coming down the access road. The rainwater runoff had undermined the BMPs at several areas creating significant rills in the soil slopes (Photo 1). Muddy runoff did not appear to have traveled to the public roadway. The LEI said that this spot had been inspected and a water bar would be added in the access road to divert water away from the tower site. The location of the water bar was painted on the access road (Photo 2).

Photo 2 – Location of a proposed water bar on the access road above tower location 41. Photo facing west.
02/05/21	SOCRE transmission corridor

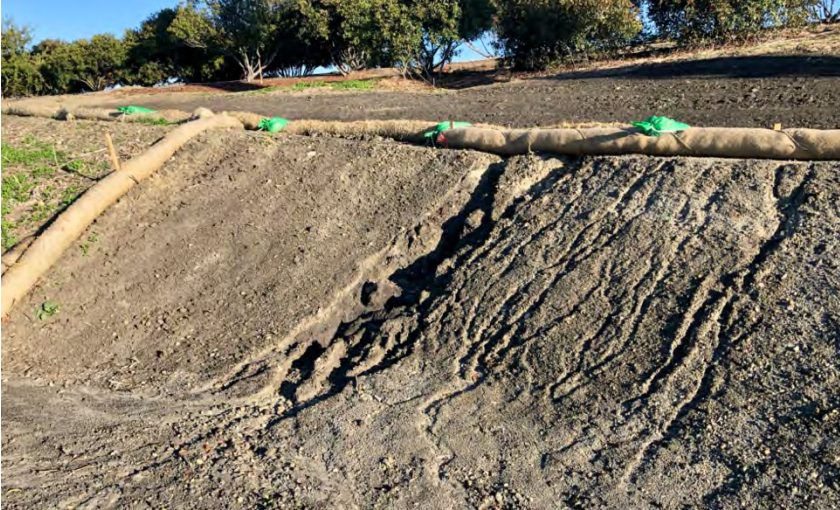
At tower location 42, rainwater runoff had undermined the straw wattles and eroded a small portion of the slope below the tower pad (Photo 3). This area required maintenance and possibly hydroseeding. The pull site below tower location 42 appeared stable but required hydroseeding (Photo 4).

Photo 3 – Erosion rills on the disturbed slope near tower location 42. Photo facing south.
02/05/21	SOCRE transmission corridor

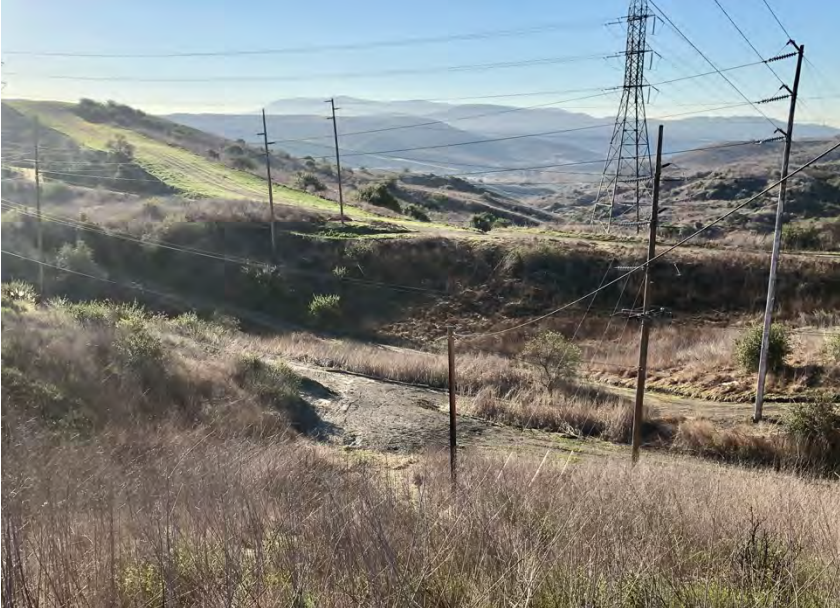
Photo 4 – Pull site north of tower location 42. Photo facing south.

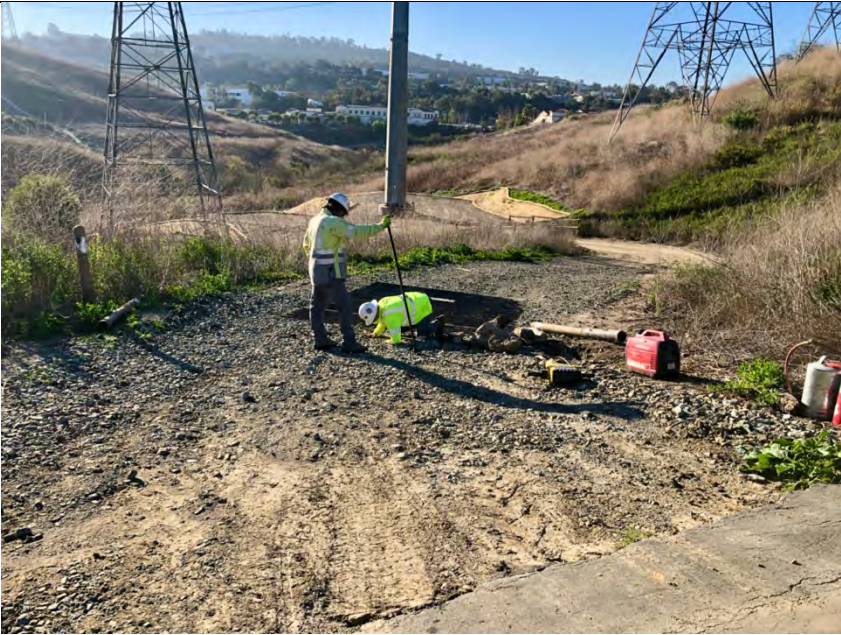
Maintenance work was underway at tower location 34 (Photo 5). The disturbed areas around the TSP appeared stable. I met with one of the Environmental Inspectors (EIs) who observed a pair of red-tailed hawks (*Buteo jamaicensis*) nesting in the nearby lattice tower. One of the birds was perched on top of the lattice tower. The EI was clearing the sites in the morning and checking for nesting birds.

Photo 5 – Maintenance work at tower location 34. Photo facing southwest.
02/05/21	SOCRE transmission corridor

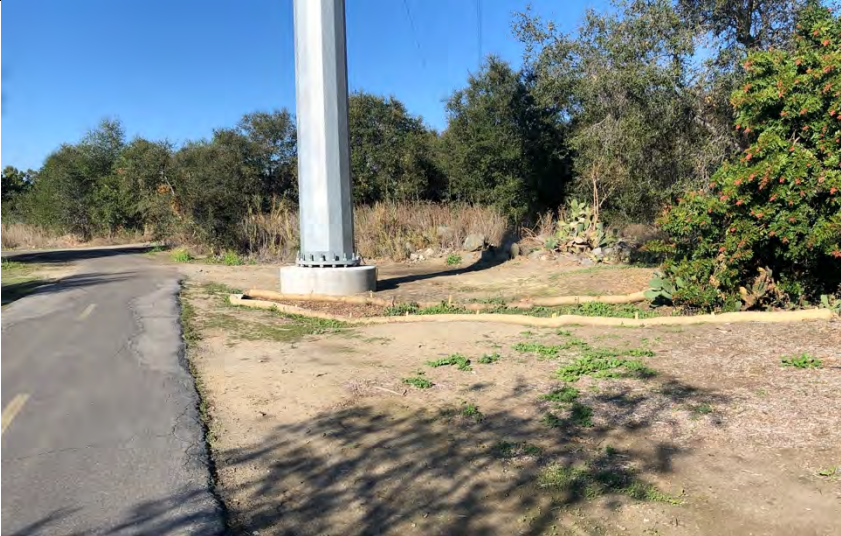
At tower location 9, the area around the tower was in good condition (Photo 6). The downstream end of the culvert running under the nearby bike path was blocked by the energy dissipating rock (Photo 7). This caused the water to pool on the uphill side of the bike path and the pipe was filled with leaves and sticks. I sent a note to the LEI and he sent a crew out to remove the debris from the pipe.

Photo 6 – The construction area at tower location 9 was in good condition. Photo facing northwest.

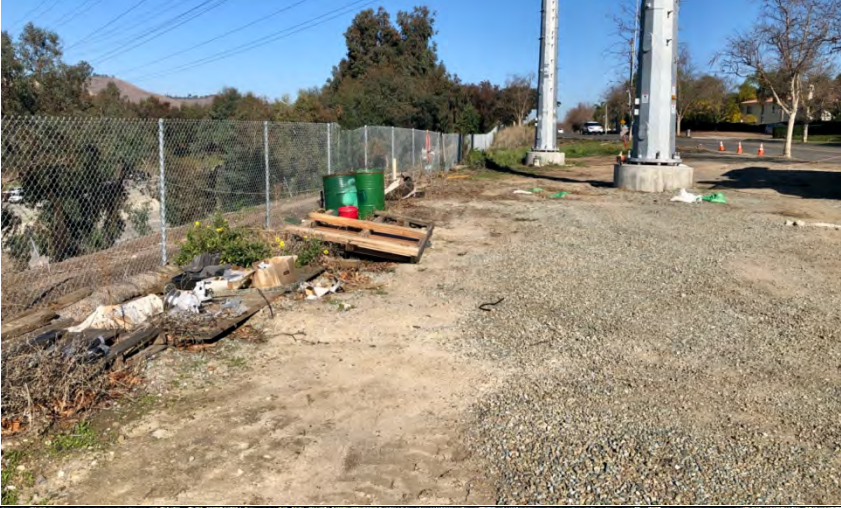
The staging area set up under the transmission corridor east of Interstate 5 had been removed, but trash and gravel remained onsite (Photo 9). Again, I notified the LEI and he had a crew clean up the site.

Photo 9 – Staging area east of Interstate 5 required removal of trash and gravel. Photo facing north.
02/05/21	San Juan Capistrano Substation

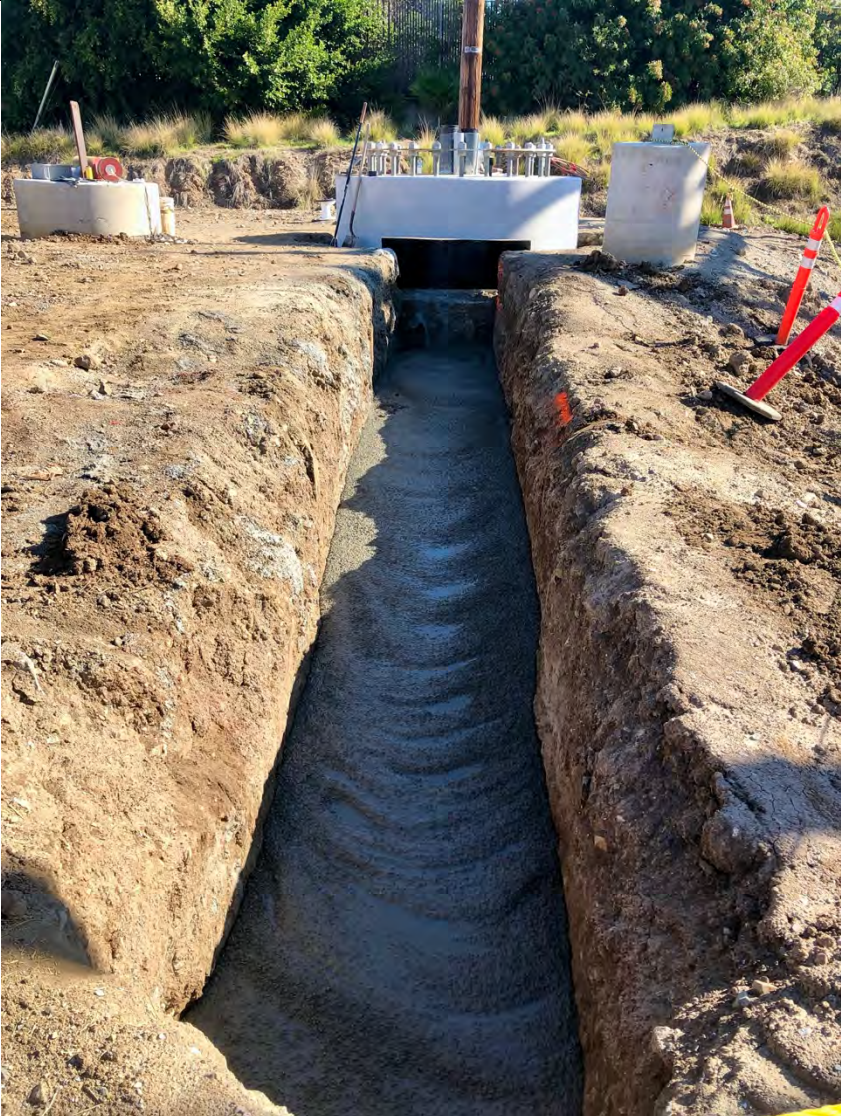
I traveled to the San Juan Capistrano Substation and met with the onsite EI. Concrete trucks were arriving onsite to pour portions of the conduit trenches near the TSP foundations by the 12-kilovolt (kV) substation facility (Photo 10).

Photo 10 – Newly poured concrete conduit trench. Photo facing east.

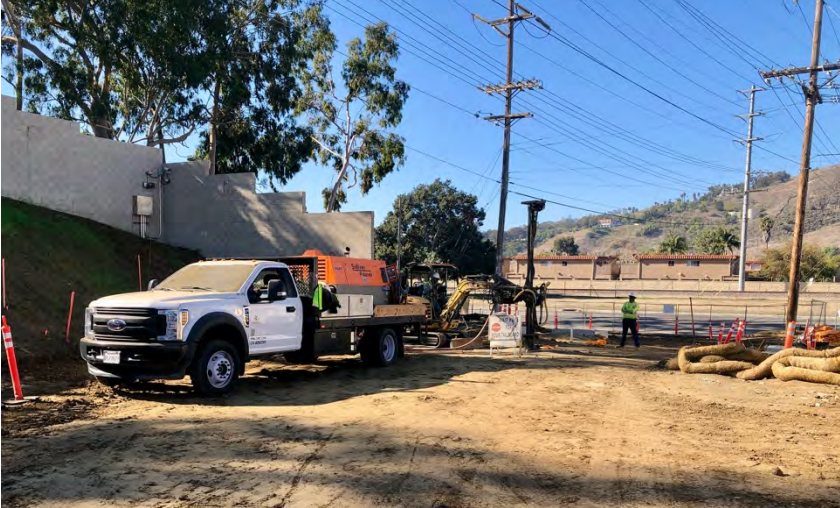
A crew was installing grounding rods by the southern substation entrance (Photo 11).

Photo 11 – Grounding rod installation near the south entrance. Photo facing west.
02/05/21	San Juan Capistrano Substation

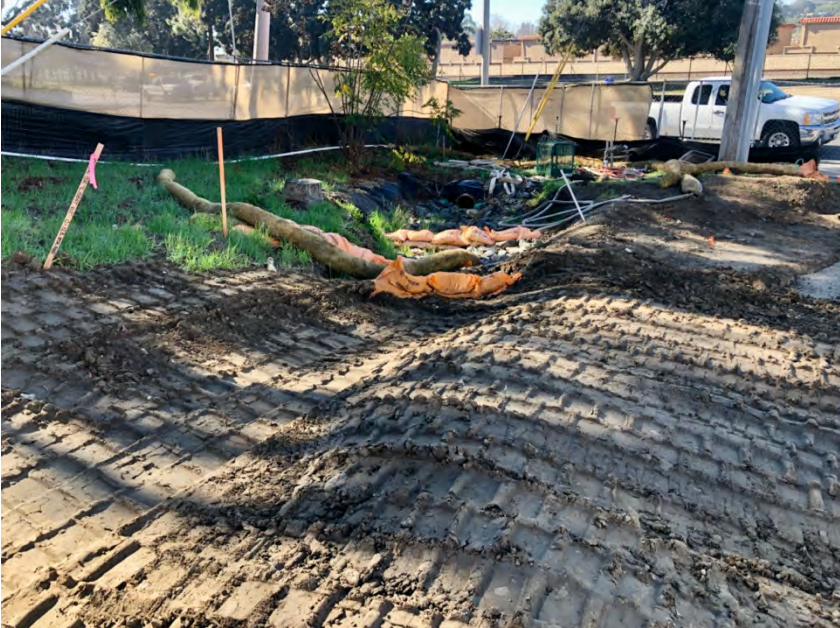
The conduit trenching near the southern entrance had been backfilled, with a berm installed to direct rainwater runoff into the rock-lined sediment trap built in front of the outlet drain (Photo 12). This sediment trap required sediment removal and replacement of the existing rocks. I spoke with the onsite EI and one of the job foremen about this; I had previously discussed this cleanup with the LEI, and he stated it would be completed prior to the next rain event.

Photo 12 – Rock-lined sediment trap. Photo facing south.

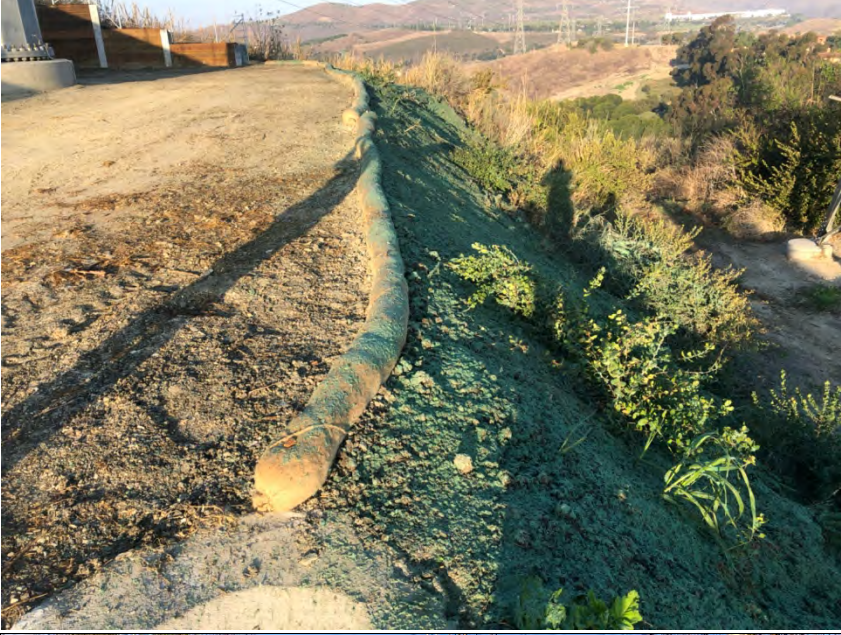
The EI and I traveled to tower location 36, where the majority of the BMP work had been completed. The last remaining open ground around the tower pad had been hydroseeded (Photos 1 and 2).

Photo 1 – Hydroseeded slope below the pad at tower location 36. Photo facing west.
02/11/21	SOCRE transmission corridor

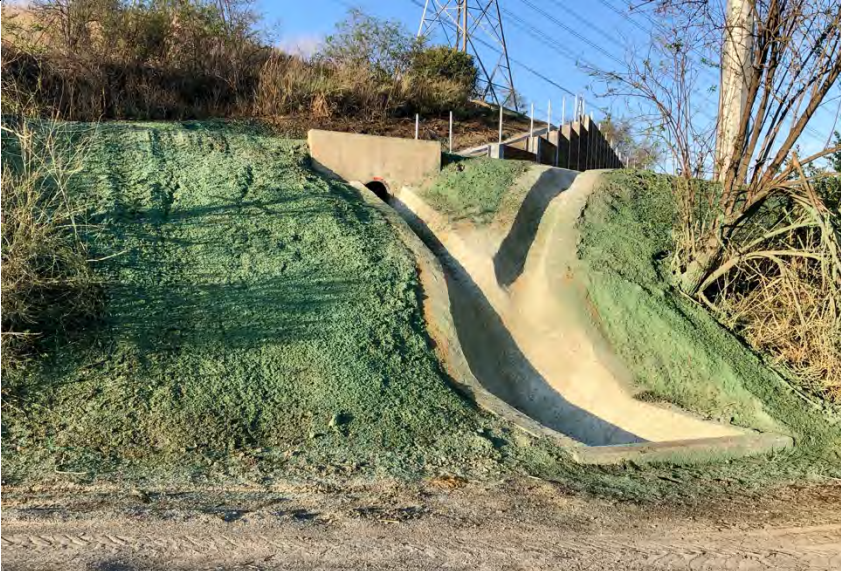
Photo 2 – Hydroseeded slope east of the pad at tower location 36. Photo facing west.

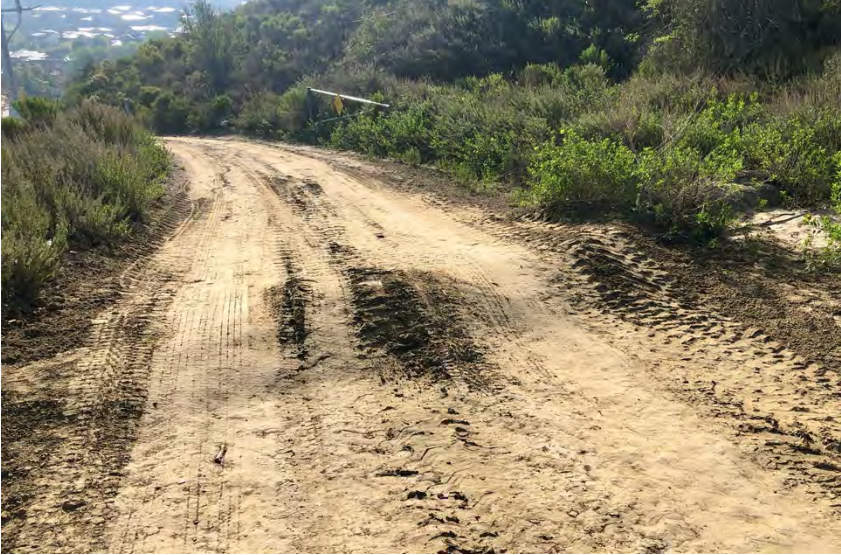
We drove to tower locations 16 and 17 and walked up the access road to tower location 14. Several earthen water bars on the access road had been built up and or enhanced after being flattened by construction equipment (Photo 5). The area around tower location 14 appeared to have adequate BMPs in place and hydroseeding had been completed (Photo 6).

Photo 5 – Maintenance work on water bars within the access road leading to tower locations 14 and 15. Photo facing southeast.
02/11/21	SOCRE transmission corridor

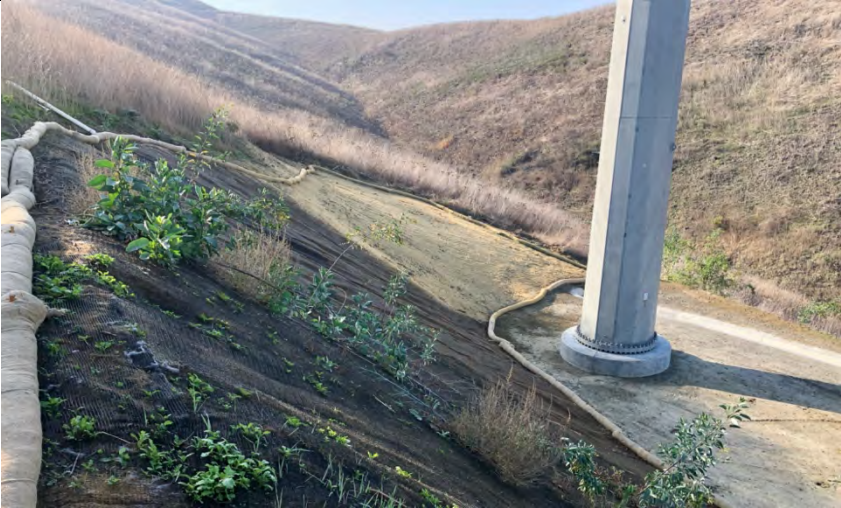
Photo 6 – Final restoration with BMPs in place at tower location 14. Photo facing south.
02/11/21	SOCRE transmission corridor

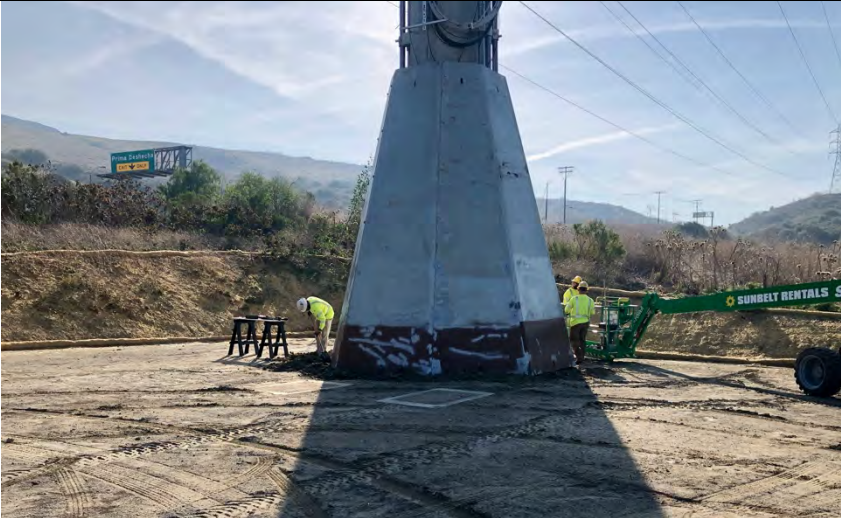
At tower locations 18 and 19, a crew was onsite painting the lower portion of the towers (Photo 7) and using cement to touch up work in the V ditches (Photo 8). I spoke to the EI about removing the castor beans (*Ricinus communis*) growing on the slopes of the tower pad.

Photo 7 – Painting the lower portions of towers 18 and 19. Photo facing south.

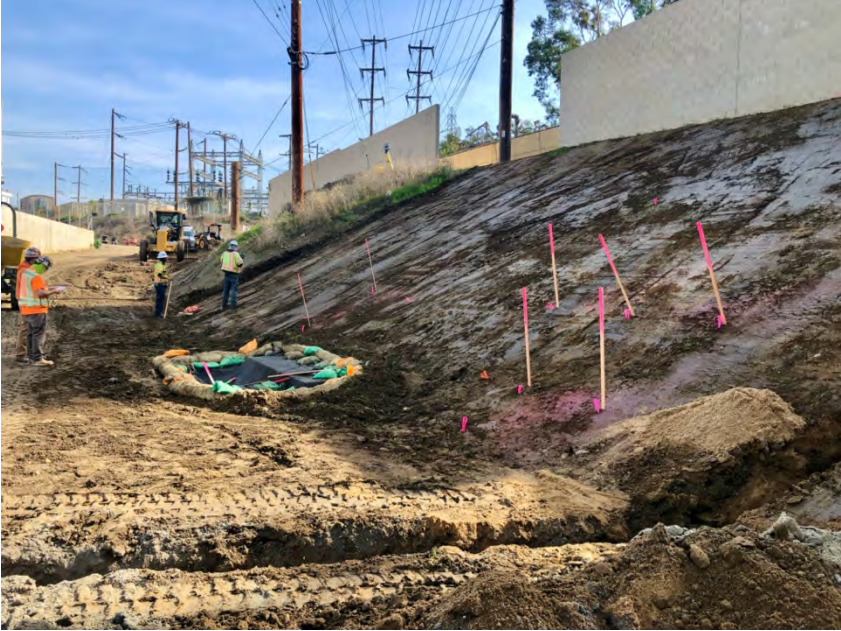
A crew was installing grounding wire in the southwestern portion of the project site (Photo 10). The crew was also working on the foundation for the new gate at the southern entrance (Photo 11) and had begun reshaping the earthen slopes along the southern boundary (Photo 12). The earth work was being completed in preparation for adding gravel armoring on the slopes.

Photo 12 – Reshaping the southern slope in preparation for rock armoring. Photo facing east.
02/11/21	San Juan Capistrano Substation

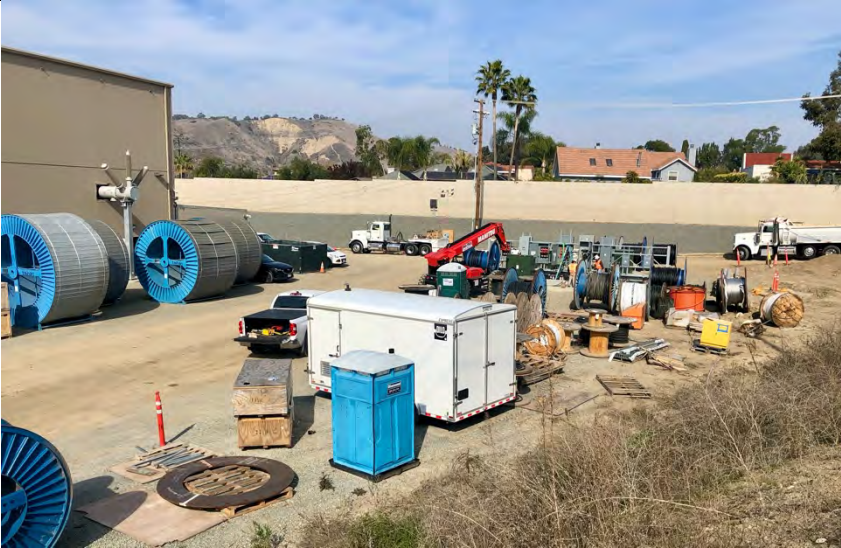
Photo 13 shows an overview of the area east of the 138-kV gas-insulated substation (GIS) building with the staged equipment and rolls of cable.

Photo 13 – Staging area east of the 138-kV GIS building. Photo facing north.

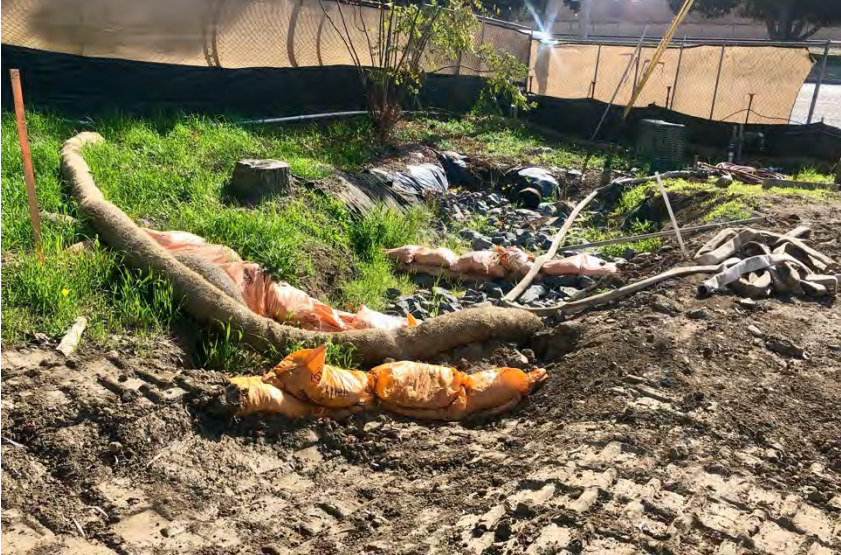
At the southern entrance, work continued on the foundations for the entry gate (Photo 3). The EI and I discussed the need to refresh the rock-lined catch basin by the southern entrance before the next rain event (Photo 4). Weather reports did not identify any storms occurring in the near future.

Photo 4 – Rock-lined catch basin near the southwestern corner of the substation site that required refreshing before the next rain event. Photo facing southwest.
02/17/21	SOCRE transmission corridor

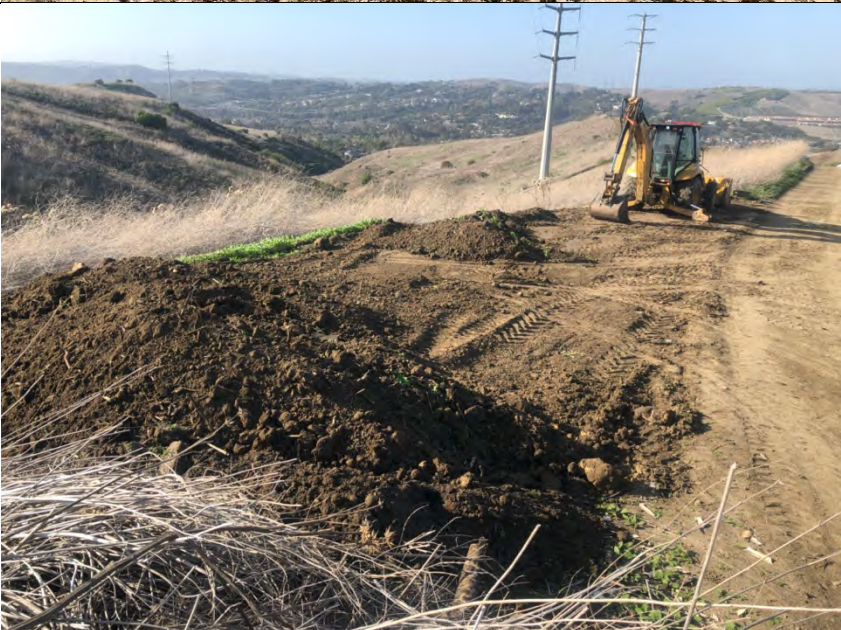
I traveled to tower location 15 where a small crew had been working on regrading the small pull site located along the access road north of the tower (Photo 5). The equipment was parked nearby and had secondary containment in place (Photo 6). The water bars had been upgraded along the access road.

Photo 5 – Regrading of the pull site near tower location 15. Photo facing northwest.
