**Re: Monthly Report Summary #43 for the South Orange County Reliability Enhancement (SOCRE) Project**

CPUC Site Inspection Reports

May 6 and 19, 2021

## South Orange County Reliability Enhancement Project CPUC Site Inspection Form

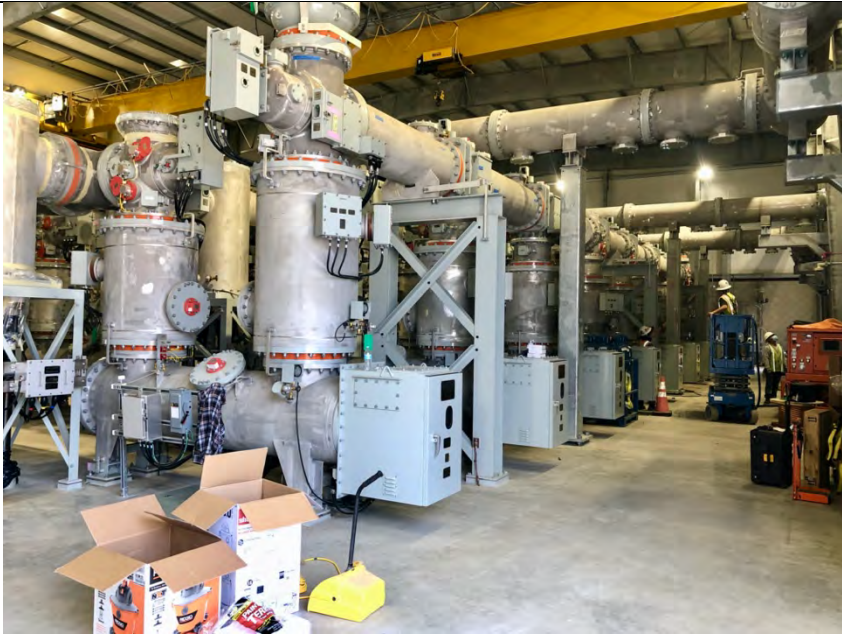
I inspected the 138-kilovolt (kV) gas-insulated substation (GIS) building where crews continued to test the equipment (Photo 3).

Photo 3 – Inside the 138kV GIS building where testing continued.
05/19/21	San Juan Capistrano Substation

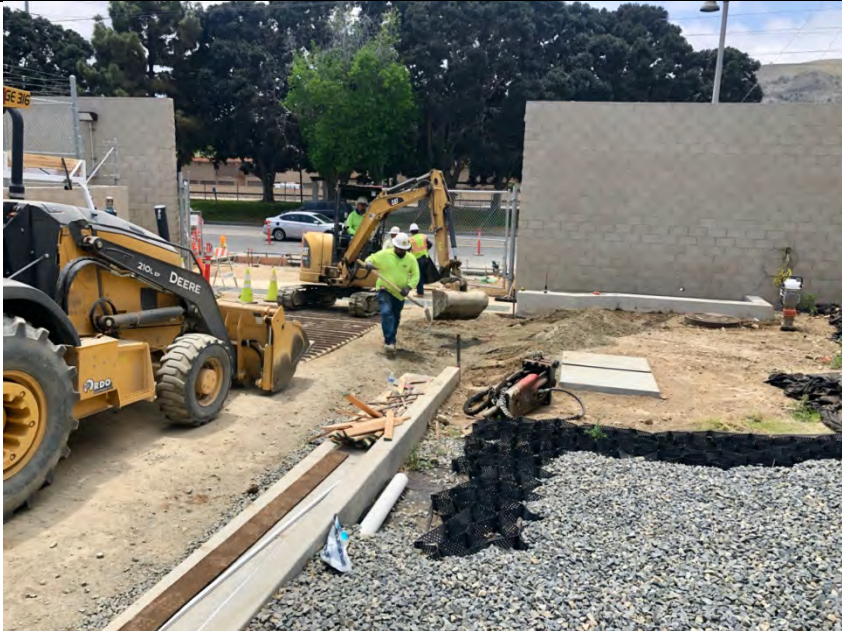
Work was concentrated at the northern entrance where crews were completing curb and gutter work on the inside of the gate (Photo 4). Another crew poured the curb outside the gate along Camino Capistrano (Photo 5). Traffic control was in place. All excavated soil was stockpiled near the 138-kV GIS building (Photo 6), and the stockpiles had been watered to reduce fugitive dust.

Photo 4 – Curb and gutter work at the northern entrance. Photo facing west.
