Re: Monthly Report Summary #45 for the South Orange County Reliability Enhancement (SOCRE) Project

CPUC Site Inspection Reports

South Orange County Reliability Enhancement Project CPUC Site Inspection Form

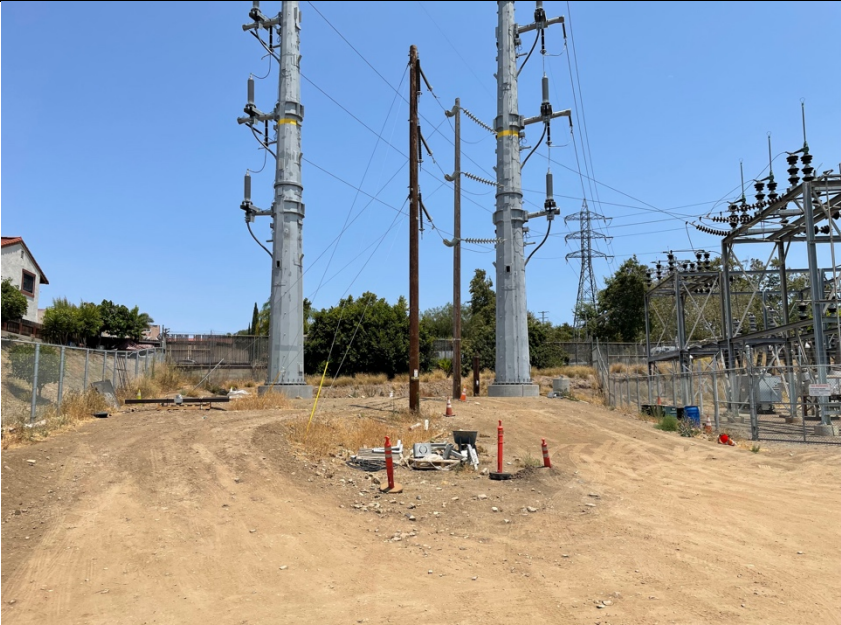
It's been three weeks since my last site visit, and most of the substation site appeared the same. I've included photos of the two large tubular steel posts (TSPs) near the 12-kilovolt (kV) substation facility (Photo 1), and the southern portion of the site, which is to be worked on (Photo 2).

Photo 1 – Two TSPs near the 12-kV substation facility. Photo facing east.

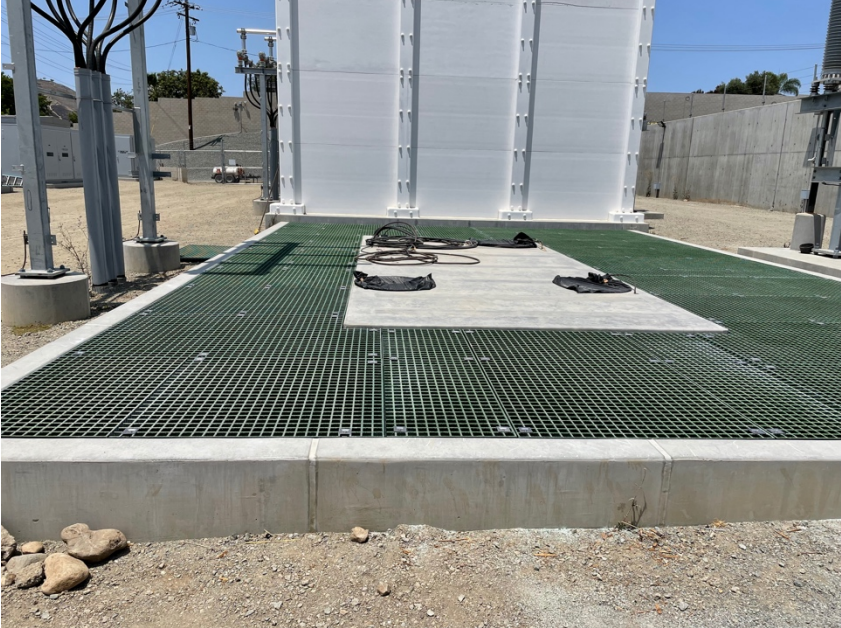
Some minor excavation work had been completed around a drain inlet (Photo 3), and the flooring for one of the transformer foundations had been installed (Photo 4).

Photo 4 – Flooring installed within one of the transformer foundations. Photo facing north.
7/15/21	San Juan Capistrano Substation

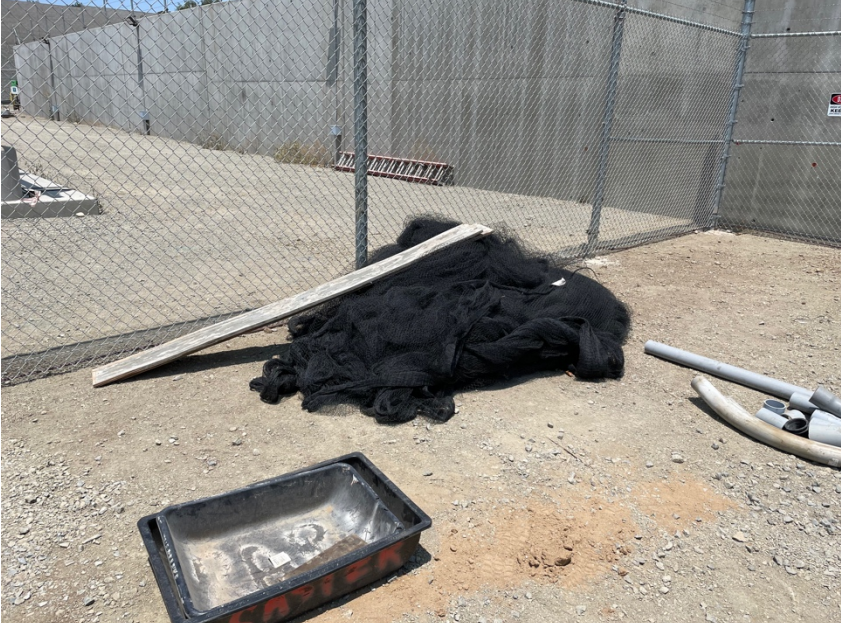
There was a large pile of bird netting near the fencing around the 138-kV GIS building (Photo 5). The EI did not know what the netting was for or why it was there. We discussed moving or storing it so that it would not pose an entrapment hazard for small animals.

Photo 5 – Piled bird netting that will need to be removed. Photo facing northwest.

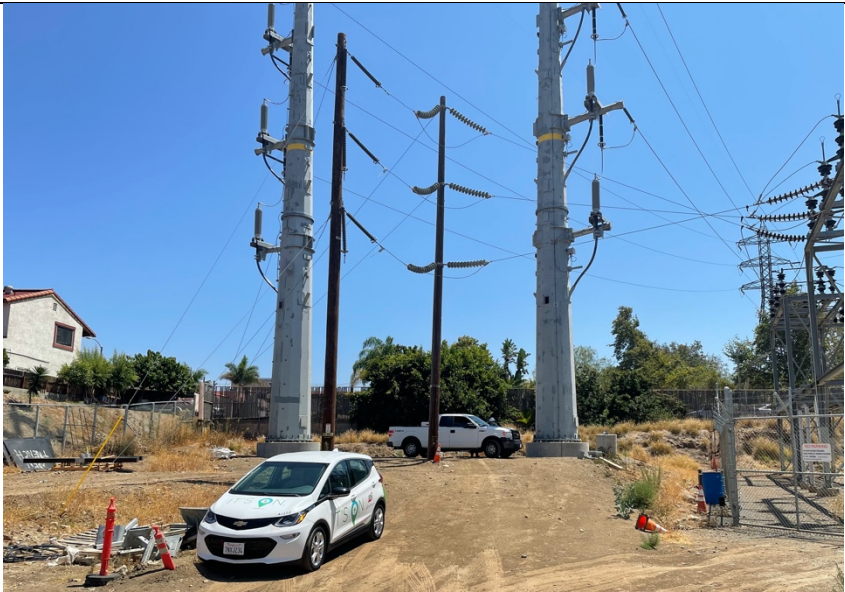
The Lead Environmental Inspector arrived onsite along with the Environmental Specialist for SDG&E to conduct a site audit of both the existing substation and the new construction zone (Photo 1). We exchanged information and briefly discussed the construction activity.

Photo 1 – SDG&E specialists onsite to perform an environmental audit. Photo facing east.
