Re: Monthly Report Summary #46 for the South Orange County Reliability Enhancement (SOCRE) Project

CPUC Site Inspection Reports

South Orange County Reliability Enhancement Project CPUC Site Inspection Form

Project:	South Orange County Reliability Enhancement (SOCRE) Project	Date:	August 12, 2021
Project Proponent:	San Diego Gas & Electric (SDG&E)	Report #:	VS125
Lead Agency:	California Public Utilities Commission (CPUC)	Monitor(s):	CPUC/WSP USA Inc. Compliance Monitor
CPUC PM:	Andrew Barnsdale, Energy Division	AM/PM Weather:	Sunny and warm with a slight breeze
CPUC CM (WSP):	Joe Donaldson	Start/End time:	1430 to 1545
Project NTP(s):	Notice to Proceed (NTP)-3, NTP-4, and NTP-5

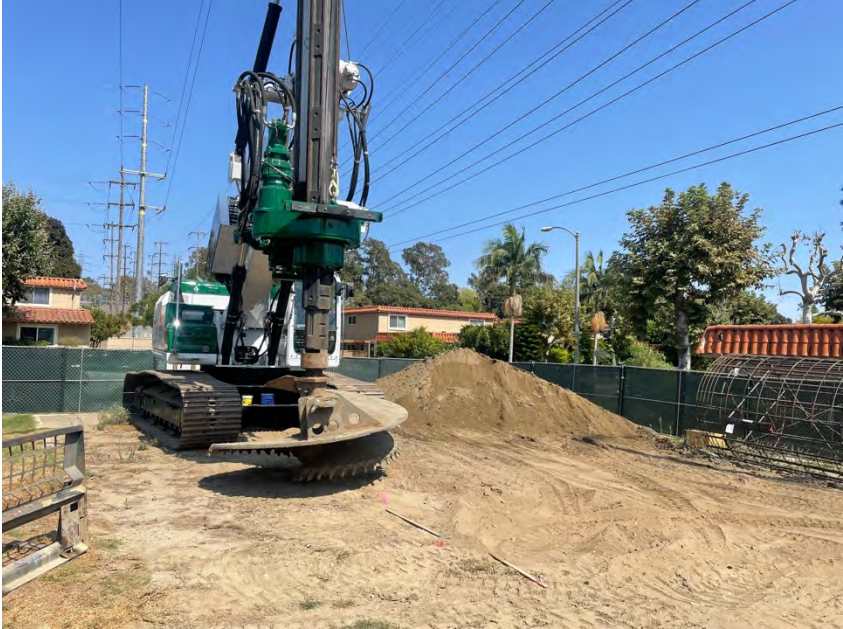
Tailings from the drilling were being loaded into dump trucks and hauled offsite (Photo 5). The equipment generated large quantities of dust during the loading activity, and that dust could potentially impact the apartment buildings on either side of the work space. The wind speed was increasing, so I spoke with the EI about spraying some water on the work area to minimize the dust. The EI was able to have the contractor bring hoses from the water buffalo in the laydown yard to use to spray the area. The contractor regularly swept the public roadway during work activities and indicated that it would be free of soil and dust once the job site was vacated.

Photo 5 – Drill rig and tailings from the TSP foundation drilling. Photo facing east.

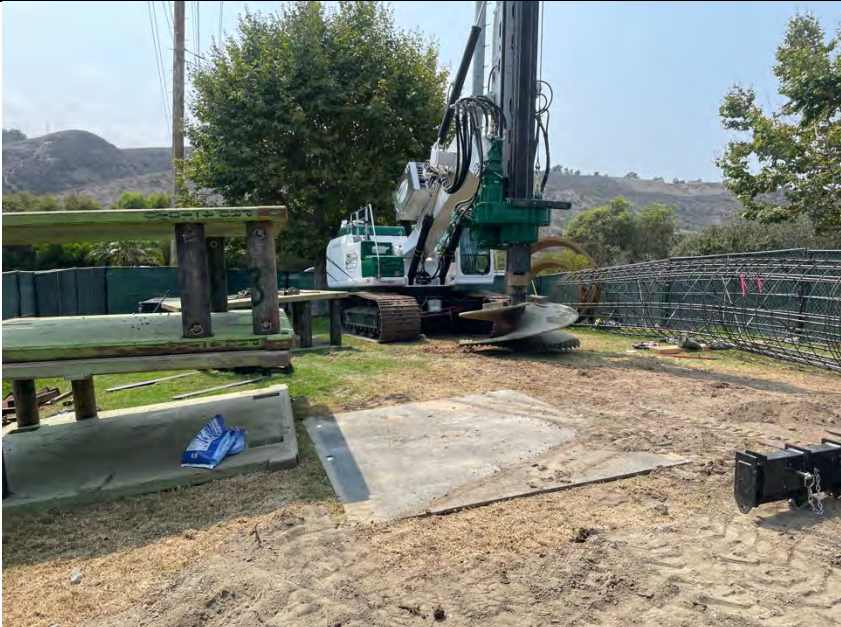
A large amount of equipment and materials were staged in the temporary construction yard. There was adequate containment under the equipment and a concrete washout bin in place (Photos 1 & 2).

Photo 1 – Staging area for equipment and materials west of the railroad tracks. Photo facing west.
