Re: Monthly Report Summary #48 for the South Orange County Reliability Enhancement (SOCRE) Project

CPUC Site Inspection Reports
for
October 5 and 20, 2021

South Orange County Reliability Enhancement Project CPUC Site Inspection Form

Project:	South Orange County Reliability Enhancement (SOCRE) Project	Date:	October 5, 2021
Project Proponent:	San Diego Gas & Electric (SDG&E)	Report #:	VS130
Lead Agency:	California Public Utilities Commission (CPUC)	Monitor(s):	CPUC/WSP USA Inc. Compliance Monitor
CPUC PM:	Andrew Barnsdale, Energy Division	AM/PM Weather:	Partly cloudy, warm, and calm
CPUC CM (WSP USA, Inc.):	Joe Donaldson	Start/End time:	1400 to 1530 hrs
Project NTP(s):	Notice to Proceed (NTP)-3, NTP-4, and NTP-5

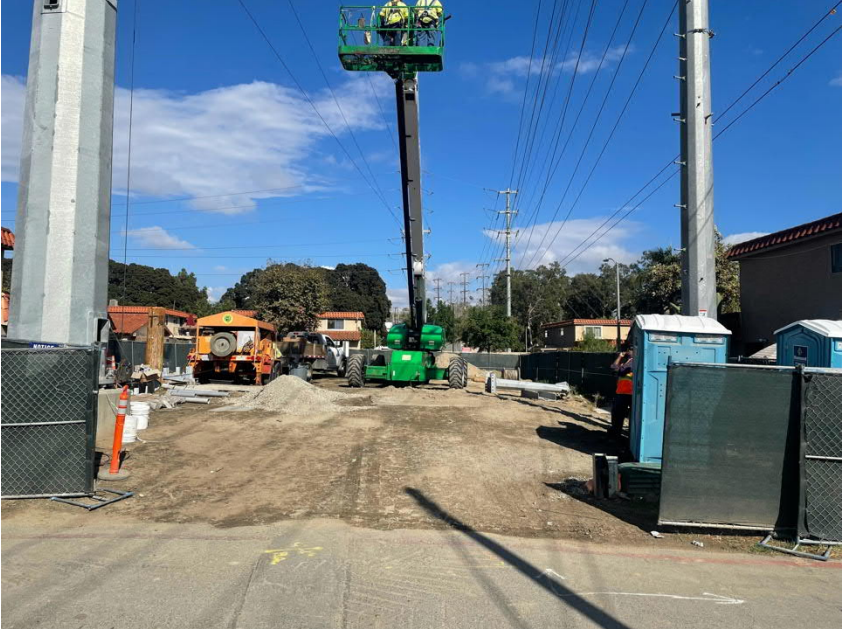
Several crews were pulling wire through the newly cleaned-out conduit and were running a large roll of wire into the conduit at the 138-kV building. The wire was being pulled through the conduit to the TSPs in the vicinity of the Westport Complex, west of the railroad tracks. The crew in the manlift was stabilizing and anchoring the newly pulled wire in the TSP (Photo 5). The work area here was also well contained and fenced off (Photo 6).

Photo 6 – Work area around the TSPs west of the railroad tracks. Photo facing east.
