## MEMORANDUM

Re: SX-PQ Pre-Construction Road Condition Assessment for Staging Yards

On November 10, 17 and 22 2016, Icon Building Supplies conducted a pre-construction road condition assessment of all entrances and exits to the staging yards anticipated to be used during construction of the Sycamore to Penasquitos 230 kV Transmission Line Project to satisfy the pre-construction requirements of mitigation measure TRA-3.

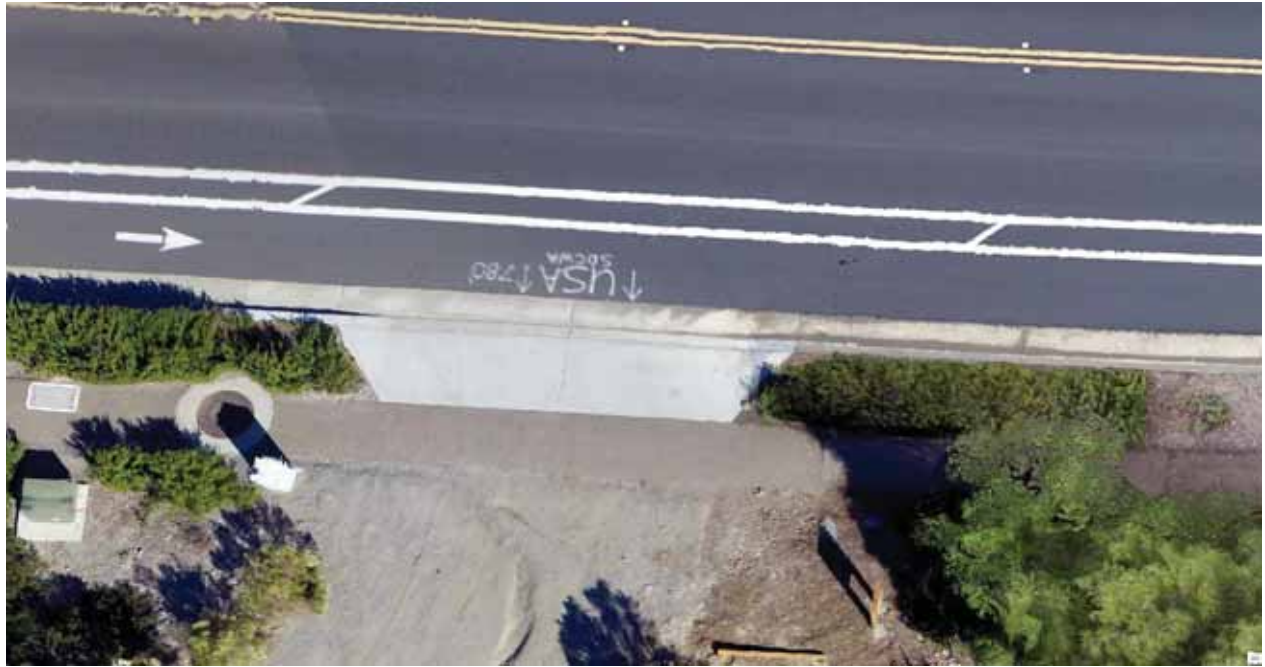
Stonebridge Yard - Aerial Photo taken 11/10/2016

This aerial photo shows the entrance to the Stonebridge Staging Yard. No noticeable cracking or damage to concrete visible on entrances to the yard. Some scratches are visible.

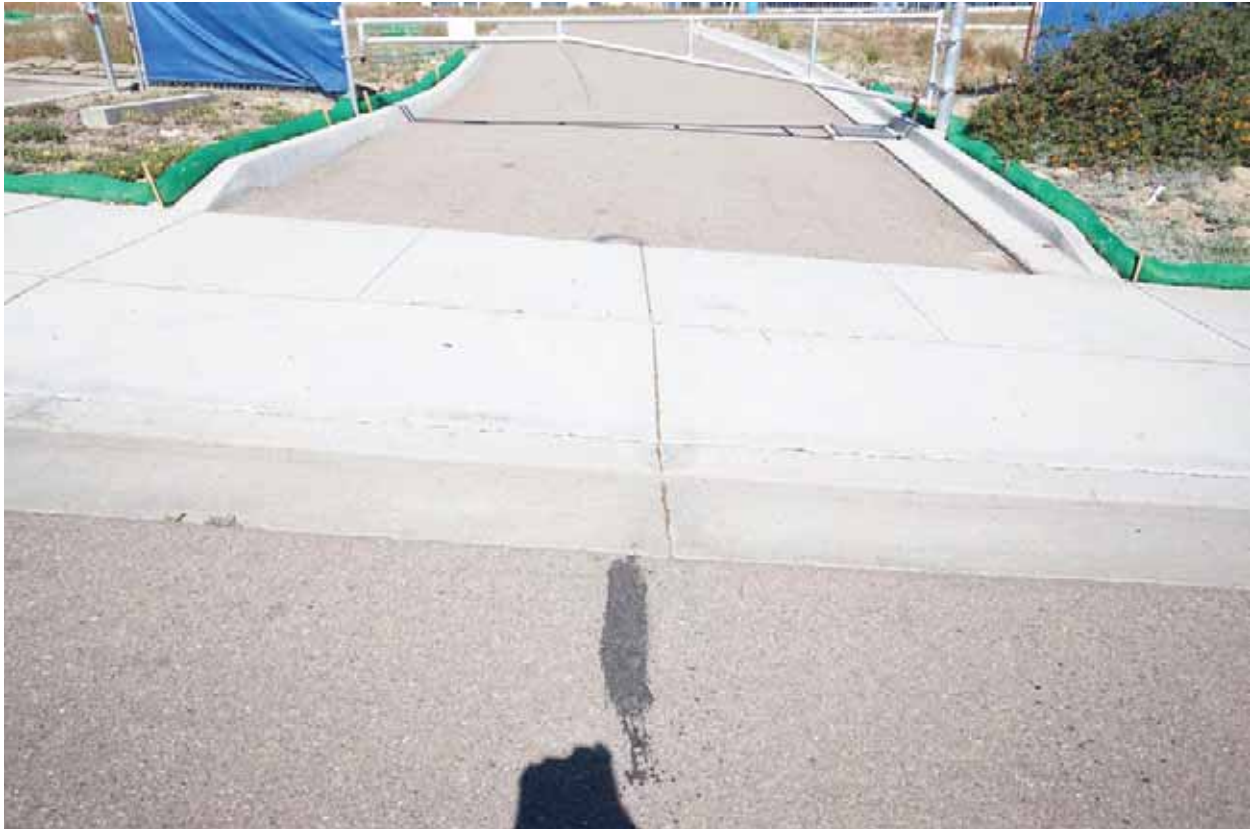
Shire Yard - Photo taken 11/17/2016

Existing asphalt is scarred and chips exist on the concrete drive entrance. Scratches also exist in the concrete on the drive-way entrance and the asphalt in the roadway. Cracking observed in the concrete gutter and cracking in existing asphalt roadway.

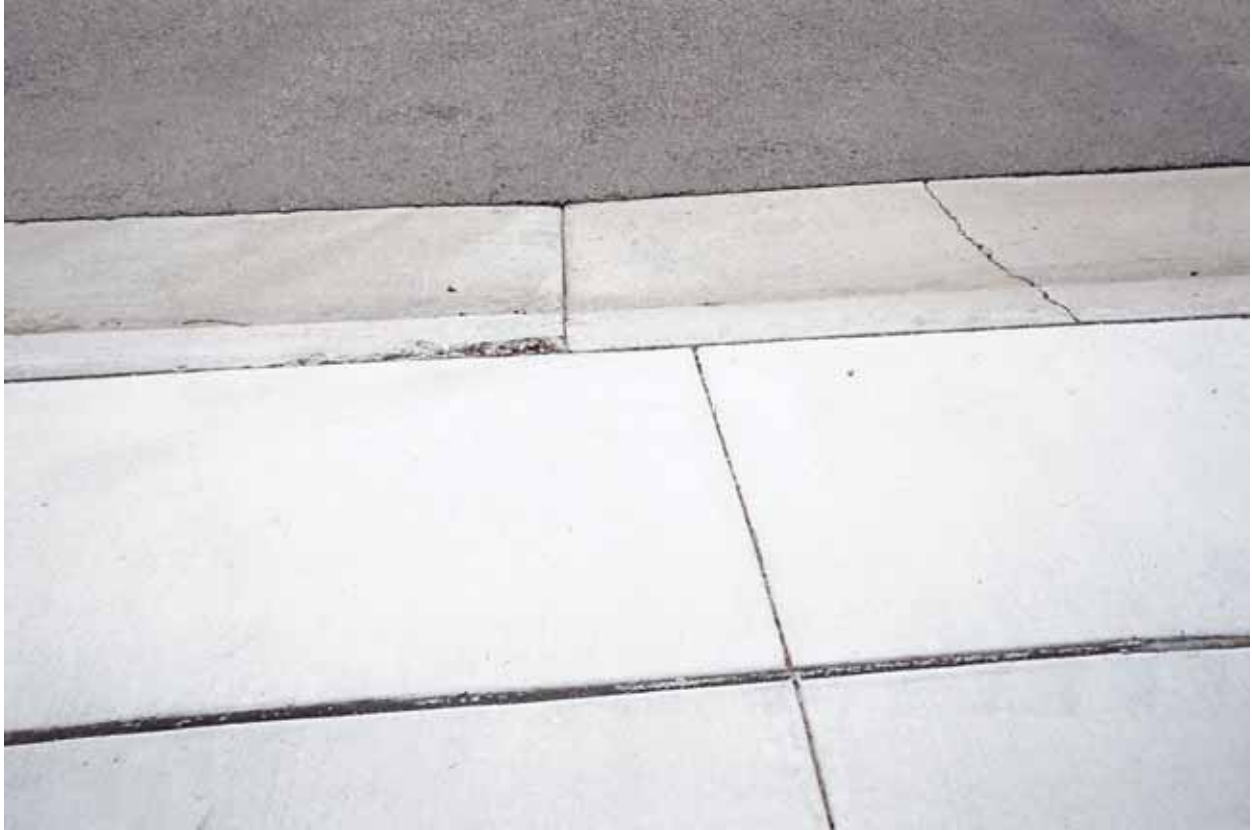
Shire Yard - Photo taken 11/17/2016

Cracking of curb and gutter and cracking of asphalt roadway.

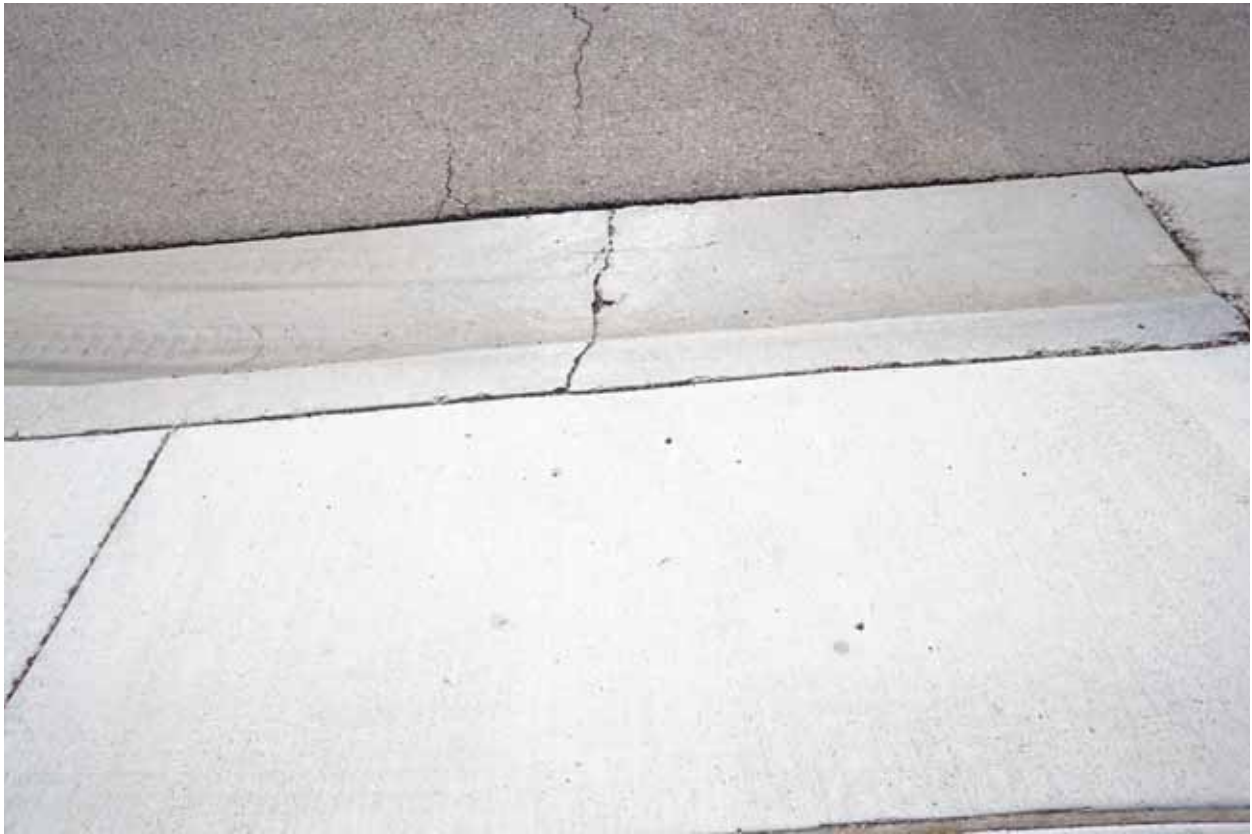
Shire Yard - Photo taken 11/17/2016

Cracking of curb and gutter and cracking of asphalt roadway.

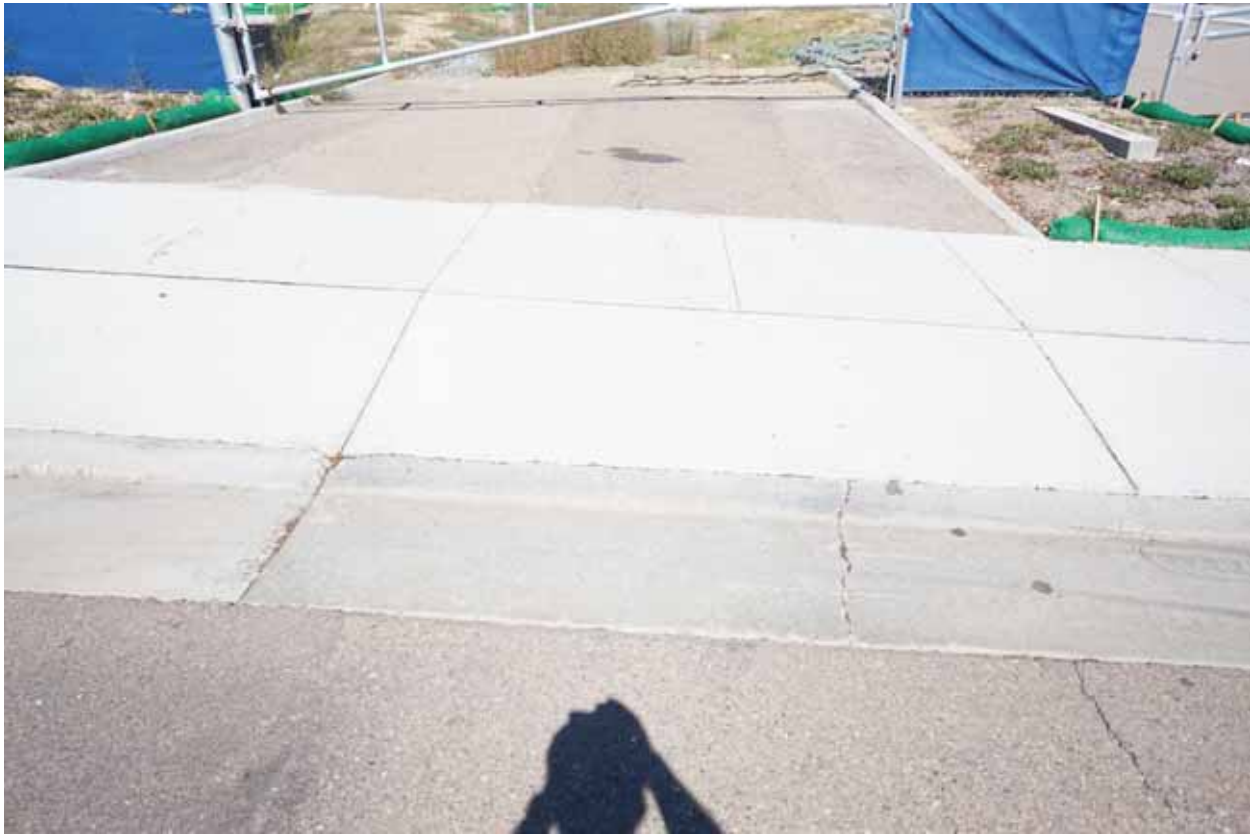
Shire Yard - Photo taken 11/17/2016

Cracking of curb and gutter and cracking of asphalt road way.

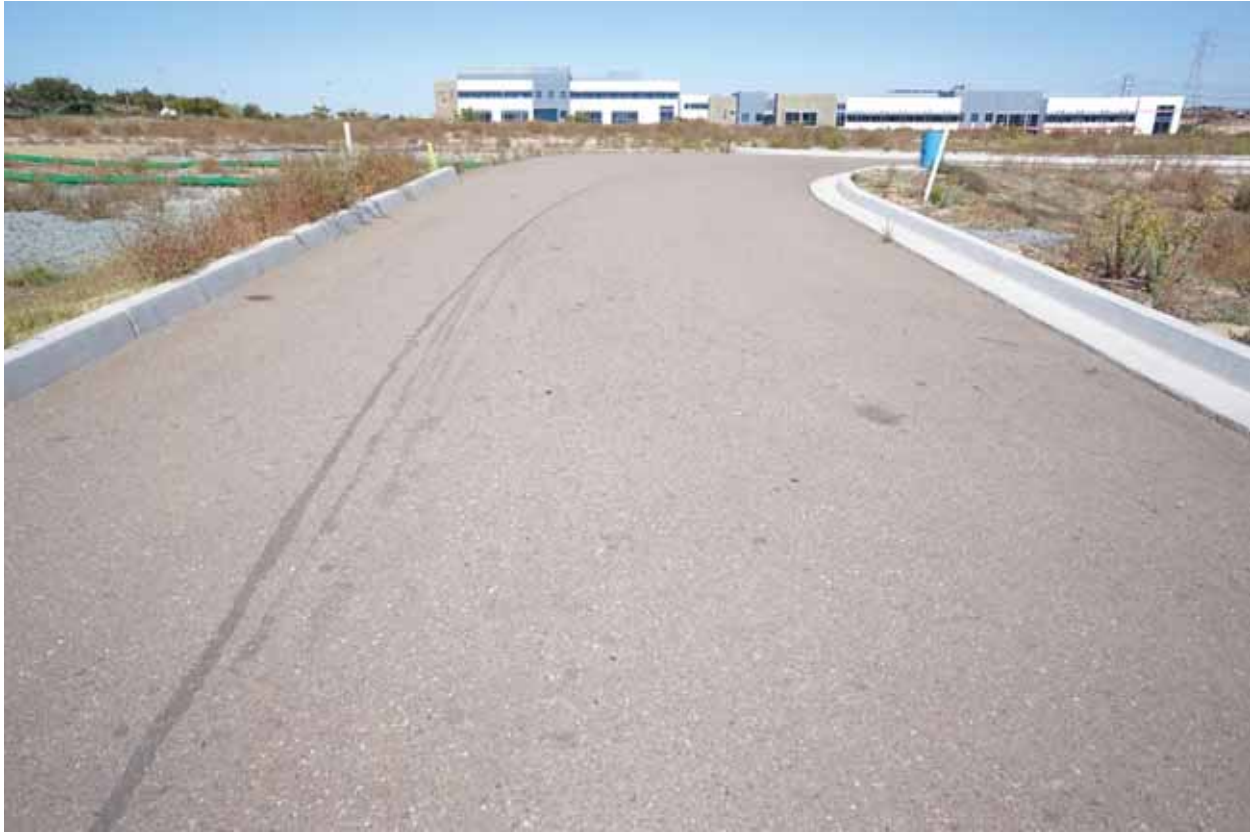
Shire Yard - Photo taken 11/17/2016

Existing driveway beyond the entrance, the existing asphalt is approximately 1 ½" from finished grade.

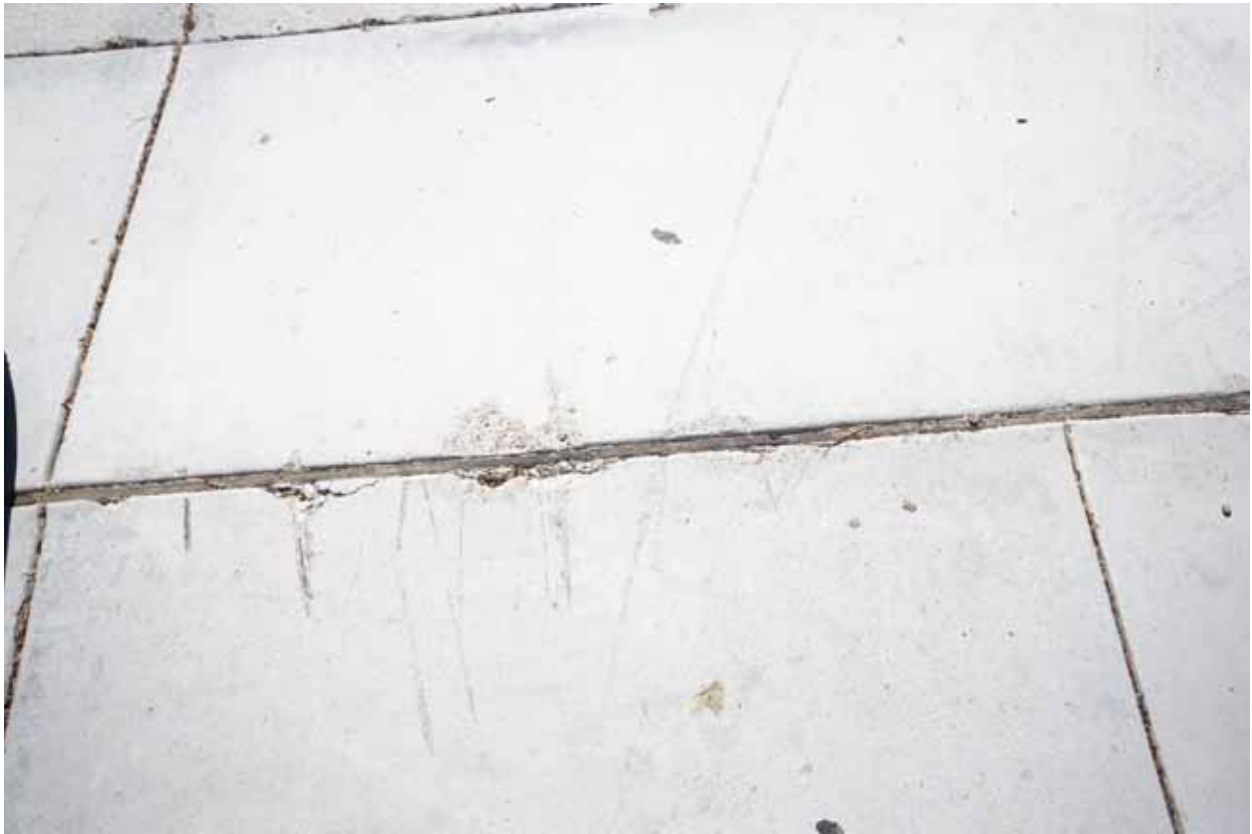
Shire Yard - Photo taken 11/17/2016

Scratches and chips to concrete at entrance way to yard.

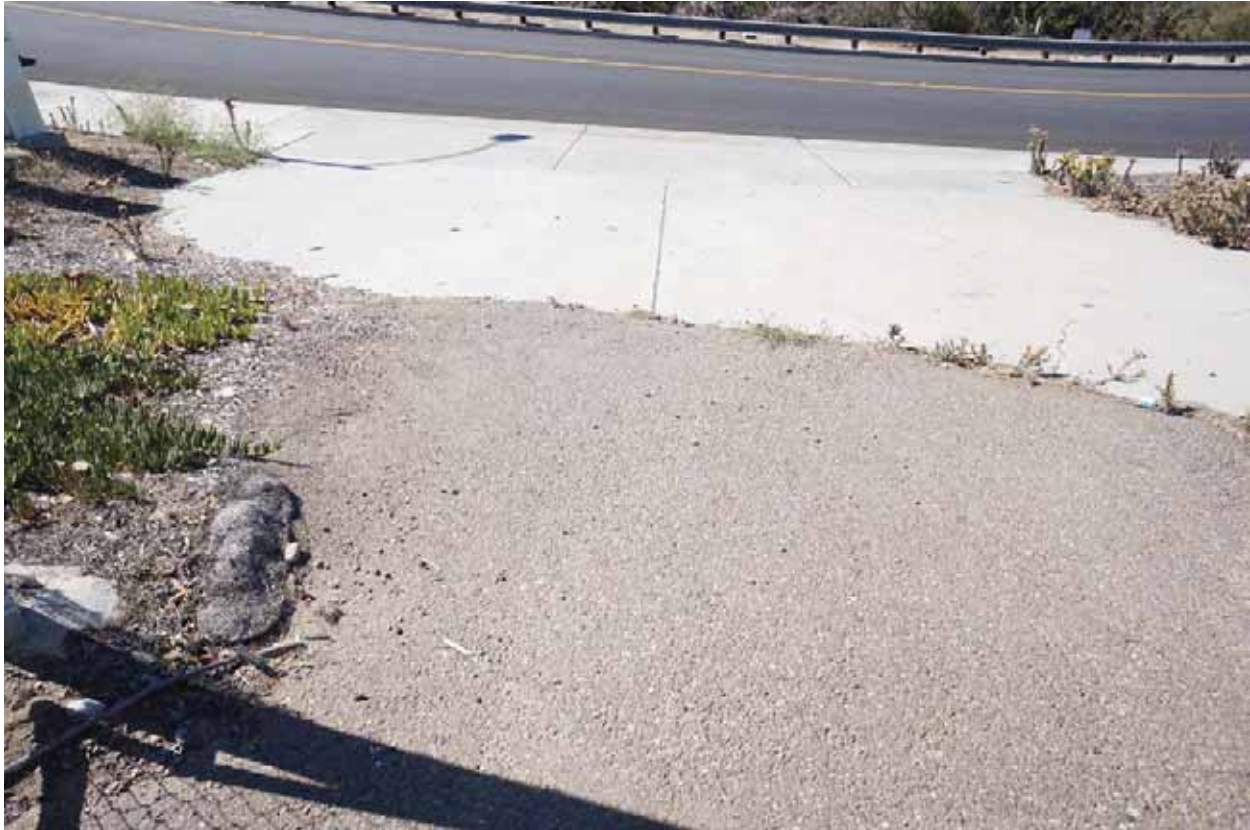
Driving Range Yard Photo taken 11/17/2016

Extensive cracking of concrete drive approach. Existing asphalt is in deteriorated condition throughout the entire drive. Cracking in the concrete gutter and cracking in existing asphalt road way.

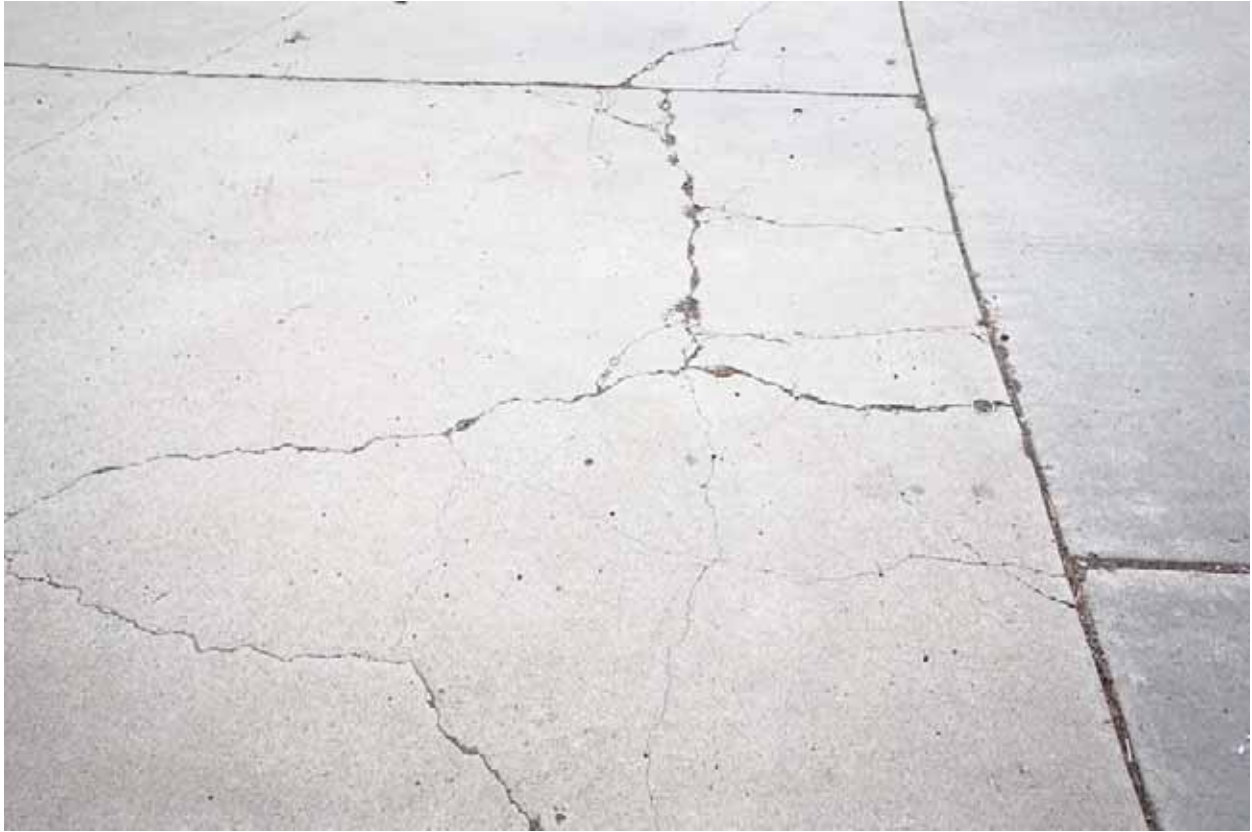
Driving Range Yard Photo taken 11/17/2016

Concrete shows cracking.

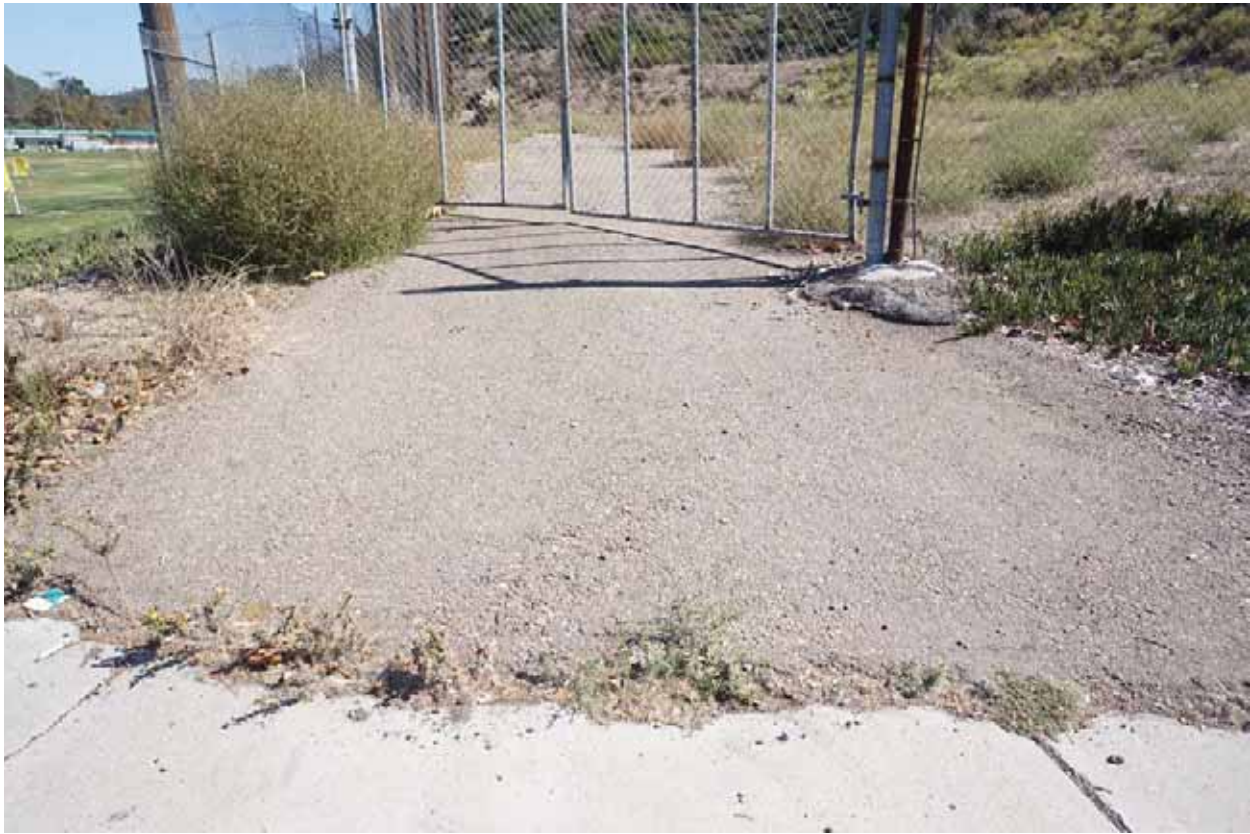
Driving Range Yard Photo taken 11/17/2016

Asphalt is deteriorated and concrete shows cracking.

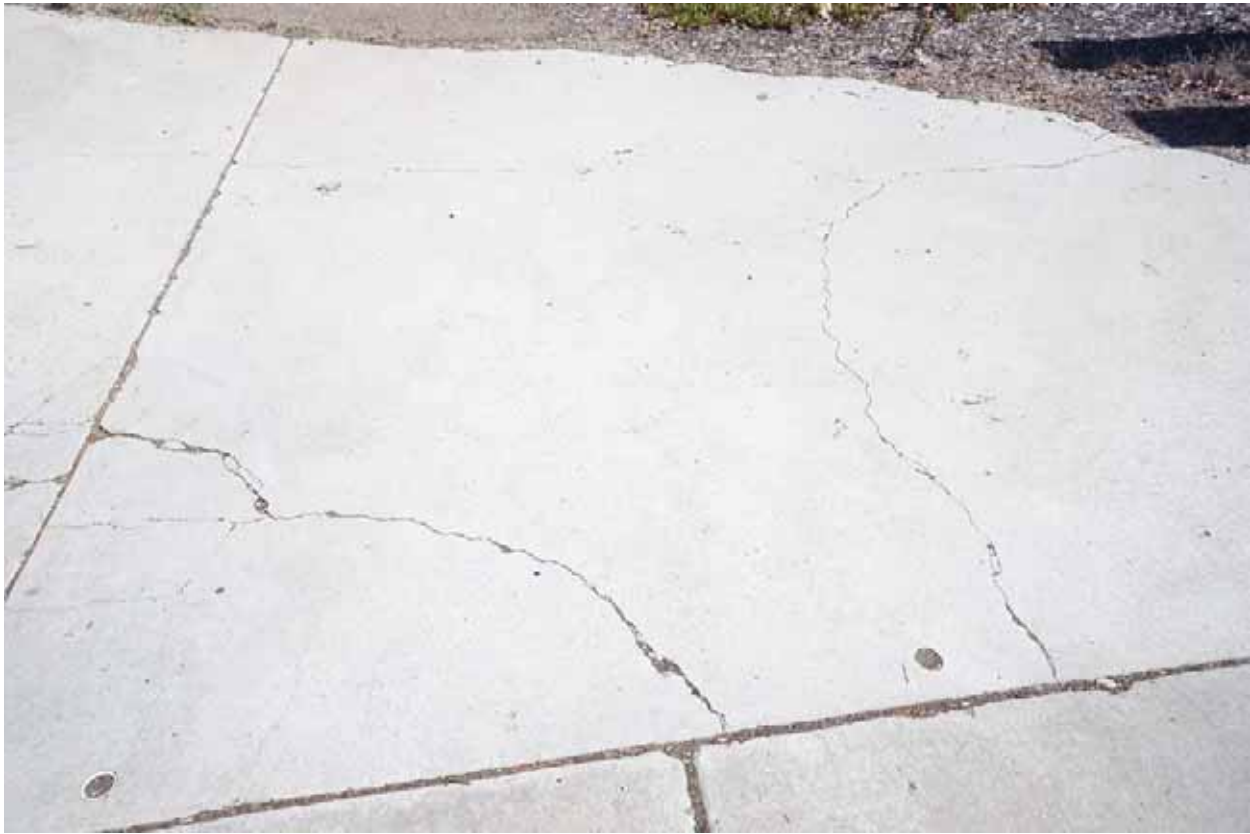
Driving Range Yard Photo taken 11/17/2016

Concrete shows cracking.

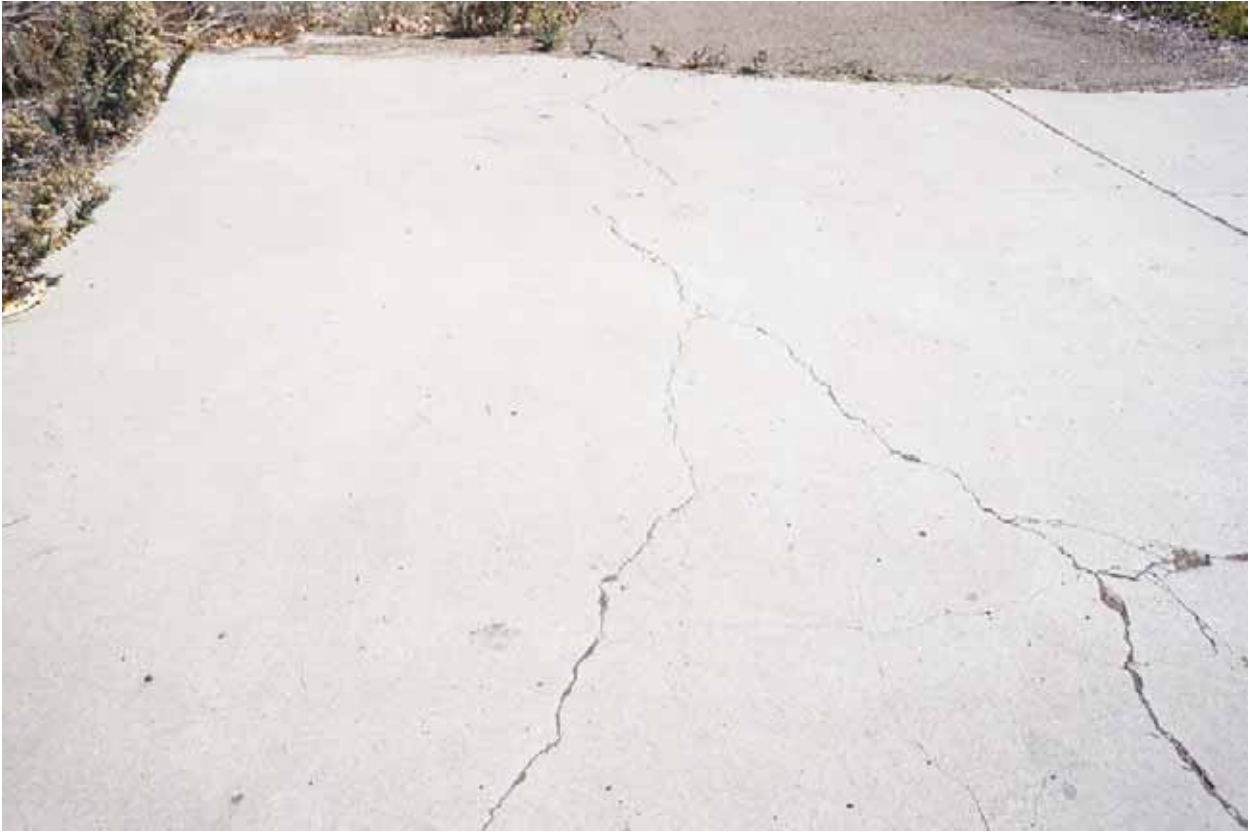
Driving Range Yard Photo taken 11/17/2016

Concrete shows cracking.

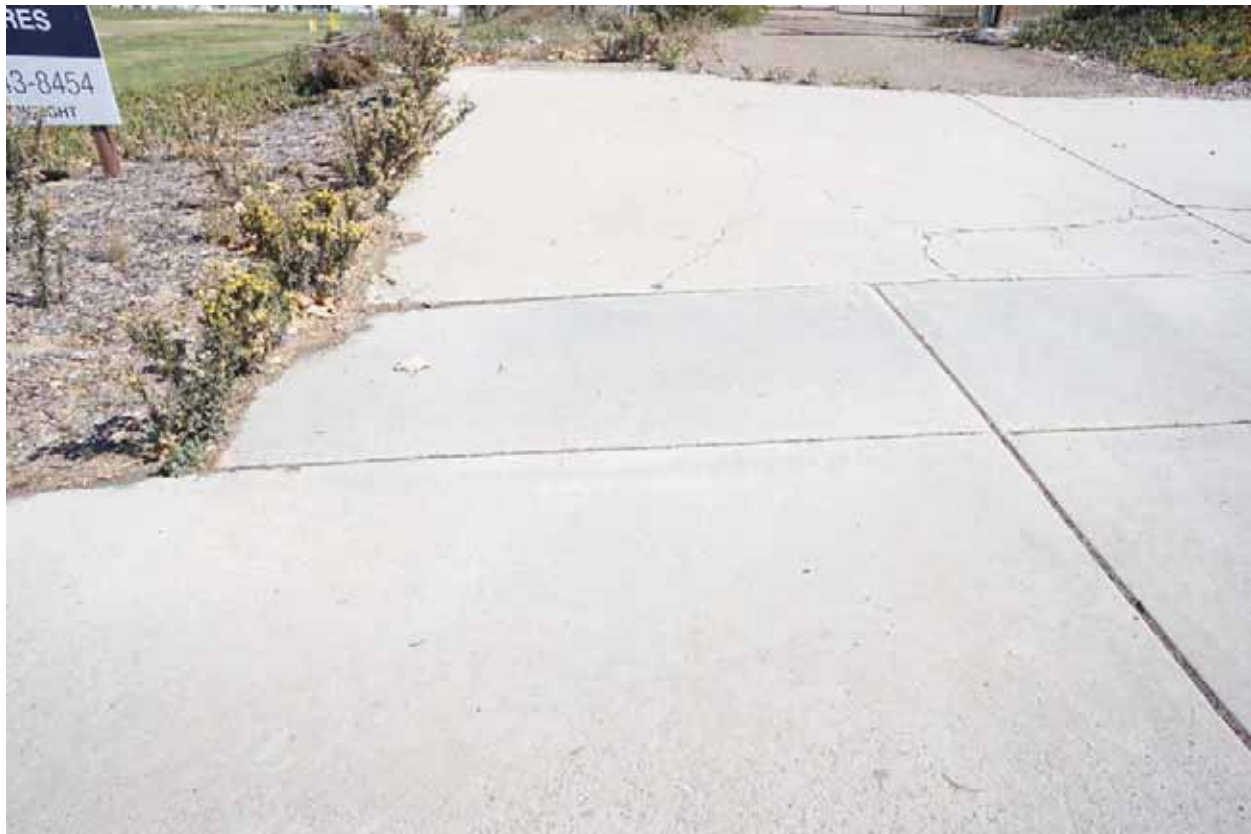
Driving Range Yard Photo taken 11/17/2016

Concrete shows cracking.

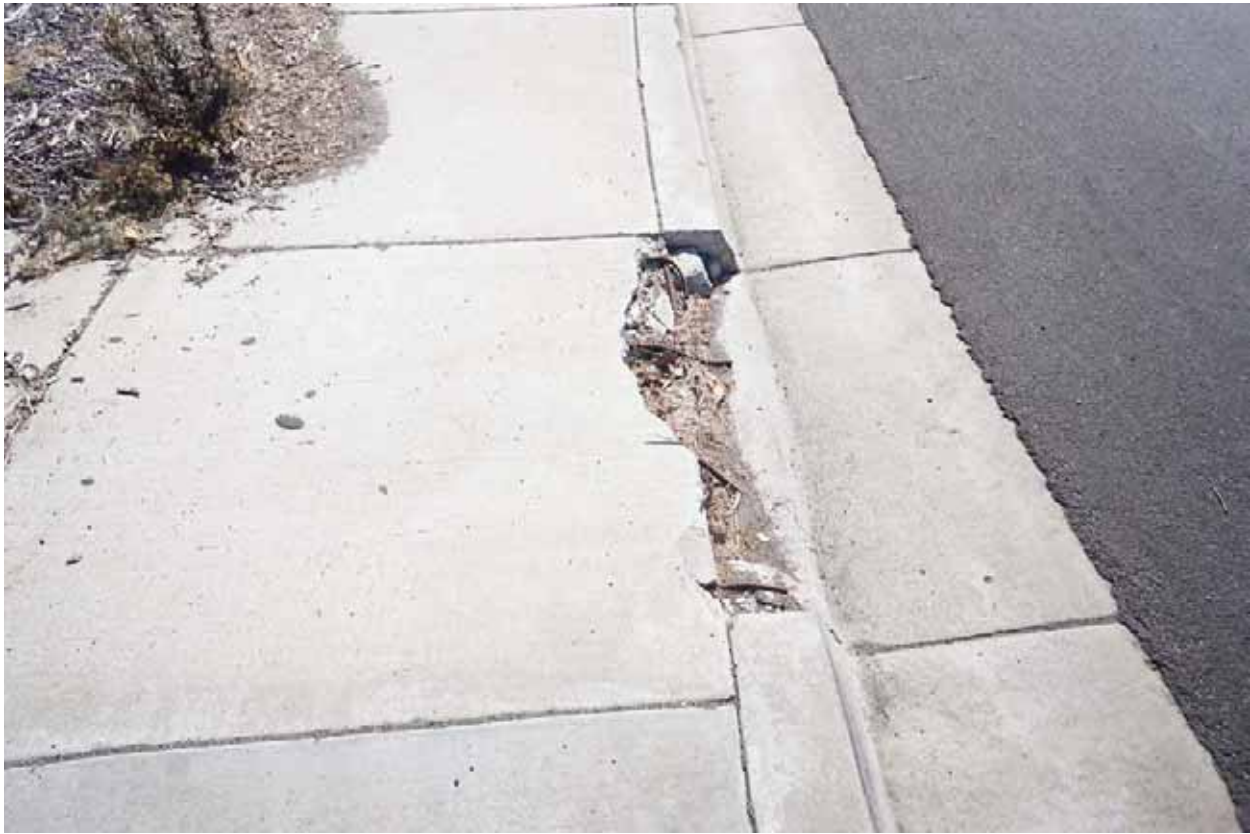
Driving Range Yard Photo taken 11/17/2016

Existing damaged concrete north of project entrance.

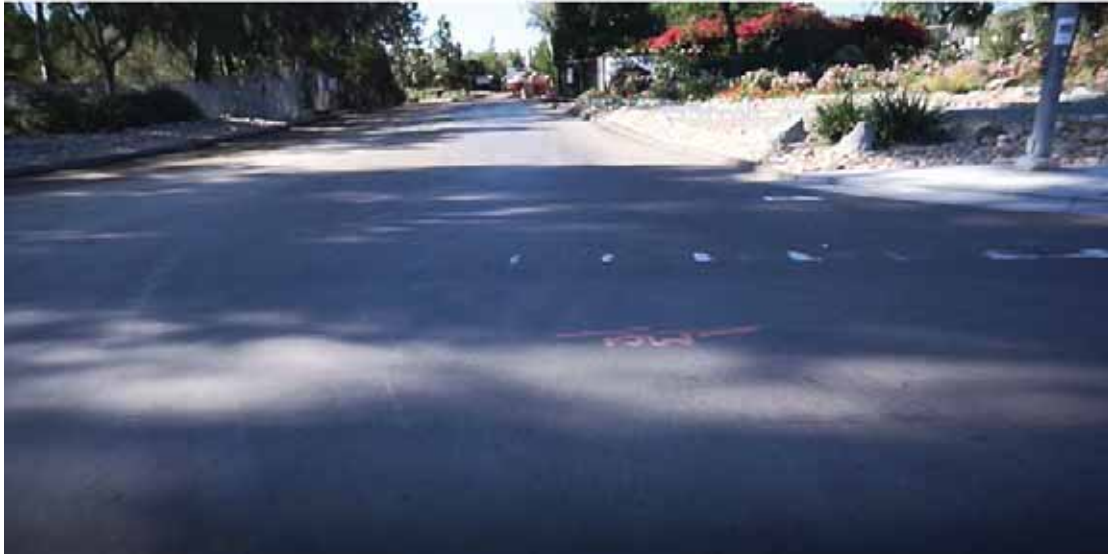
Vulcan Mine Yard Photo taken 11/22/2016

The entrance to sites 1A & 1B is well maintained asphalt and does not show signs of any existing damage.

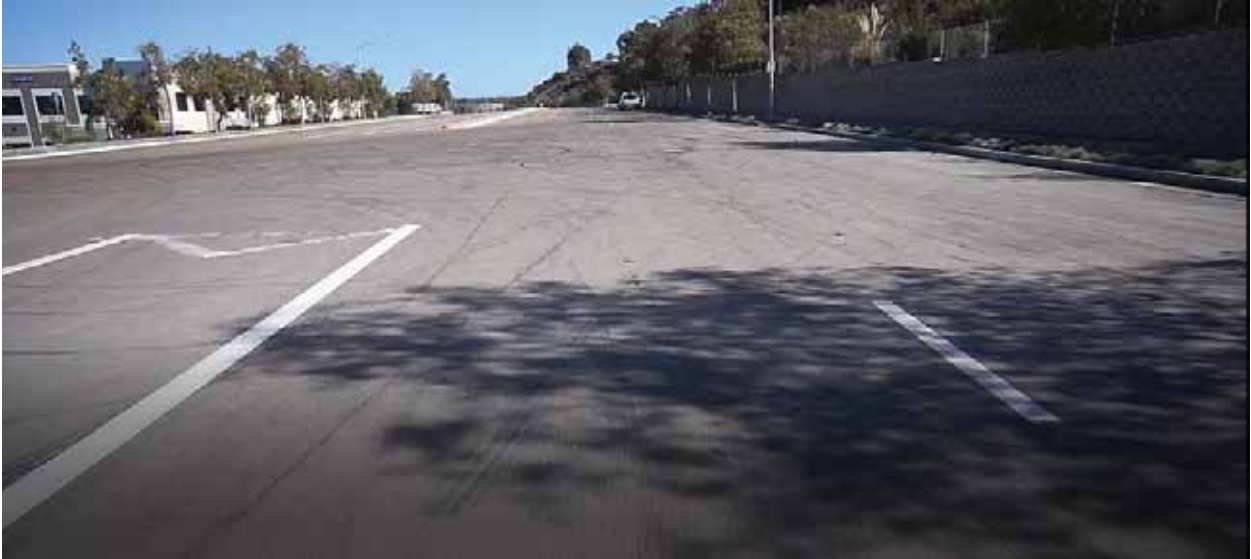
Vulcan Mine Yard Photo taken 11/22/2016

The entrance point to site 2 (shown looking directly east) has minor scratching and cracking to the asphalt.

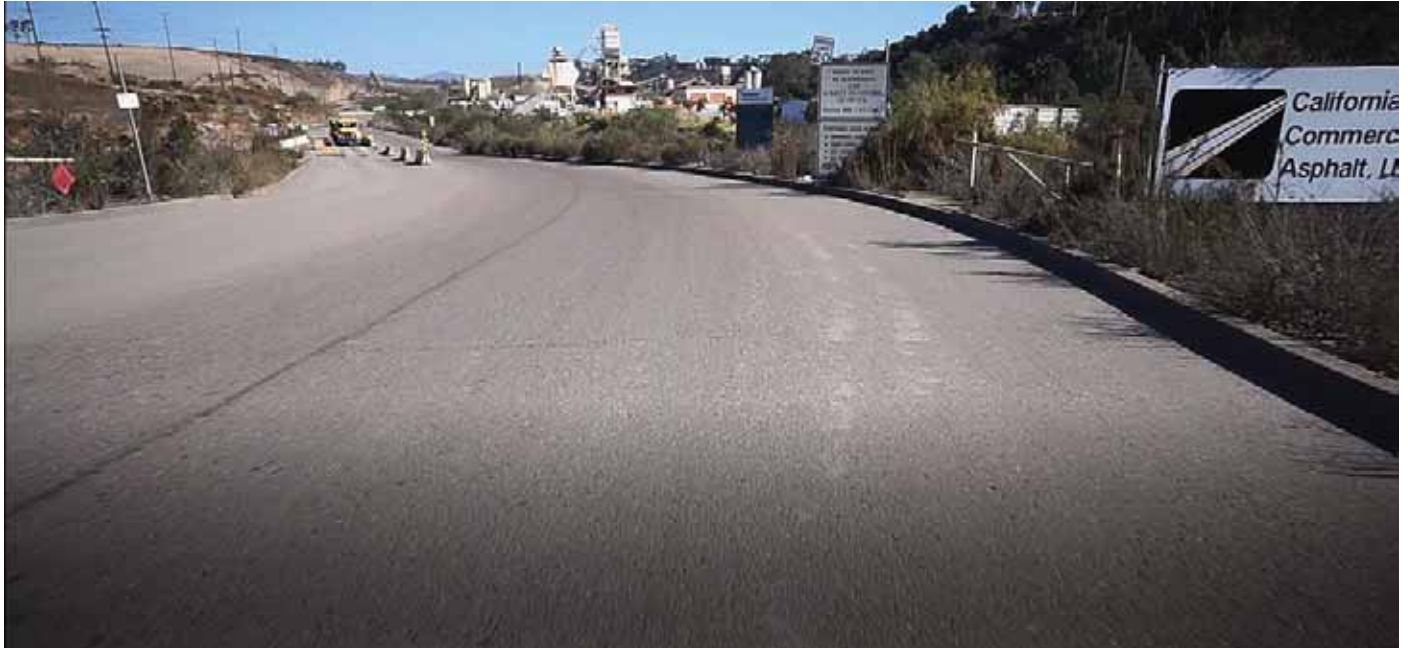
Vulcan Mine Yard Photo taken 11/22/2016

The entrance point to site 3 would need to be developed. The photo shows the anticipated entrance point to this yard. The asphalt here is well maintained and does not show much signs of wear or damage.

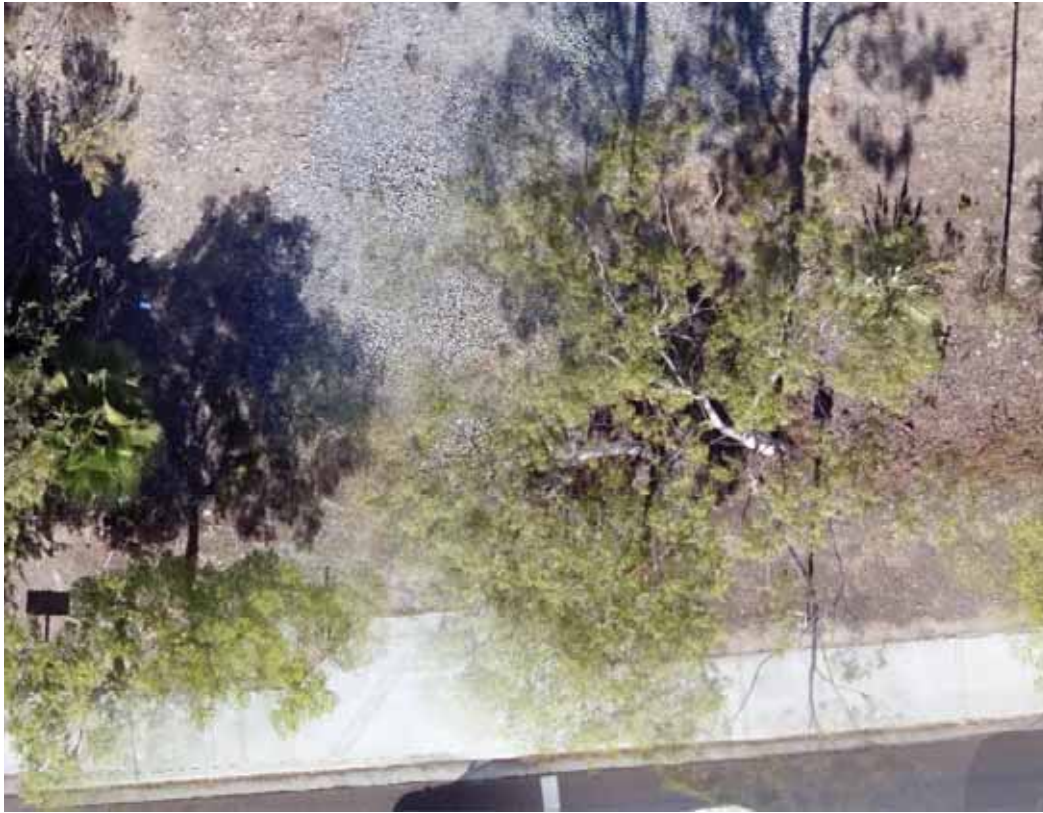
Stowe Staging Yard Aerial Photo taken 11/17/2016

The photo shows the anticipated entrance point to this yard on the south-side of the yard off of Stowe Drive. Driveway improvements would be needed to accommodate access to the site.

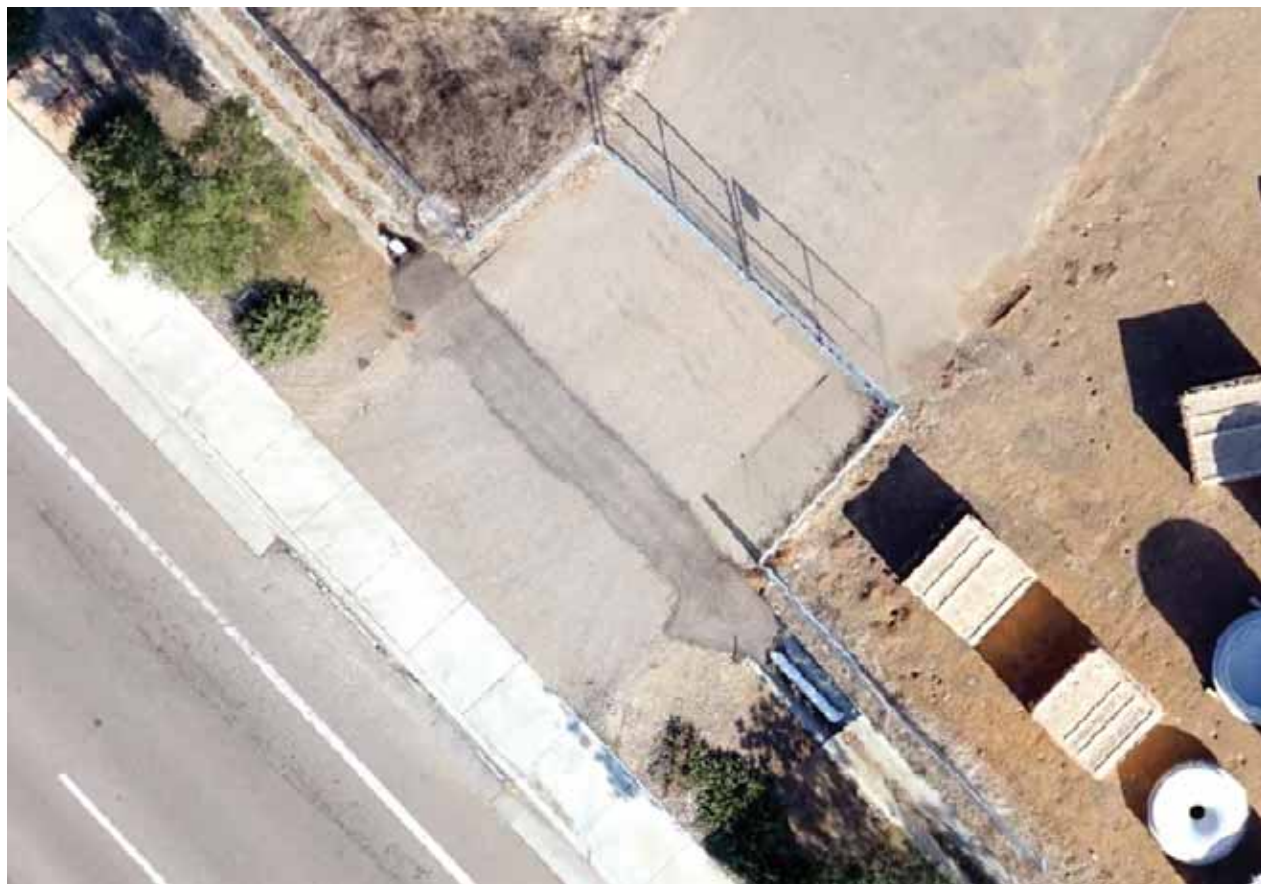
Carmel Valley Staging Yard Aerial Photo taken 11/17/2016

Considerable amounts of damage, cracking and scratching to both the concrete and the asphalt can be seen in this aerial photo of the entrance to the Carmel Valley Staging Yard.

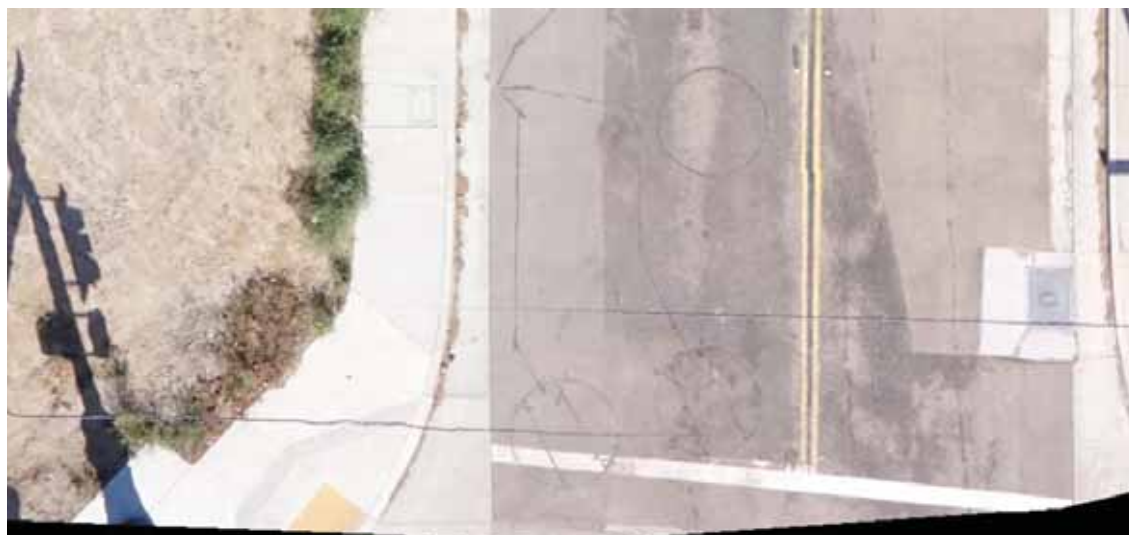
Evergreen Nursery Staging Yard Aerial Photo taken 11/17/2016

The entrance to the Evergreen Nursery Staging Yard appears to be at the intersection of Carmel Valley Road and Via Abertuna Drive. This photo shows the entrance on Via Abertuna Drive. Cracking and scratches to the asphalt and the concrete are visible.
