Memo

**Re: MM TRA-3 SX-PQ Pre-Construction Road Condition – UG Alignment Update
– Carroll Canyon at Scranton Road (Station 16+50 – 35+25)**

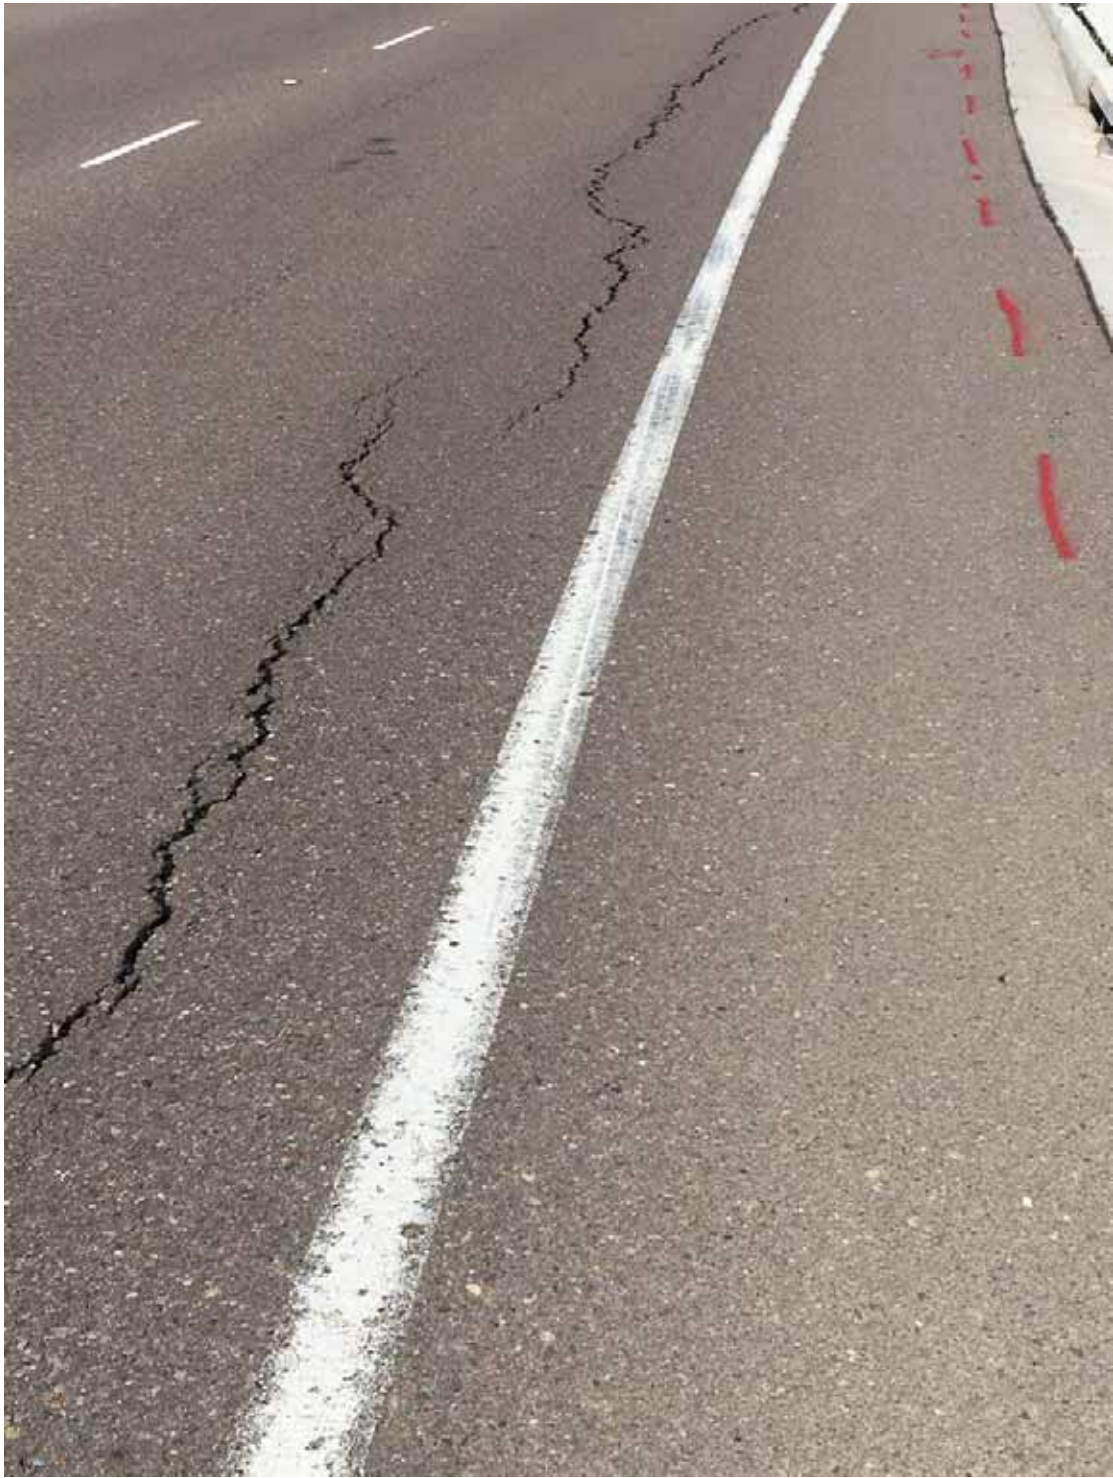
Photo 1: Pavement differential settlement

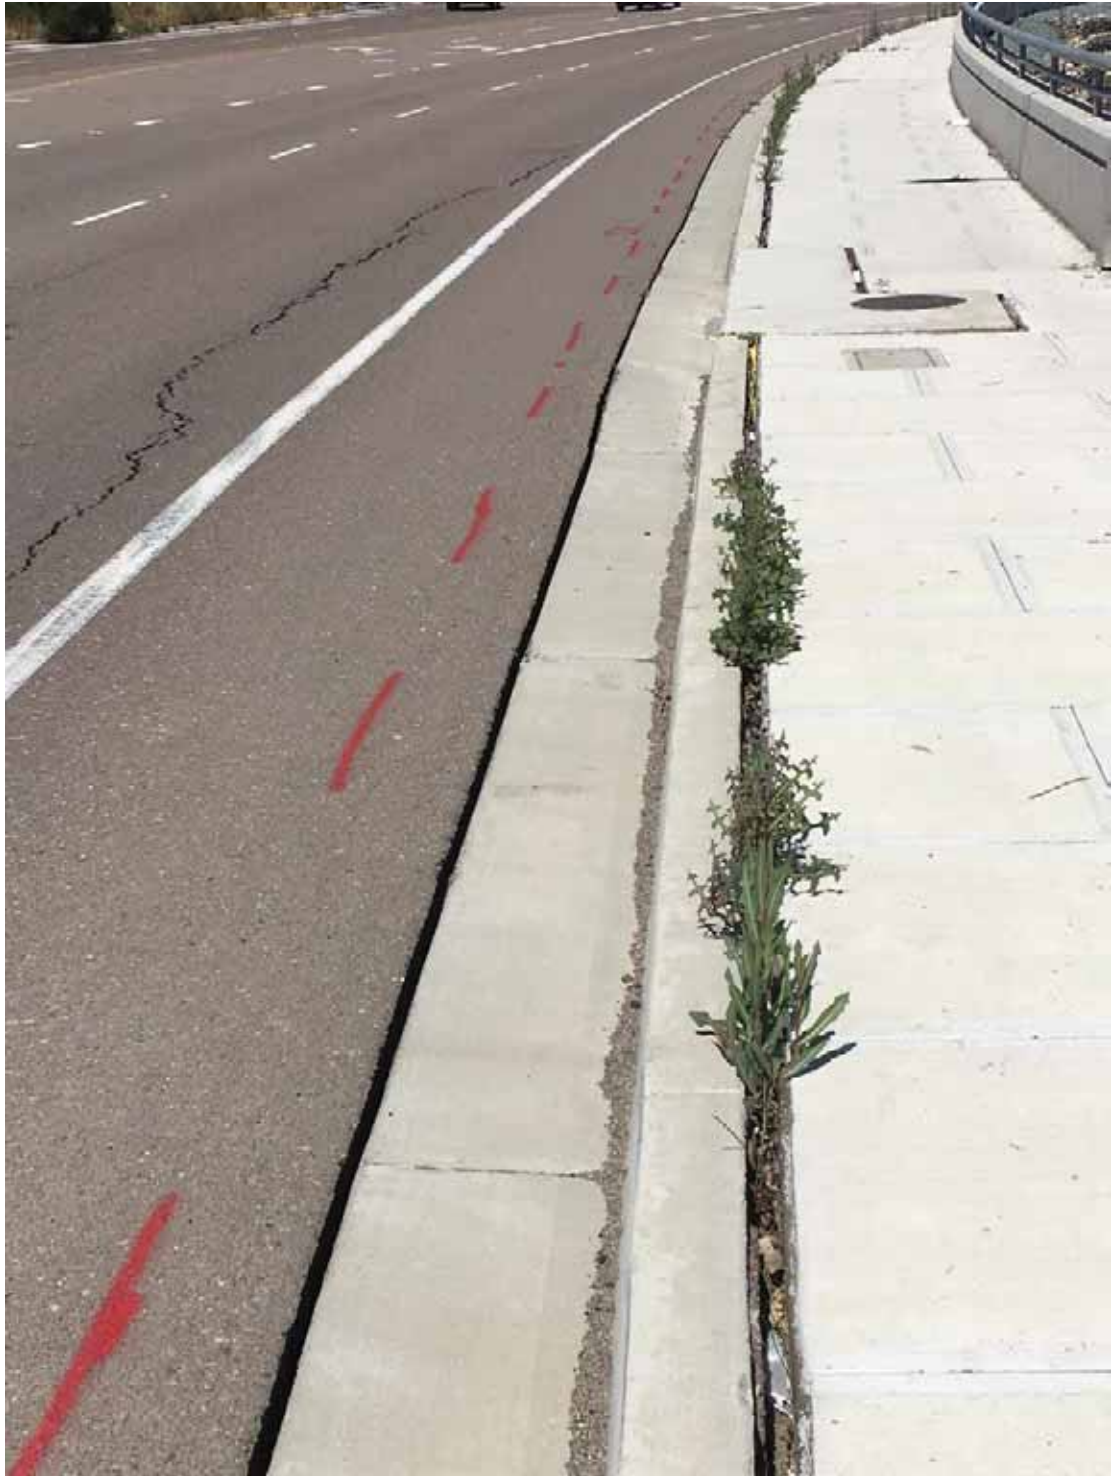
Photo 2: Pavement differential settlement

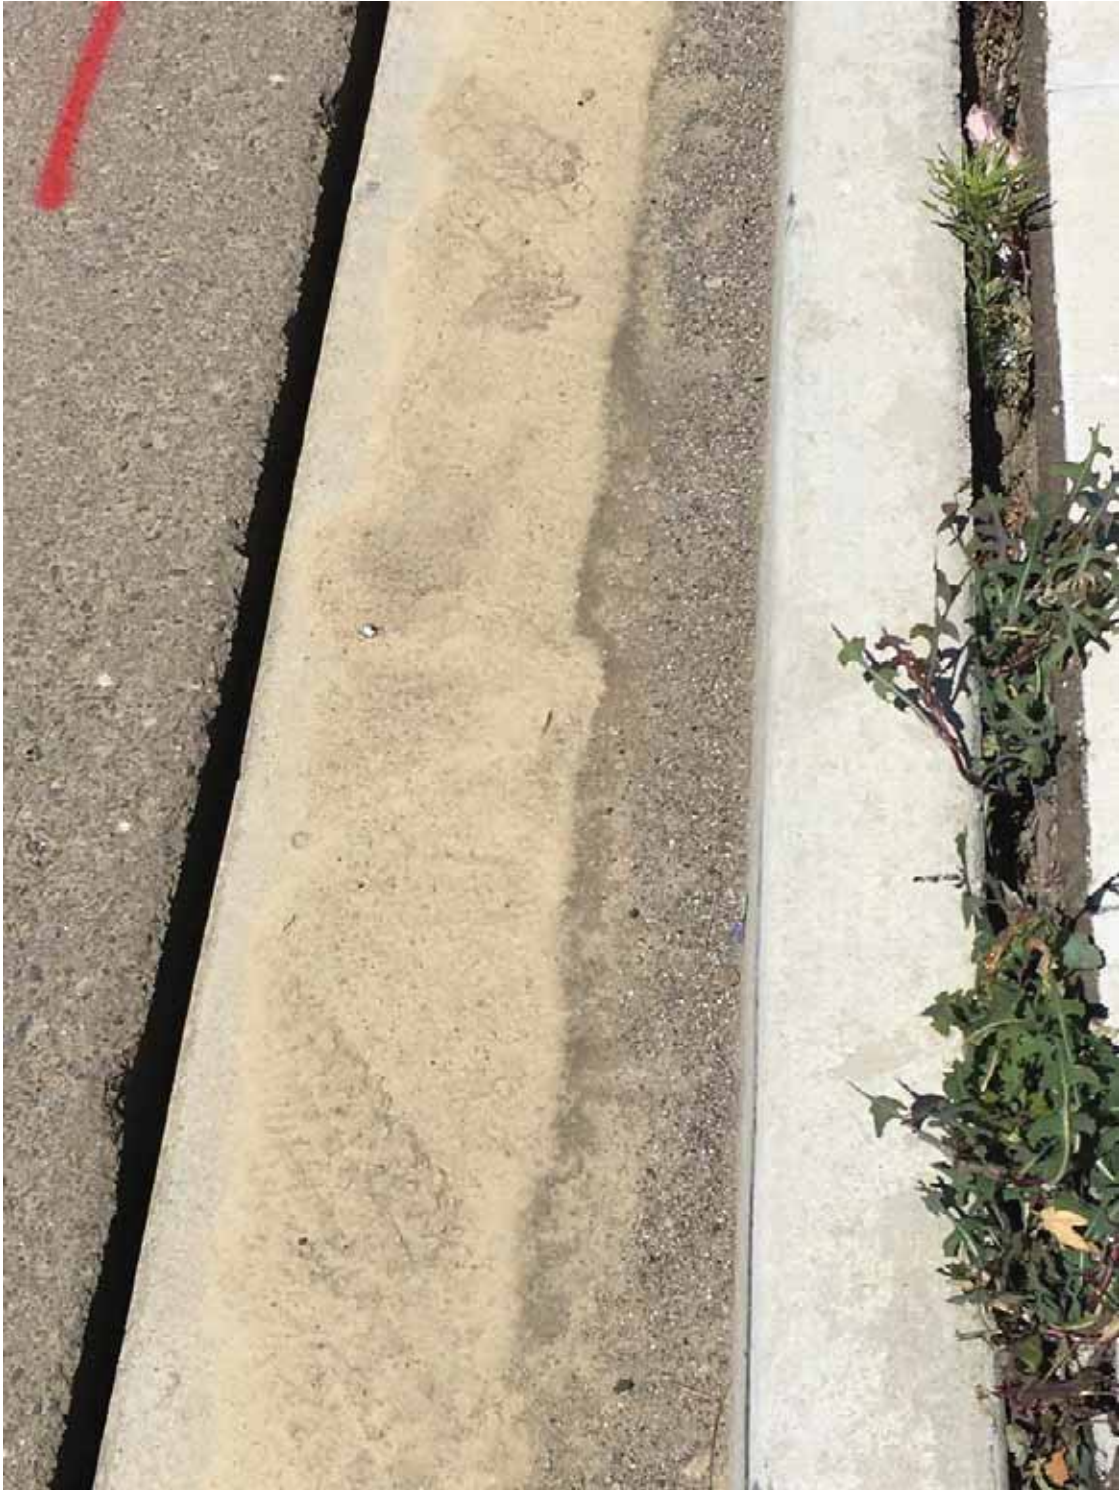
Photo 3: Pavement differential settlement

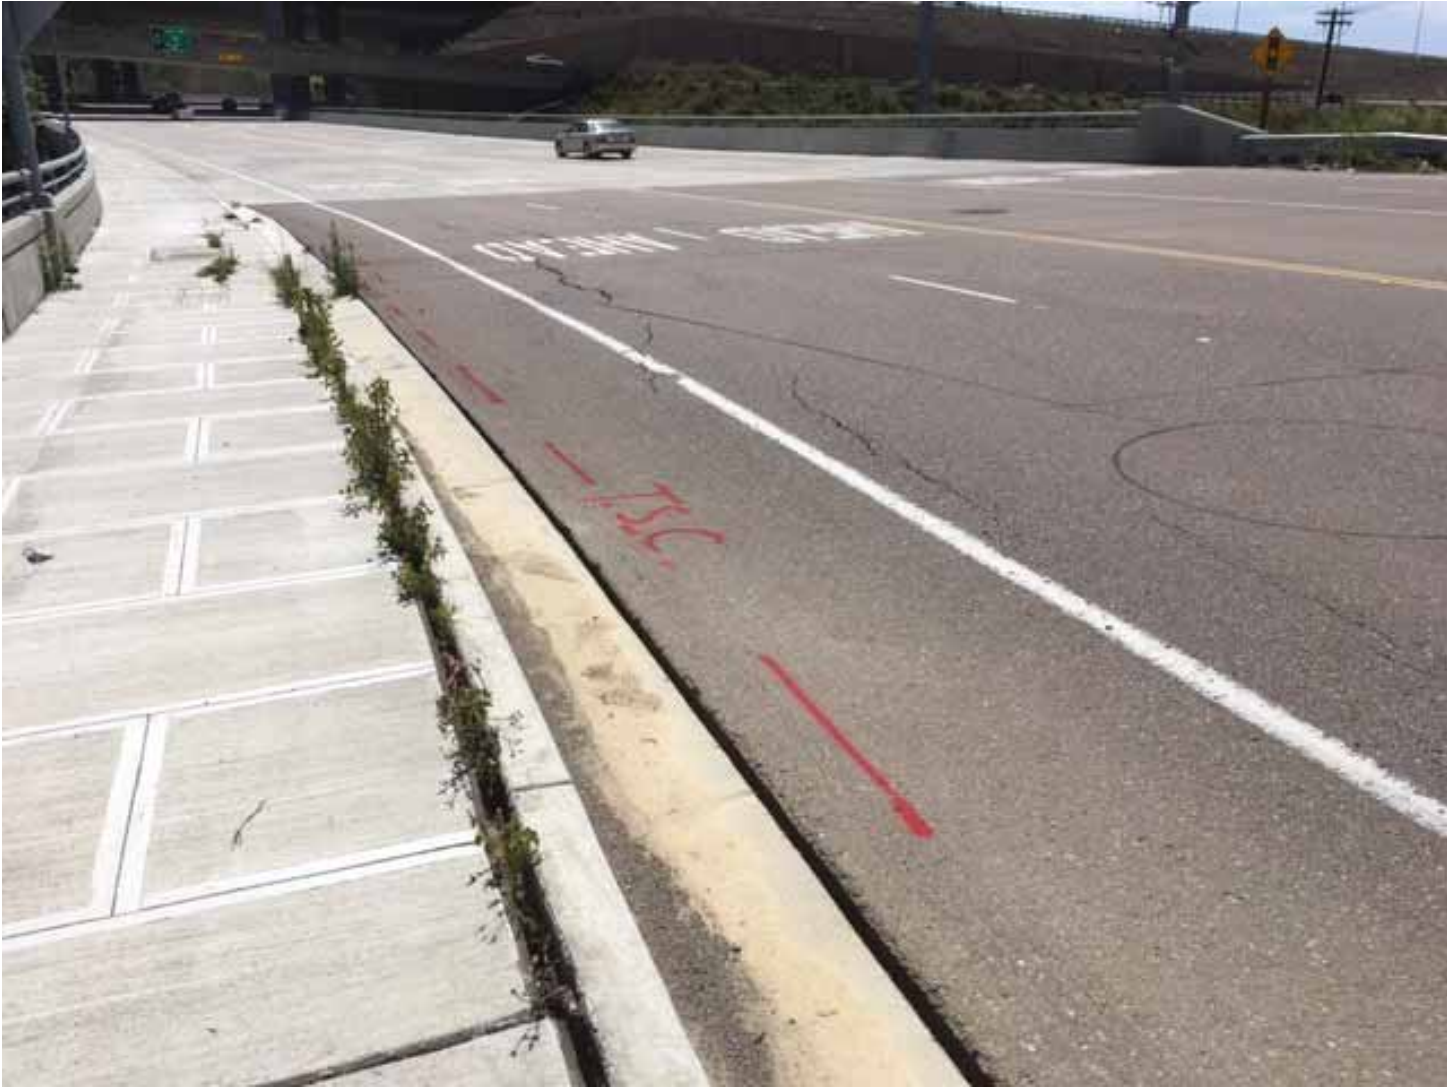
Photo 4: Pavement differential settlement

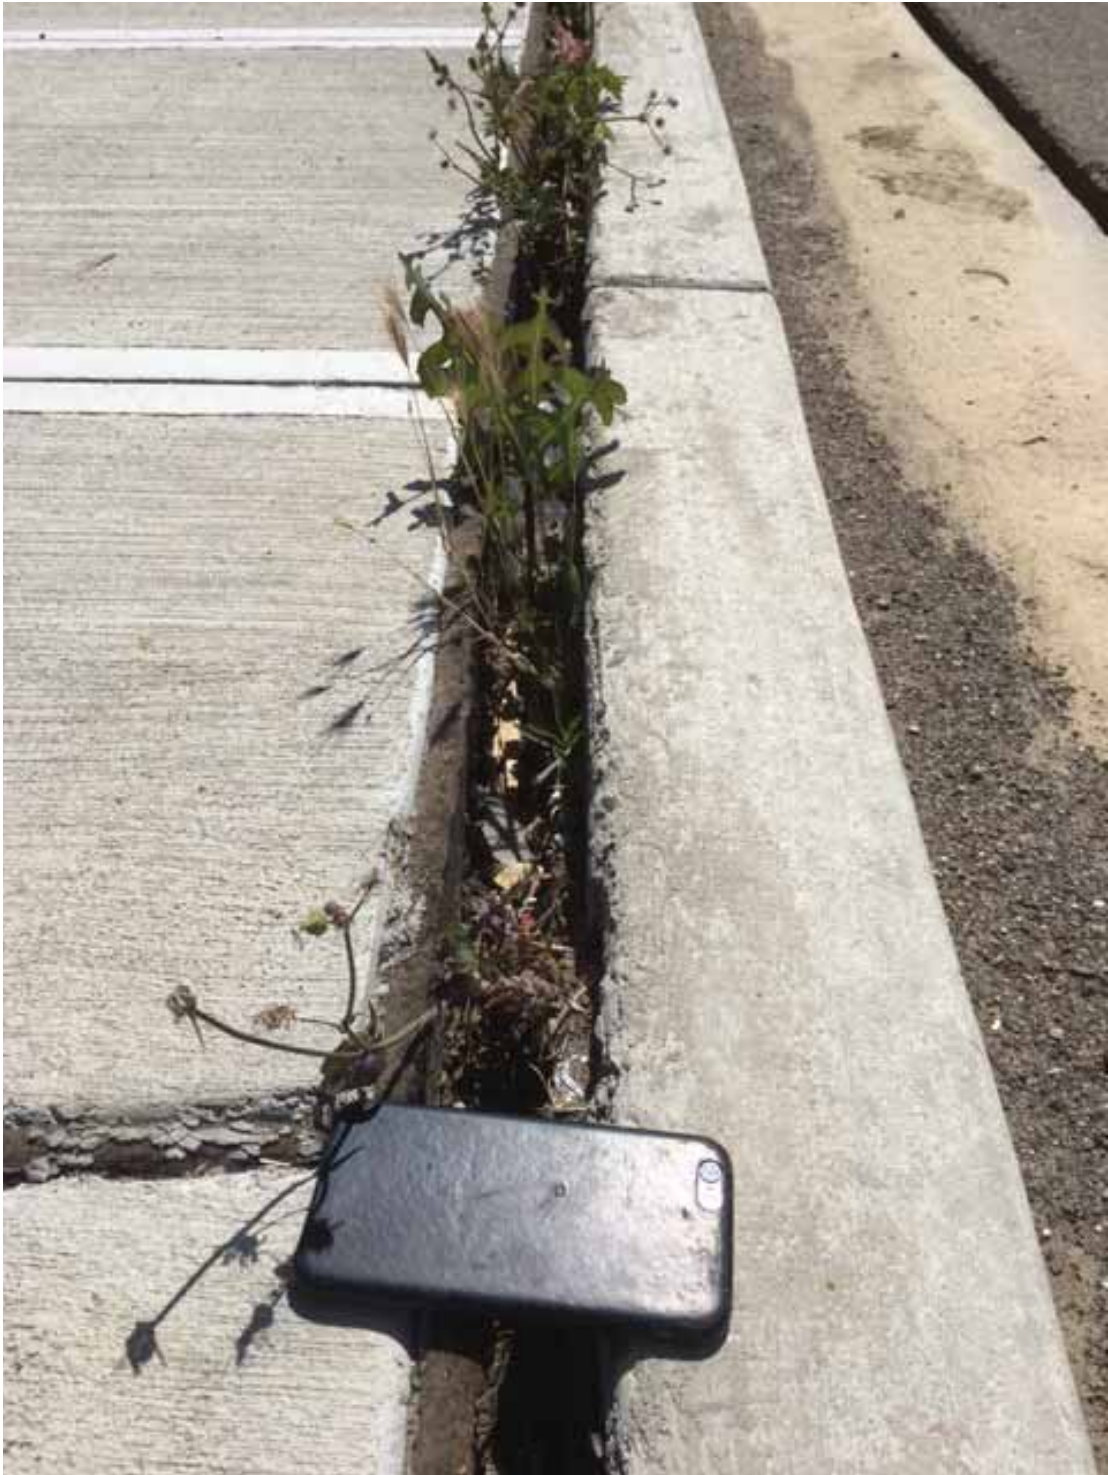
Photo 5: Pavement differential settlement

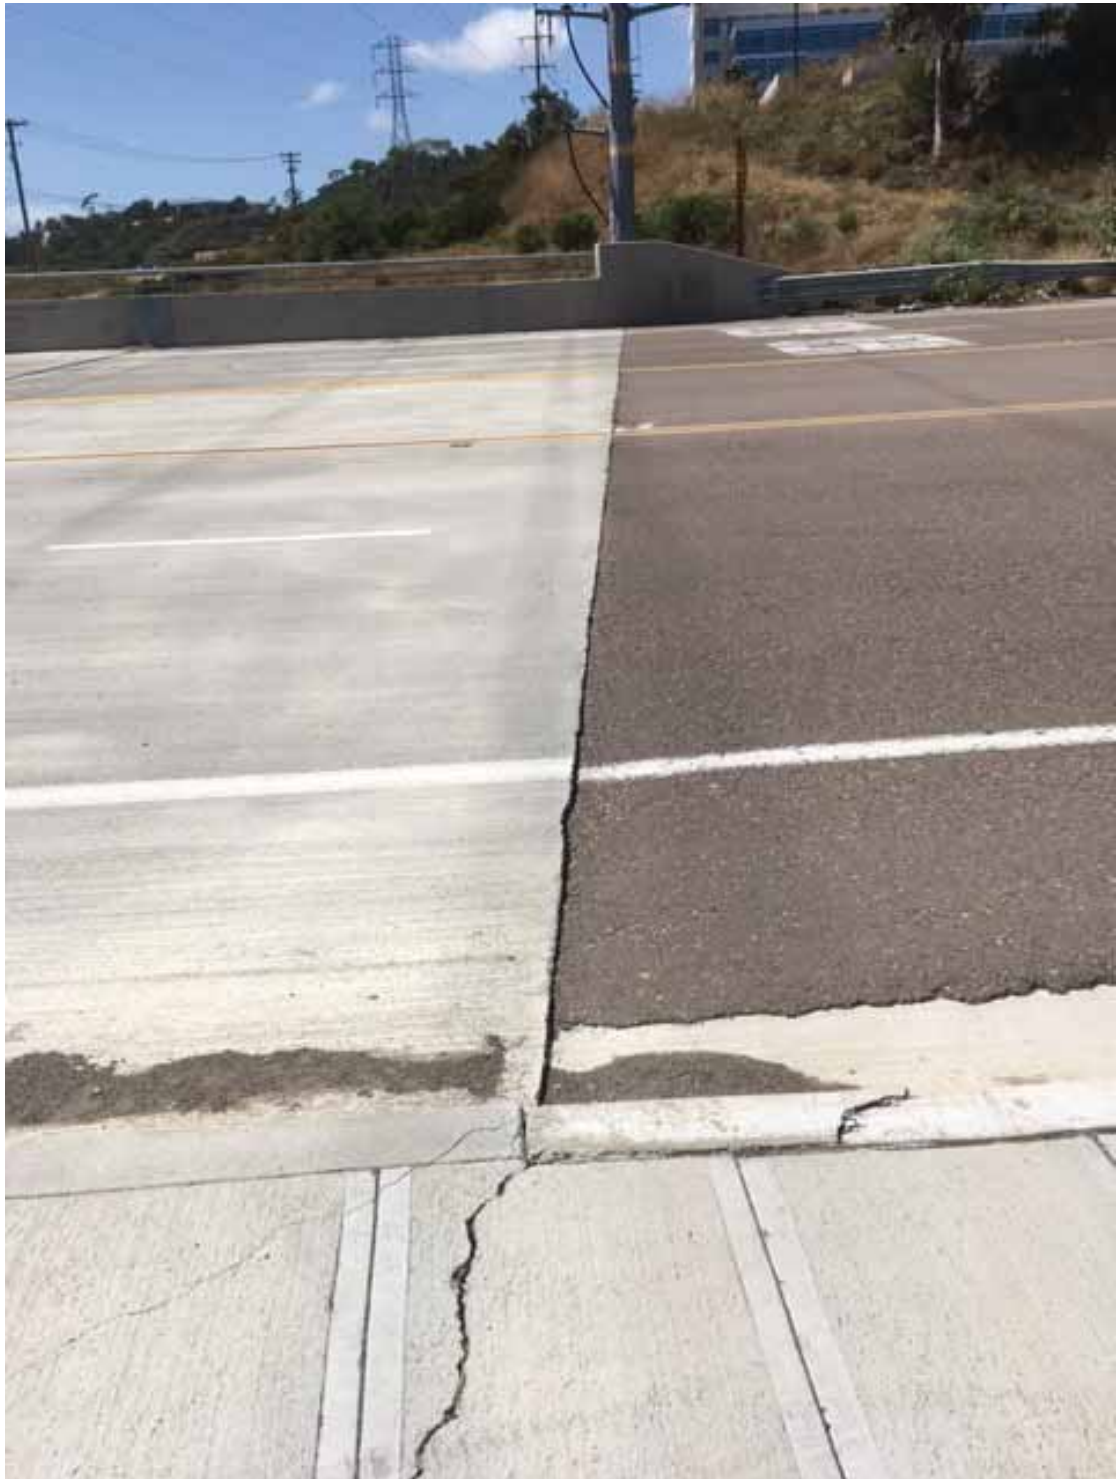
Photo 6: Pavement differential settlement

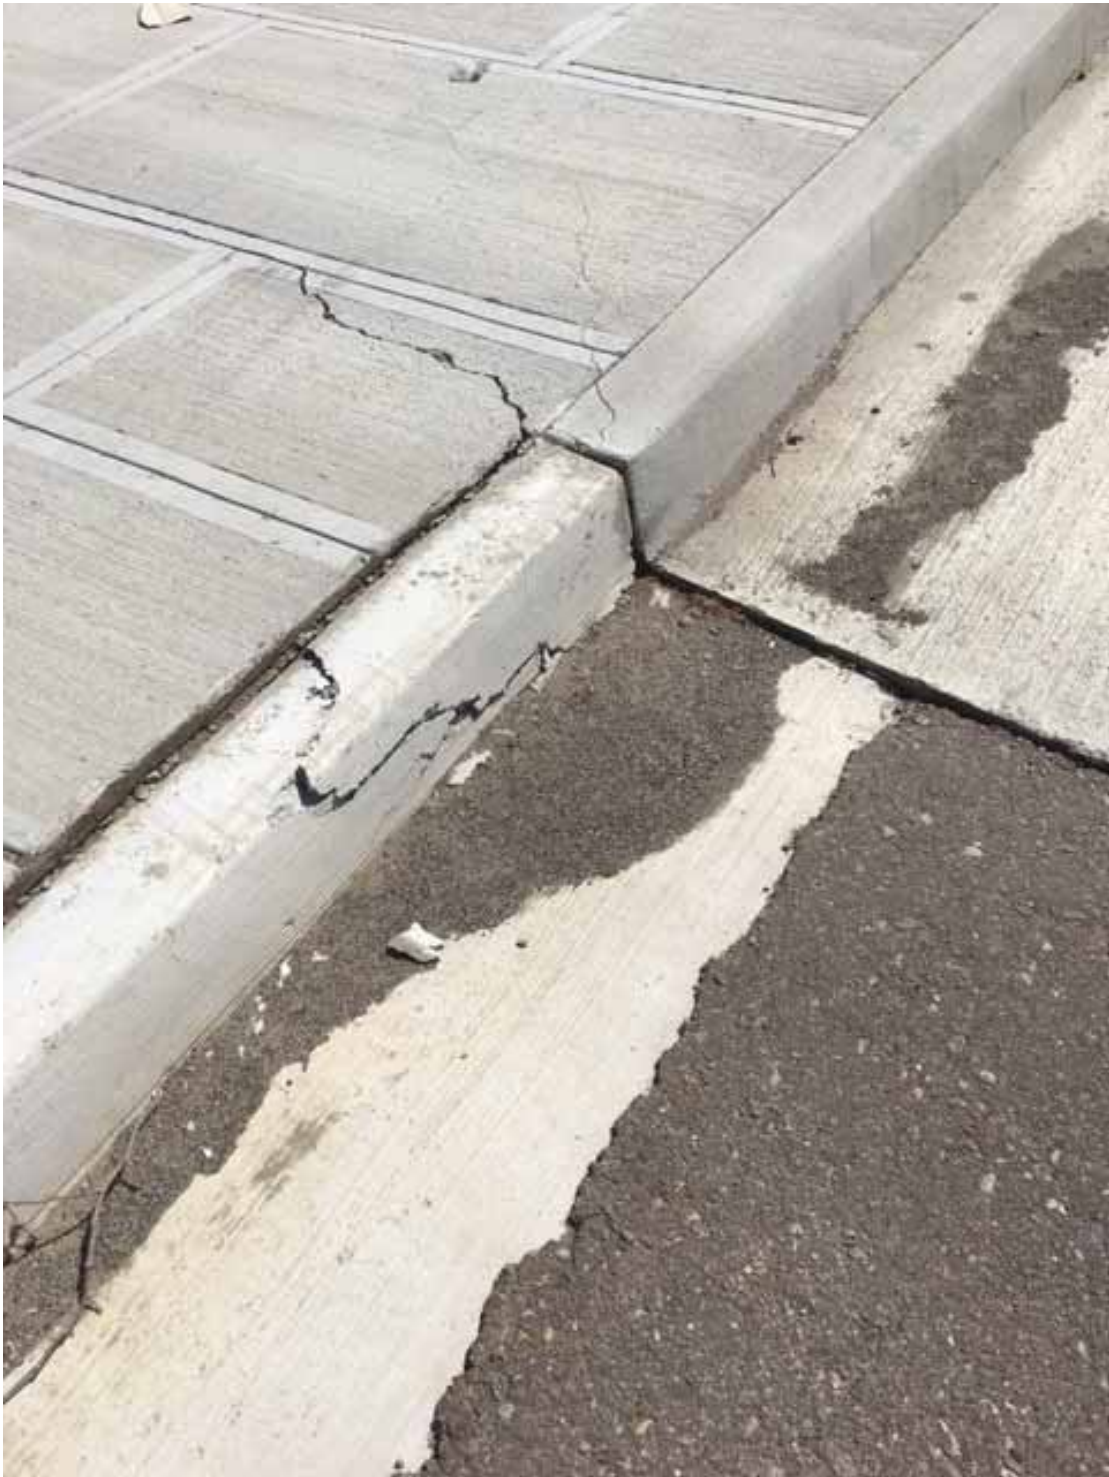
Photo 7: Pavement differential settlement

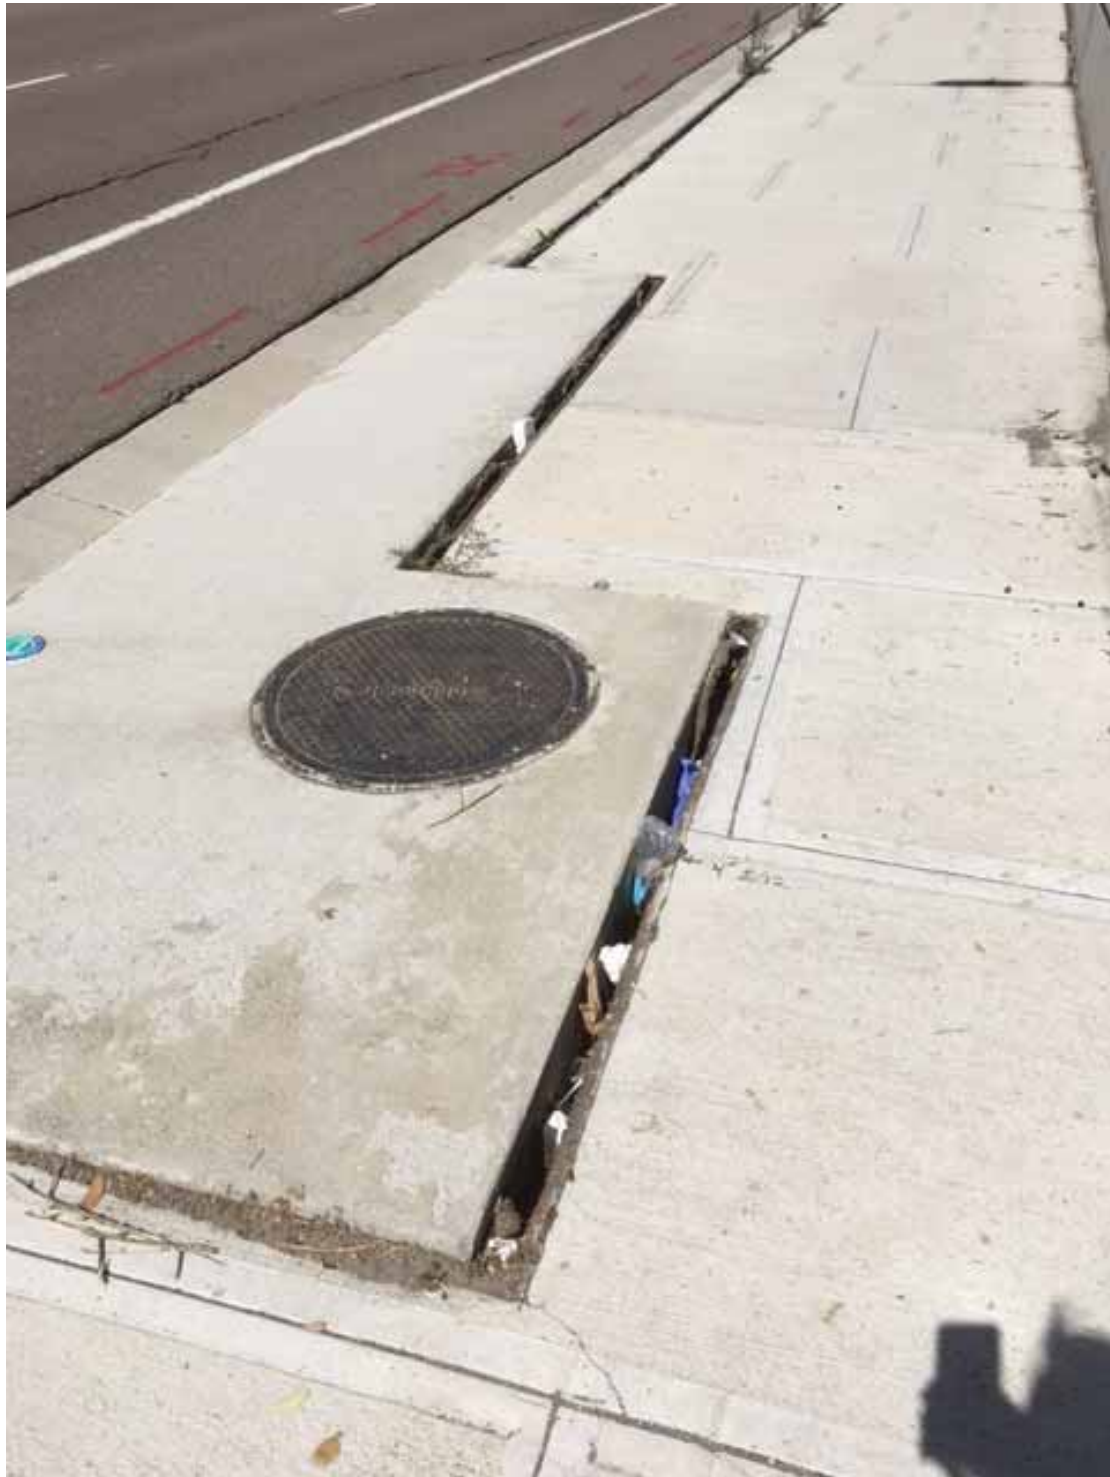
Photo 8: Pavement differential settlement

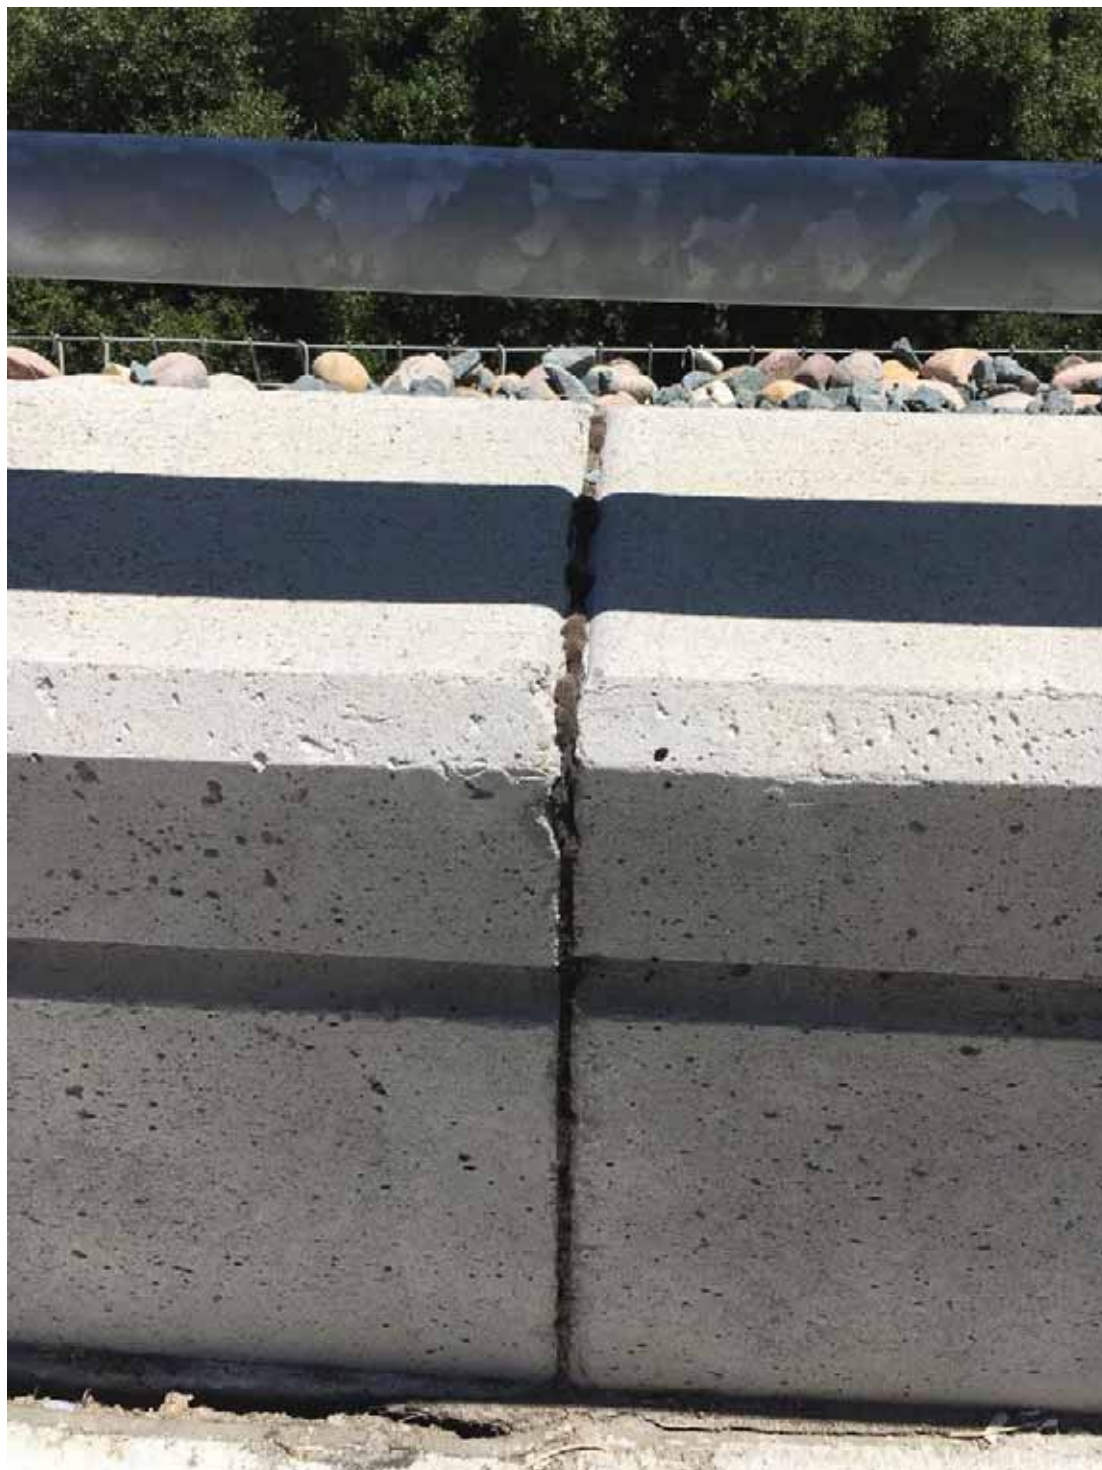
Photo 9: Pavement differential settlement

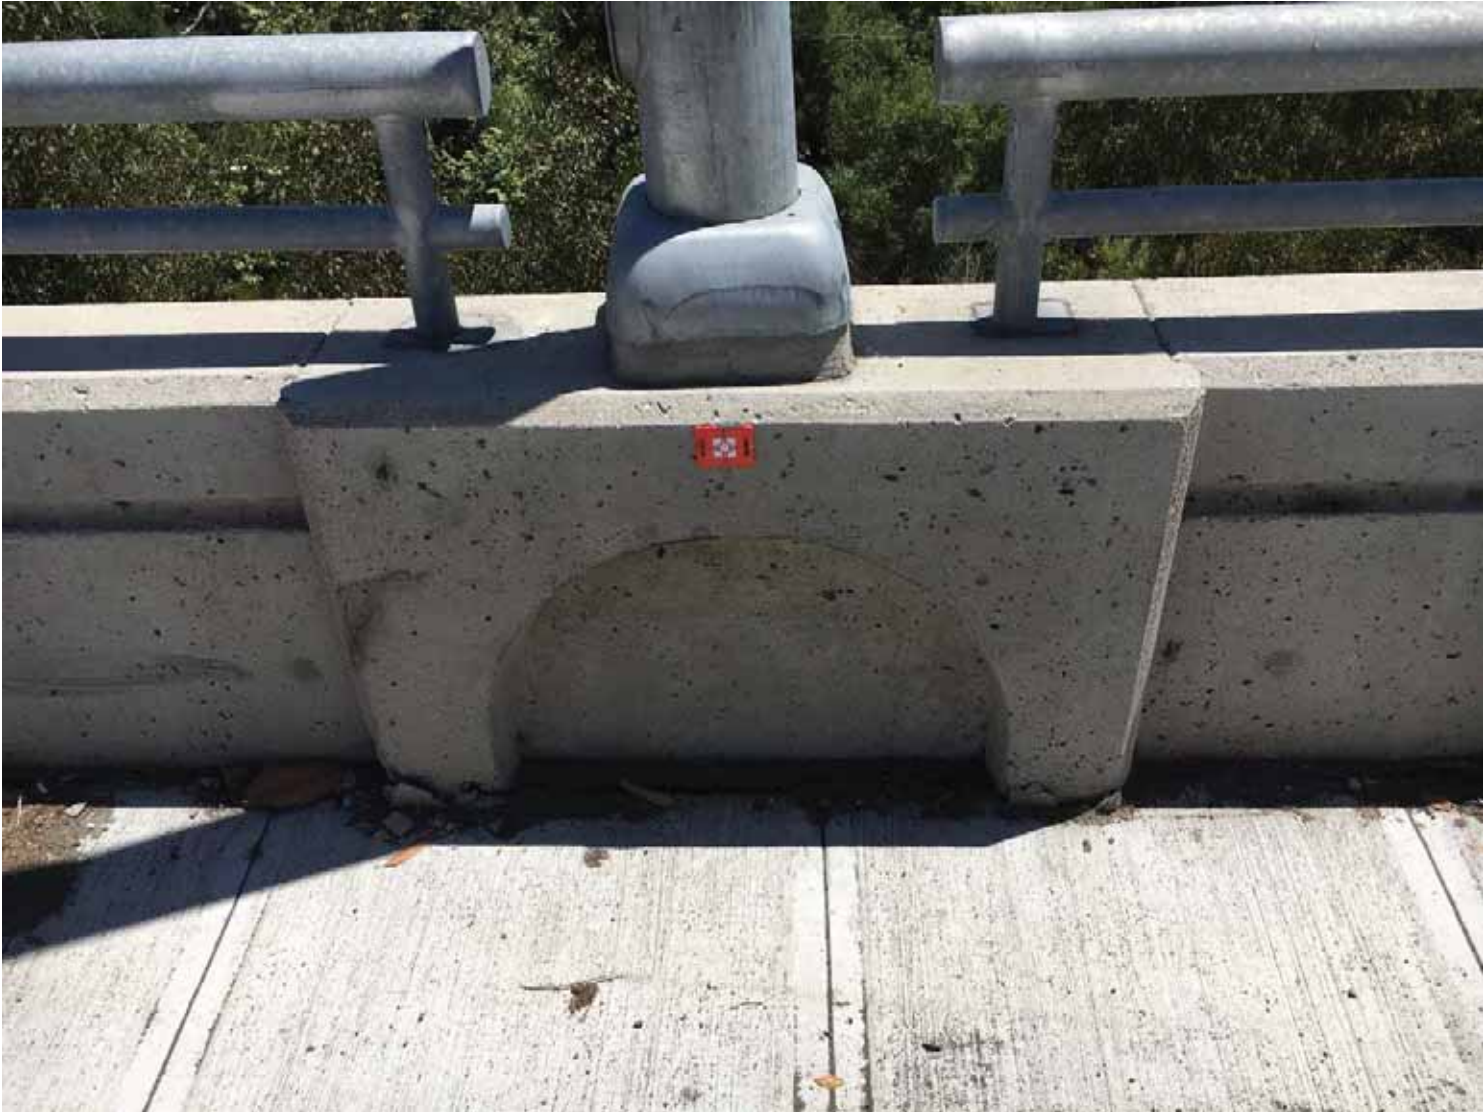
Photo 10: Pavement differential settlement

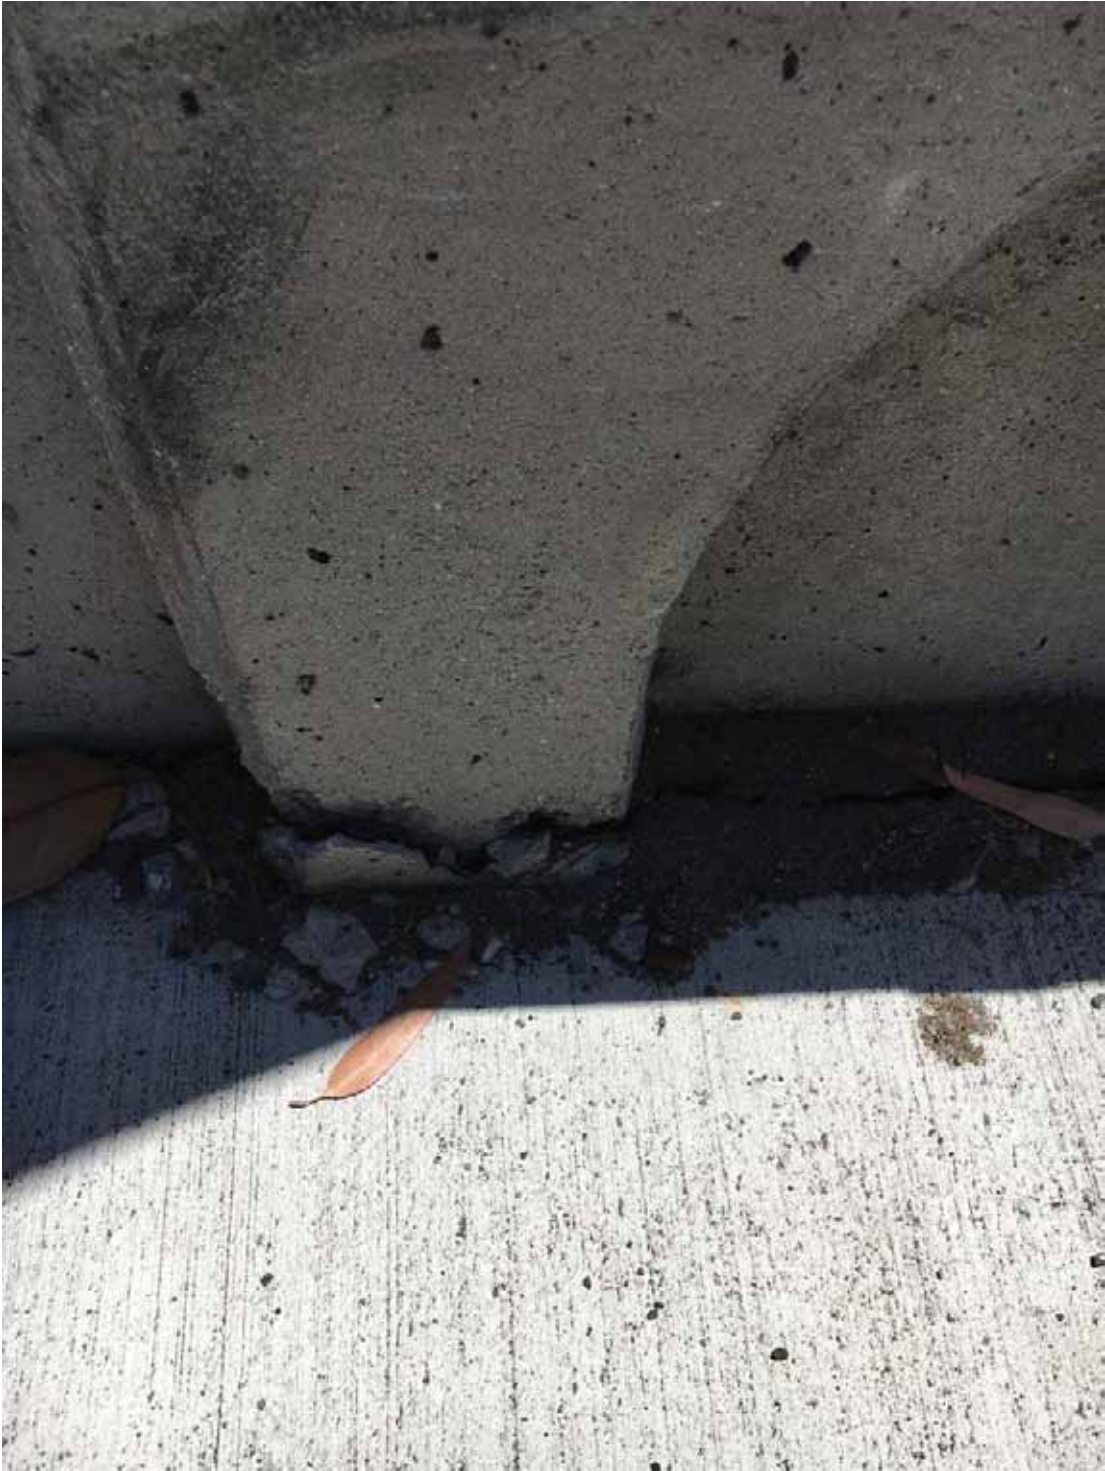
Photo 11: Pavement differential settlement

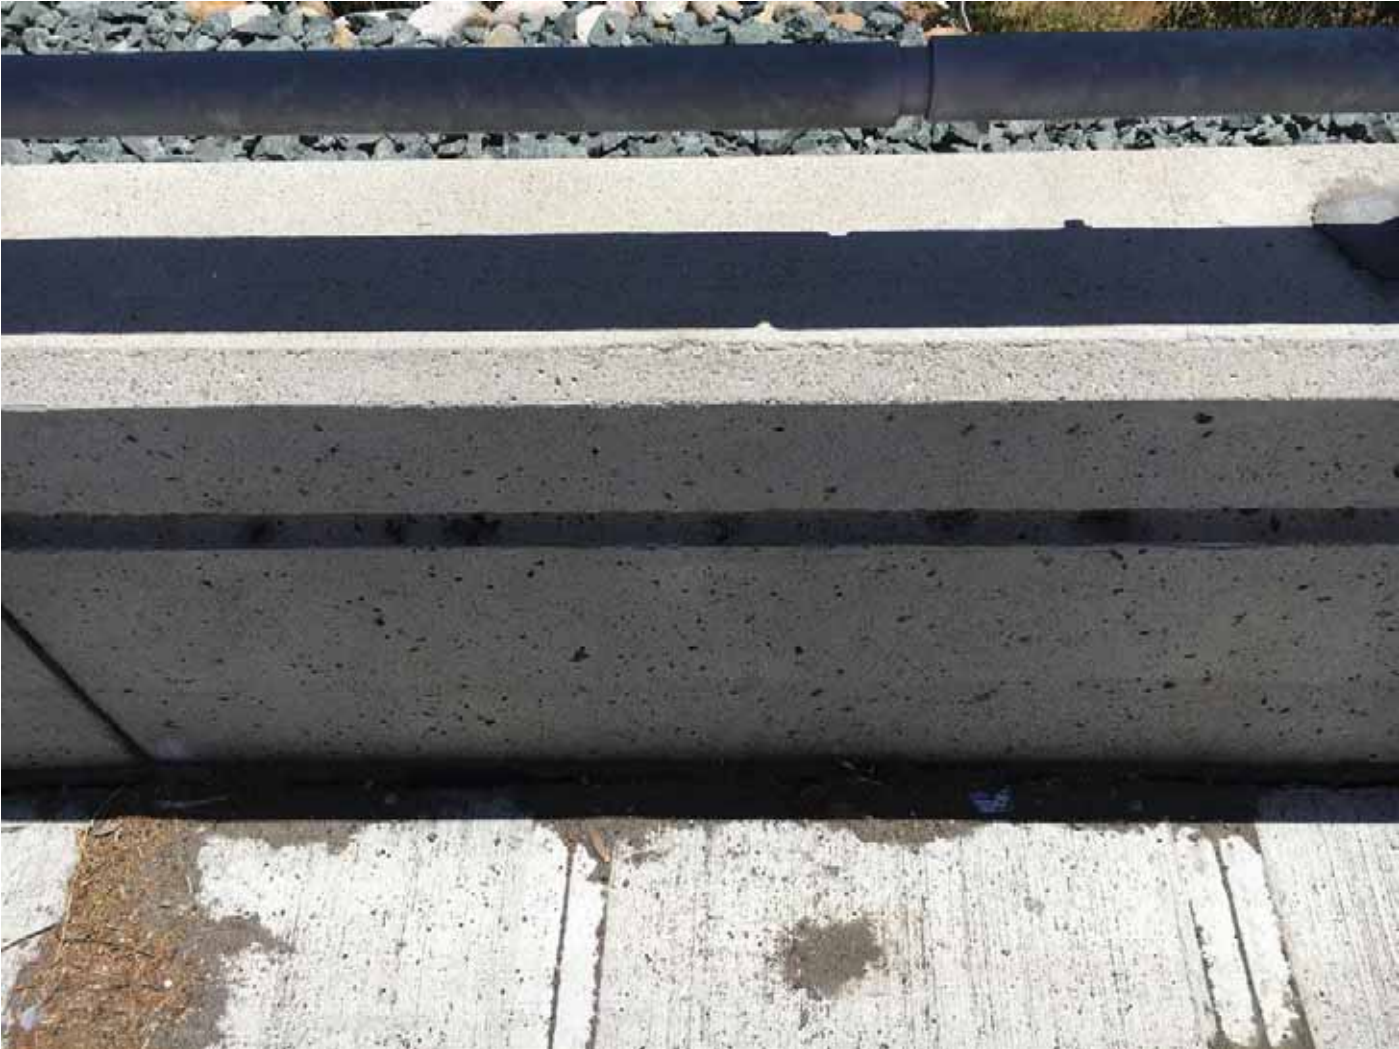
Photo 12: Pavement differential settlement

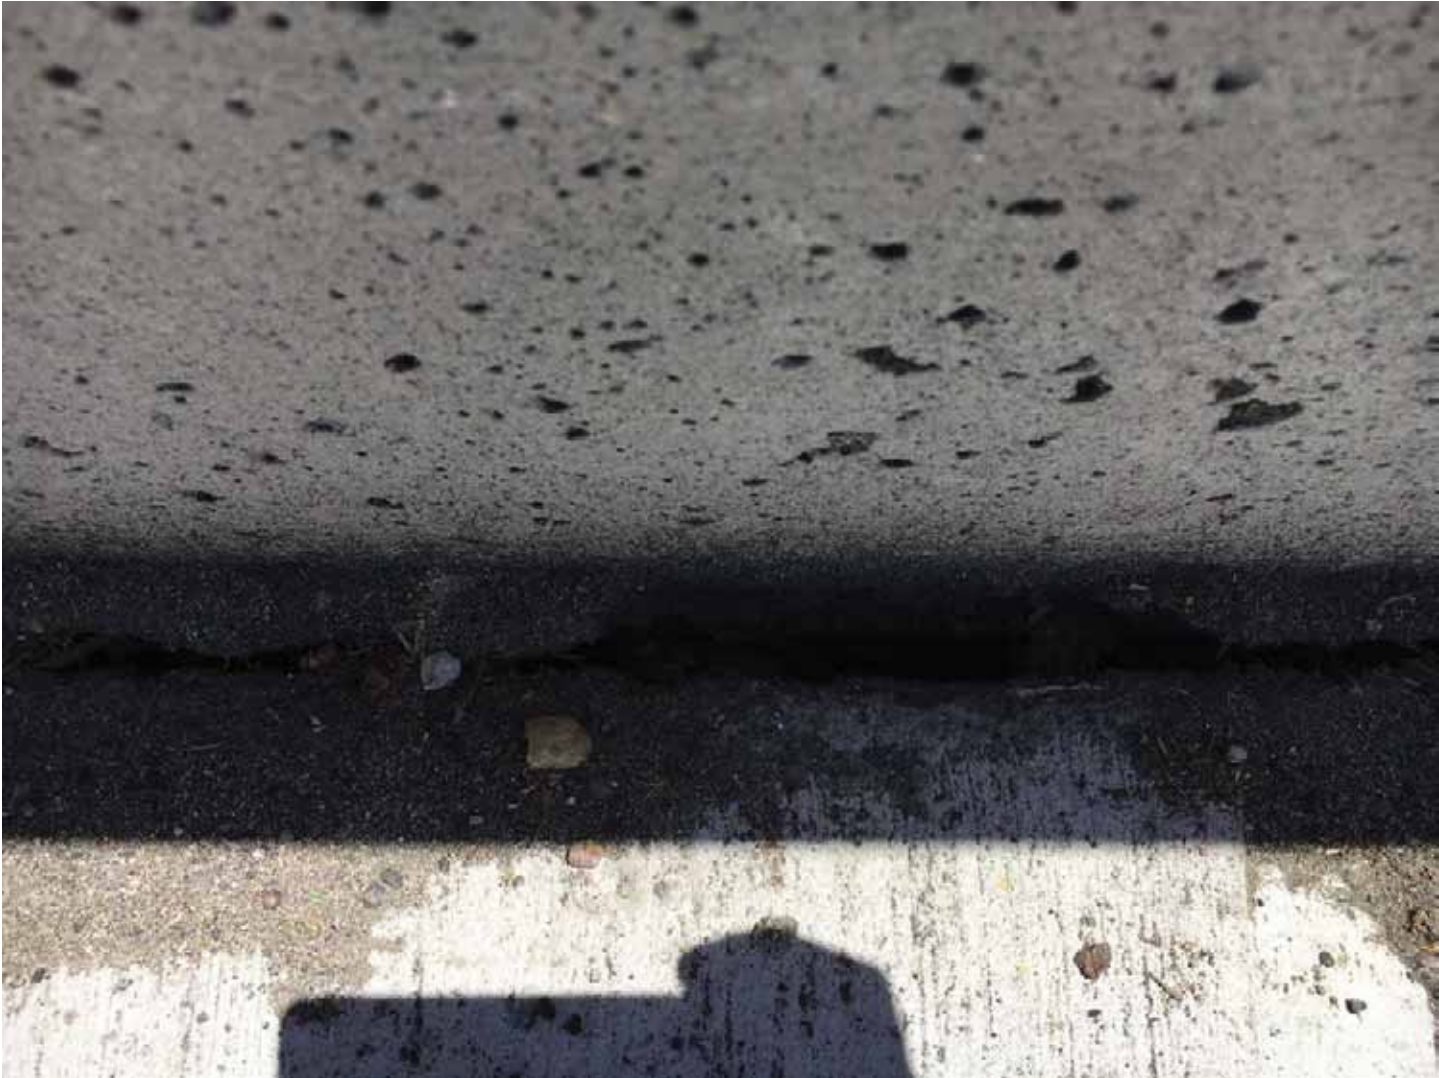
Photo 13: Pavement differential settlement
