PROJECT MEMORANDUM SYCAMORE-PEÑASQUITOS 230-KV TRANSMISSION LINE PROJECT

Date: May 12, 2017
To: Billie Blanchard, CPUC Project Manager
From: Sheila Hoyer, CPUC Monitoring Supervisor
Subject: Weekly Report #18 – April 30 to May 5, 2017

SDG&E Sycamore-Peñasquitos 230-kV Transmission Line Project: Daily Inspection Report

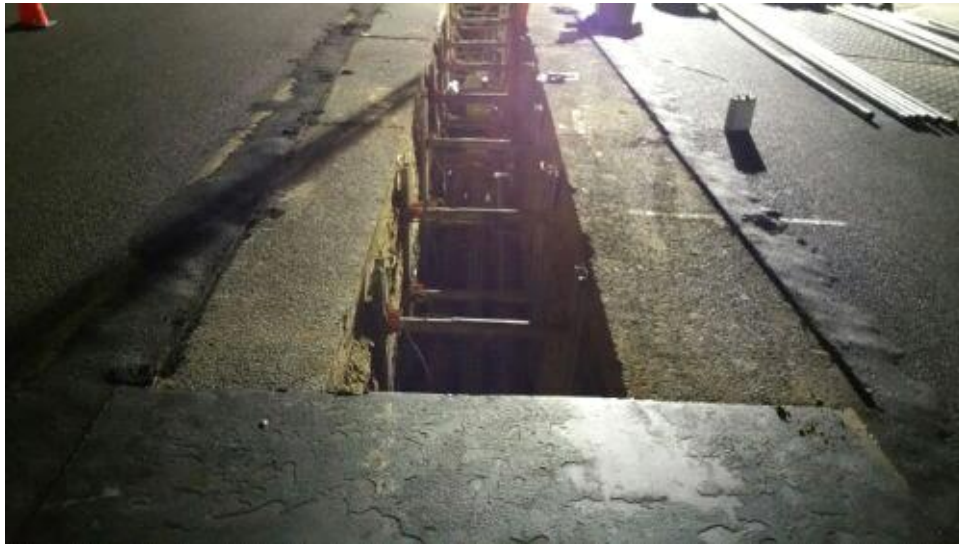
Caption Placing conduit in trench (Trade St).

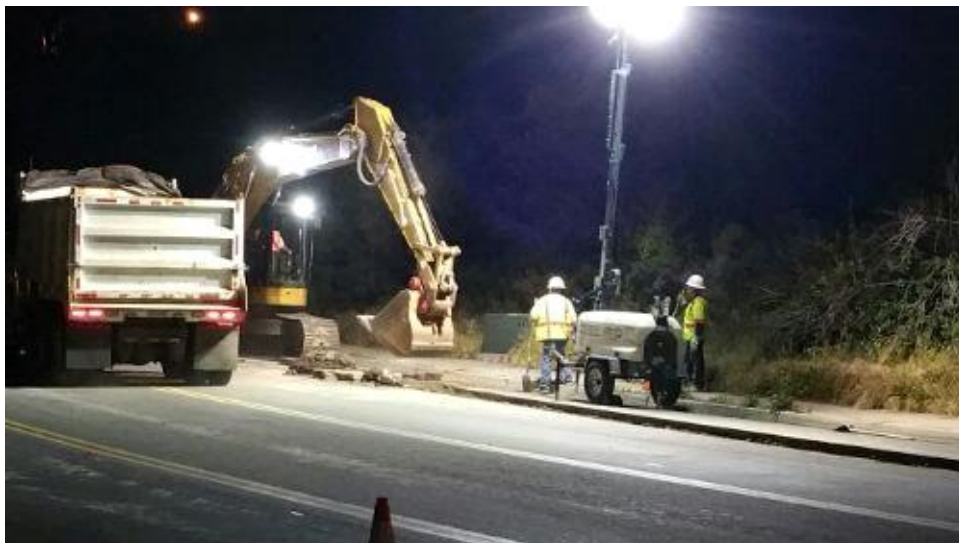
Caption Removing asphalt (Carroll Road).

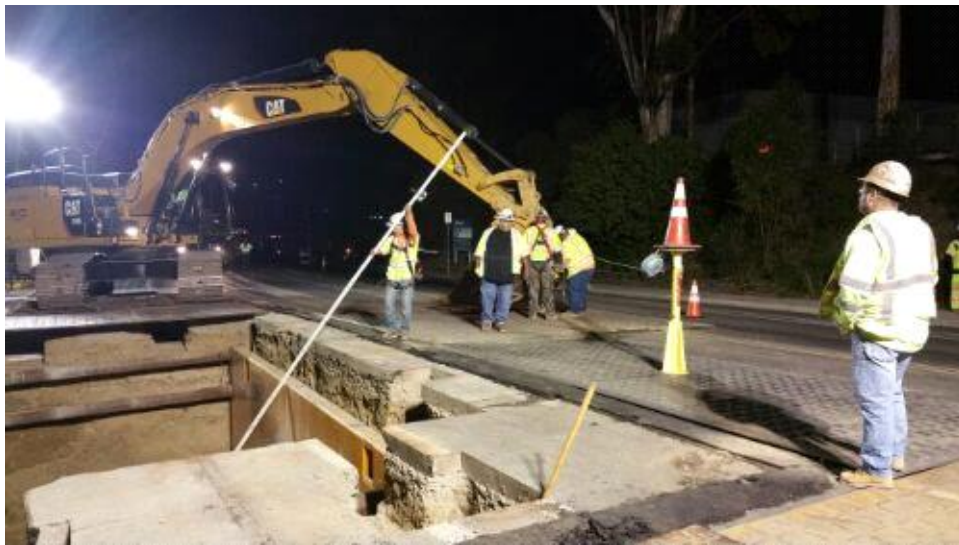
Caption Workers connected to anti-fall device near vault.

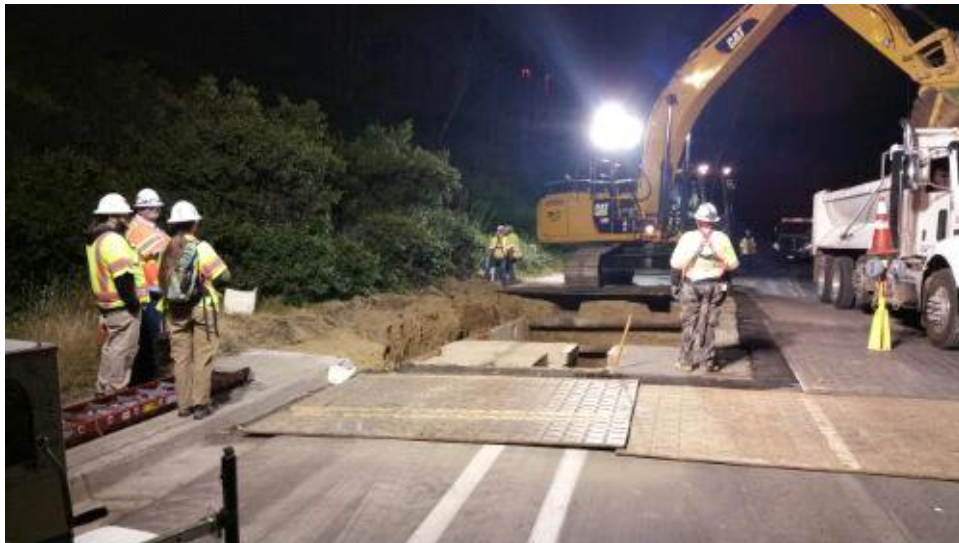
Caption Digging vault (Carroll Rd), paleo monitor present.

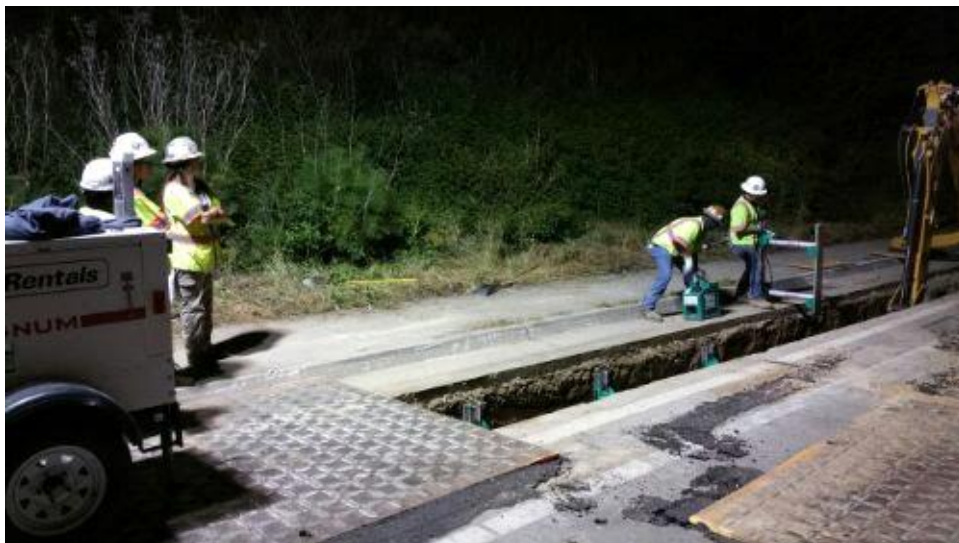
Caption Trenching (Carroll Rd).

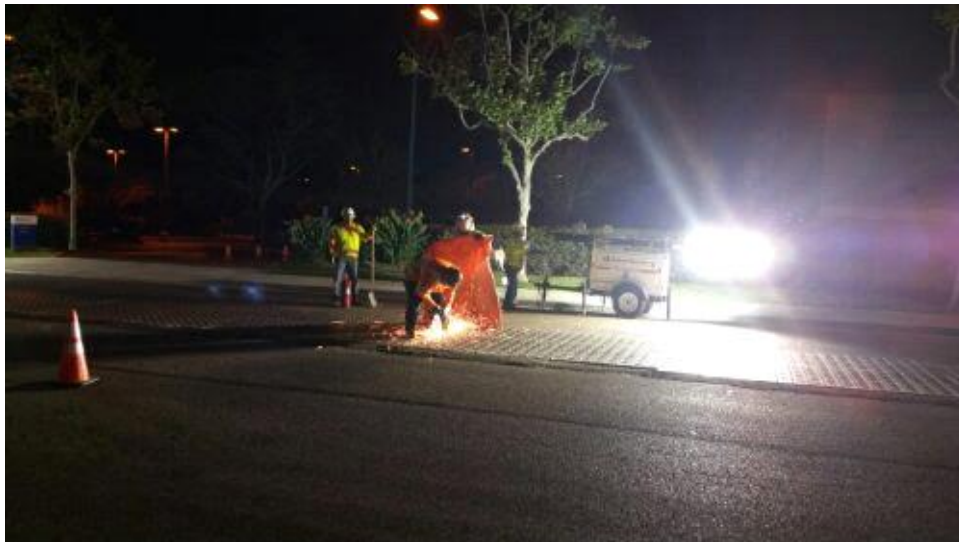
Caption Cutting trench plate with proper fire safety measures.

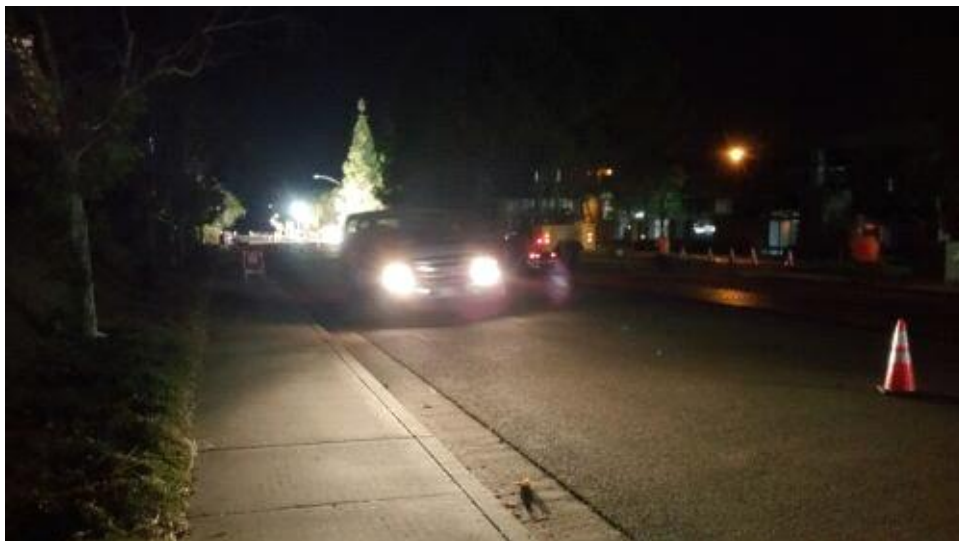
Caption Traffic controls in place and traffic flowing smoothly (Trade St).
 Photo Attributes Capture Date/Time: Sun Apr 30 2017 20:55:49 GMT-0700 (PDT)
 Coordinates: 32.888587, -117.163259
 View Direction: West

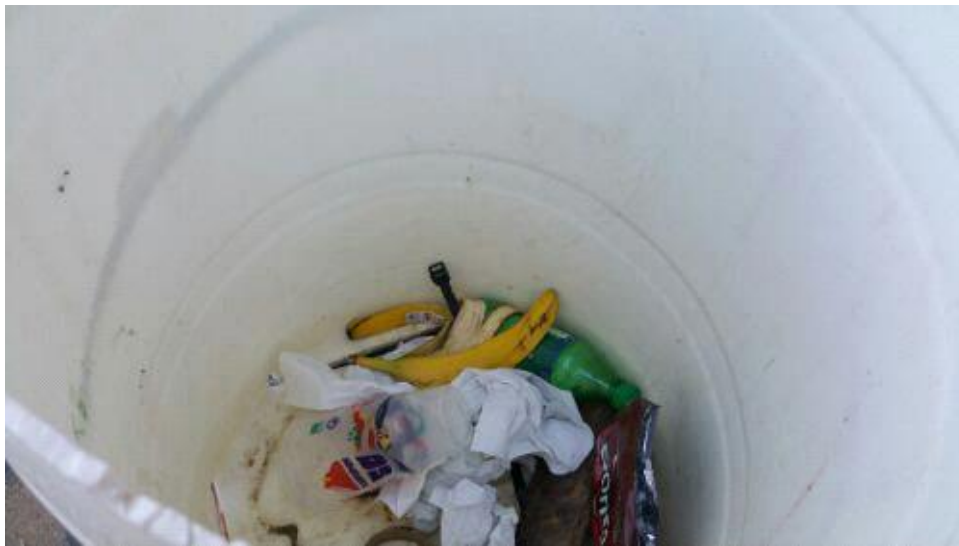
Caption Trash placed in trash can (Carroll Rd.).

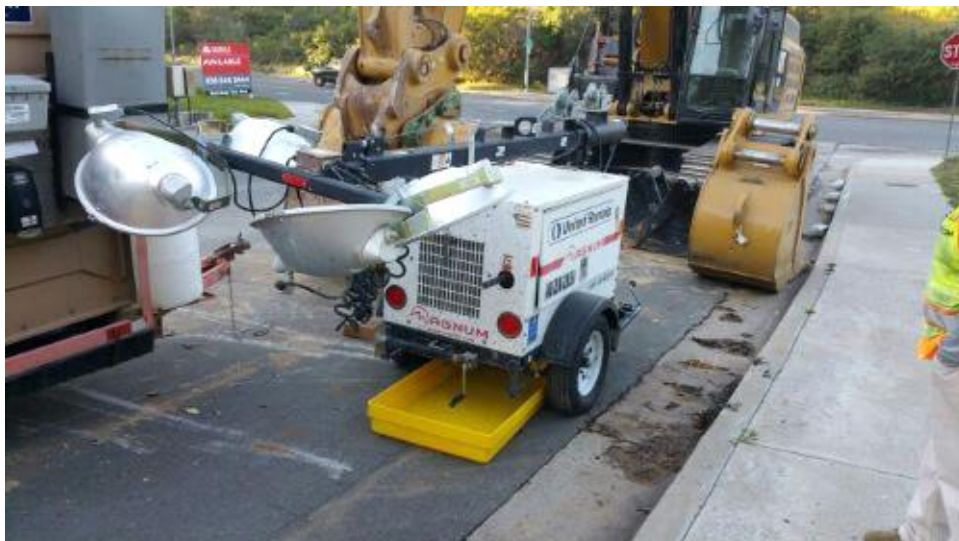
Caption Drip container in place under equipment.

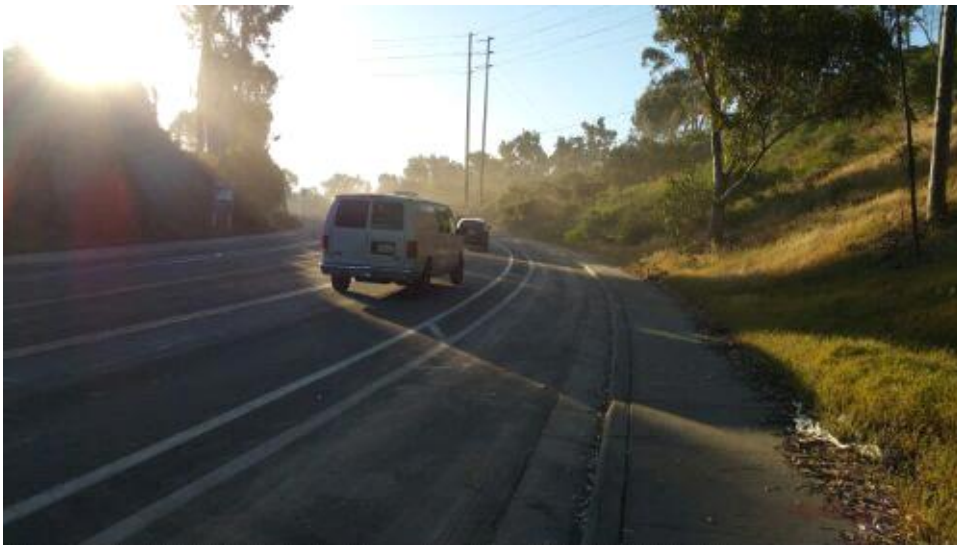
Caption Minor dust generated by vehicular traffic.

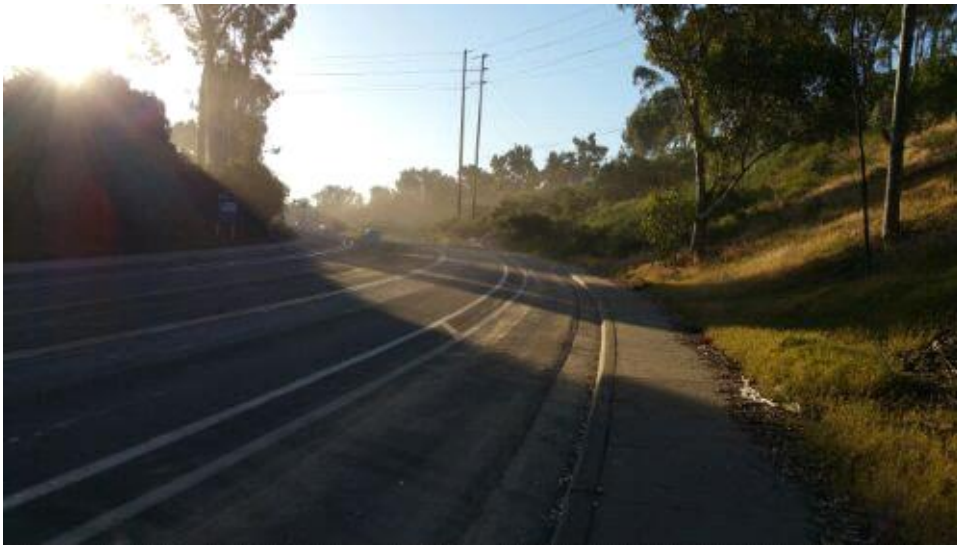
Caption Dust in air at Carroll Rd.

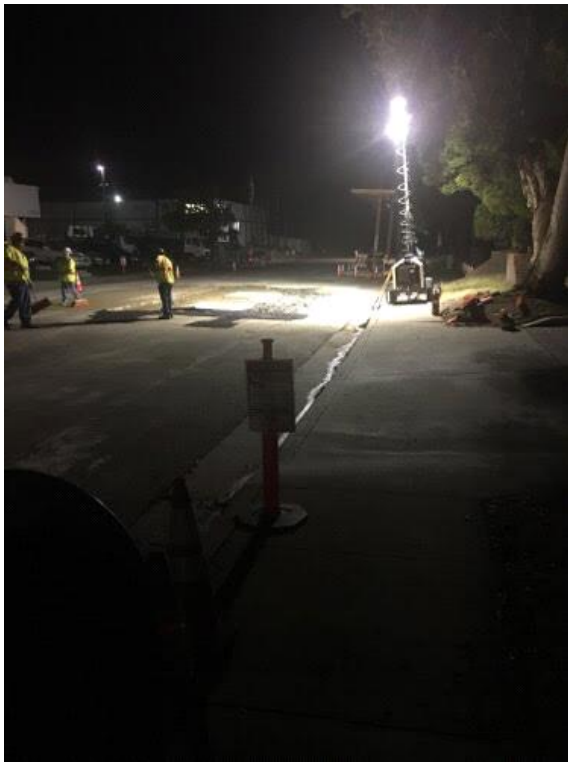
Caption Arjons vault backfilling

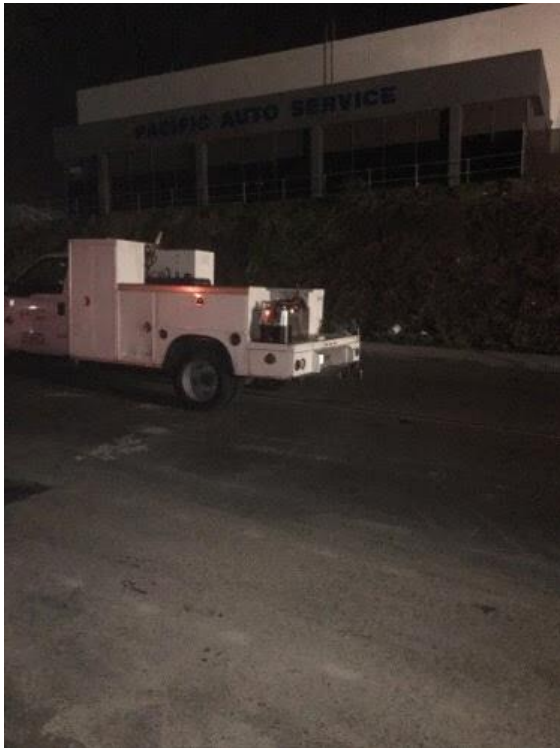
Caption Vehicle within ROW with fire tools

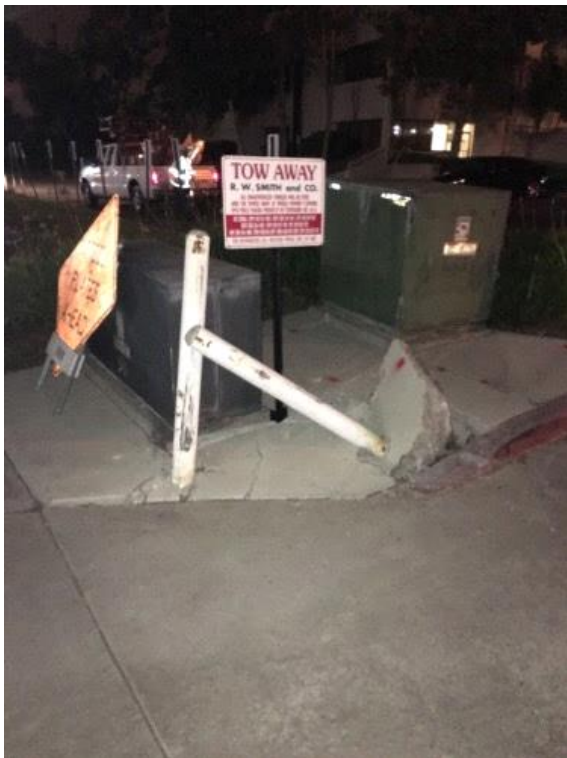
On May 3, 2017, a traffic incident occurred when a non-construction-related semi-trailer truck with the label “Swift Trucking” was entering the Snapple/7-Up facility located at 7598 Trade Street just north of Station 177 + 00. Construction personnel removed the traffic control cones in the area so that the semi-trailer truck could turn left into the facility from Trade Street. In the process of turning left, the vehicle struck the bollards protecting an SDG&E electrical transformer located on the side of the driveway. The vehicle and bollards were damaged as part of the incident. A traffic control flagger witnessed the accident and immediately notified the SDG&E and ARB safety team. Upon notification, the SDG&E and ARB Safety Team notified the Snapple Plant/7-Up Plant Manager of the accident and the damage caused by the vehicle. The ARB Safety Manager also notified the San Diego Police Department (SDPD). SDPD Officer A. Ruiz arrived at the scene of the accident and completed a police report. No injuries or fatalities were recorded, and there is no indication that this accident was associated in any way with the traffic control set-up or implementation. Written notification of the incident was provided to the CPUC on May 4, 2017. No other health and safety incidents were observed or reported during this period.

Caption Ballard collision site from 5/3/17

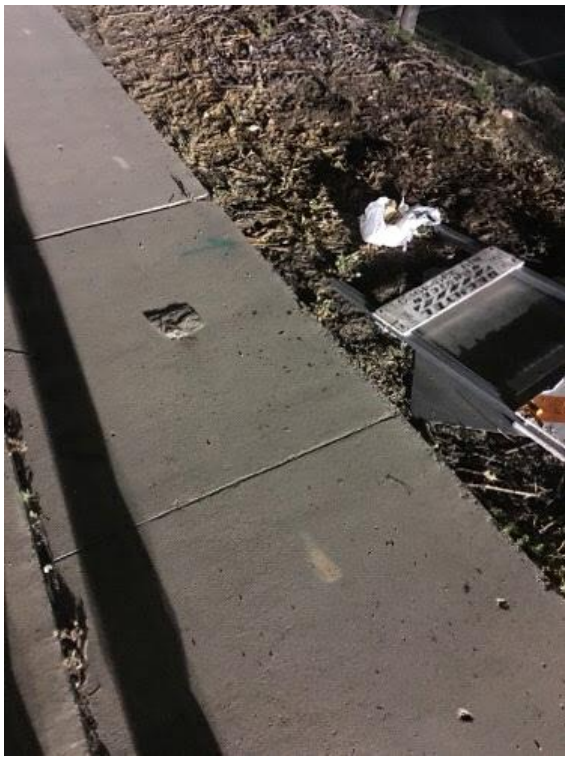
Caption Trash adjacent to work site

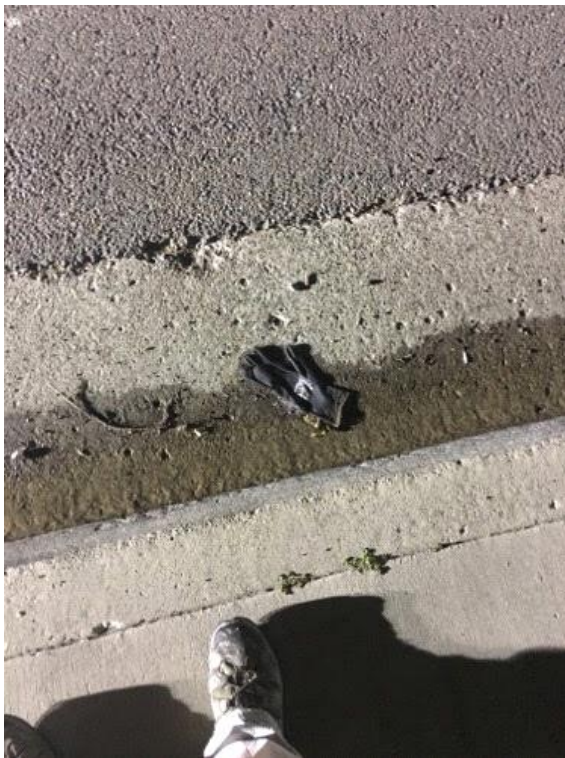
Caption Work site debris in gutters

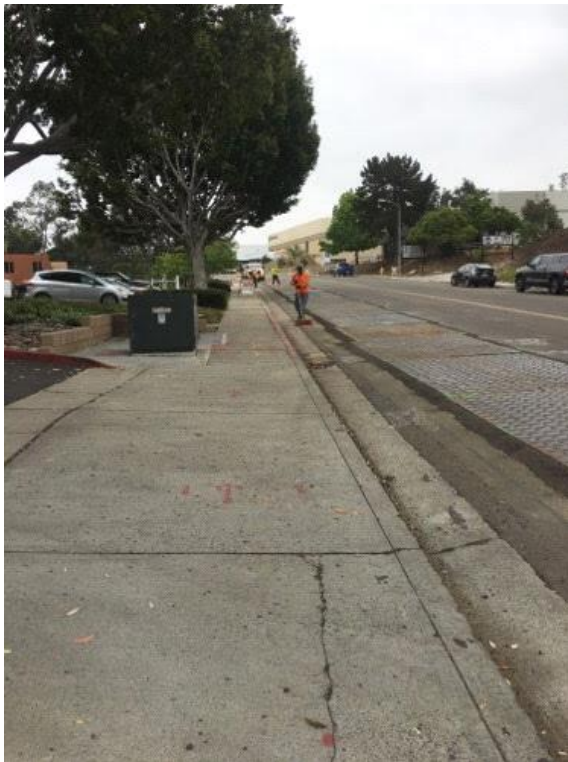
Caption Crew cleaning road on Trade Street.

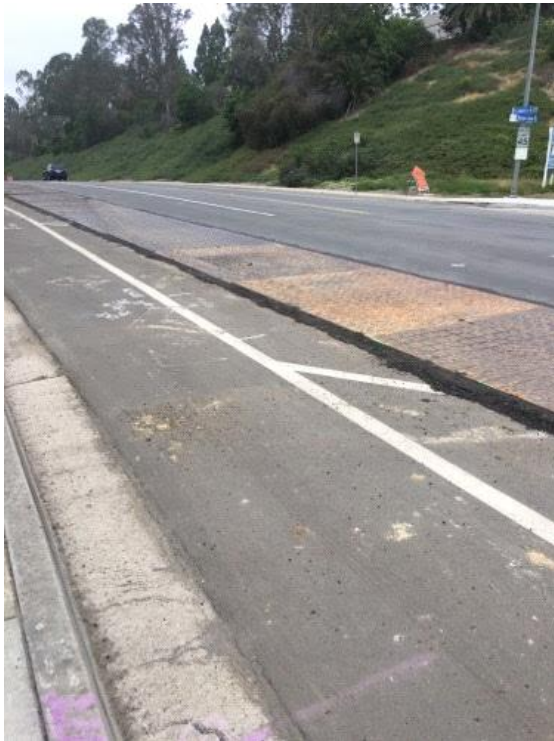
Caption Carrol Rd, note loose dirt and gravel

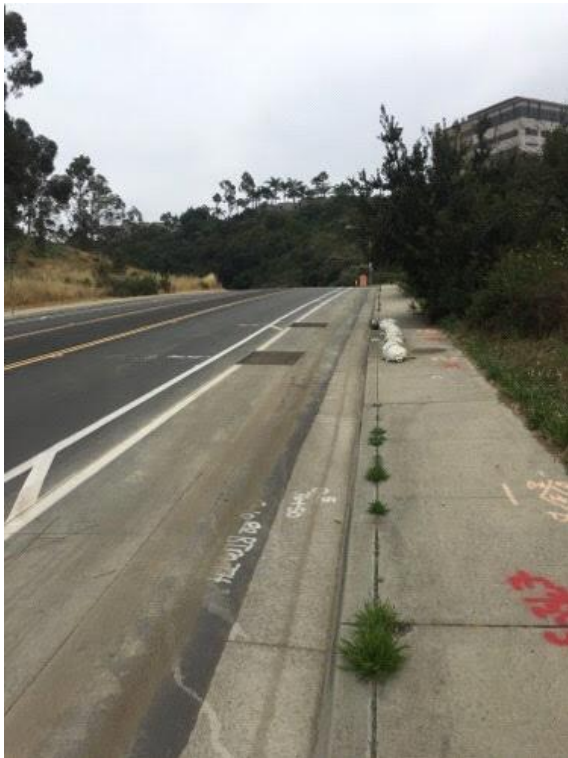
Caption Storm drain without water quality protection measures.
