PROJECT MEMORANDUM SYCAMORE-PEÑASQUITOS 230-KV TRANSMISSION LINE PROJECT

Date: May 19, 2017
To: Billie Blanchard, CPUC Project Manager
From: Sheila Hoyer, CPUC Monitoring Supervisor
Subject: Weekly Report #19 – May 7 to May 12, 2017

SDG&E Sycamore-Peñasquitos 230-kV Transmission Line Project: Daily Inspection Report

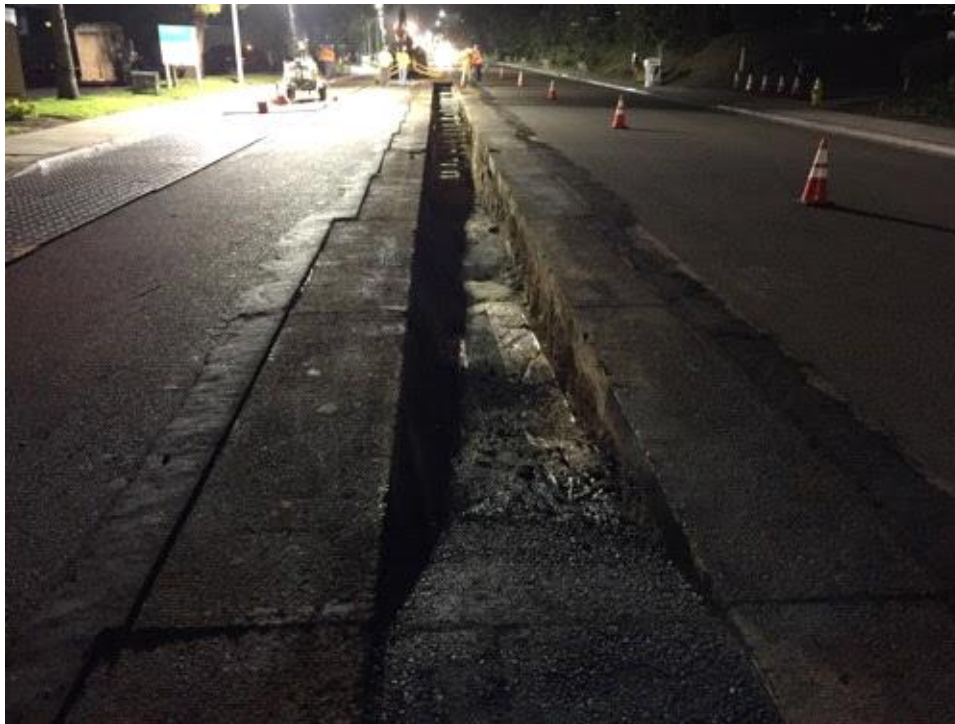
Caption Ramps installed in trenches for egress.

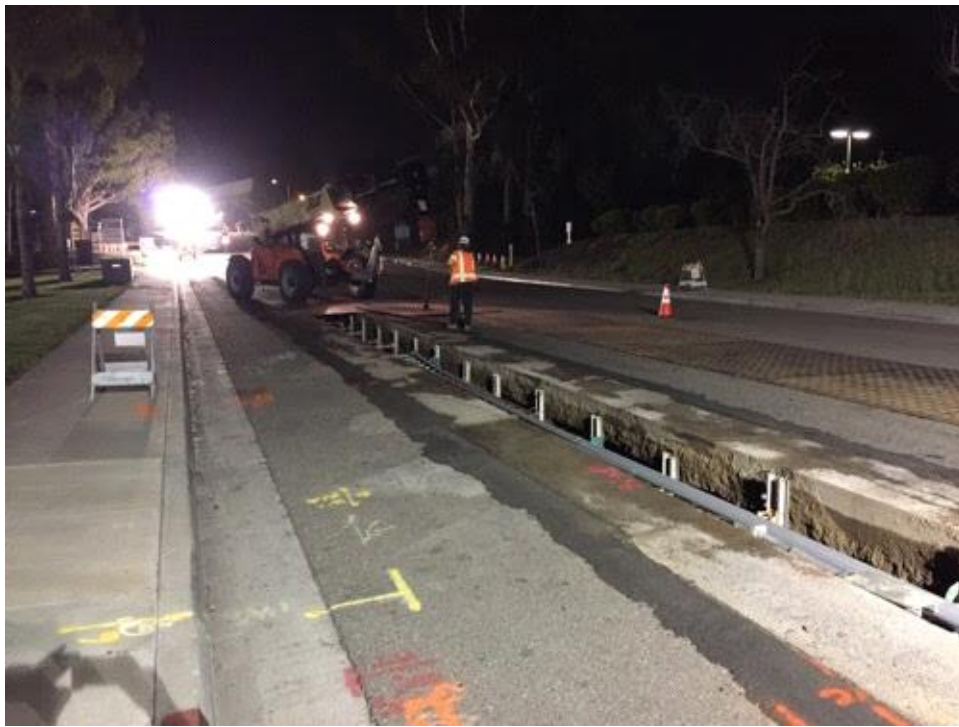
Caption Open trenches with clearly marked boundaries

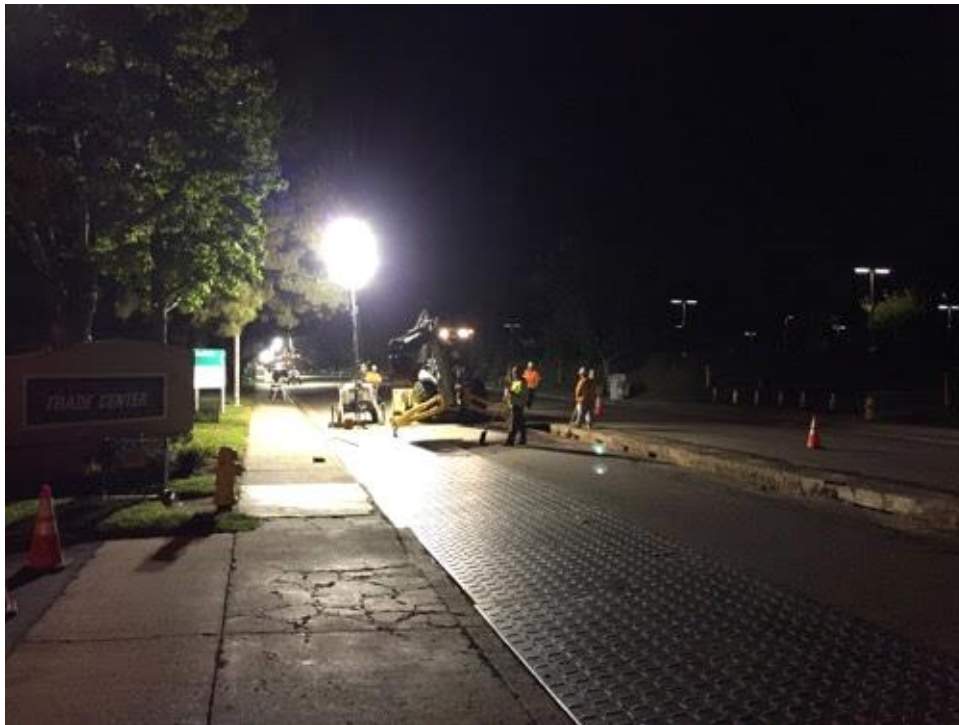
Caption Removing steel plates to continue with underground work.

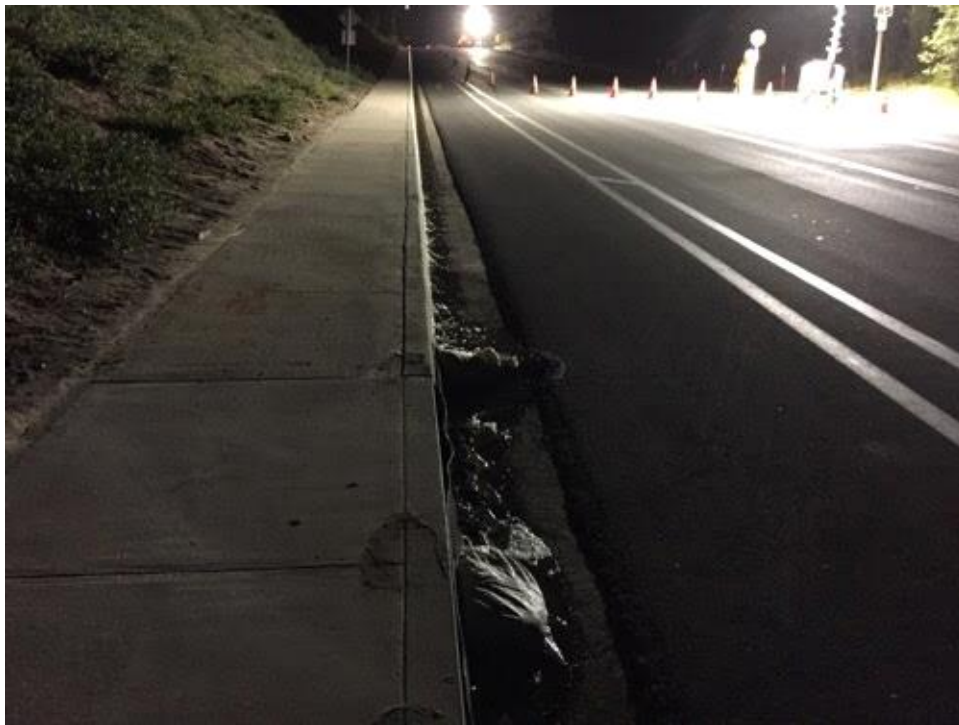
Caption BMPs in place and in good working condition.

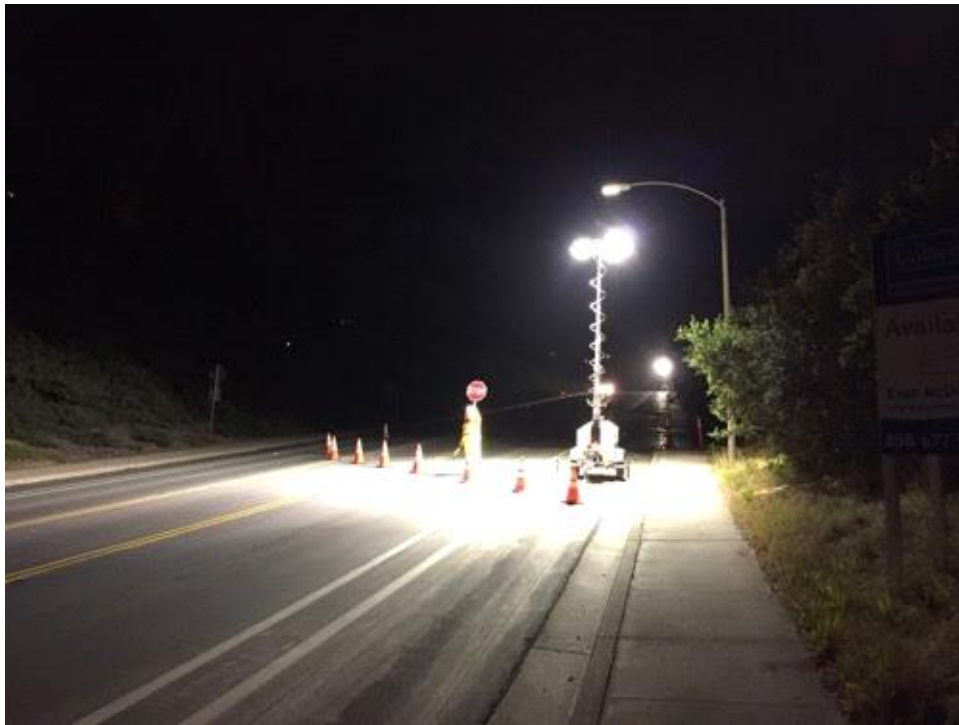
Caption Downward-facing lighting in place as well as traffic flaggers.

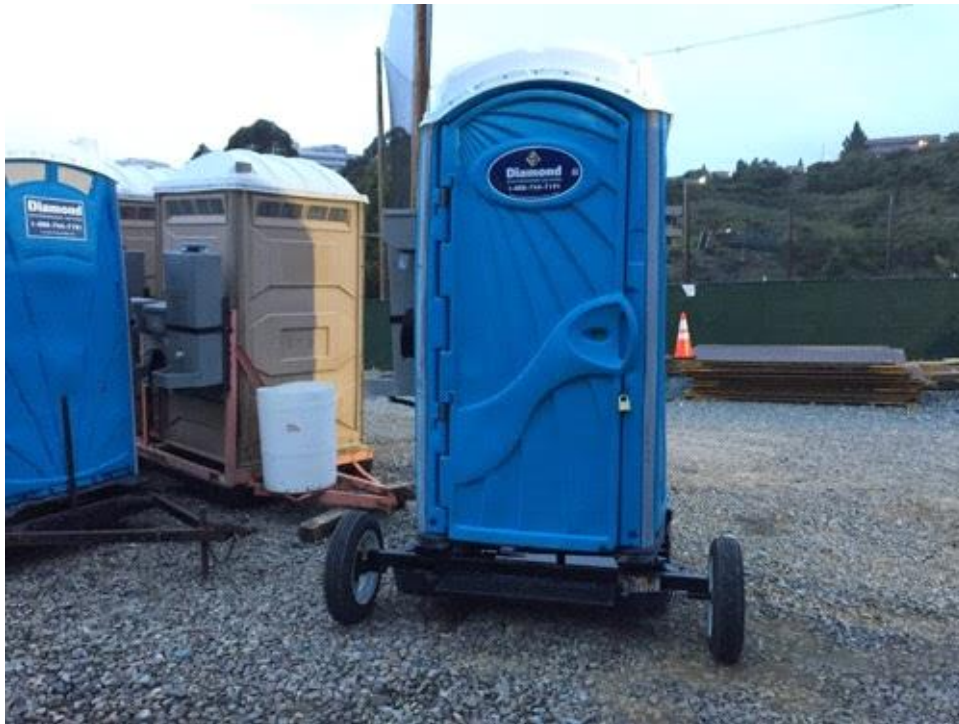
Caption Locked restrooms for the ladie's use
Photo Attributes Capture Date/Time: Tue May 09 2017 05:53:17 GMT-0700 (PDT)
Coordinates: 32.891089, -117.191602
View Direction: Northwest

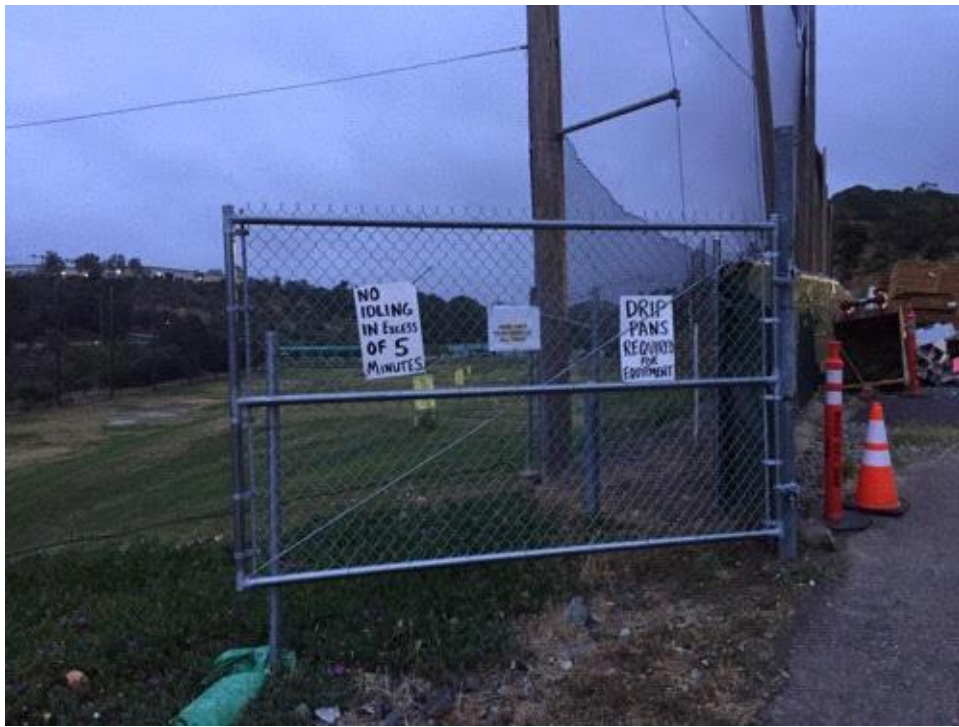
Caption Requirement reminders posted at entrance to storage yard.

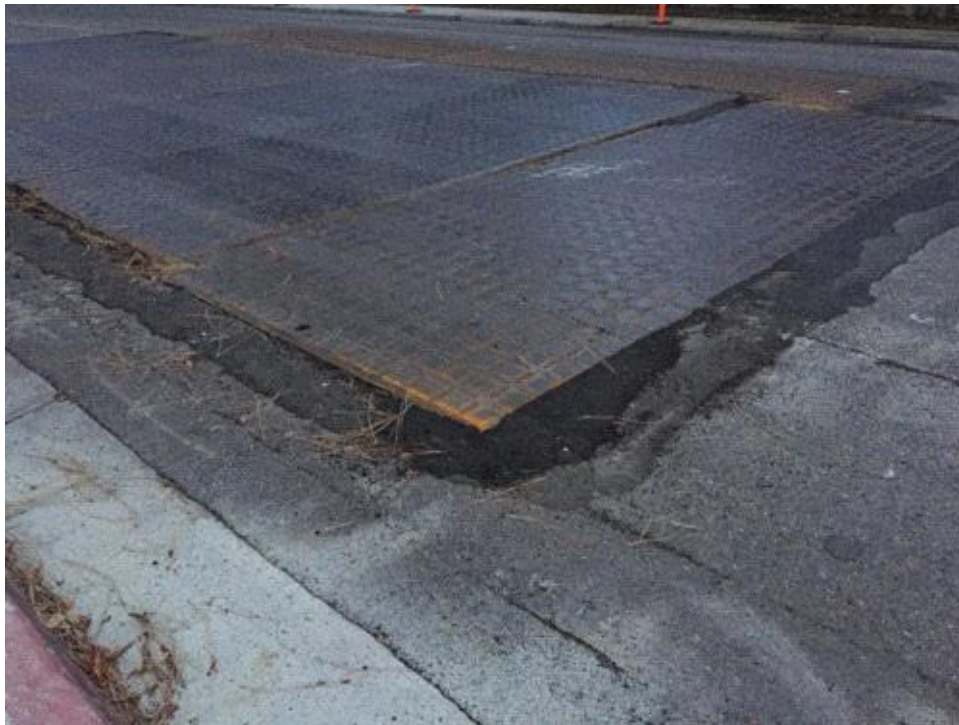
Caption Steel plates covering trenches and sealed with asphalt.

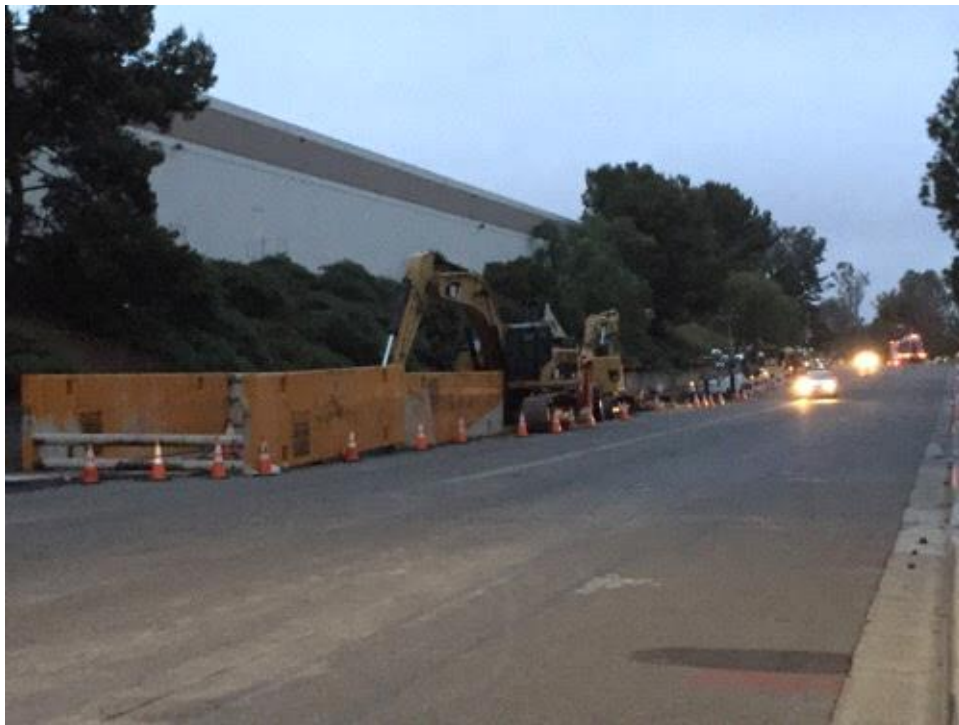
Caption Equipment returned to storage location and street is cleared.

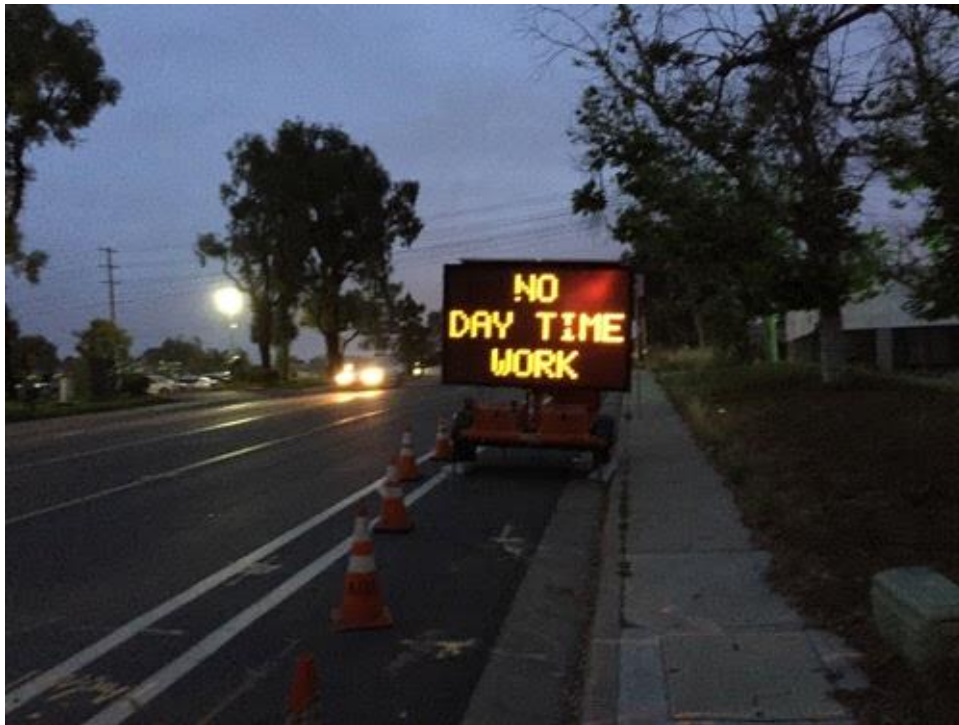
Caption Digital signage in place.

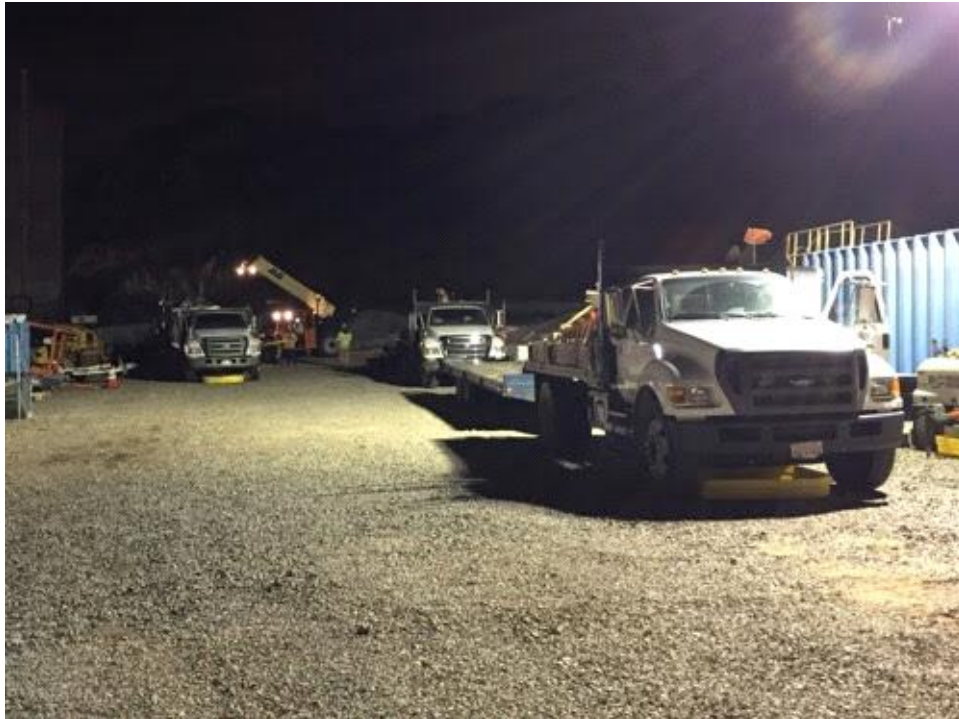
Caption Secondary containment pans in place under parked equipment in the storage yard.

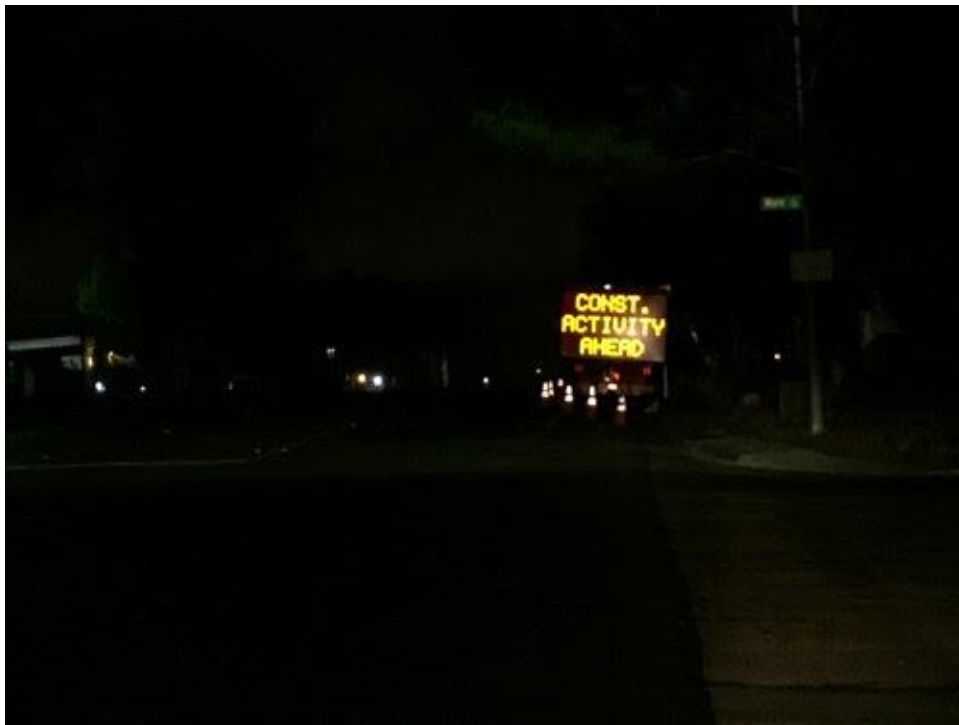
Caption Digital signage in place.

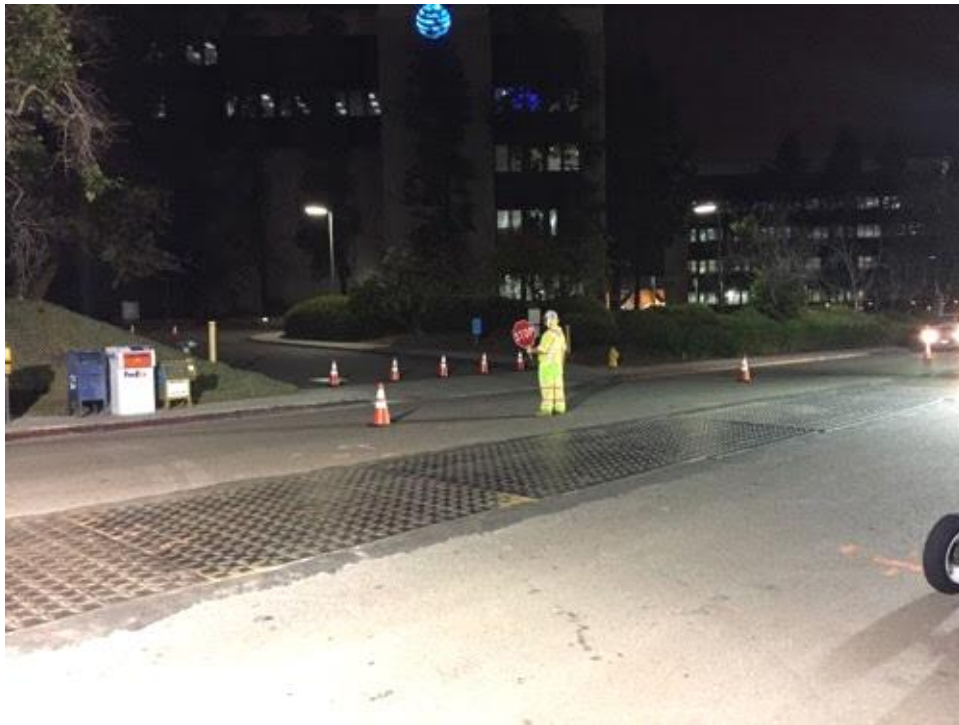
Caption Traffic flaggers in place.

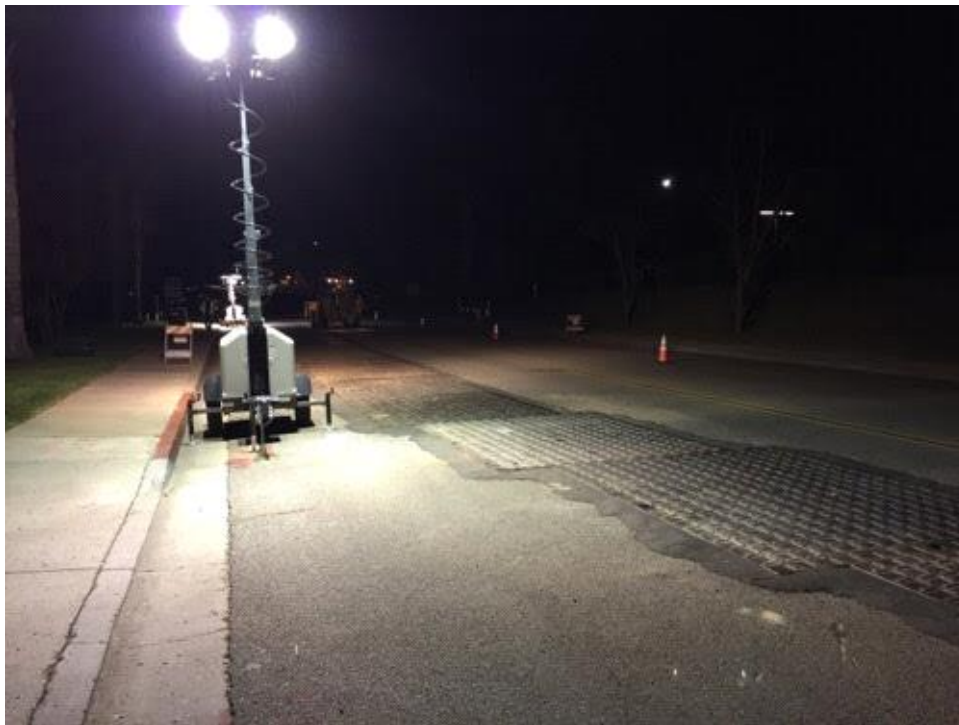
Caption Steel plates in place covering the trenches.

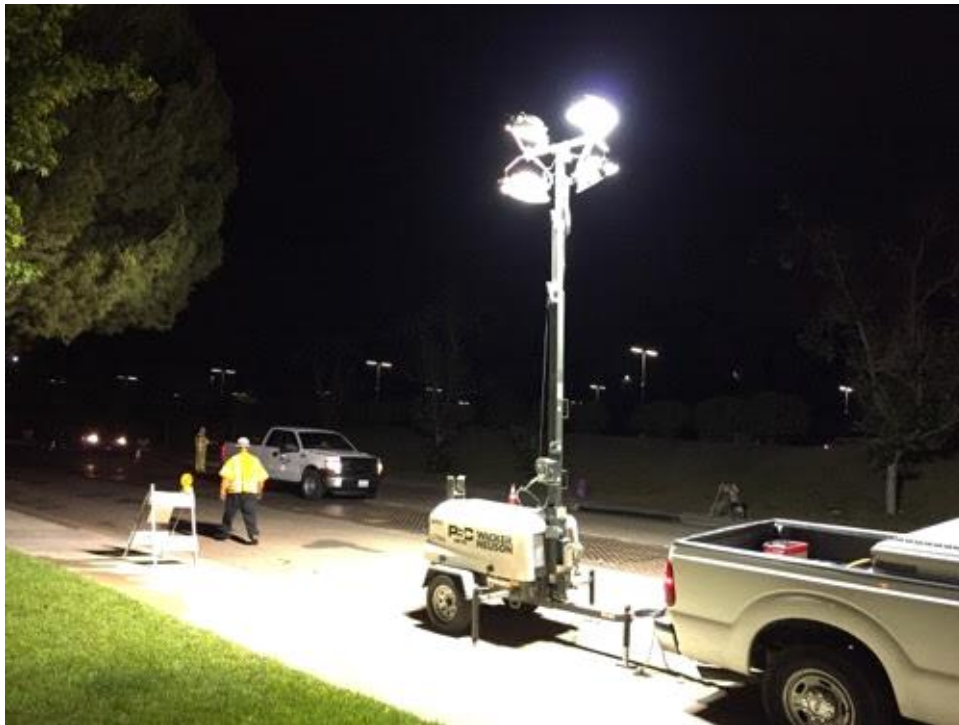
Caption Setting up lighting for tonight's work.

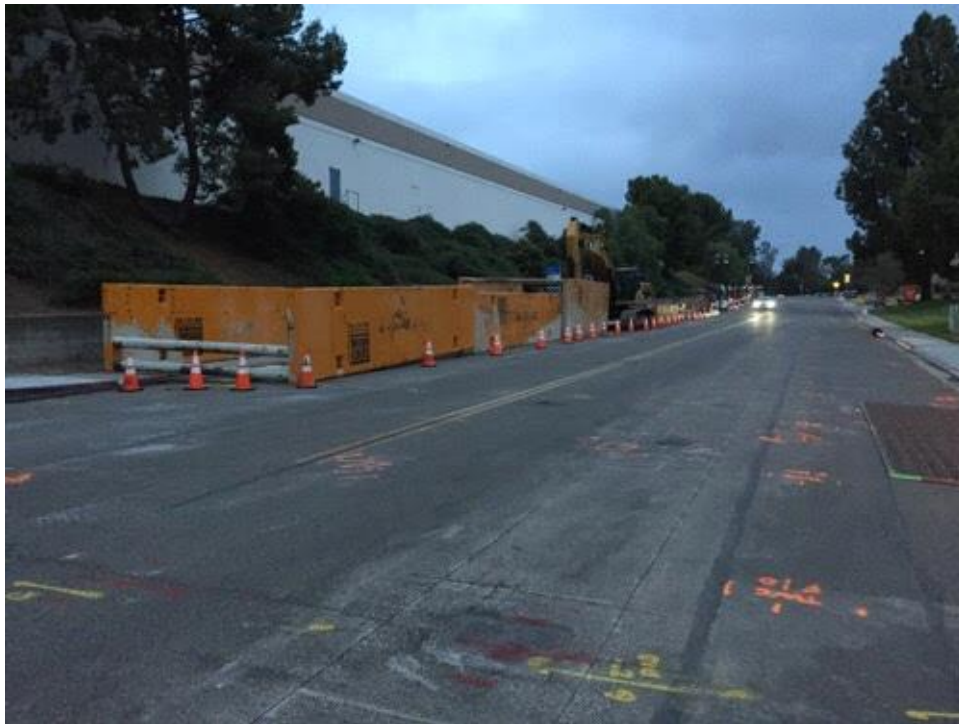
Caption Roads cleared and equipment returned and stored with cones surrounding.

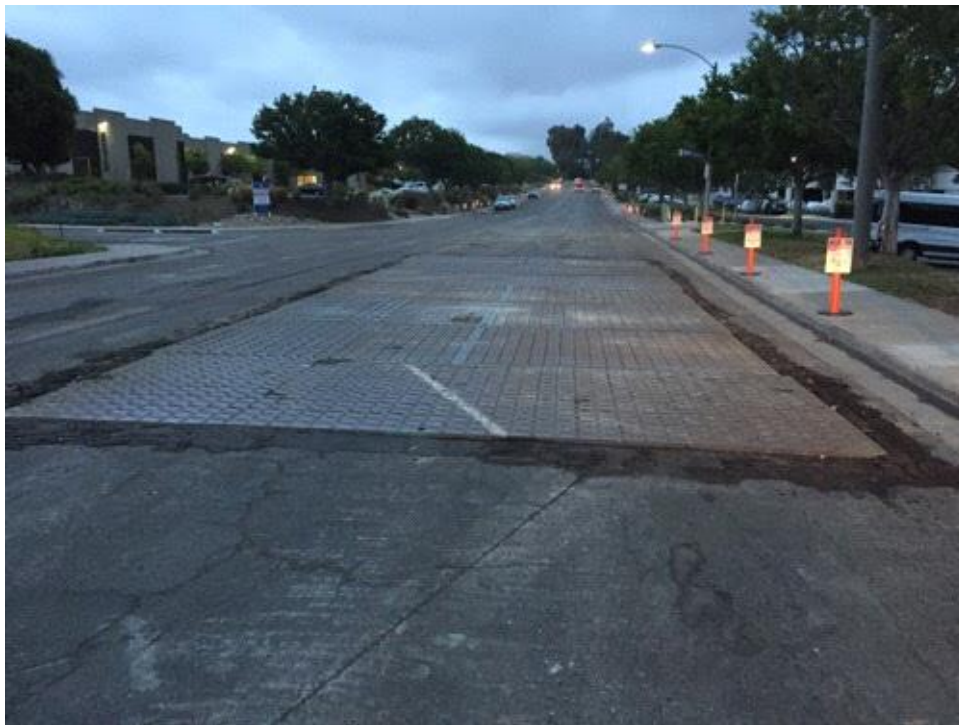
Caption Trenches covered with steel plates and capped with asphalt.

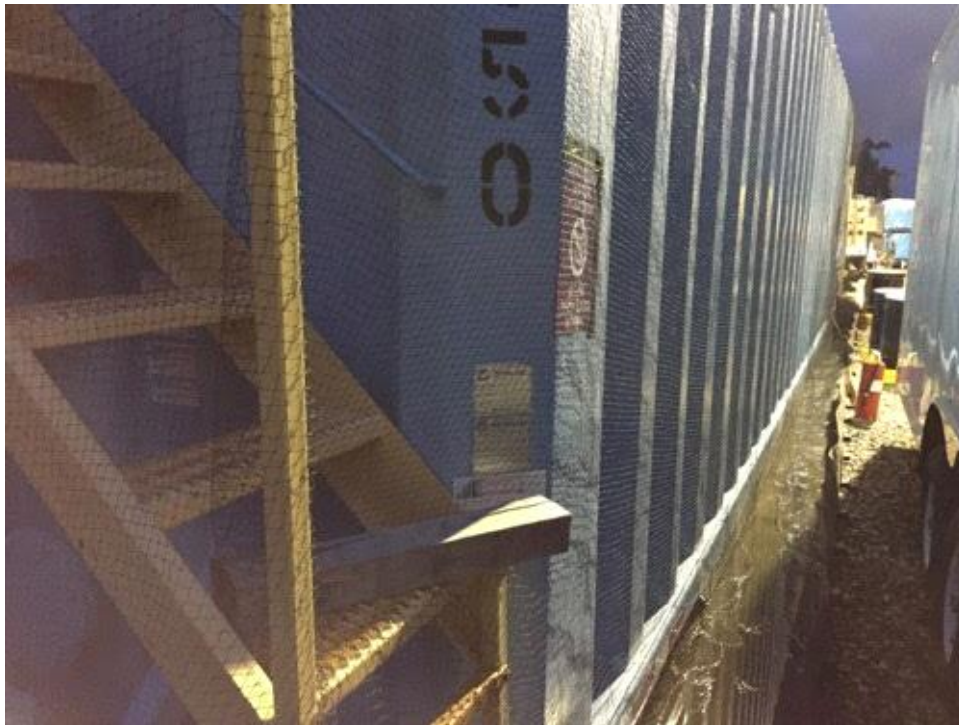
Caption Bird netting in place to discourage nest building on stationary equipment.

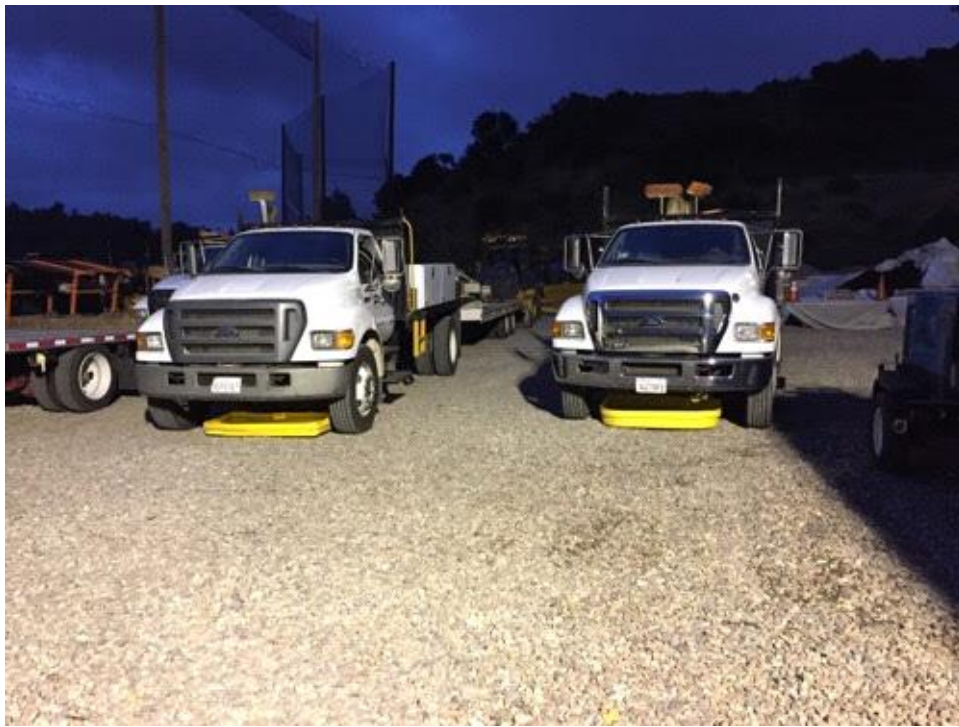
Caption Drip pans in place as required.

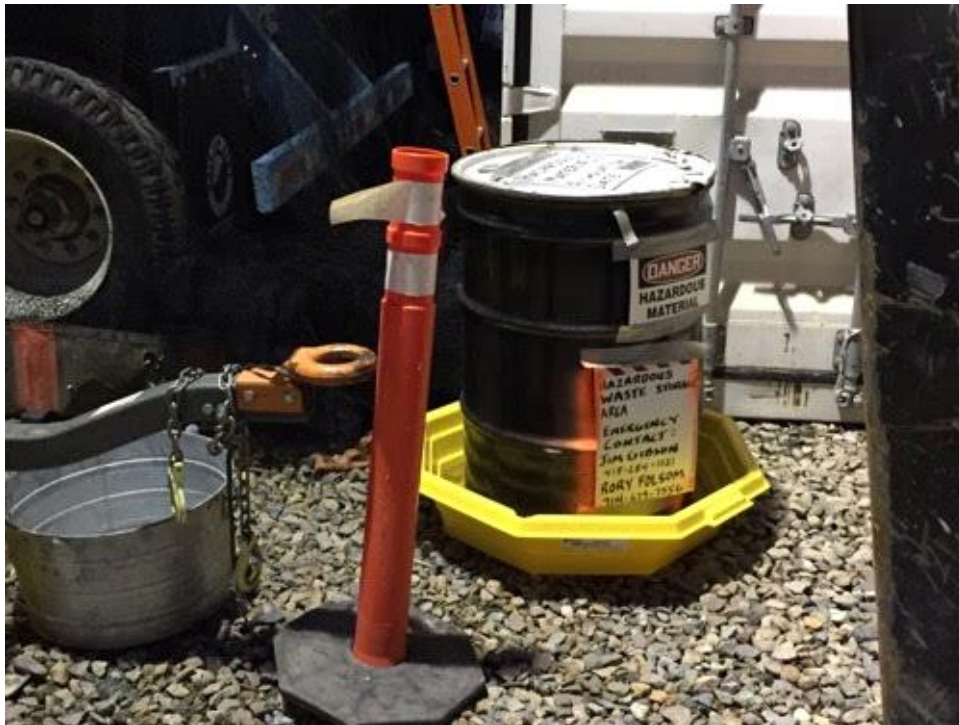
Caption Hazardous materials clearly marked and stored in secondary containment.

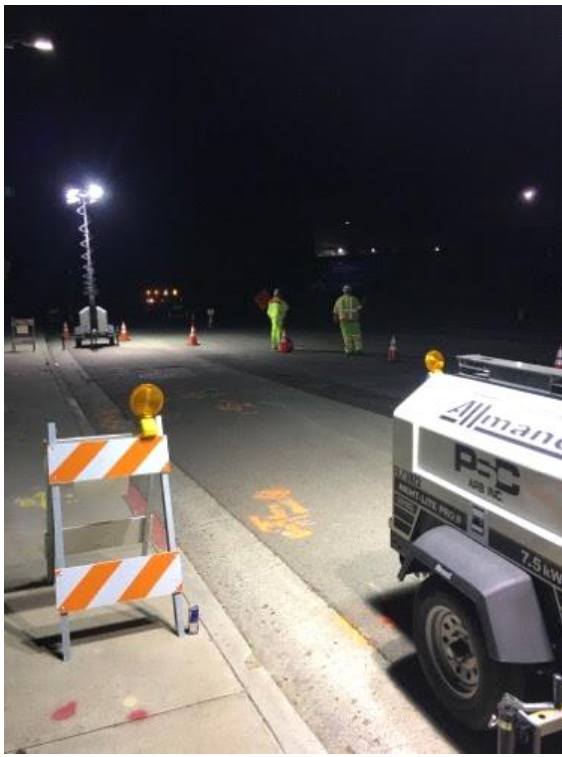
Caption Traffic control at Trade St

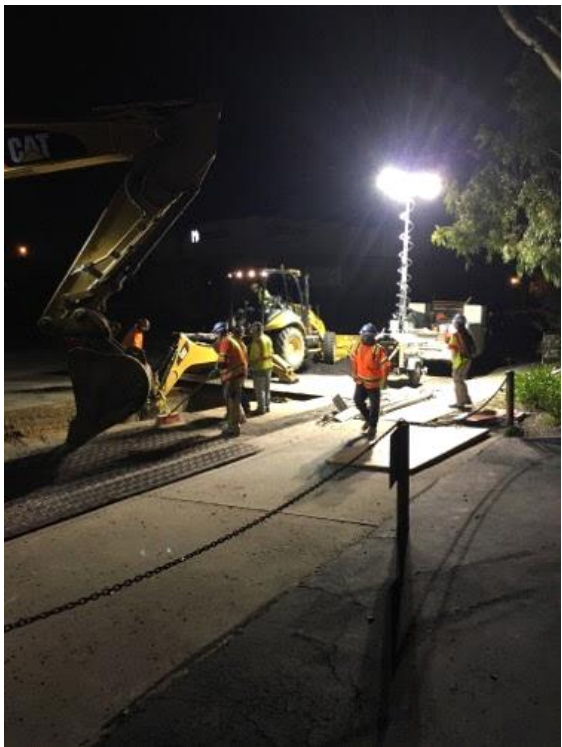
Caption Trade excavation with Paleo monitor

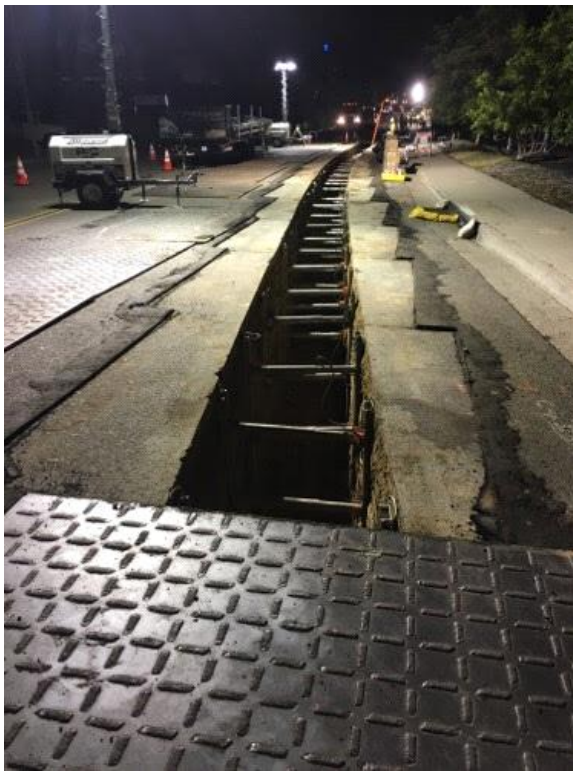
Caption Trade St open trench with shoring

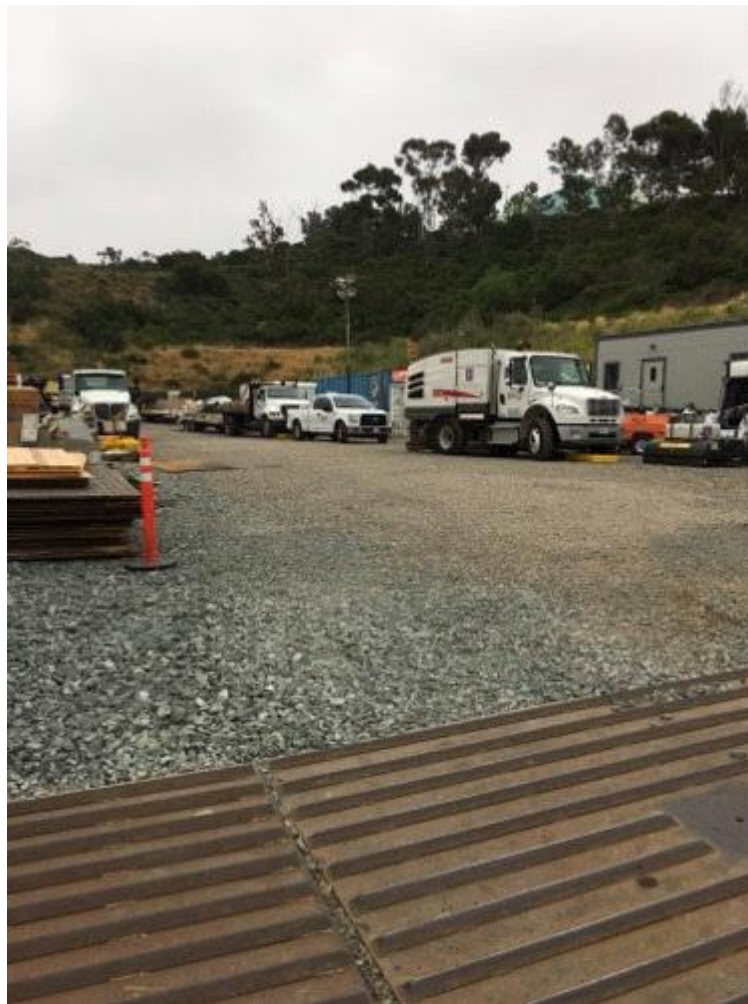
Caption Equipment properly stored at Driving Range Yard.

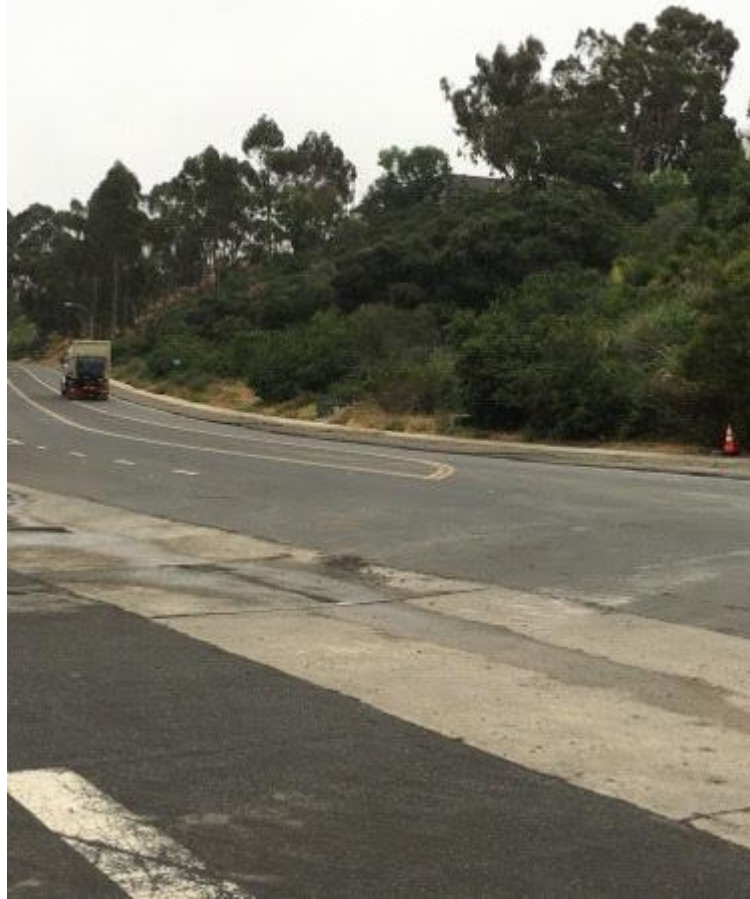
Caption Carrol Rd work site from previous night.

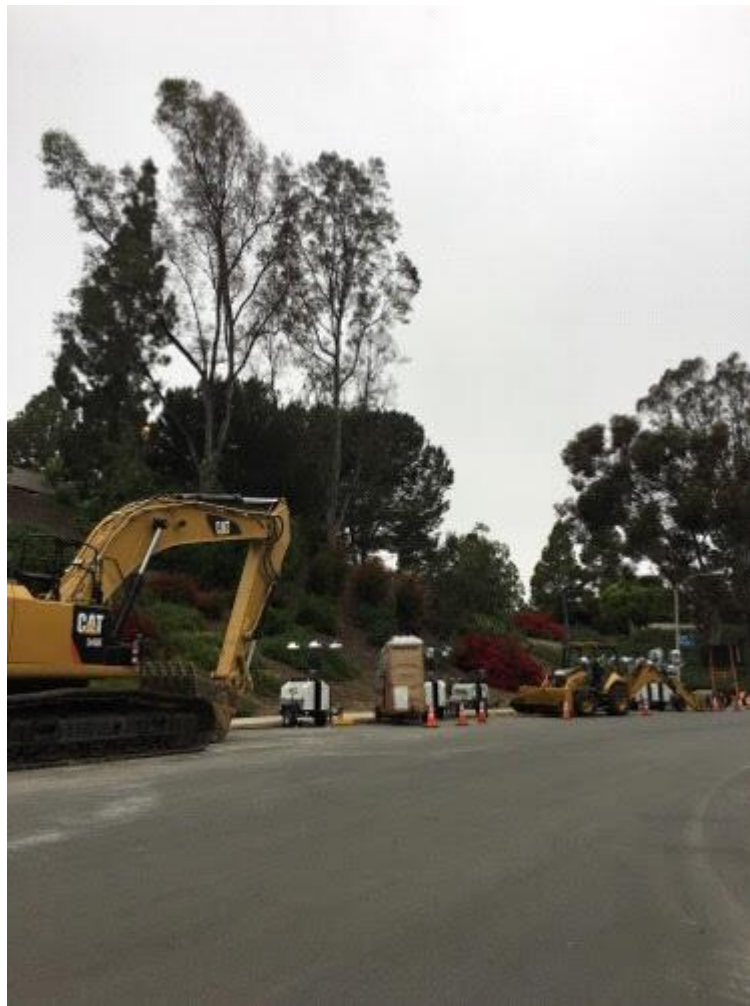
Caption Carrol Rd and Brown Deer Rd equipment storage.
