PROJECT MEMORANDUM  
SYCAMORE-PEÑASQUITOS 230-KV  
TRANSMISSION LINE PROJECT

Date: June 16, 2017  
To: Billie Blanchard, CPUC Project Manager  
From: Sheila Hoyer, CPUC Monitoring Supervisor  
Subject: Weekly Report #23– June 4 to June 9, 2017

## SDG&E Sycamore- Peñasquitos 230-kV Transmission Line Project: Daily Inspection Report

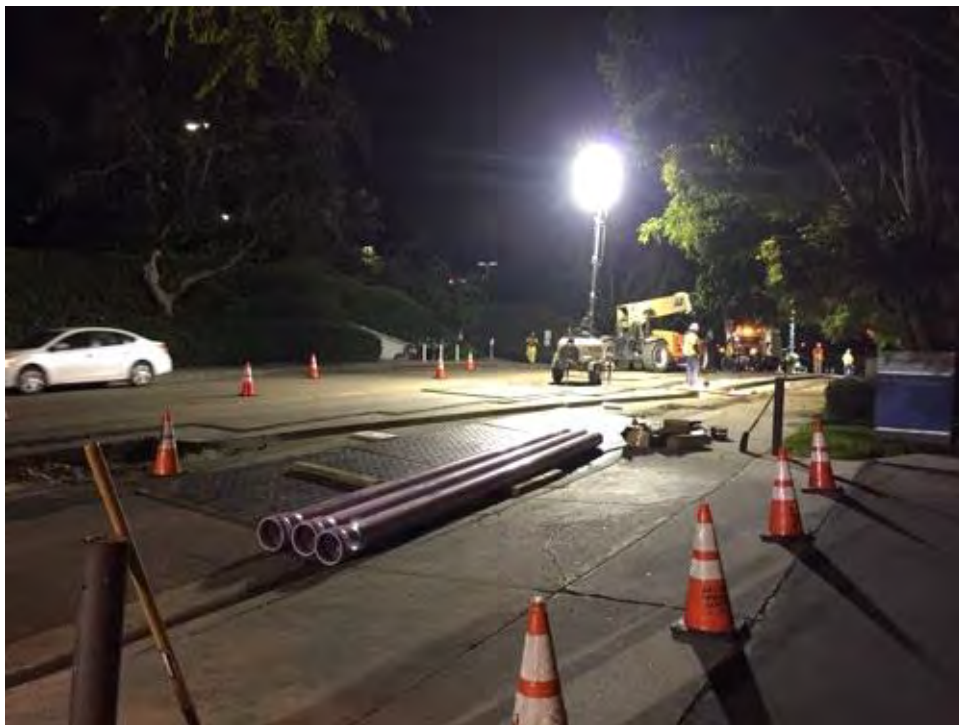
Caption Conduit installation.

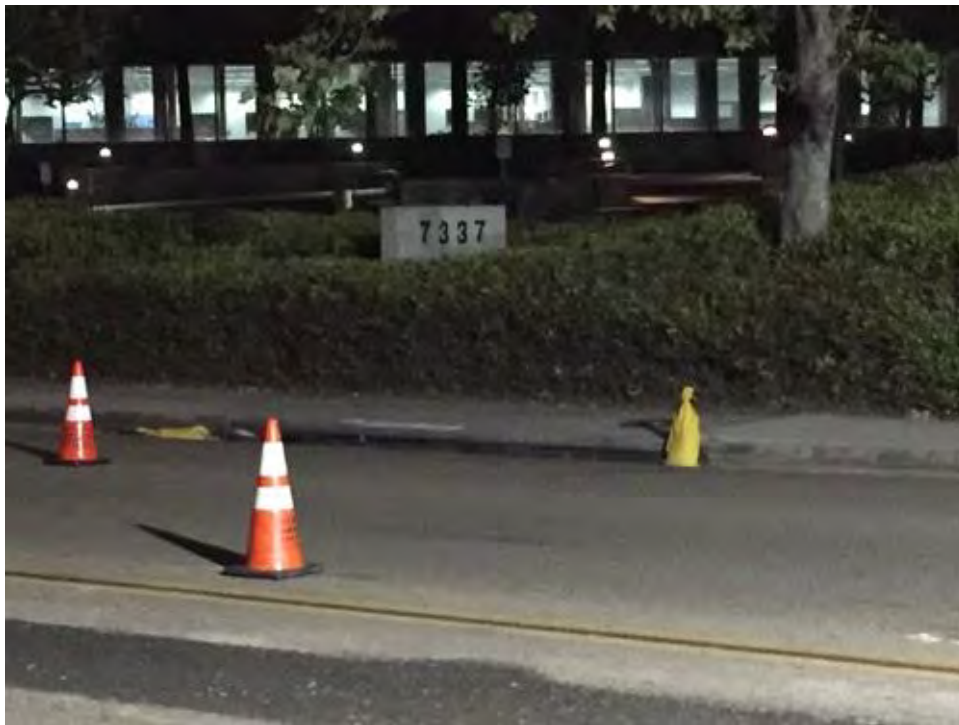
Caption BMPs in place and good working order.

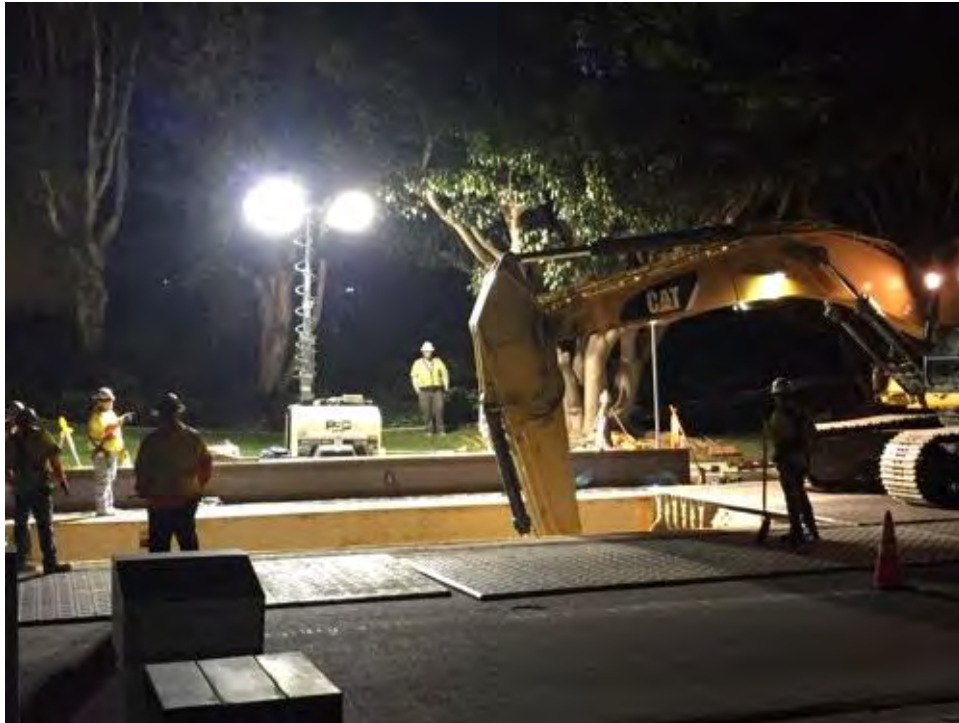
Caption Vault construction.

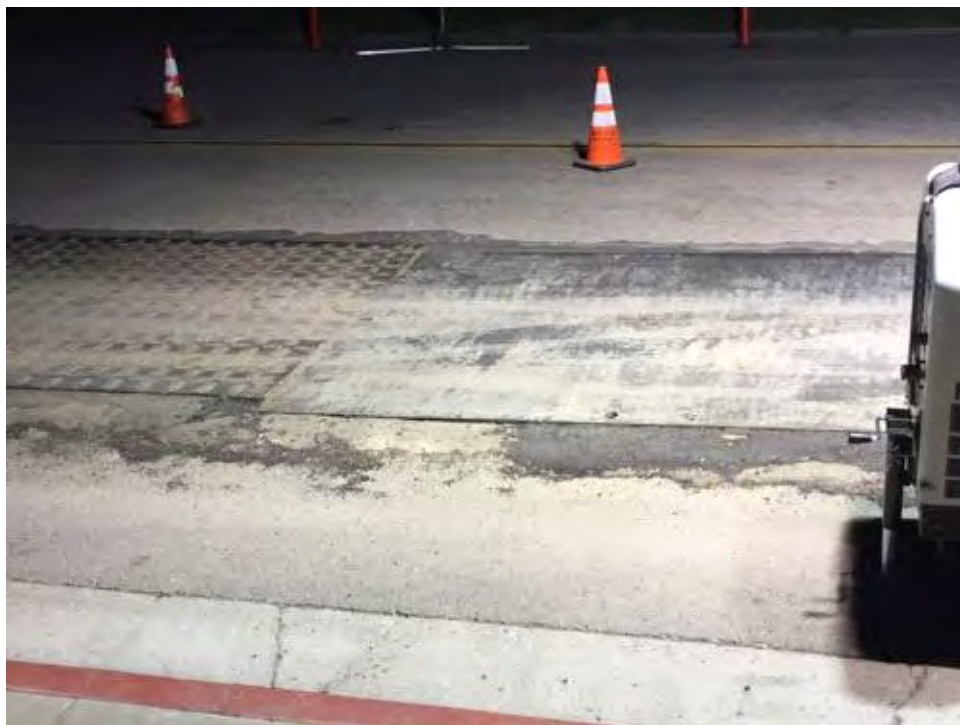
Caption Steel plates covering trenches.

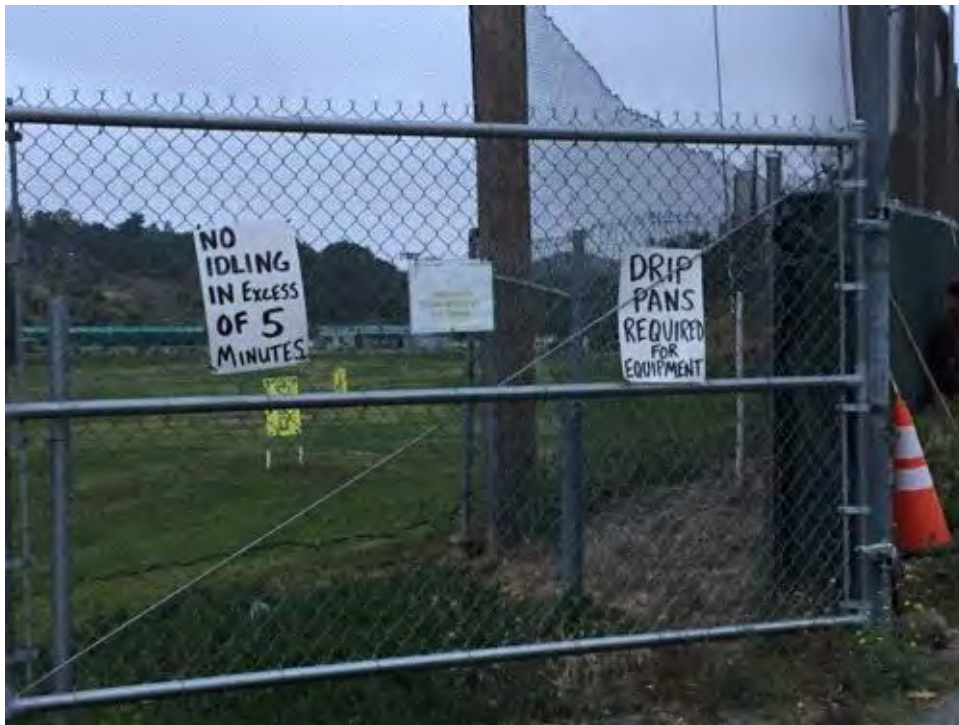
Caption Signage at construction yard entrance.

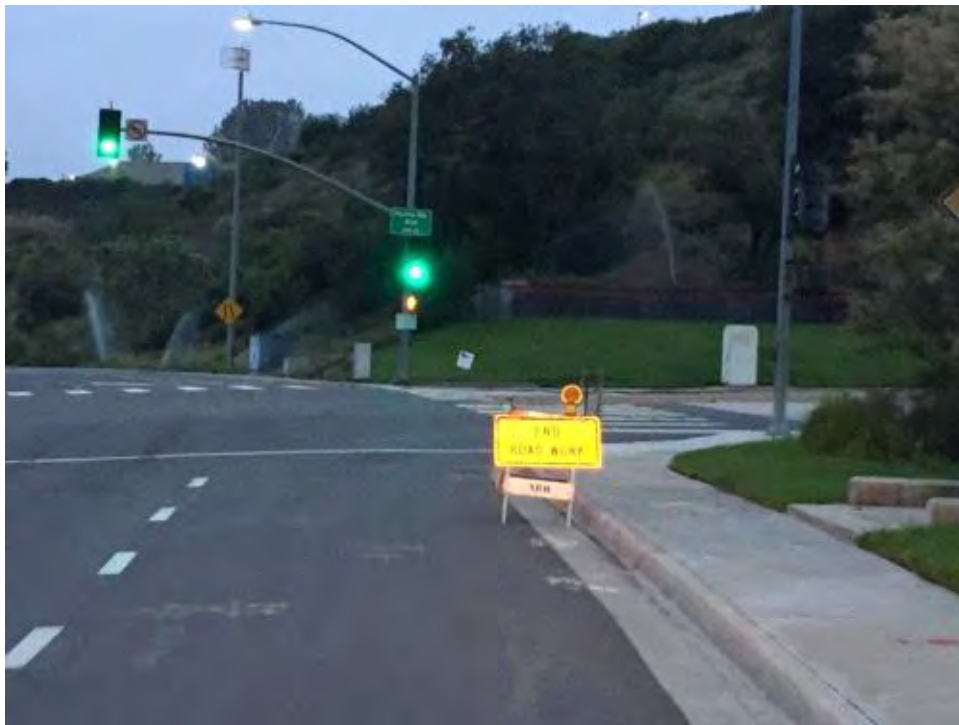
End of construction area clearly marked.

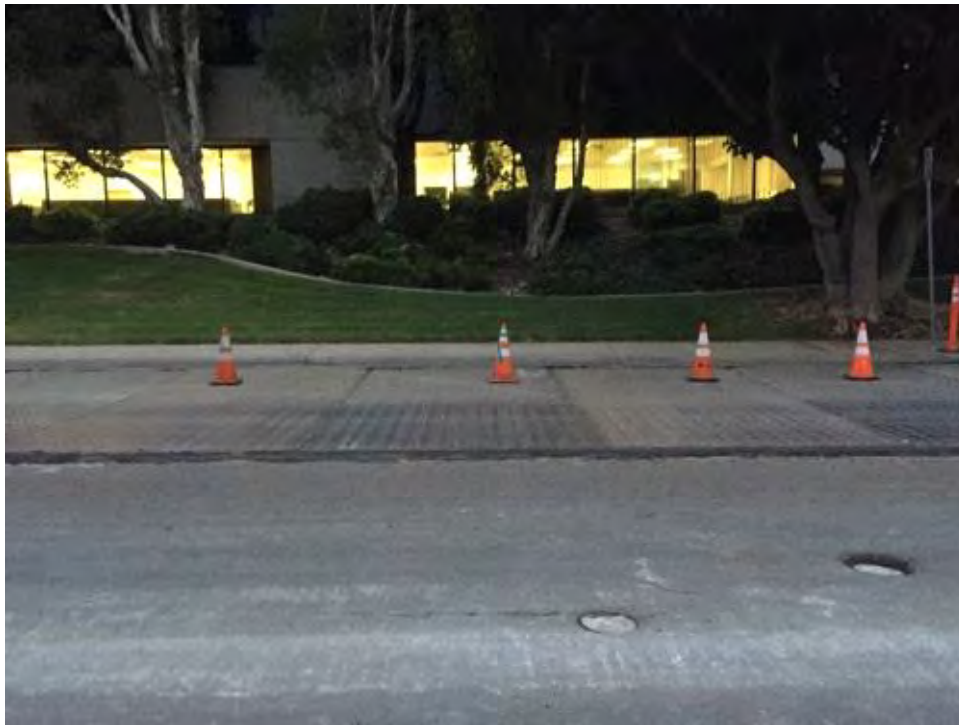
Steel plates covering vault at end of construction.

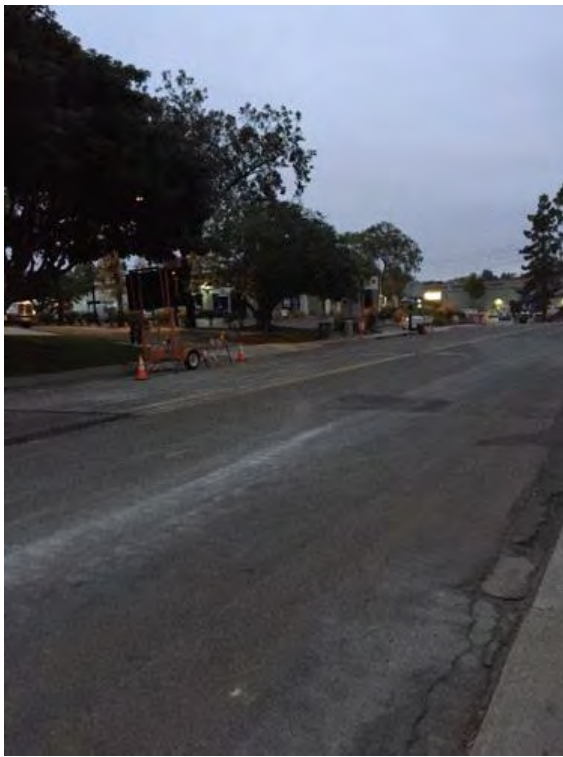
Caption      Constrction removed from street by 5:00 A.M.

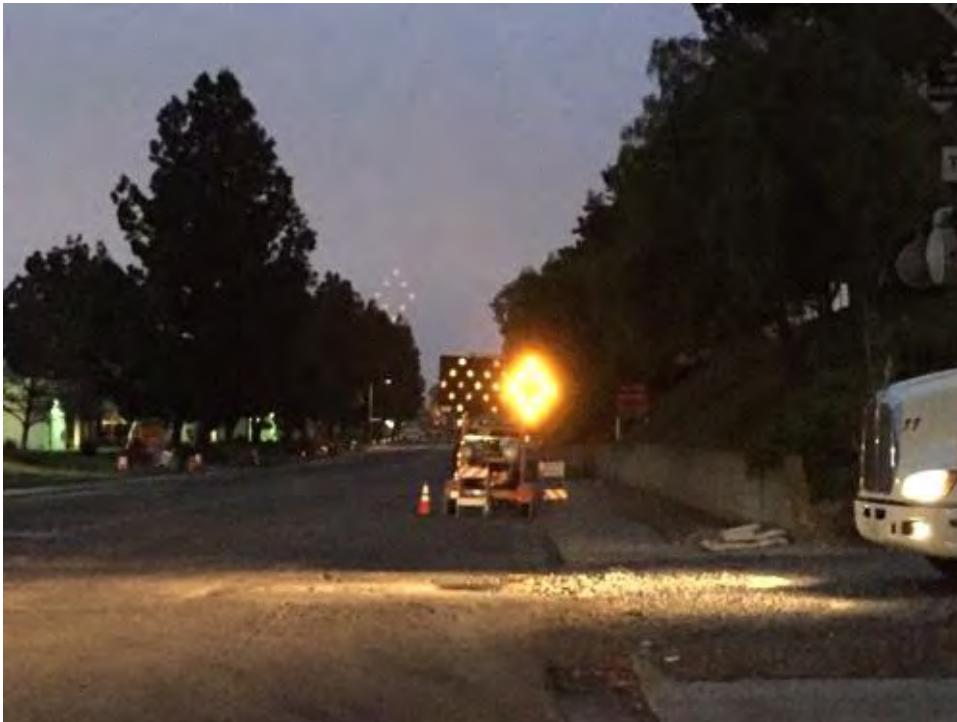
Caption      Digital traffic signage

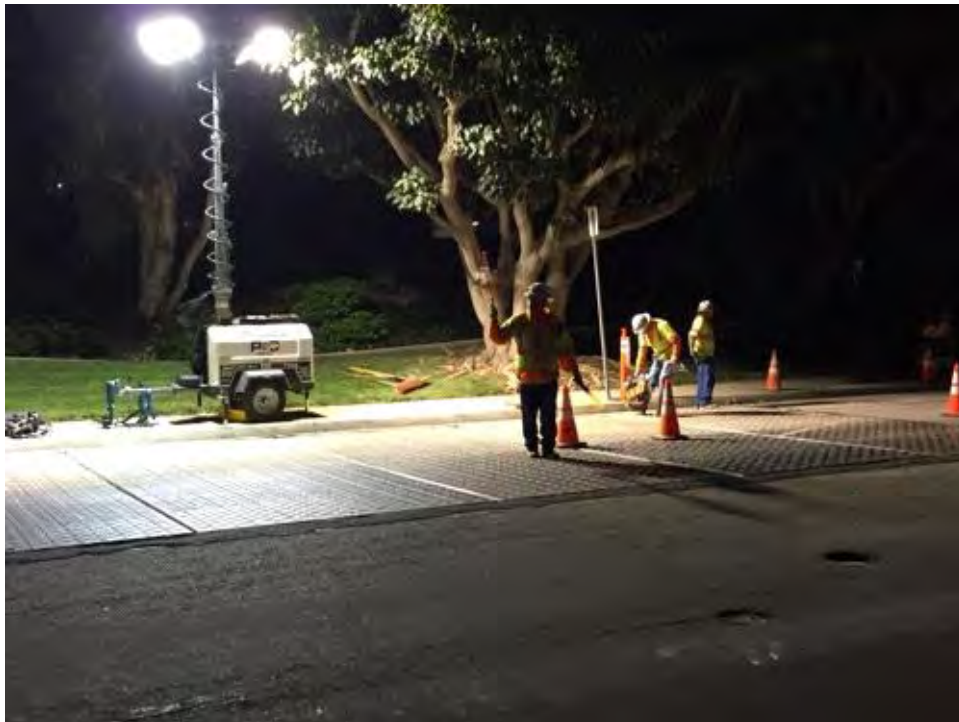
Caption Traffic flagger in place for vault construction.

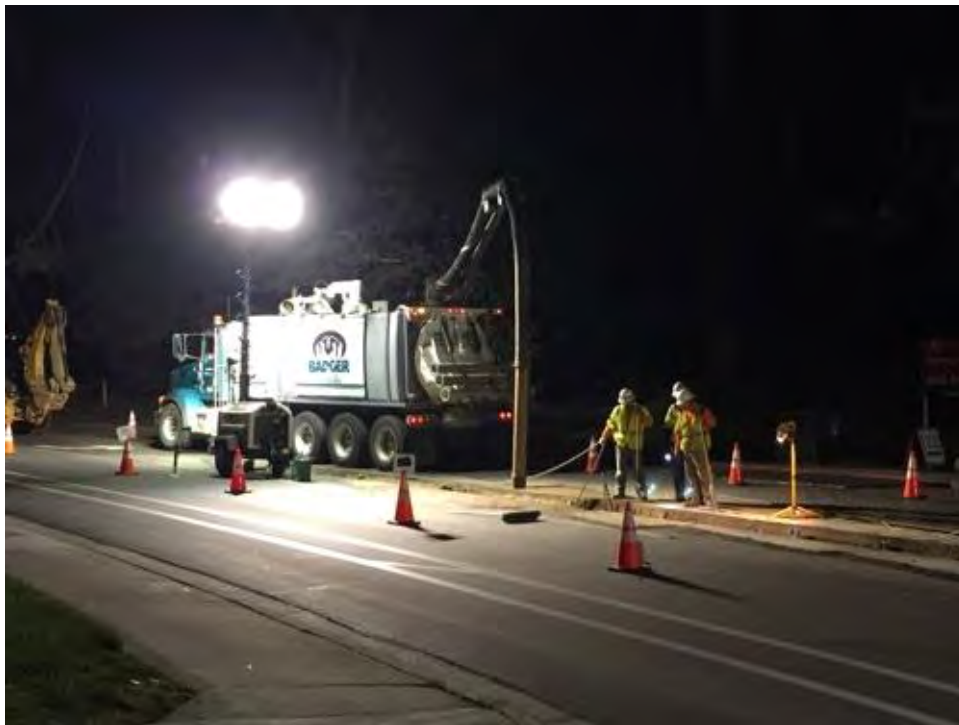
Caption Potholing in progress.

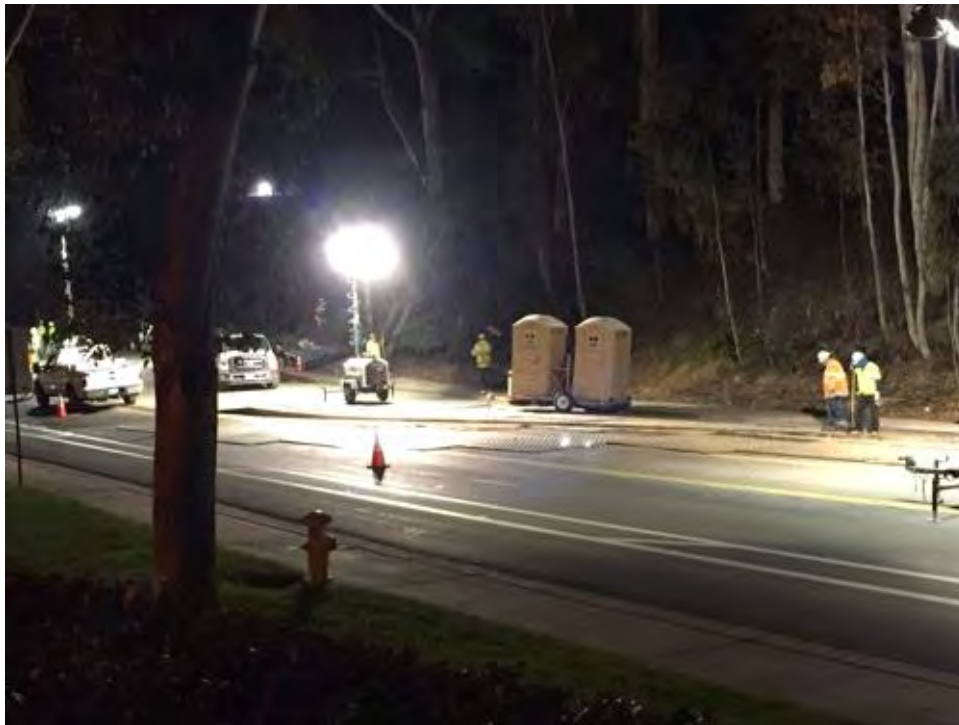
Caption Well-lit work area.

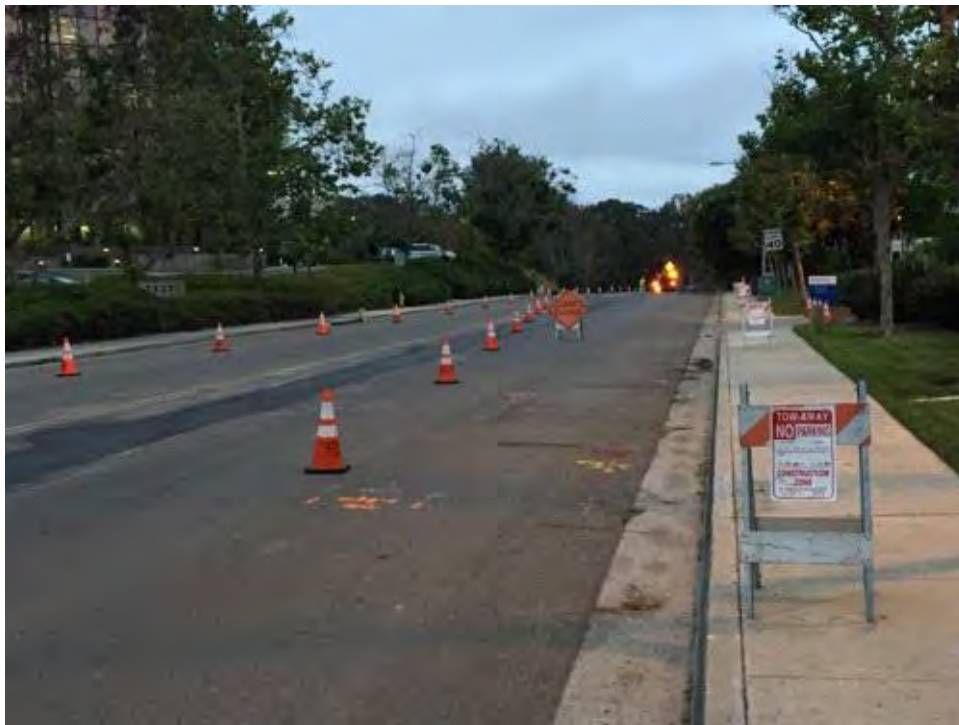
Caption Traffic cones and signage in place.

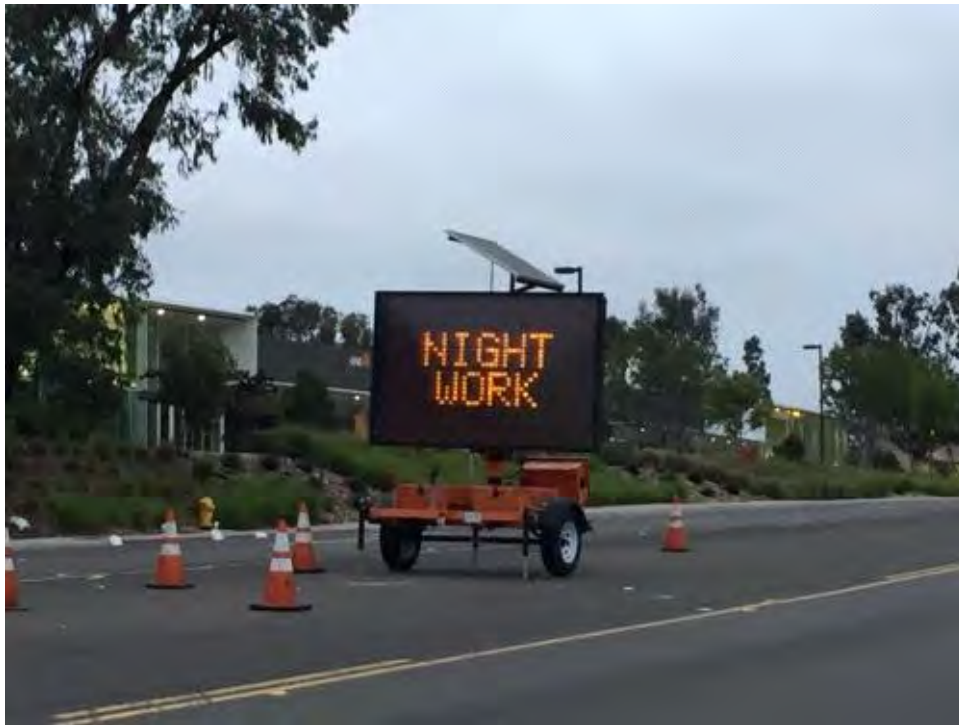
Caption Digital traffic signage in place.

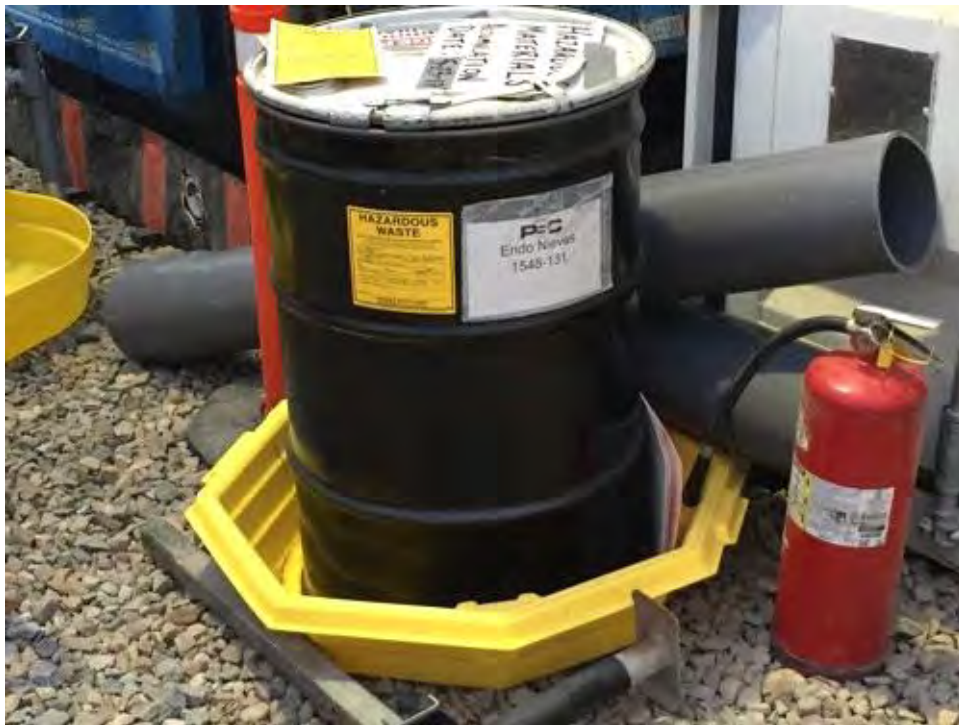
Caption Hazardous materials clearly labeled and stored in secondary containment.

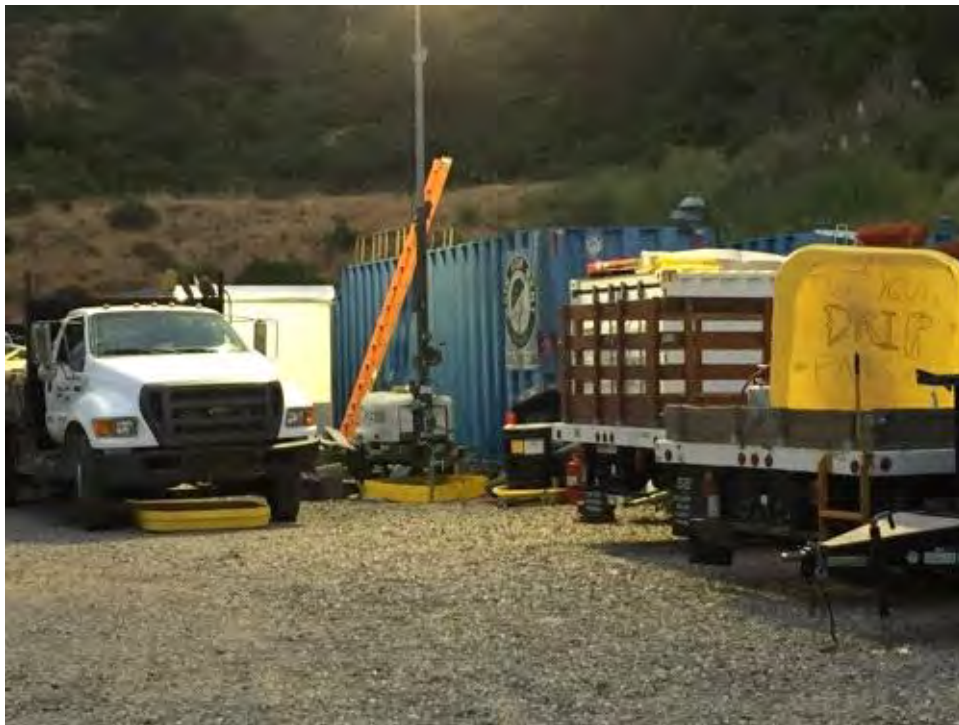
Caption Drip pans for secondary containment in place.

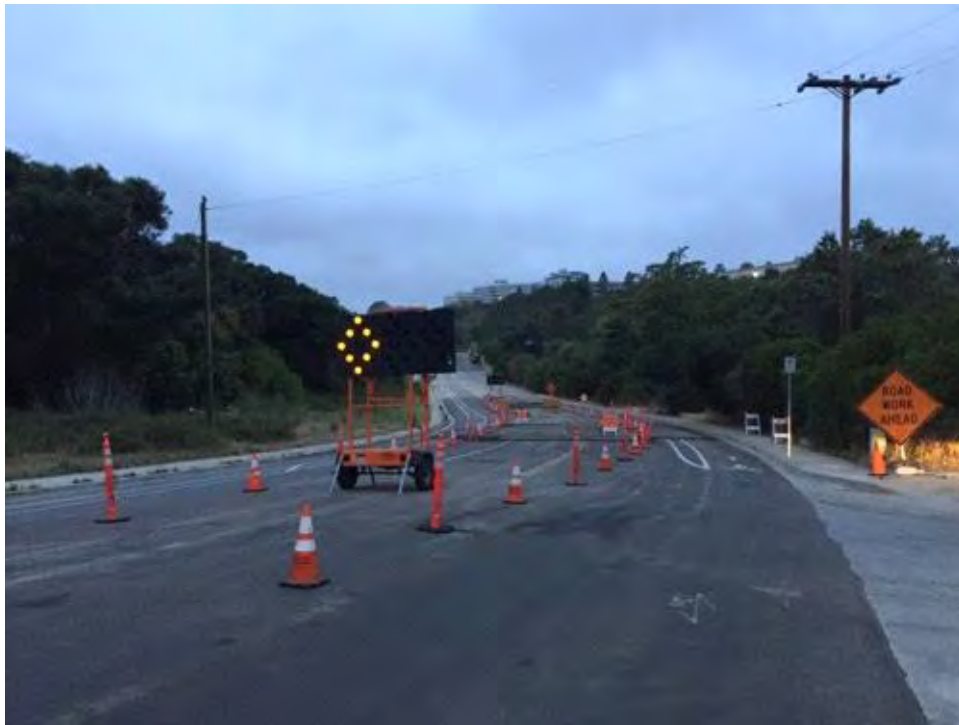
Caption Traffic signage and cones in place.

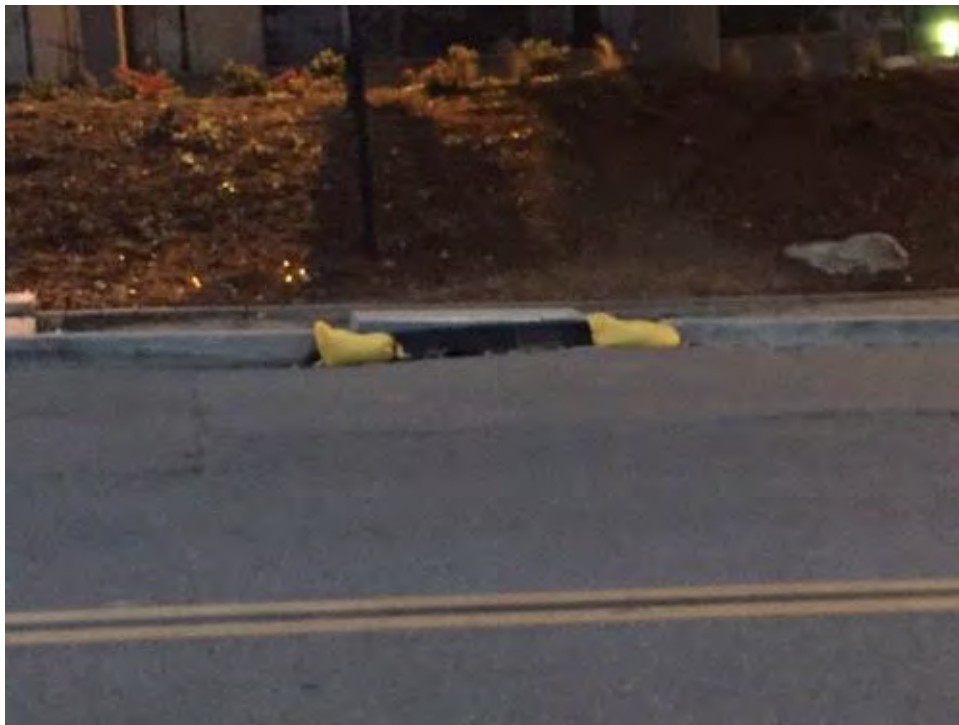
Caption BMPs in place and in good working order.

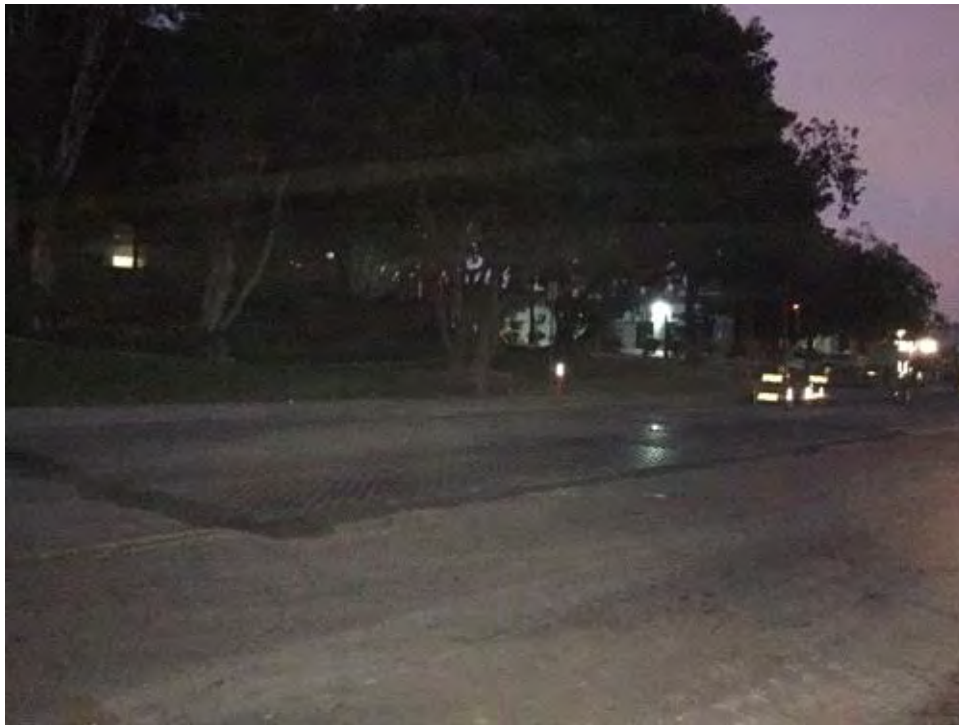
Caption Vault covered with steel plates and street returned to full public use.
