PROJECT MEMORANDUM
SYCAMORE-PEÑASQUITOS 230-KV
TRANSMISSION LINE PROJECT

Date: June 29, 2017
To: Billie Blanchard, CPUC Project Manager
From: Sheila Hoyer, CPUC Monitoring Supervisor
Subject: Weekly Report #25 – June 18 to June 23, 2017

SDG&E Sycamore-Peñasquitos 230-kV Transmission Line Project: Daily Inspection Report

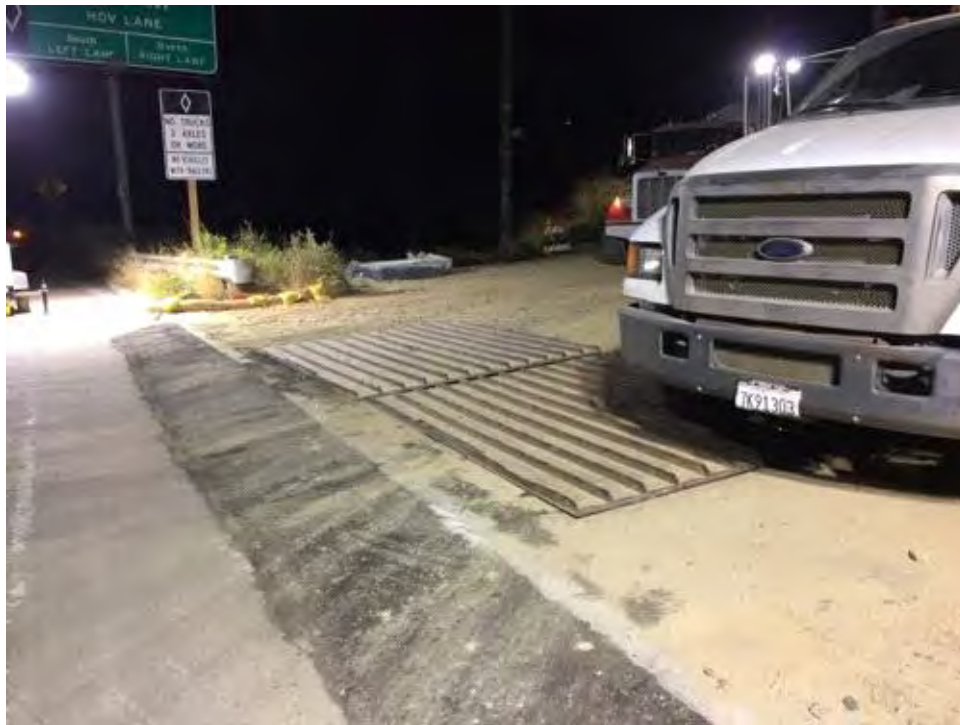
Caption Steel shaker plates at I-15.

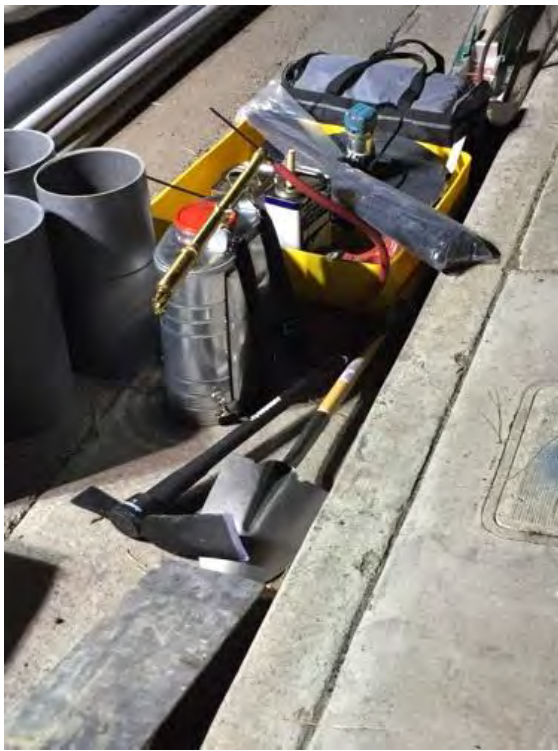
Caption Fire prevention equipment on site.

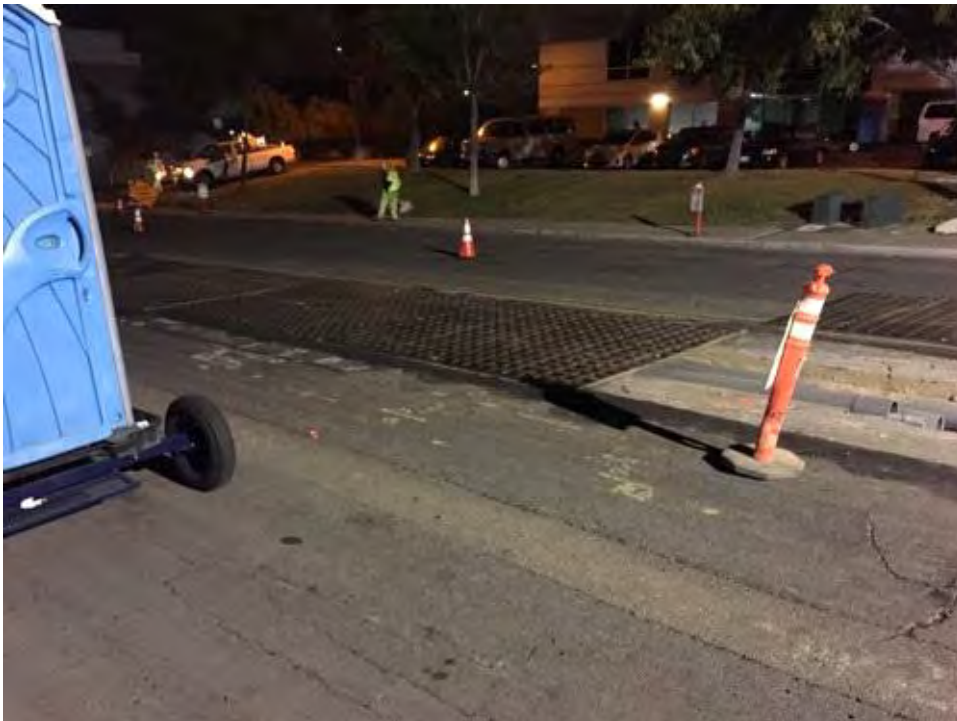
Caption Trenches covered with steel plates.

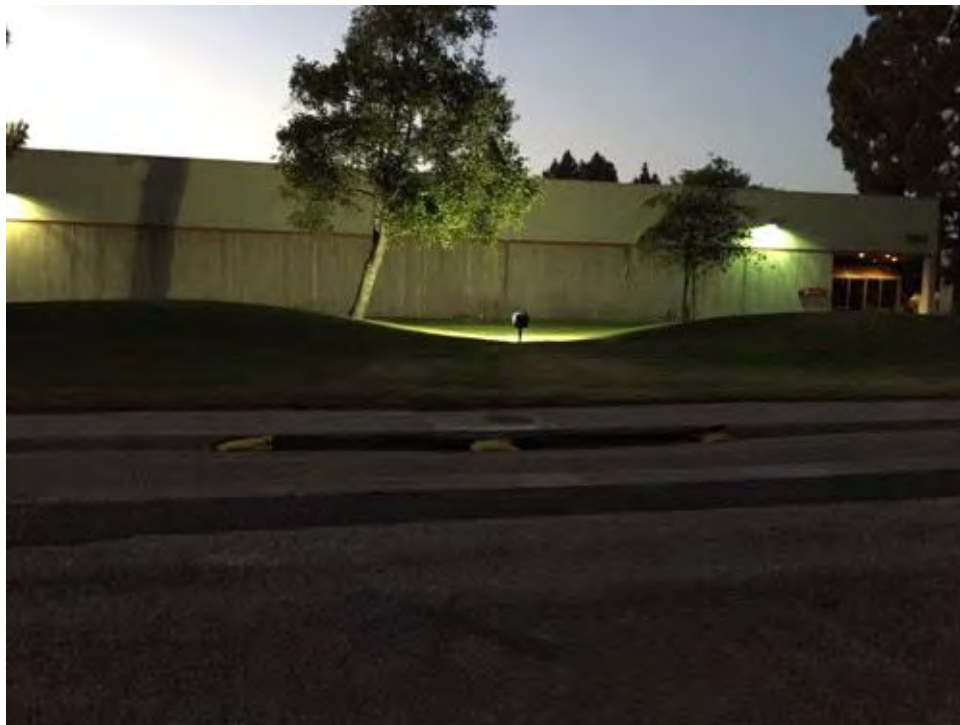
Caption BMPs in place and in good working order.

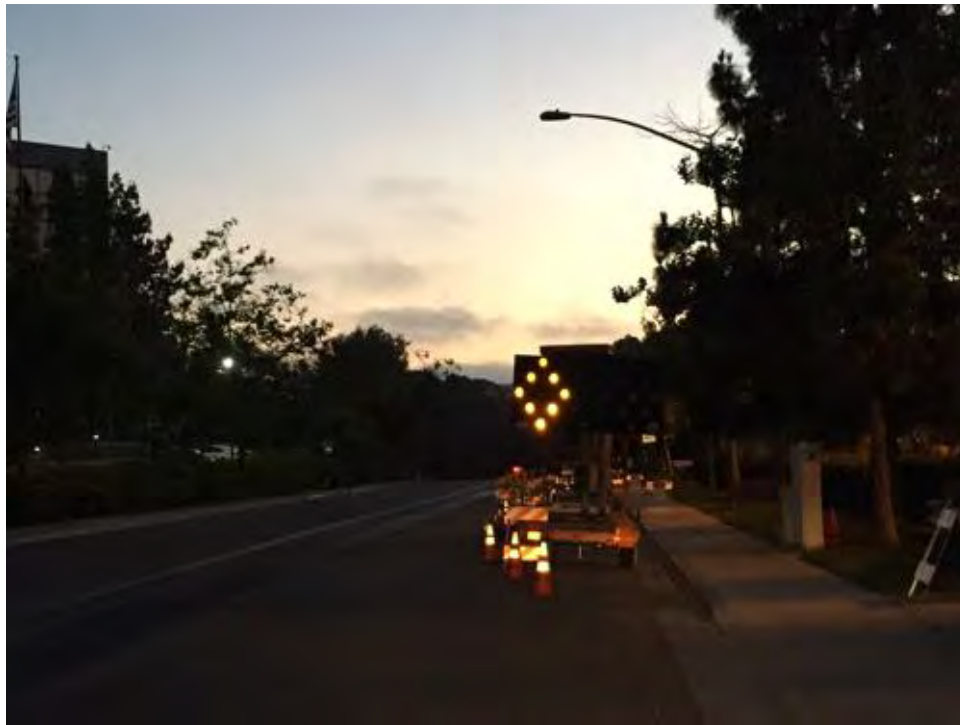
Caption Digital signage in place.

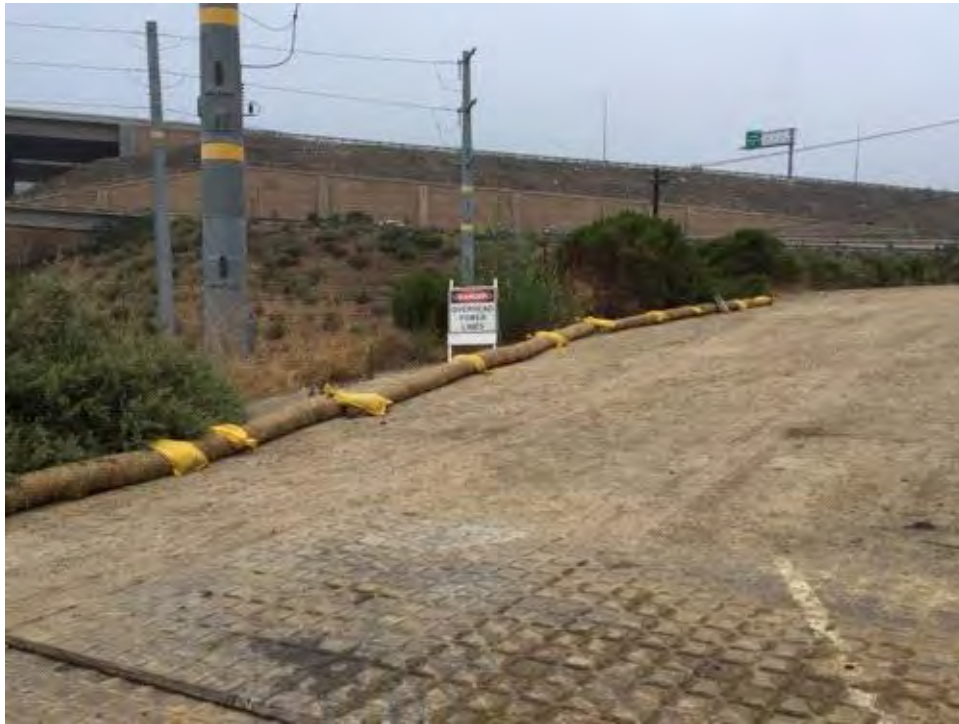
Caption BMPs in place.

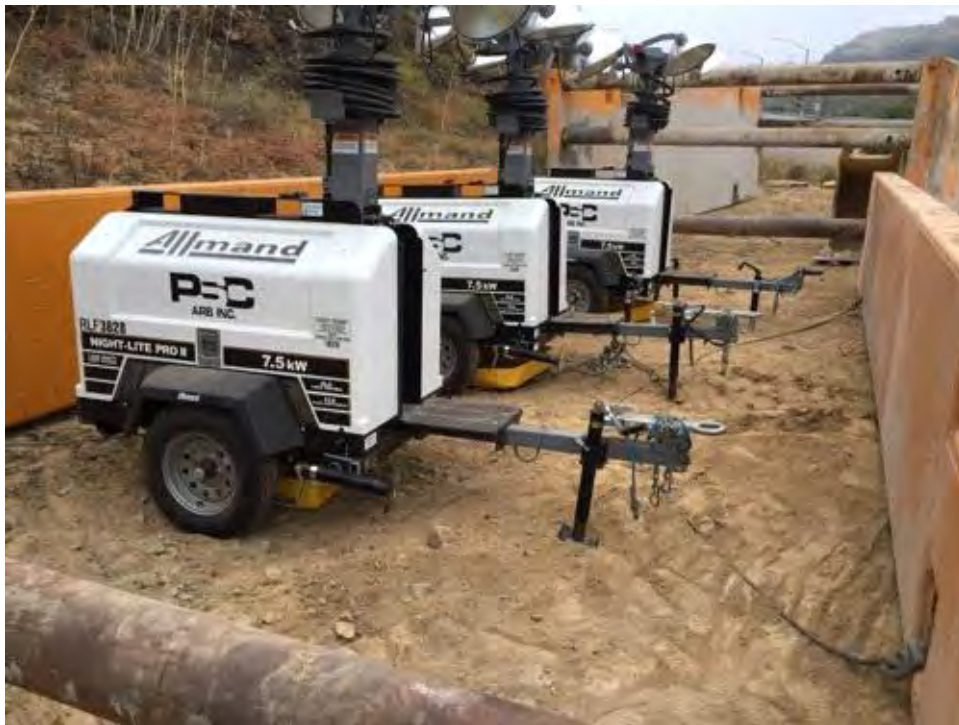
Caption Drip pans in place.

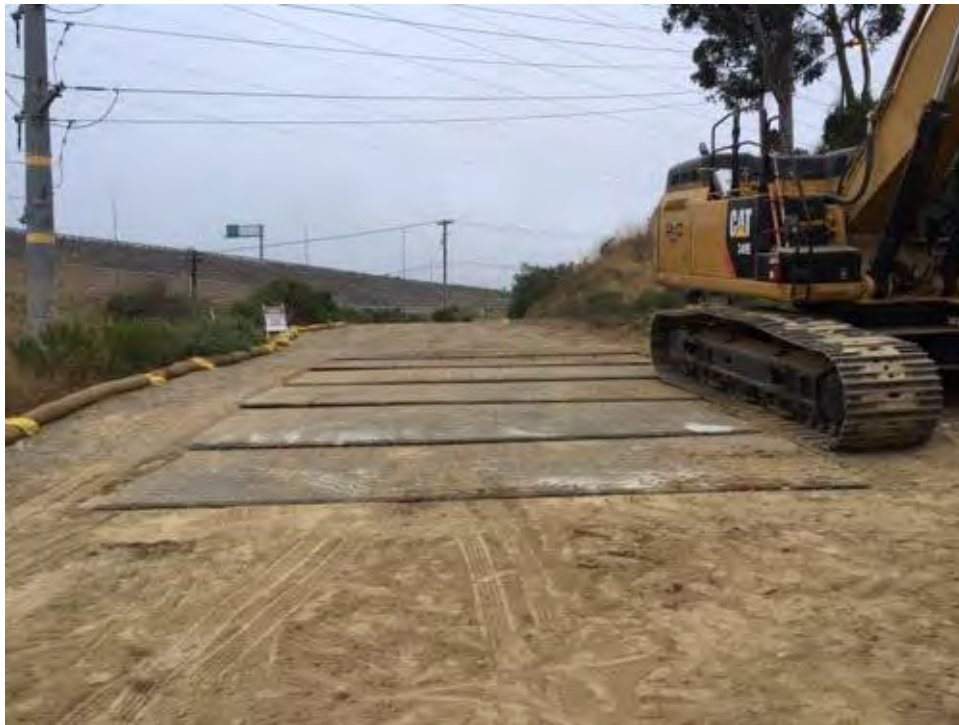
Caption Steel plates covering vault.

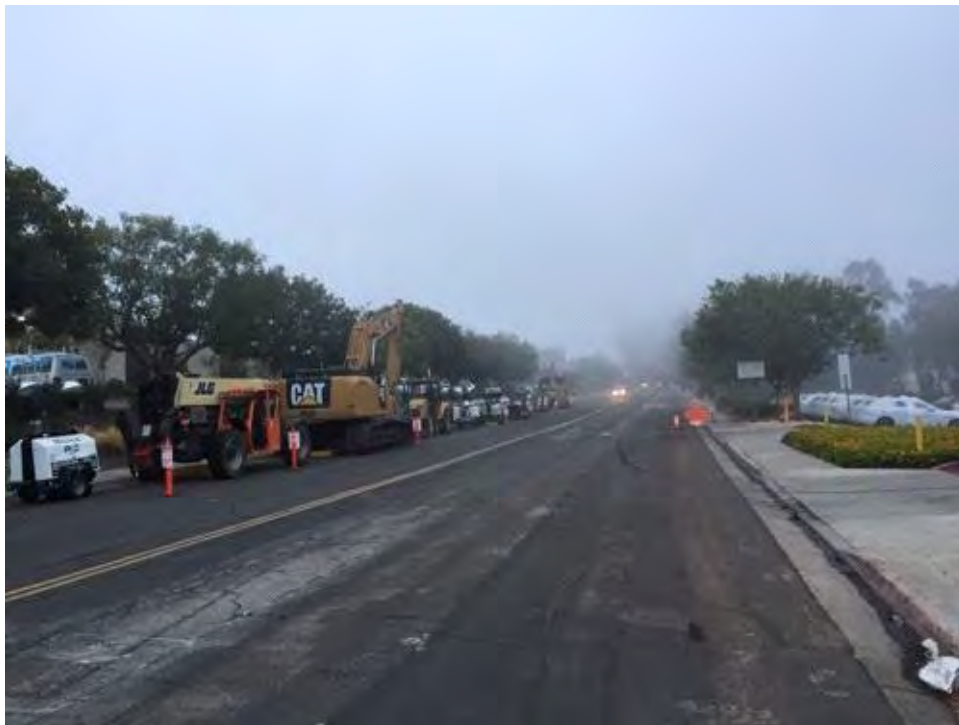
Caption Equipment safely stored and returned to unrestricted public access.

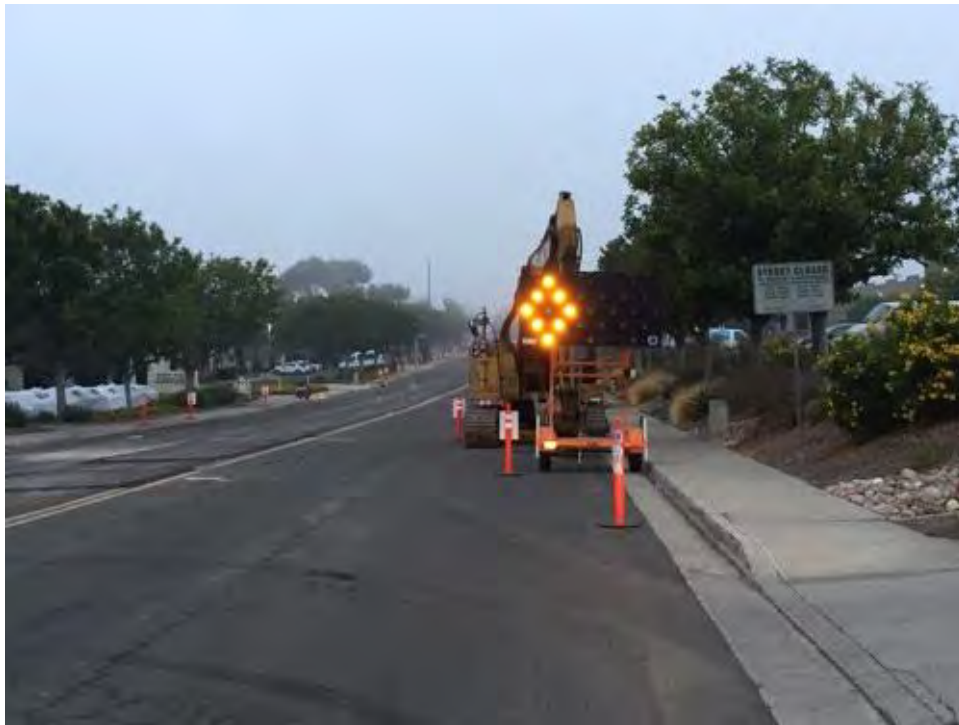
Caption Digital signage in place.

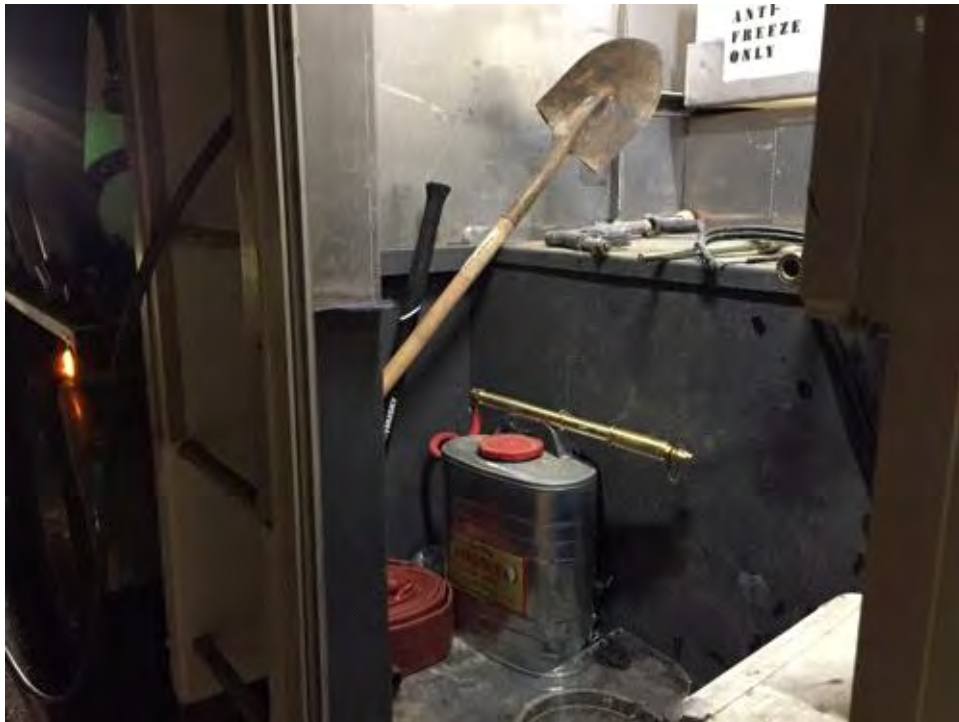
Caption Fire prevention equipment inside the potholing rig.

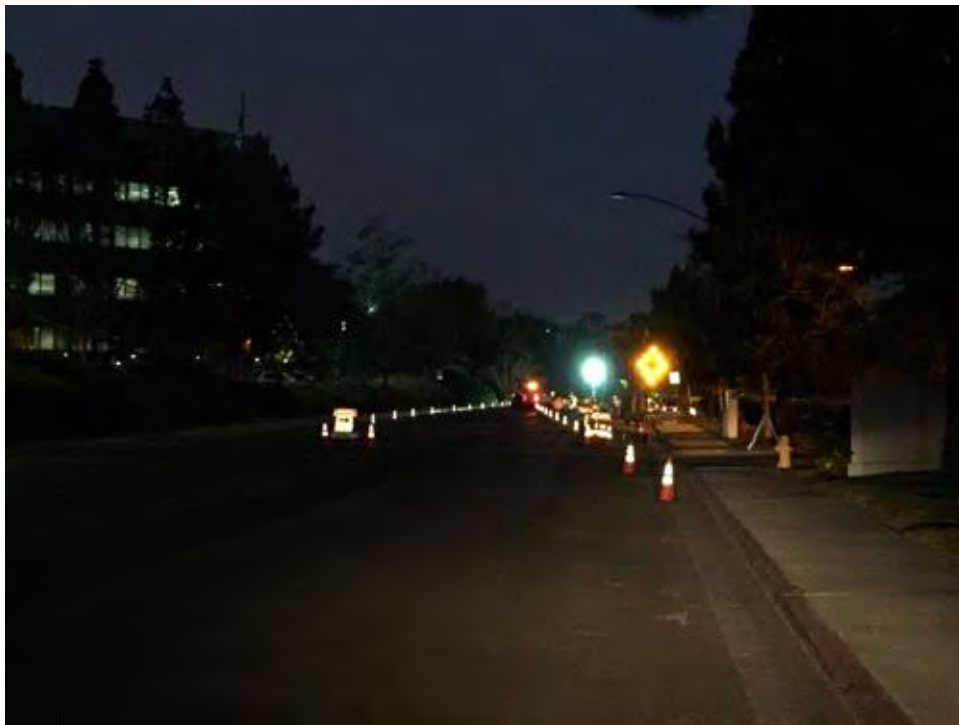
Caption Cones and signage in place.

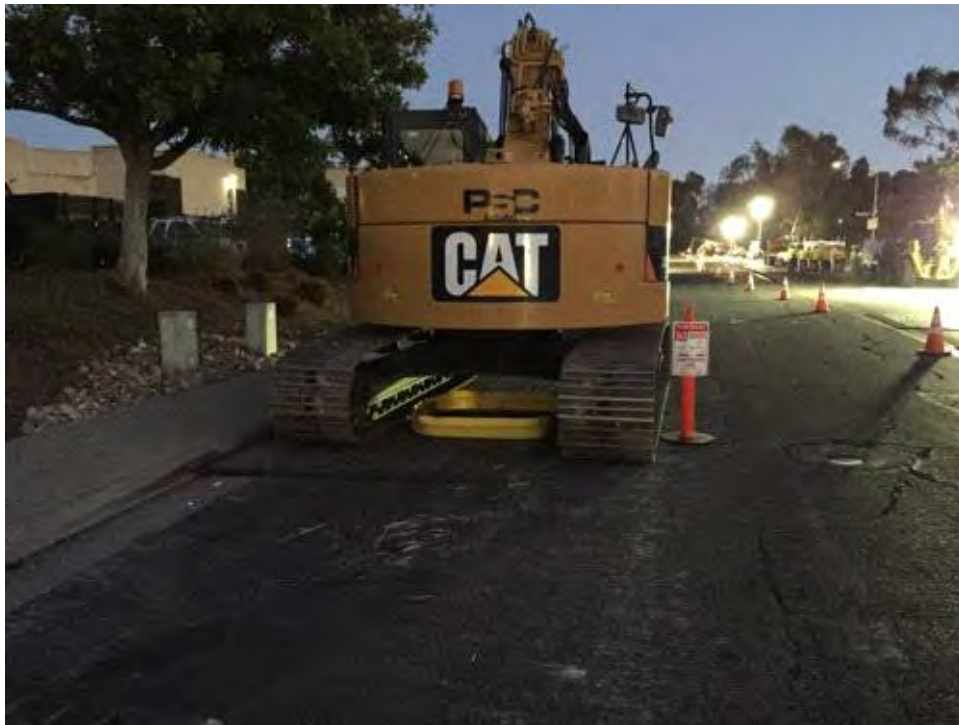
Caption Drip pans in place.

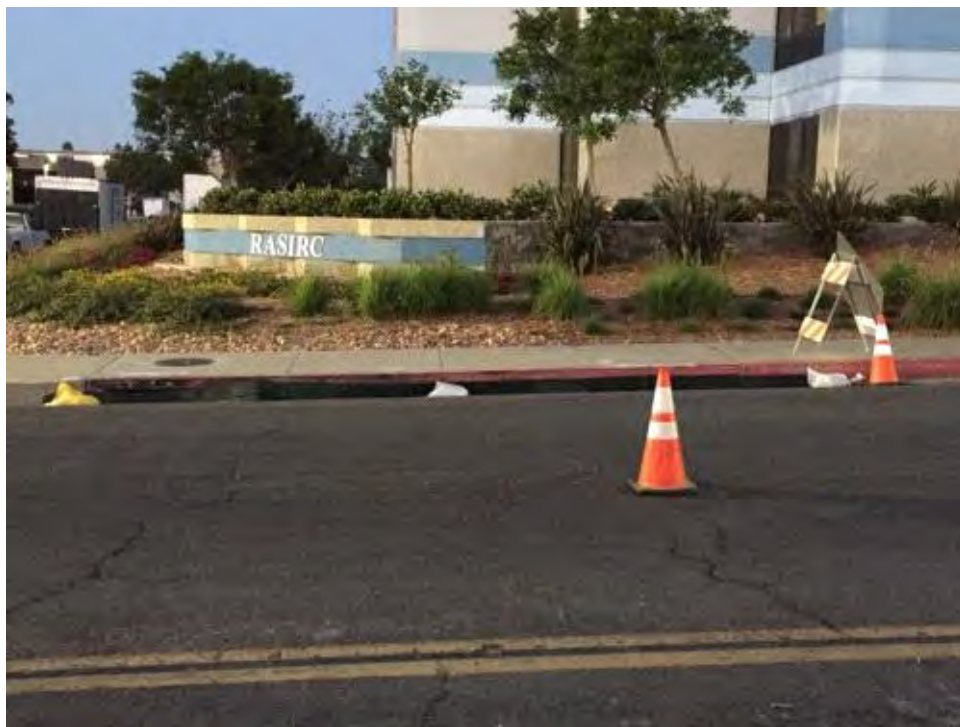
Caption BMPs in place and in good working order.

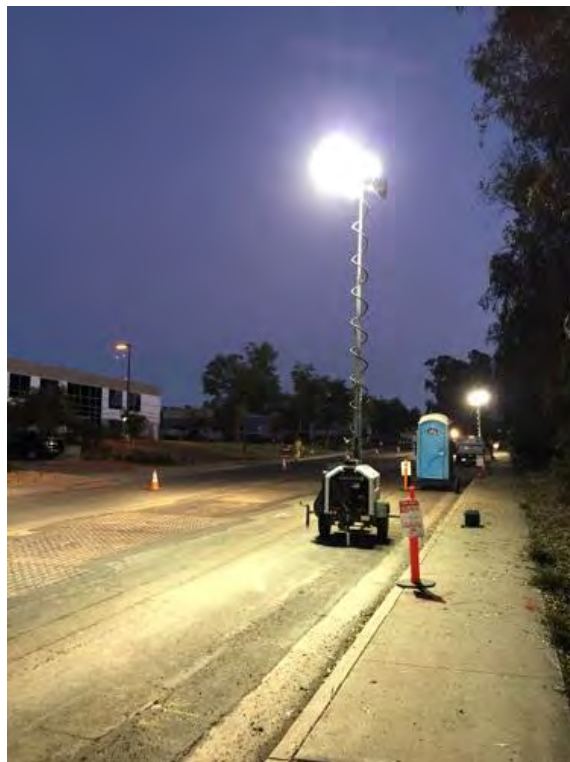
Caption Lighting in place for the night's work.

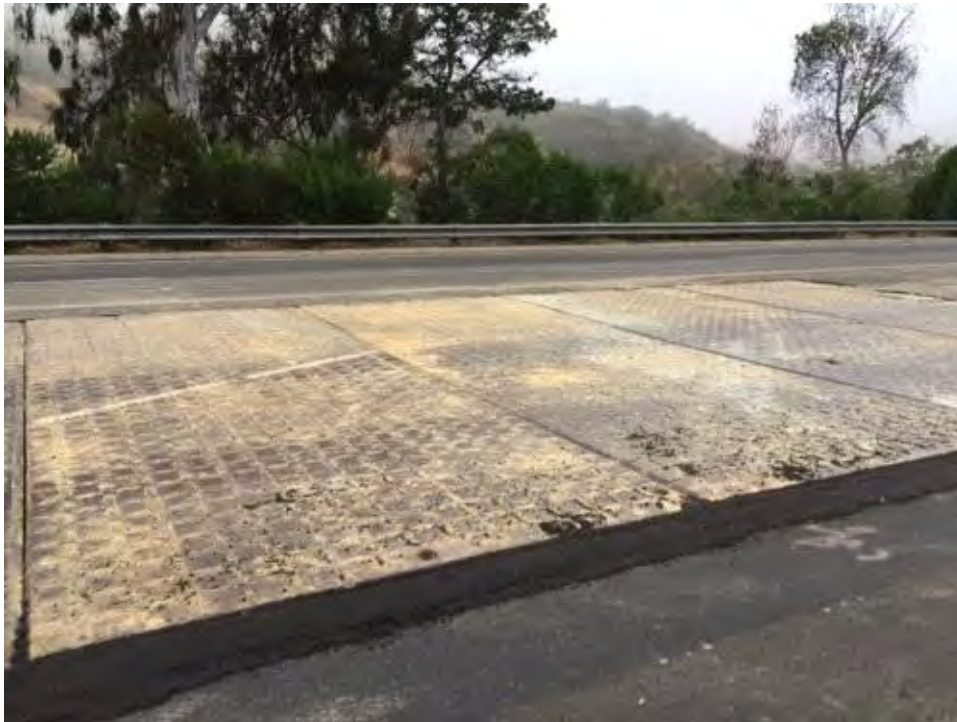
Caption Steel plates covering excavations.

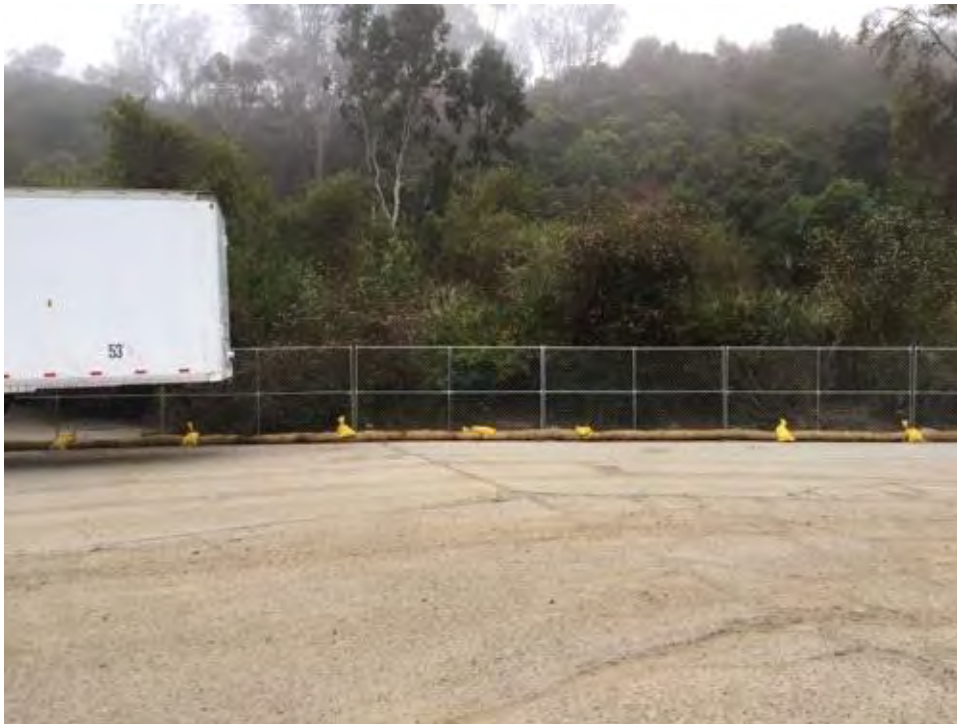
Caption BMPs in place and in good working order.

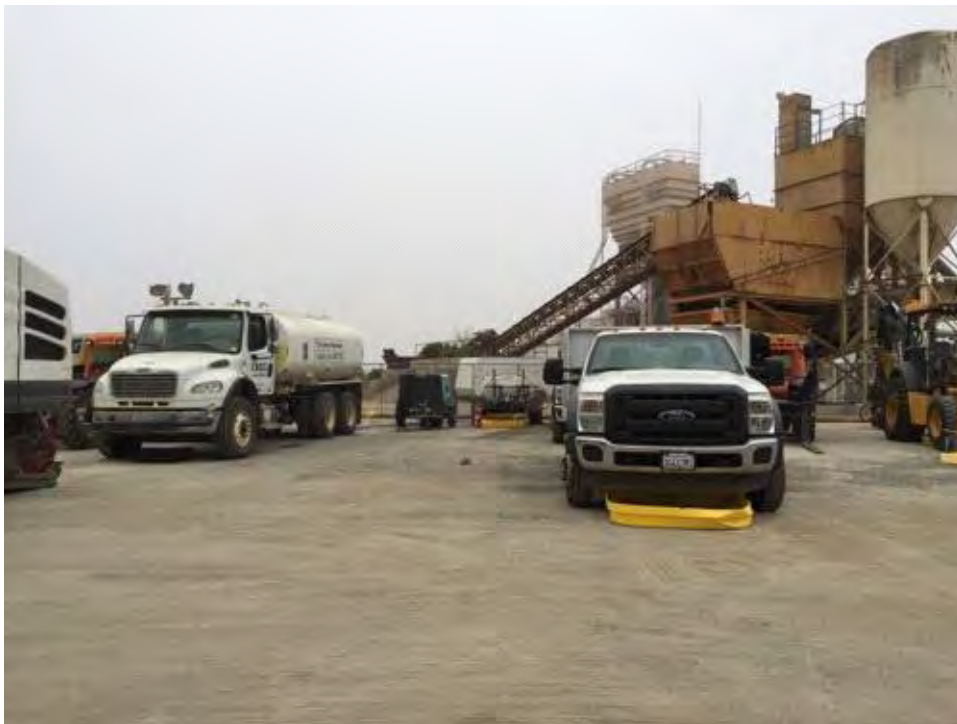
Caption Drip pans in place at Vulcan Staging Yard.

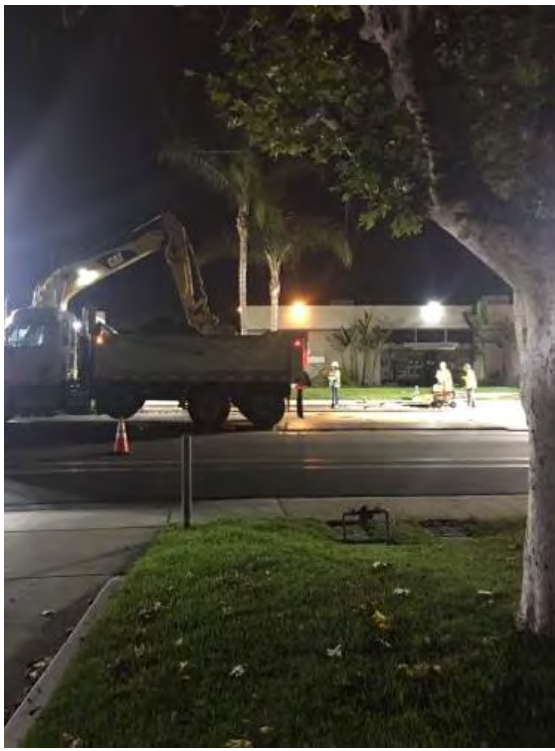
Caption Trenching on eastern portion of Carroll Rd.

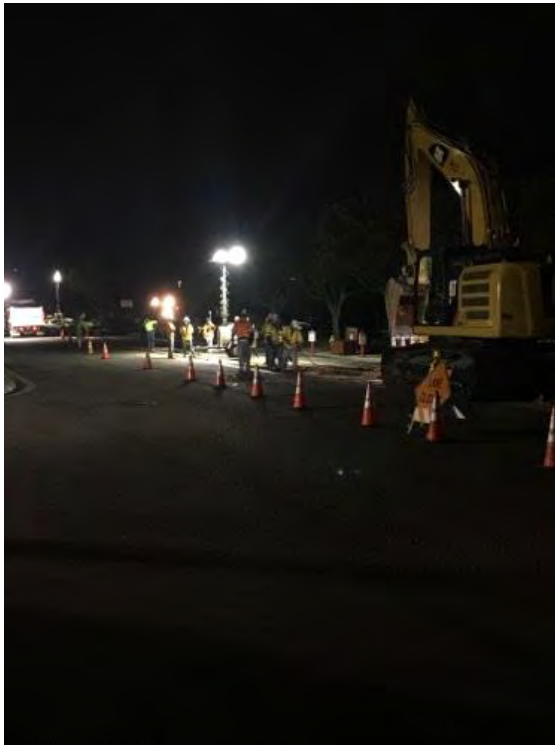
Caption Trade Place trenching.

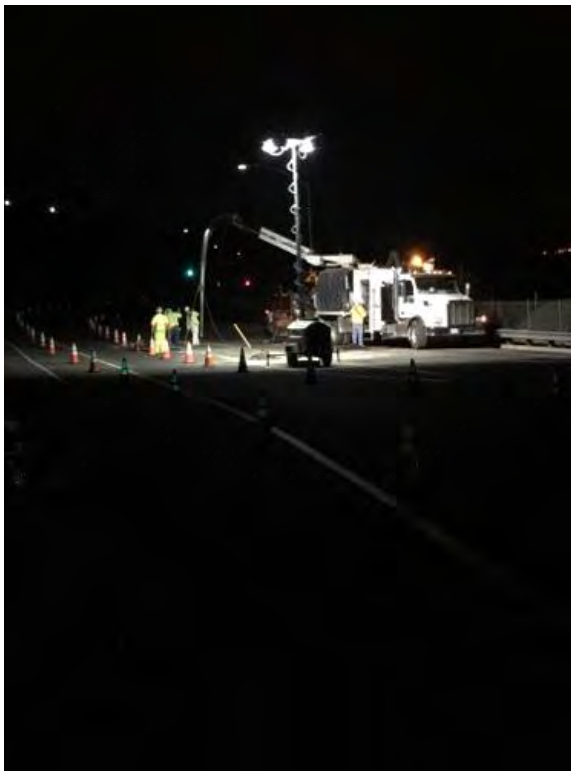
Caption Potholing on Carroll Rd. just east of Nancy Ridge Rd.

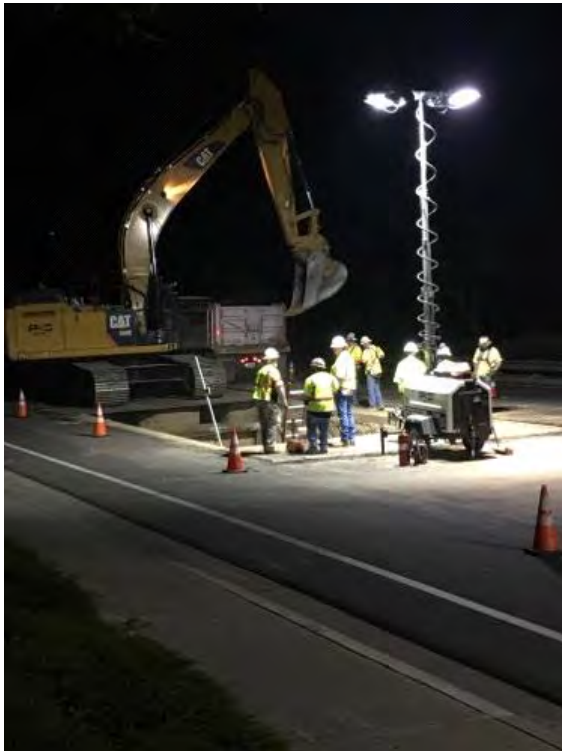
Caption Trenching western end of Carroll Rd.

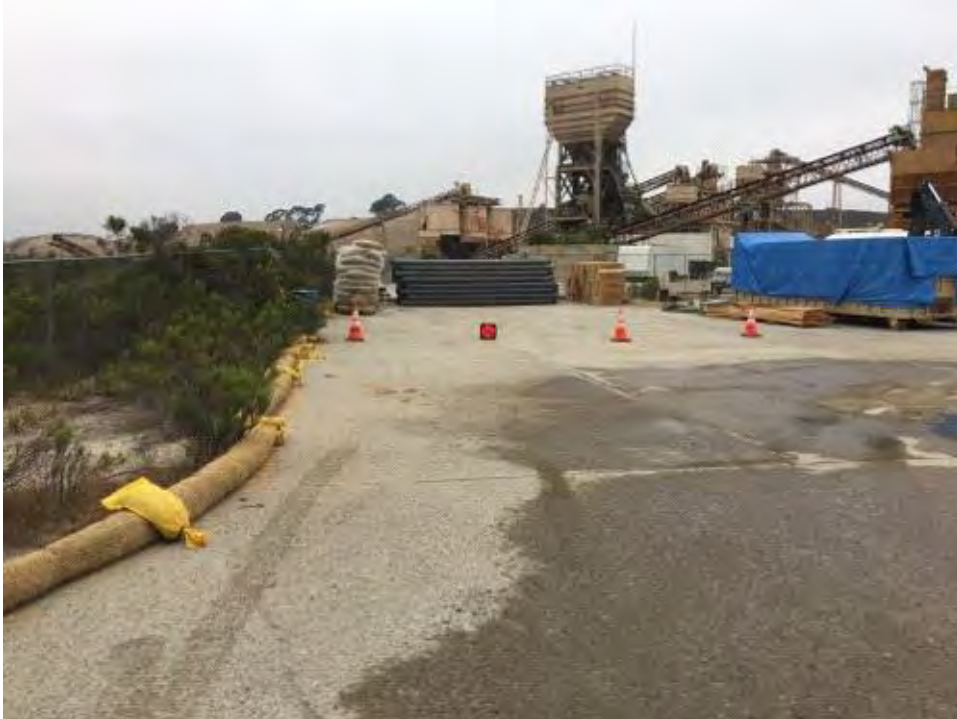
Caption BMPs Vulcan Staging Yard.

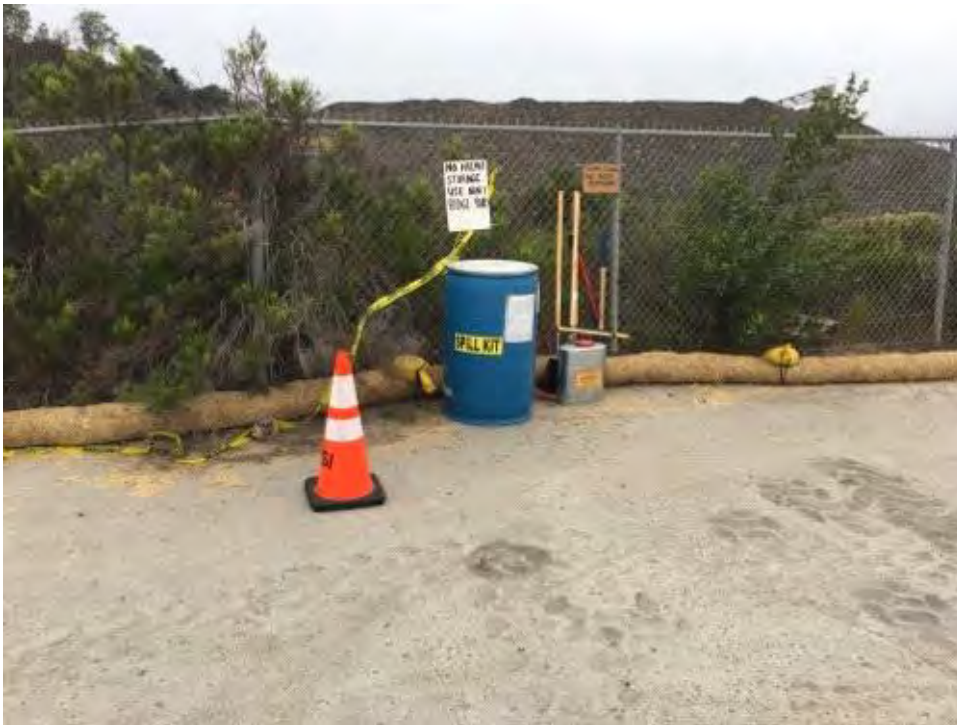
Caption Fire equipment at Vulcan Staging Yard.

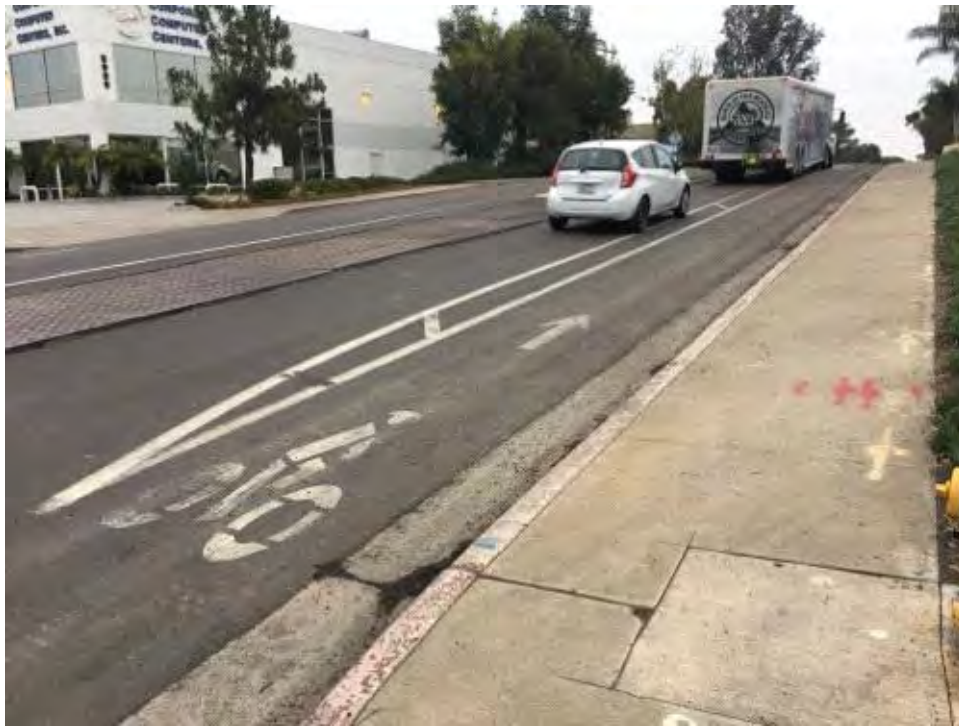
Carroll Rd. work site with asphalt rock debris.
