PROJECT MEMORANDUM SYCAMORE-PEÑASQUITOS 230-KV TRANSMISSION LINE PROJECT

Date: August 7, 2017
To: Billie Blanchard, CPUC Project Manager
From: Sheila Hoyer, CPUC Monitoring Supervisor
Subject: Weekly Report #30 – July 23 to July 29, 2017

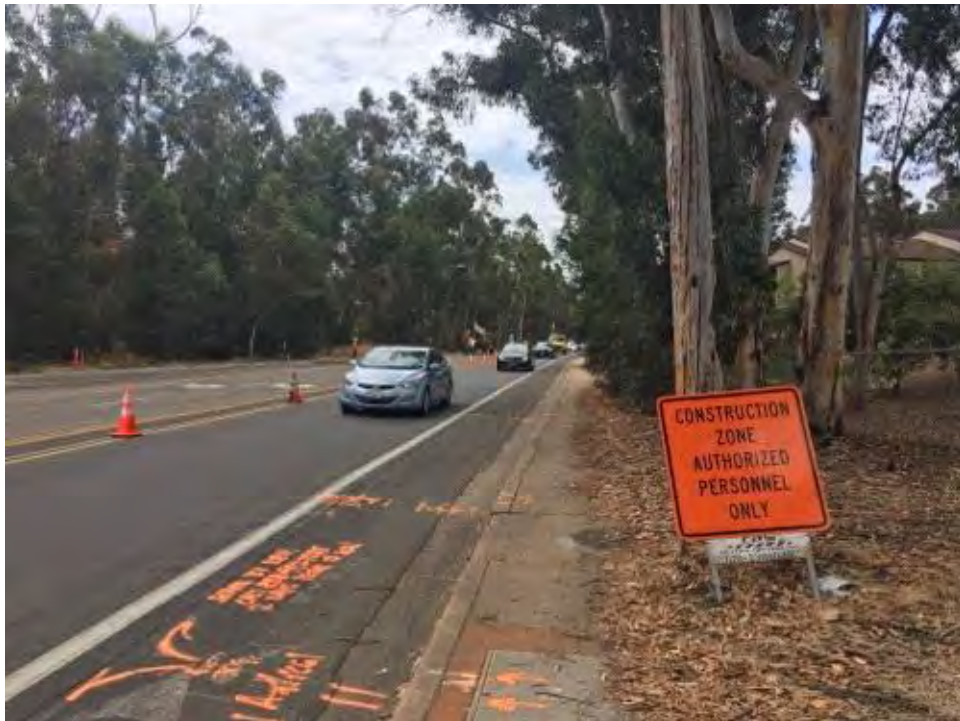
Caption Traffic control along Pomerado Road.

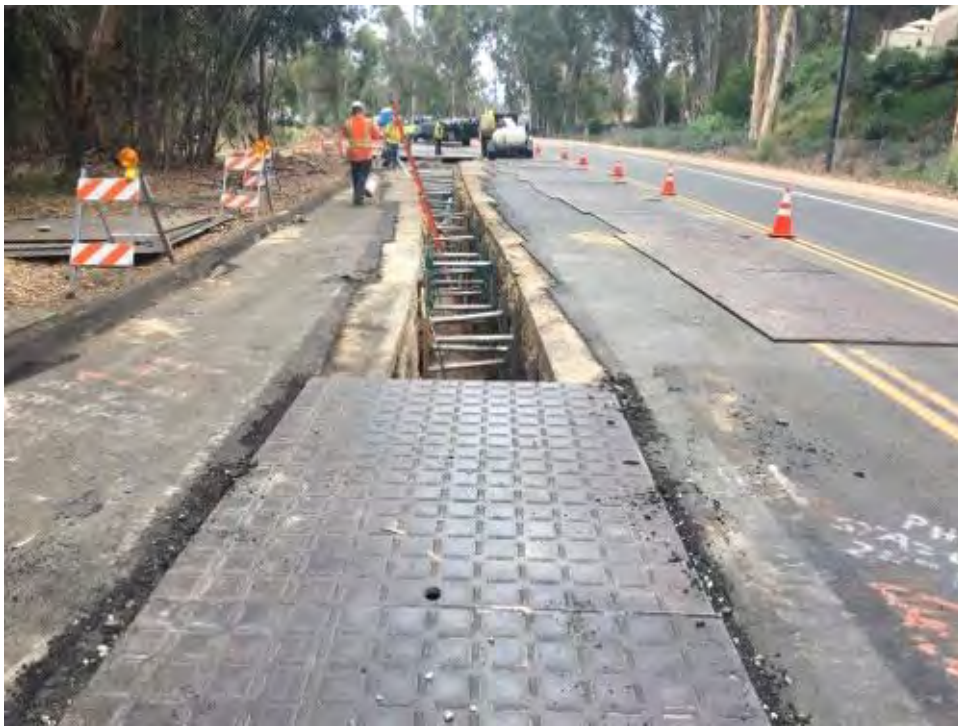
Caption Trench along Pomerado Road
Photo Attributes Capture Date/Time: Mon Jul 24 2017 15:34:43 GMT-0700 (PDT)
Coordinates: 33.157055, -117.312533
View Direction: West

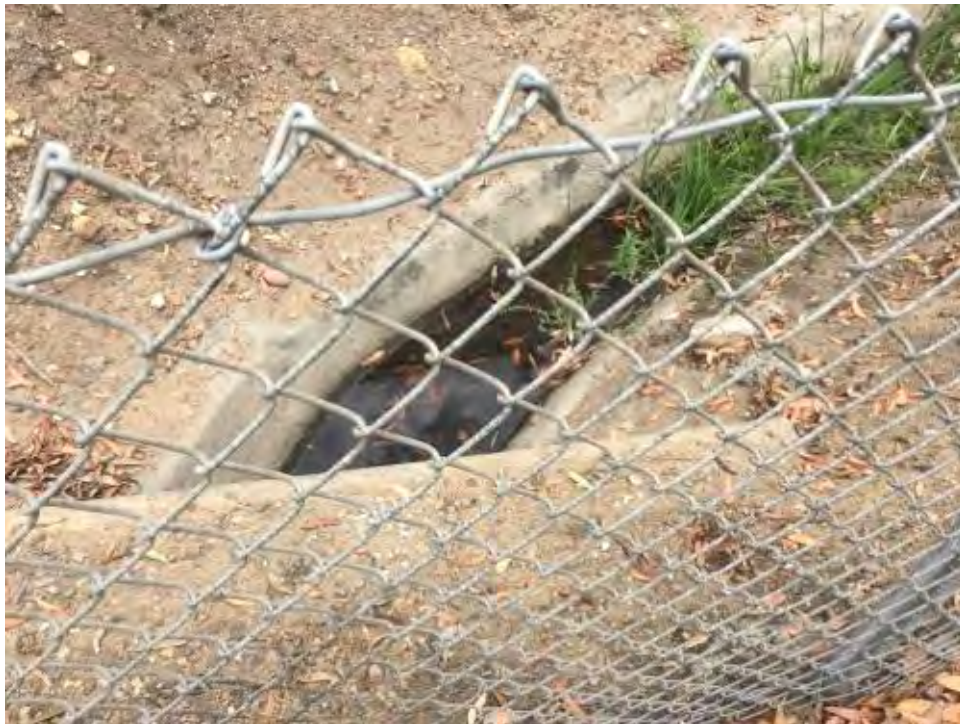
Caption Ponding offsite following morning rainstorm.
Photo Attributes Capture Date/Time: Mon Jul 24 2017 15:34:03 GMT-0700 (PDT)
Coordinates: 33.157055, -117.312533
View Direction: North

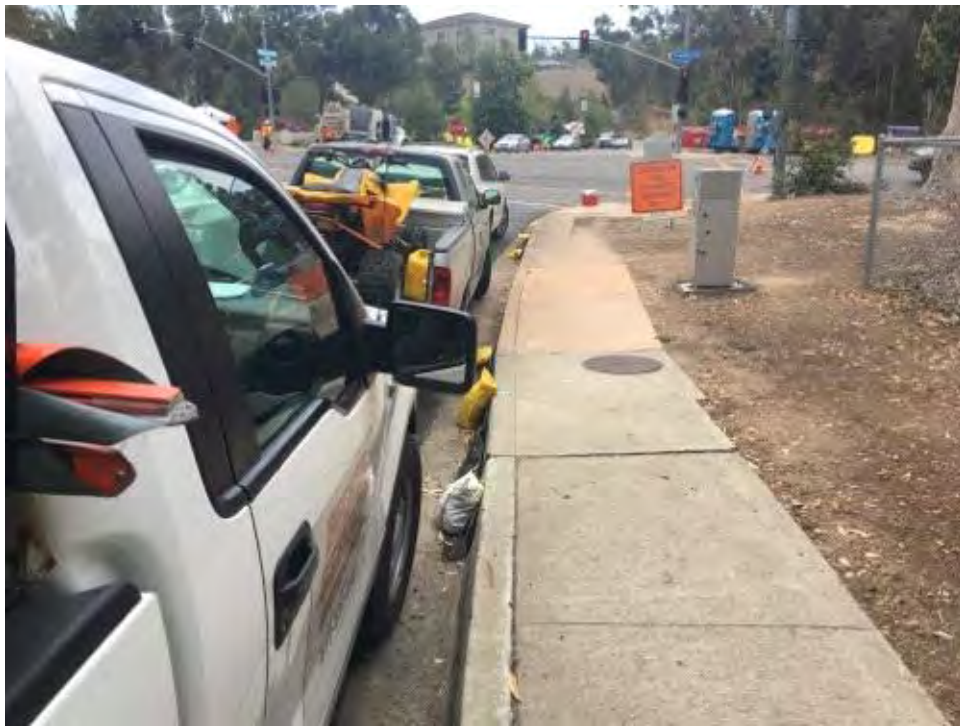
Caption Pomerado Road/Avenue of Nations BMPs functioning following morning rainstorm.

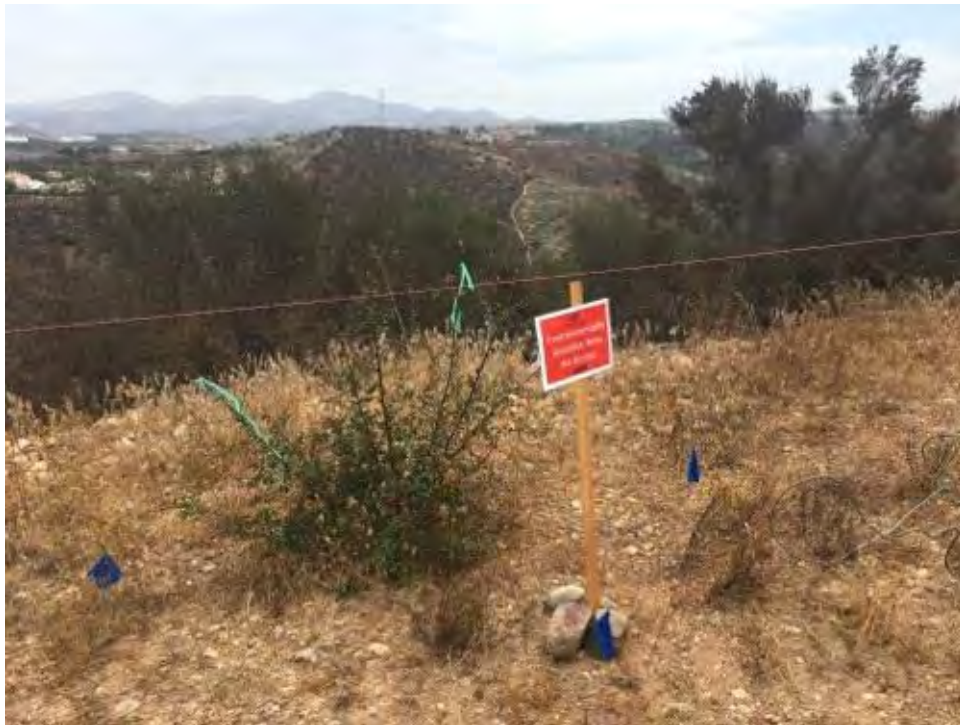
Caption P04 rare plant.

Q3 Notes Puttalls scrub oak was not impacted at P04

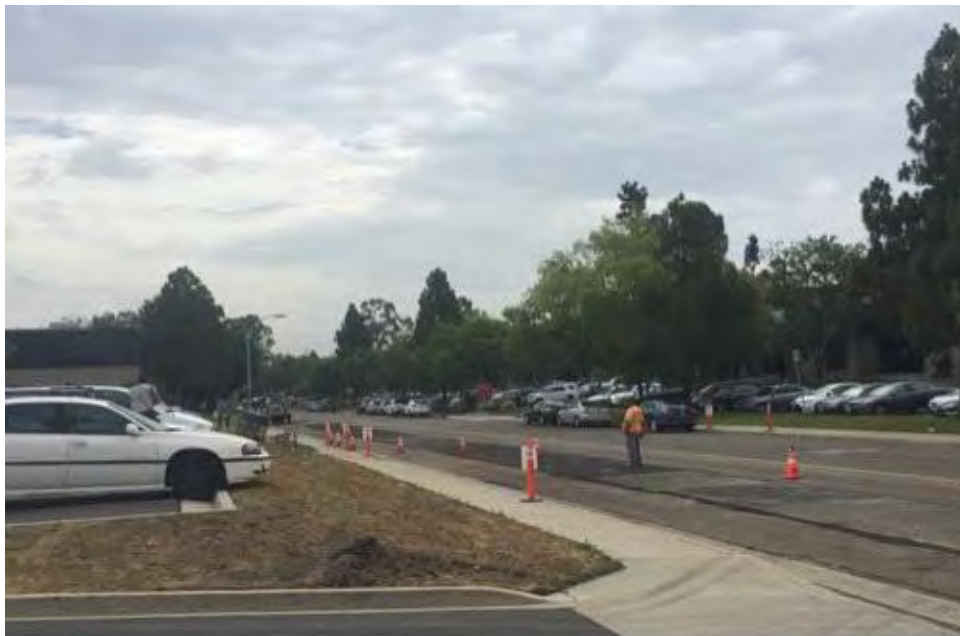
Caption Traffic control active during daylight hours on Miralani Drive.

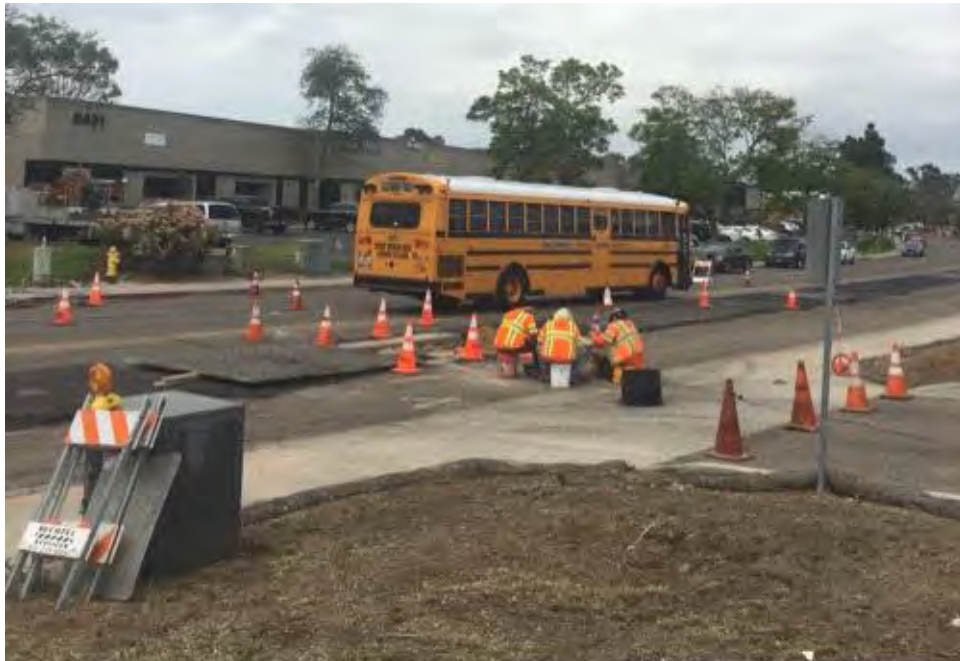
Caption Communication workers on Miralani Drive.

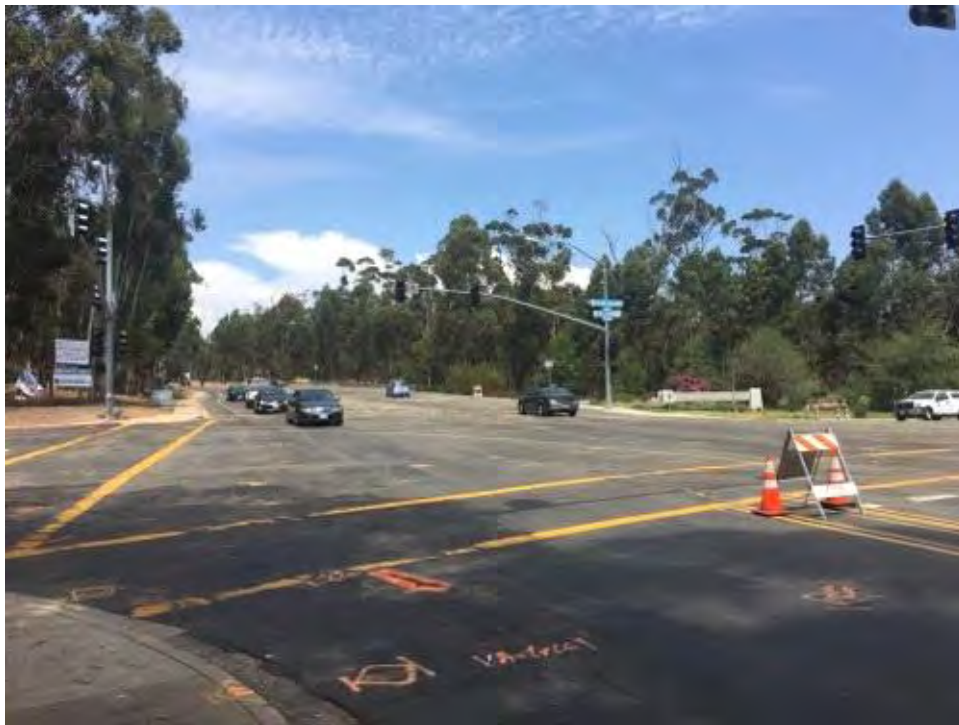
Caption Traffic flowing normally following work on Pomerado Road.

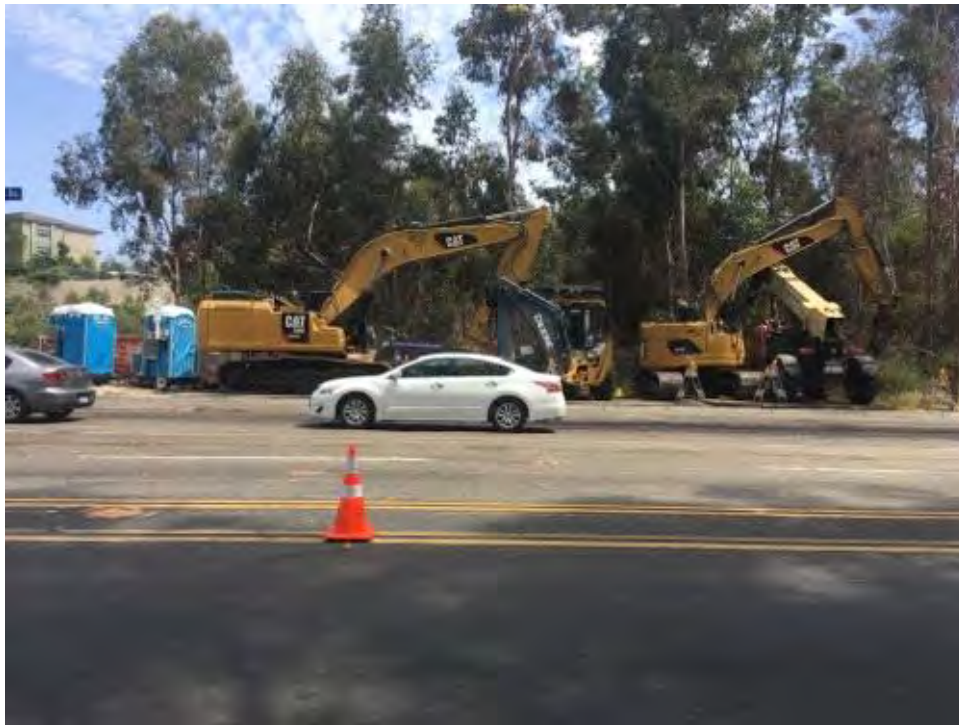
Caption Equipment stored following completion of work at Pomerado Road.

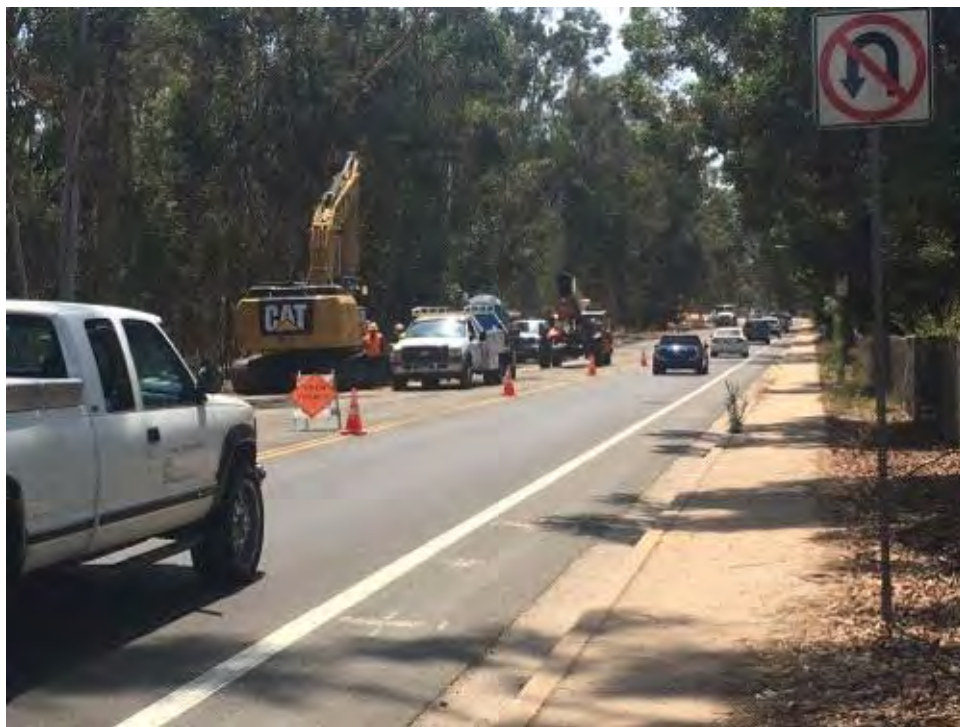
Caption Work west of Ave of Nations.

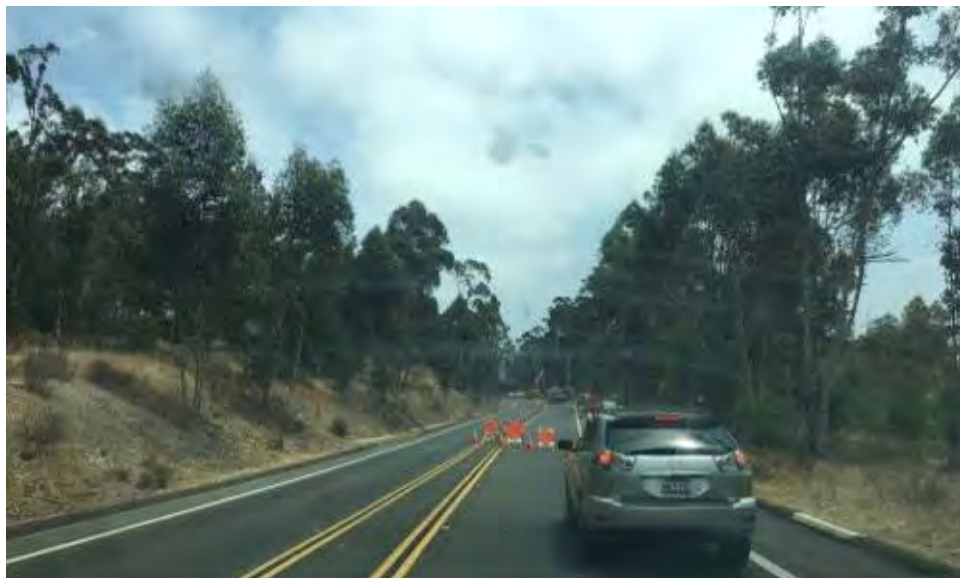
Caption Traffic control on Pomerado Road just west of active vault work site.

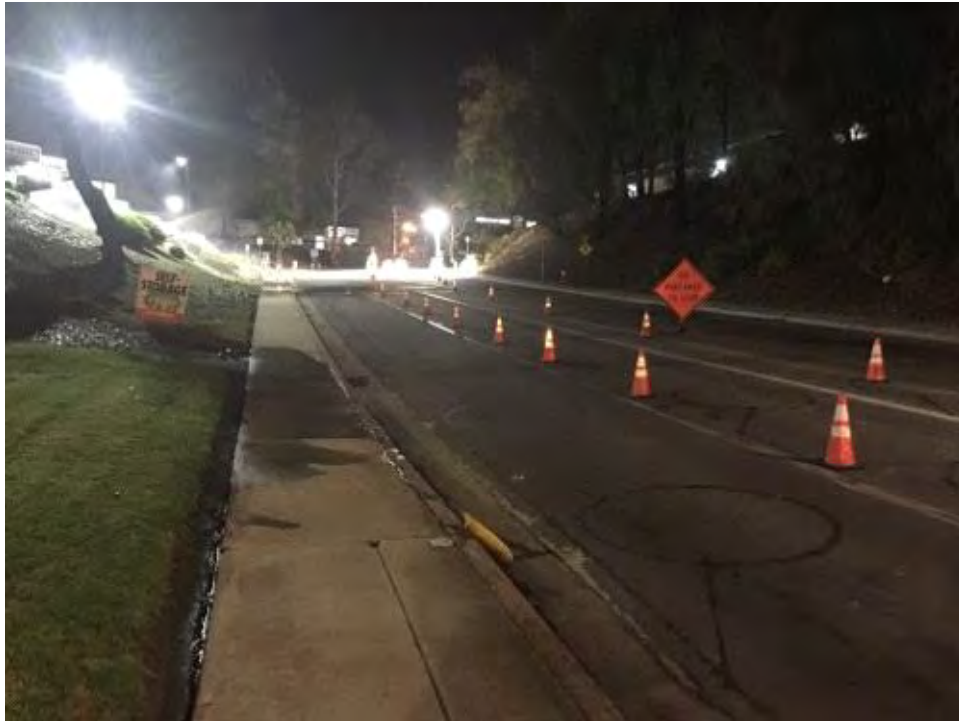
Caption Traffic control setup at eastern portion active work site (eastern portion of Miralani Drive).

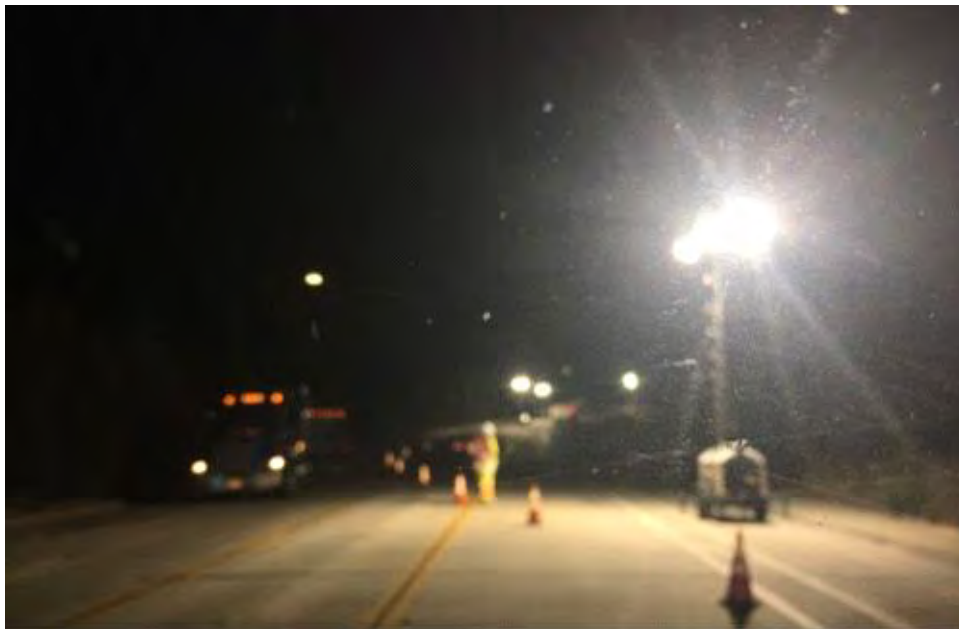
Caption Carroll Road work site along western most portion of the active work sites.

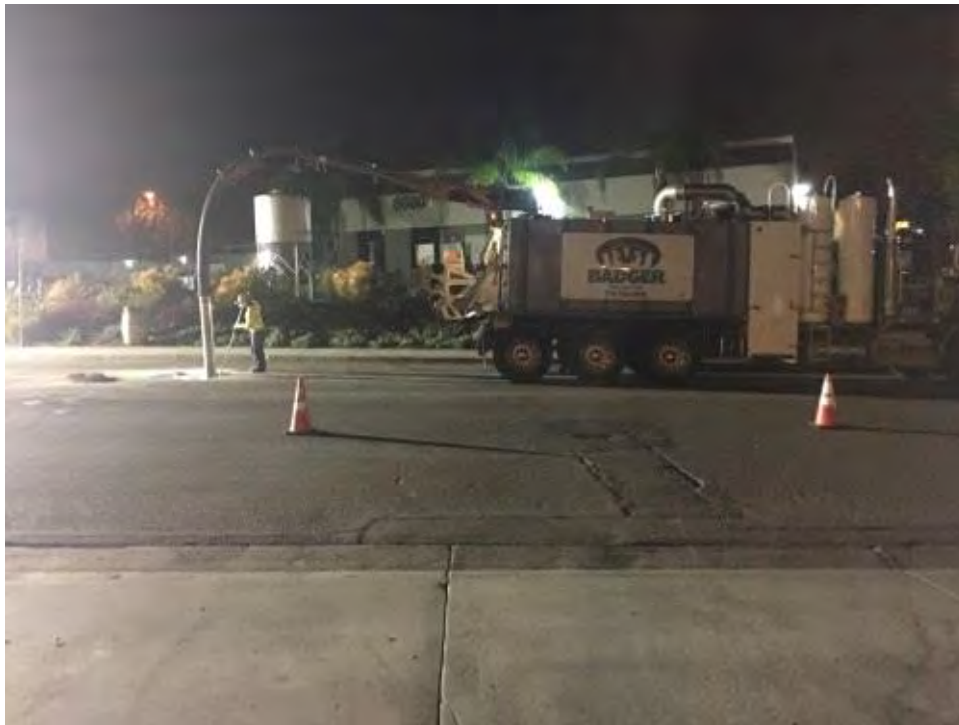
Caption Potholling

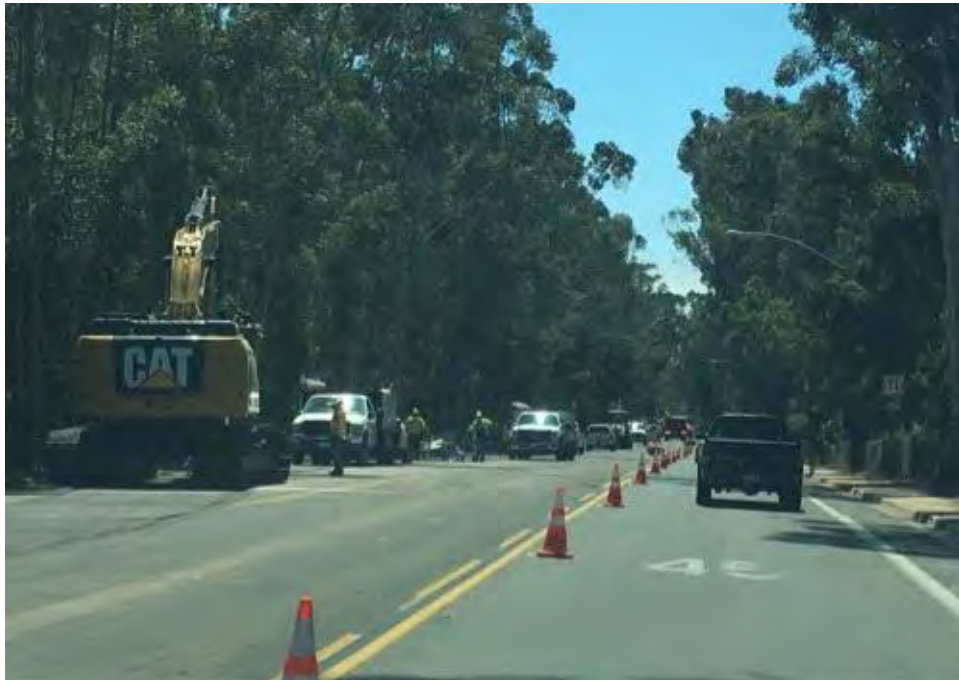
Caption Wrapping up work west of Ave of Nations.

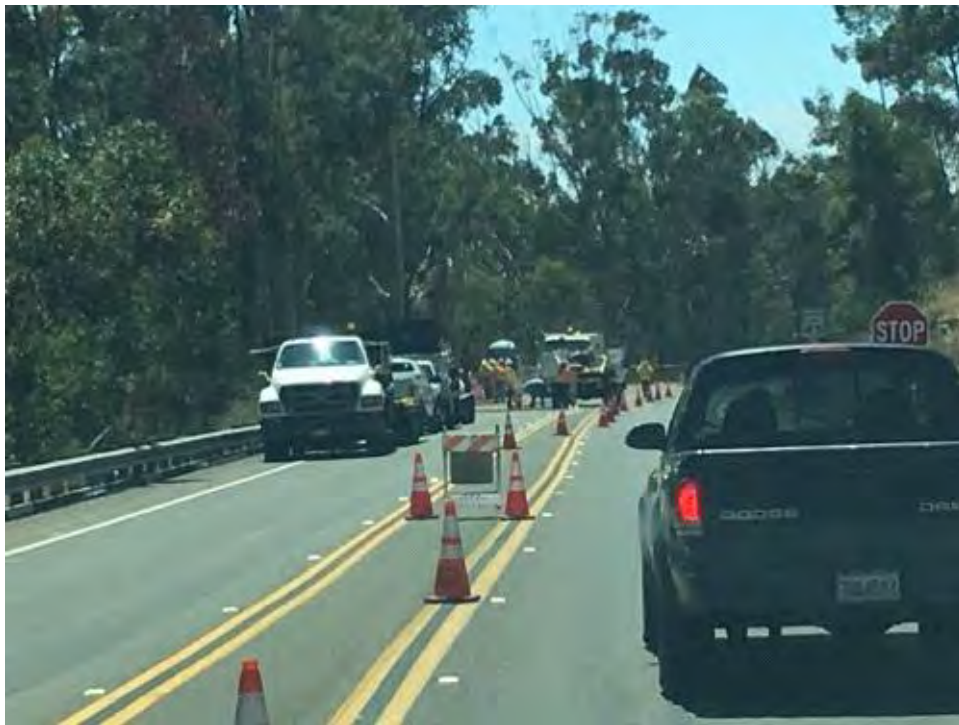
Caption Pomerado Road vault work site east of Ave of Nations.

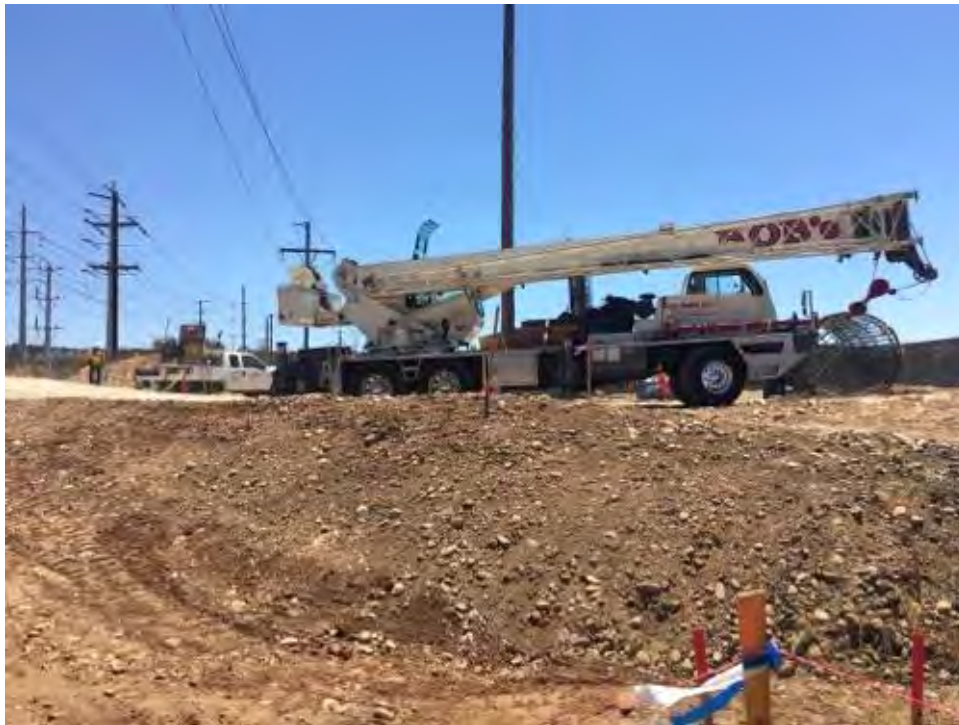
Caption Crane at P0.3

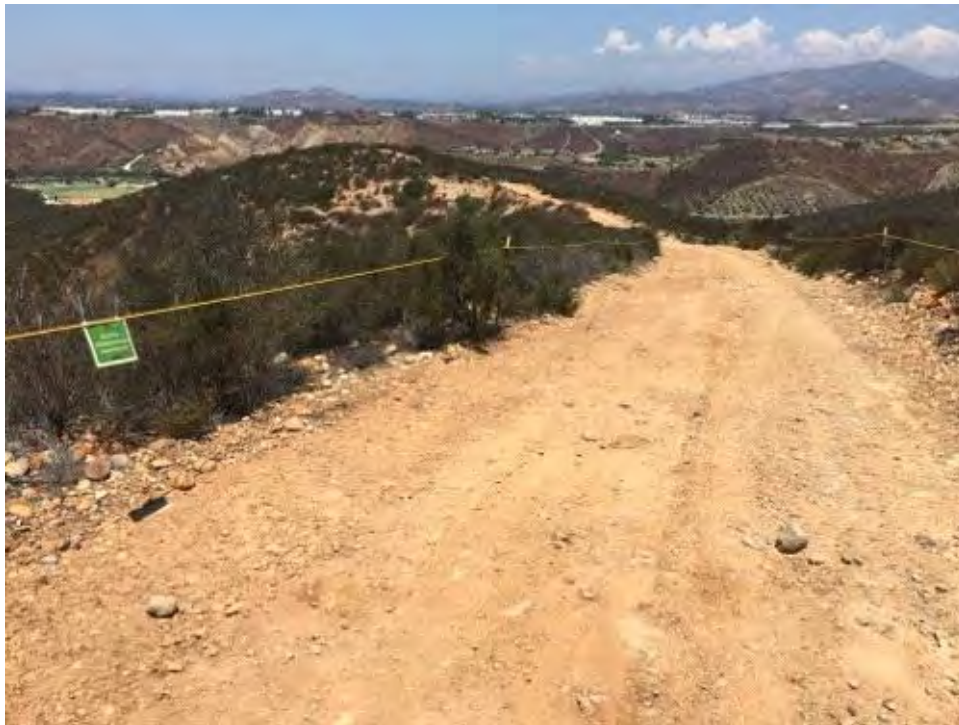
Caption Access road to P04. Note fencing and signage.

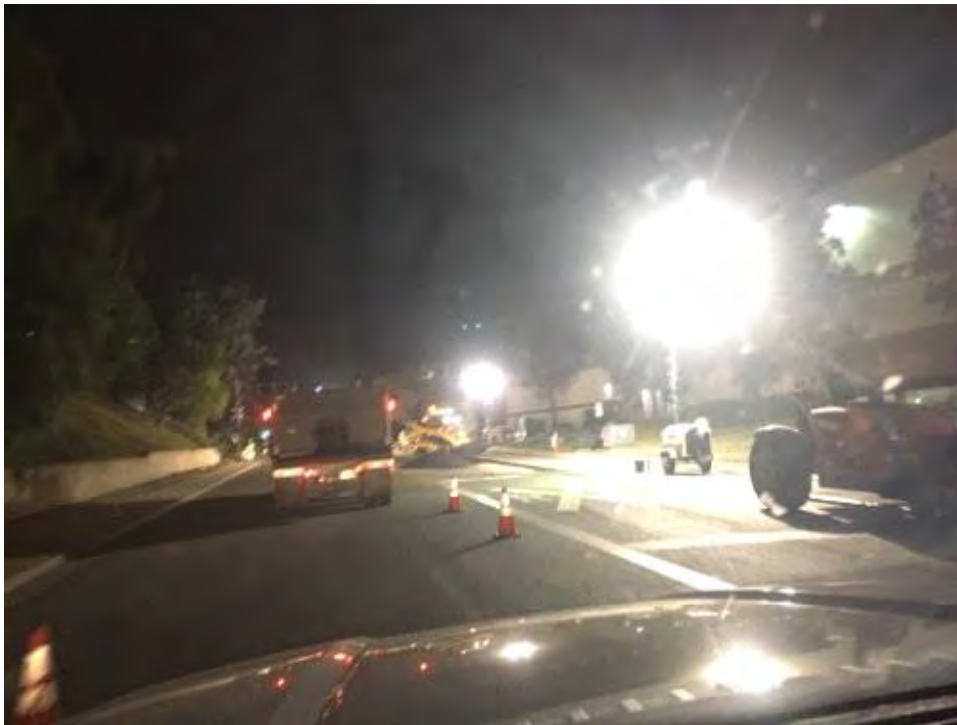
Caption Trade Place resurfacing.

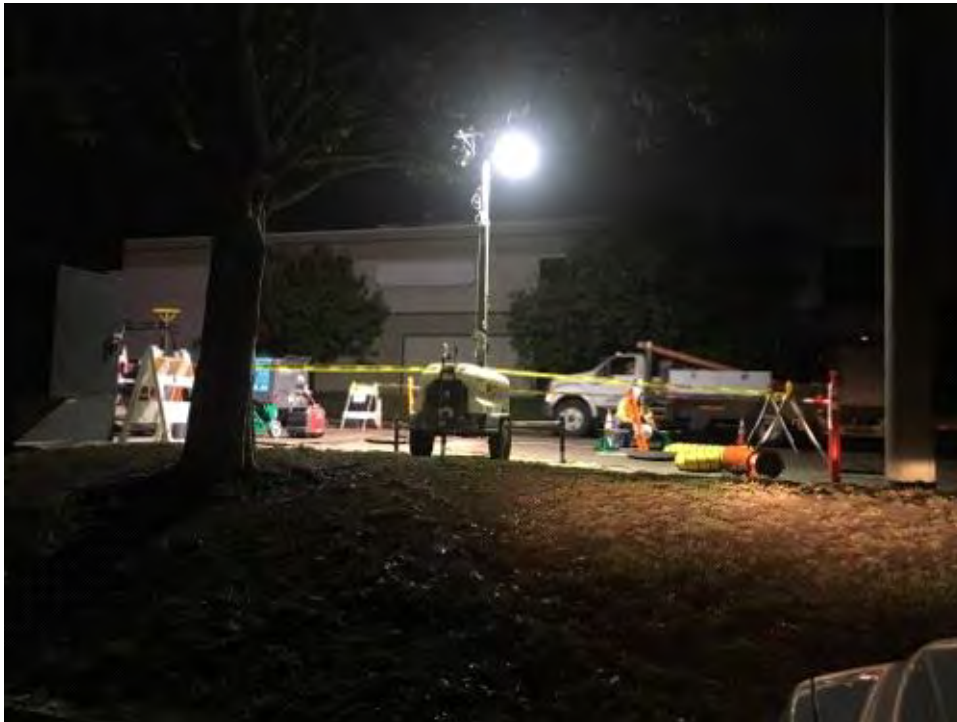
Caption Vault work site on Trade Place.

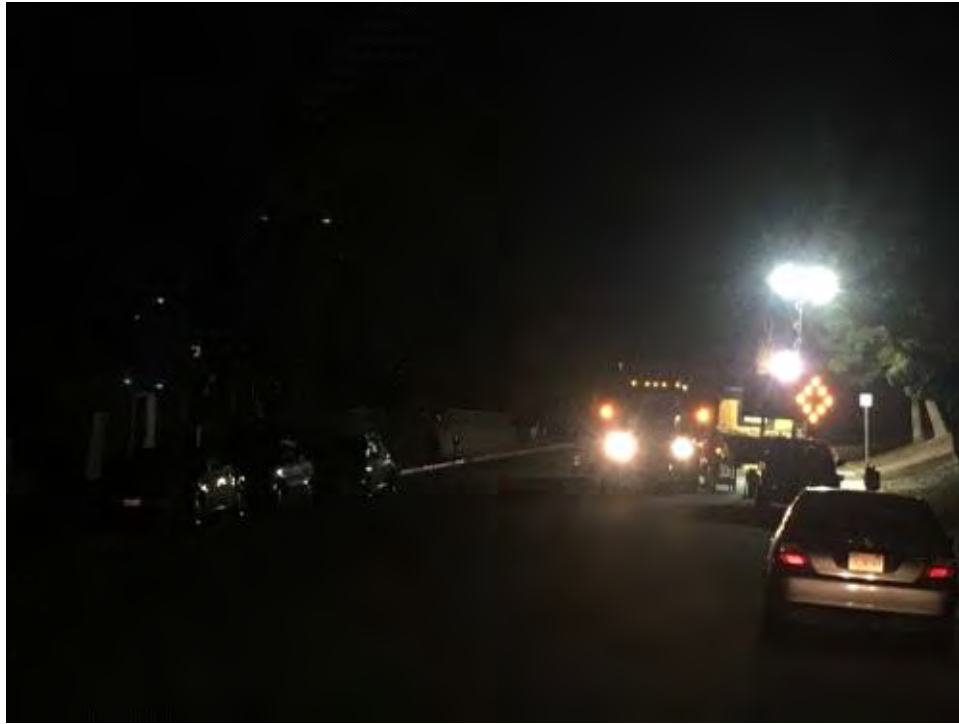
Caption Equipment staging area on Clayton Drive.
Photo Attributes Capture Date/Time: Wed Jul 26 2017 23:13:43 GMT-0700 (PDT)
 Coordinates: 32.895044, -117.130942
 View Direction: North

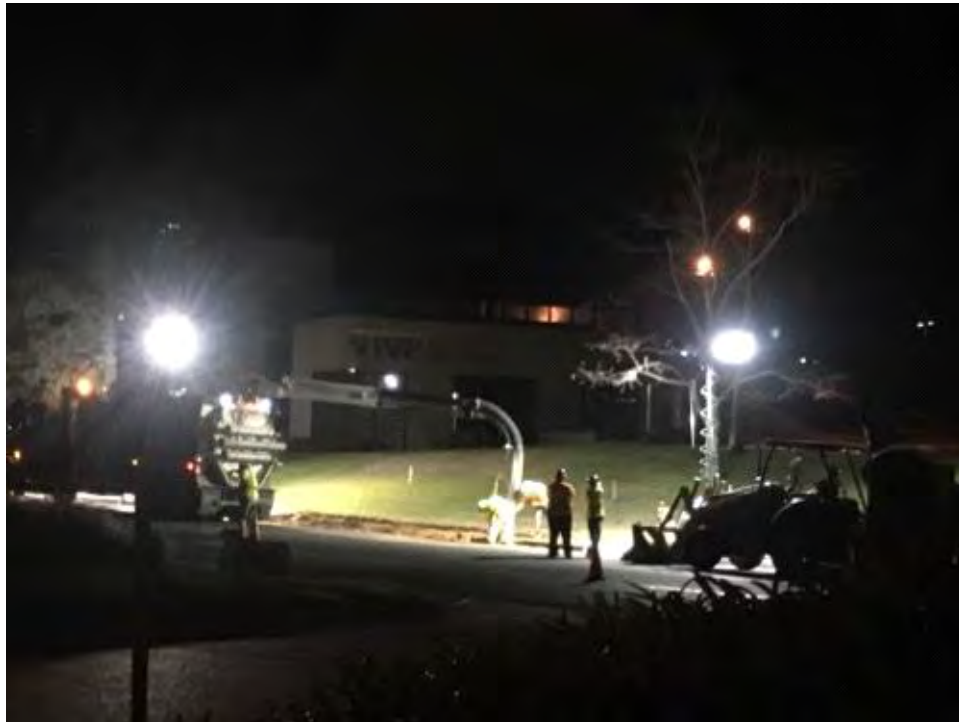
Caption Potholing/excavation on Activity Road.
Photo Attributes Capture Date/Time: Wed Jul 26 2017 23:06:54 GMT-0700 (PDT)
 Coordinates: 32.896514, -117.134524
 View Direction: Southeast

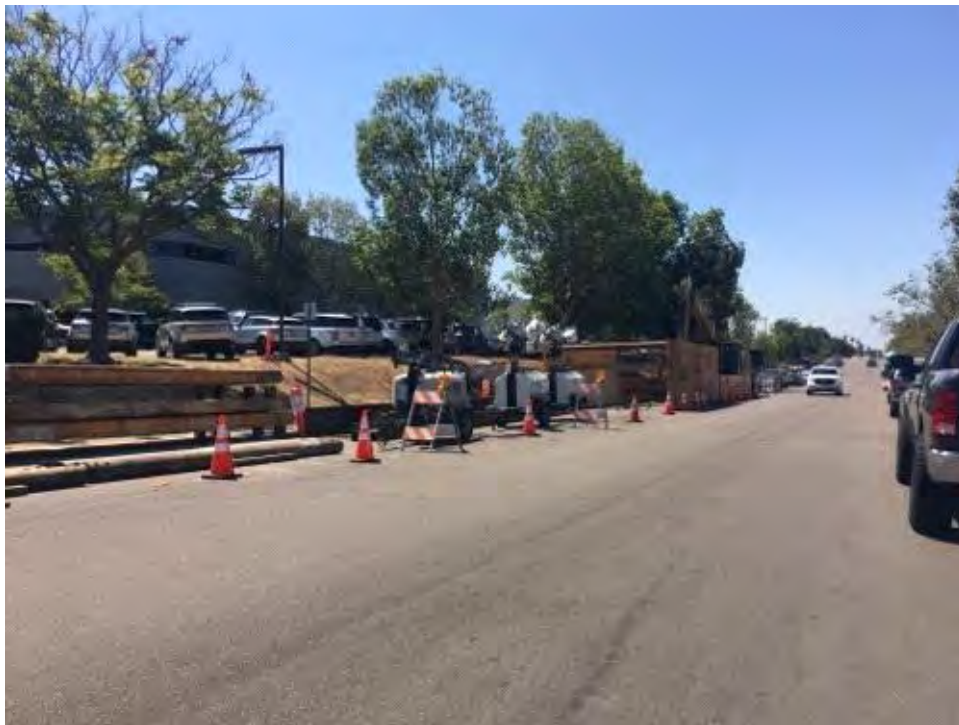
Caption Equipment storage area on Activity Road.

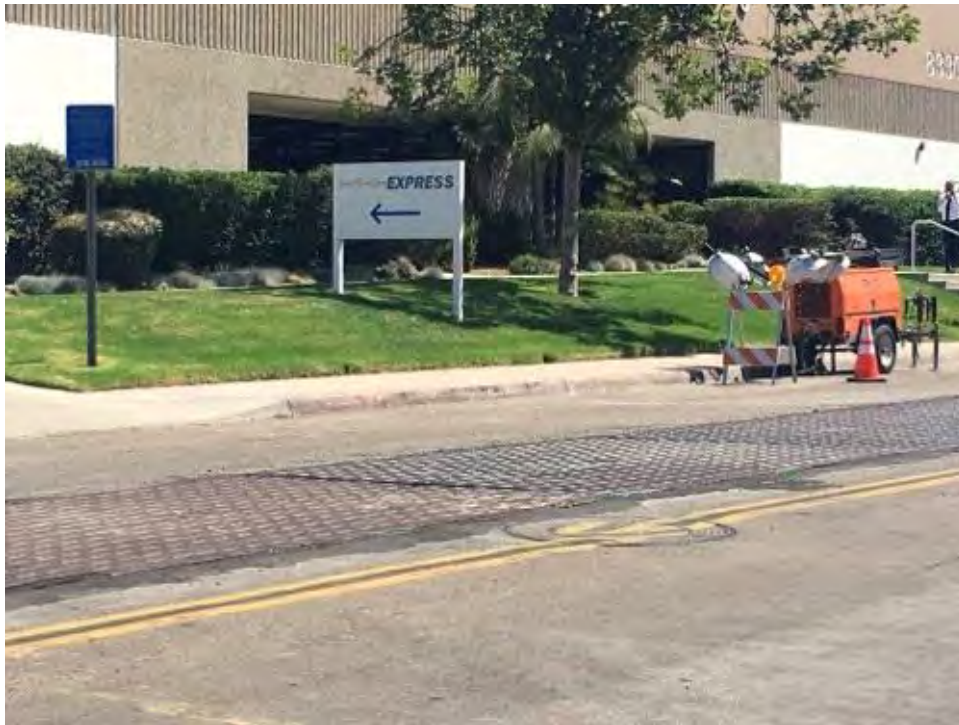
Caption Coldpatch asphalt debris on Miralani Drive.

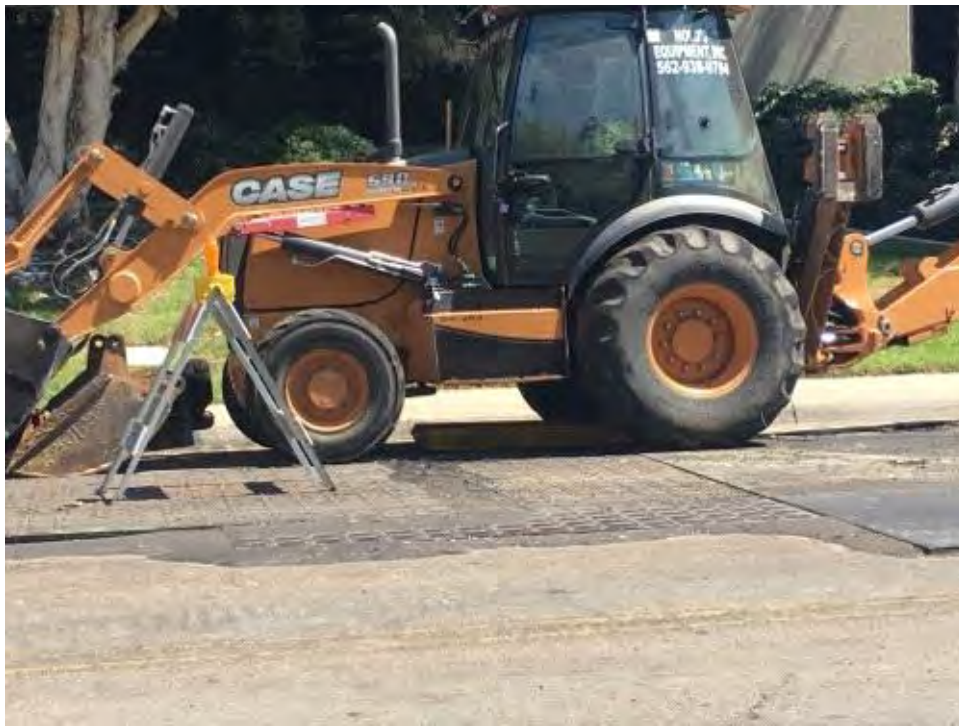
Caption Equipment storage on Miralani Drive.

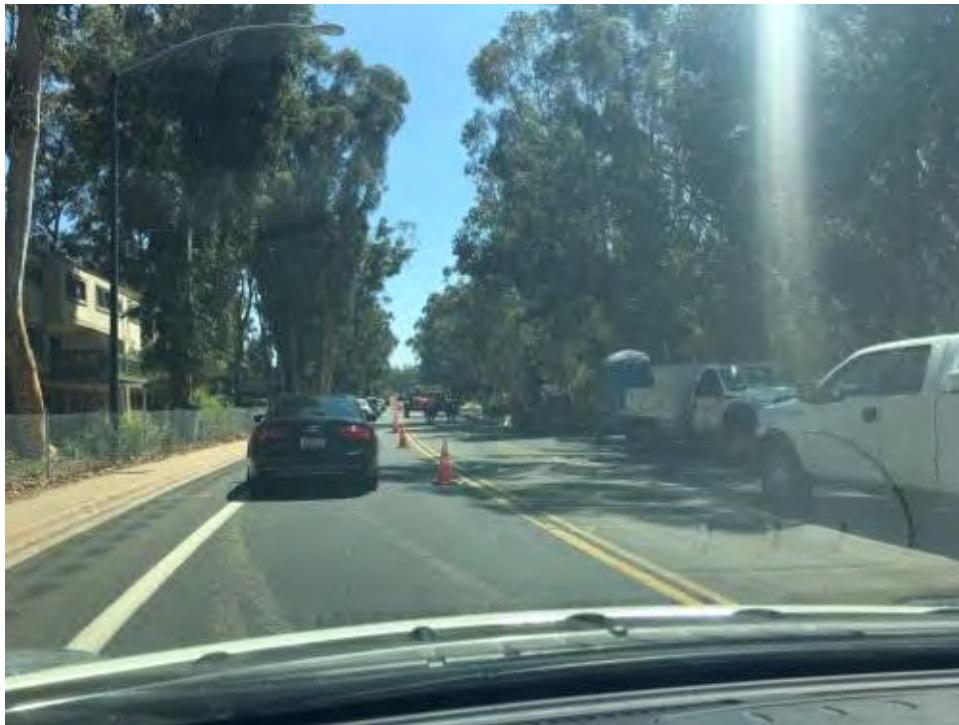
Caption Traffic control on Pomerado Road just east of I-15

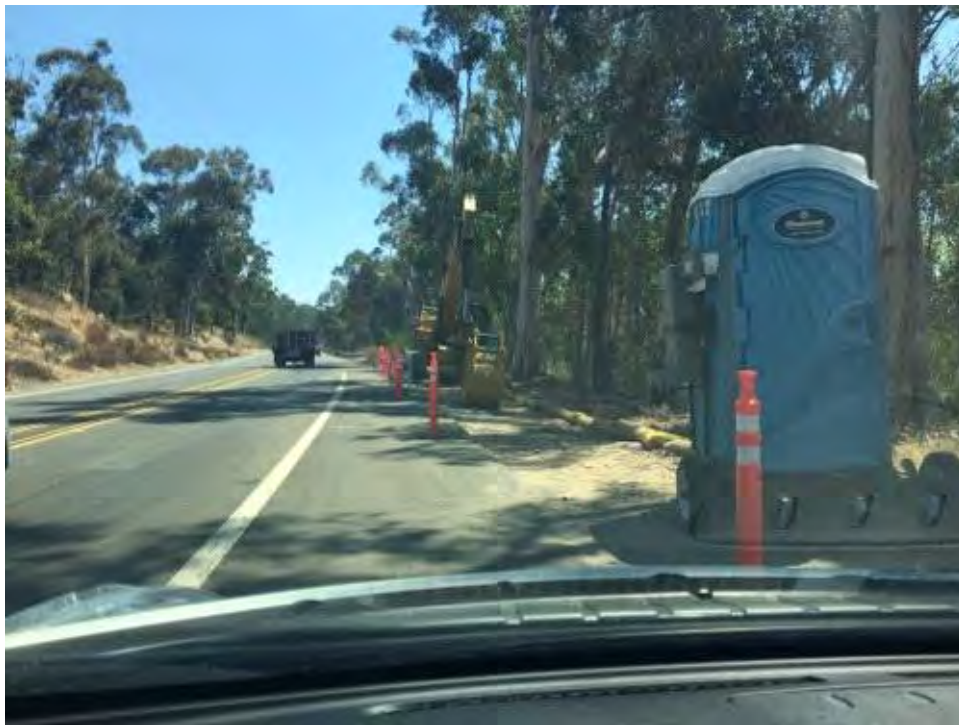
Caption Staging area along Pomerado Road.

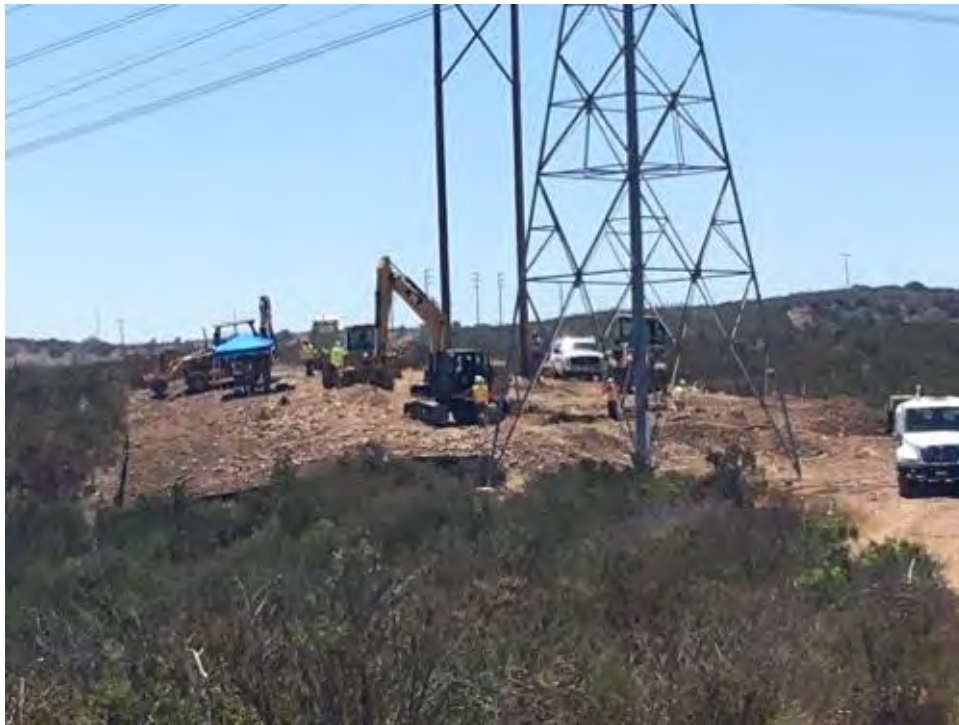
Caption P04 overview of grading

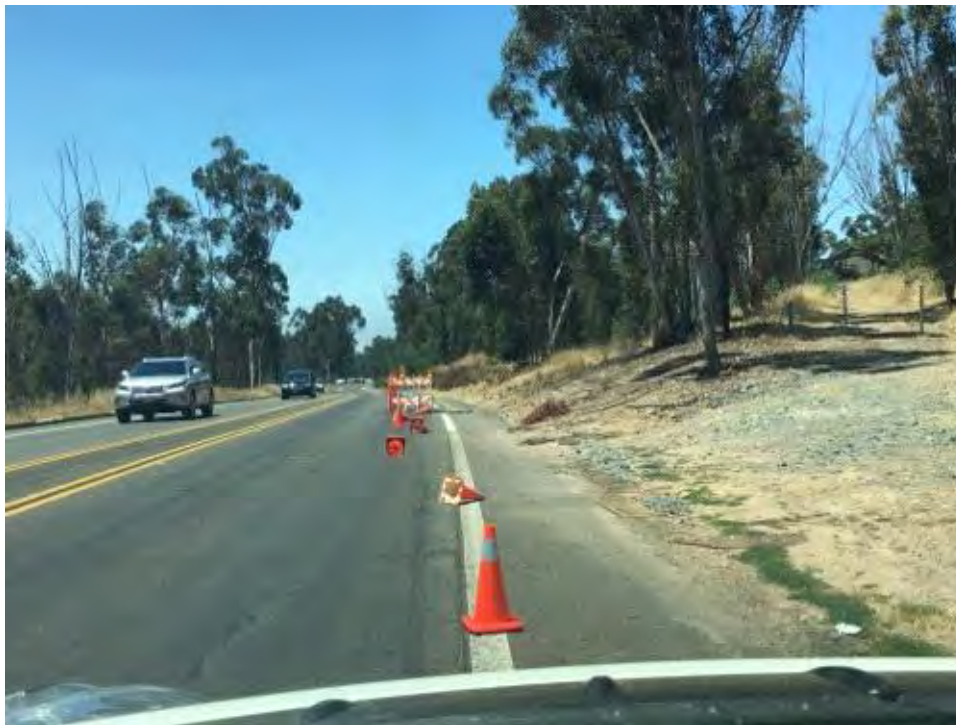
Caption Unrelated pothole with cones on Pomerado Road east of Ave Nations outside work area. This is not a SycPen traffic issue.
