PROJECT MEMORANDUM SYCAMORE-PEÑASQUITOS 230-KV TRANSMISSION LINE PROJECT

Date: September 1, 2017
To: Billie Blanchard, CPUC Project Manager
From: Sheila Hoyer, CPUC Monitoring Supervisor
Subject: Weekly Report #34 – August 20 to August 26, 2017

SDG&E Sycamore-Peñasquitos 230-kV Transmission Line Project: Daily Inspection Report

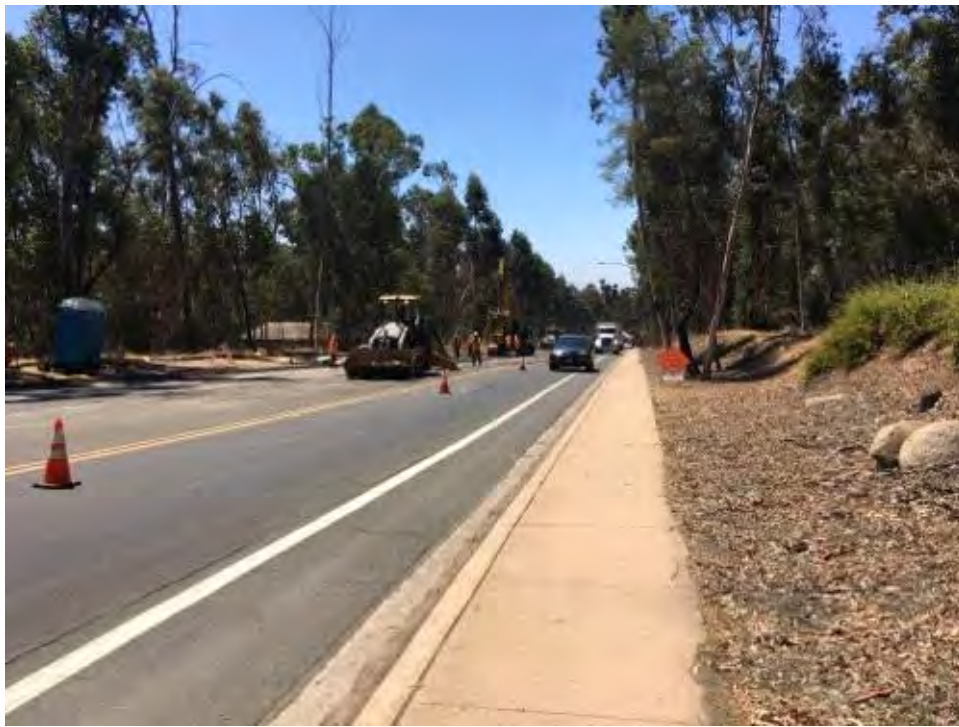
Caption Active work site on Pomerado Road east of Avenue of Nations and West of Scripps Ranch Blvd.

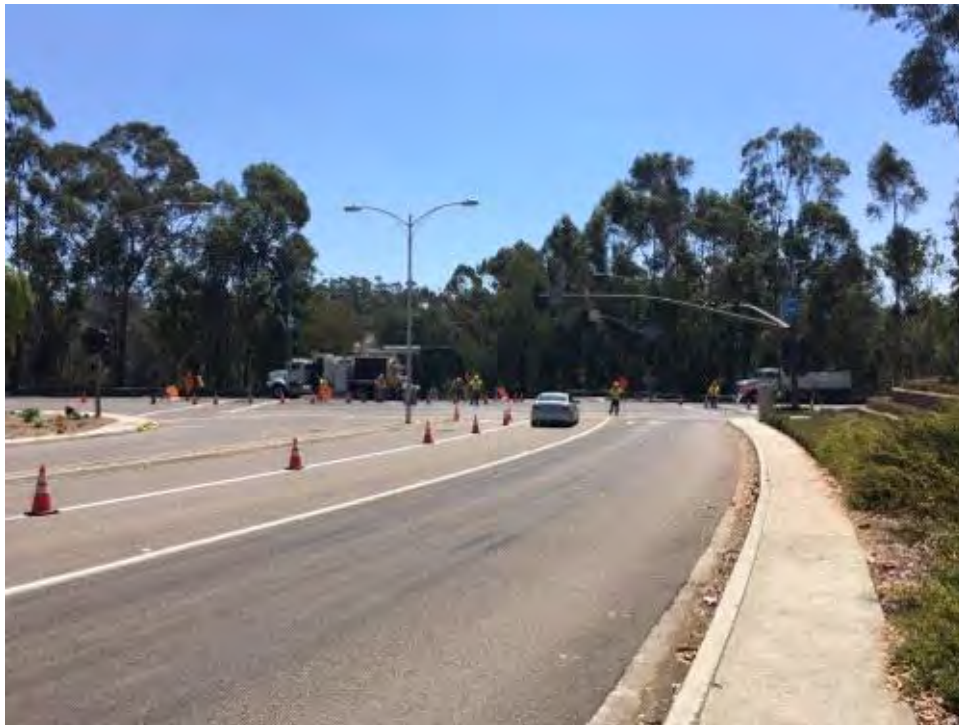
Caption Traffic control Pomerado Road and Scripps Ranch Blvd.

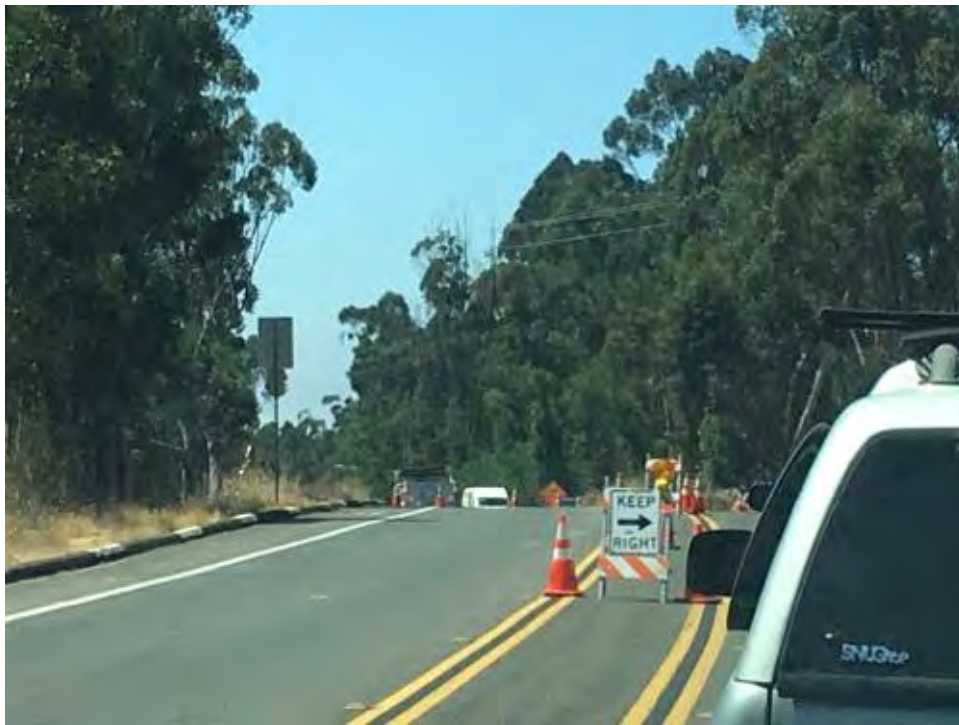
Caption Traffic control on Pomerado Road going west, east of active work site.

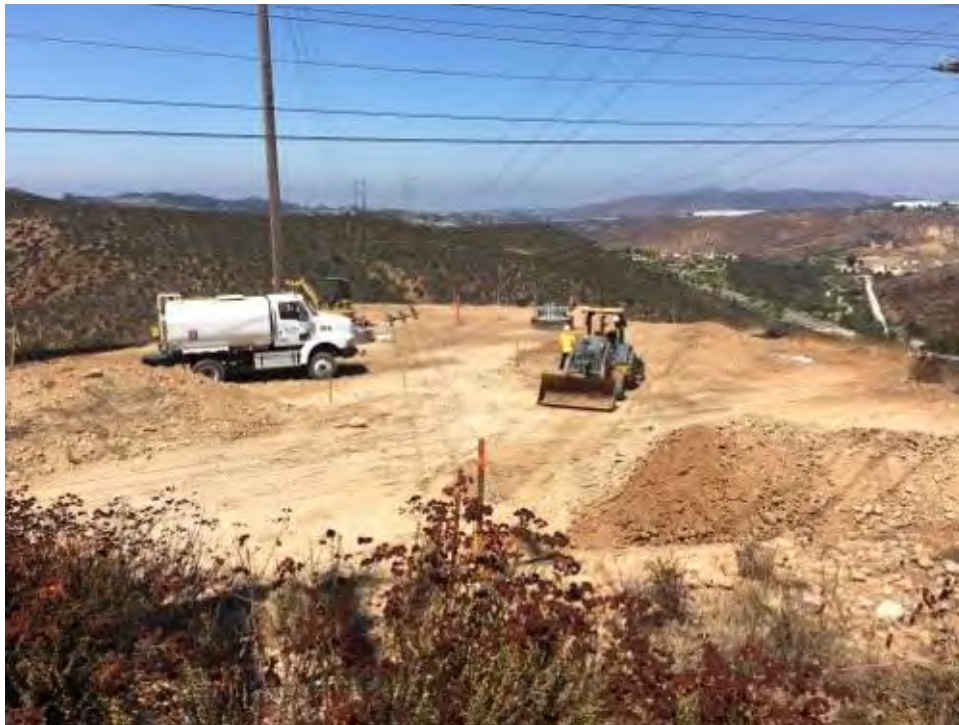
Caption P03 move day, equipment moving to P06.

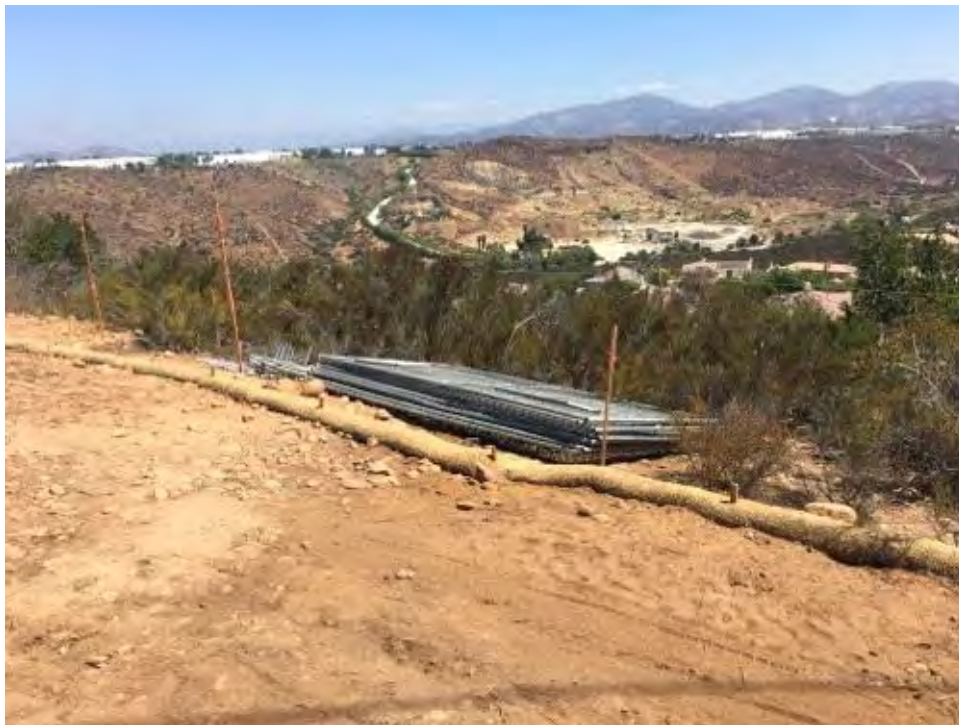
Caption Fencing delivered to P06.

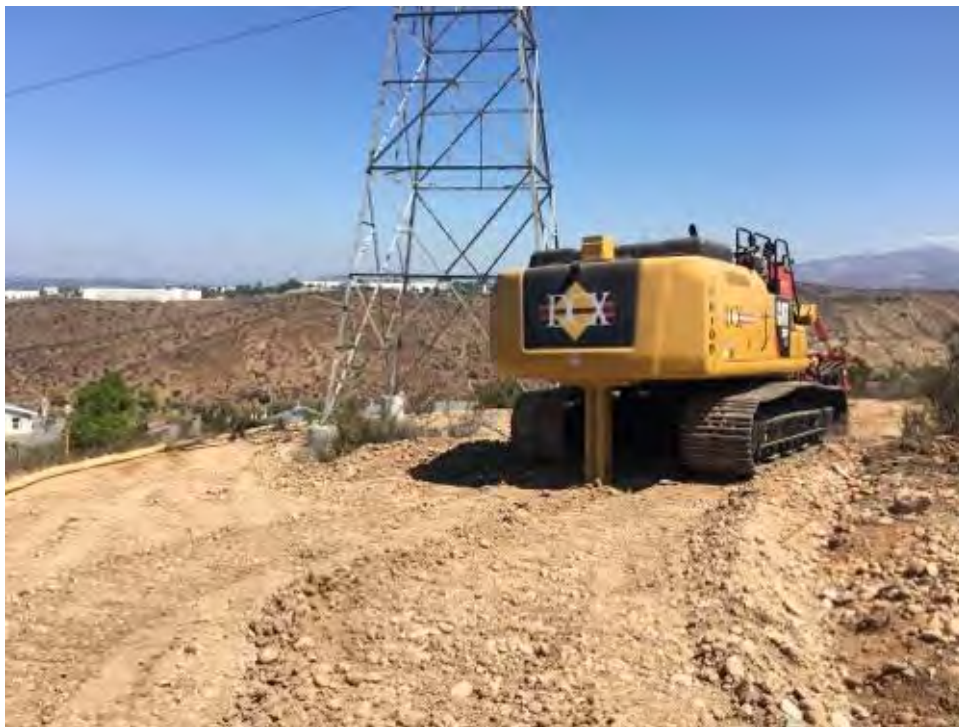
Caption Drill rig delivered to P06.

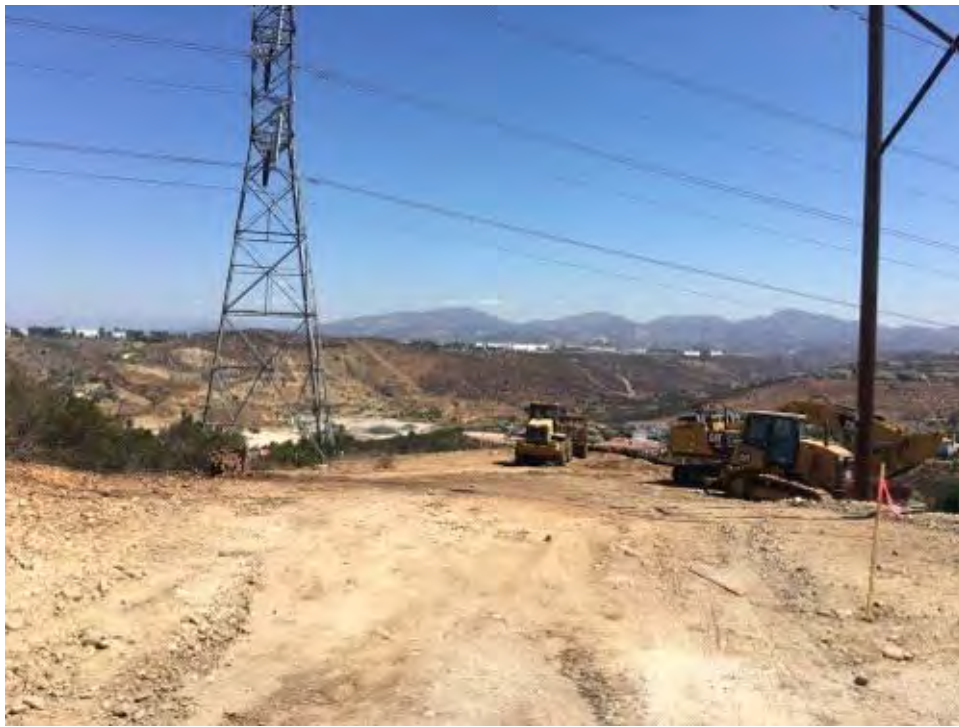
Caption P05 being used to stage equipment.

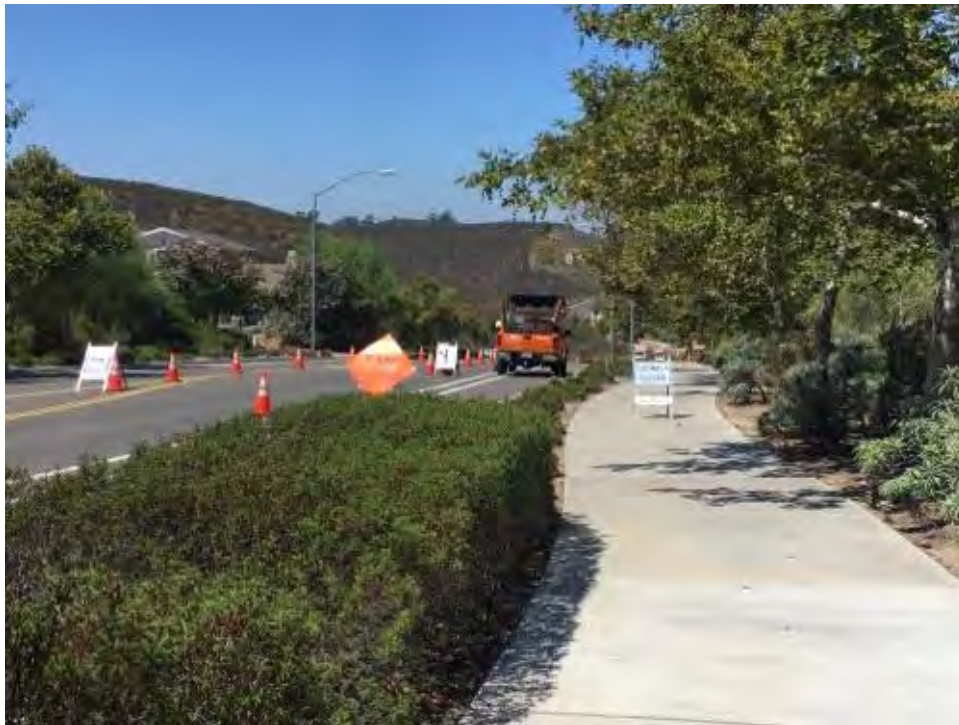
Caption Traffic control on Stonebridge Parkway near P05.

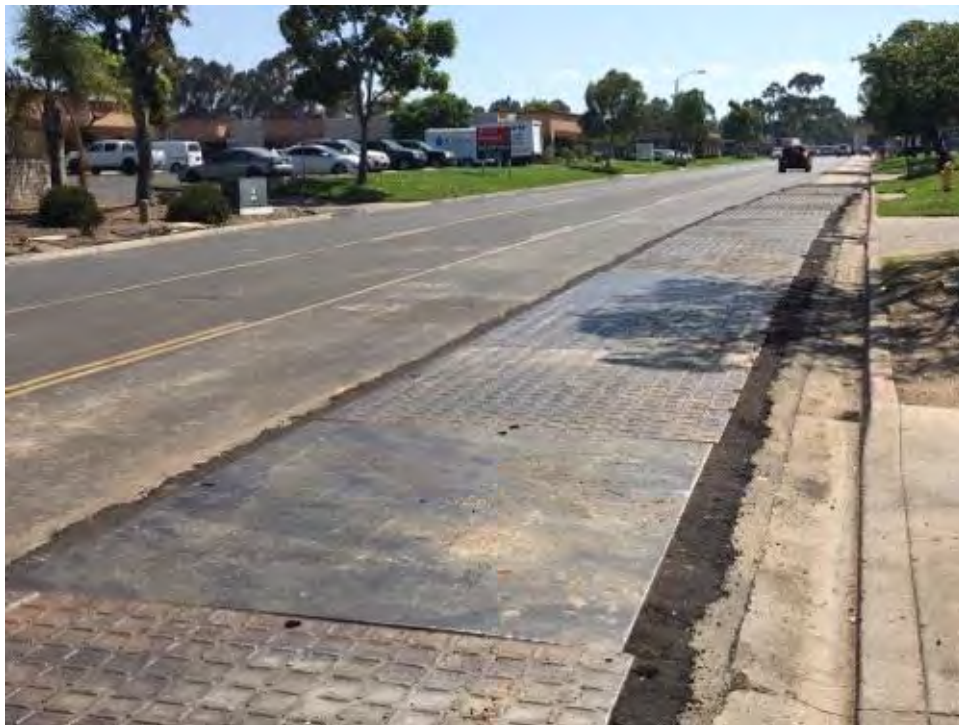
Caption Abundant asphalt debris on Activity Road.

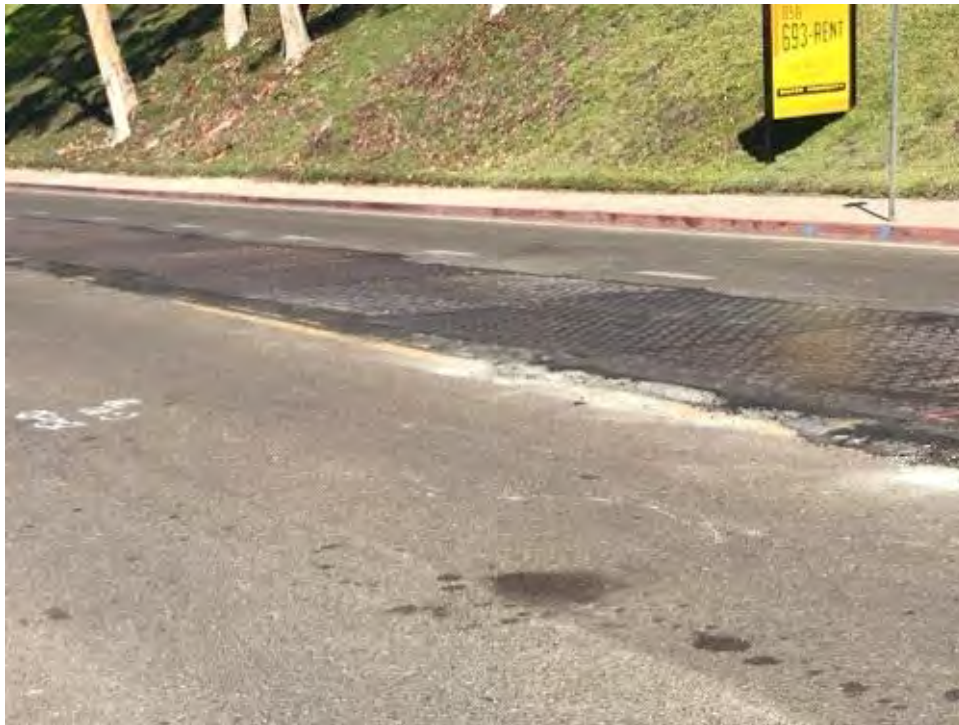
Caption Abundant asphalt debris along western portion of Trade Street.

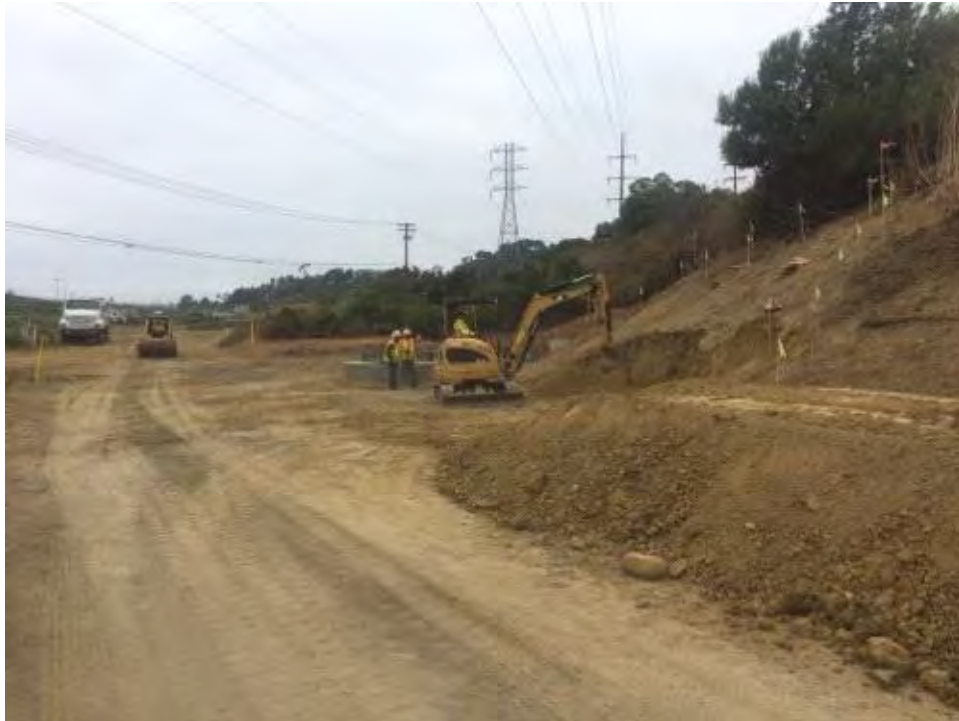
Caption CC MM CP grading for retaining wall.

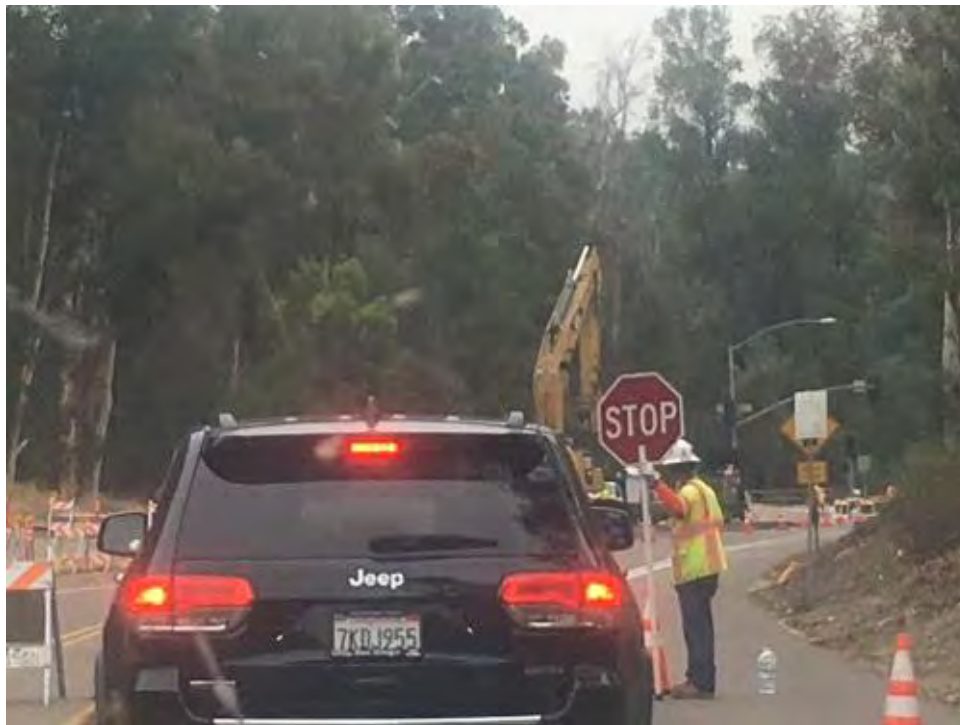
Caption Traffic control east of Fairbrook Road, vault work site active.

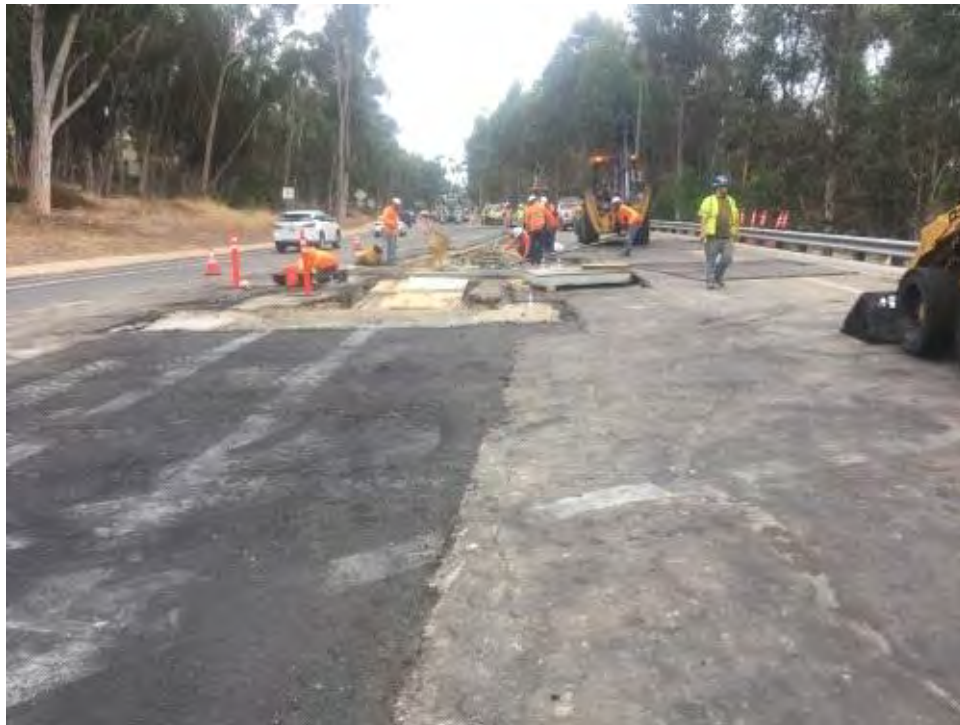
Caption Trench work

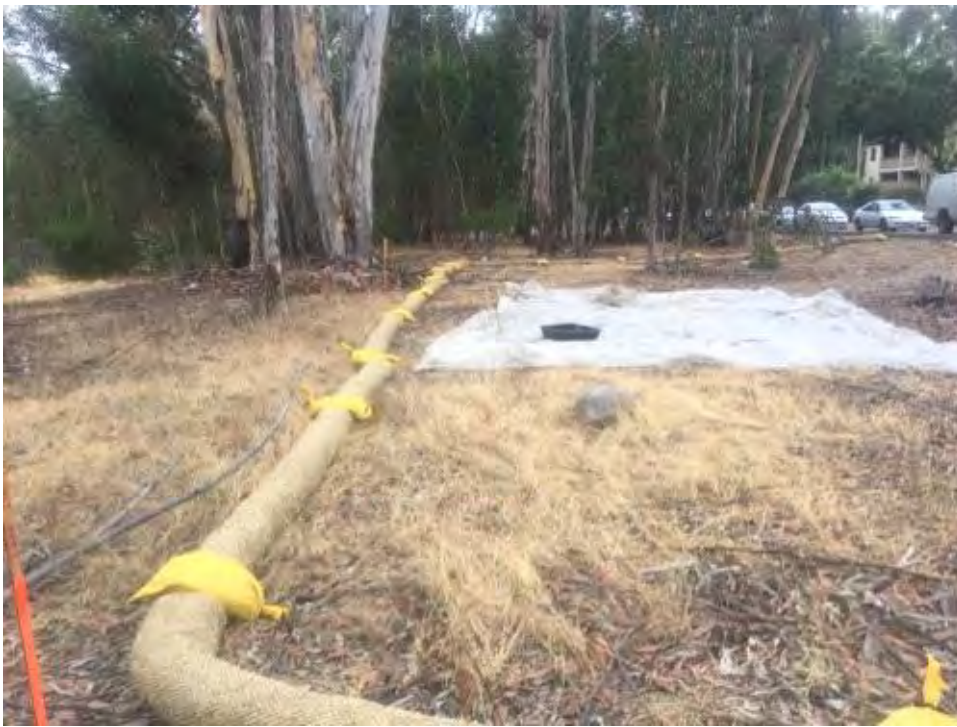
Caption MPR #5 storage area not currently in use.

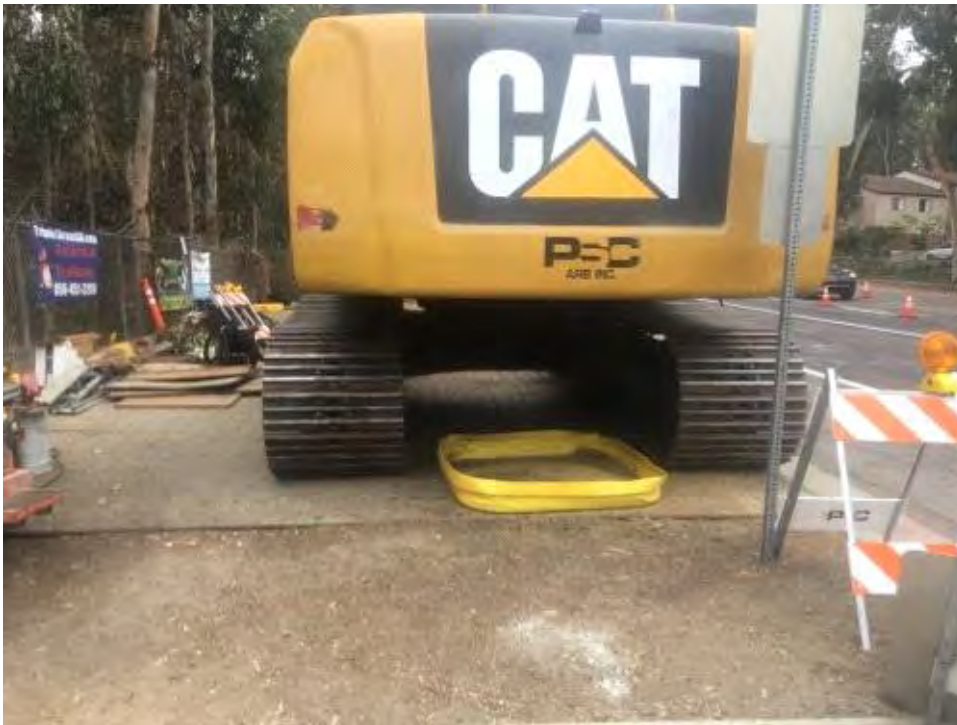
Caption Drip pan beneath excVator.

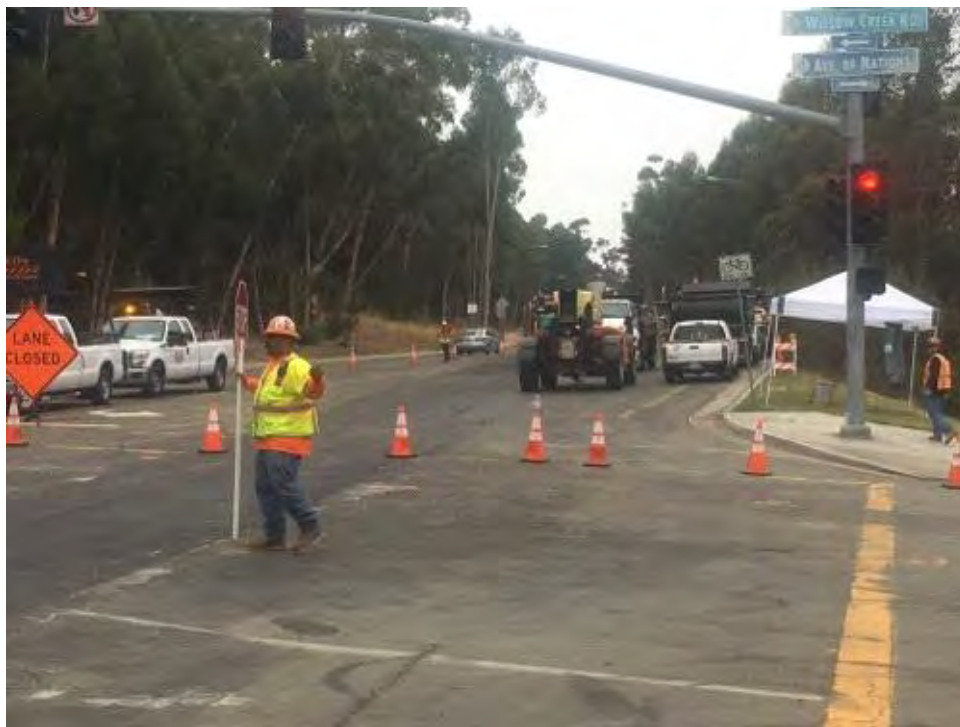
Caption Pomerado Road work site east of Avenue of Nations.

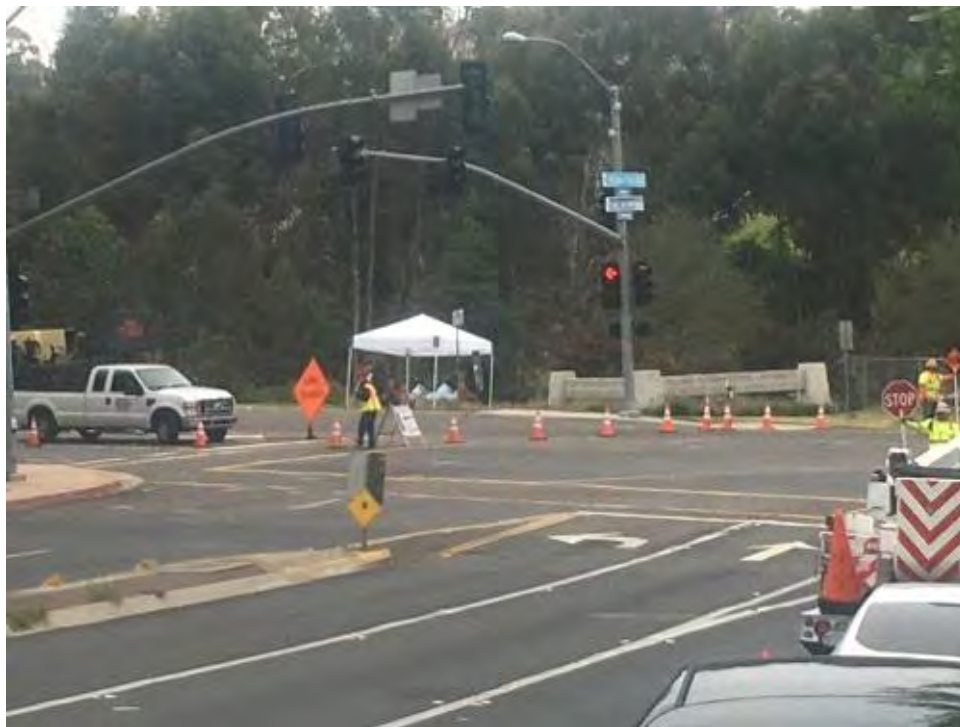
Caption Traffic control at Pomerado Road and Avenue of Nations.

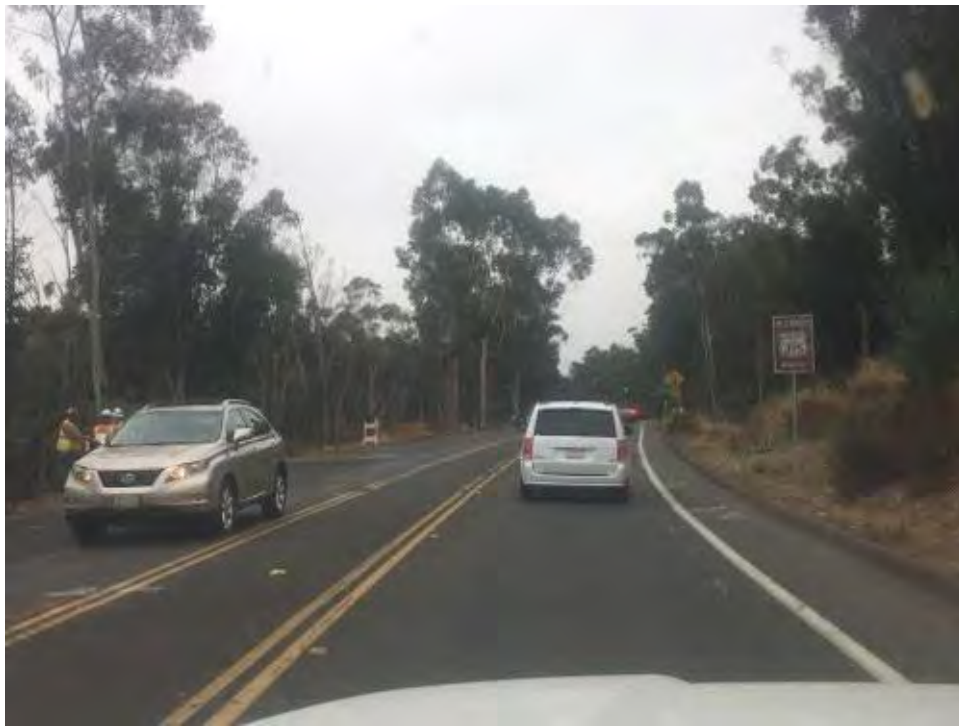
Caption West-bound traffic pre-work on Pomerado Road.

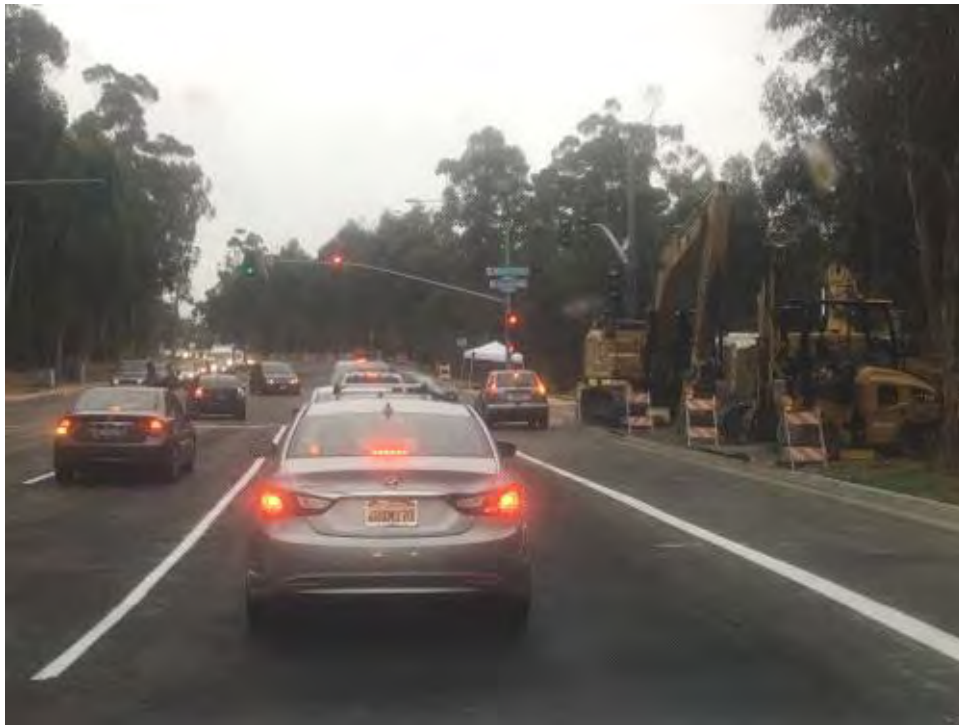
Caption Equipment stored and traffic normal pre-work on Pomerado Road.

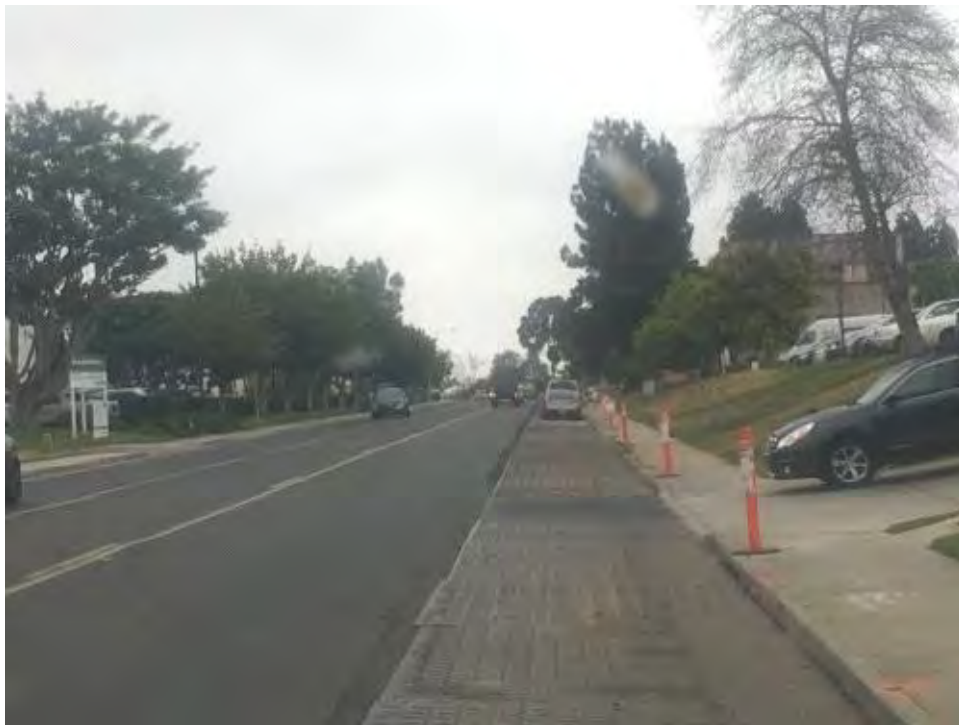
Caption Traffic flowing normally on Activity Road during the morning commute.

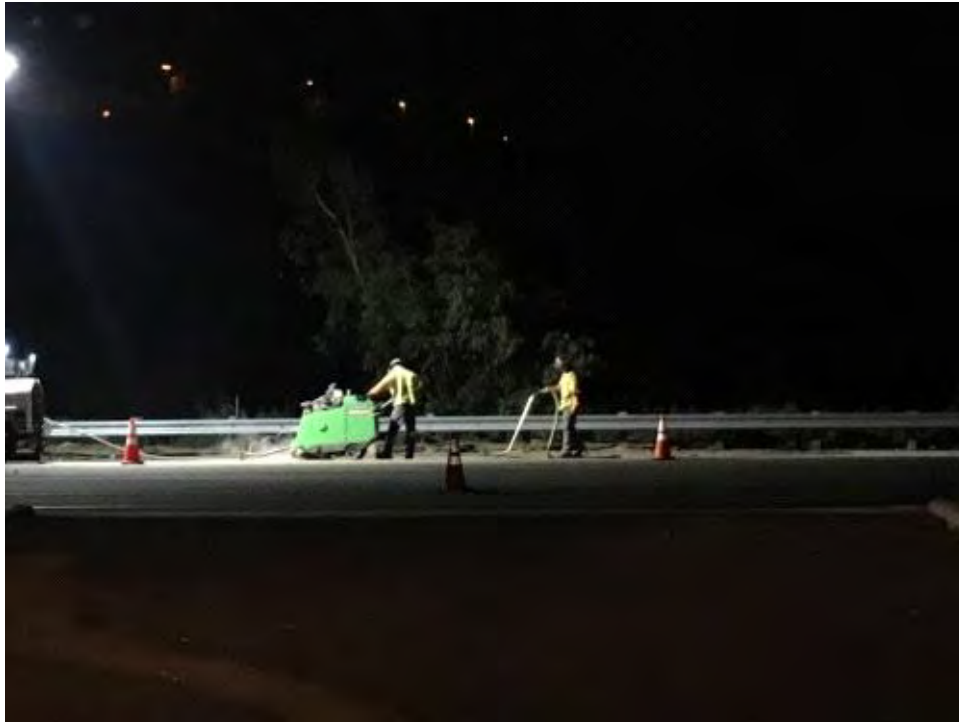
Caption Asphalt cutting on Carroll Road near 805.

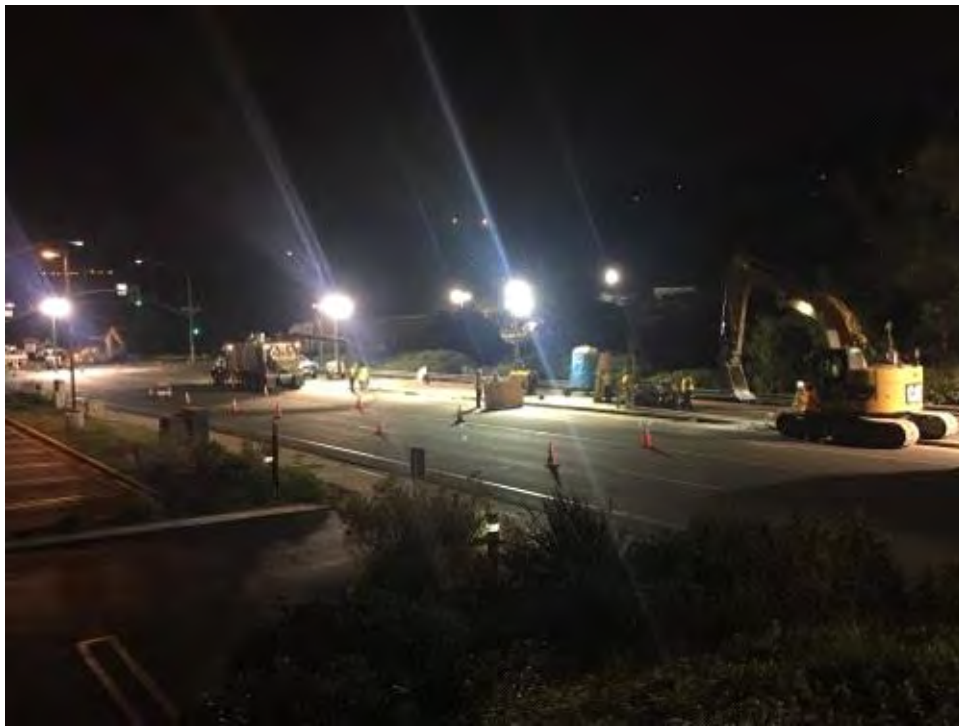
Caption Trenching/excavation on Carroll Road east of Nancy Ridge Drive.

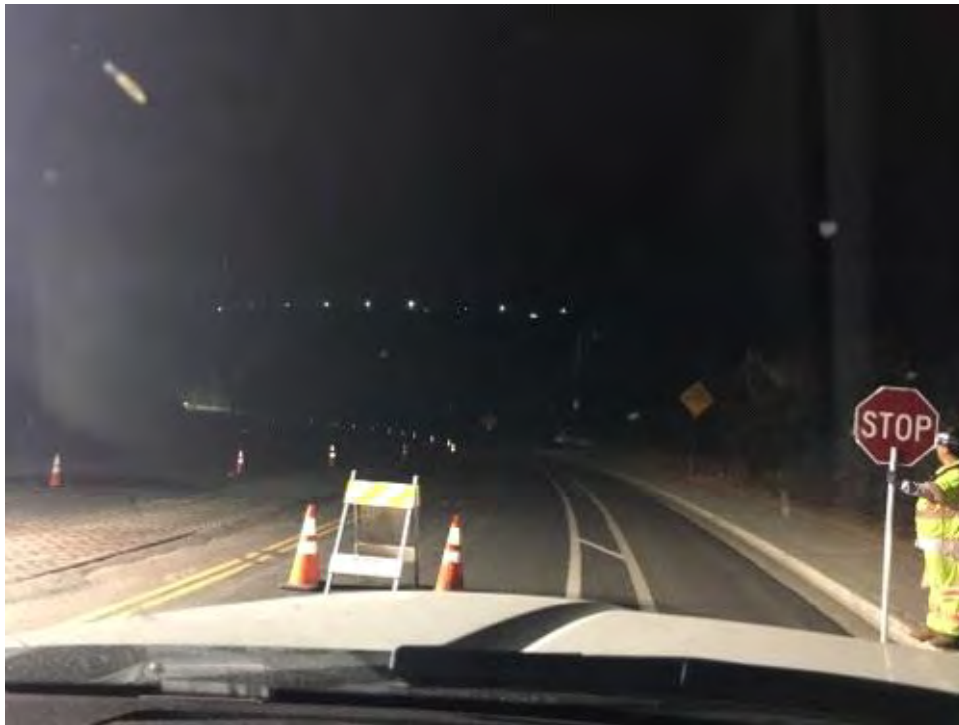
Caption Traffic control on Carroll Road.

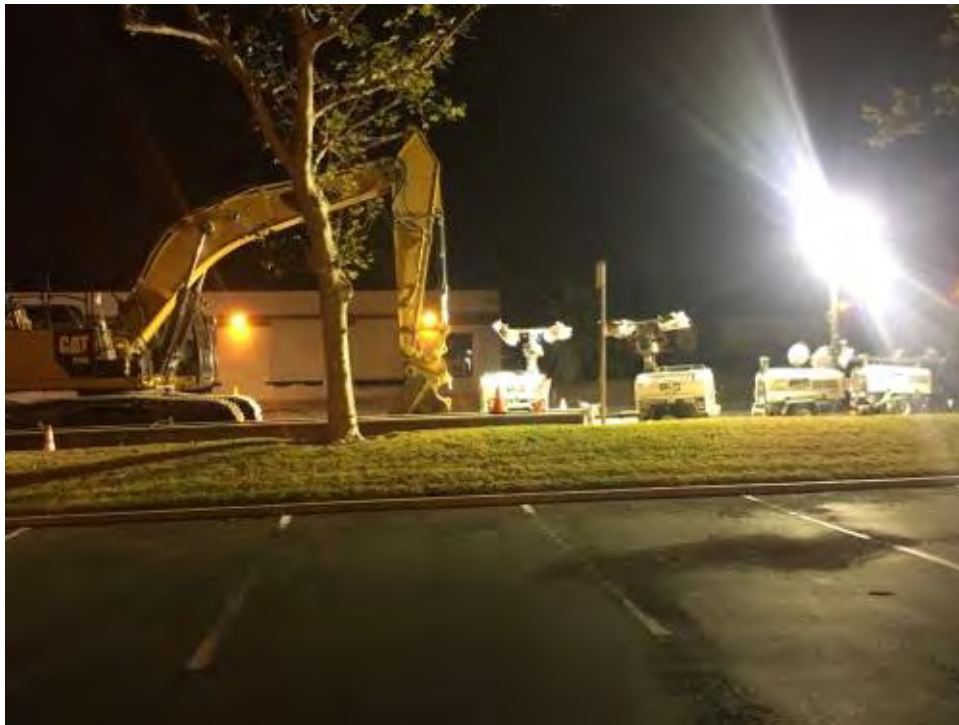
Caption Equipment on Padgett Street.

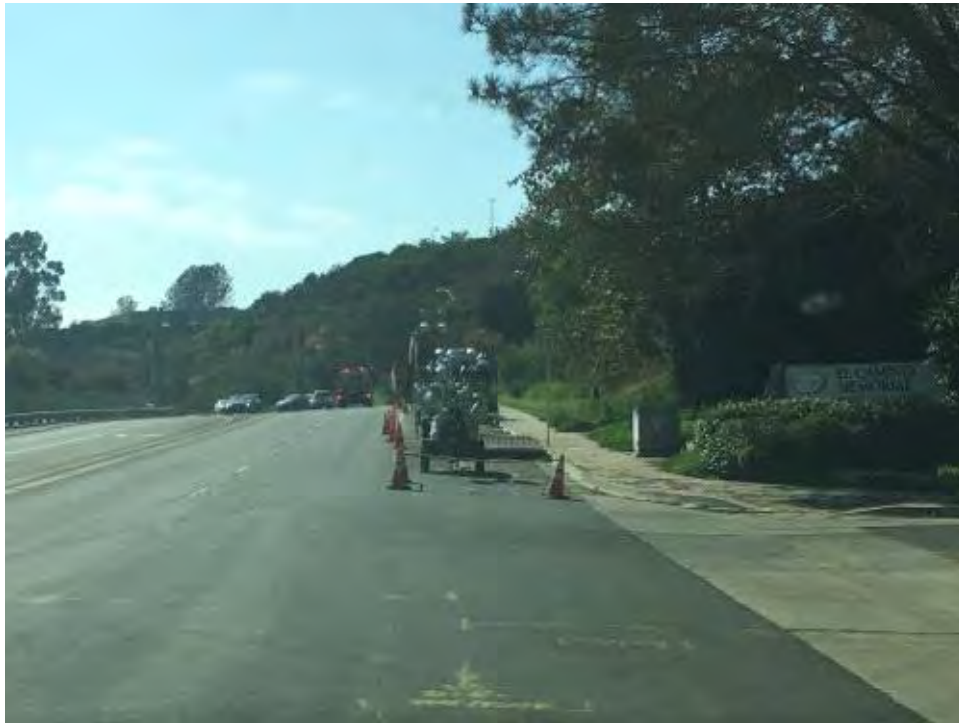
Caption Equipment properly stored along Carroll Road.

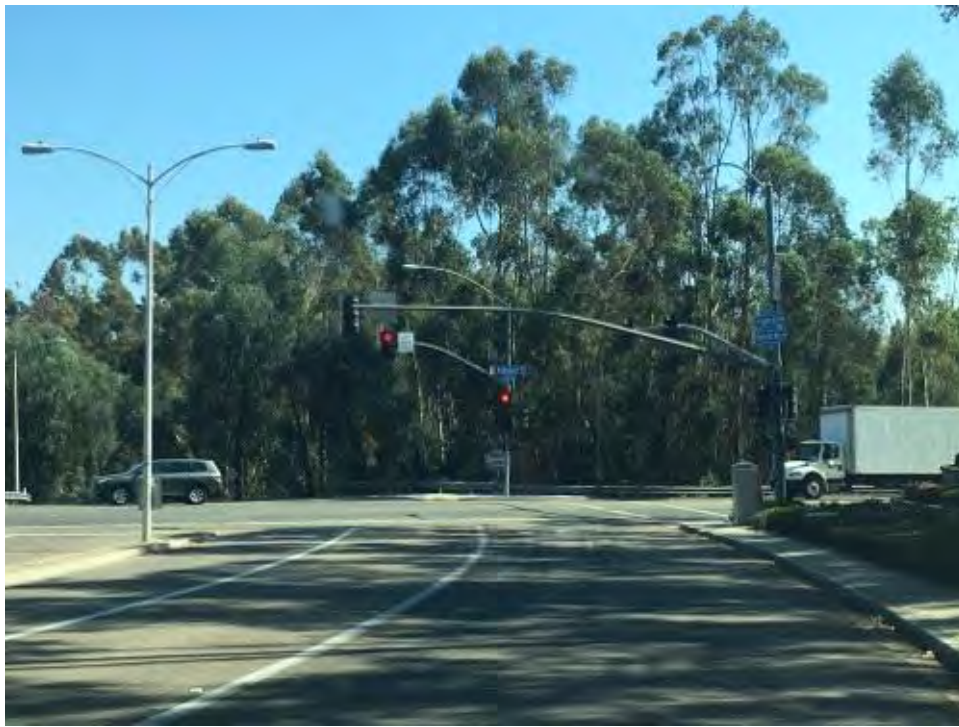
Caption Pomerado Road and Scripps Ranch Blvd. following construction.

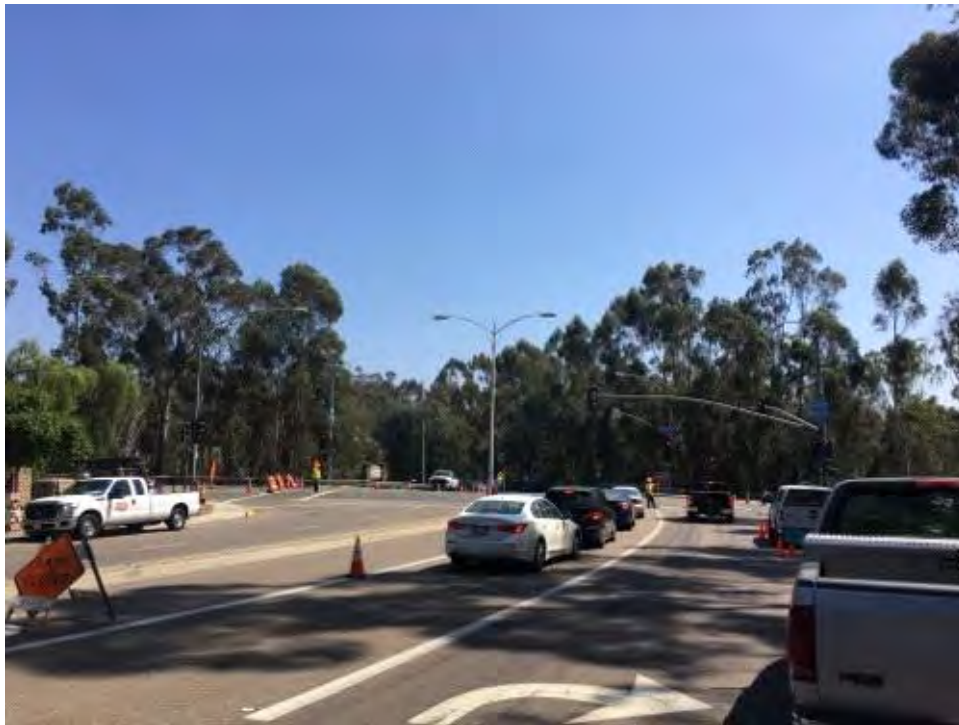
Caption Traffic control at Pomerado Road and Scripps Ranch Blvd.

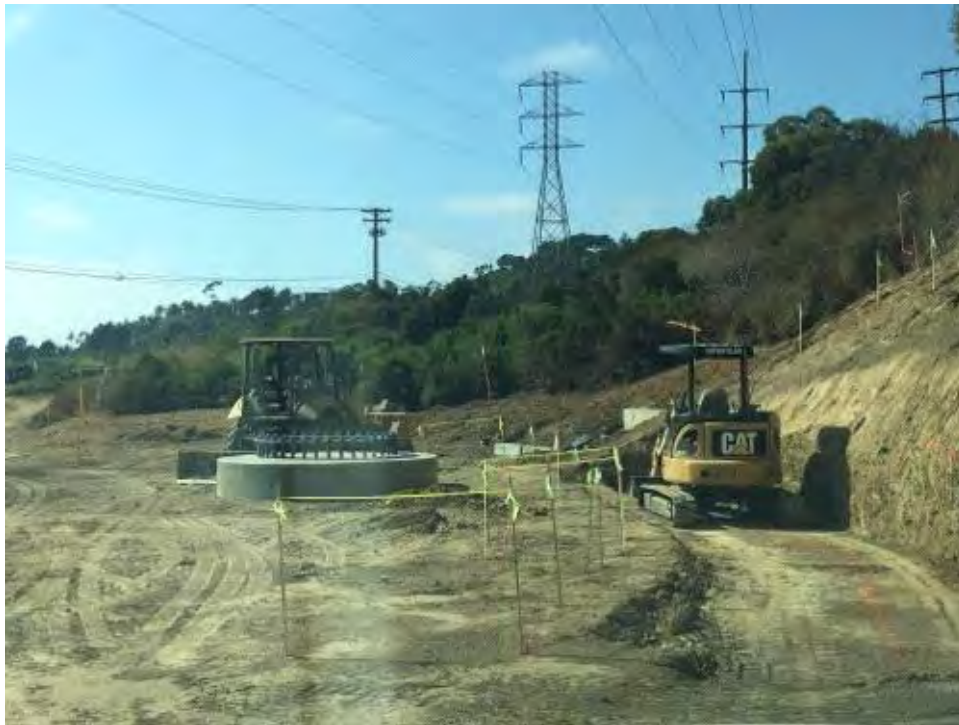
Caption CC MM CP retaining wall grading.

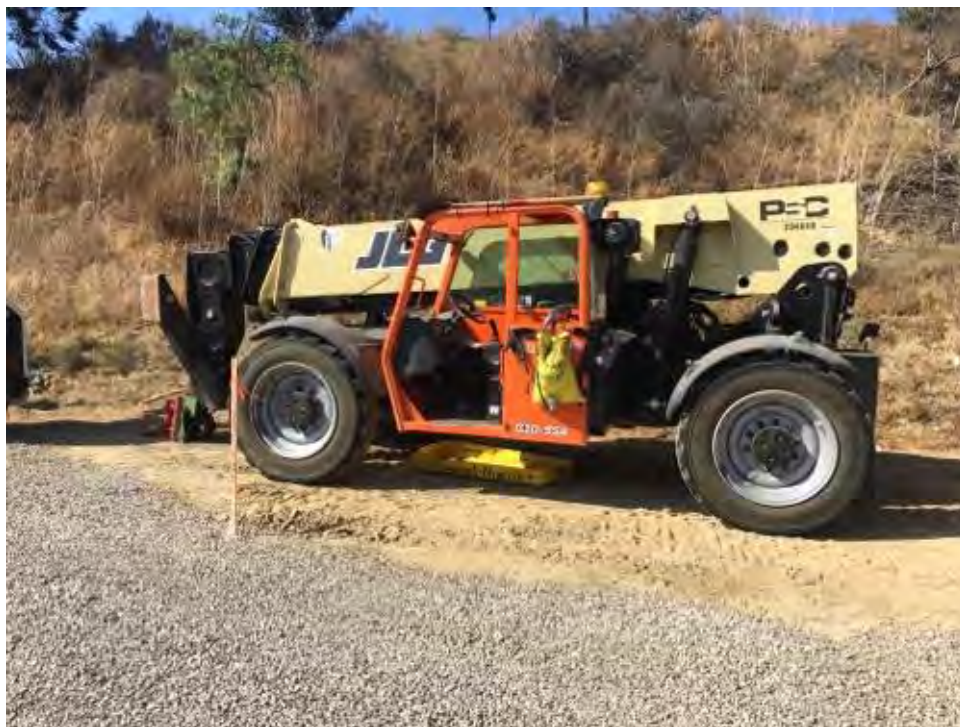
Caption Drip pans properly places beneath equipment.
