PROJECT MEMORANDUM SYCAMORE-PEÑASQUITOS 230-KV TRANSMISSION LINE PROJECT

Date: October 27, 2017
To: Billie Blanchard, CPUC Project Manager
From: Sheila Hoyer, CPUC Monitoring Supervisor
Subject: Weekly Report #42 – October 15 to October 21, 2017

2017-10-16 AM Inspection Report

SDG&E Sycamore-Peñasquitos 230-kV Transmission Line Project: Daily Inspection Report

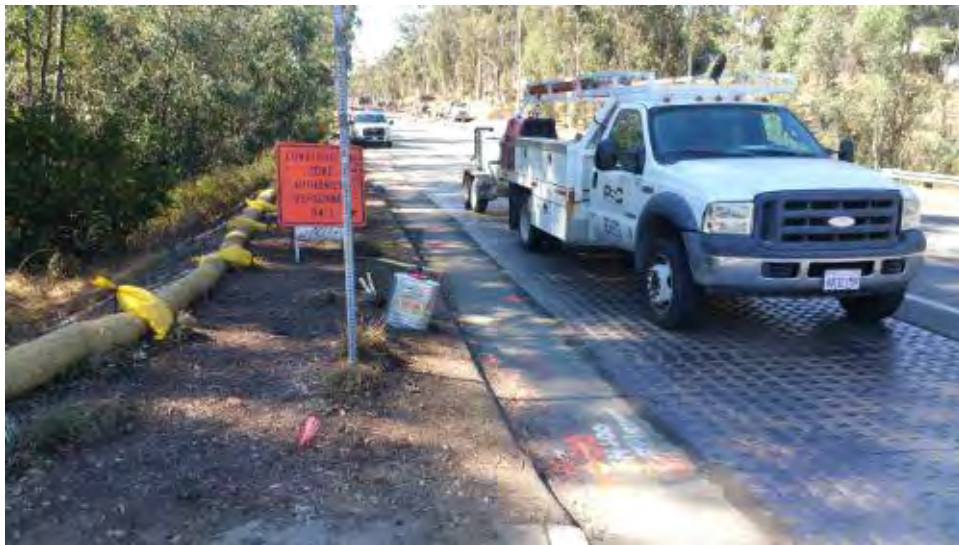
Caption Fire tools accessible, Pomerado Road at Avenida Magnifia.

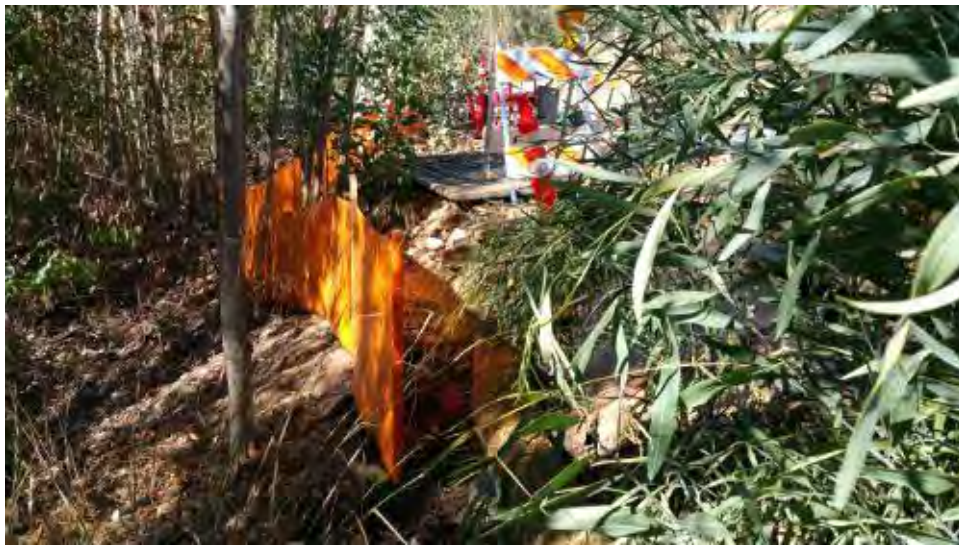
Caption Silt fencing behind straw wattles adjacent to small storage area off Pomerado Road.

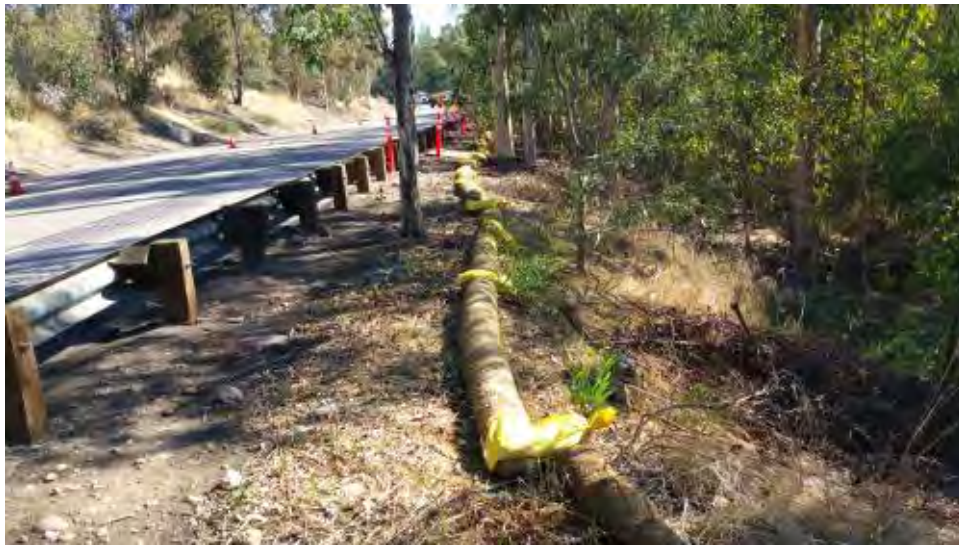
Caption Runoff control wattles off Pomerado Road.

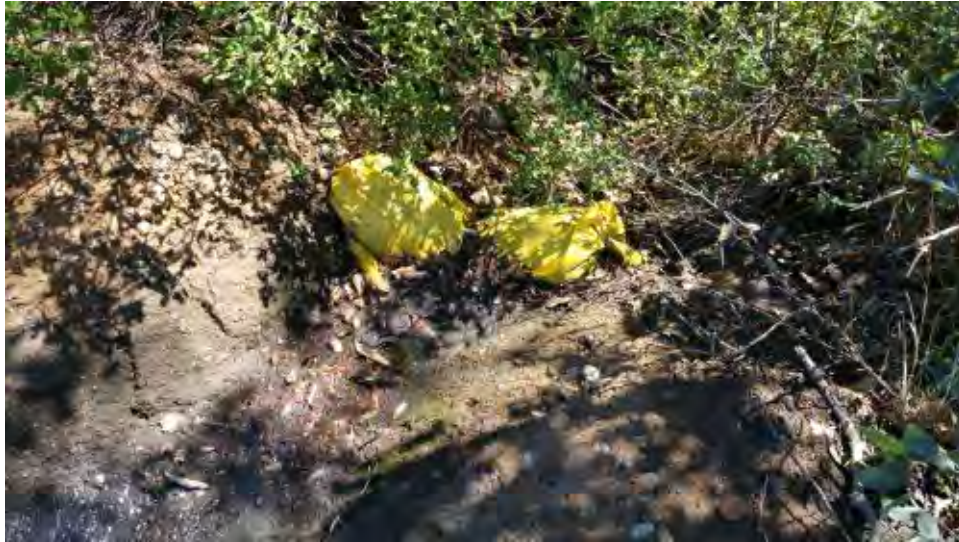
Caption Sediment on top of gravel bags at outfall into 1-foot-wide drainage south side of Pomerado, west of Avenida Magnifica.

maintenance occurred throughout the week. On October 18, 2017, the BMP subcontractor added more sandbags for drainage protection at station 215 + 00 per CPUC monitor recommendations.

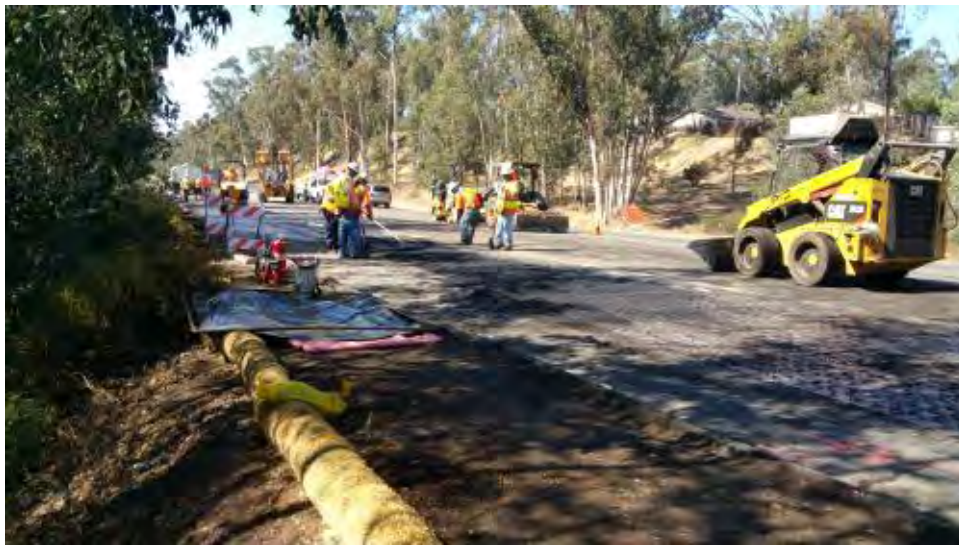
Caption Fire safety tools on hand, Pomerado Road and Avenida Magnifica.

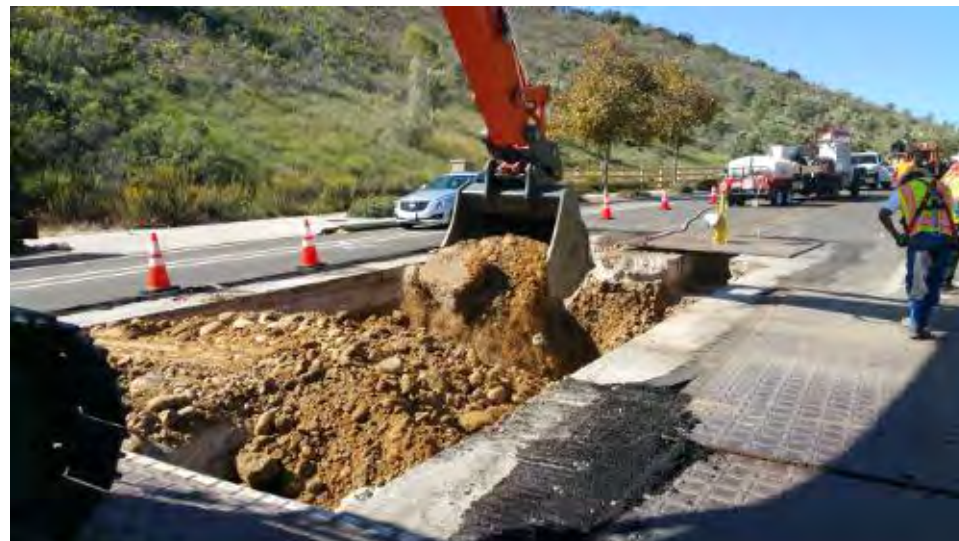
Caption Excavating on Stonebridge Pkwy at Rose Garden. No monitors present; they are spot-checking different locations.

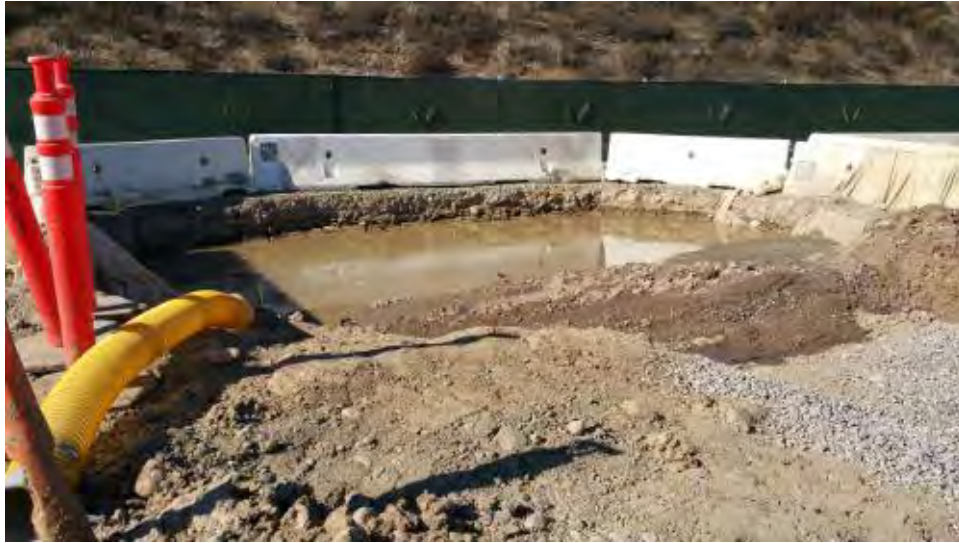
Caption Detention basin for street sweeper runoff, Stonebridge Yard.

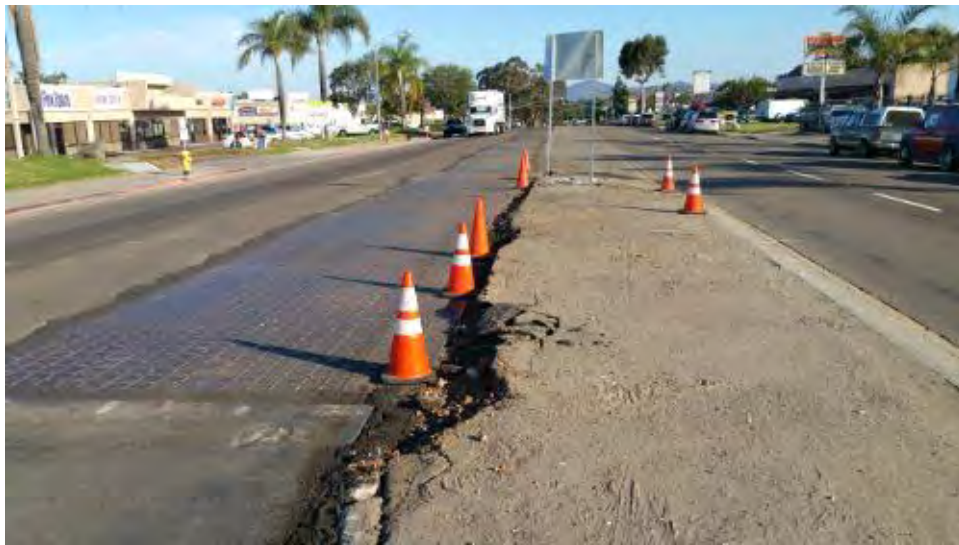
Caption Cones placed next to broken traffic island, Black Mtn. Road.

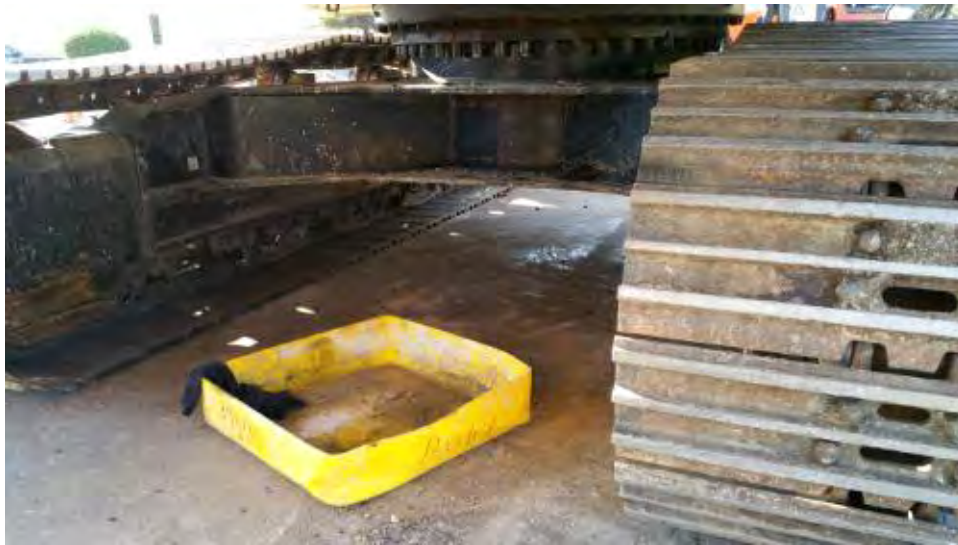
Caption Drip pans are placed beneath equipment, but not actually beneath those that would leak oil, making them ineffective. Padgett Road storage area. No leaks present.

Q9 Notes	Drip pans were not under actual source of drips (visible hoses) for two excavators in Padgett Road storage area. EI (Tim) was informed of issue via text. No drips observed.
Q10 – Fire Management: (a) Were fire prevention procedures in place? (b) Was firefighting equipment available on site?	Met Requirements
Q10 Notes	Fire tools evident throughout site. Soil adjacent to work areas was moistened.
Q11 – Cultural, Paleontological, and Tribal Resources: (a) Were cultural, paleontological, and tribal resources monitoring and impact avoidance occurring as required? (b) If potential resources or human remains were inadvertently discovered, were response procedures and protocols implemented as required?	Met Requirements
Q11 Notes	All monitors were spot checking excavation sites.
Q12 – Construction Noise: (a) Were noise minimization measures in place, as required? (b) If noise complaints were received, were they documented and addressed, as required?	Met Requirements

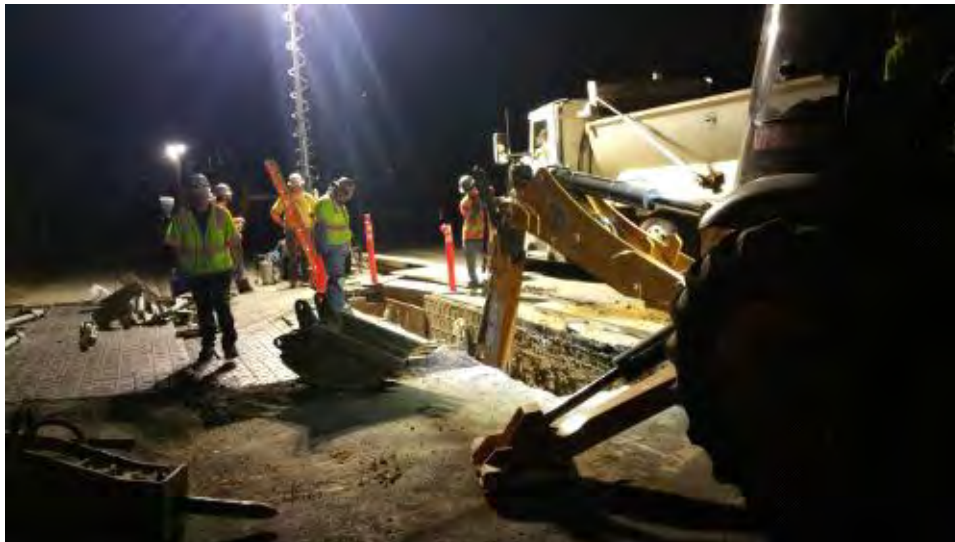
Caption Excavation to repair broken conduit, monitors not present during visit, but foreman reports "they've been in and out".

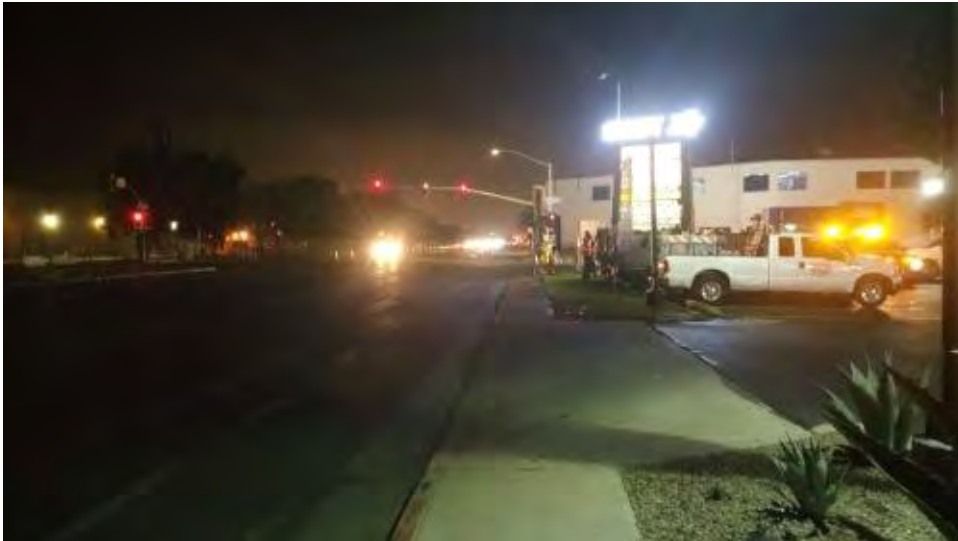
Caption Flashing stop lights only visible traffic control at Black Mtn Road & Miramar. Traffic flows into single right and left lanes; flaggers direct traffic through work area.

Flaggers were present throughout work areas, except at the intersection of Miramar Road and Black Mtn. Road where flashing red lights were operating.

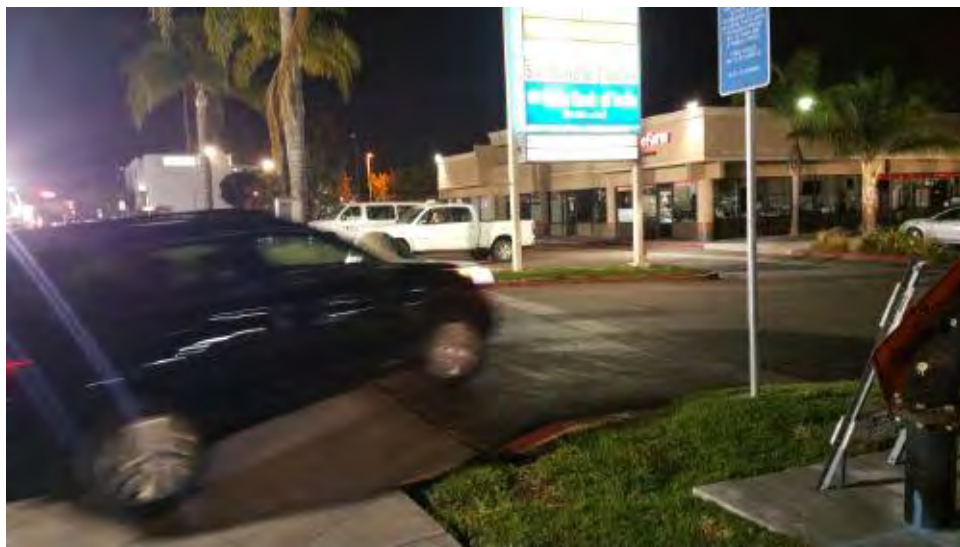
Caption Access to businesses maintained, Black Mtn. Road.

Multiple businesses are present along Black Mtn. Road. Customers were entering and exiting readily.
