PROJECT MEMORANDUM SYCAMORE-PEÑASQUITOS 230-KV TRANSMISSION LINE PROJECT

Date: November 10, 2017
To: Billie Blanchard, CPUC Project Manager
From: Sheila Hoyer, CPUC Monitoring Supervisor
Subject: Weekly Report #44 – October 29 to November 4, 2017

SDG&E Sycamore-Peñasquitos 230-kV Transmission Line Project: Daily Inspection Report

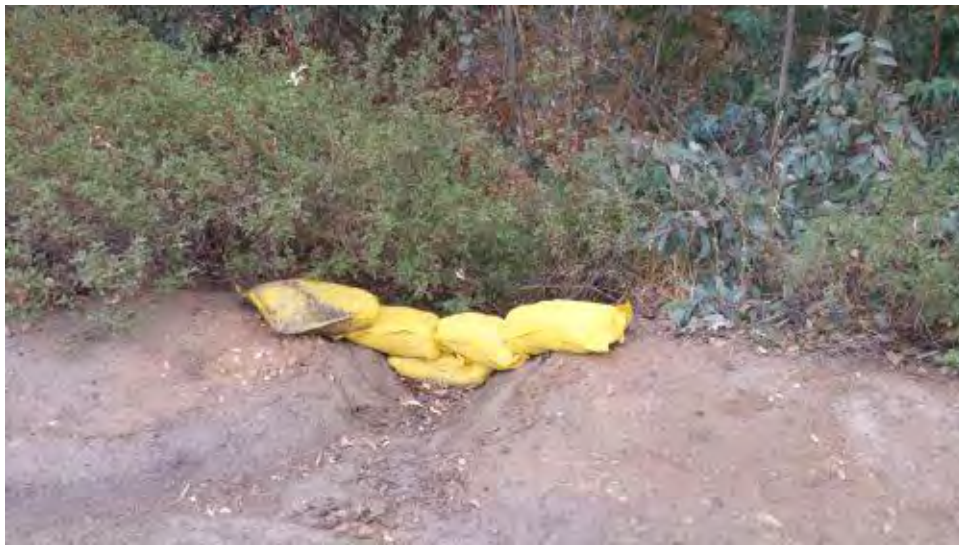
Caption Gravel bag BMP enhanced and fully functional on Pomerado Road east of Avenida Magnifica. (Noted in previous report).

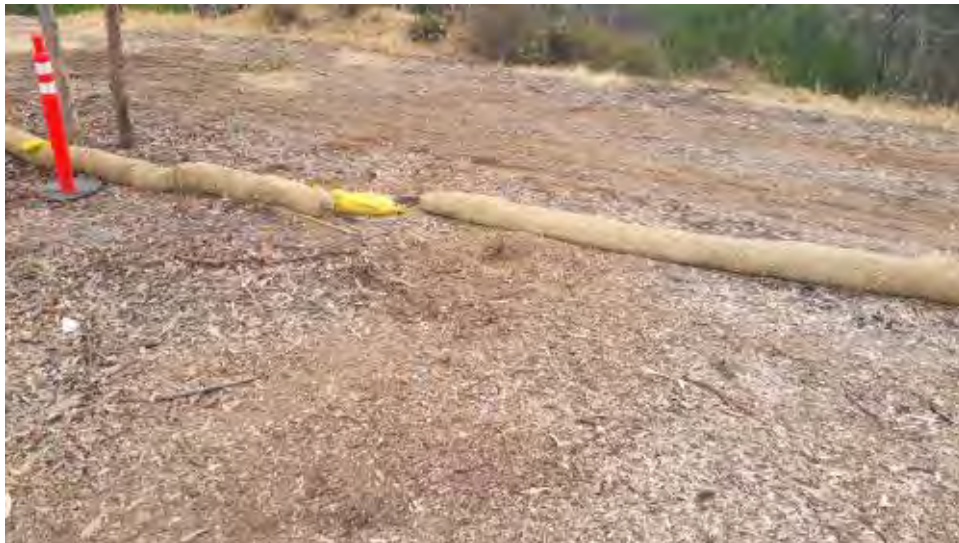
Caption Improper placement of erosion control BMPs on Pomerado Road east of Avenida Magnifica.

staging yards, had drip pans or absorbent pads in place to capture oil drips/leaks. On November 1, 2017 the CPUC monitor notified the LEI regarding BMP maintenance concerns at multiple locations along Activity Road and Pomerado road. The contractor was notified, and corrective actions were immediately implemented in order to help secure the fiber rolls. The contractor is planning to trench and stake the fiber rolls along Pomerado Road where there is no asphalt curb, in order to prevent potential unauthorized non-stormwater discharges from flowing underneath the fiber rolls.

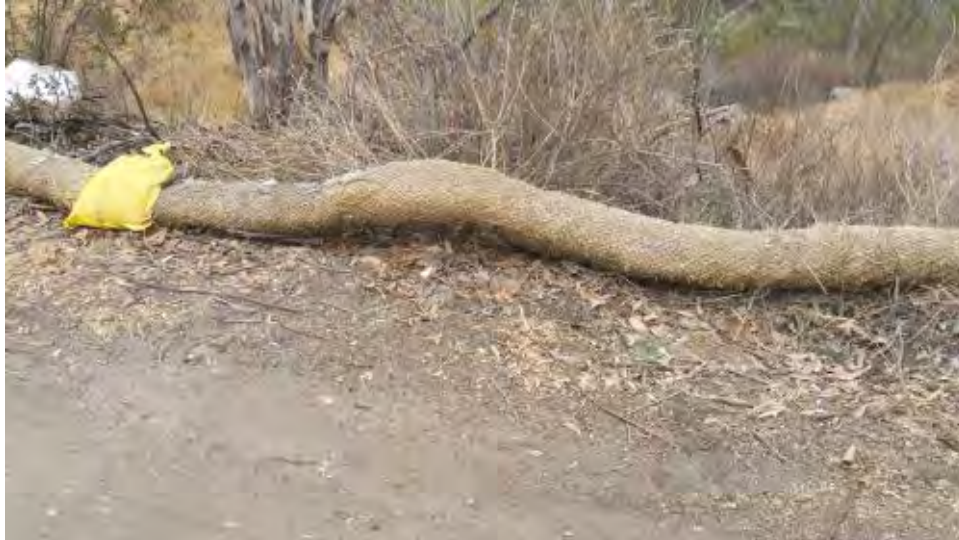
Caption Improper erosion control BMP installation on Pomerado Road.

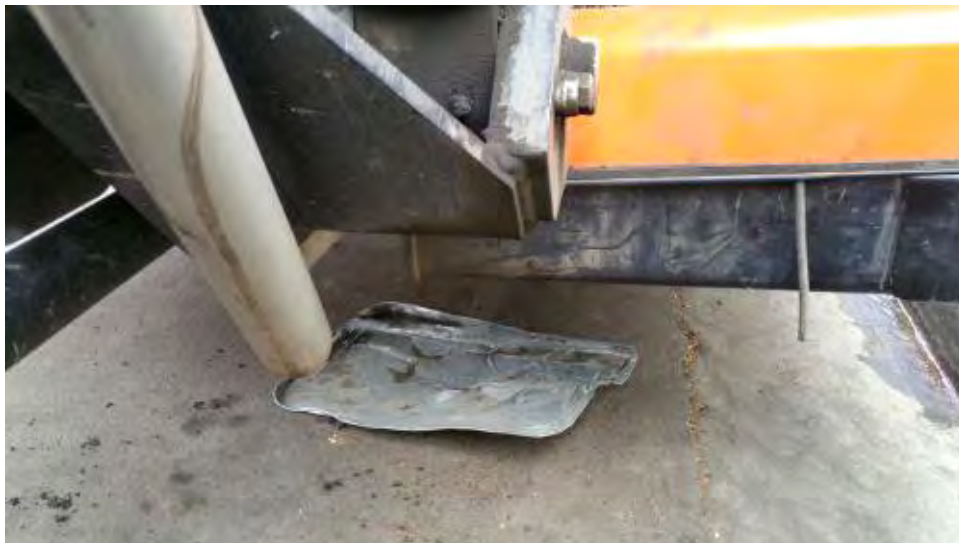
Caption Inadequate/damaged drip protection beneath lift XB4X8Y on Clayton Road.

Q9 – Hazardous Materials and Waste Management: (a) Were hazardous materials stored and labeled properly? (b) Was hazardous material waste disposed of appropriately? (c) Were any spills or leaks addressed adequately? (d) Was solid waste collected and disposed of adequately?	Needs Correction
Q9 Notes	A damaged and ineffective drip pan was observed and crew was approached in addressing the issue. No drips were noted.

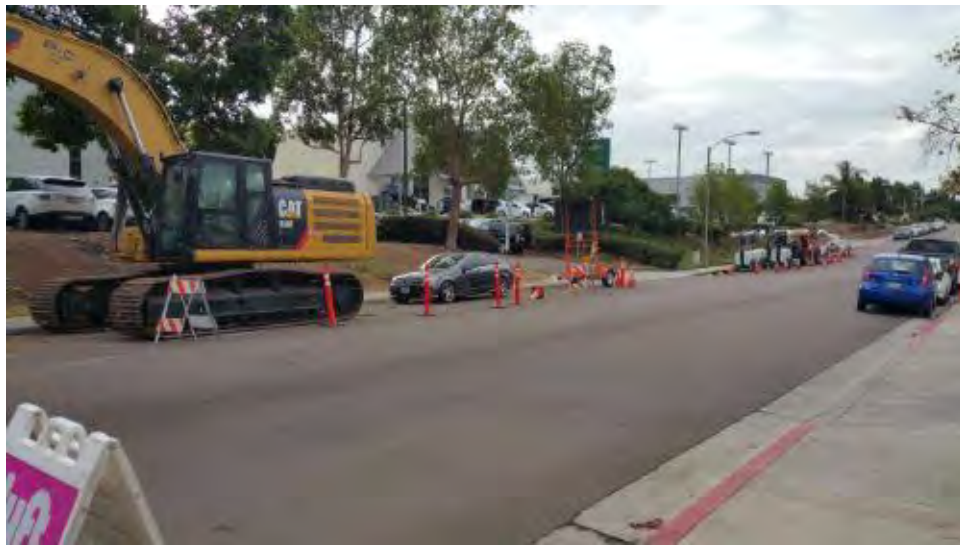
Caption Equipment storage on Clayton has resulted in two drivers parking within coned and signed staging area and three other vehicles (see background) to park in driveway red zones.

Q13 Notes	Staging area on Clayton Rd. has displaced enough parking spots that vehicles were parking illegally, in red zones and in the cone staging area. I mentioned this to EI, who told me these areas are permitted by City.
Q14 – Traffic Control (a) Were flaggers present at all times? (b) Were barriers, cones, and signs in place? (c) Were detours clearly marked?	Met Requirements
Q15 – Helicopter Use (a) Were helicopter use restrictions implemented adequately? (b) Were helicopter take-off and landing sites within prescribed limits?	N/A
Q16 – Worker Training and Communication: Have all workers on site received the required environmental trainings for the project?	Met Requirements
Q17 – MMCRP Implementation: (a) Were project activities consistent with the approved project as defined in the EIR and subsequent CPUC authorizations? (b) Were MMCRP procedures implemented adequately?	Met Requirements

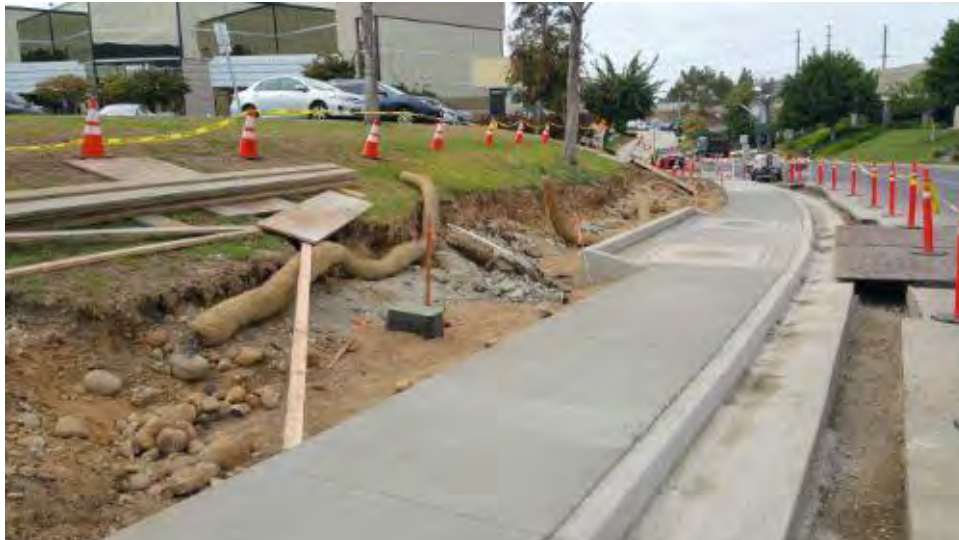
Caption Sidewalk replacement on Activity Rd. Fiber rolls would not work for erosion control; poor site maintenance.

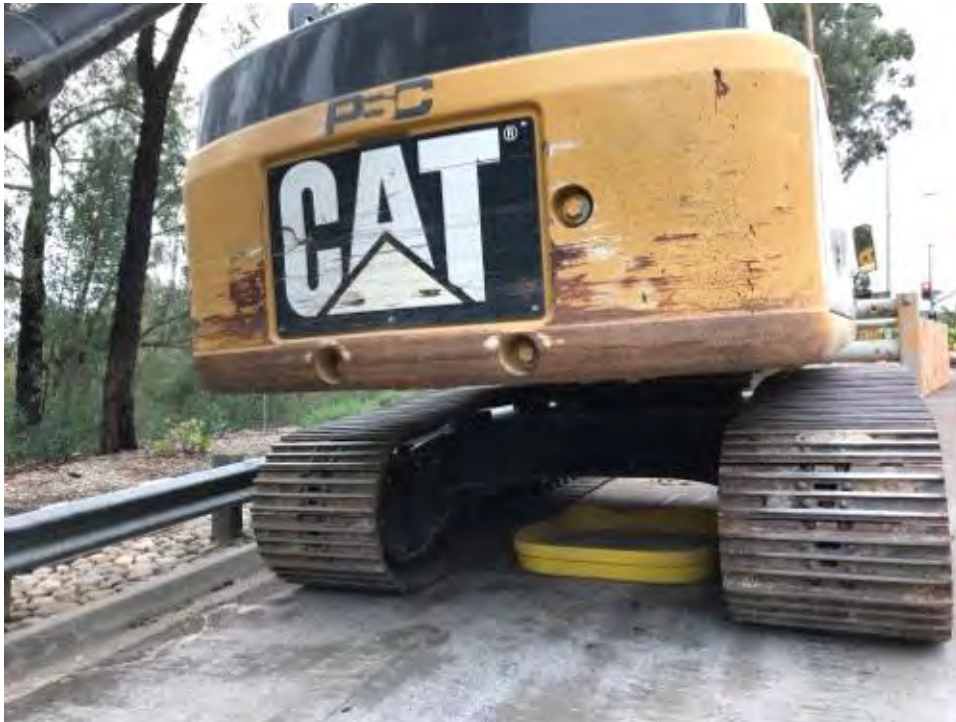
Caption Drip pans located under staged equipment on Semillon Blvd.

Q9 Notes	Drip pans were paced under stored equipment.
Q10 – Fire Management: (a) Were fire prevention procedures in place? (b) Was firefighting equipment available on site?	Met Requirements
Q11 – Cultural, Paleontological, and Tribal Resources: (a) Were cultural, paleontological, and tribal resources monitoring and impact avoidance occurring as required? (b) If potential resources or human remains were inadvertently discovered, were response procedures and protocols implemented as required?	Met Requirements
Q12 – Construction Noise: (a) Were noise minimization measures in place, as required? (b) If noise complaints were received, were they documented and addressed, as required?	Met Requirements
Q13 – Maintain Access: (a) Was access to driveways (e.g., businesses, schools, residences) maintained as required? (b) Was access to recreational areas maintained and appropriate signage installed? (c) Was pedestrian and bicycle access maintained, or were detours clearly defined?	Met Requirements

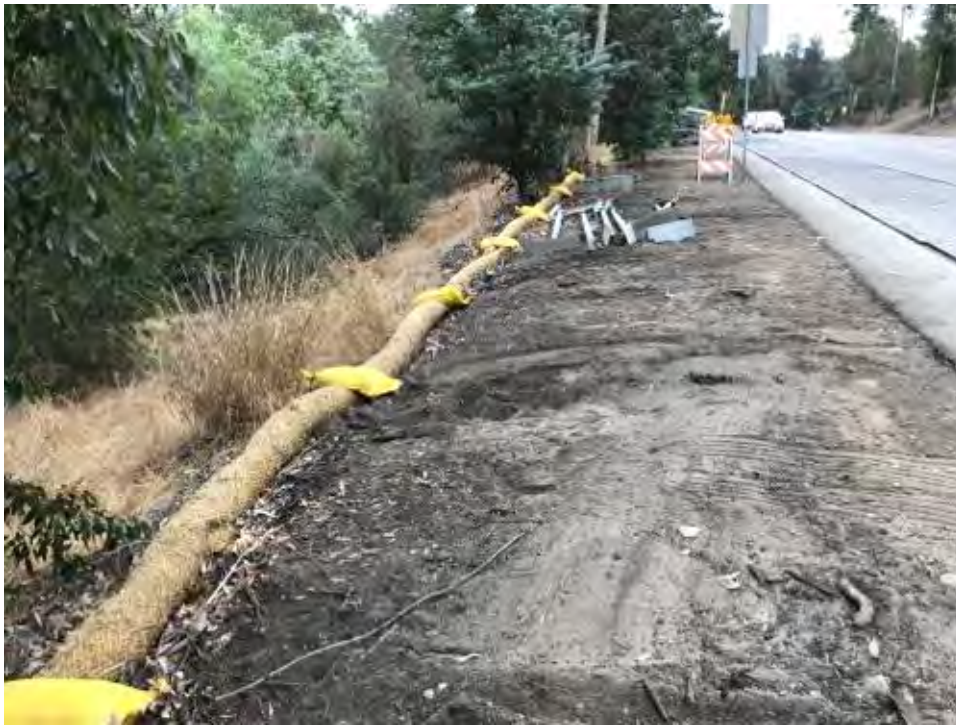
Caption BMPs improperly installed at section 551+00 along disturbed area on Pomerado Road east of Fairbrook Road.

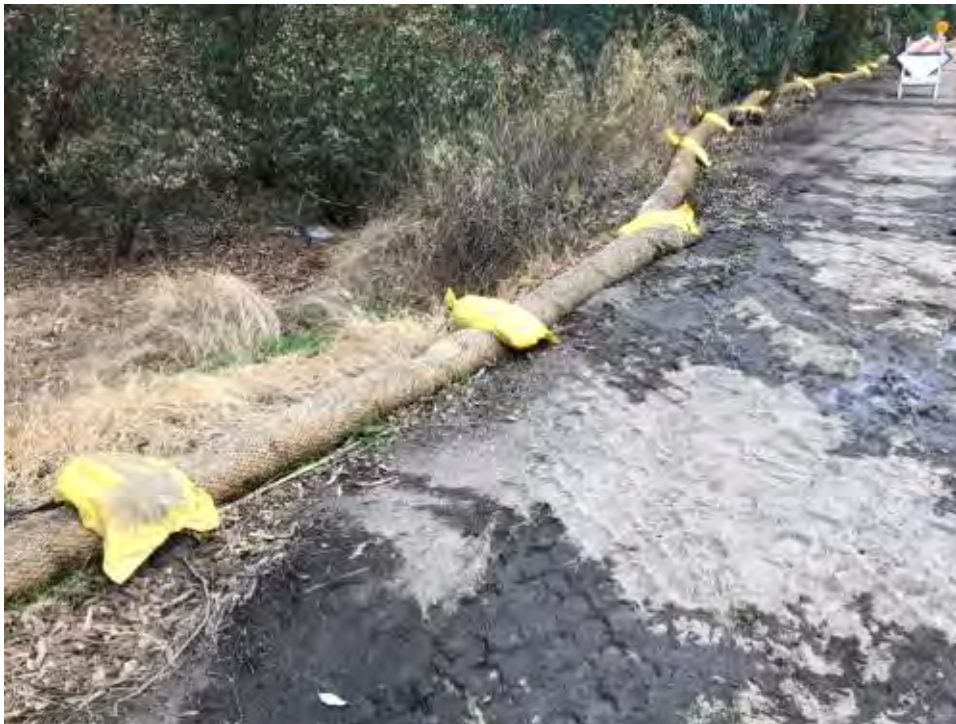
Caption BMPs improperly installed all along disturbed area at section 535+50 along Pomerado Road.

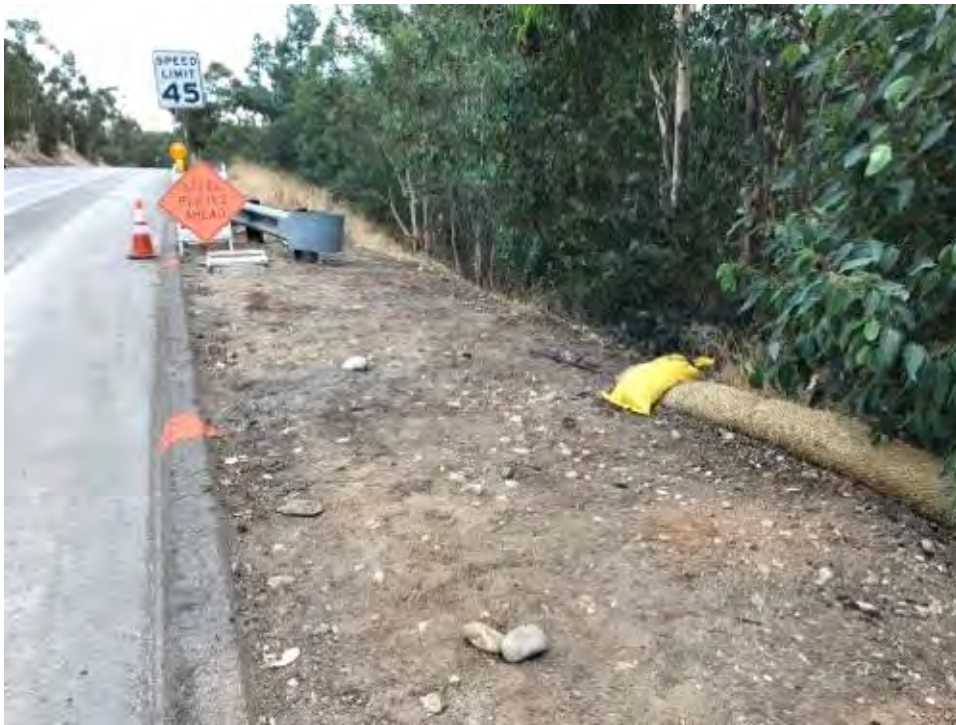
Caption BMPs missing at section 517 + 50 on Pomerado Road east of Avenida Magnifica.

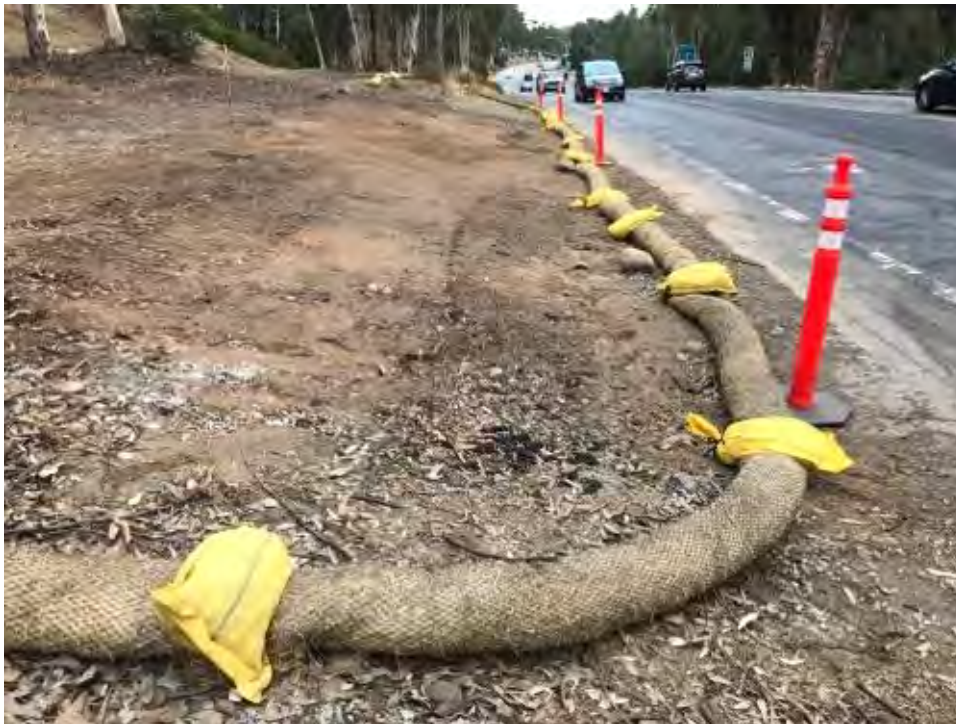
Caption BMPs at section 507+25 on Pomerado Road are improperly installed.

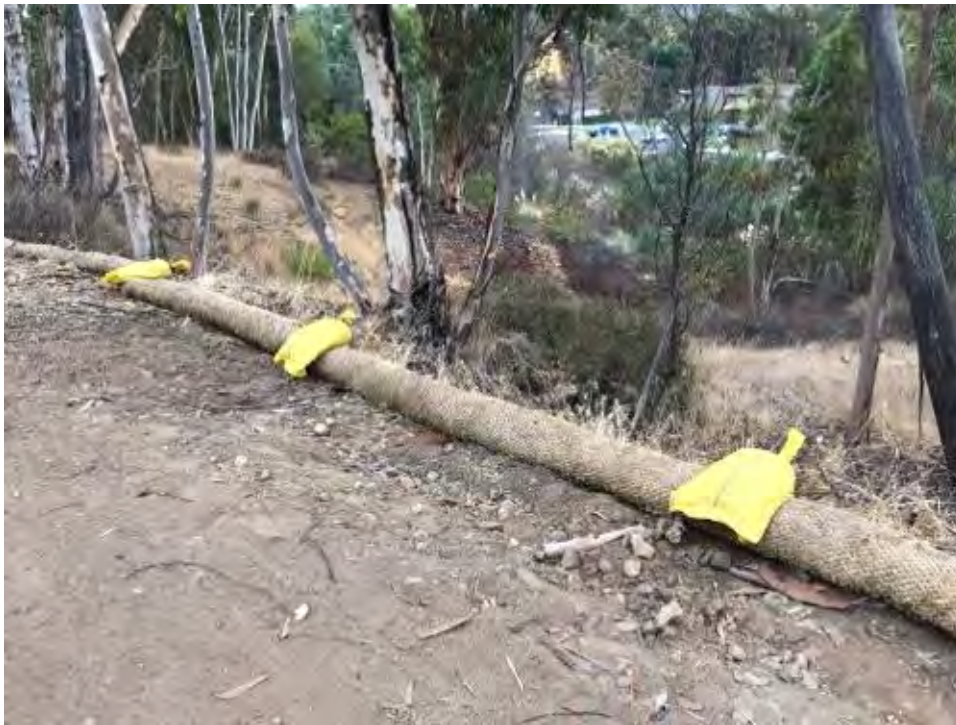
Caption BMPs at section 485+25 on Pomerado Road improperly installed Will not protect drainage basin.

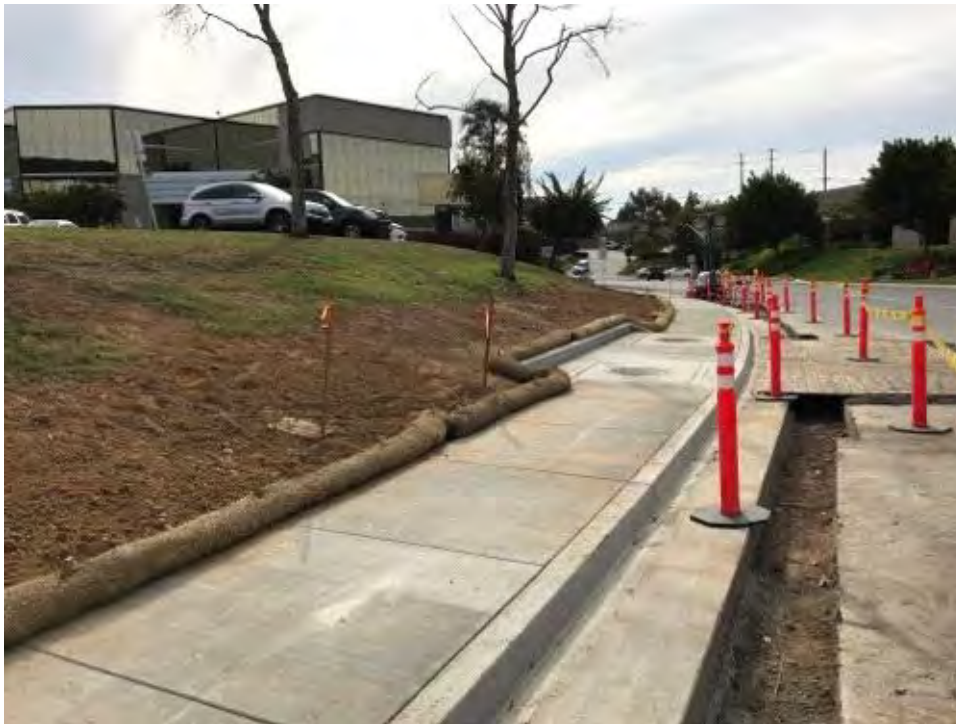
Caption BMPs still need to be trenched in place on Activity Road.
